JOINT-USER COMPLEX AND JOINT-USER GENERAL OFFICE BUILDING  
AT AREA 29, KWU TUNG NORTH

# **Landscape Impact Assessment**

## **Section 16 Planning Application for Joint-user Complex and Joint-user General Office Building at Area 29, Kwu Tung North**

Urban Design & Planning Consultants Limited  
(UDP International)

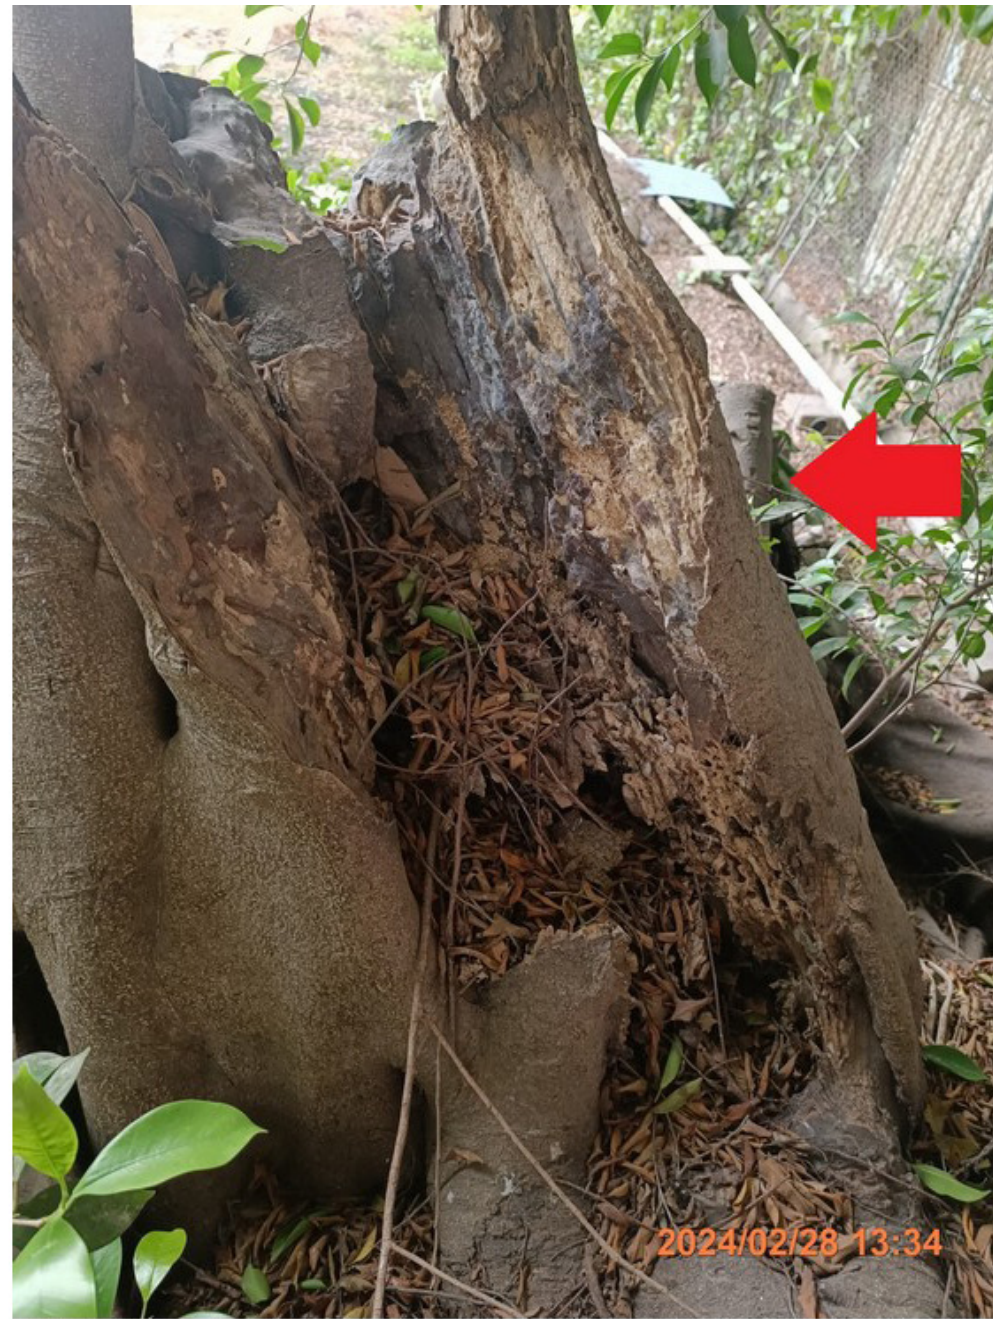
T064\_Ficus\_microcarpa (6)\_Fell\_ Removed primary limb with decayed wound

“The tree exhibits significant decay, with two primary limbs previously removed, leaving stumps that are now severely decayed and likely to impact the trunk base in the future. The TPI is in poor condition with multiple structural defects, and the anticipated survival and recovery after transplantation is low. Should transplanting be carried out, the tree would require substantial root pruning to form a reasonable sized root ball. Additionally, the presence of the existing U-channel and fence footings restricts root growth on the west side, impeding the formation of a balanced root ball. Extensive crown pruning would be necessary for transplantation, which would result the loss of the tree's natural form and further compromise the tree's structure and stability. In view of the tree's maturity and very large size, the tree has low resilience to transplanting shock and the anticipated survival rate after transplanting is low. As such, T064 is not recommended to be transplanted.”

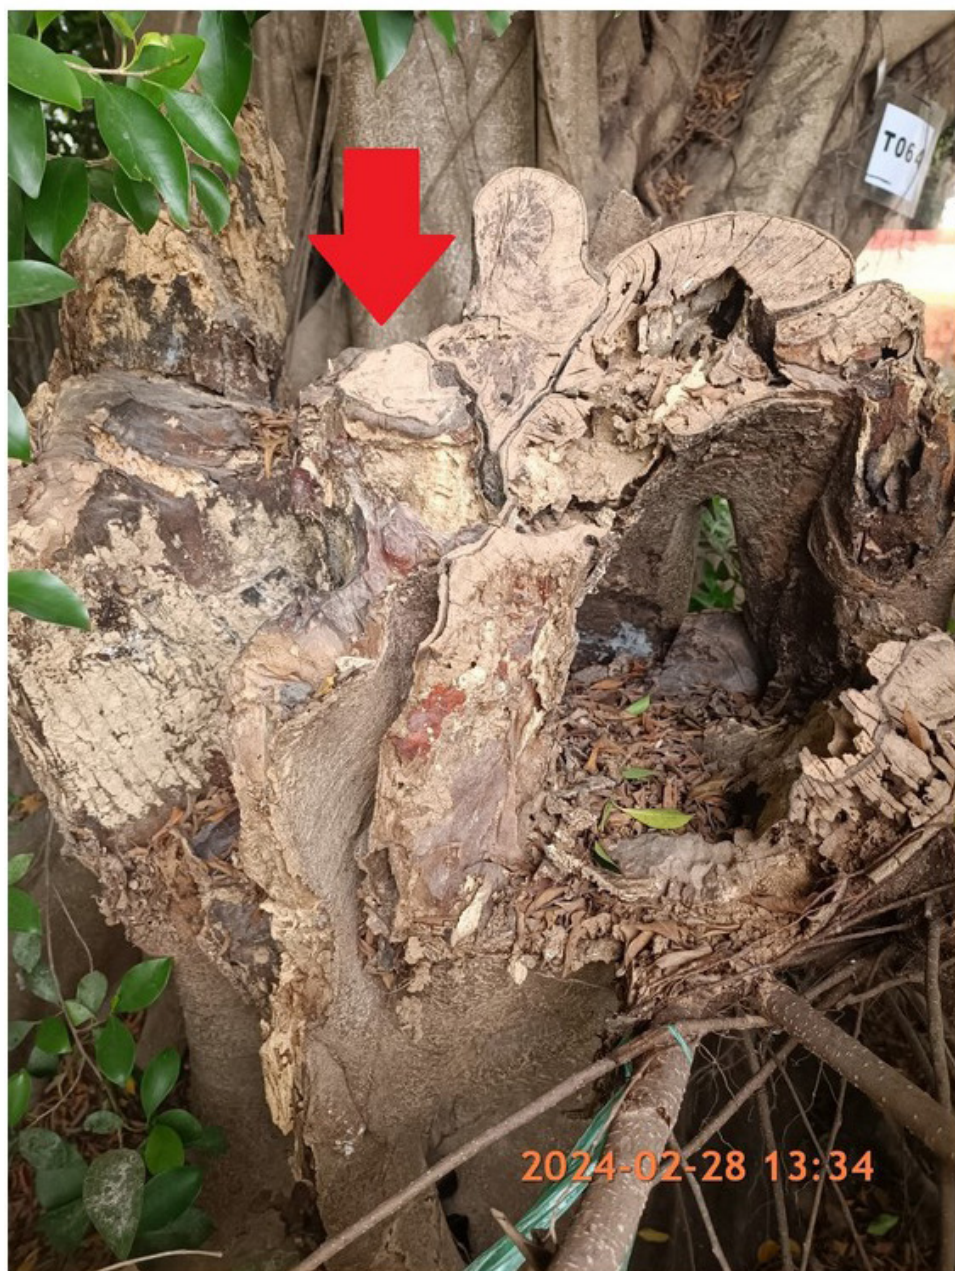
T064\_Ficus\_microcarpa (7)\_Fell\_ Removed primary limb with decayed wound

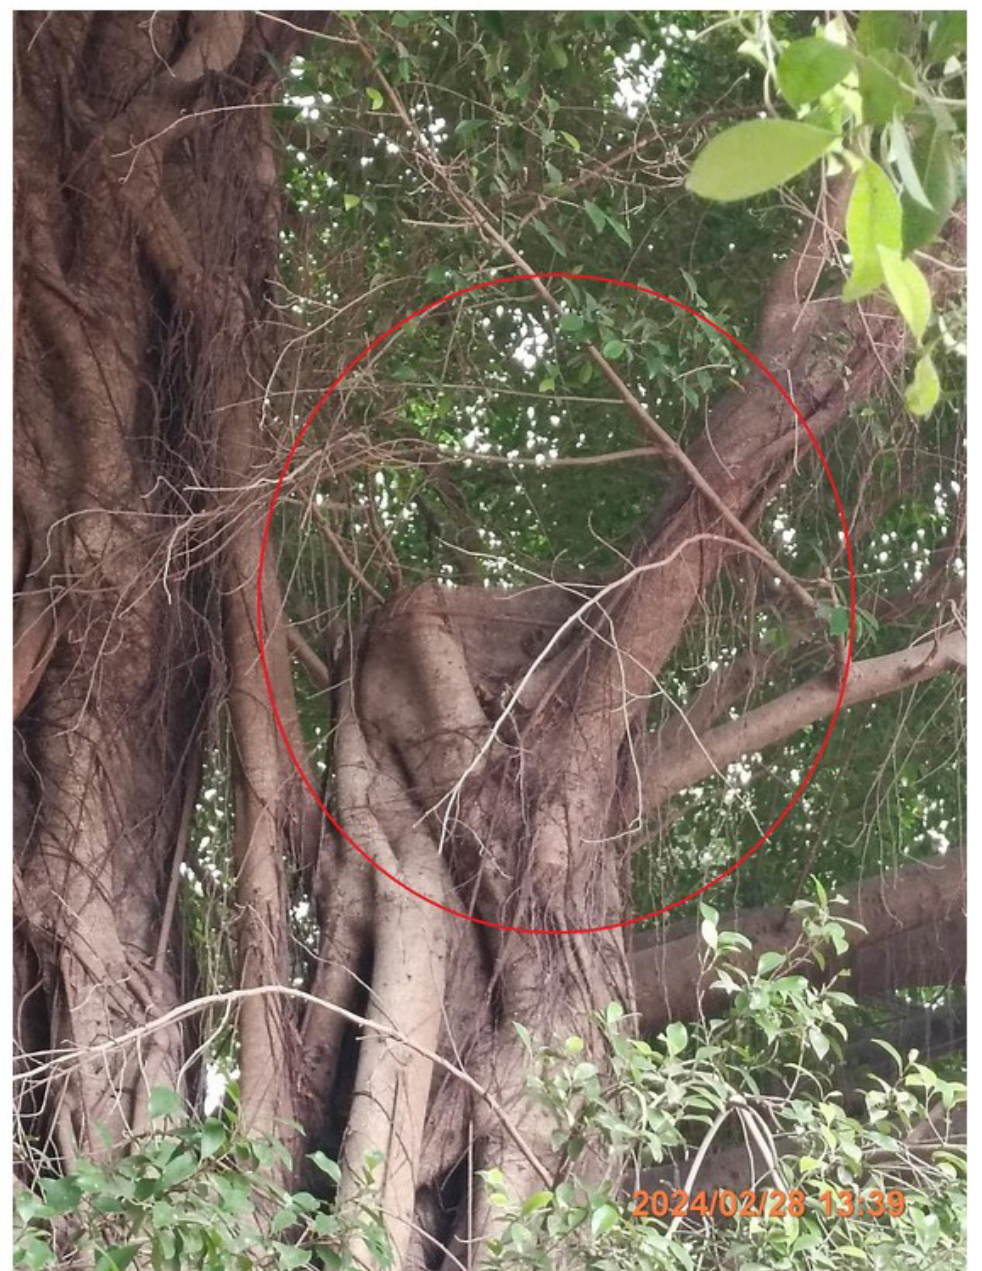
T064\_Ficus\_microcarpa (8)\_Fell\_ Dead branches

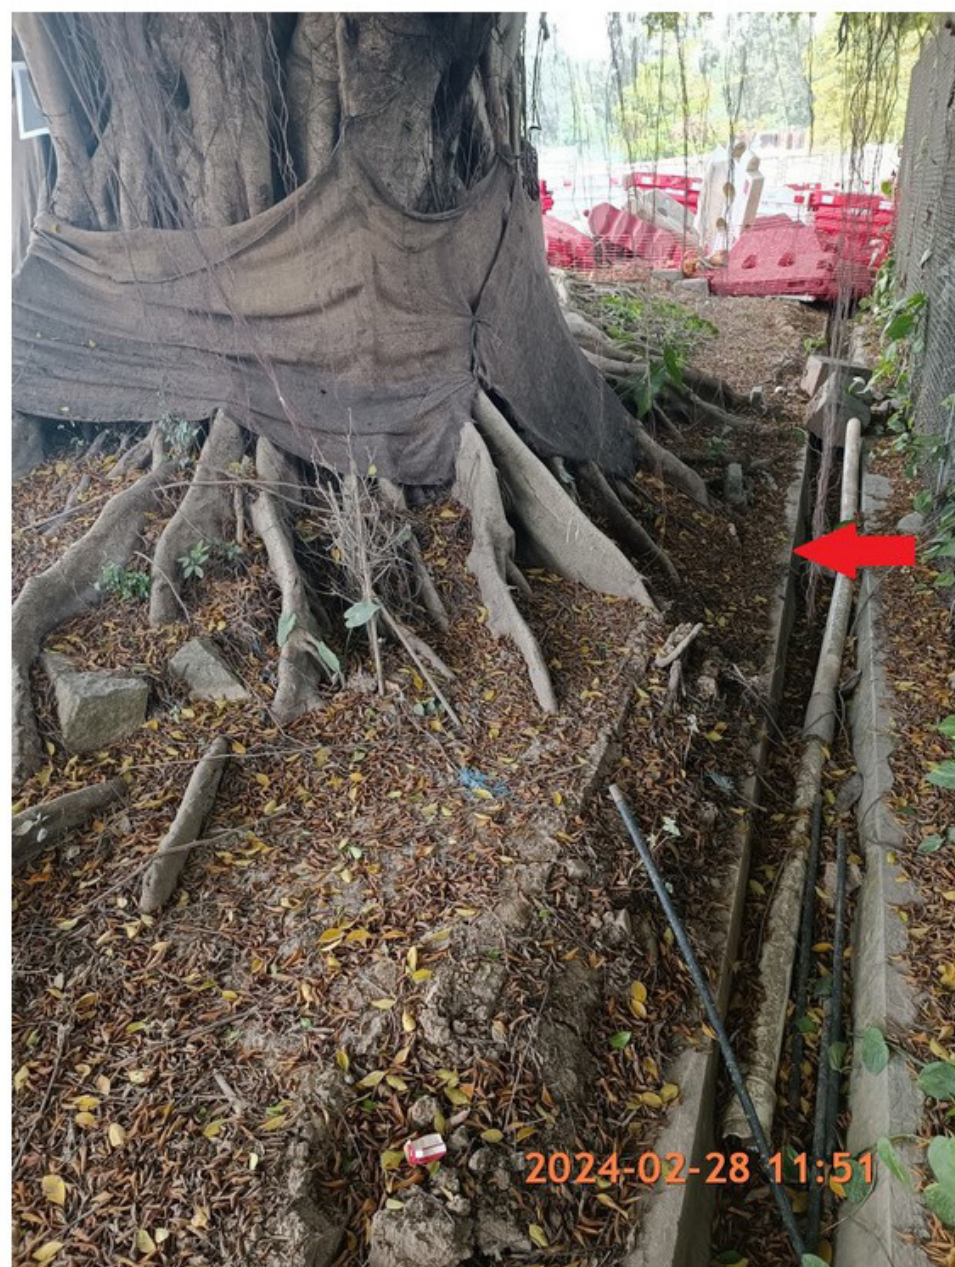
T069\_Ficus\_microcarpa (5)\_Fell\_Restricted Root

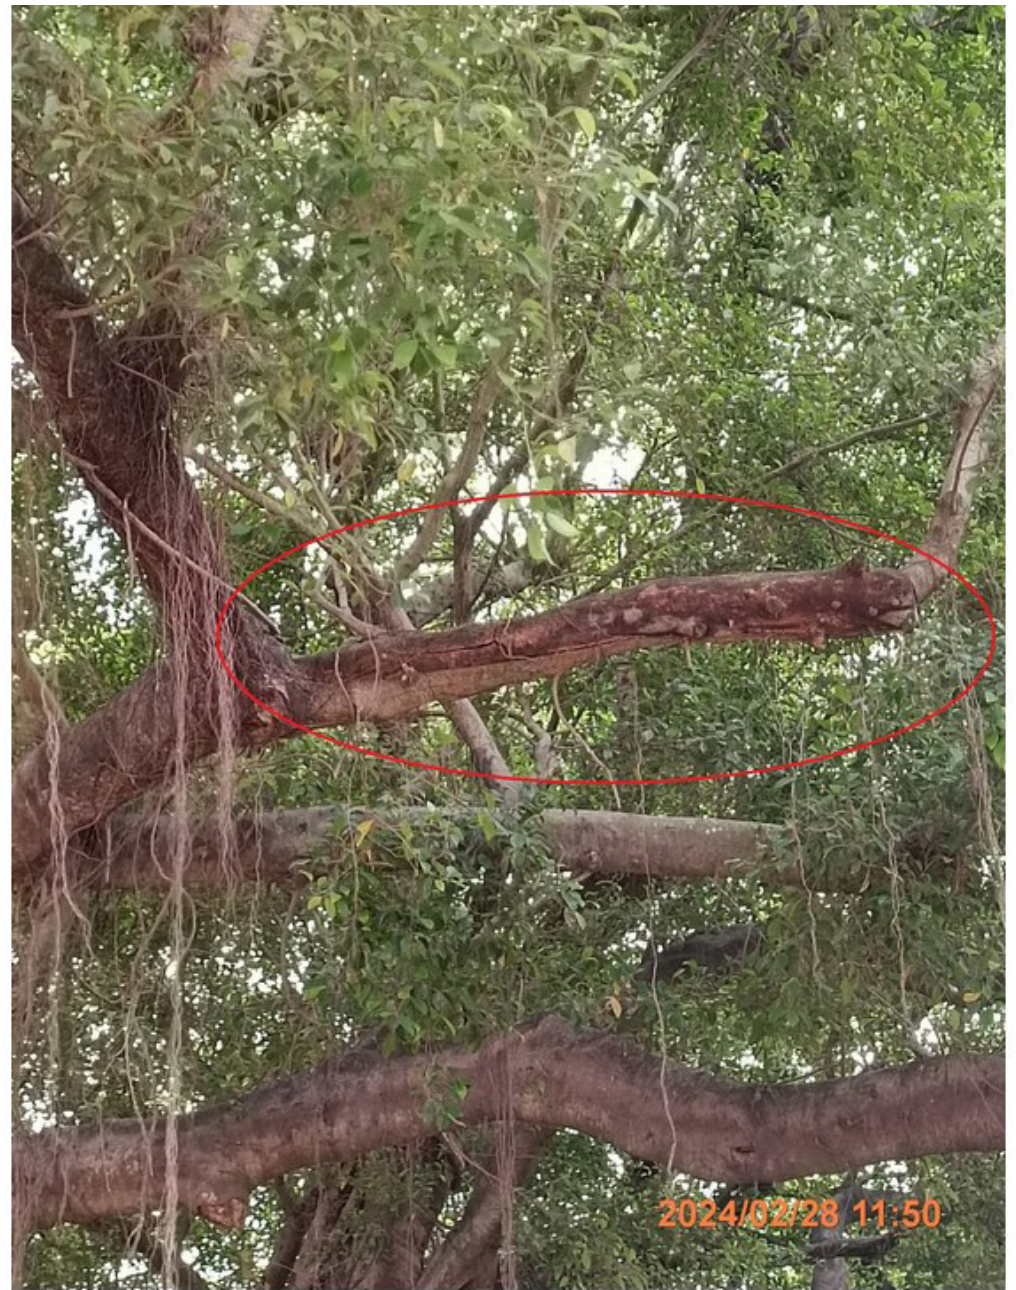
T069\_Ficus\_microcarpa (7)\_Fell\_Exposed deadwood on branch

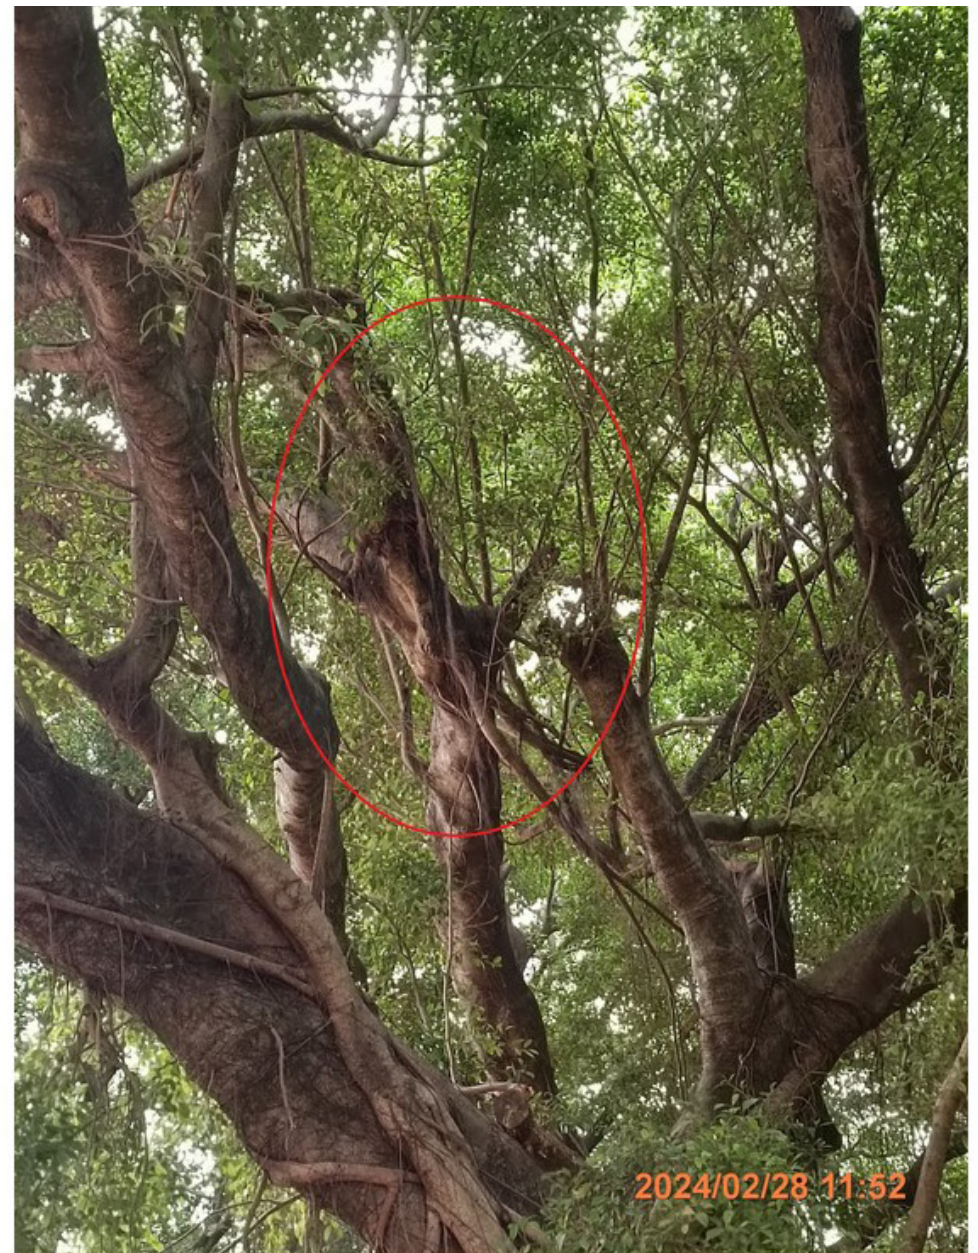
T069\_Ficus\_microcarpa (9)\_Fell\_Epicormics

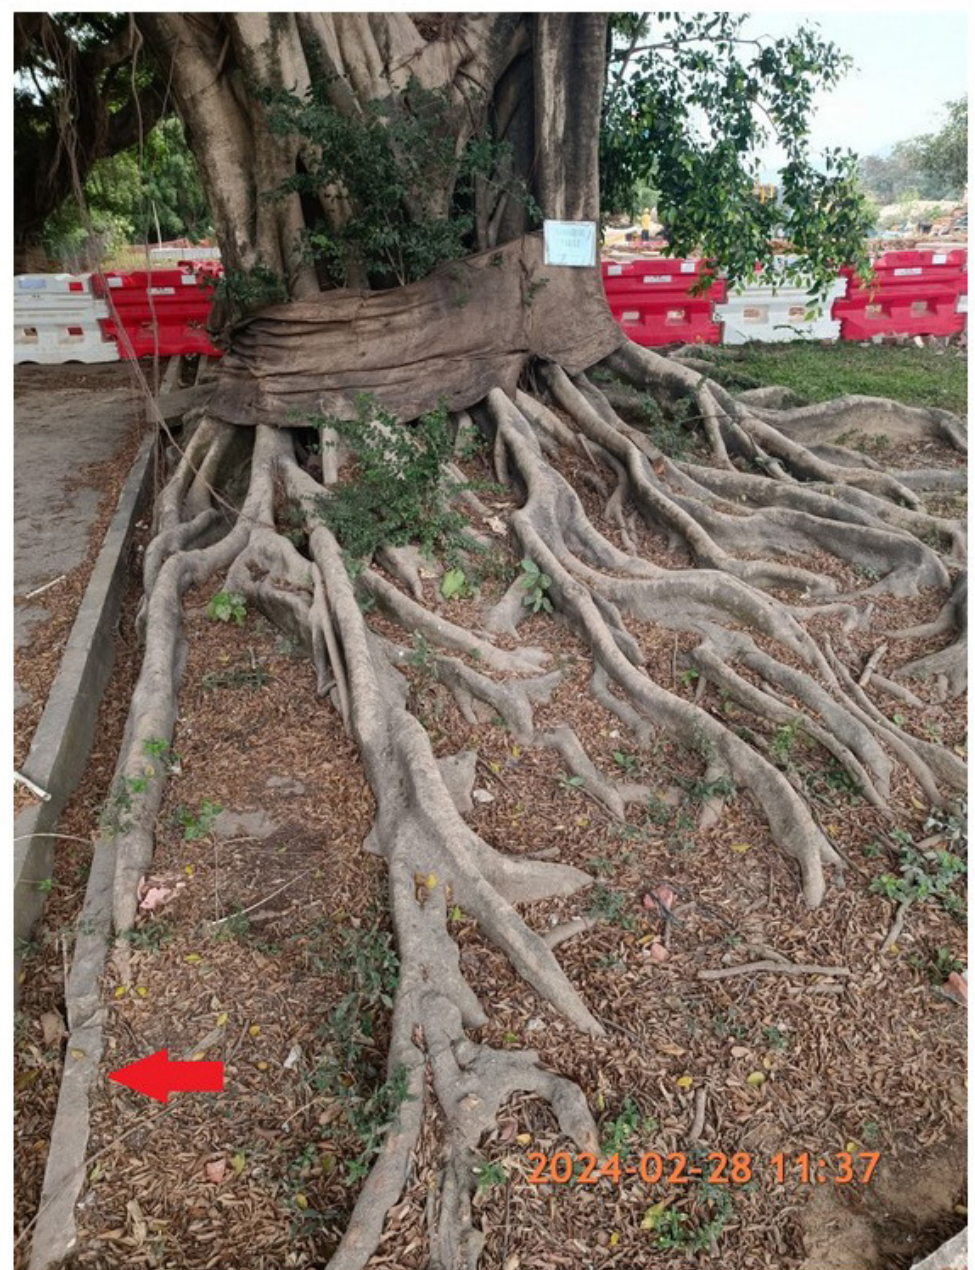
T070\_Ficus\_microcarpa (4)\_Fell\_Restricted root

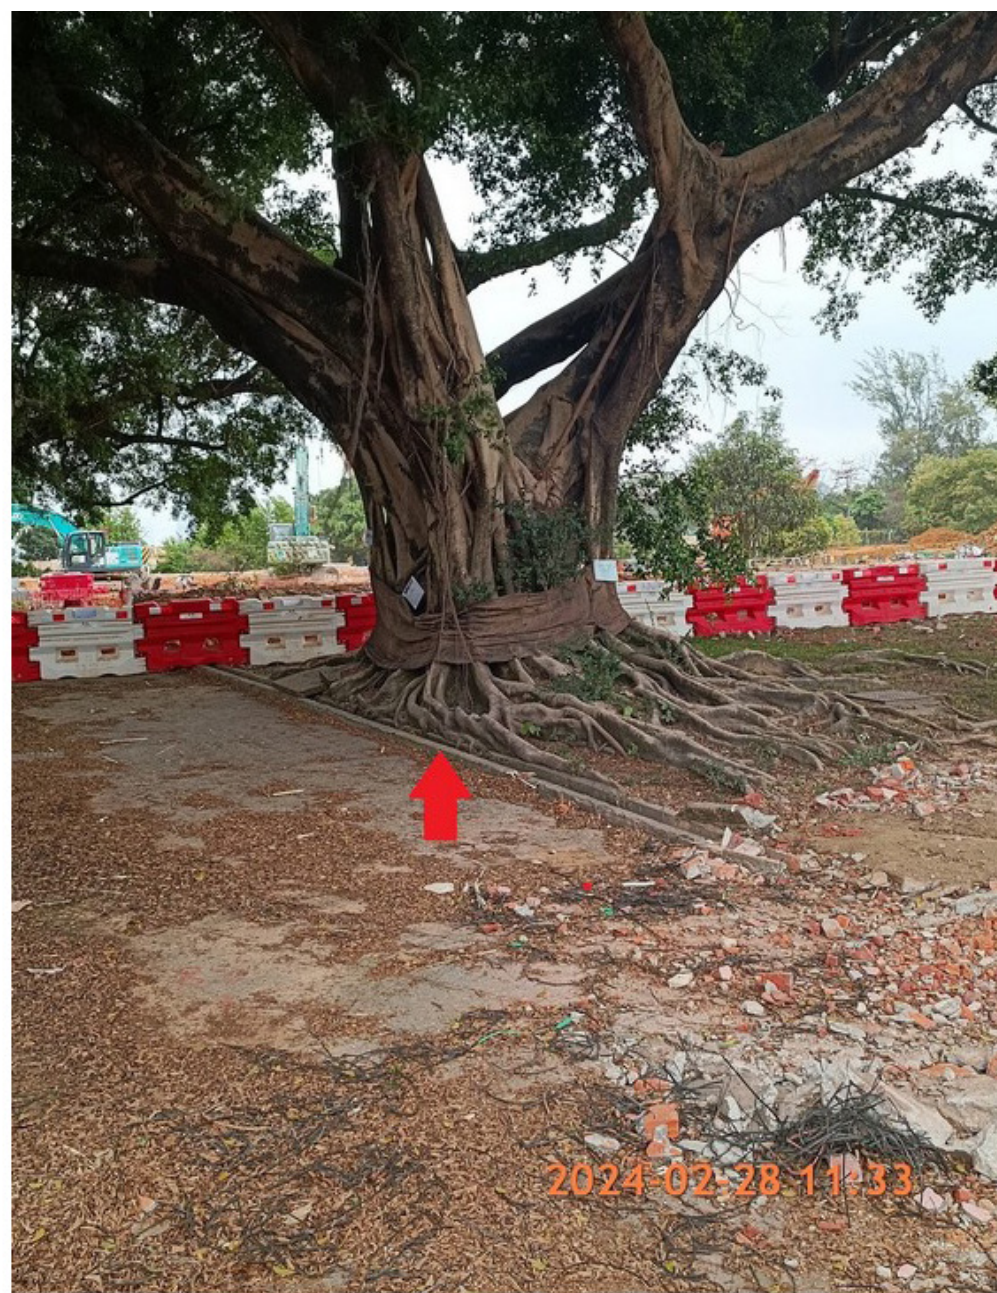
T070\_Ficus\_microcarpa (6)\_Fell\_Restricted root

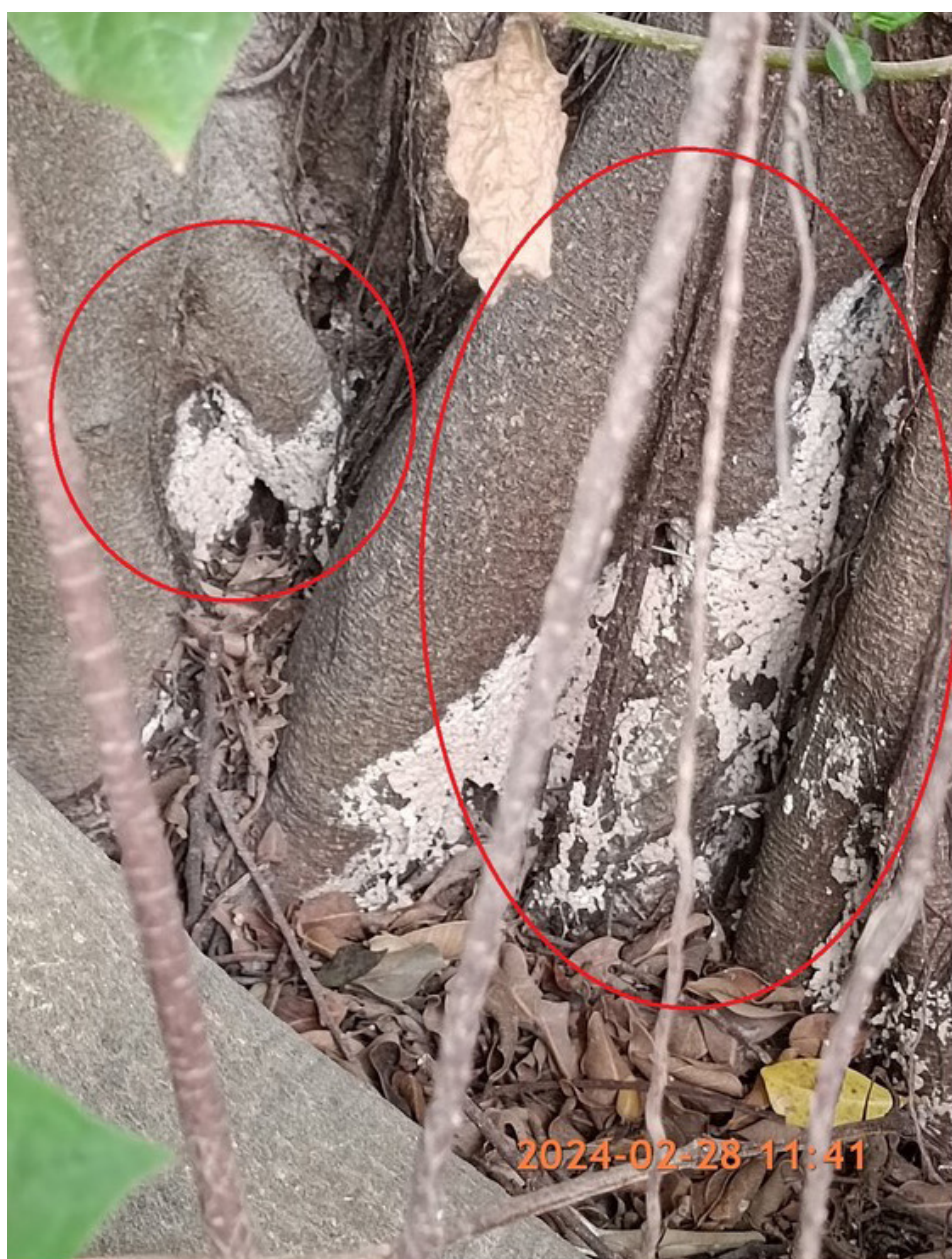
T070\_Ficus\_microcarpa (7)\_Fell\_Fungal infection at trunk base

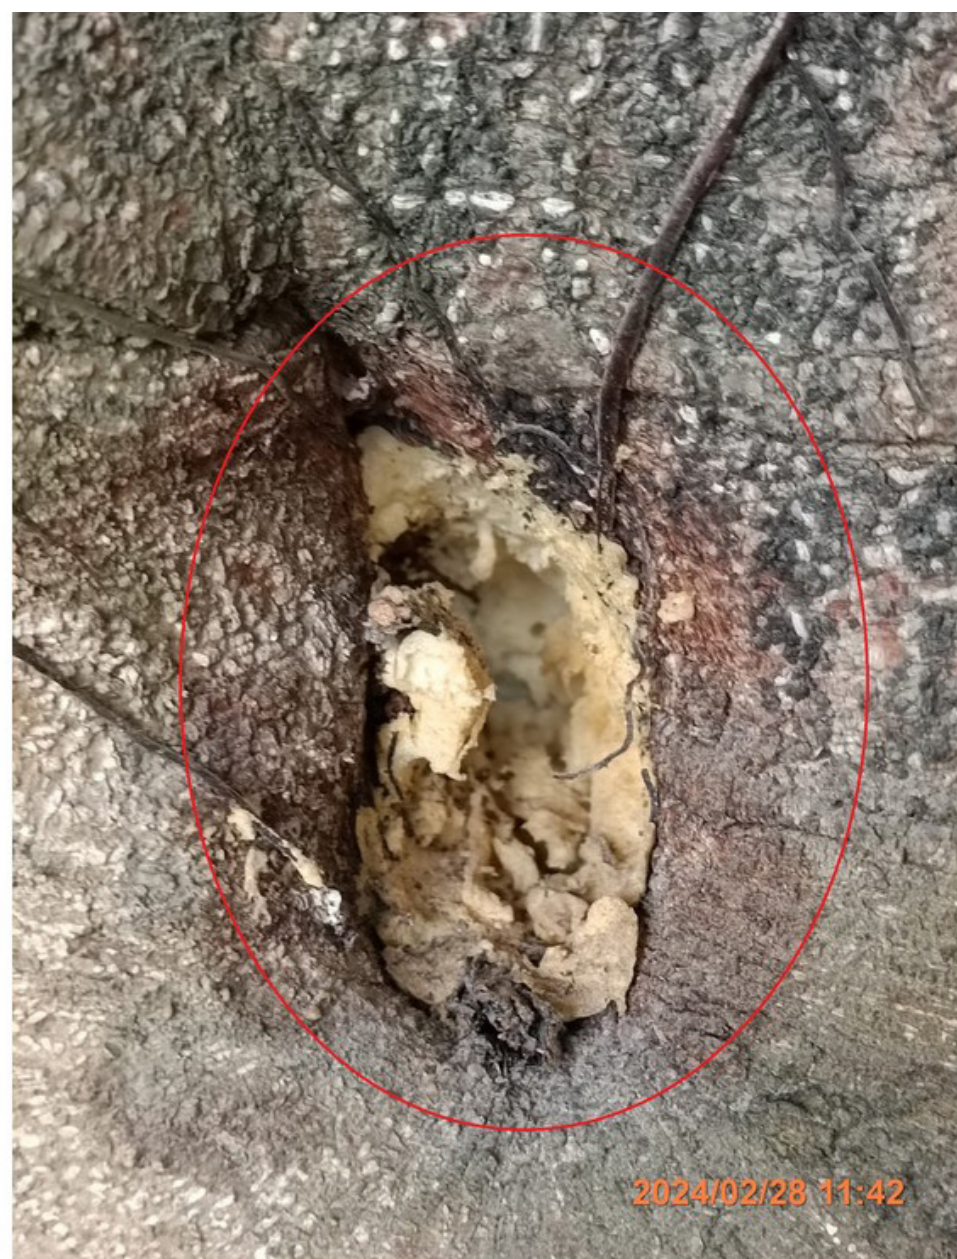
T070\_Ficus\_microcarpa (8)\_Fell\_Wounded area filled with foam

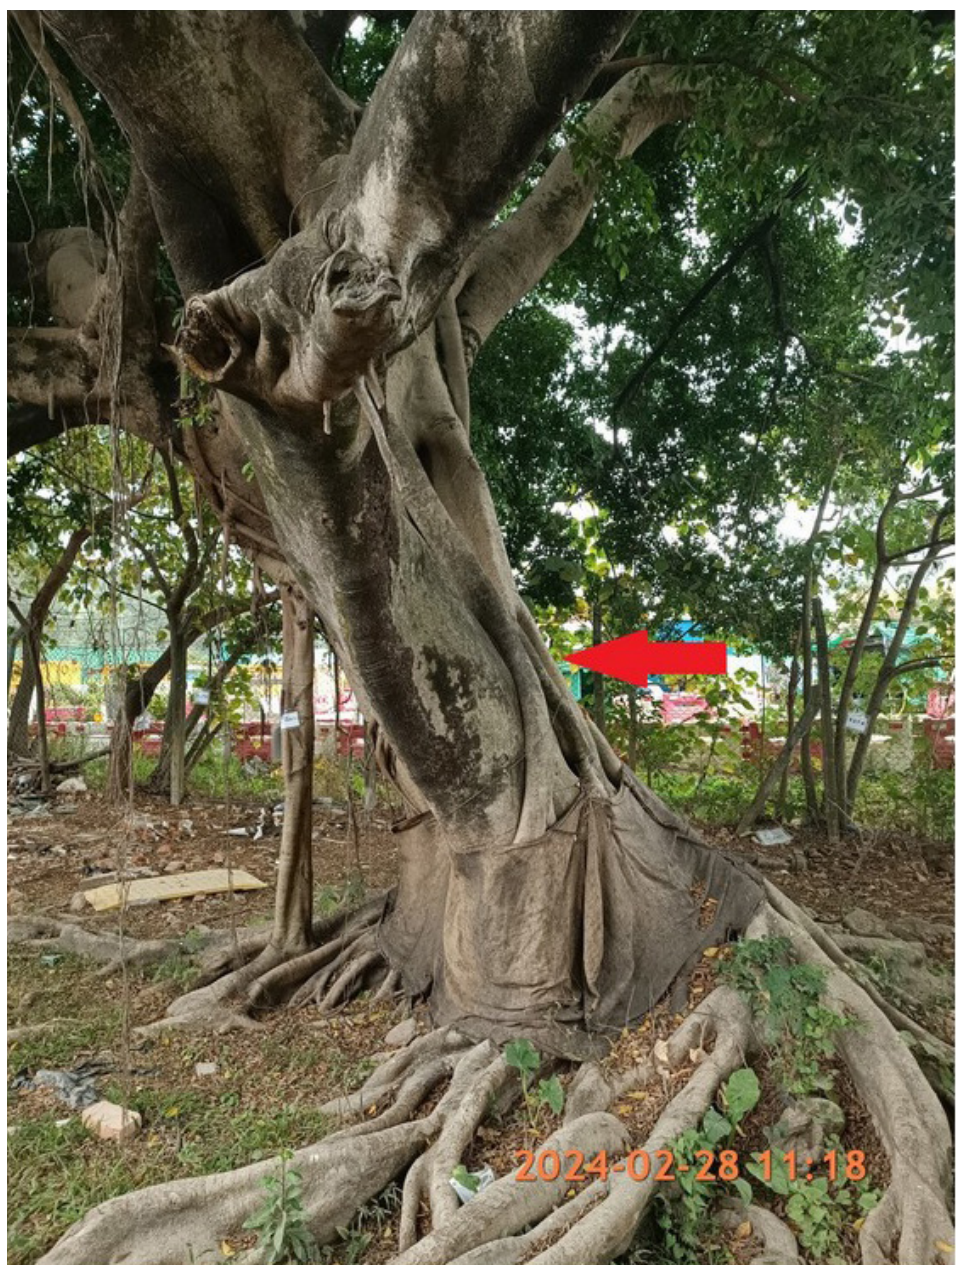
T073\_Ficus\_microcarpa (3)\_Fell\_Trunk\_Leaning

“This TPI has about 20° lean towards the south and with restricted root zone behind the lean. As a general rule, trees with poor form should not be considered for transplanting under normal circumstances. Meanwhile, T073 is restricted by the existing U-channel and the footing of the adjacent fence. Due to restricted root growth, the formation of a balance, reasonable sized root ball is not feasible. Should transplanting be carried out, the tree would require substantial root pruning which could lead to severe root damage during excavation and loss of sufficient root integrity would impact on the tree’s chances of survival. Extensive crown pruning would be necessary for transplantation, which would result the loss of the tree’s natural form and further compromise the tree’s structure and stability. In view of the tree’s maturity and very large size, the tree has low resilience to transplanting shock and the anticipated survival rate after transplanting is low. As such, T073 is not recommended to be transplanted.”

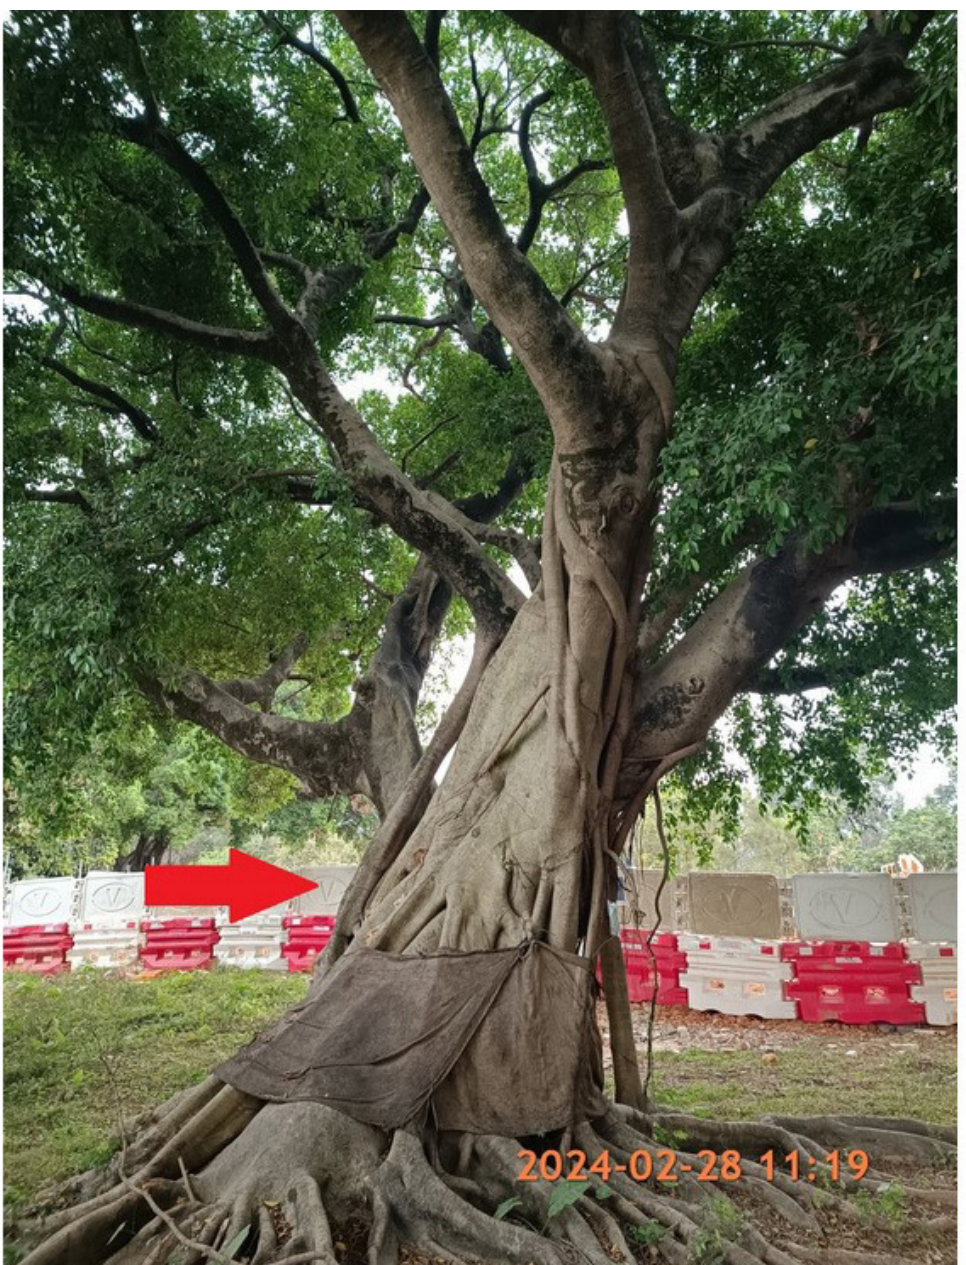
T073\_Ficus\_microcarpa (4)\_Fell\_Trunk\_Leaning

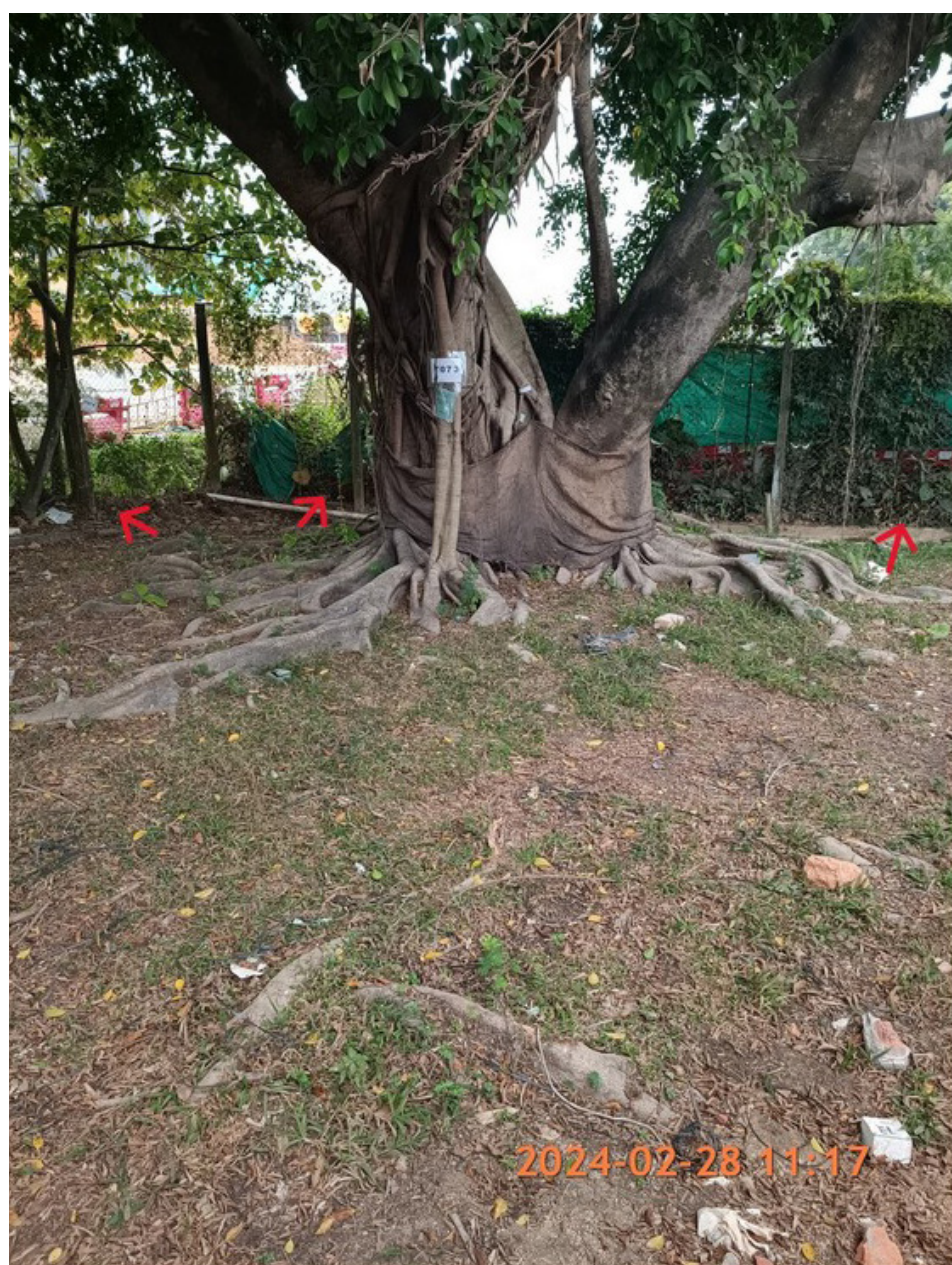
T073\_Ficus\_microcarpa (7)\_Fell\_Root\_Restricted root

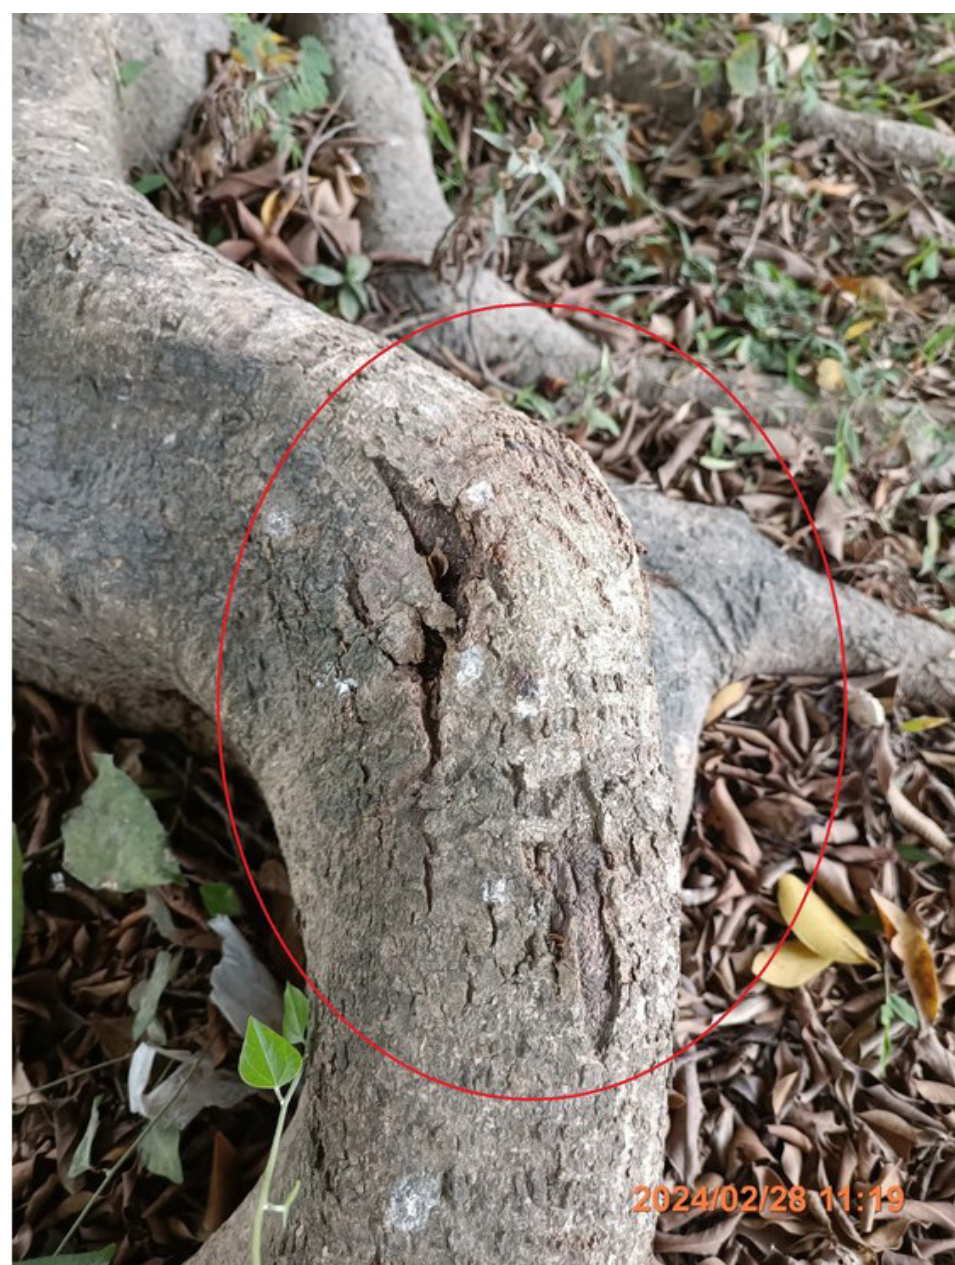
T073\_Ficus\_microcarpa (8)\_Fell\_Mechanical injury on root
