PROPOSED TEMPORARY WAREHOUSE (EXCLUDING DANGEROUS GOODS GODOWN) WITH ANCILLARY FACILITIES FOR A PERIOD OF 5 YEARS, LOT 138 (PART) IN D.D. 52, FU TEI AU, SHEUNG SHUI, NEW TERRITORIES

Geotechnical Planning Review Report

Jan 2026

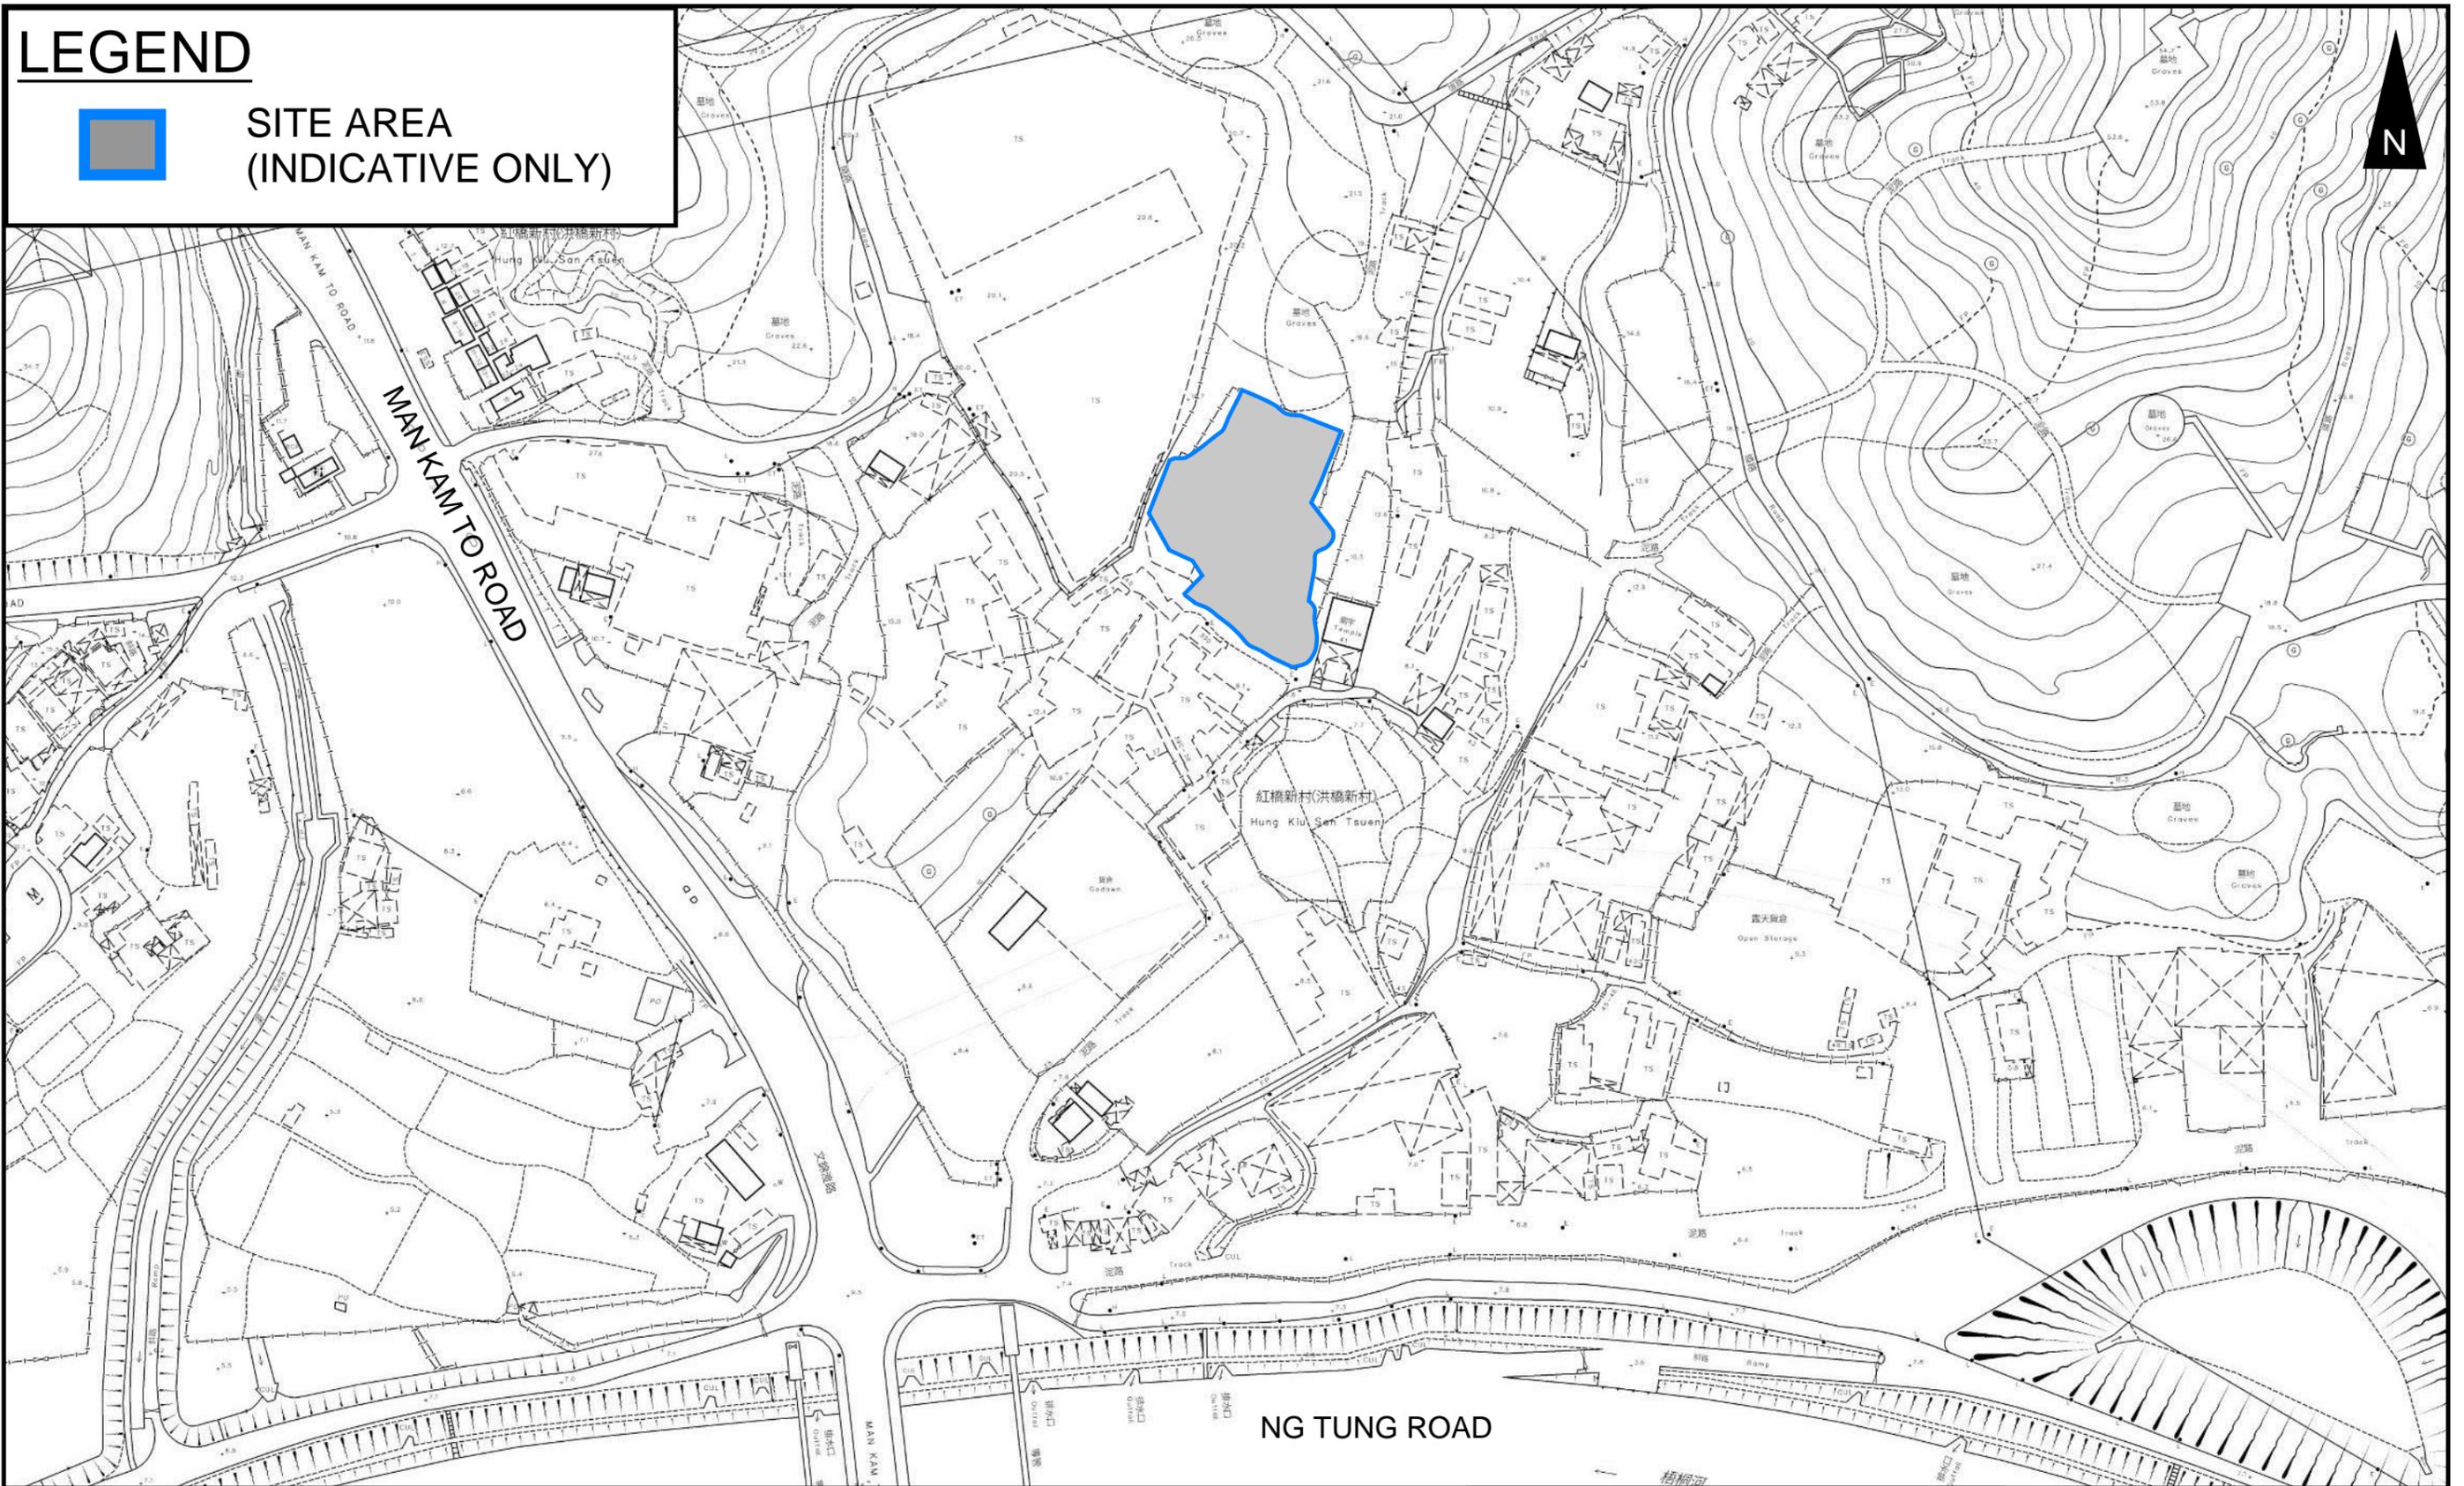
Figure 1 – Site Location Plan

- 2.1.1 The development site situates beside Man Kam To Road near Hung Kiu San Tsuen. It has an area of about 2,151m². The site location plan and aerial photo view are shown in **Figure 1** and **Figure 2** respectively.

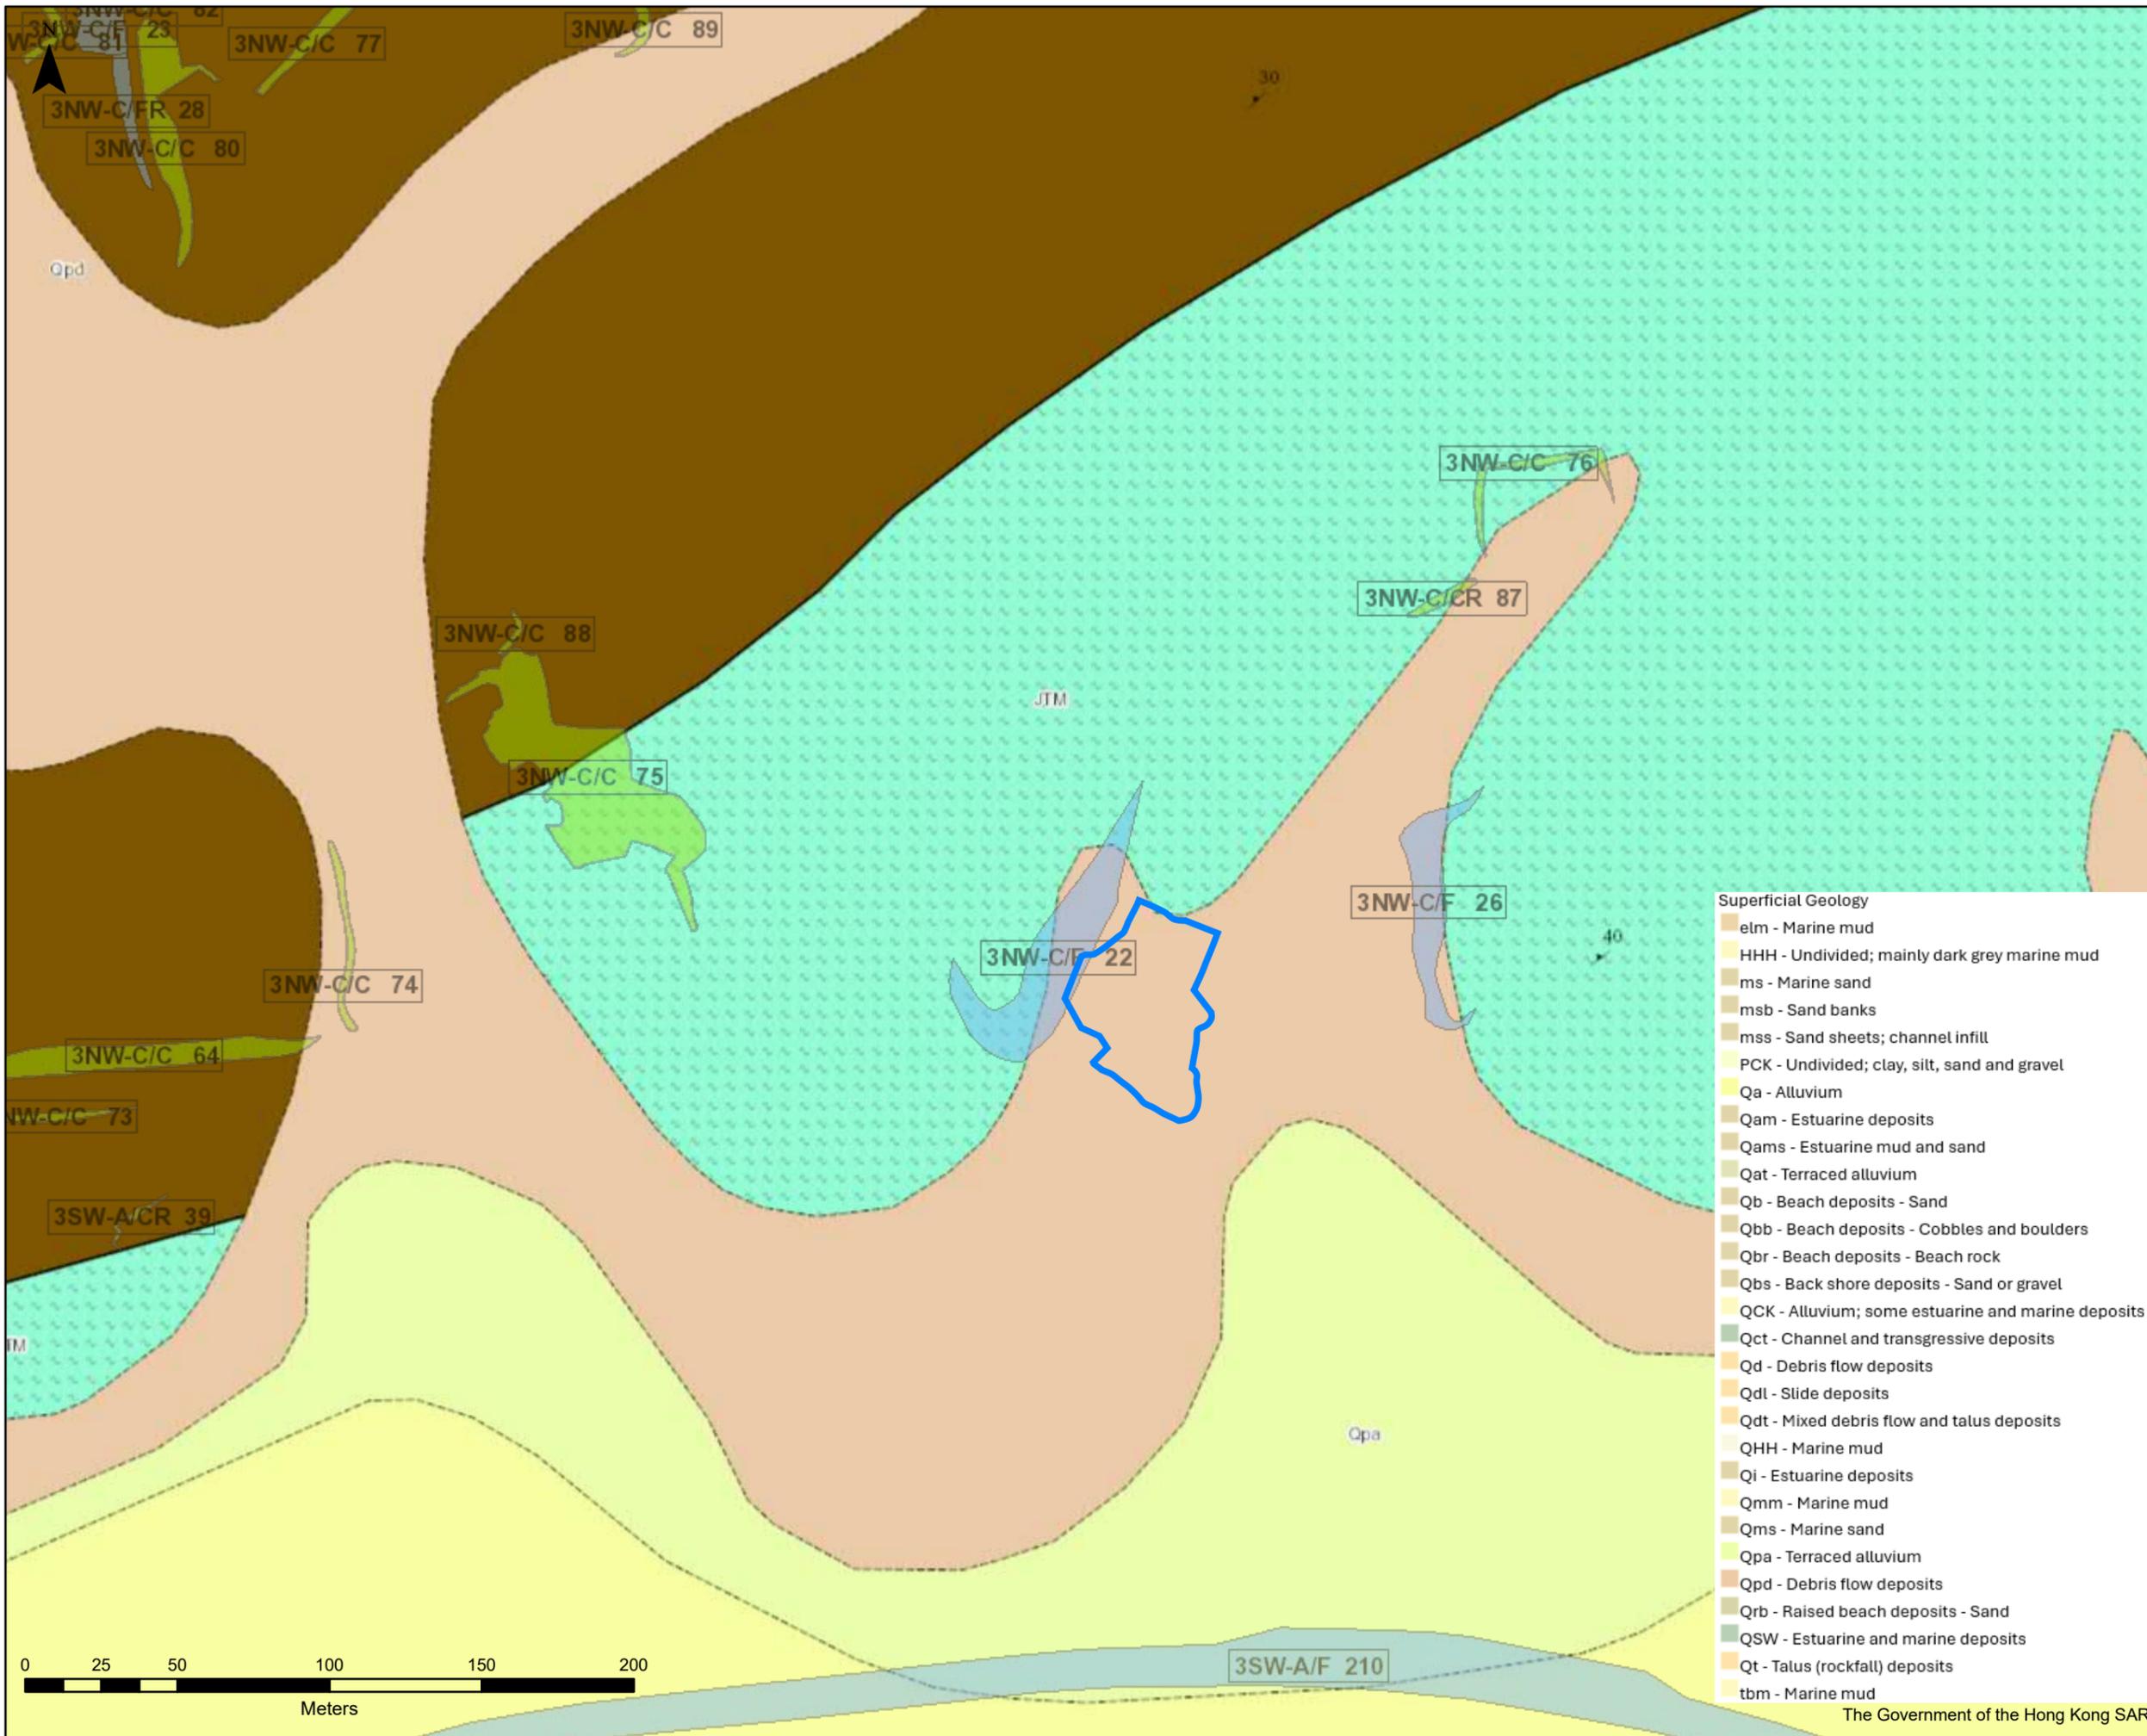
Figure 4 – Geological Map

3.1.1 The geology of the Study Area is shown on 1:20000 scale HGM20 Series Solid and Superficial Geology Map Sheet 3, Published by the GEO, HKSAR. The Application Site is generally underlain by debris flow deposits. A part print of geological map is presented in **Figure 4**.

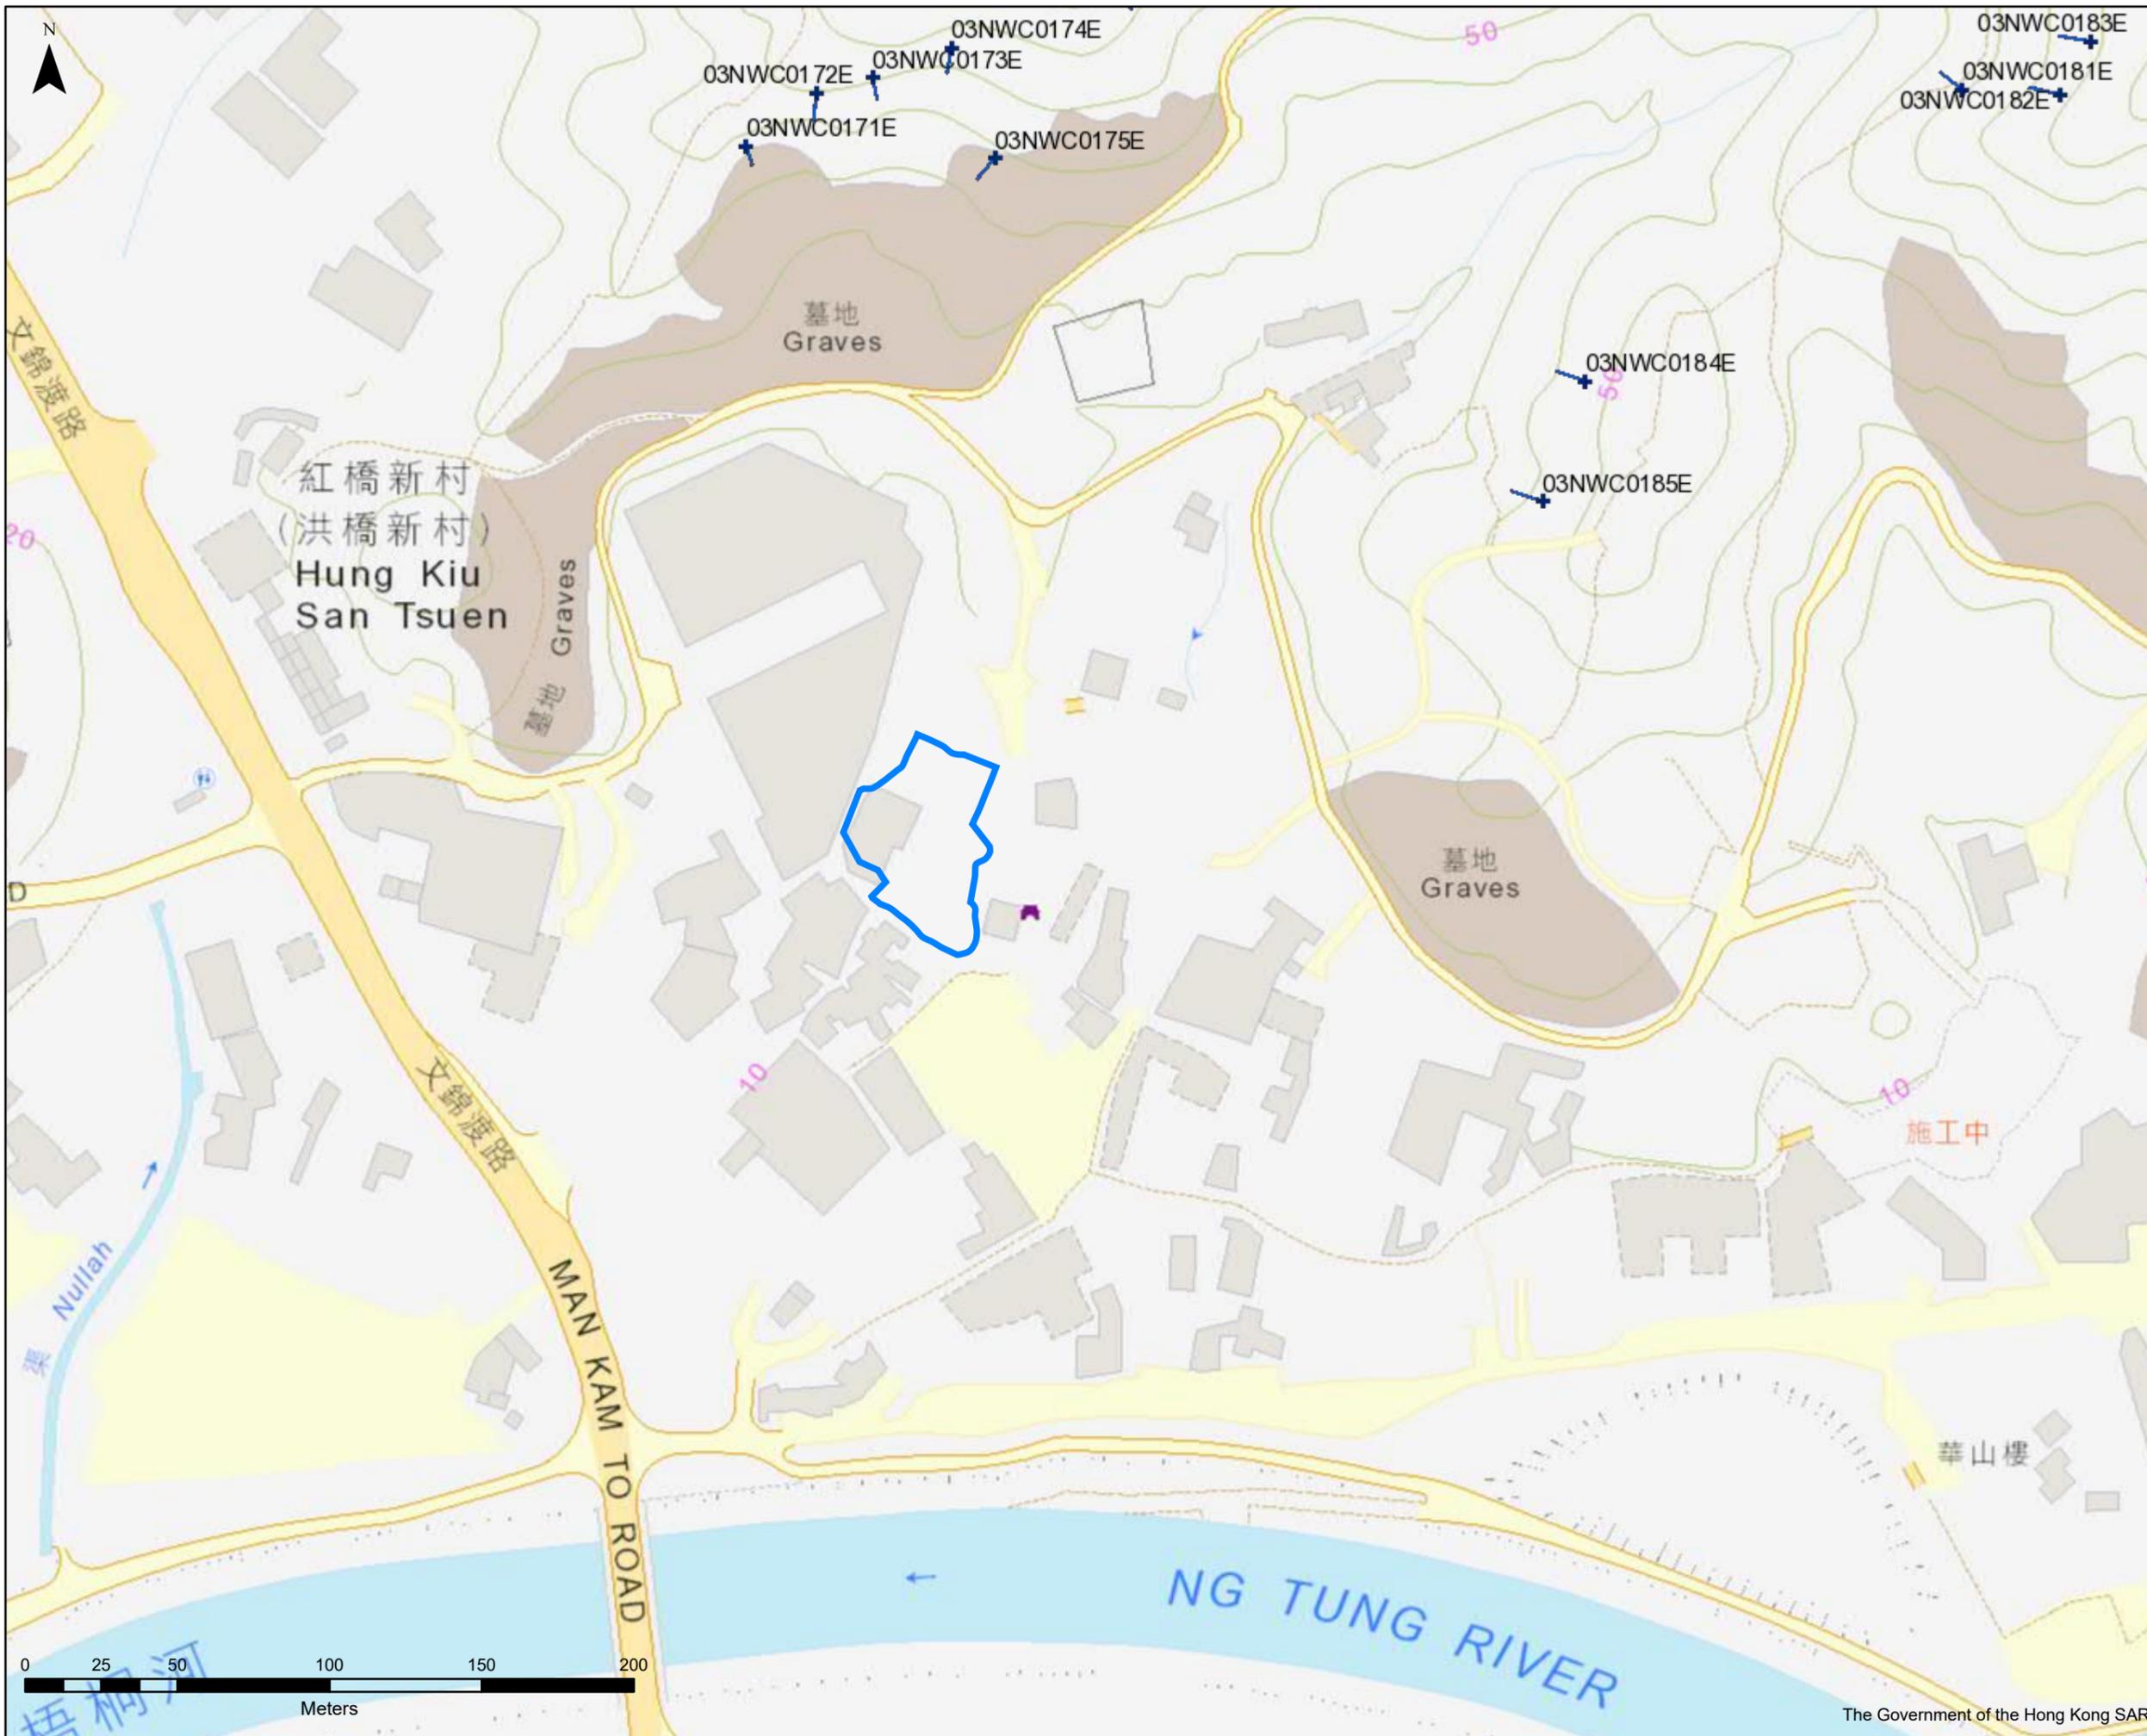
Figure 5 – ENTLI Record

- 3.4.1 According to the GEO's Enhanced Natural Terrain Landslide Inventory (ENTLI) data, there is neither recent nor relict relevant natural terrain landslide identified for the Application Site.
- 3.4.2 Other landslides as recorded in ENTLI are indicated in **Figure 5** for reference.

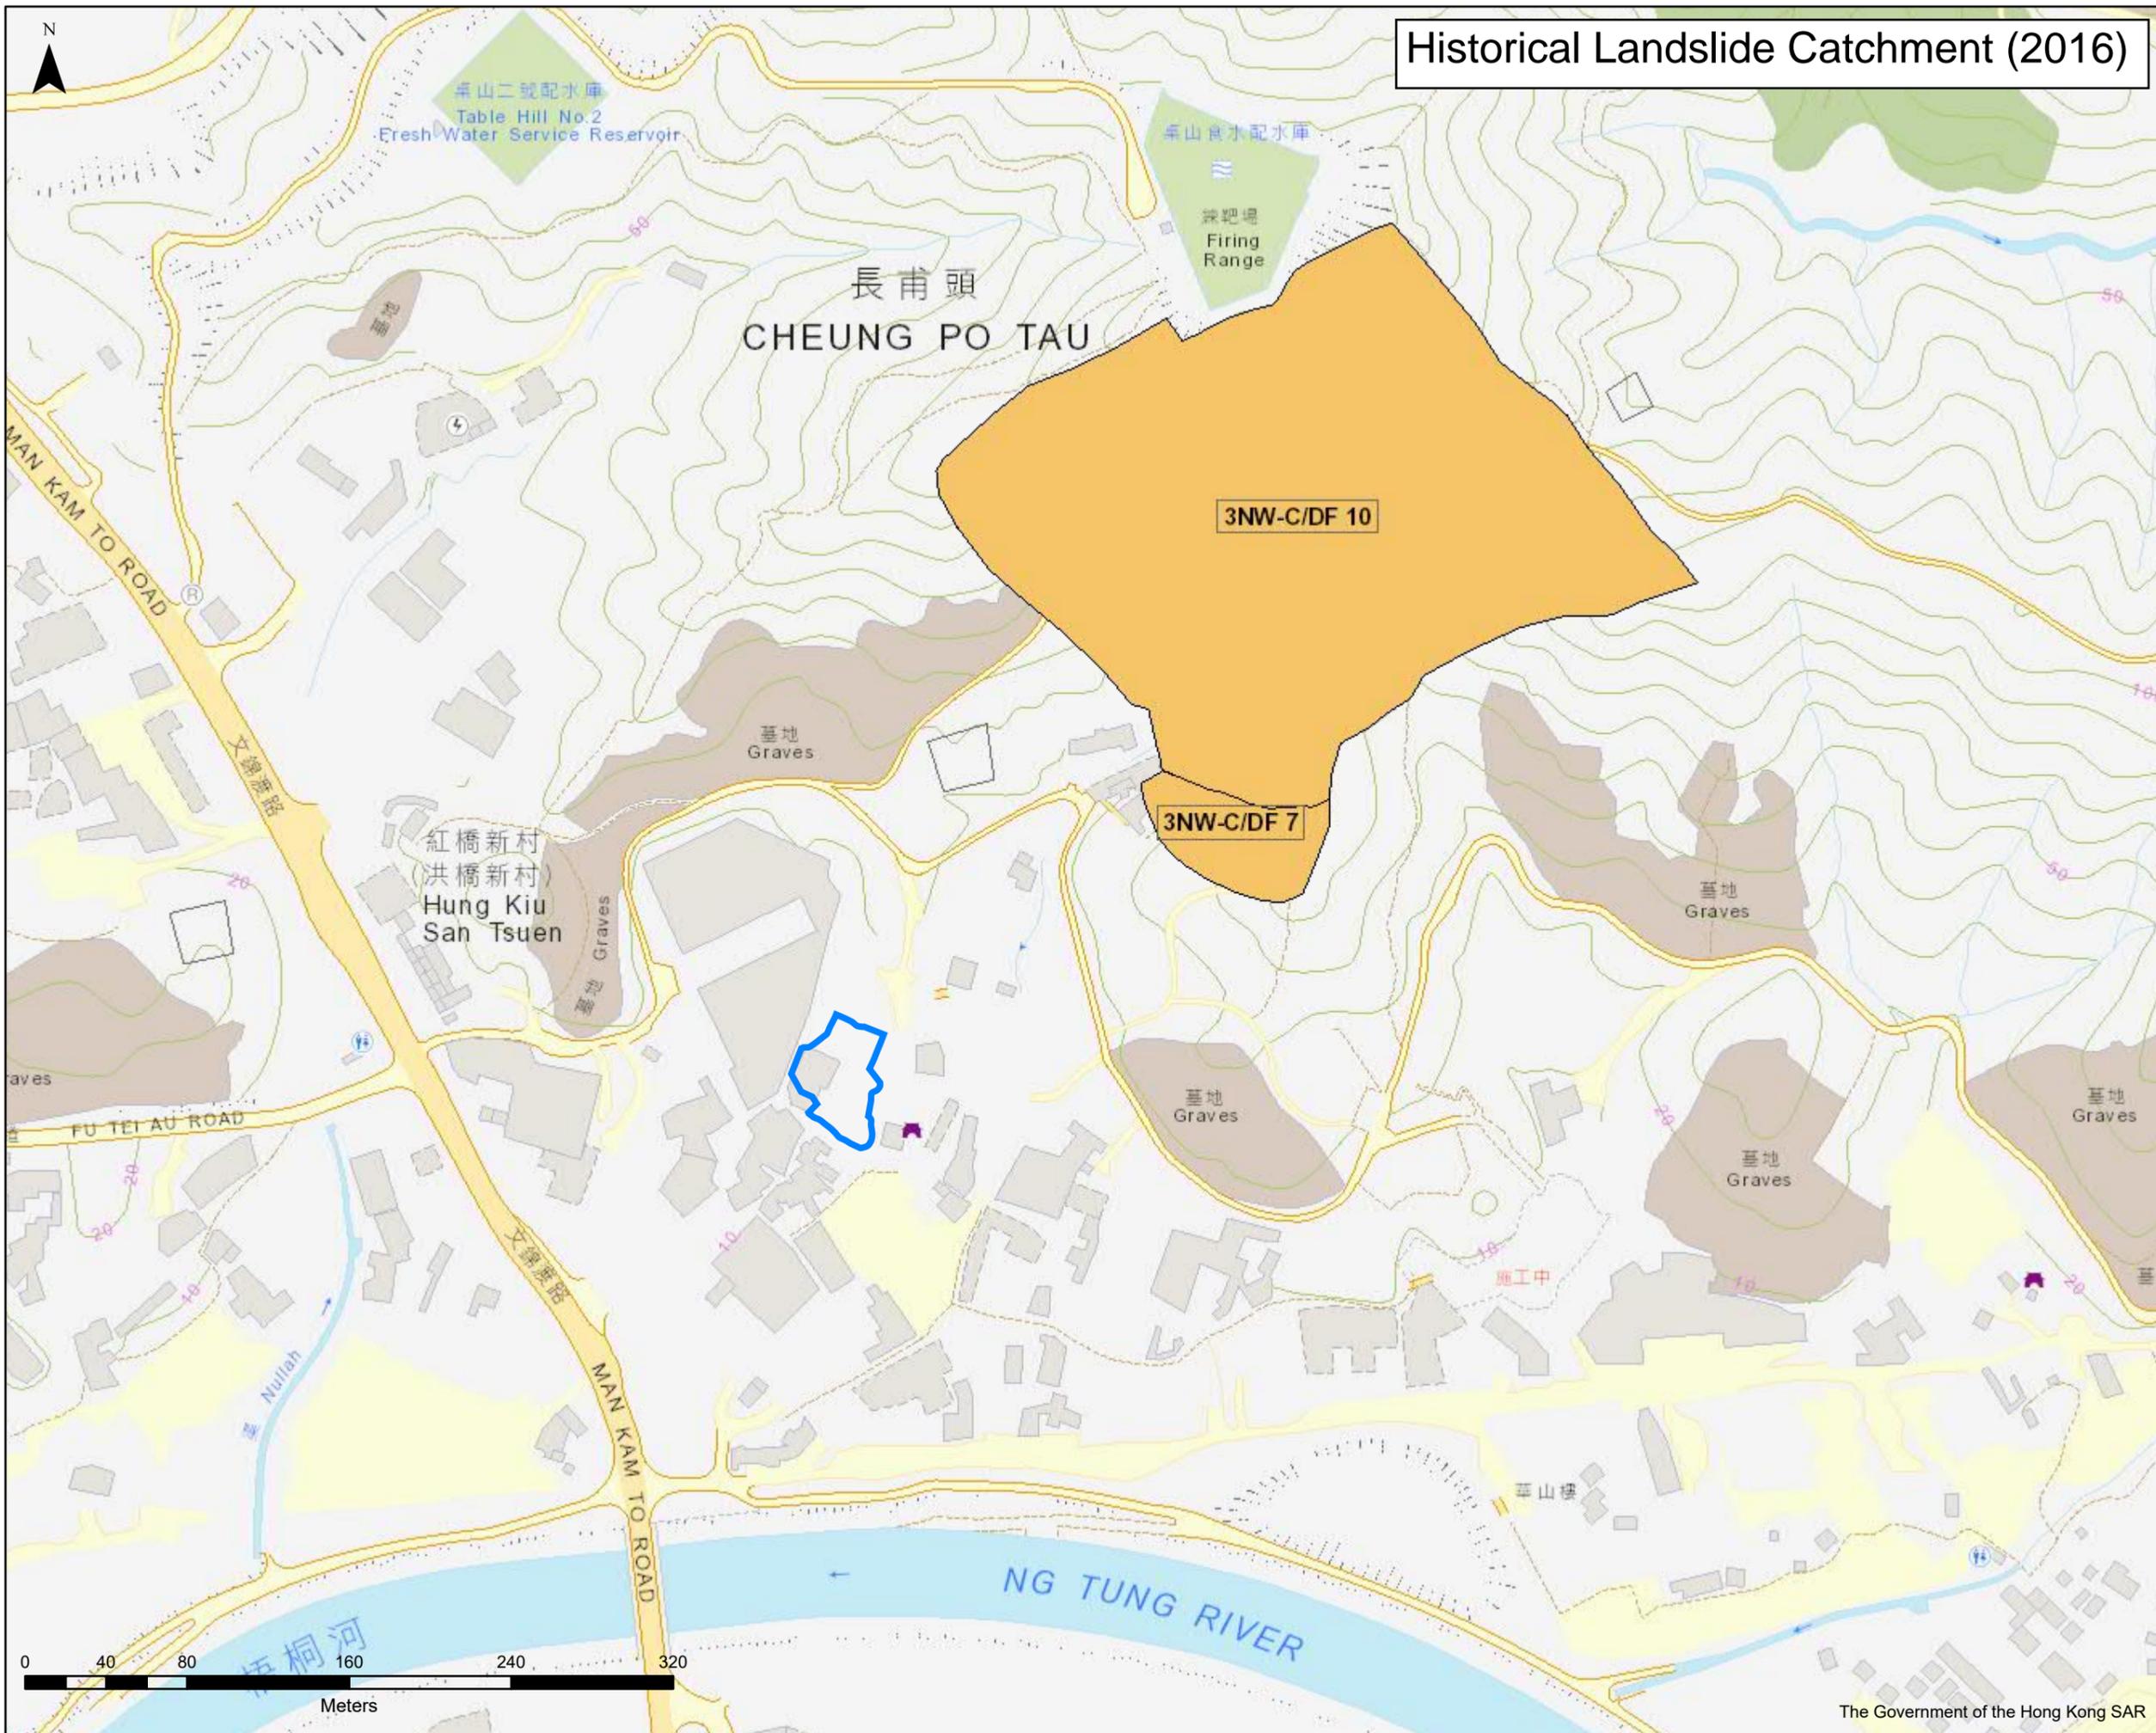
Historical Landslide Catchment (2016)

- 3.5.1 There is no relevant Historical Landslide Catchments (HLC) (MFJV, 2007), identified adjoining to the Application Site. The HLC of nearby Area are shown in **Figure 7** for reference.

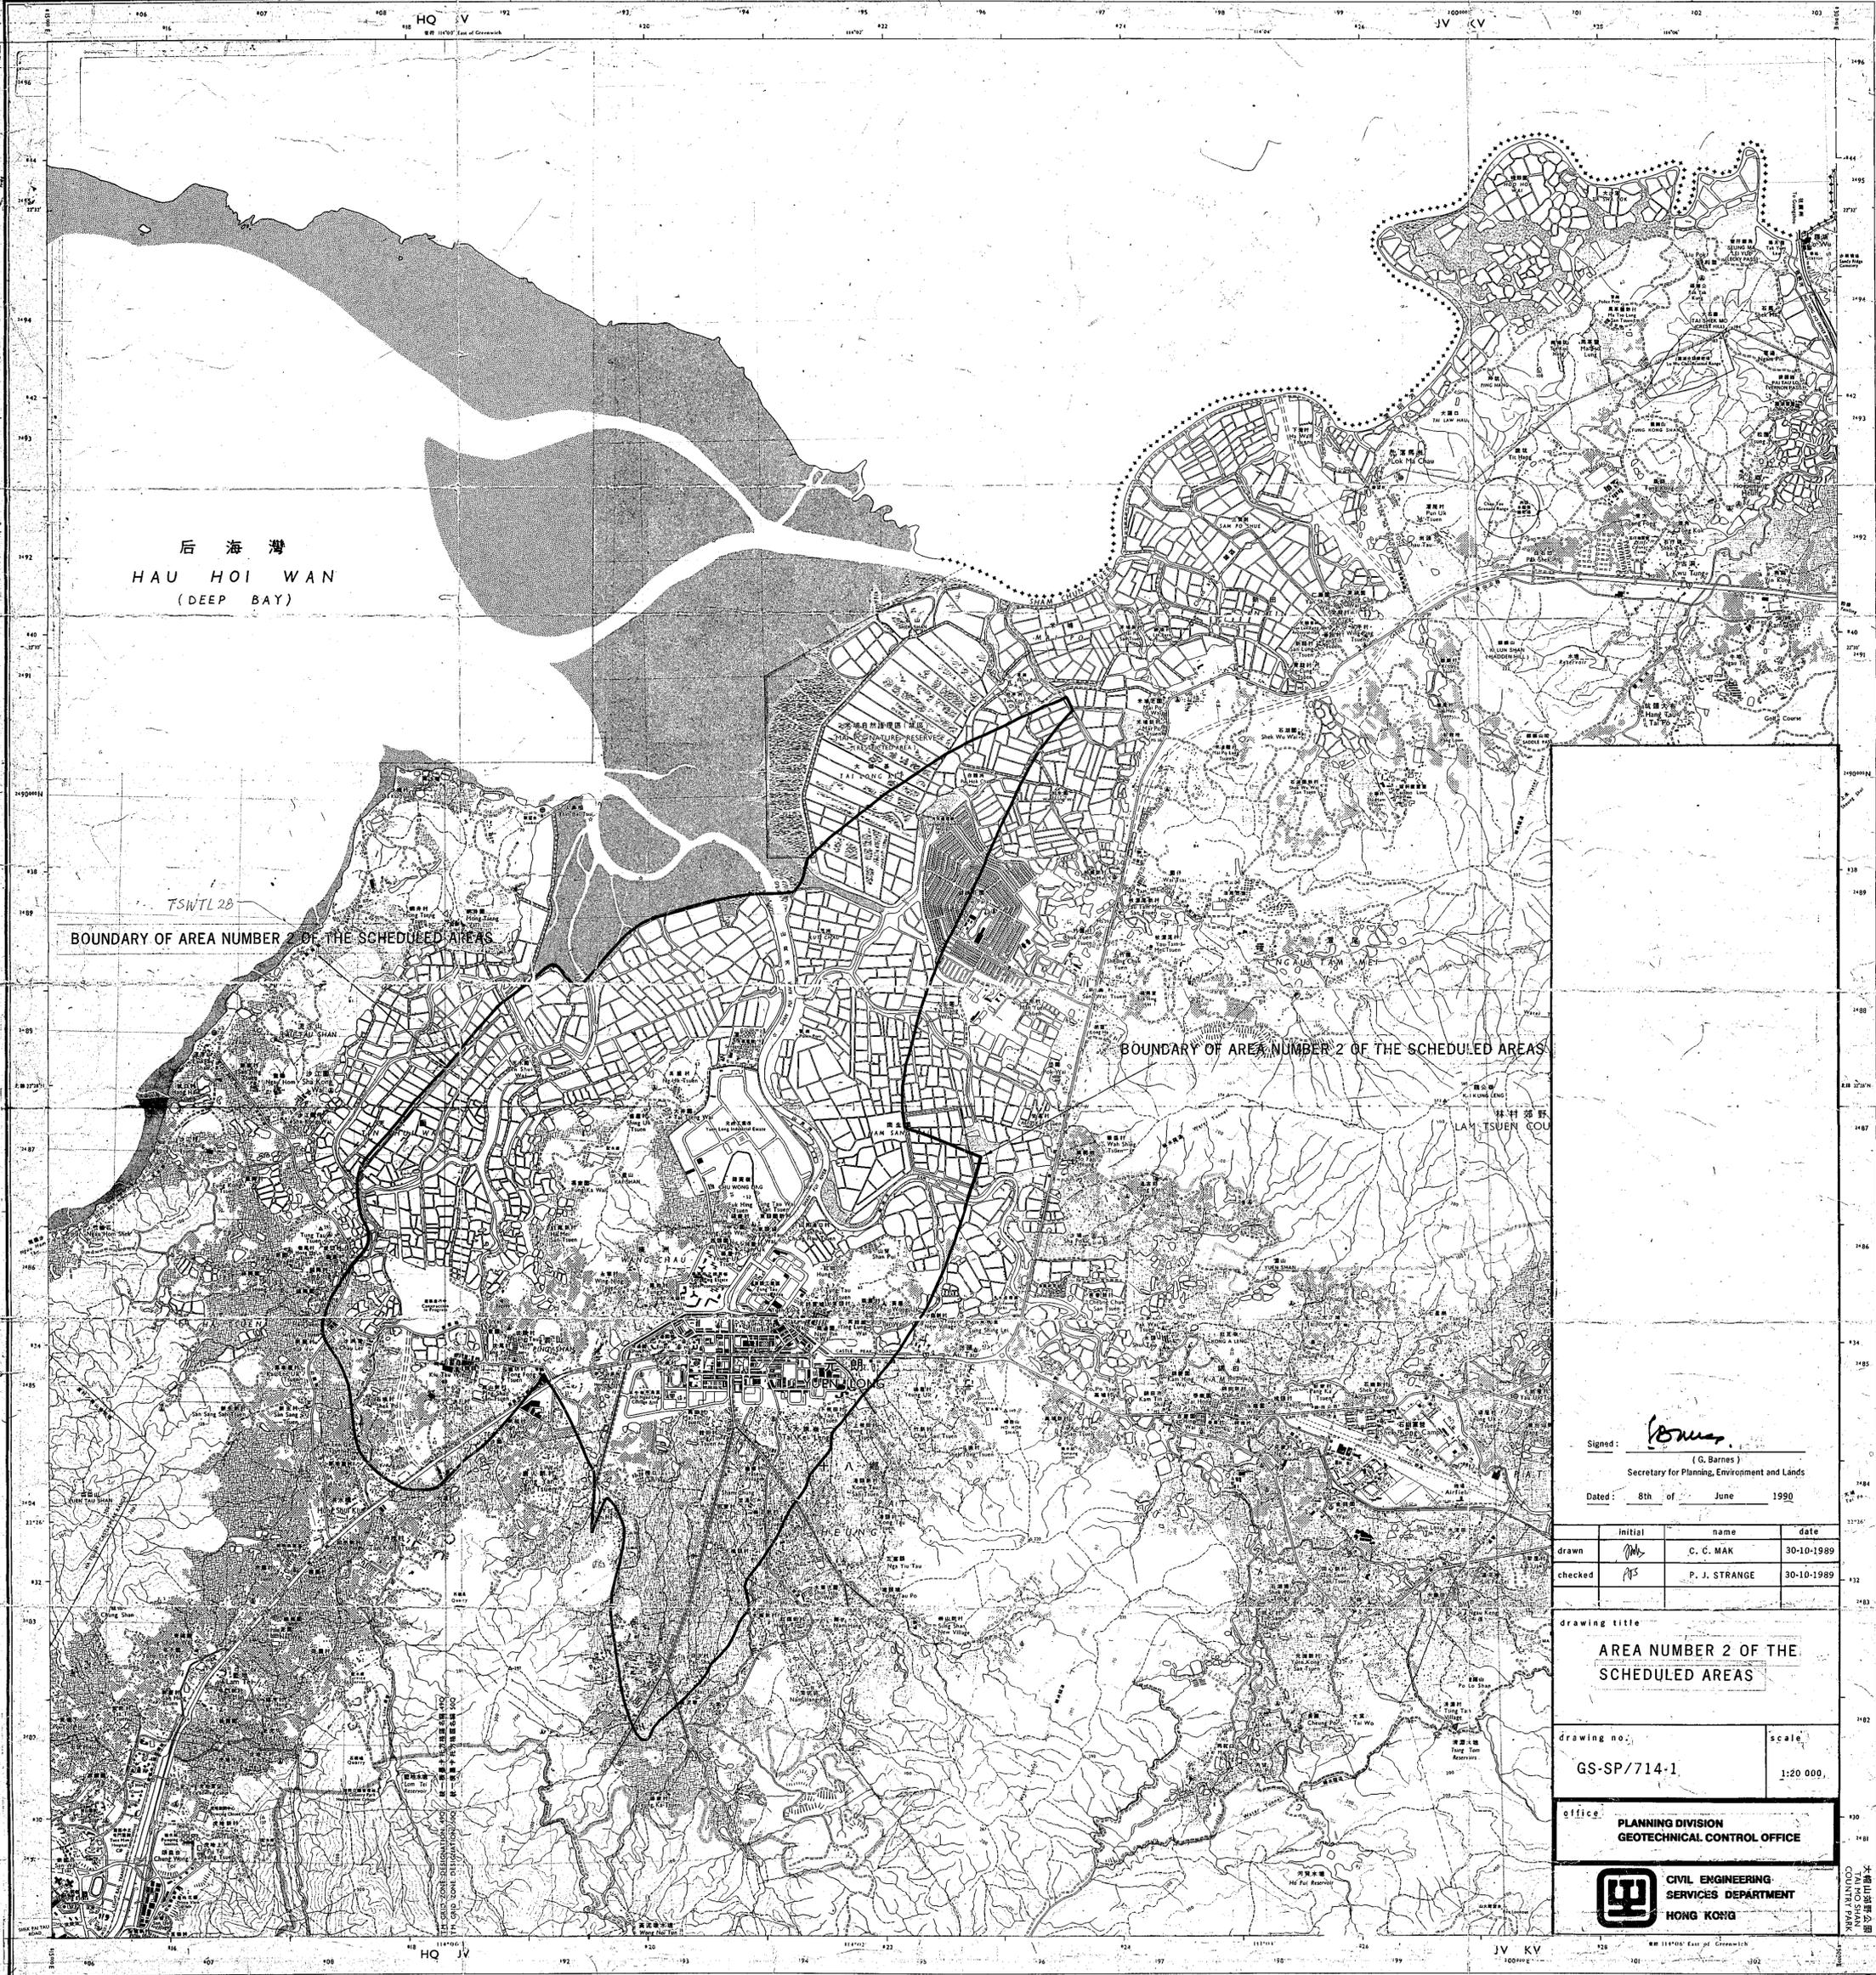
drawing title
AREA NUMBER 2 OF THE SCHEDULED AREAS

3.2.1 The Site is located outside the Schedule Area No. 2 (North-western New Territories) and Schedule Area 3 (The Railway Protection Zone). Plan of the Schedule Areas are enclosed in **Appendix C**.

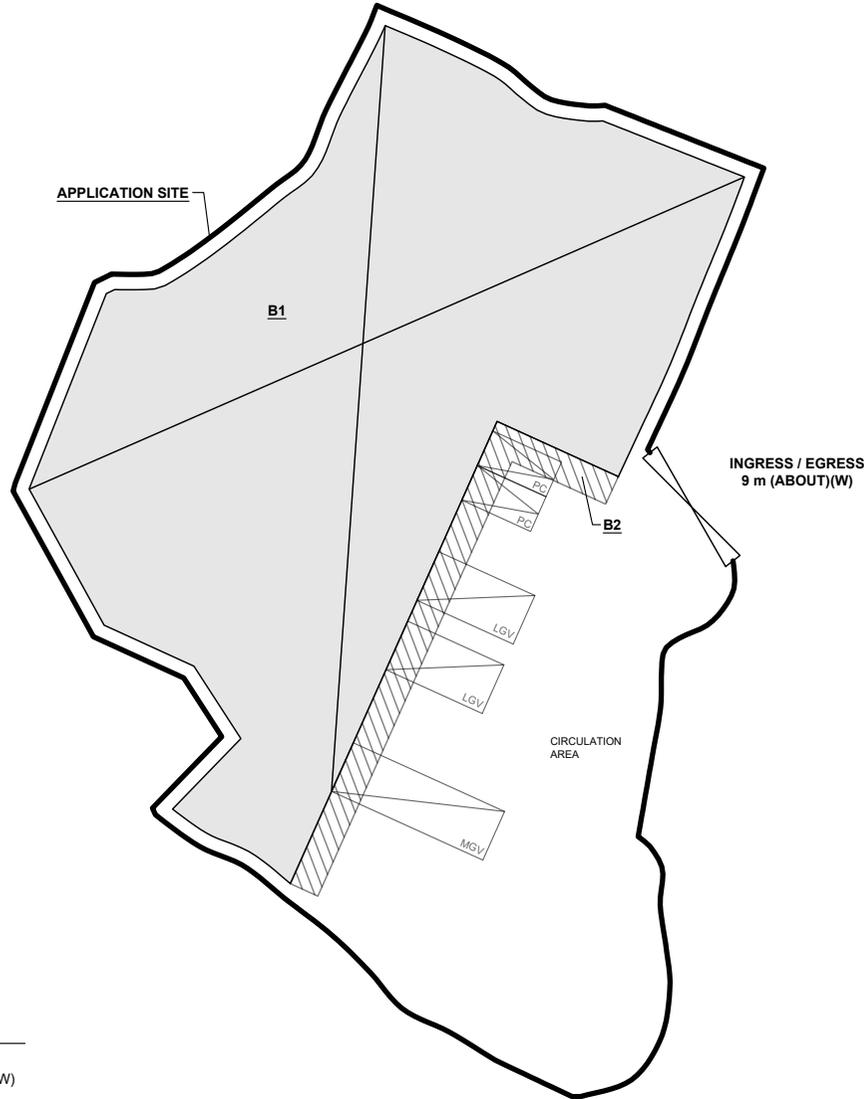
- 4.2.1 The proposed Application Site is applying for temporary warehouse for a period of 5 years. A 2-storey structure and a 1-storey structure are provided at the Site for warehouse (excluding D.G.G.), site office, washroom etc. The proposed development layout plan is shown in **Appendix E**.
- 4.2.2 In view of loadings from low-rise temporary structures is comparatively general, no foundation is proposed for the temporary structures. Excavation for drainage, sewerage and utilities works are minimal, no deep Excavation and Lateral Support (ELS) is anticipated.

STRUCTURE	USE	COVERED AREA	GFA	BUILDING HEIGHT
B1	WAREHOUSE (EXCL. D.G.G.) SITE OFFICE, WASHROOM, FS WATER TANK AND PUMP ROOM	1,236 m ² (ABOUT)	2,472 m ² (ABOUT)	15 m (ABOUT)(2-STOREY)
B2	RAIN SHELTER FOR L/UL ACTIVITIES	80 m ² (ABOUT)	80 m ² (ABOUT)	7 m (ABOUT)(1-STOREY)
TOTAL		1,316 m² (ABOUT)	2,552 m² (ABOUT)
