PROPOSED WAREHOUSE (EXCLUDING DANGEROUS GOODS GODOWN) WITH ANCILLARY FACILITIES FOR A PERIOD OF 5 YEARS

FSIs PROPOSAL (1/4)

**PROPOSED TEMPORARY WAREHOUSE (EXCLUDING  
DANGEROUS GOODS GODOWN) WITH ANCILLARY  
FACILITIES FOR A PERIOD OF 5 YEARS, LOT 138 (PART)  
IN D.D. 52, FU TEI AU, SHEUNG SHUI, NEW  
TERRITORIES**

## **Geotechnical Planning Review Report**

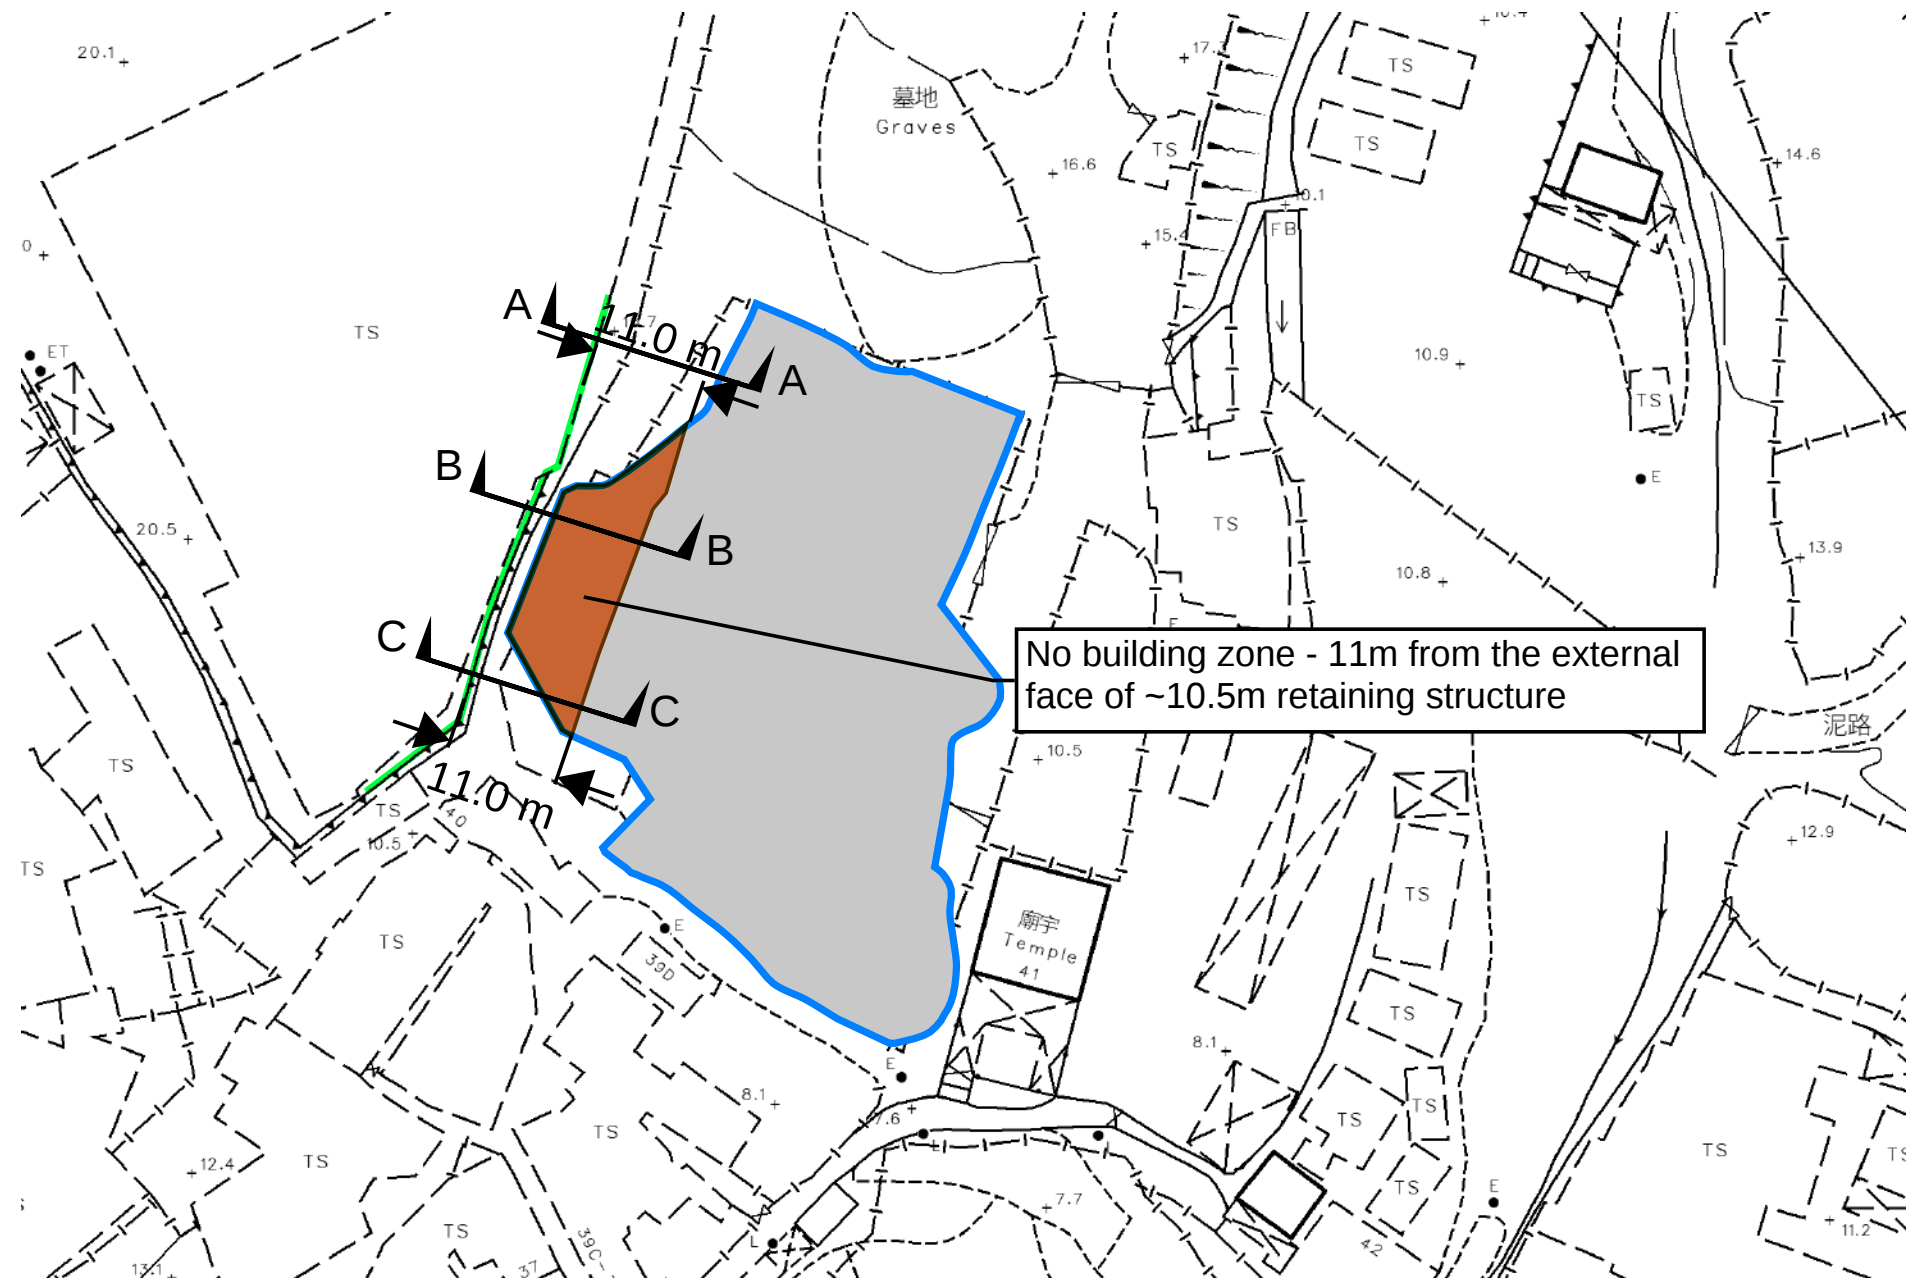
- 5.1.1 According to the topographic survey and site photos, the existing feature **3NW-C/F 22** within the Application Site is no longer exists and the level difference is retained by a retaining structure under other development. Cross sections showing the relocation of existing retaining structure and the site boundary are shown in **Figure 7** for reference. It is noted that the retaining structure is unauthorized and there is no information regarding its design and construction. The retaining structure is about 10.6m height, it is proposed a no building zone from 11m of external face of existing retaining structure. The proposed no building zone is also shown in **Figure 7**.

- 6.1.1 A geotechnical planning review has been conducted for Application Site. The physical conditions as well as the geological conditions of the Application Site have been reviewed and discussed.
- 6.1.2 Existing feature **3NW-C/F 22** within the Application Site is no longer exists and the level difference is retained by a retaining structure under other development. If excavation is required in close proximity of the existing retaining wall, ELS, monitoring, stabilization works are to be proposed if find necessary after detail assessment in detail design stage.
- 6.1.3 In conclusion, the proposed development at the Application Site is not anticipated to case adverse geotechnical impact to the nearby area and considered geotechnically feasible.
