**2<sup>nd</sup> Further Information**

**Proposed Temporary Warehouse (excluding Dangerous Goods Godown) with Ancillary Facilities  
and Associated Filling of Land for a Period of 3 Years in "Agriculture" Zone,  
Lot 207 in D.D. 38, Man Uk Pin, New Territories**

**GEOTECHNICAL PLANNING REVIEW REPORT (GPRR)**

**LOT 207 IN DD38, MAN UK PIN, NEW TERRITORIES**

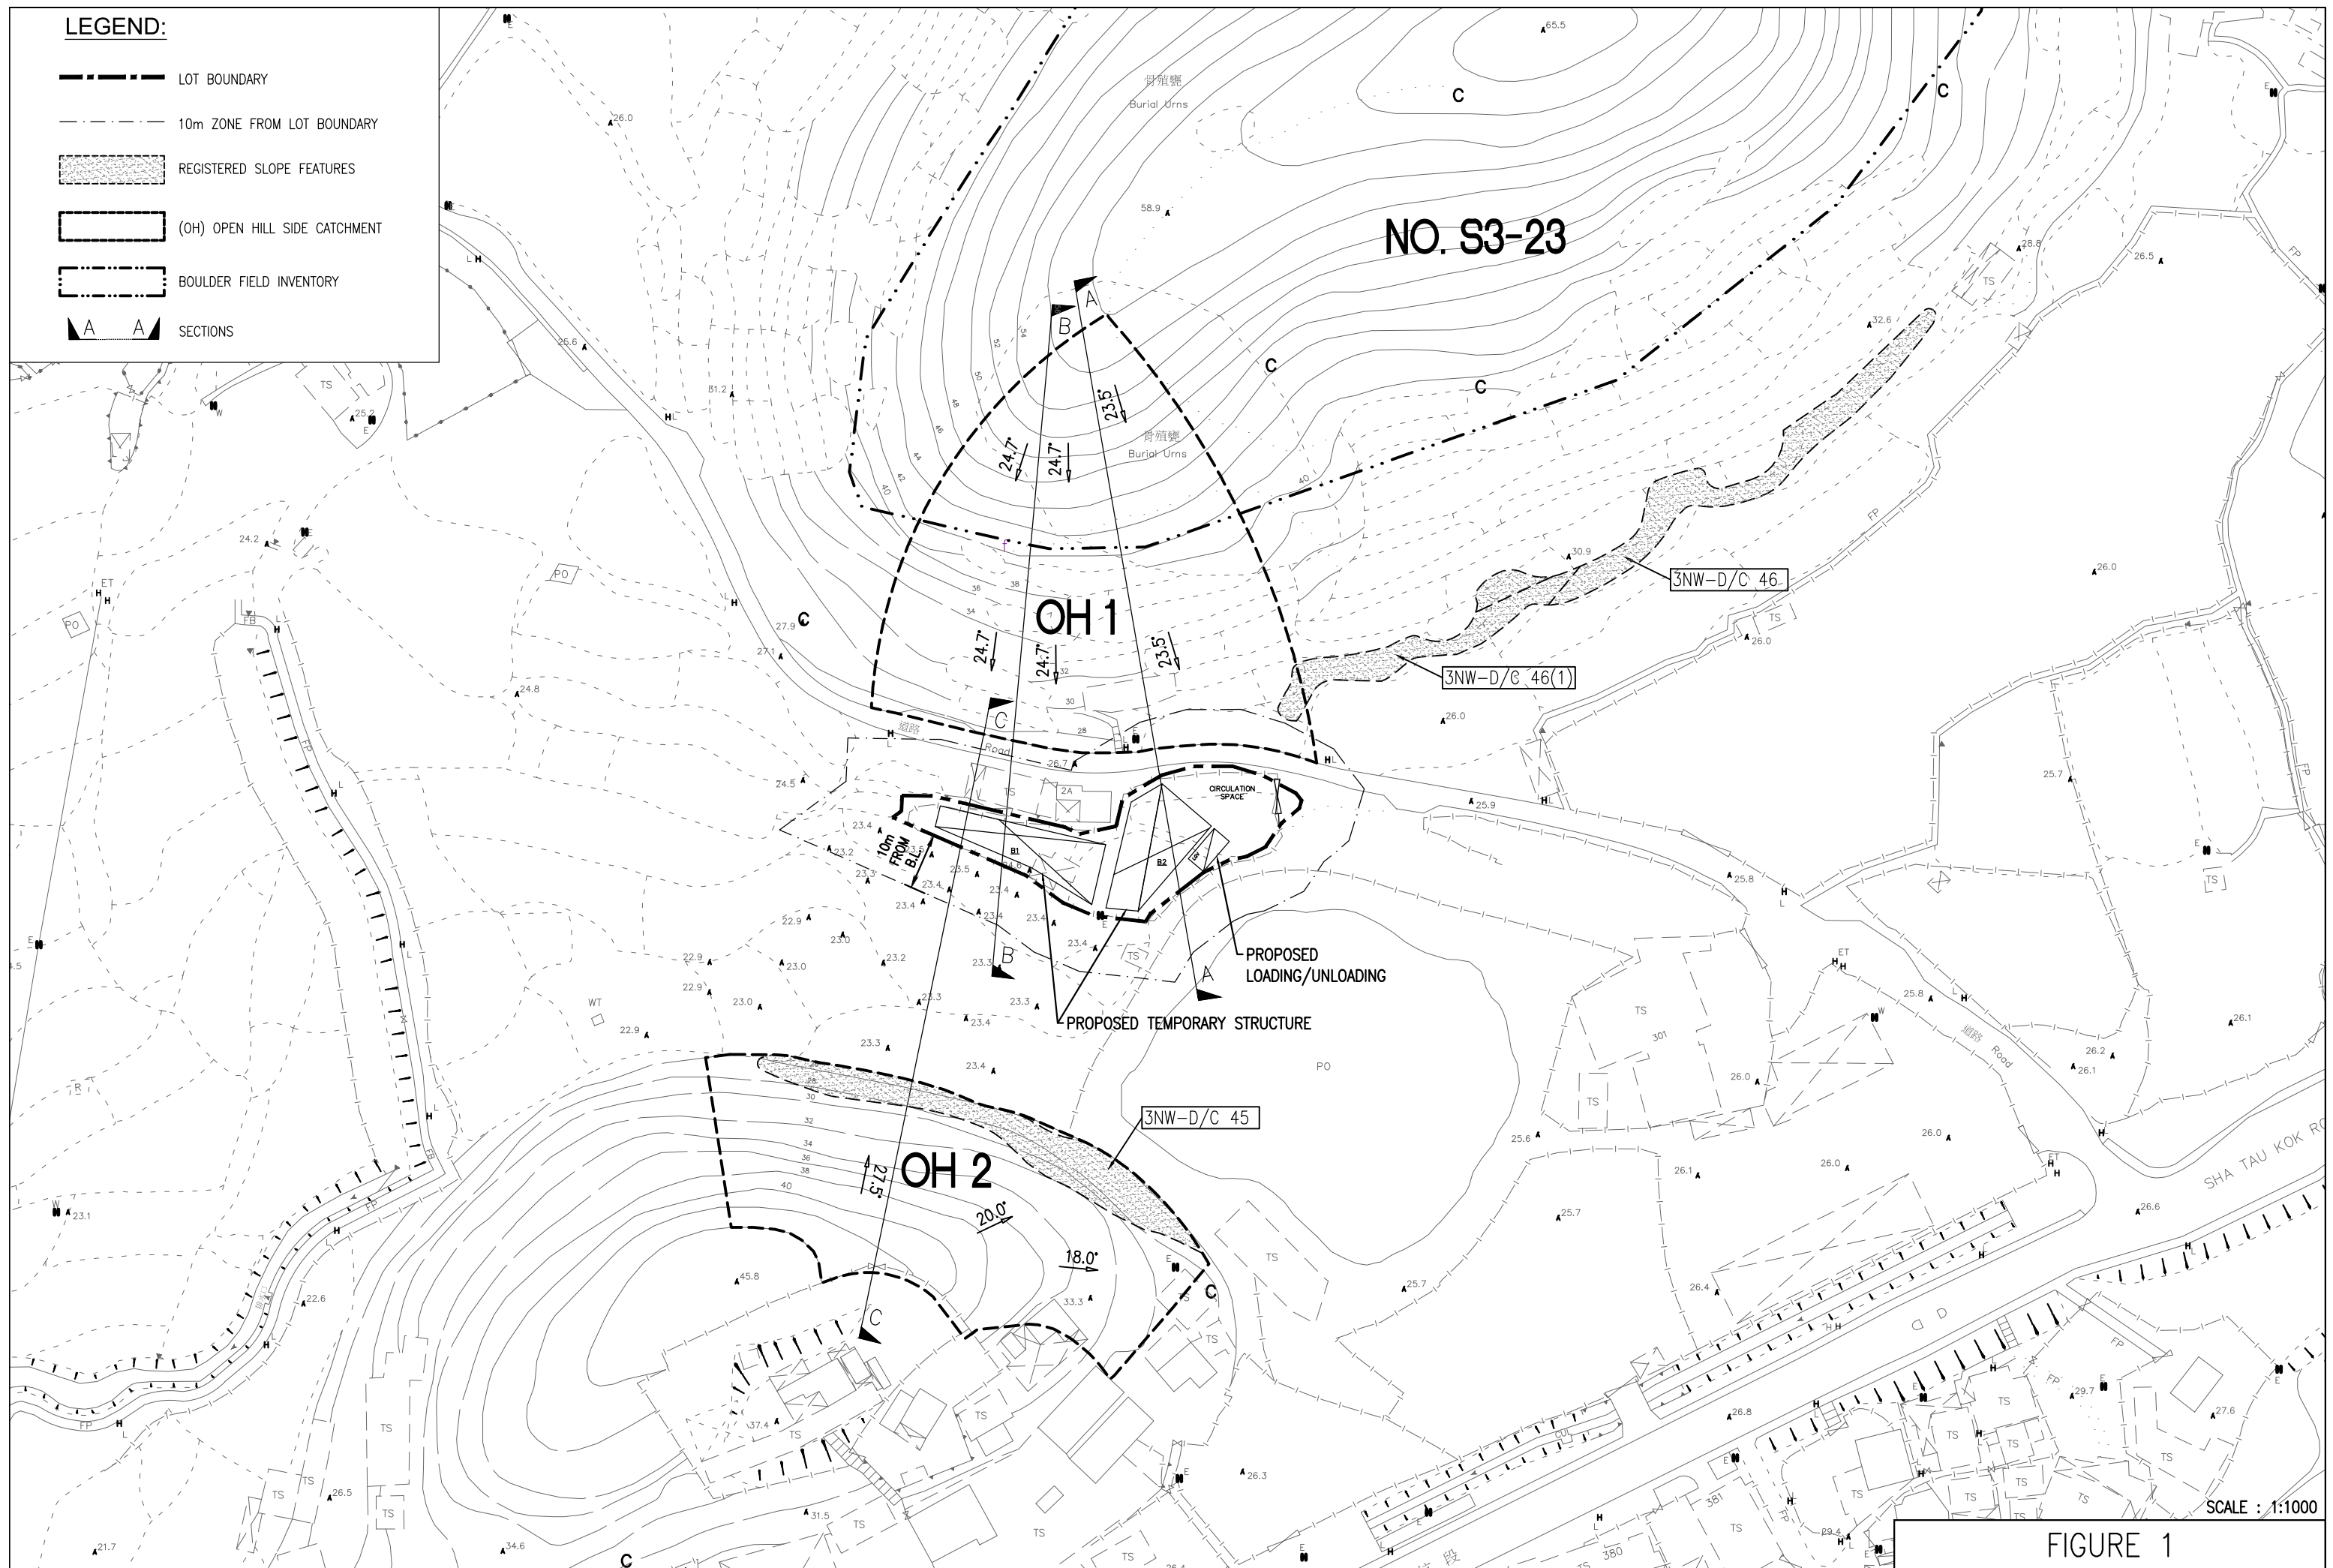
FIGURE 1

| Figure 1 | Layout plan for Hillside Catchments |

The subject Site is overlooked by natural terrain on its north and south side. Based on available topographic maps No. 3 NW-25B of Hong Kong from the Survey & Mapping Office (SMO) of the Lands Department, the hillside catchments are described below, and presented as Figure 1, with relevant cross-sections of the catchment presented as Figure 2 to 4. An overall photographic plan view of the Catchments and the Site as shown in Figure 5.

##### **4.1 Description of the Catchment Areas (Figure 1 & 5)**
