**APPLICATION FOR PERMISSION UNDER SECTION 16 TOWN PLANNING  
APPLICATION FOR PROPOSED TEMPORARY PRIVATE CLUB FOR A PERIOD OF  
FIVE YEARS AT LOTS 229 S.B SS.1 AND 227 RP IN D.D. 41, SHA TAU KOK, NEW  
TERRITORIES**

**Town Planning Application No. A/NE-STK/34 – Further Information (2)**

Proposed Development of The temporary Private club  
at Lot 27 RP and 229S.B.ss.1 in  
DD41, Sha Tau Kok, N.T., Hong Kong

Geotechnical planning review report

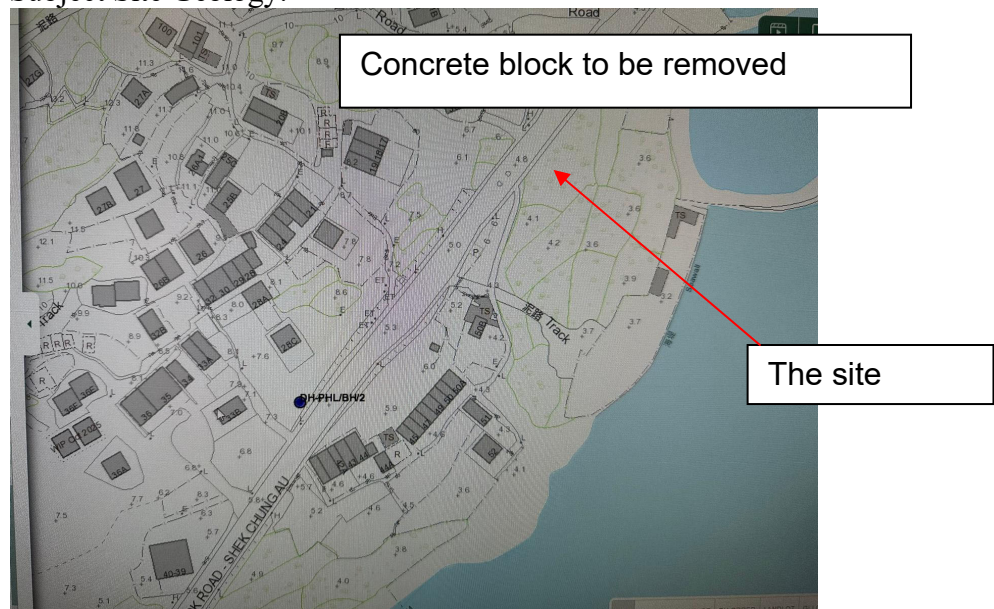
Based on GInfo Geological Map of Solid Geology, there are no available ground investigation results within the Site. We have found the nearly GI record (PHL/BH/2) were located on flat lying found just to the west of starling inlet (sha tau kok hoi.).

Based on the GI Record , the top layer of soil would be fill(1.5m thickness.),the second layer is alluvium(5.75m thickness.) ,the third layer is completely decomposed tuff/ Grade V(>3.15m thickness).

The GI record is attached in **Appendix C**.

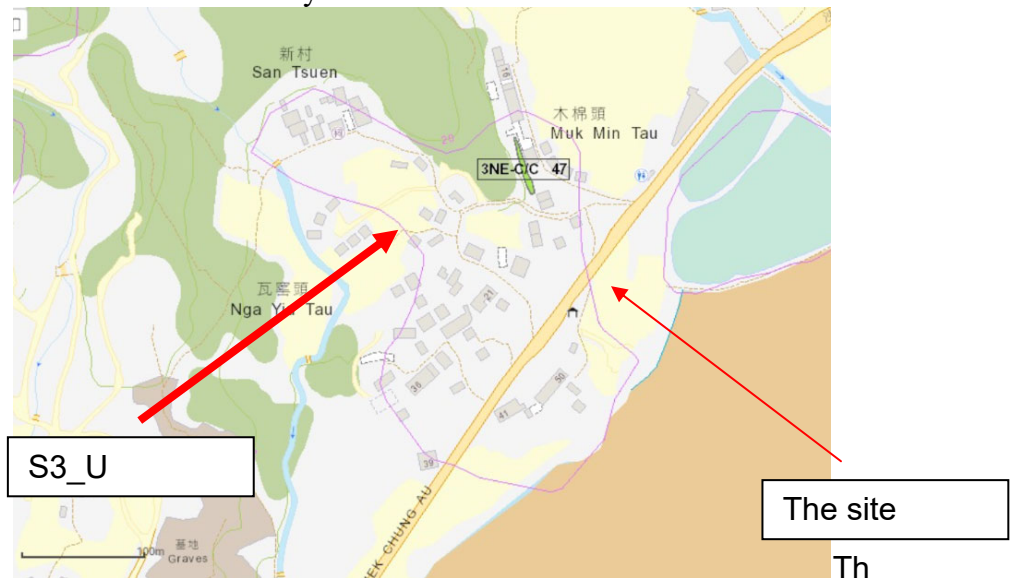
The Site itself partly falls in Boulder Field Inventory Polygon No.S3-U of the Boulder Field Inventory.

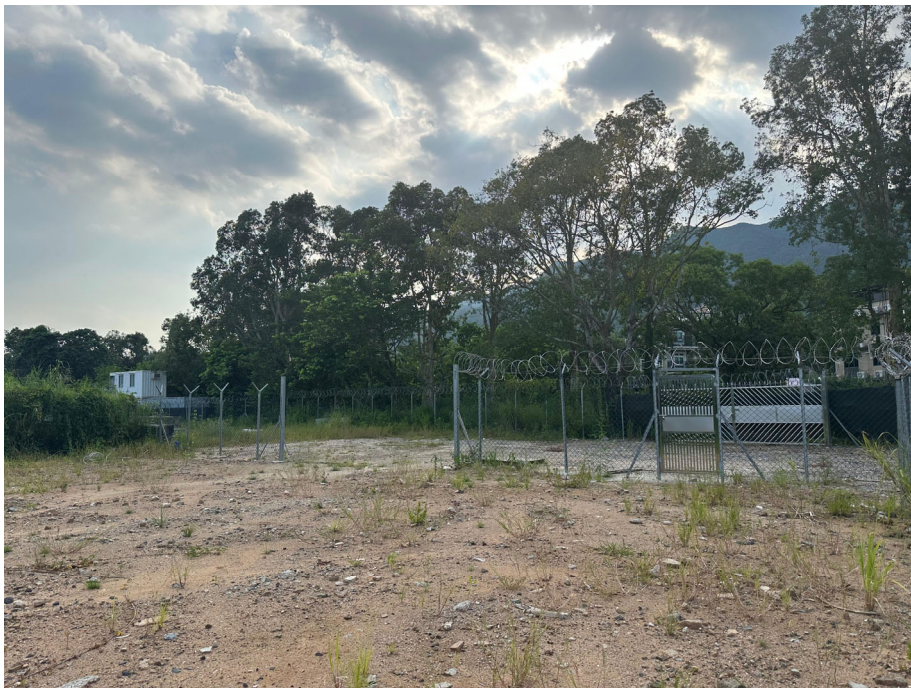
*PHOTO 1 Site photo at the south of the Lots 229 S.B ss.1 and 227 RP in D.D.41*

Since the existing level inside our lot haven't change, there only have some concrete block and soil backfill(800mm THK.) , will remove the concrete block and soil backfill inside lot boundary.

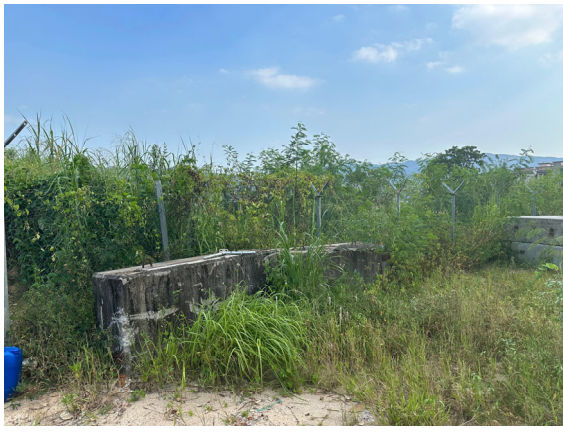
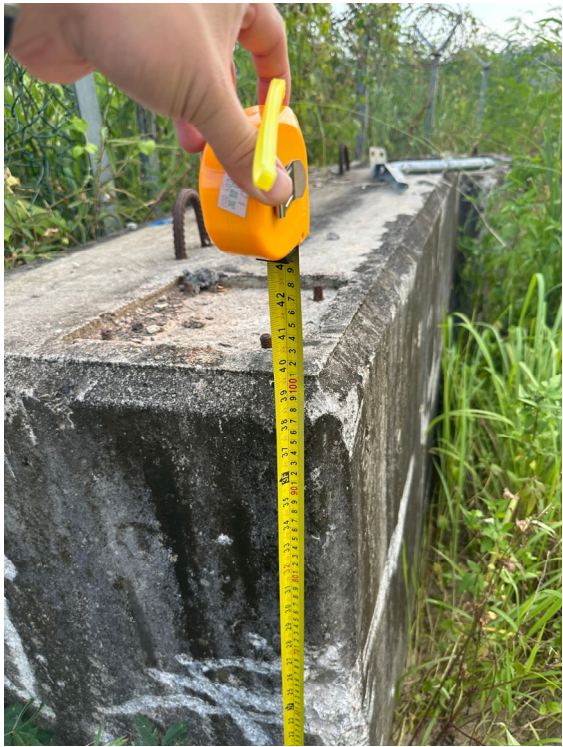
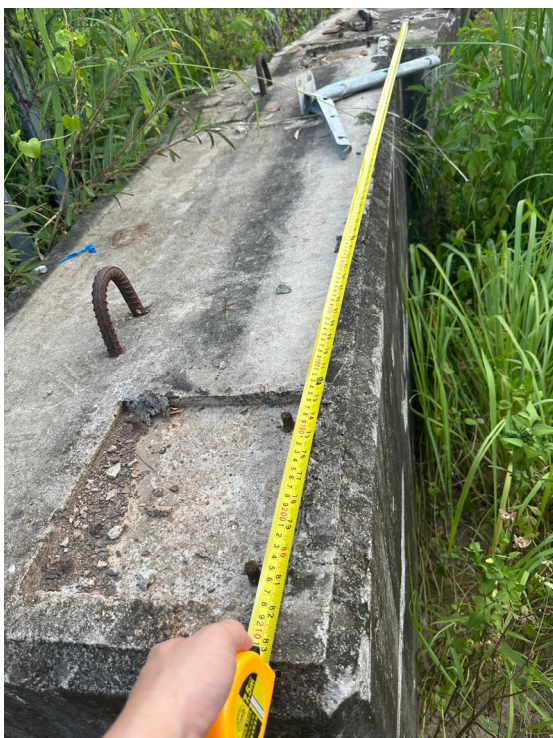
*PHOTO 3-5 Site photo for the concrete block type 1 to be removed*

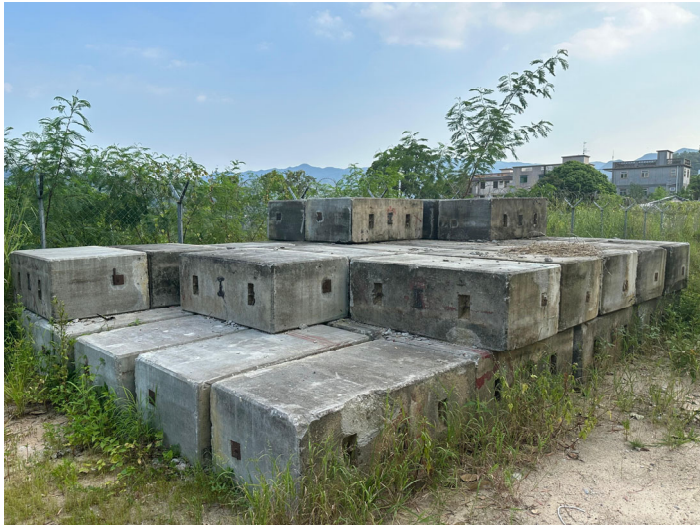
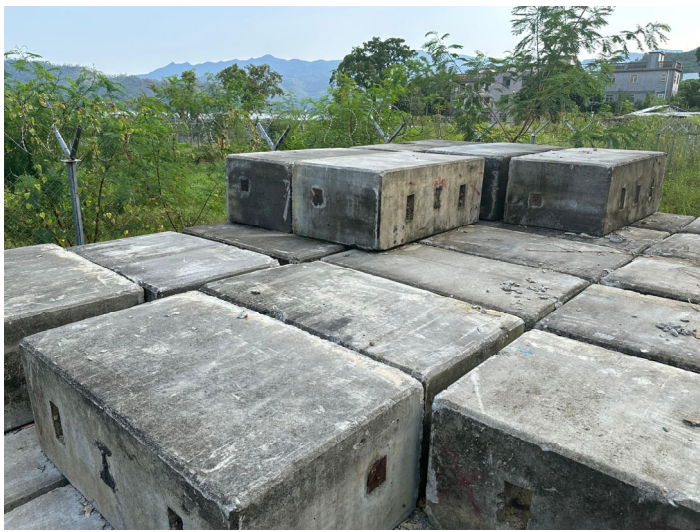
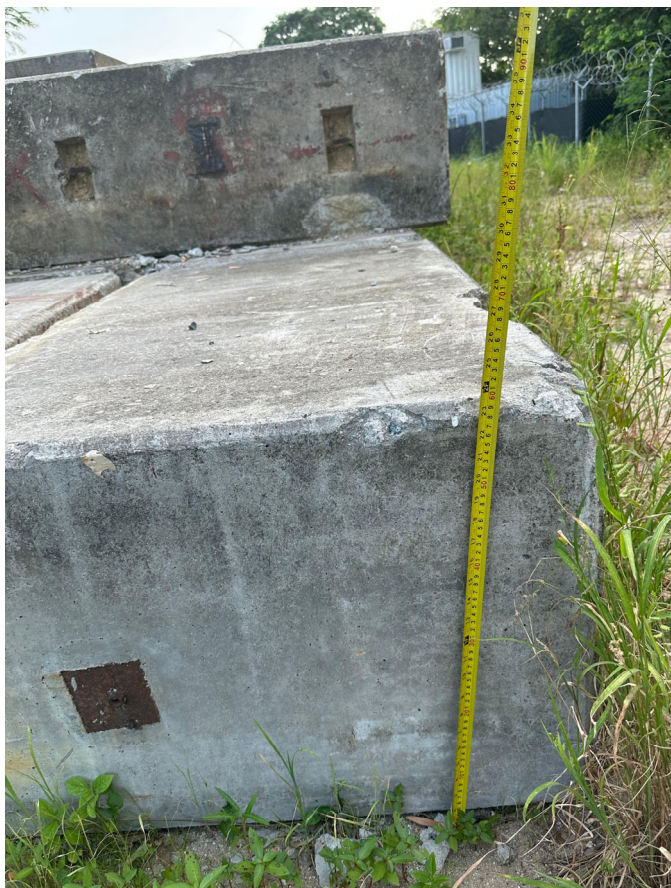
*PHOTO 6-8 Site photo for the concrete block type 2 to be removed*  
**S.T.WONG & PARTNERS LTD**

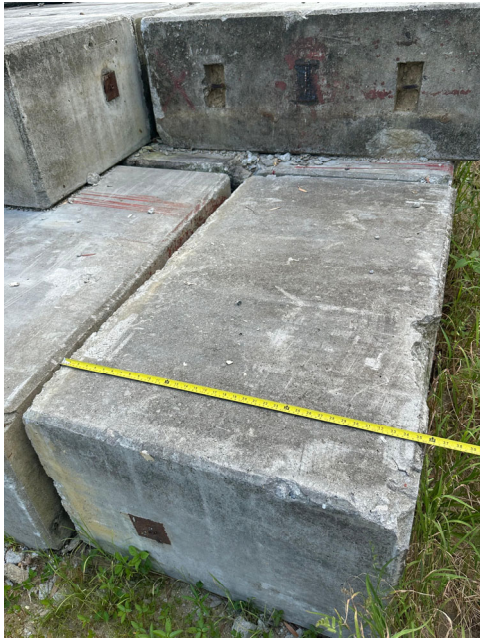
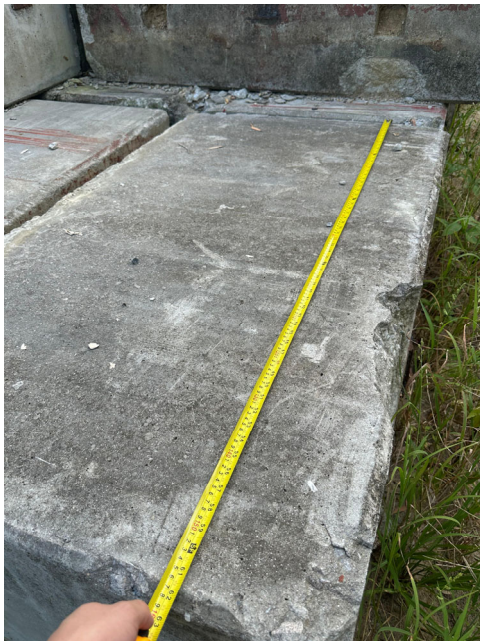
*PHOTO 9-10 Site photo for the concrete block type 2 to be removed*

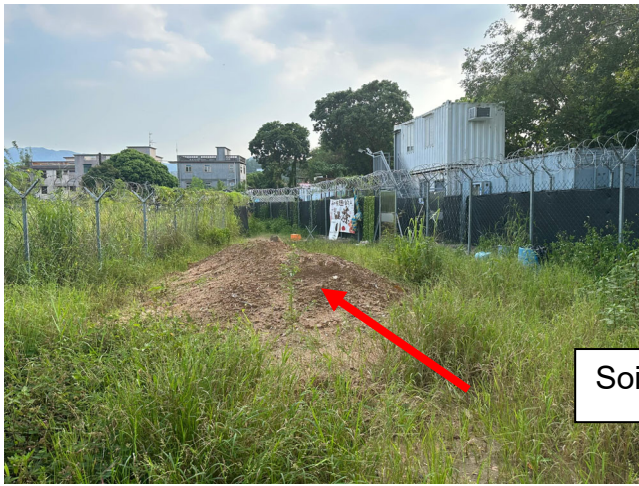
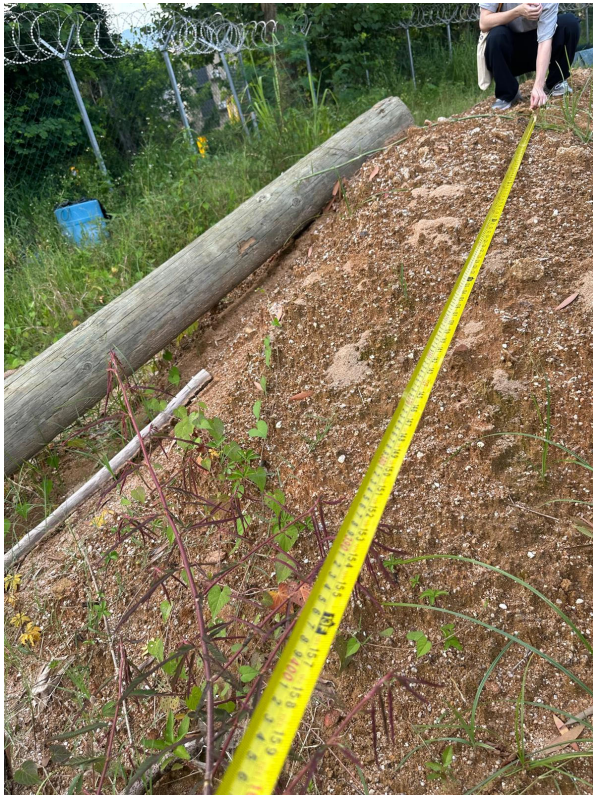
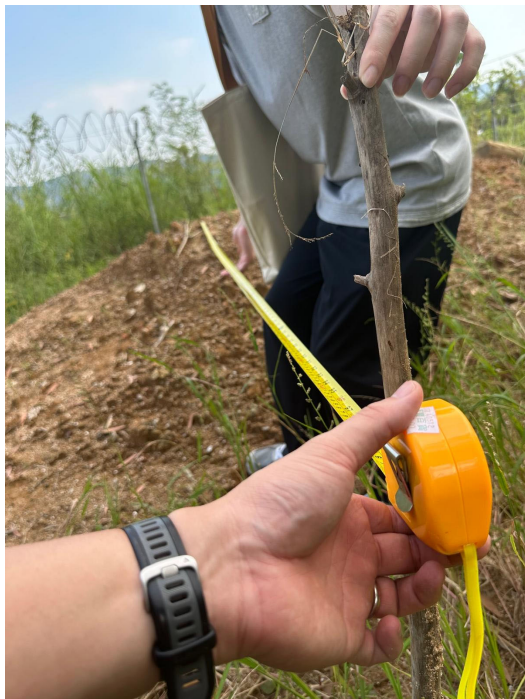
Soil on top to be removed

PHOTO11 Site photo for the soil fill to be removed (app. 4.1m(wide) x8.3m(Length)

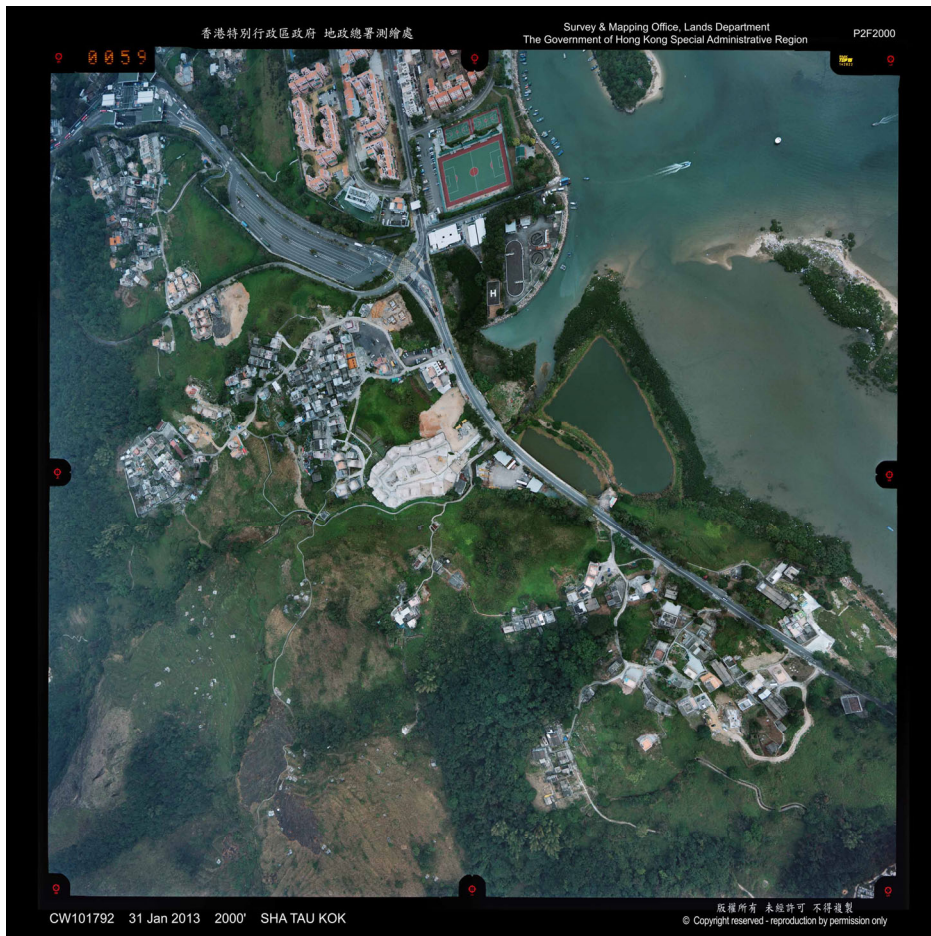
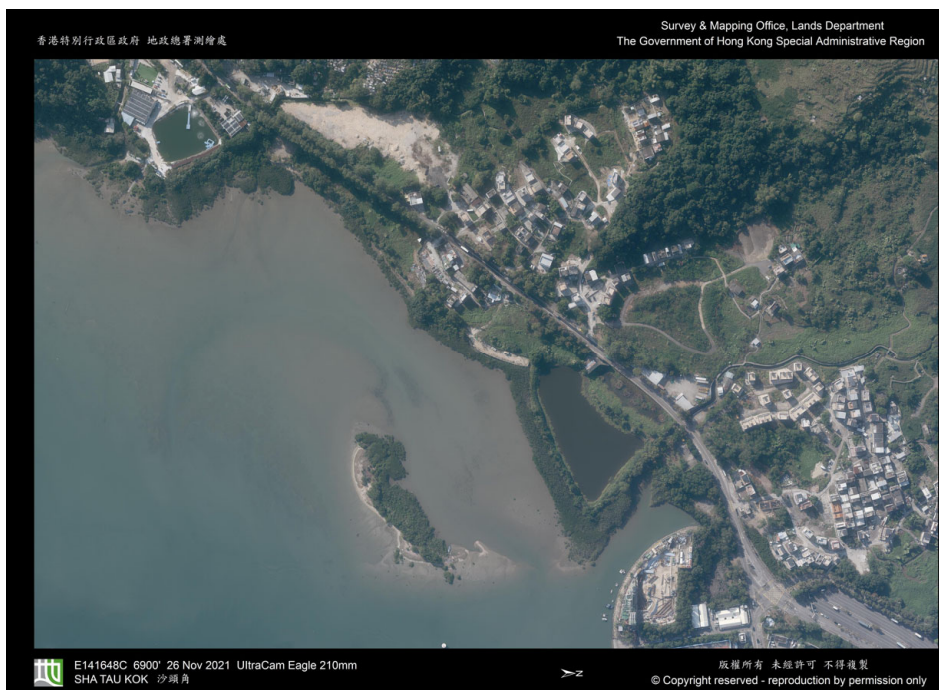
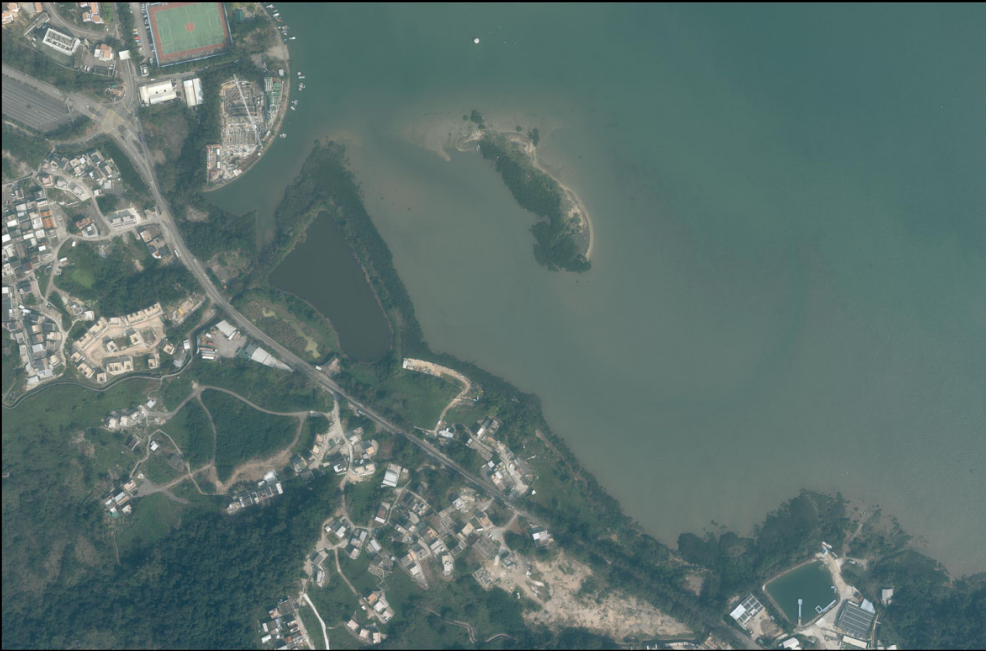
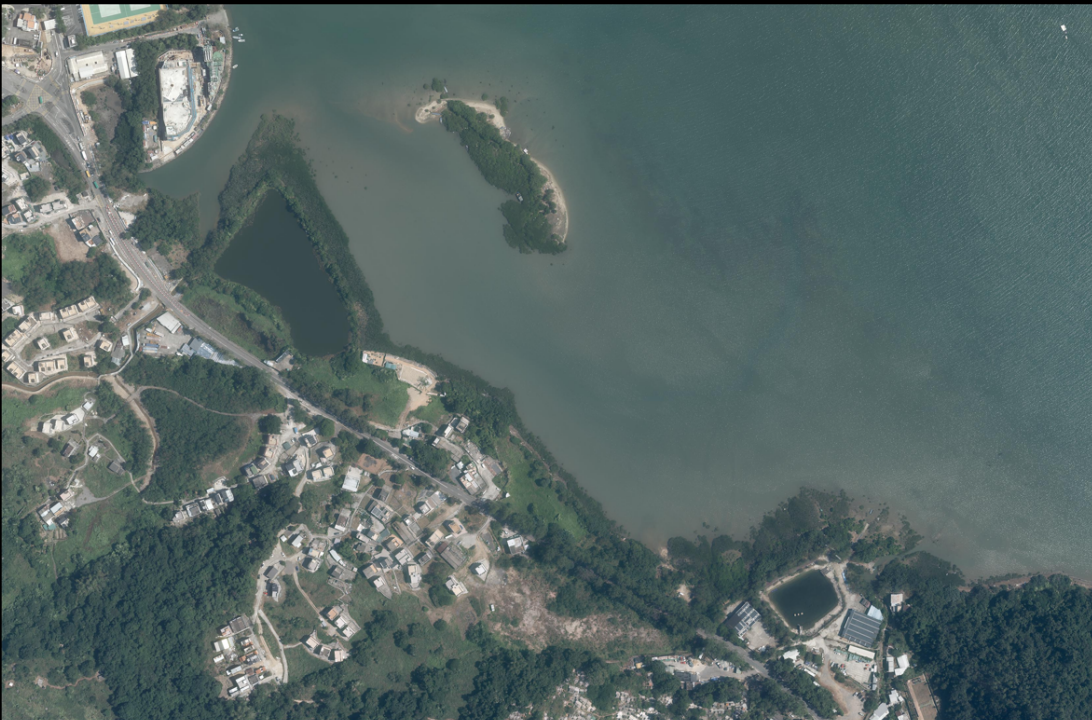
Aerial Photograph Interpretation (API) for the subject site based on the aerial photo retrieved from Land Department between 2013to 2024 reviews that there has been no significant change of the existing site profile

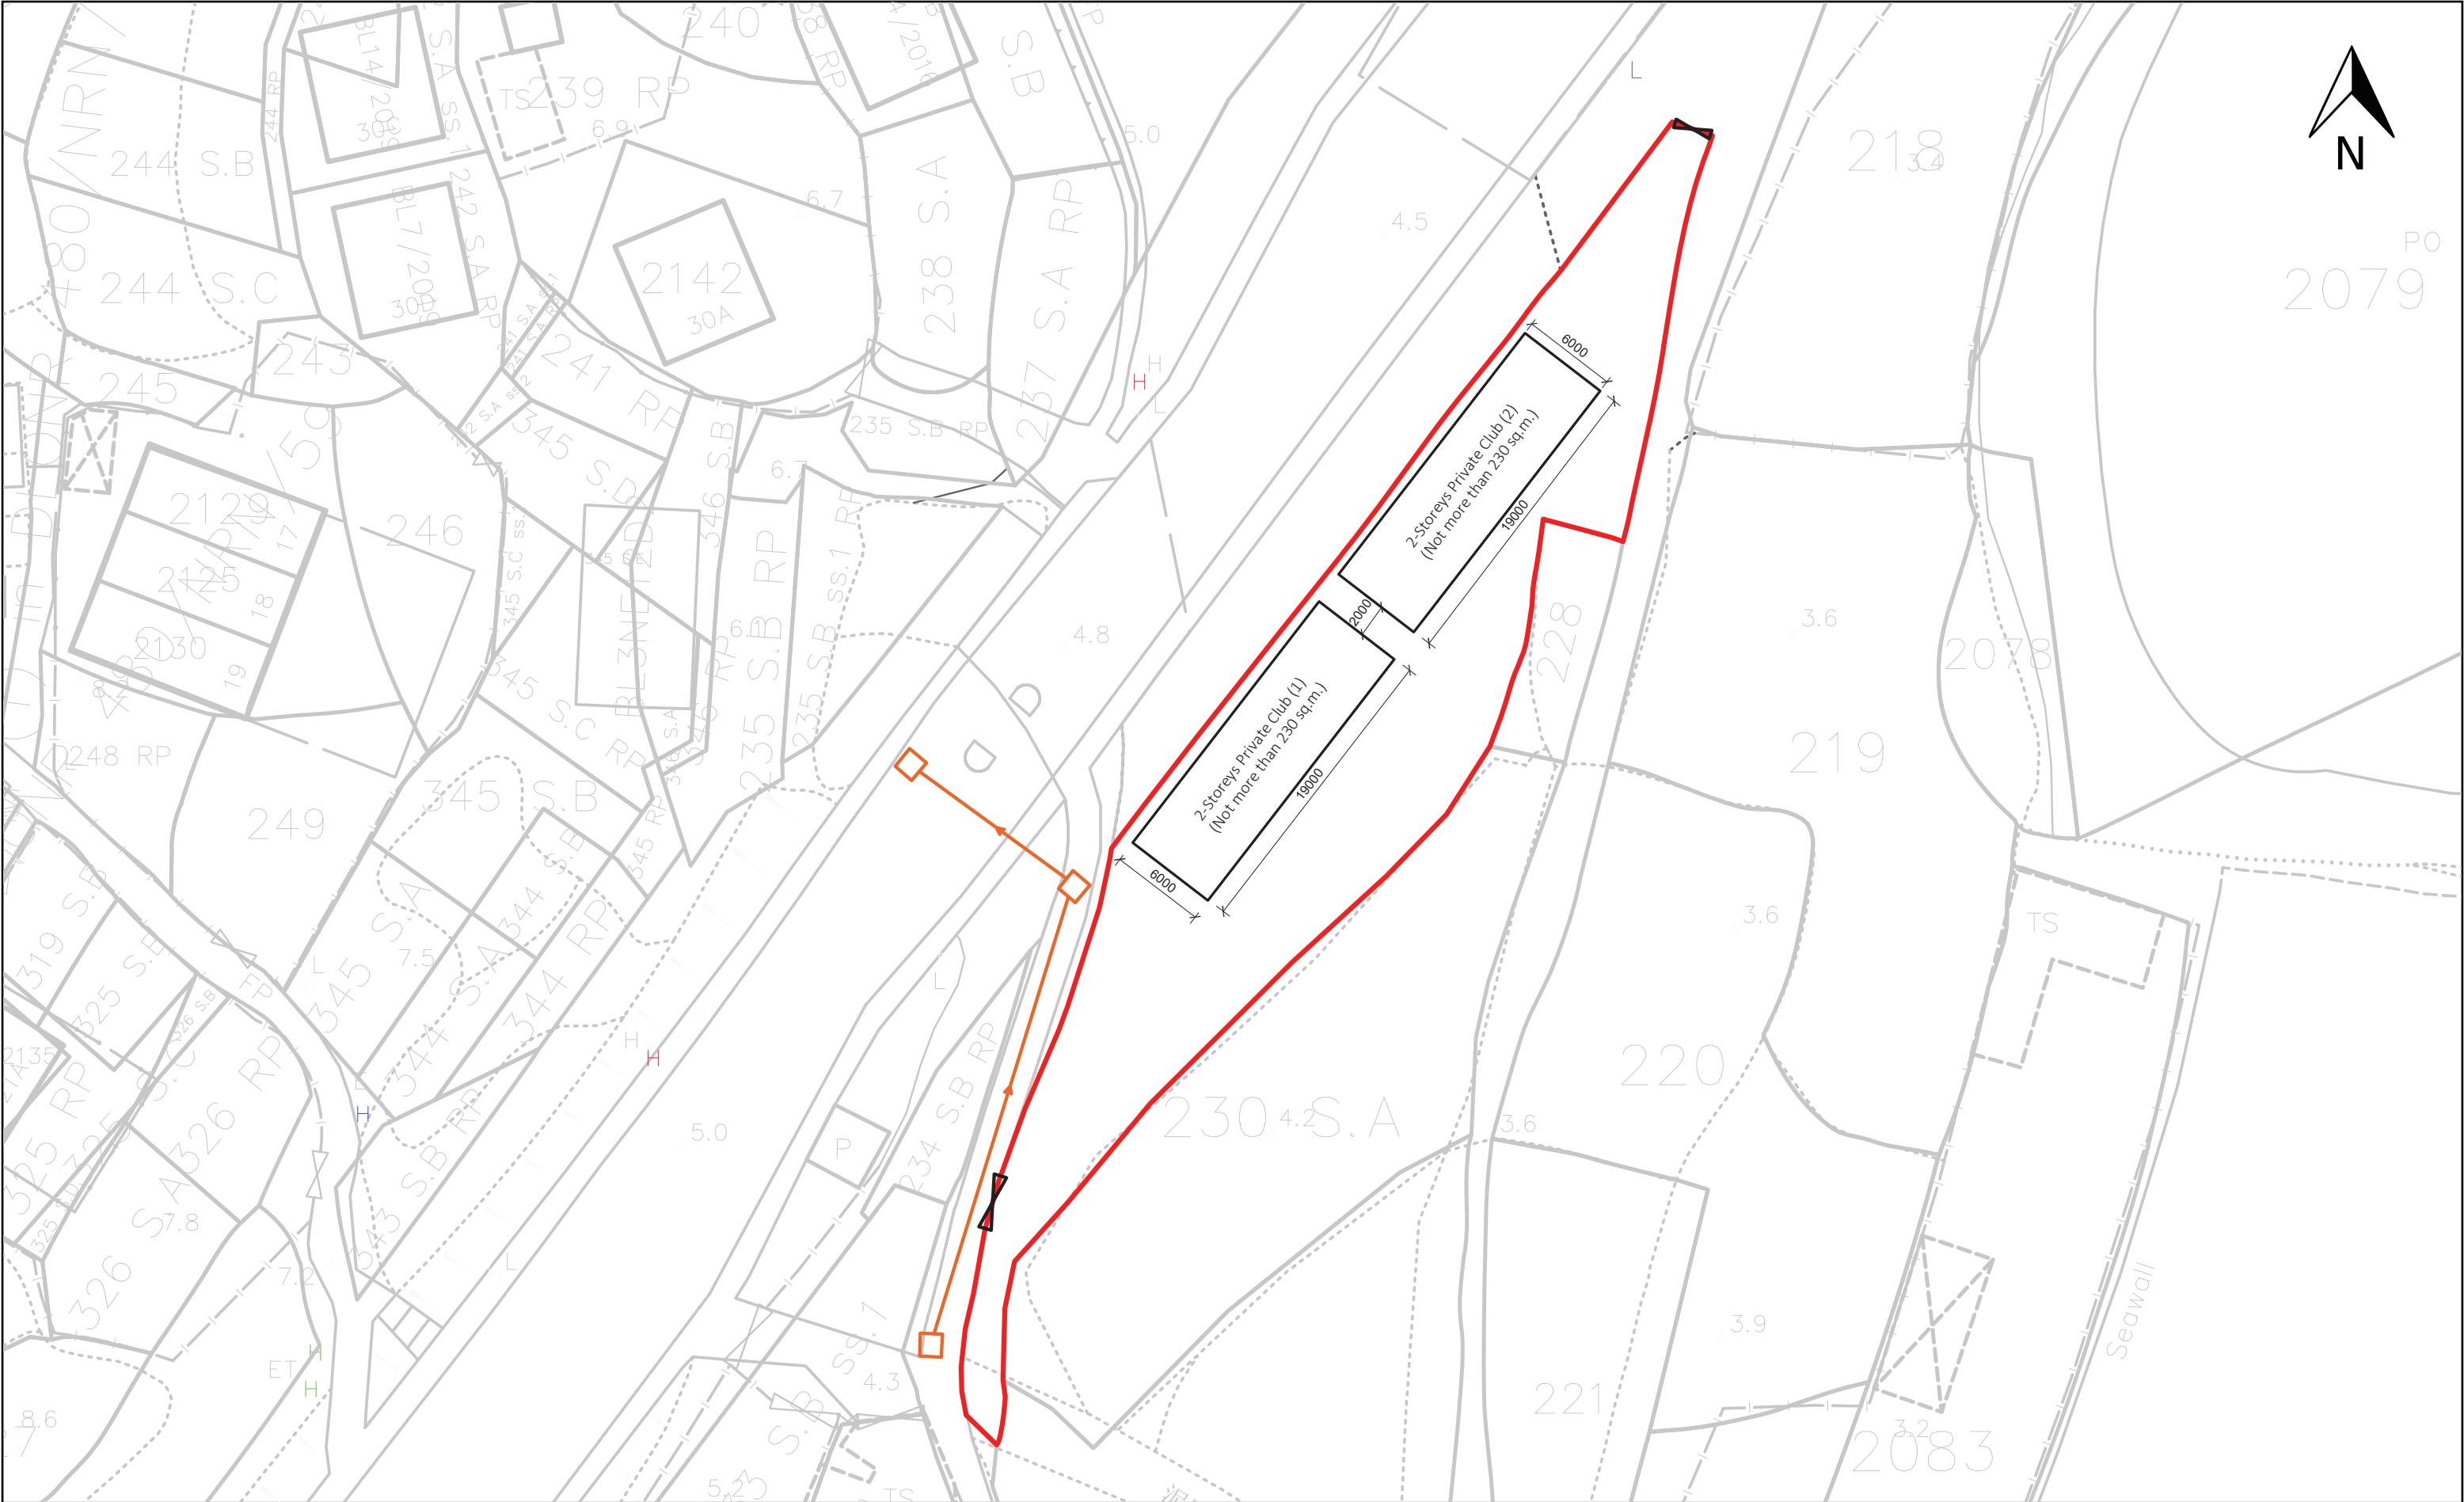
| <b>DRAWING TITLE:</b><br>SITE PLAN | <b>LEGEND:</b><br><div><div><div></div> APPLICATION BOUNDARY</div><div><div></div> EXISTING SEWER MANHOLE</div><div><div></div> EXISTING SEWER PIPE</div><div><div></div> PROPOSED PEDESTRIAN ENTRANCE(S)</div></div> | <b>SCALE:</b><br>N.T.S | <b>PREPARED BY:</b><br> DeSPACE (International) Limited |
