# Tree Survey Report

**Date of Survey: 27<sup>th</sup> October 2025**

**Various Lots In D.D. 77, Ta Kwu Ling, New Territories**

PROPOSED TEMPORARY OPEN STORAGE OF CONSTRUCTION MATERIALS AND MACHINERY AND ASSOCIATED FILLING OF LAND FOR A PERIOD OF 3 YEARS

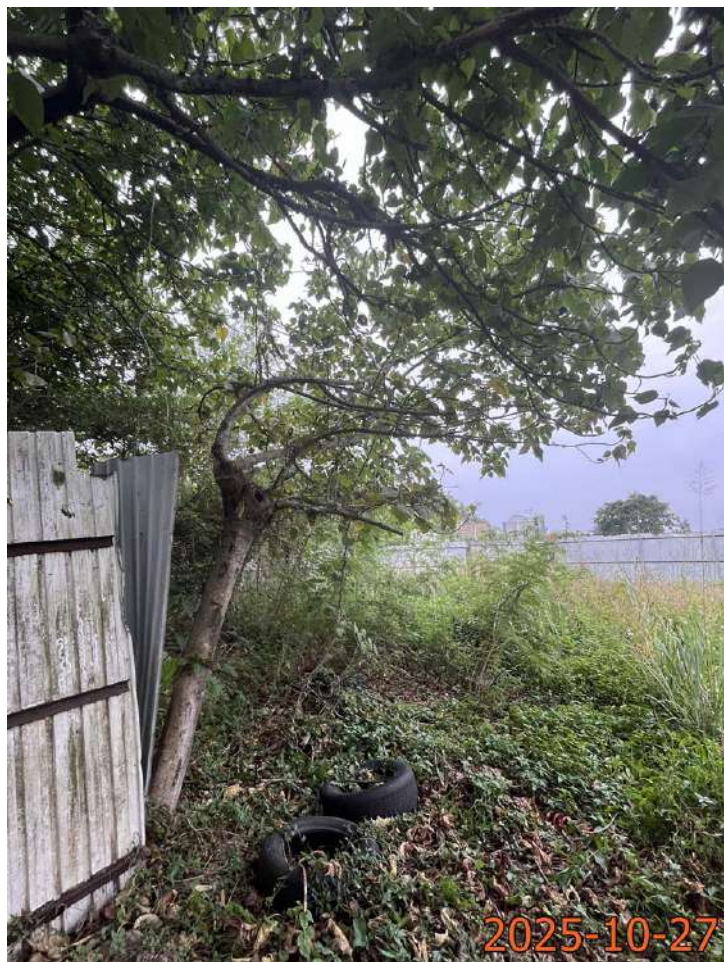
| Tree No. | Tree Species | | Tree Size Measurements | | | Amenity Value | Form | Health Condition | Structural Condition | Suitability for Transplanting | Remarks |
|---|---|---|---|---|---|---|---|---|---|---|---|
| T5 | <i>Macaranga tanarius</i> var. | 血桐 | 4.0 | 200 | 3.0 | Low | Poor | Poor | Poor | Low | leaning |

2025-10-27  
T5 (Overview) (Leaning)

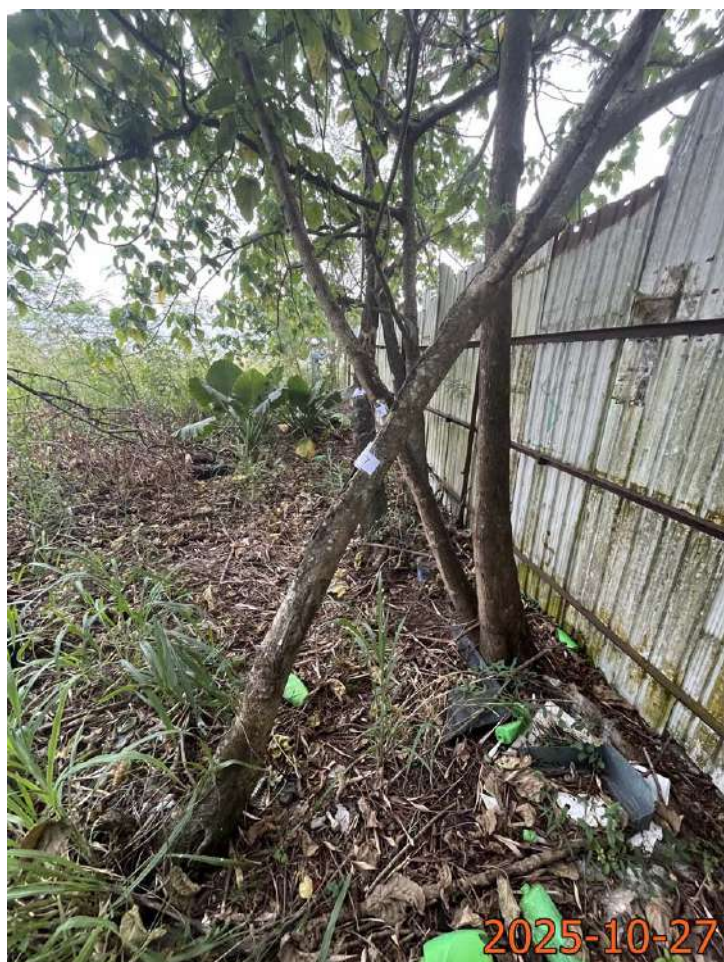
| Tree No. | Tree Species | | Tree Size Measurements | | | Amenity Value | Form | Health Condition | Structural Condition | Suitability for Transplanting | Remarks |
|---|---|---|---|---|---|---|---|---|---|---|---|
| T7 | <i>Leucaena leucocephala</i> | 銀合歡 | 5.0 | 120 | 3.0 | Low | Poor | Poor | Poor | Low | co-dominant trunks |

2025-10-27  
T7 Leaning

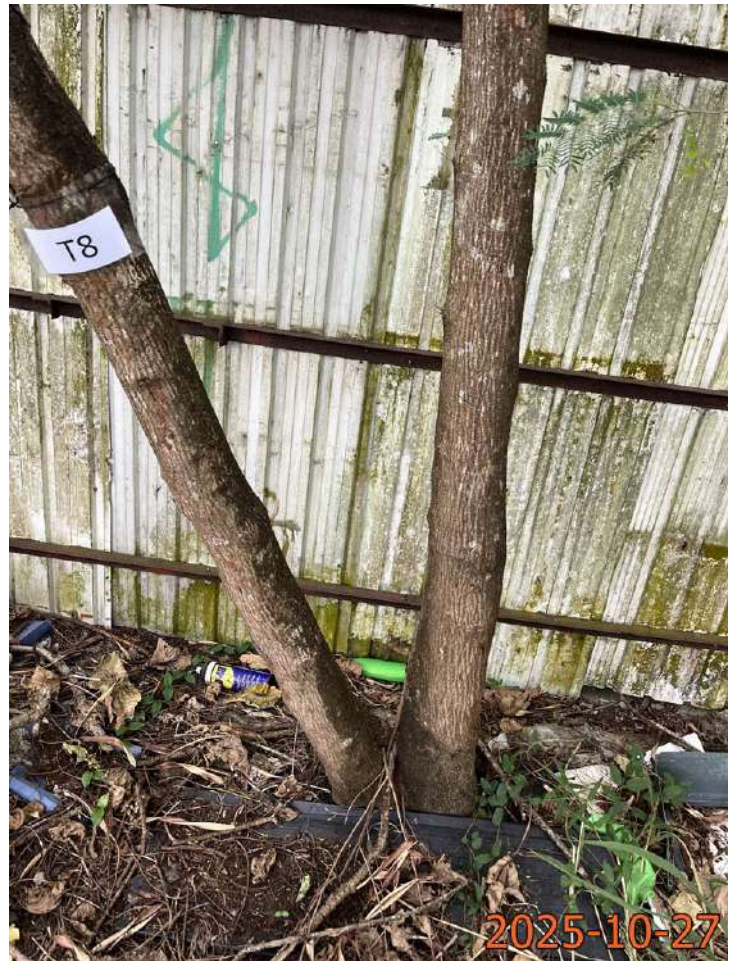
T8 Co-dominant trunk (Restricted root)

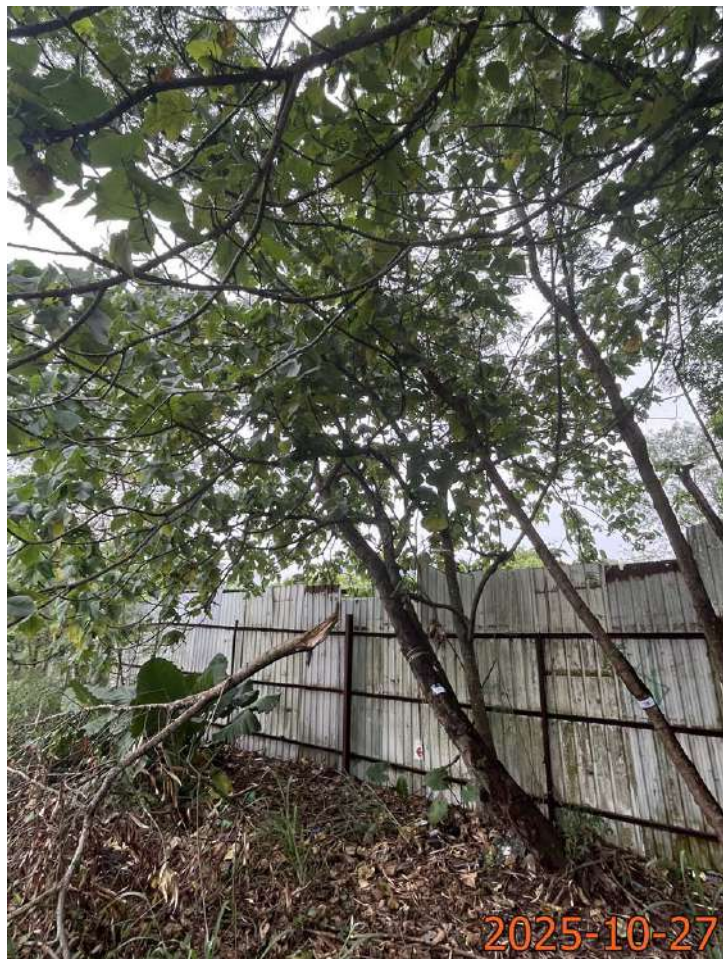
| Tree No. | Tree Species | | Tree Size Measurements | | | Amenity Value | Form | Health Condition | Structural Condition | Suitability for Transplanting | Remarks |
|---|---|---|---|---|---|---|---|---|---|---|---|
| T9 | <i>Leucaena leucocephala</i> | 銀合歡 | 7.0 | 230 | 5.0 | Low | Poor | Poor | Poor | Low | cross trunks, leaning |

T9 (Overview) (Leaning)

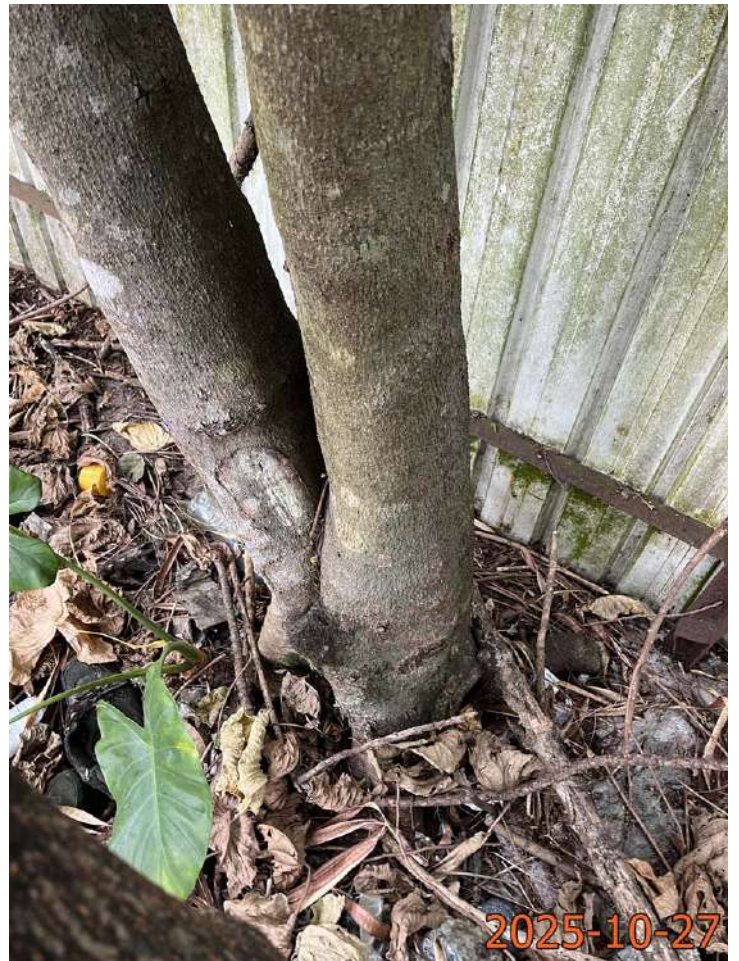
| Tree No. | Tree Species | | Tree Size Measurements | | | Amenity Value | Form | Health Condition | Structural Condition | Suitability for Transplanting | Remarks |
|---|---|---|---|---|---|---|---|---|---|---|---|
| T10 | <i>Macaranga tanarius</i> var. | 血桐 | 7.0 | 170 | 6.0 | Low | Poor | Poor | Poor | Low | co-dominant trunks |

T10 Co-dominant trunks

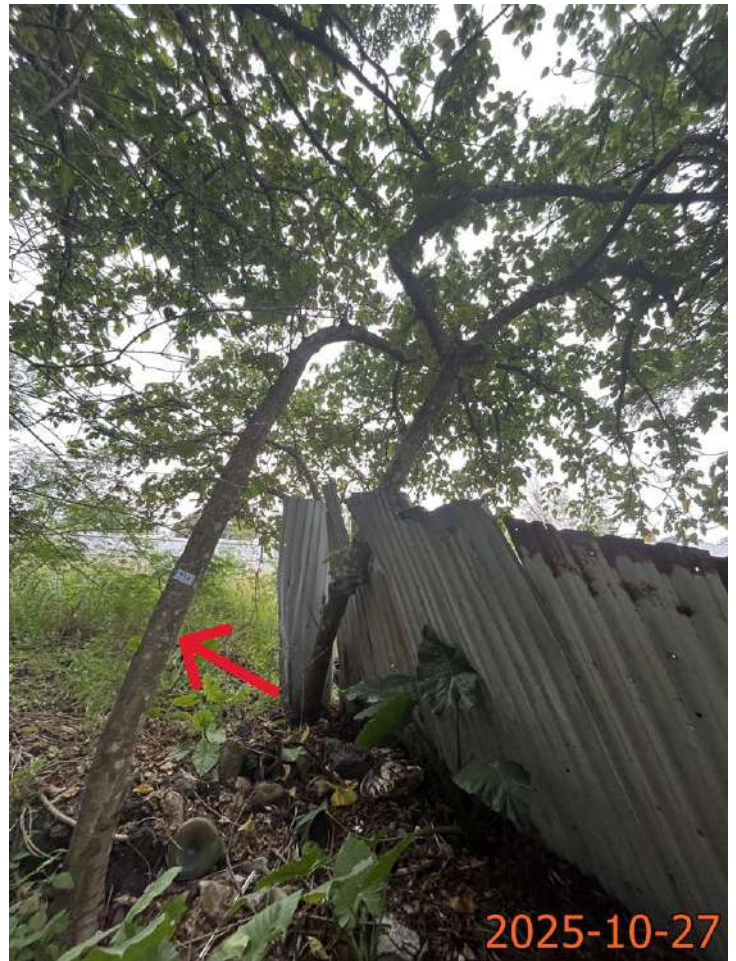
| Tree No. | Tree Species | | Tree Size Measurements | | | Amenity Value | Form | Health Condition | Structural Condition | Suitability for Transplanting | Remarks |
|---|---|---|---|---|---|---|---|---|---|---|---|
| T14 | <i>Macaranga tanarius</i> var. | 血桐 | 4.0 | 150 | 3.0 | Low | Poor | Poor | Poor | Low | leaning, bending, crooked trunk |

T14 (Overview) (Leaning, Bending)

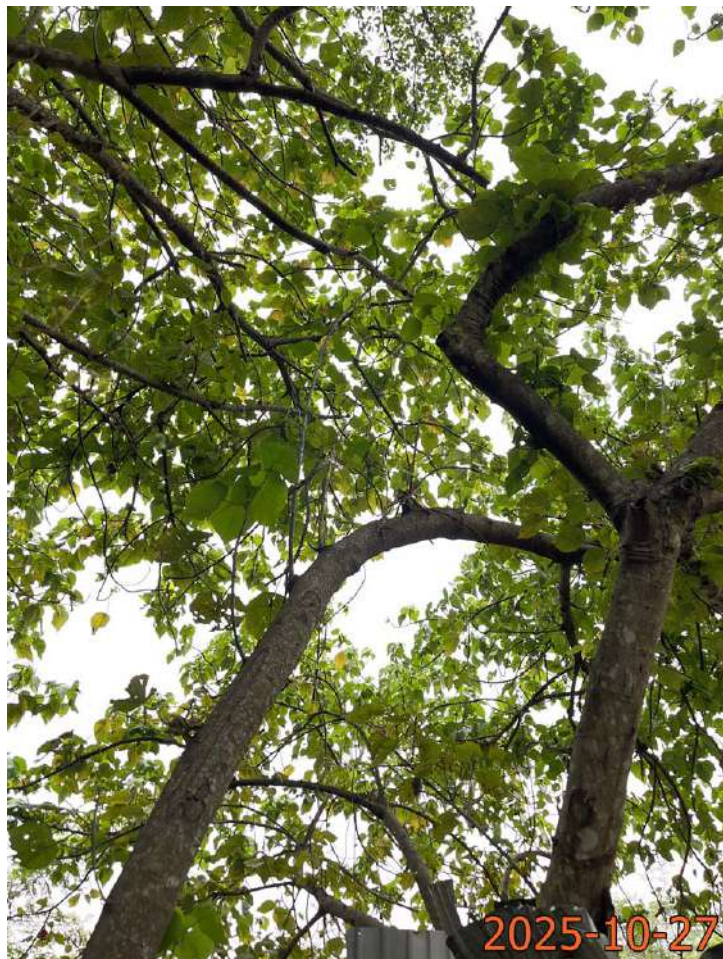
T14 Crooked trunk

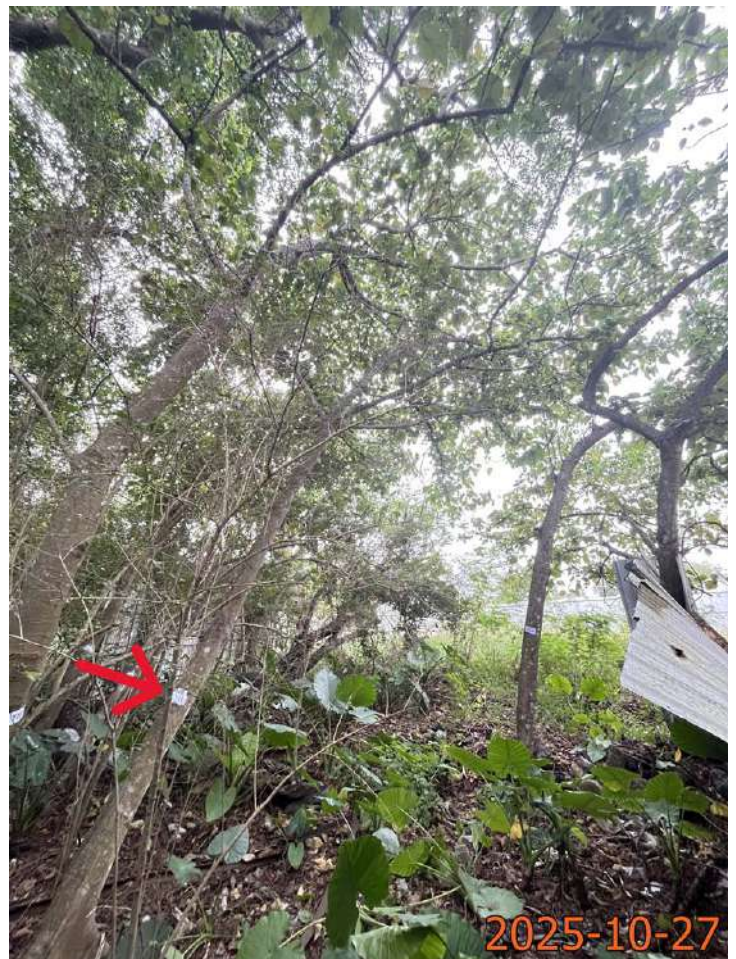
| Tree No. | Tree Species | | Tree Size Measurements | | | Amenity Value | Form | Health Condition | Structural Condition | Suitability for Transplanting | Remarks |
|---|---|---|---|---|---|---|---|---|---|---|---|
| T15 | <i>Macaranga tanarius</i> var. | 血桐 | 6.0 | 200 | 5.0 | Low | Poor | Poor | Poor | Low | leaning |

T15 (Overview) (Leaning)

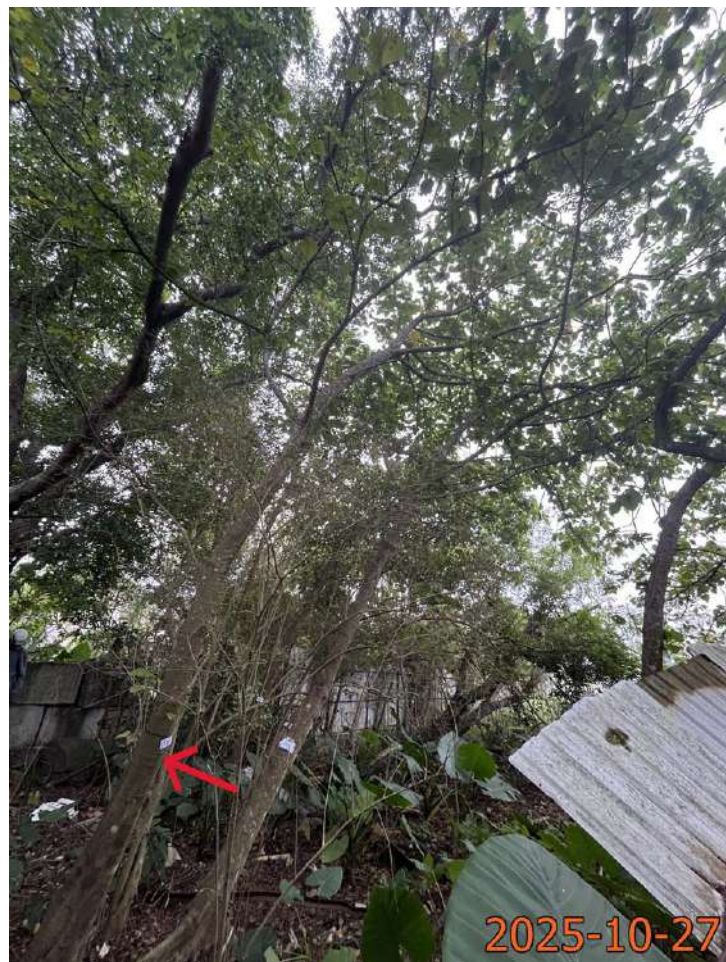
T16 (Overview) (Leaning)

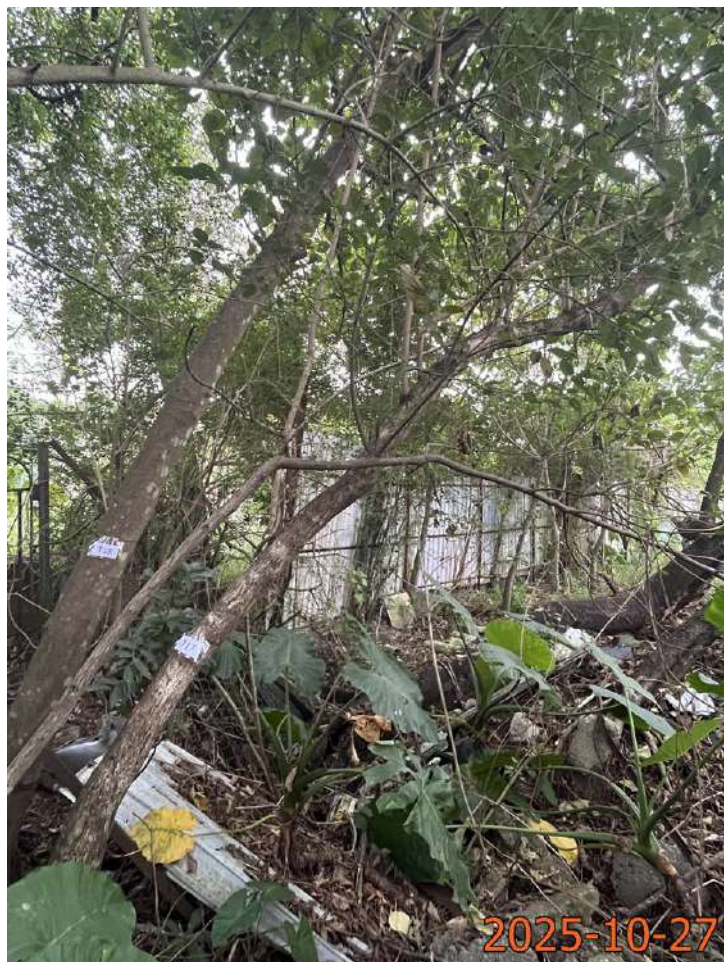
T17 (Overview) (Leaning)

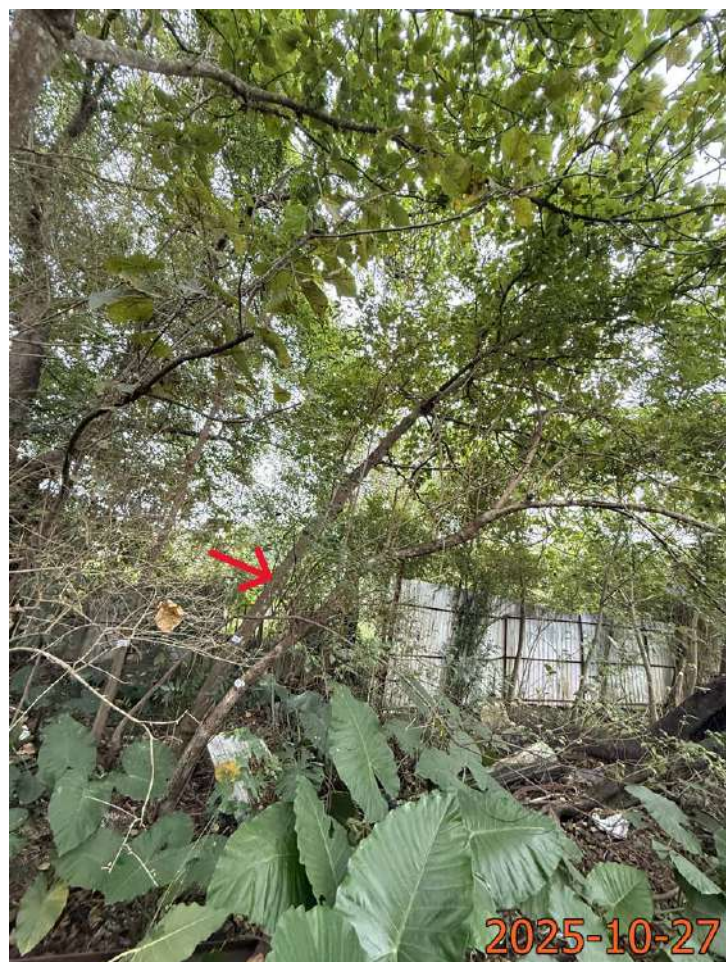
| Tree No. | Tree Species | | Tree Size Measurements | | | Amenity Value | Form | Health Condition | Structural Condition | Suitability for Transplanting | Remarks |
|---|---|---|---|---|---|---|---|---|---|---|---|
| T18 | <i>Macaranga tanarius</i> var. | 血桐 | 6.0 | 200 | 5.0 | Low | Poor | Poor | Poor | Low | leaning |

T18 (Overview) (Leaning)

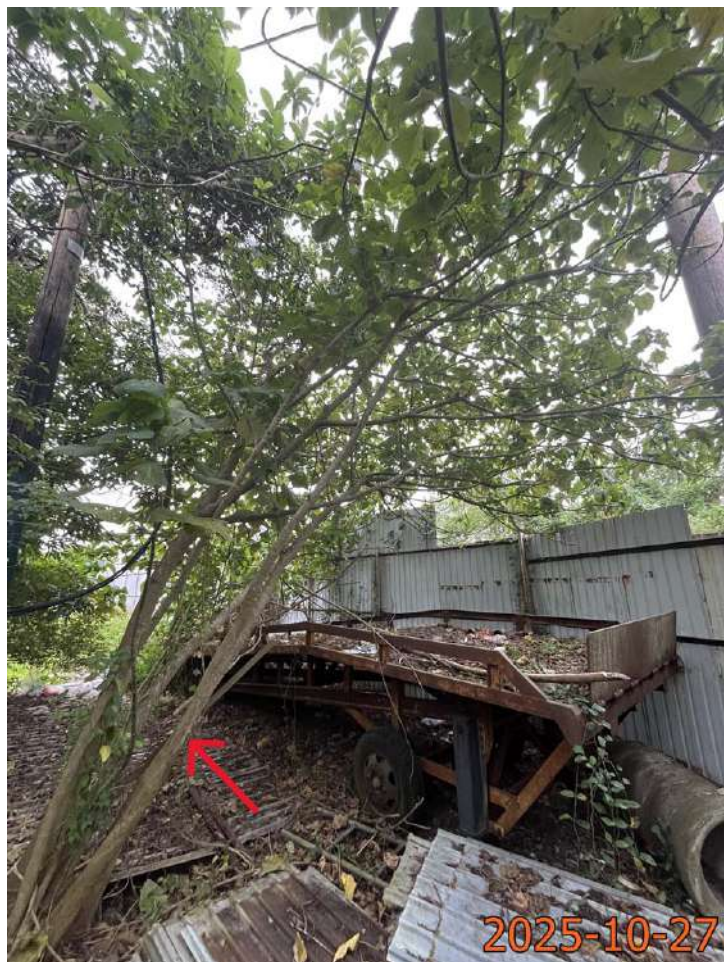
T21 (Overview) (Leaning)

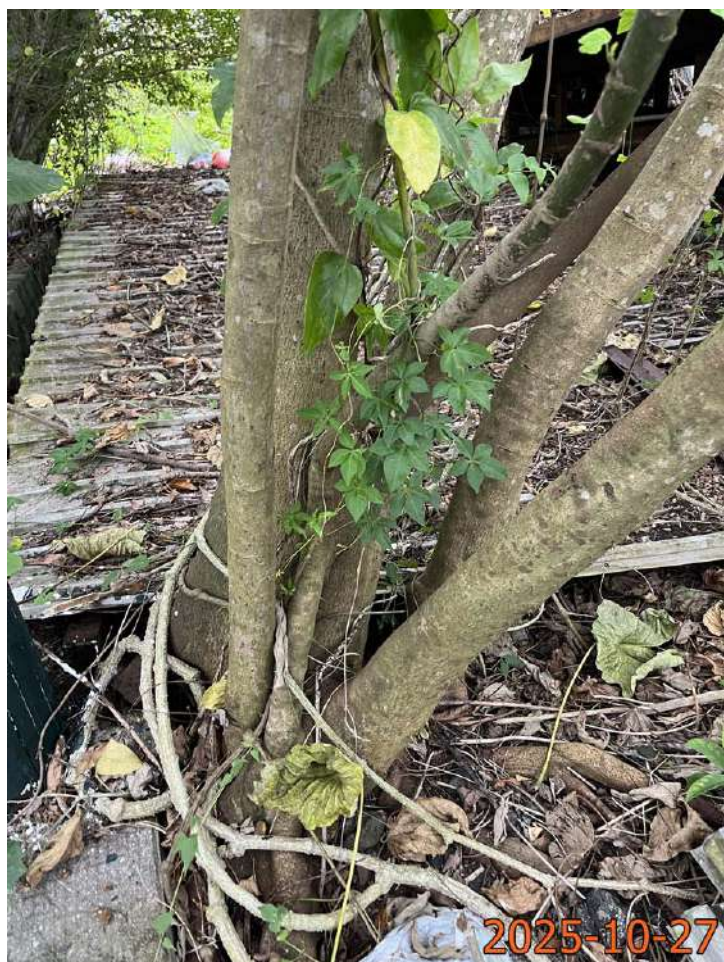
| Tree No. | Tree Species | | Tree Size Measurements | | | Amenity Value | Form | Health Condition | Structural Condition | Suitability for Transplanting | Remarks |
|---|---|---|---|---|---|---|---|---|---|---|---|
| T21 | <i>Macaranga tanarius</i> var. | 血桐 | 5.0 | 195 | 6.0 | Low | Poor | Poor | Poor | Low | multi-trunks |

T21 Multi-trunks

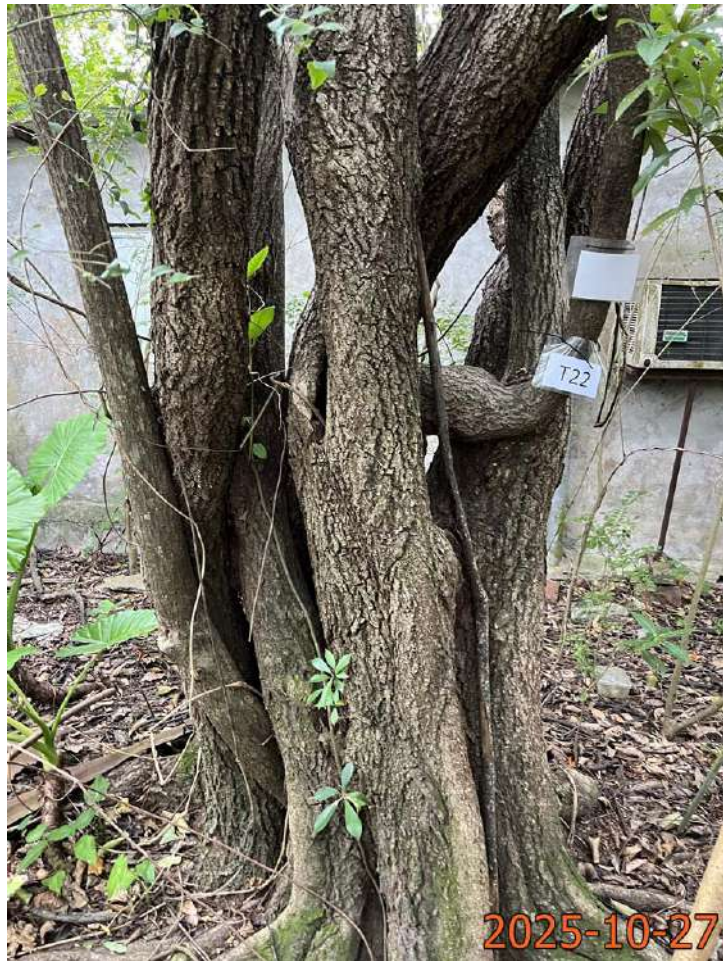
| Tree No. | Tree Species | | Tree Size Measurements | | | Amenity Value | Form | Health Condition | Structural Condition | Suitability for Transplanting | Remarks |
|---|---|---|---|---|---|---|---|---|---|---|---|
| T22 | <i>Annona glabra</i> | 圓滑番荔枝 | 7.0 | 600 | 7.0 | Low | Poor | Poor | Poor | Low | multi-trunks |

T22 Multi-trunks

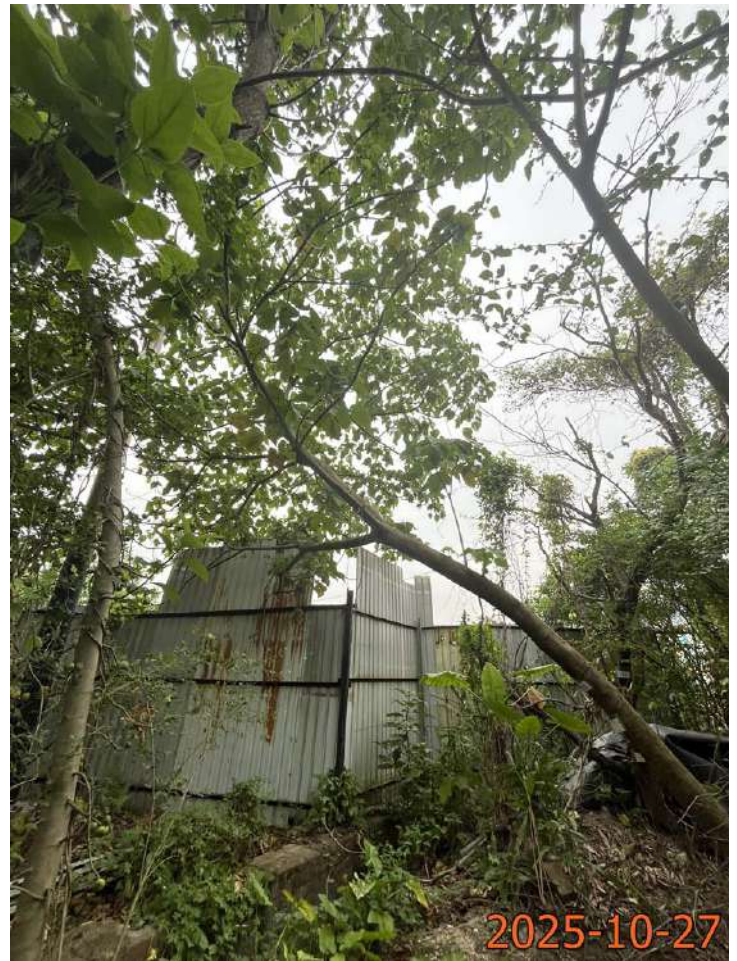
| Tree No. | Tree Species | | Tree Size Measurements | | | Amenity Value | Form | Health Condition | Structural Condition | Suitability for Transplanting | Remarks |
|---|---|---|---|---|---|---|---|---|---|---|---|
| T23 | <i>Macaranga tanarius</i> var. | 血桐 | 5.0 | 180 | 6.0 | Low | Poor | Poor | Poor | Low | leaning |

T23 (Overview) (Leaning)

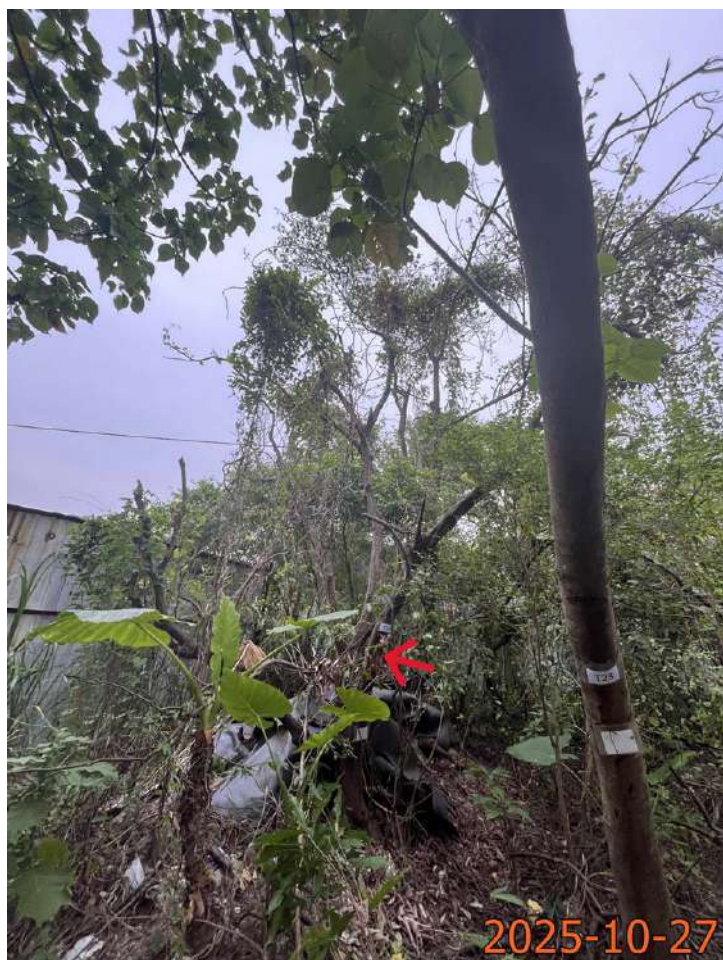
T24 (Overview)

| Tree No. | Tree Species | | Tree Size Measurements | | | Amenity Value | Form | Health Condition | Structural Condition | Suitability for Transplanting | Remarks |
|---|---|---|---|---|---|---|---|---|---|---|---|
| T24 | Dead tree | 死樹 | 5.0 | 165 | 4.0 | - | - | Dead | - | - | dead tree |

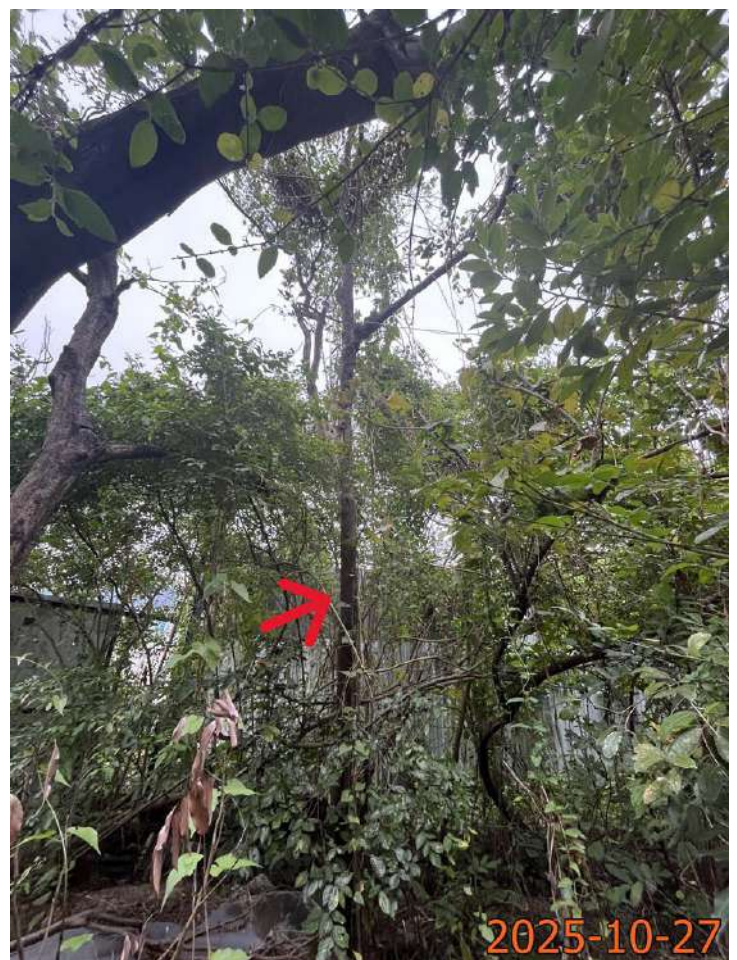
T25 (Overview)

| Tree No. | Tree Species | | Tree Size Measurements | | | Amenity Value | Form | Health Condition | Structural Condition | Suitability for Transplanting | Remarks |
|---|---|---|---|---|---|---|---|---|---|---|---|
| T25 | Dead tree | 死樹 | 6.0 | 160 | 3.0 | - | - | Dead | - | - | dead tree |

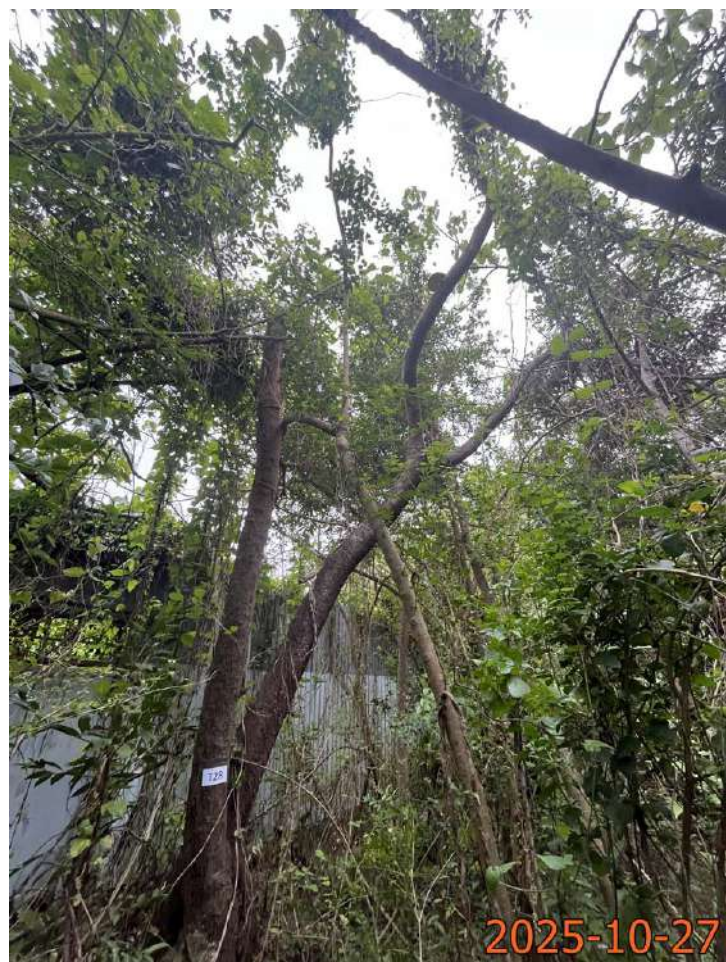
T28 (Overview)

| Tree No. | Tree Species | | Tree Size Measurements | | | Amenity Value | Form | Health Condition | Structural Condition | Suitability for Transplanting | Remarks |
|---|---|---|---|---|---|---|---|---|---|---|---|
| T28 | Dead tree | 死樹 | 7.0 | 265 | 4.0 | - | - | Dead | - | - | dead tree |

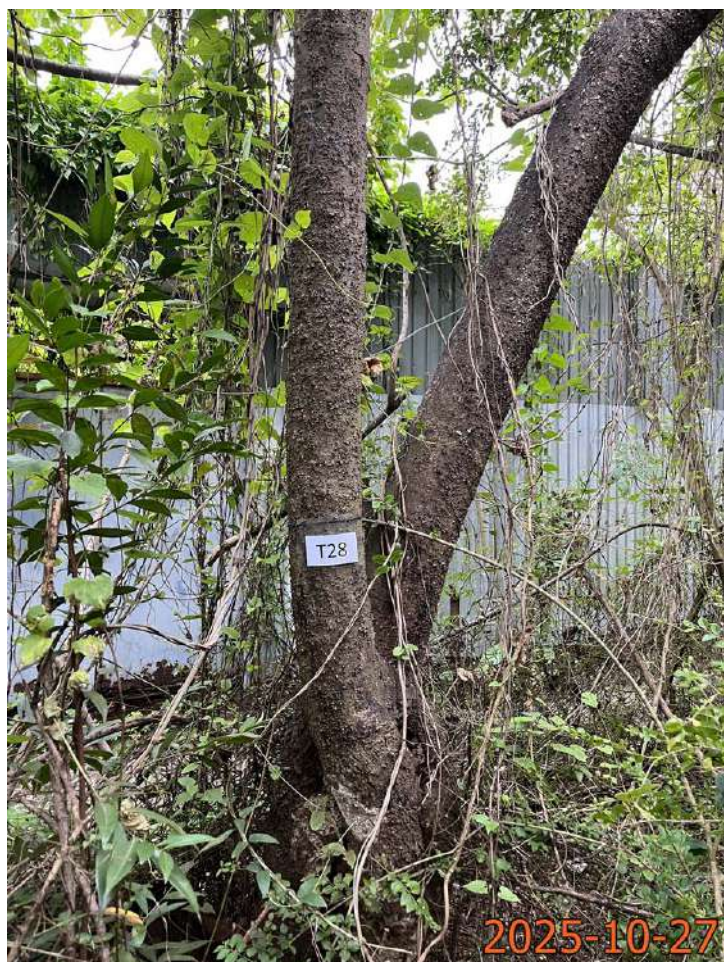
T28 Co-dominant trunks

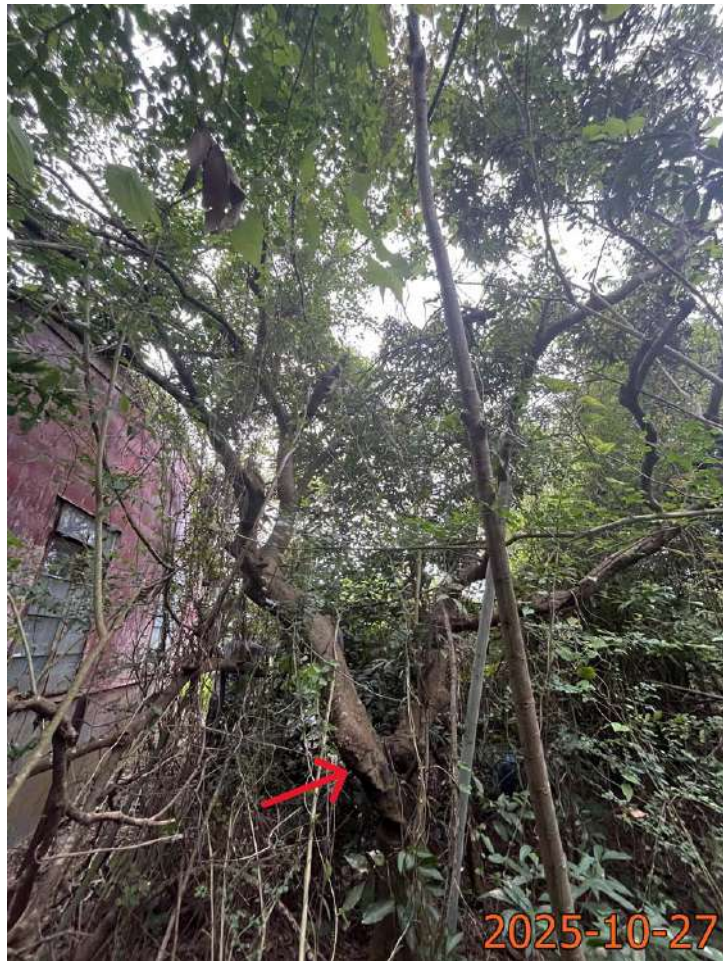
| Tree No. | Tree Species | | Tree Size Measurements | | | Amenity Value | Form | Health Condition | Structural Condition | Suitability for Transplanting | Remarks |
|---|---|---|---|---|---|---|---|---|---|---|---|
| T29 | Dead tree | 死樹 | 6.0 | 235 | 7.0 | - | - | Dead | - | - | dead tree |

T29 (Overview) (Dead tree)

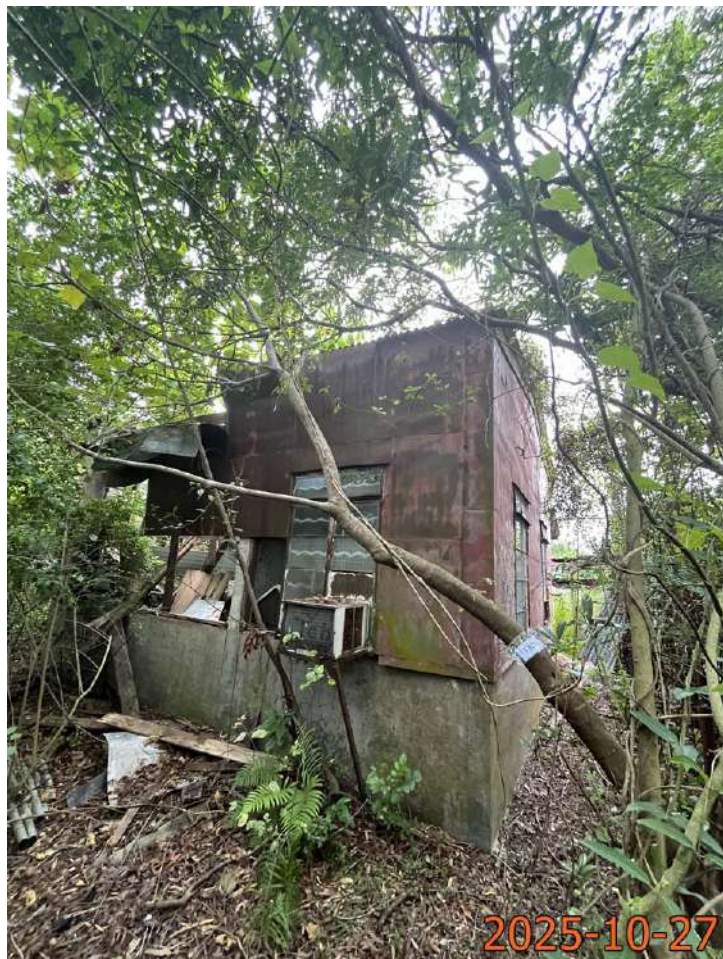
| Tree No. | Tree Species | | Tree Size Measurements | | | Amenity Value | Form | Health Condition | Structural Condition | Suitability for Transplanting | Remarks |
|---|---|---|---|---|---|---|---|---|---|---|---|
| T30 | <i>Macaranga tanarius</i> var. | 血桐 | 5.0 | 100 | 4.0 | Low | Poor | Poor | Poor | Low | leaning |

T30 (Overview) (Leaning)

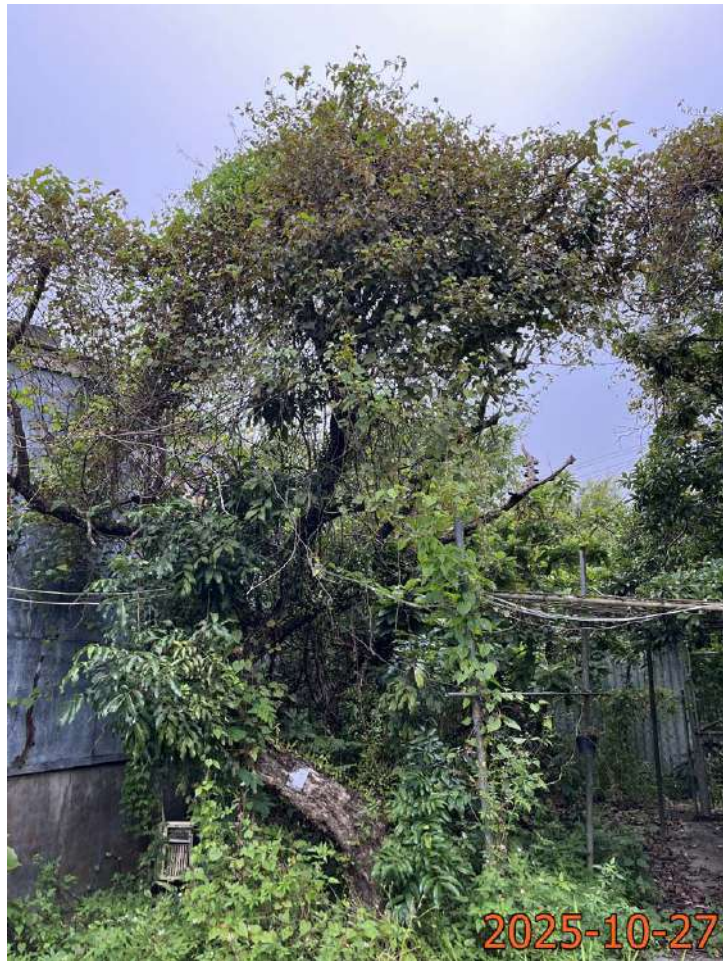
| Tree No. | Tree Species | | Tree Size Measurements | | | Amenity Value | Form | Health Condition | Structural Condition | Suitability for Transplanting | Remarks |
|---|---|---|---|---|---|---|---|---|---|---|---|
| T32 | <i>Clausena lansium</i> | 黃皮 | 4.0 | 420 | 5.0 | Low | Poor | Poor | Poor | Low | climber |

T32 (Overview) (Climber)

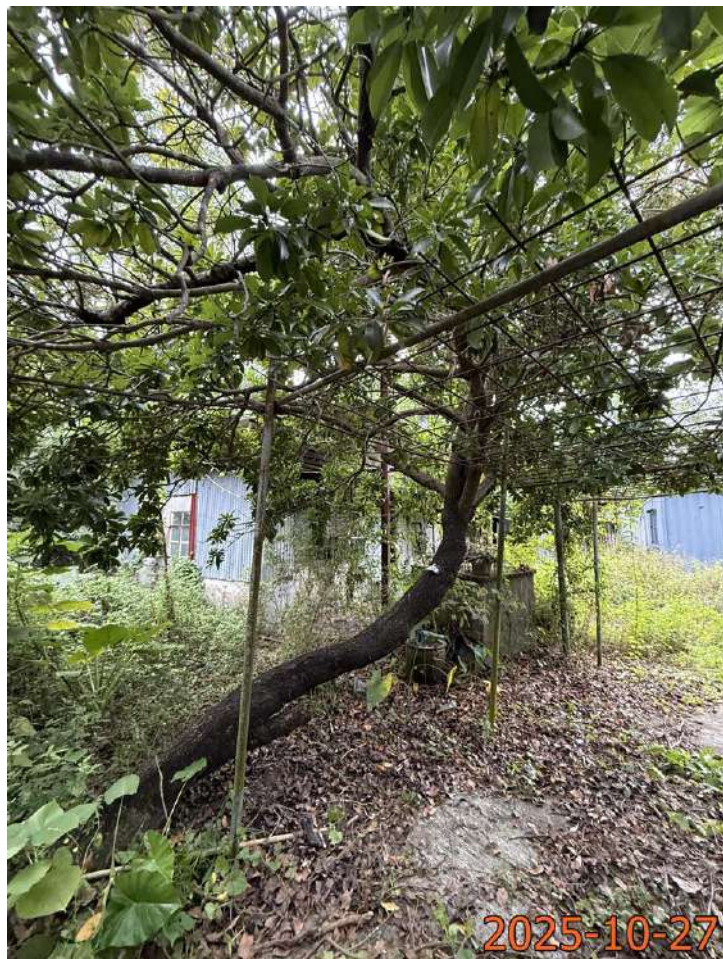
T33 Leaning (Crooked trunk)

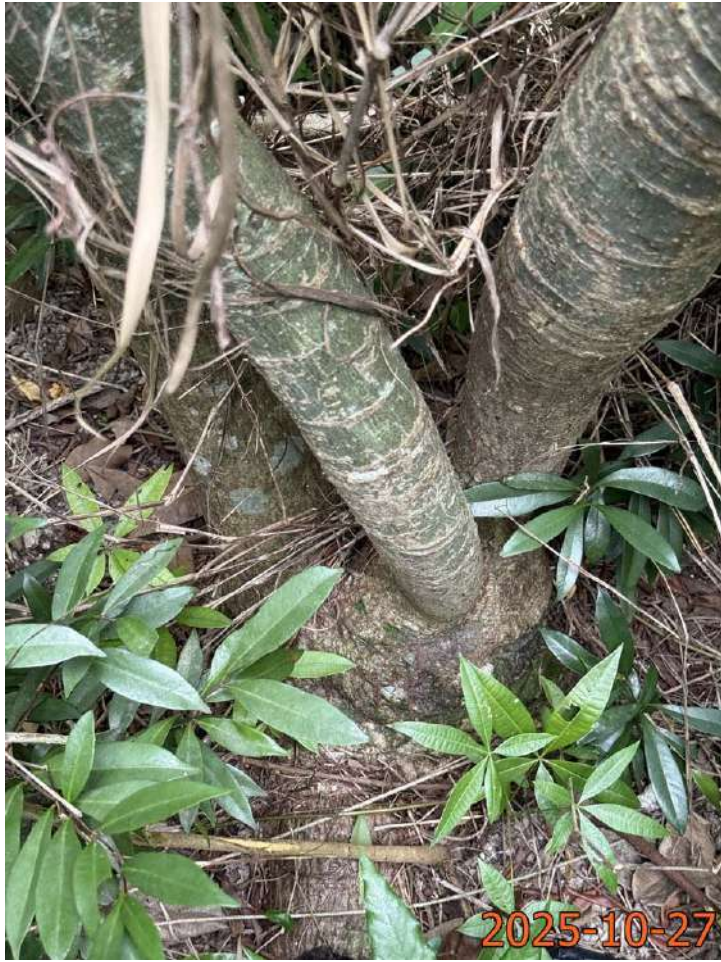
| Tree No. | Tree Species | | Tree Size Measurements | | | Amenity Value | Form | Health Condition | Structural Condition | Suitability for Transplanting | Remarks |
|---|---|---|---|---|---|---|---|---|---|---|---|
| T34 | <i>Carica papaya</i> | 番木瓜 | 5.0 | 143 | 5.0 | Low | Poor | Poor | Poor | Low | multi-trunks |

T34 Multi-trunks

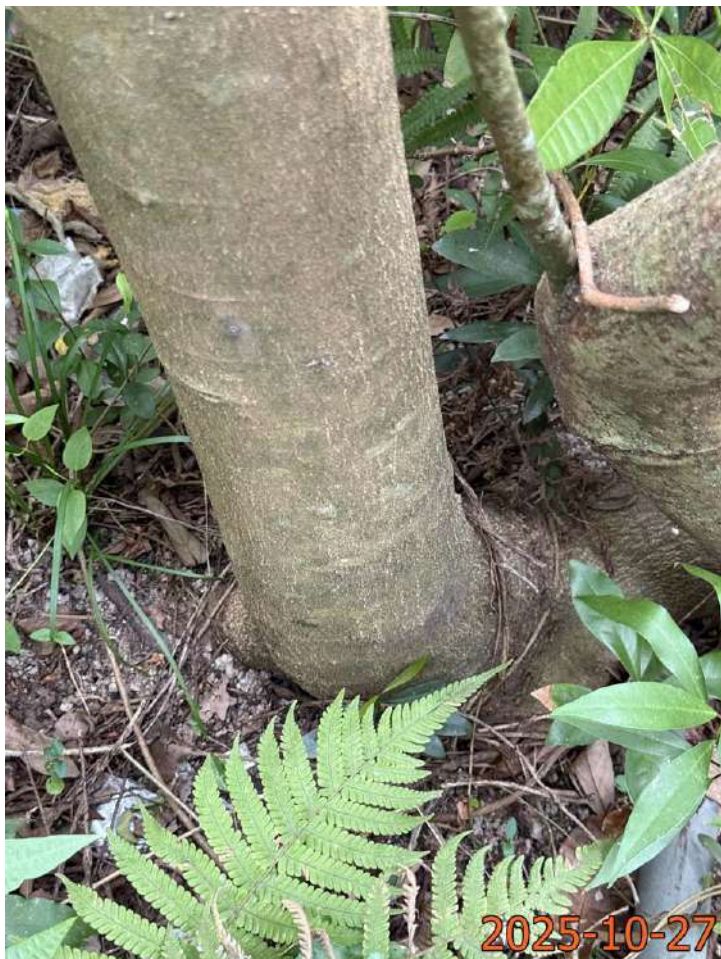
| Tree No. | Tree Species | | Tree Size Measurements | | | Amenity Value | Form | Health Condition | Structural Condition | Suitability for Transplanting | Remarks |
|---|---|---|---|---|---|---|---|---|---|---|---|
| T35 | <i>Celtis sinensis</i> | 朴樹 | 6.0 | 135 | 5.0 | Low | Poor | Poor | Poor | Low | co-dominant trunks |

T35 Co-dominant trunks
