**Proposed Flat, Minor Relaxation of Plot Ratio and Building Height  
Restriction, Lots 531 RP, 532 S.D RP and 532 RP in D.D. 130 and  
Adjoining Government Land, Lam Tei,  
Tuen Mun, New Territories**

**Tree Preservation Proposal**

**7<sup>th</sup> November 2025**

**SCENIC Landscape Studio Limited**

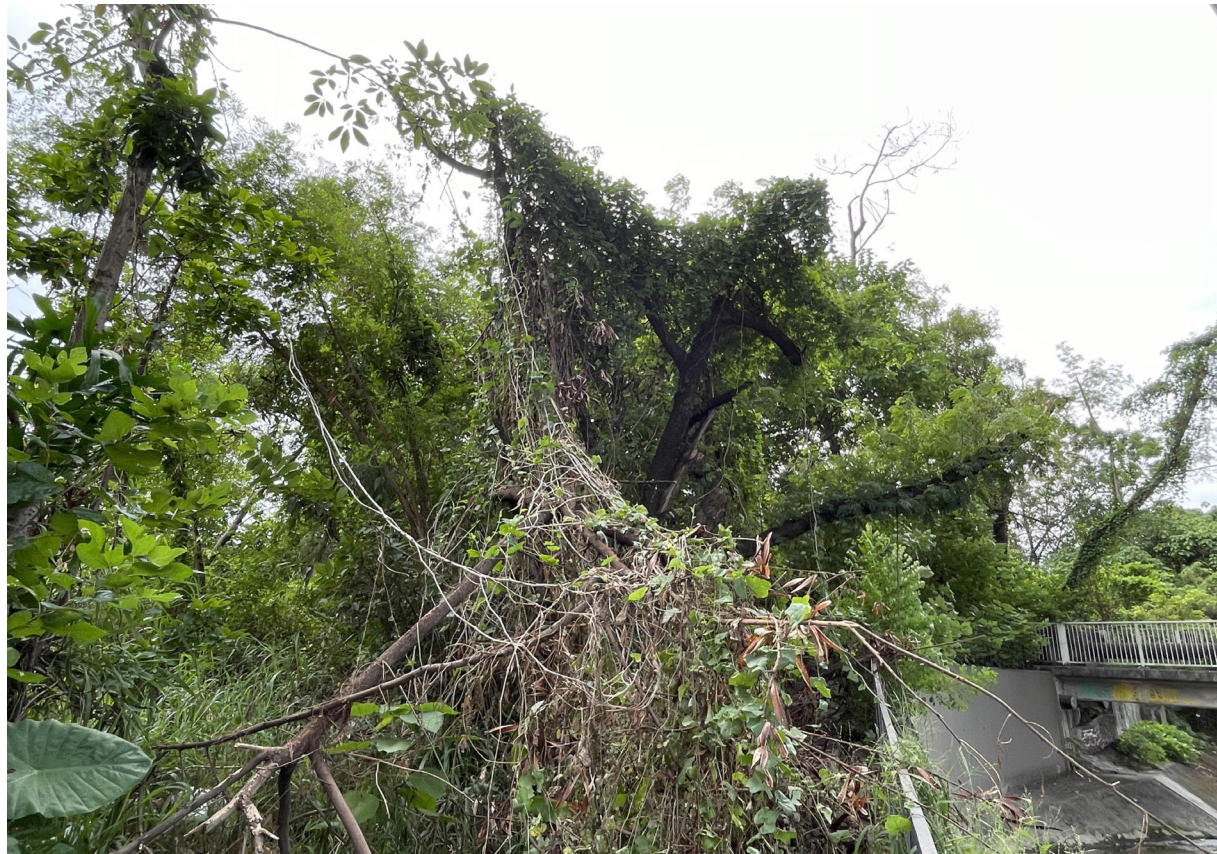
VP 01: Tree Group 01

- 4.4 Within the development site, the most numerous existing trees are *Cinnamomum camphora* (5 nos.), *Macaranga tanarius* (L.) Müll. Arg. var. *tomentosa* (4 nos.) and *Leucaena leucocephala* (3 nos.). Other species include *Bombax ceiba*, *Melia azedarach* and *Morus alba*. Other species identified are generally present in quantities of less than 3 nos.. The photographs in **Annex IV** show the condition of the existing trees.

- 4.7 A high proportion of the trees exhibit a fair to poor existing form and condition and have a low amenity value. This includes a large proportion of the trees which have a spindly, contorted and often leaning form with asymmetrical canopy growth due to their close proximity to one another and the competition for light.

5.7 It should be noted that the majority of these trees which are recommended for felling have a poor to average form, an average to poor health condition and structural condition and low amenity value. The majority of the affected trees have a low suitability for transplantation. In addition, 3 nos of the trees recommended for felling within the Development Site are the weed species *Leucaena leucocephala*.
