## Appendix 6

### Tree Survey

**Project Title: Lot 2447 S.A RP in D.D. 130**

**Date of survey: 5-12-2025**

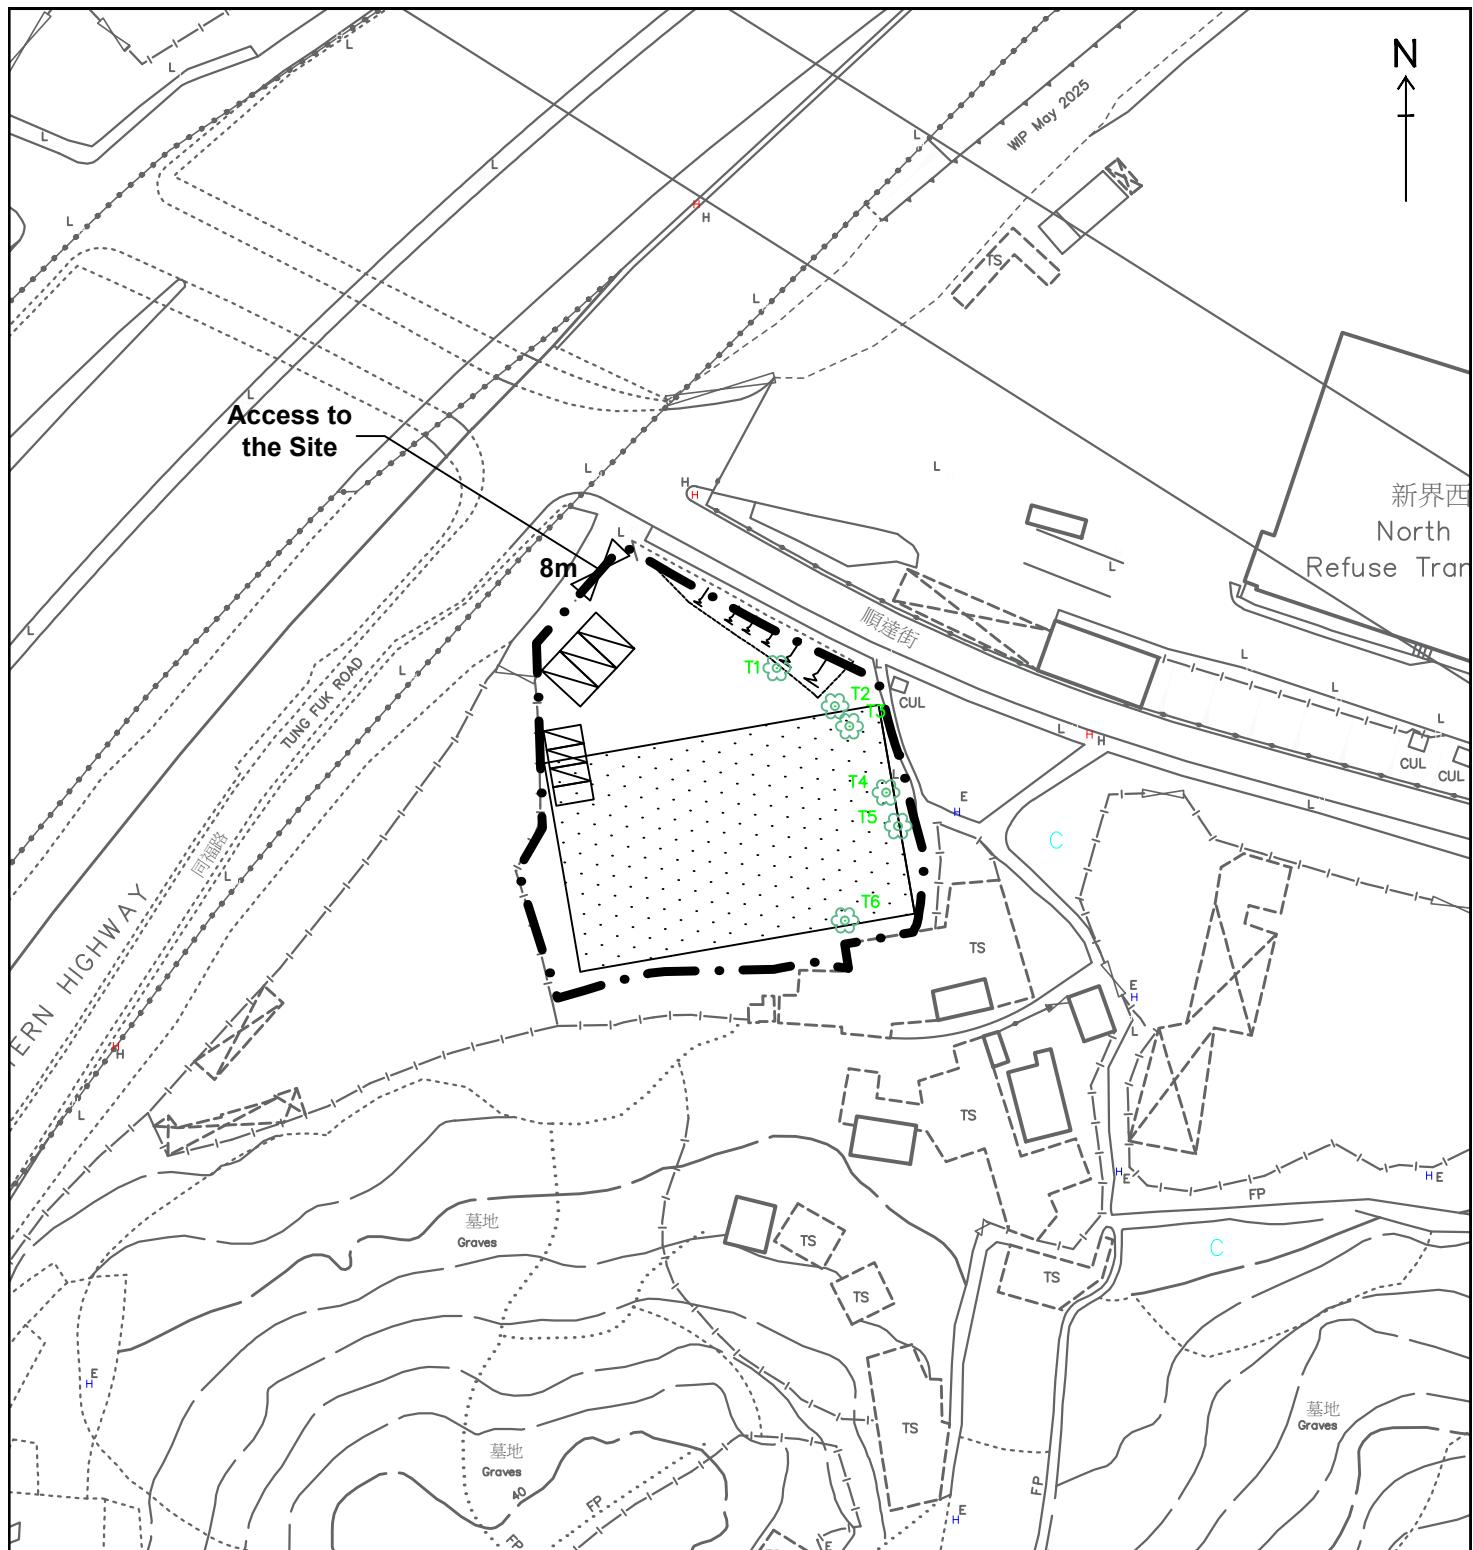
Figure 6

## Existing Trees within the Application Site

## **T1 - T6 *Ficus microcarpa* (All proposed to be felled)**

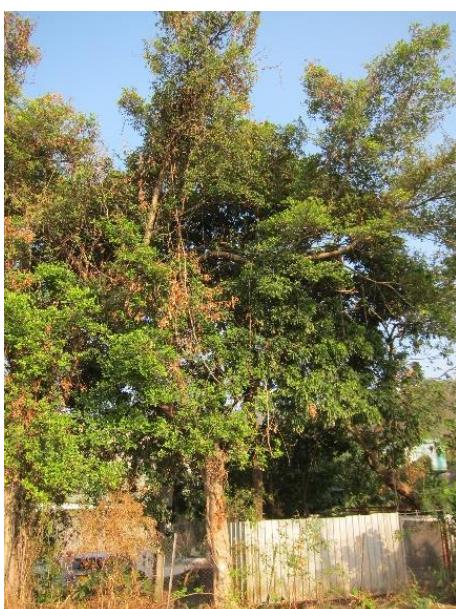
Tree No.	Photo No.	Species		Measurements			Location		Top of soil level above root collar (mPD)	Amenity Values	Form	Health	Structural Condition	Suitability for Transplanting		# Conservation Status	Additional Remarks
		Botanical Name	Chinese Name	Height (m)	Trunk DBH (mm)	Crown Spread (m)	Northing	Easting		(High(H)/ Medium(M) /Low(L))	Good(G)/ Average(A)/ Poor(P)		(High(H)/ Medium(M) /Low(L))	*	Remarks		
T1	T1	<i>Ficus microcarpa</i>	細葉榕	7	350	5	817581.988	831464.121	22.7	L	P	A	A	L	a b	Nil	Hangers, wound on trunk, codominant stems
T2	T2	<i>Ficus microcarpa</i>	細葉榕	9	500	8	817589.690	831459.084	22.8	L	A	A	A	L	a b c d	Nil	Codominant stems
T3	T3	<i>Ficus microcarpa</i>	細葉榕	8	520	6	817591.595	831456.419	22.9	L	A	A	A	L	a b	Nil	Codominant stems
T4	T4	<i>Ficus microcarpa</i>	細葉榕	12	400	10	817596.444	831447.656	23.2	L	A	A	A	L	a b c d	Nil	Codominant stems
T5	T5	<i>Ficus microcarpa</i>	細葉榕	12	420	10	817598.031	831443.229	23.4	L	P	A	A	L	a b c d	Nil	Crooked, wound on trunk

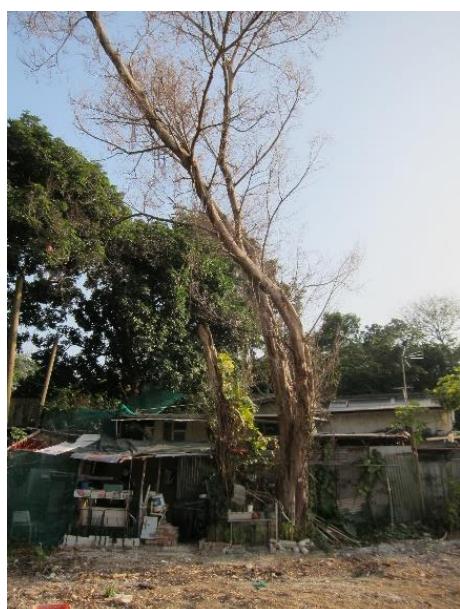
T6	T6	<i>Ficus microcarpa</i>	細葉榕	12	350	10	817591.005	831430.752	24.4	L	P	P	P	L	a b c d	Nil	Restricted root, Significant diebacks, crooked, epicormics
