**Proposed House Development at  
Tuen Mun Town Lot No. 550 (TMTL 550),  
Tuen Mun, N.T.**

**Landscape Proposal  
with  
Tree Survey Report**

**July 2025**

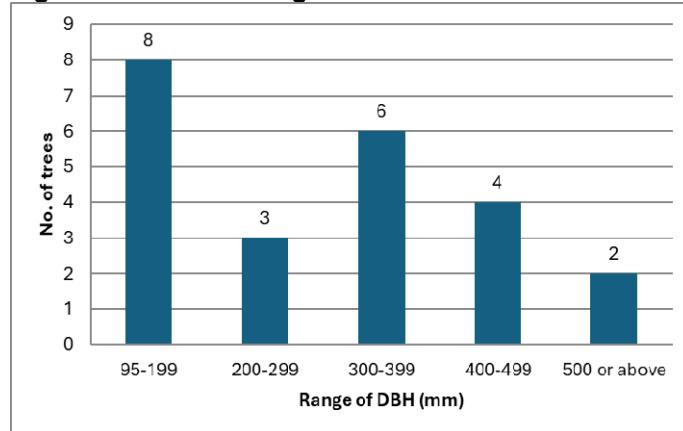
- 3.4 The average DBH of the surveyed trees is about 295mm, with average height of 8.3m and average crown spread of 6.4m which indicates their fast growing nature of weedy trees or fruit trees. **Figure A2.1 Existing Tree Size Distribution** below shows that over half of existing trees have a DBH less than 300mm which indicates that they are relatively young and are trees recently self-seeded in the area. The fruit tree/ weedy tree, such as *Artocarpus heterophyllus* and *Leucaena leucocephala*, have larger DBH over 500mm regarding their fast growing nature. Given the dense growing condition, the average crown spread of the plantation species on slope is relatively small while their tree growth is constrained by adjacent trees, low live crown ratio and “lion tail”/ “poor taper” are common evidences observed on these trees.

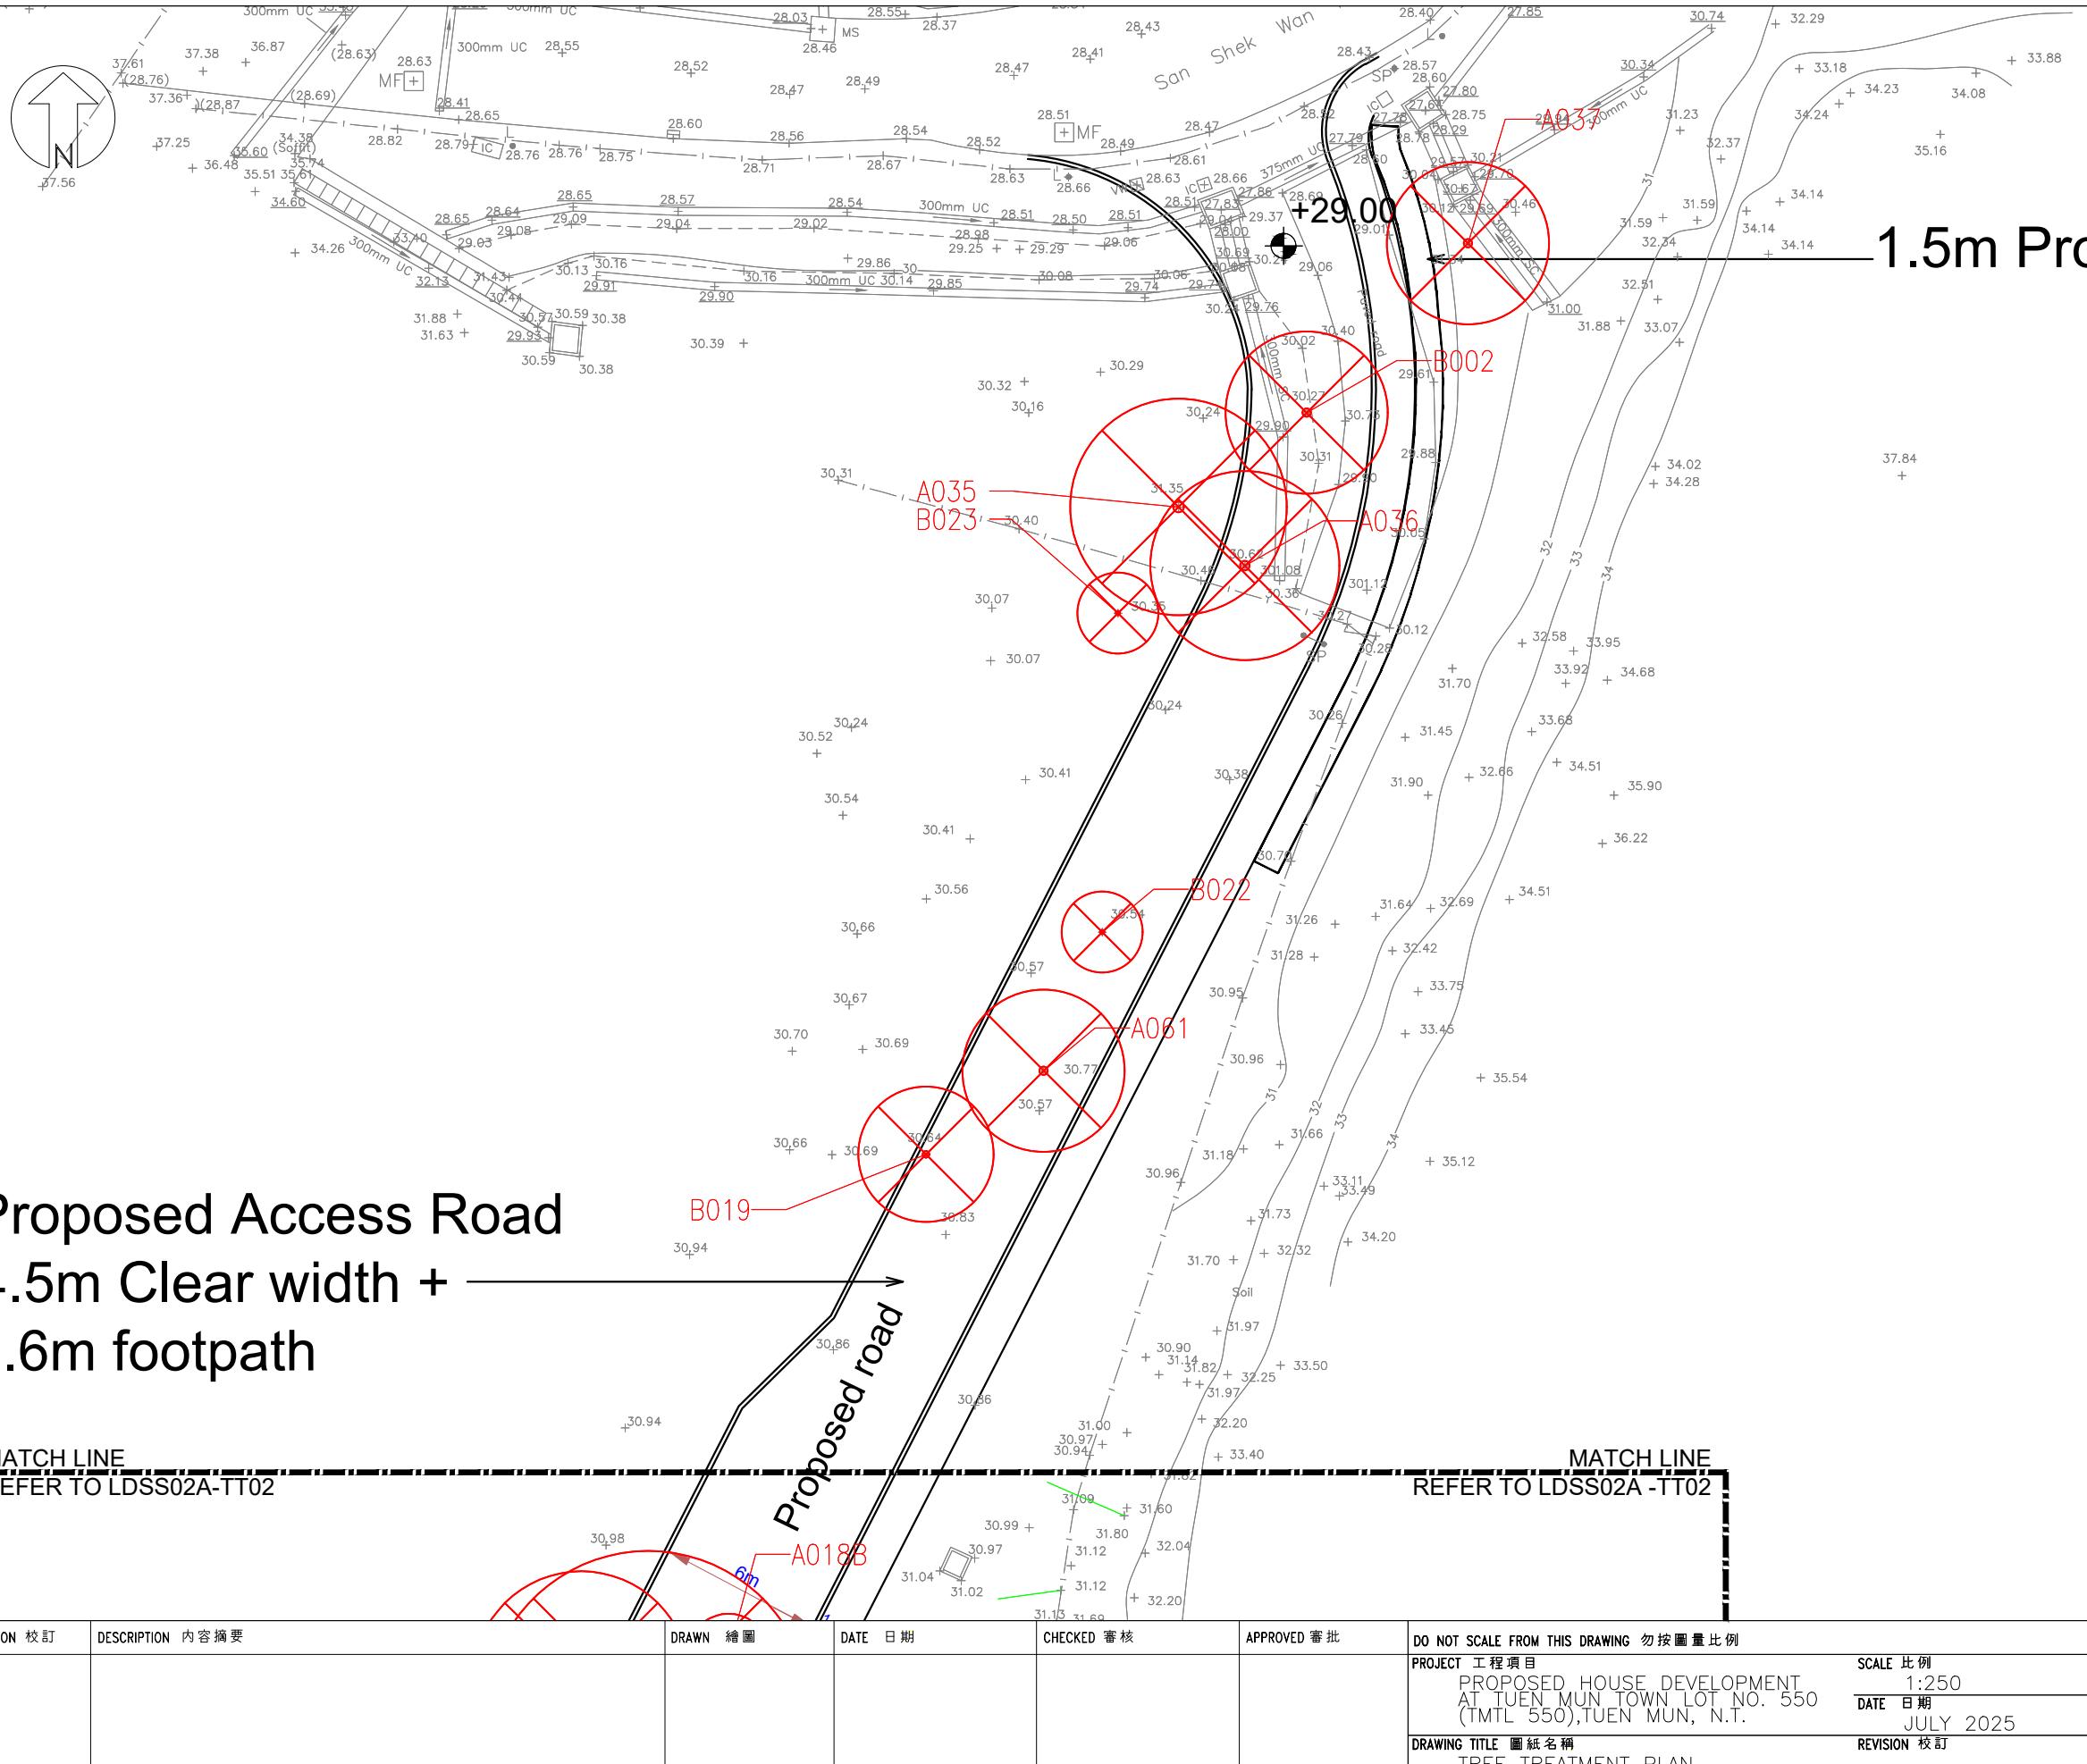
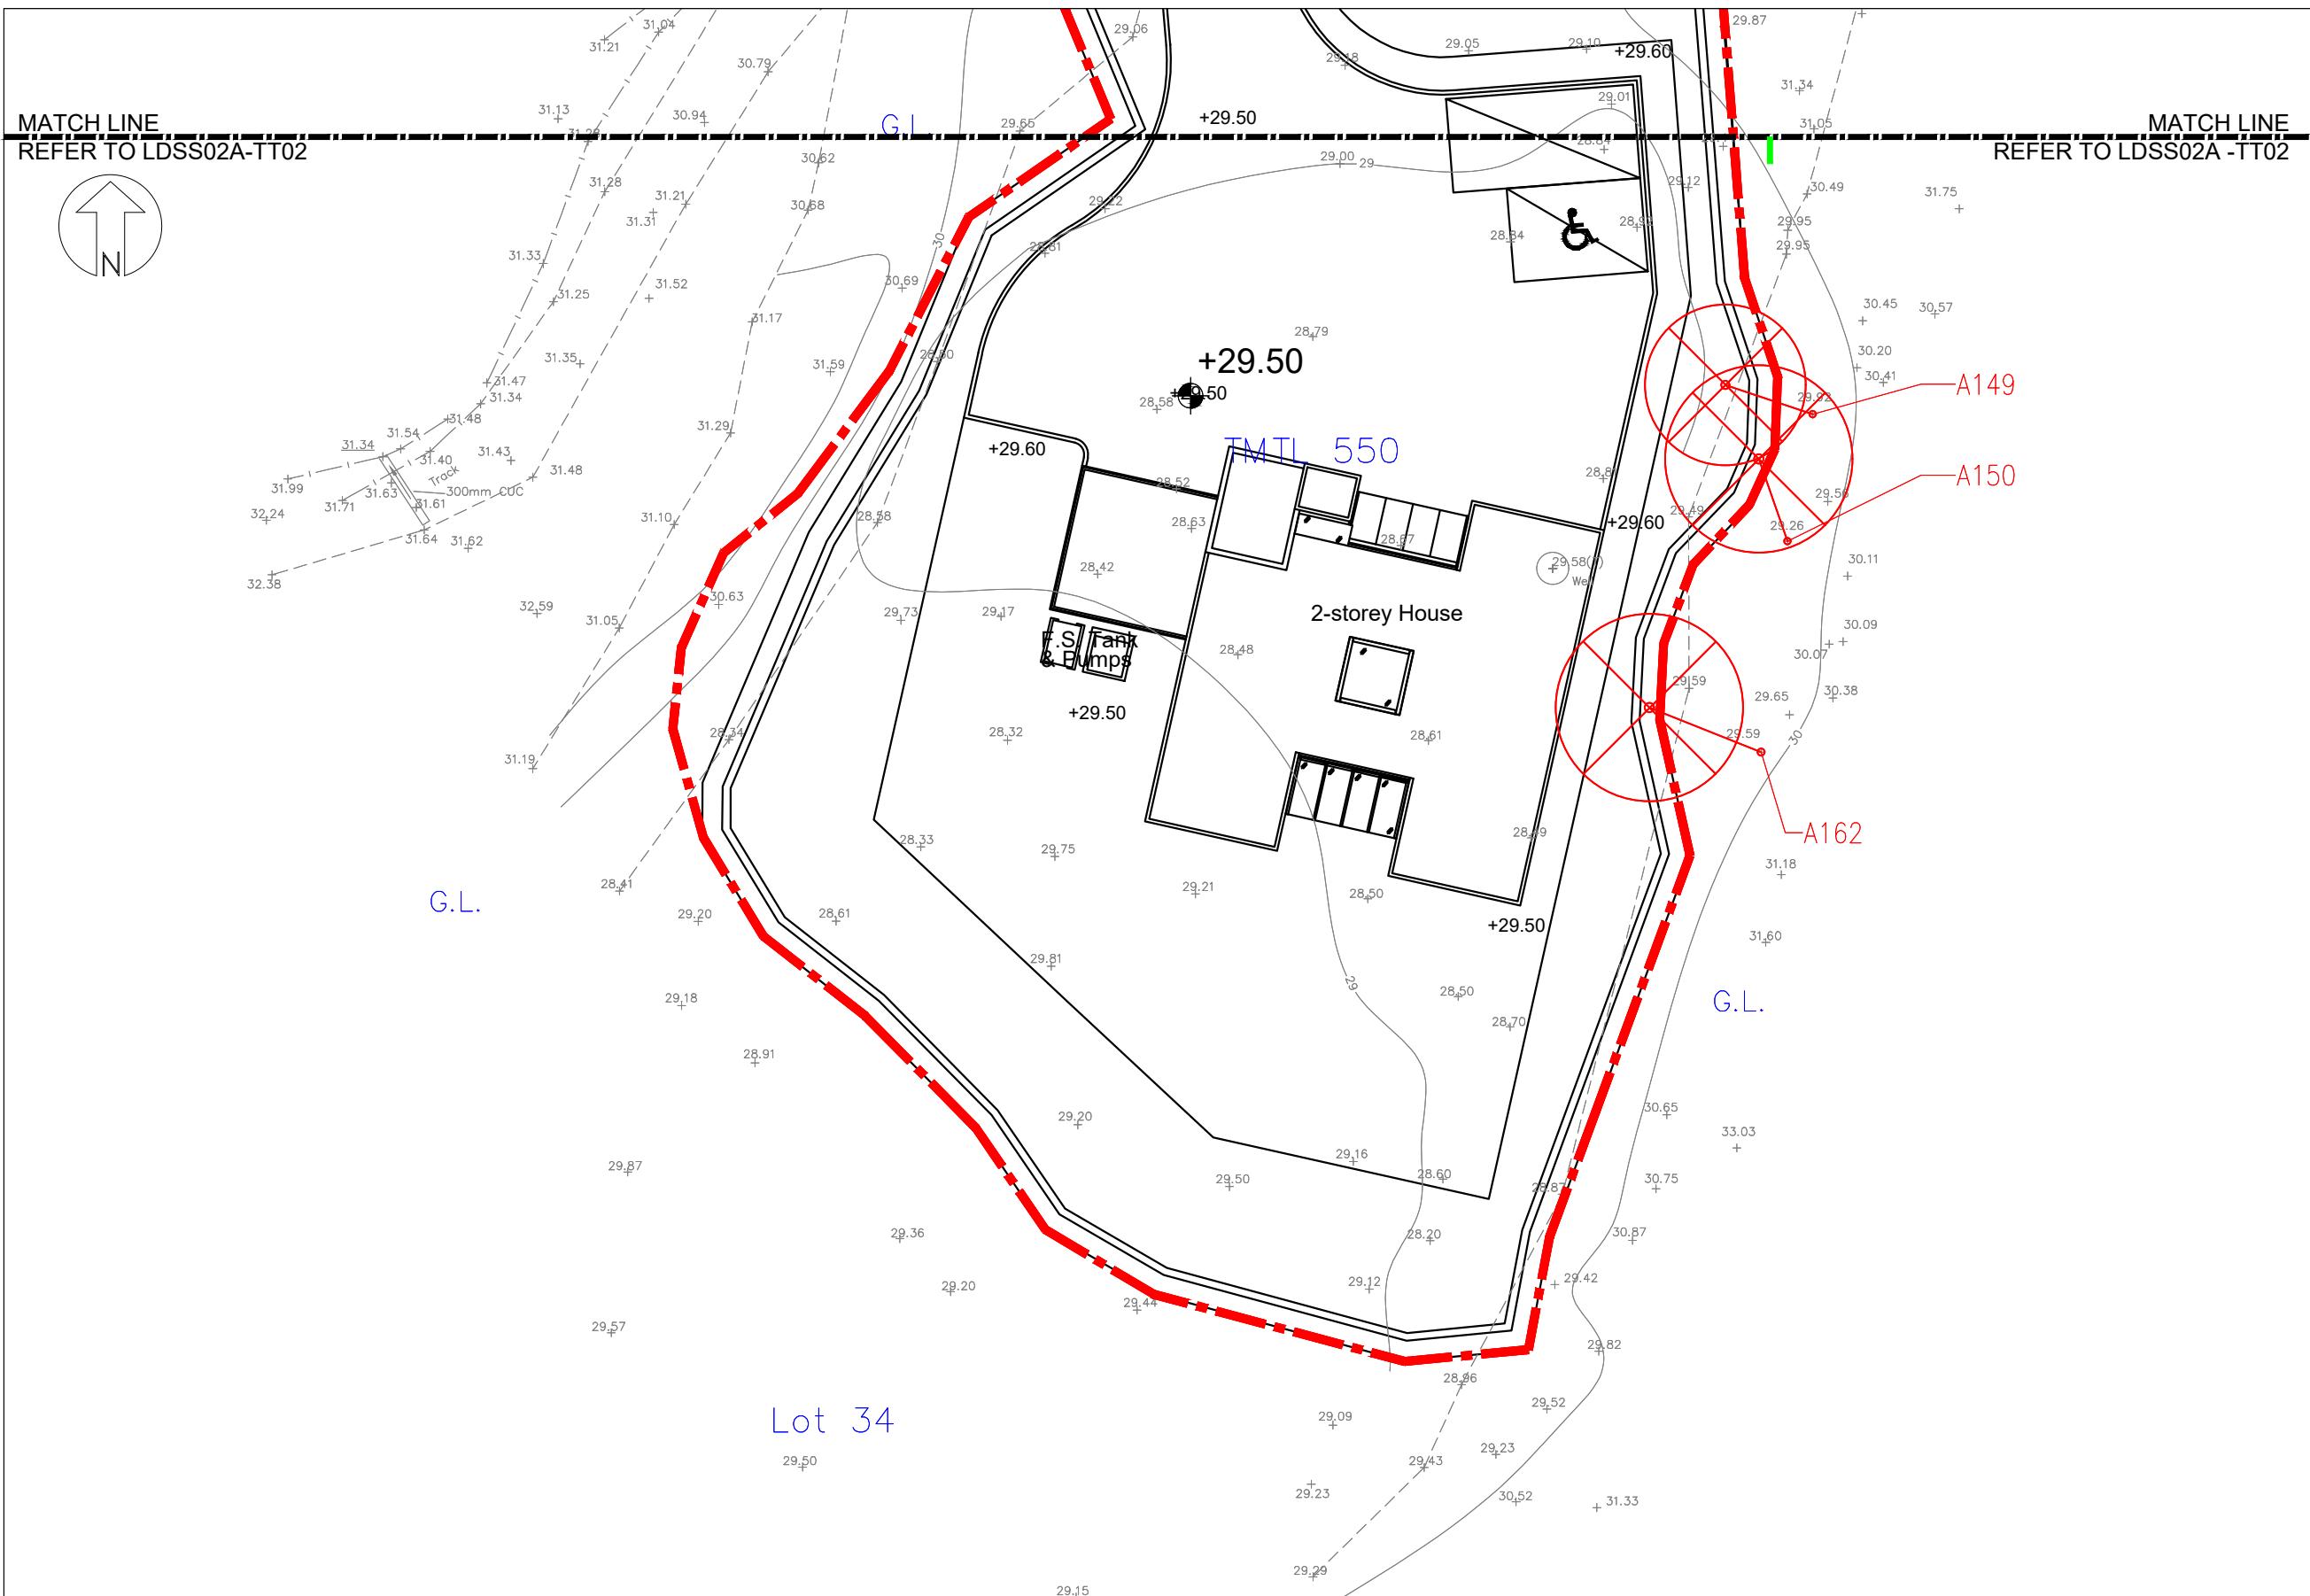
### **Tree Treatment Plan**

- 3.3 The existing tree locations are illustrated on **Annex III – Tree Treatment Plan**. Identification of tree species, form and health condition of these trees are reviewed in the following paragraphs and listed in **Annex II - Tree Treatment Schedule**. A **Photographic Record of Existing Trees** is enclosed in Annex IV.

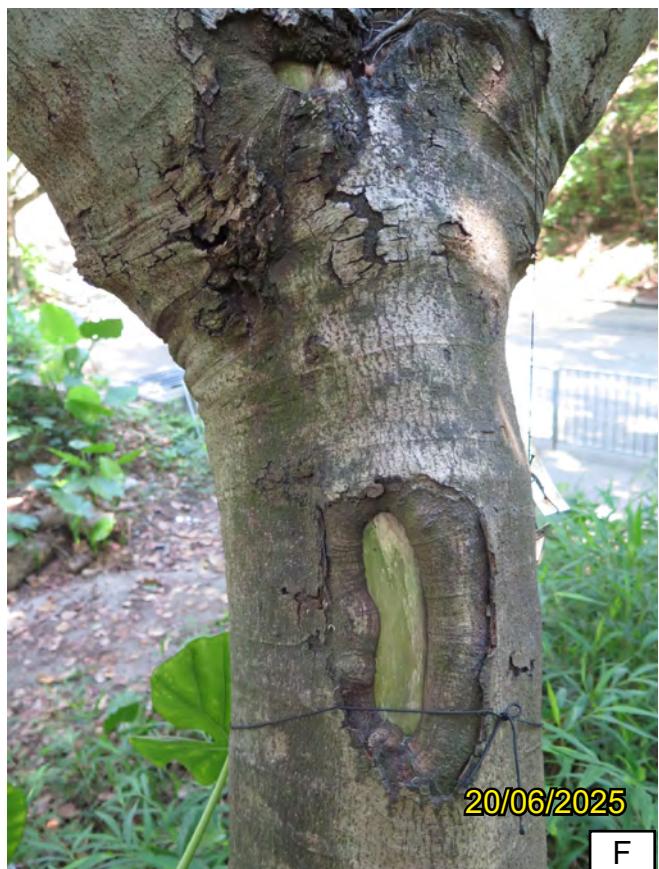
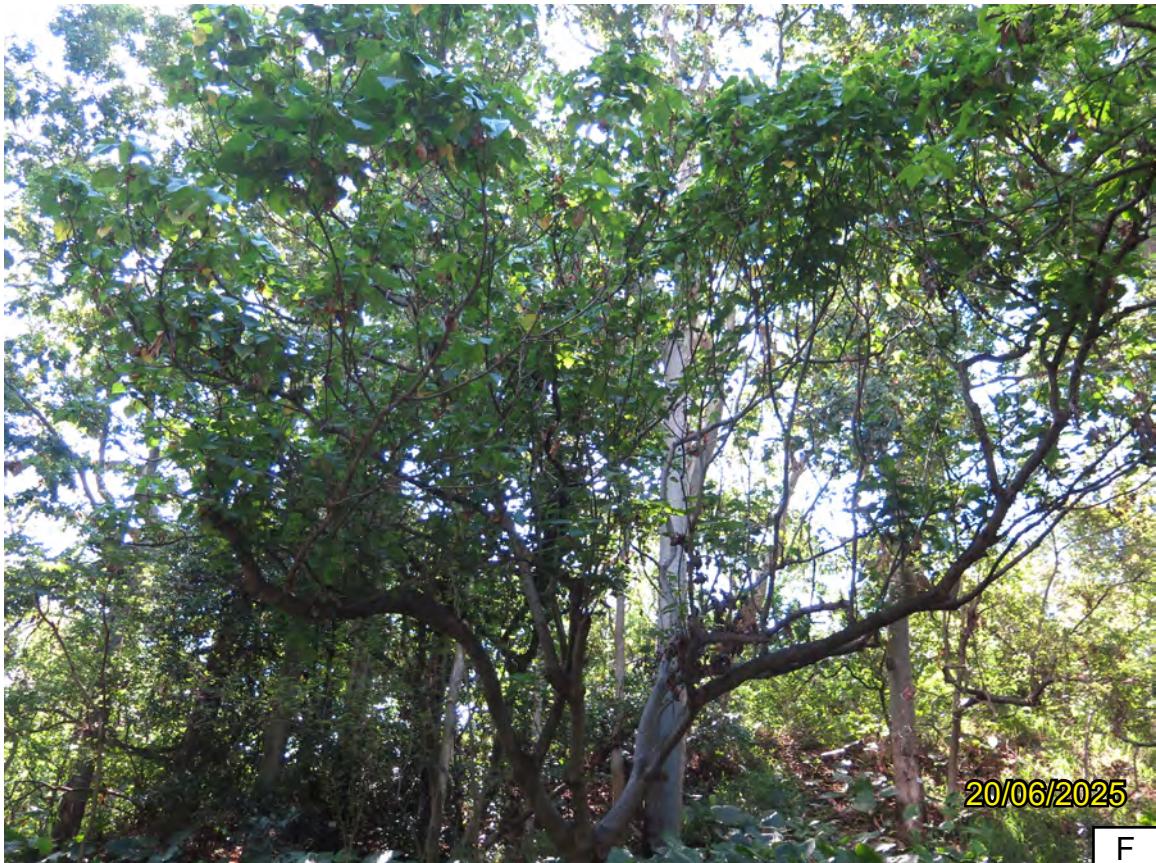
A037(DEFECT)

| Tree ID | Photo No. | Tree Species | | | | | Top of soil level above root collar (mPD) | Form | | | Health Condition | | | Structural Condition | | | Anticipated Survival Rate after Transplanting | | | Location | | Proposed Treatment | | | Justification | Remarks | | | |
|---|---|---|---|---|---|---|---|---|---|---|---|---|---|---|---|---|---|---|---|---|---|---|---|---|---|---|--|---|--|
| A037 | A037 | <i>Macaranga tanarius</i> var. <i>tomentosa</i> | 血桐 | 300 | 7 | 6 | 31.34 | | 1 | | 1 | | | 1 | | | | 1 | 1 | 1 | | | Not listed | | | 1 | B,E | Root exposed, leaning 15°, attached to concrete structure, broken branch with dead wood | |

- 4.3 Having considered the tree species, which are weedy trees, poor condition of these affected trees, trees have unrecoverable defects, the affected trees are not suitable candidate for tree transplanting, and therefore tree felling is recommended.

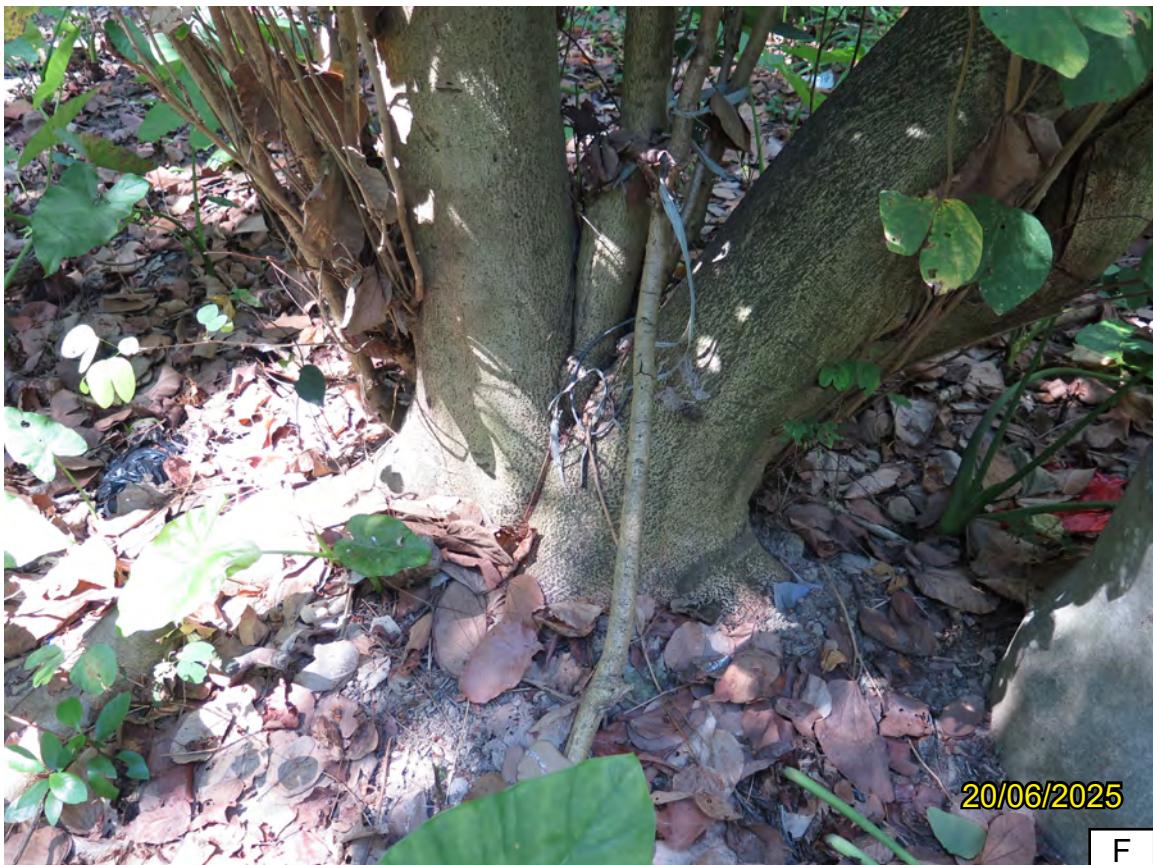
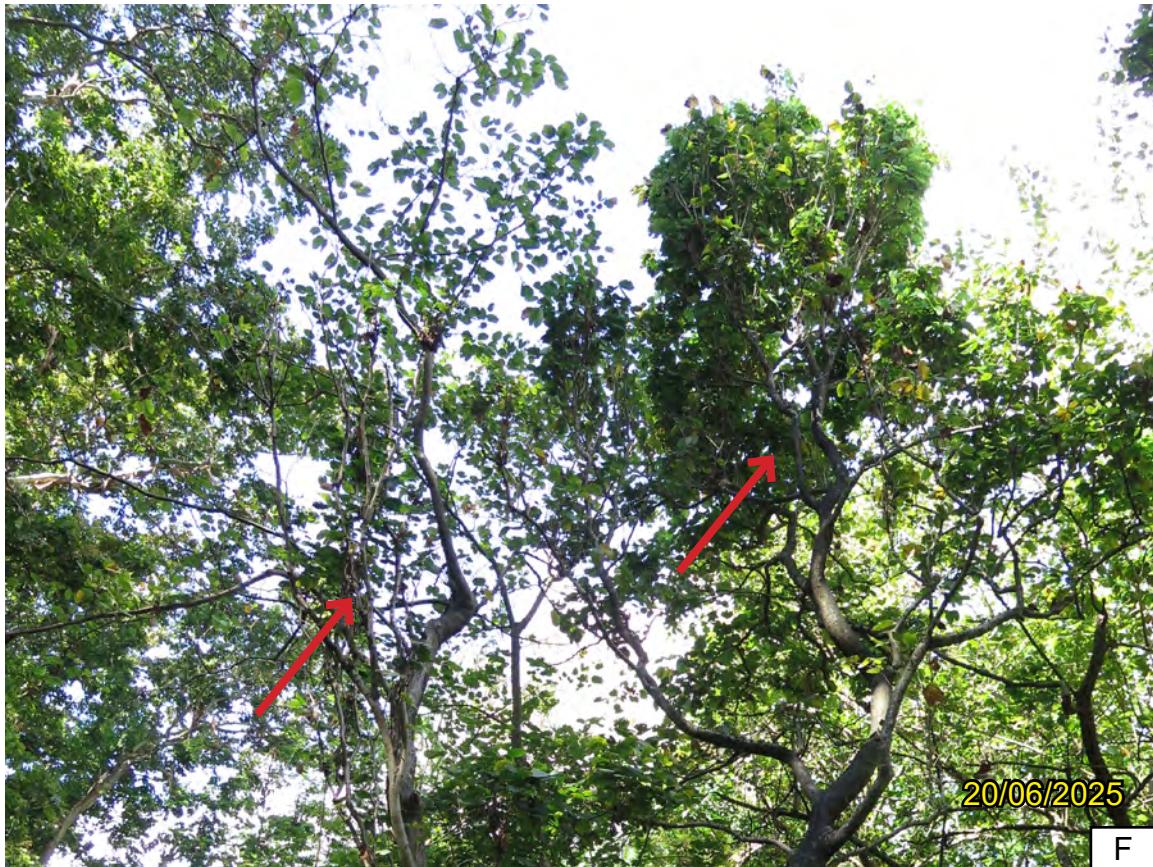
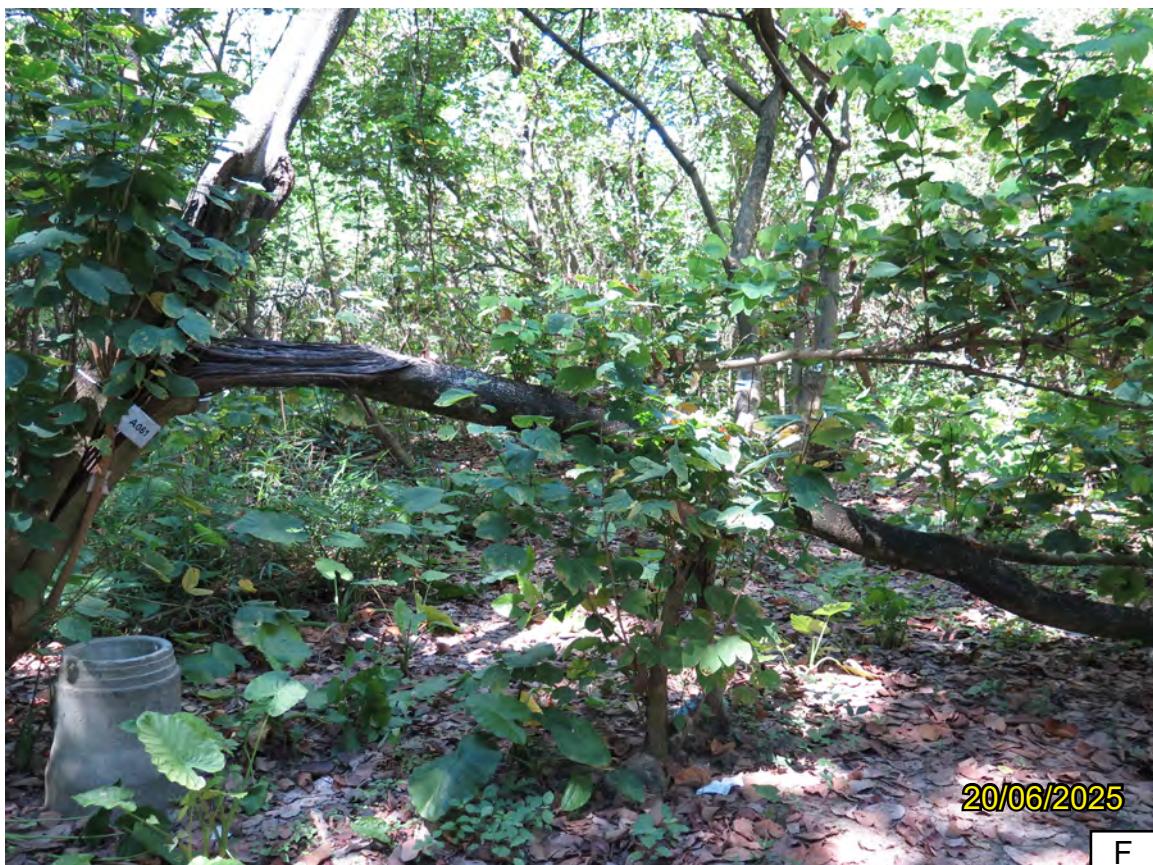
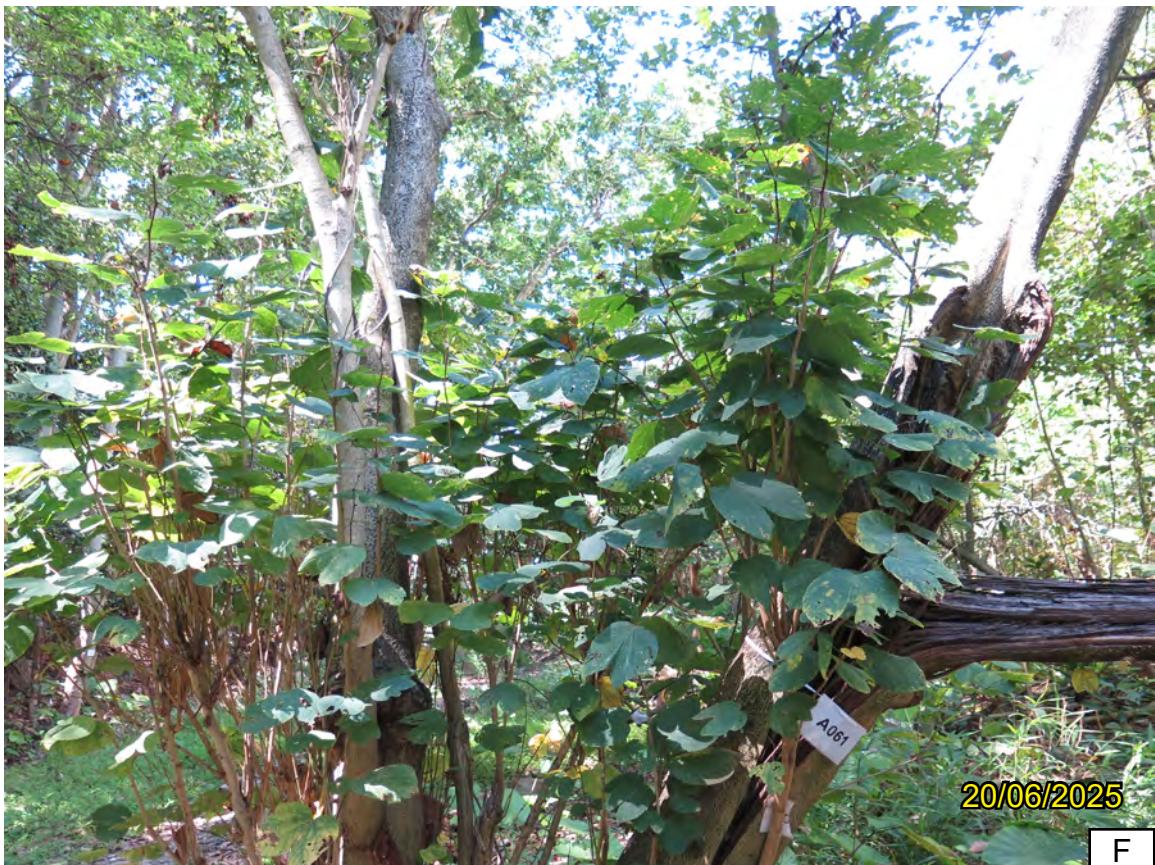
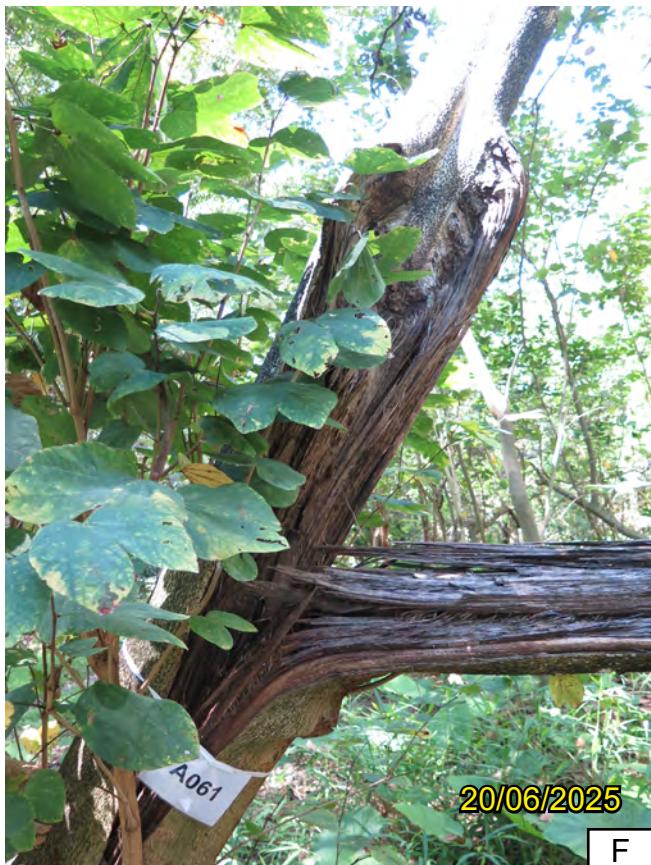
A061 (DEFECT)

| Tree ID | Photo No. | Tree Species | | | | | Top of soil level above root collar (mPD) | Form | | | Health Condition | | | Structural Condition | | | Anticipated Survival Rate after Transplanting | | | Location | | Proposed Treatment | | | Justification | Remarks | | | |
|---|---|---|---|---|---|---|---|---|---|---|---|---|---|---|---|---|---|---|---|---|---|---|---|---|---|---|--|---|--|
| A061 | A061 | <i>Bauhinia variegata</i> | 宮粉羊蹄甲 | 360 | 7 | 6 | 30.77 | | 1 | | 1 | | | 1 | | | | 1 | 1 | | | | Not listed | | | 1 | B,E | Codominant trunk forked at base, sucker at base, one trunk broken | |

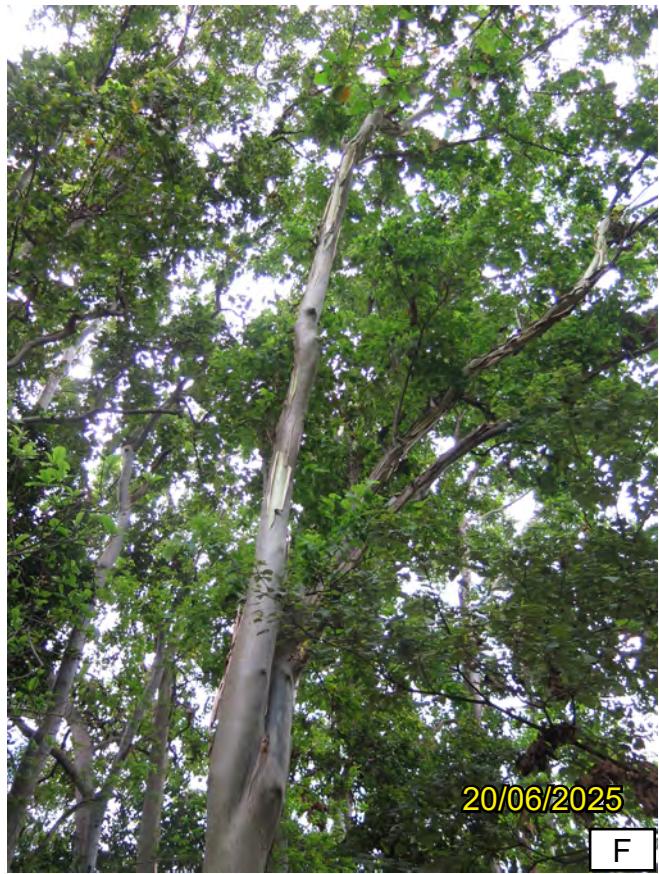
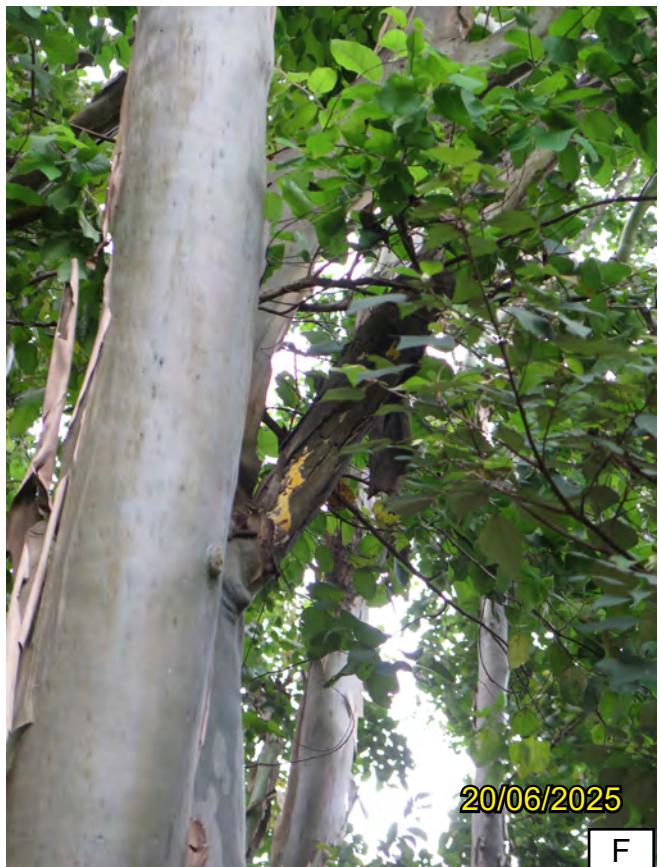
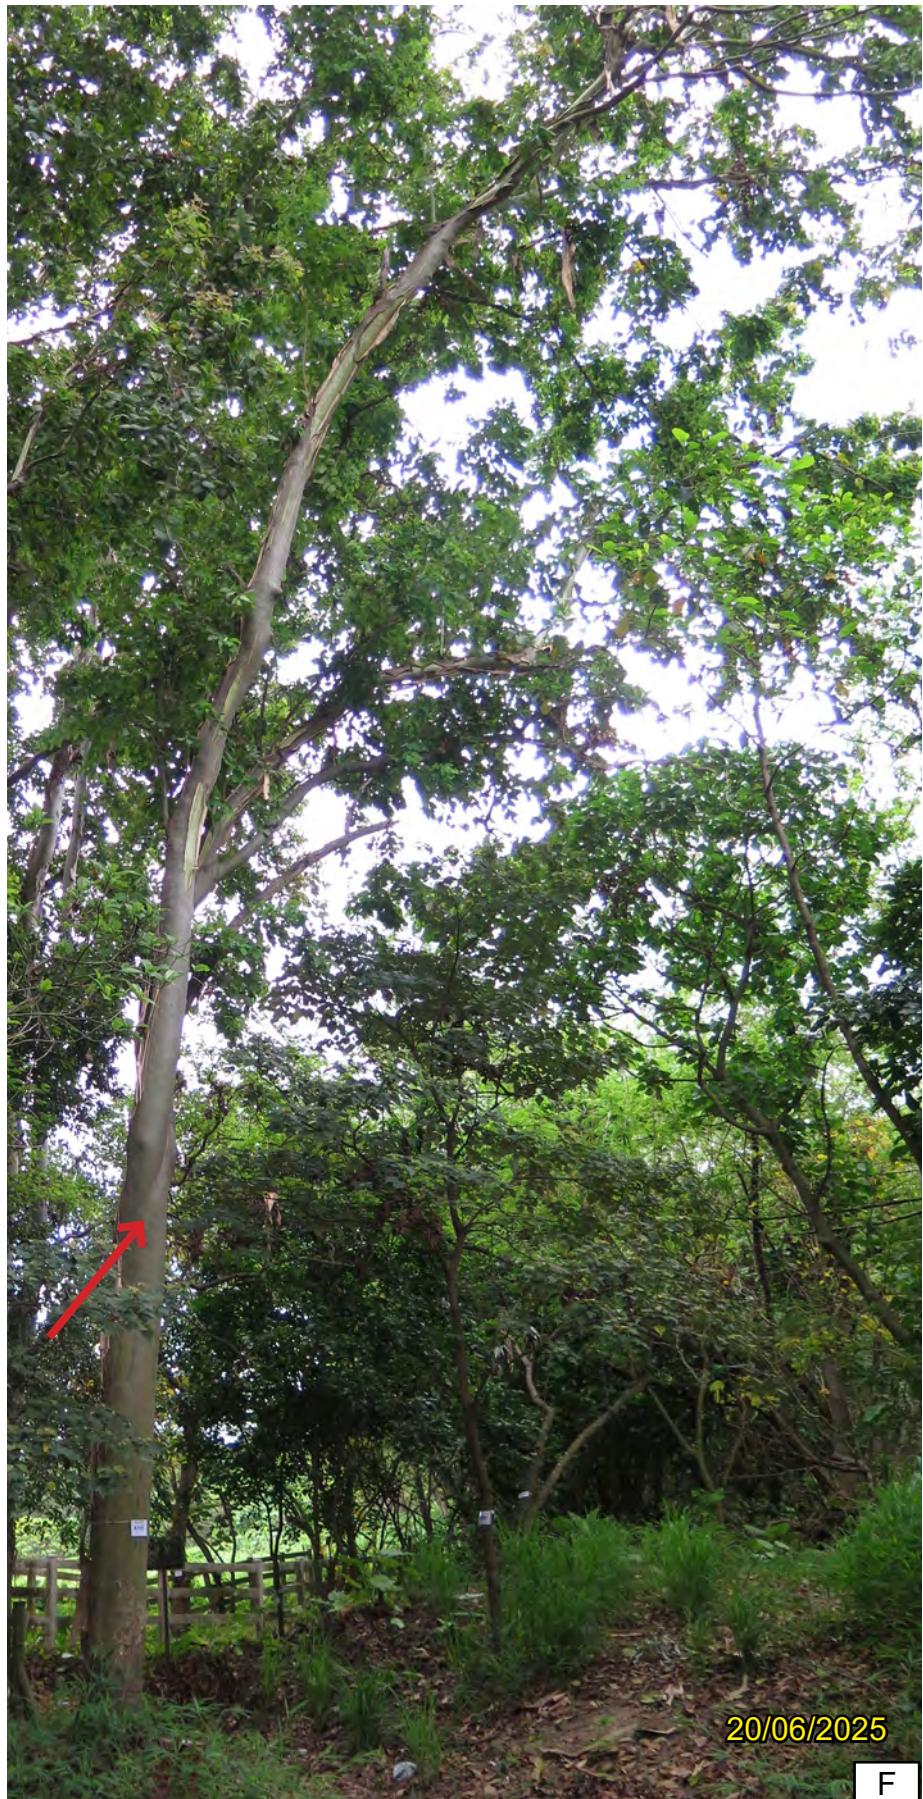
A115 (DEFECT)

| Tree ID | Photo No. | Tree Species | | | | | Top of soil level above root collar (mPD) | Form | | | Health Condition | | | Structural Condition | | | Anticipated Survival Rate after Transplanting | | | Location | | Proposed Treatment | | | Justification | Remarks | | | |
|---|---|---|---|---|---|---|---|---|---|---|---|---|---|---|---|---|---|---|---|---|---|---|---|---|---|---|--|---|--|
| A115 | A115 | <i>Eucalyptus torelliana</i> | 毛葉桉 | 450 | 10 | 7 | 29.95 | | 1 | | 1 | | | 1 | | | | 1 | 1 | | | | Not listed | | | 1 | B,E | Contorted trunk, bending trunk 5°, codominant trunk, one broken & decay trunk | |

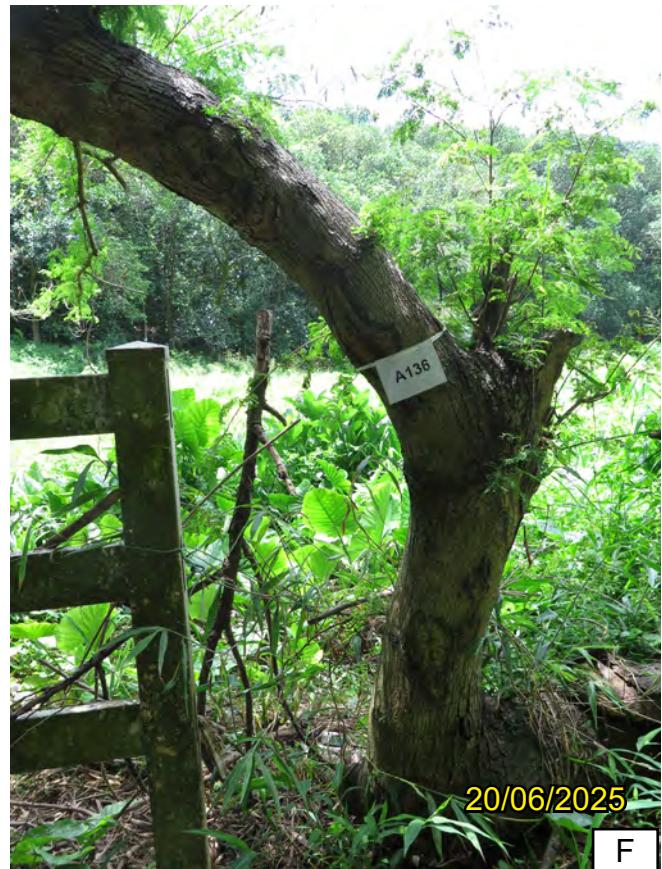
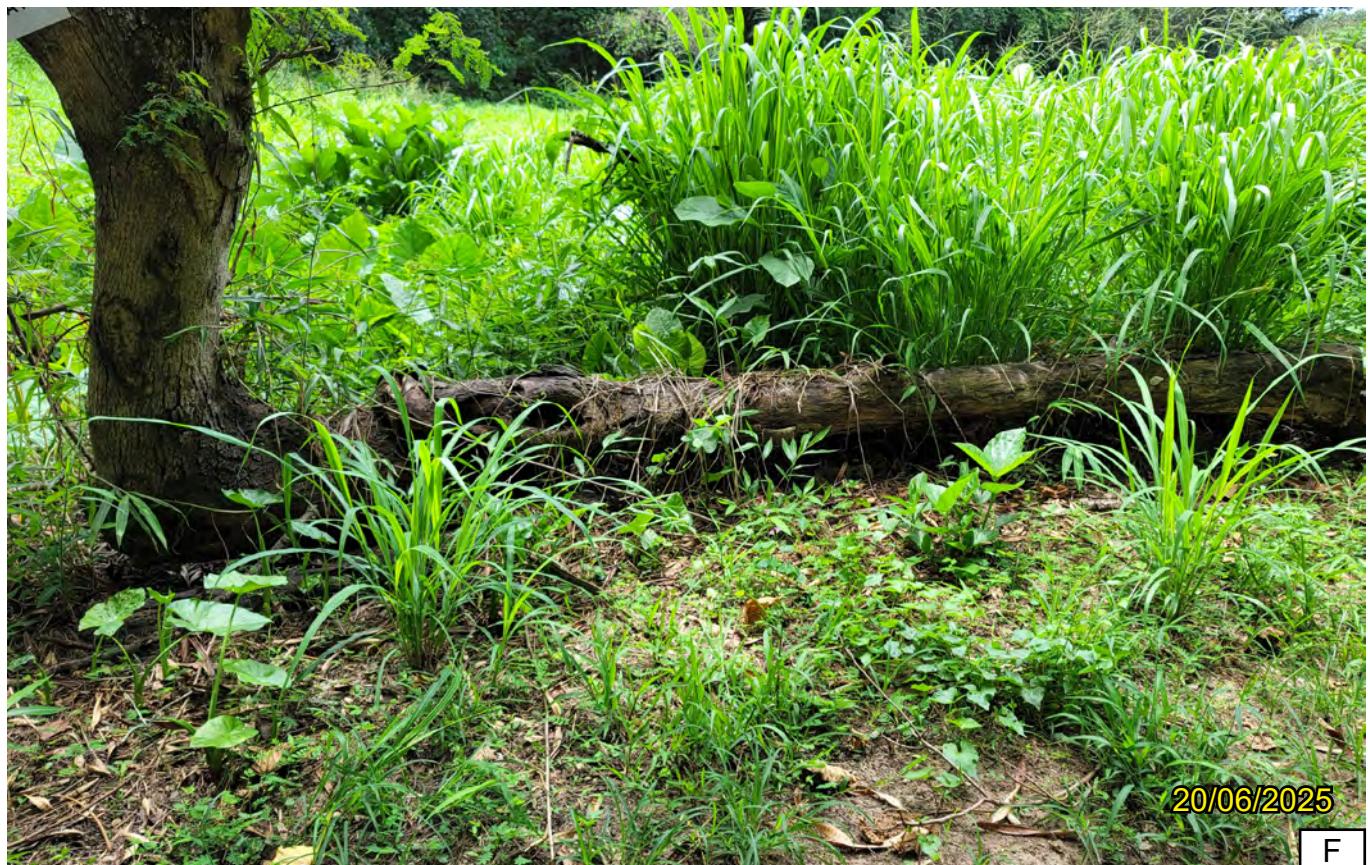
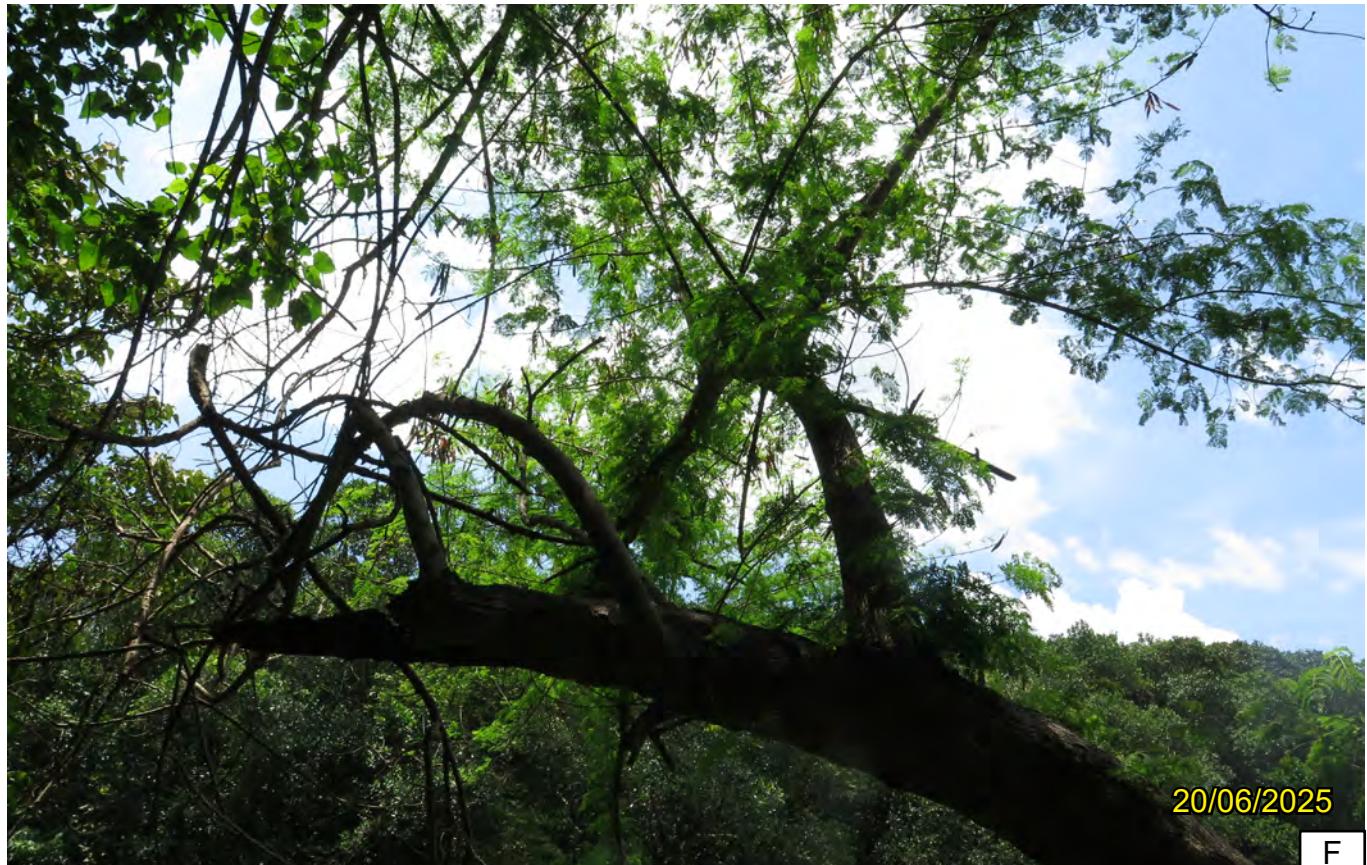
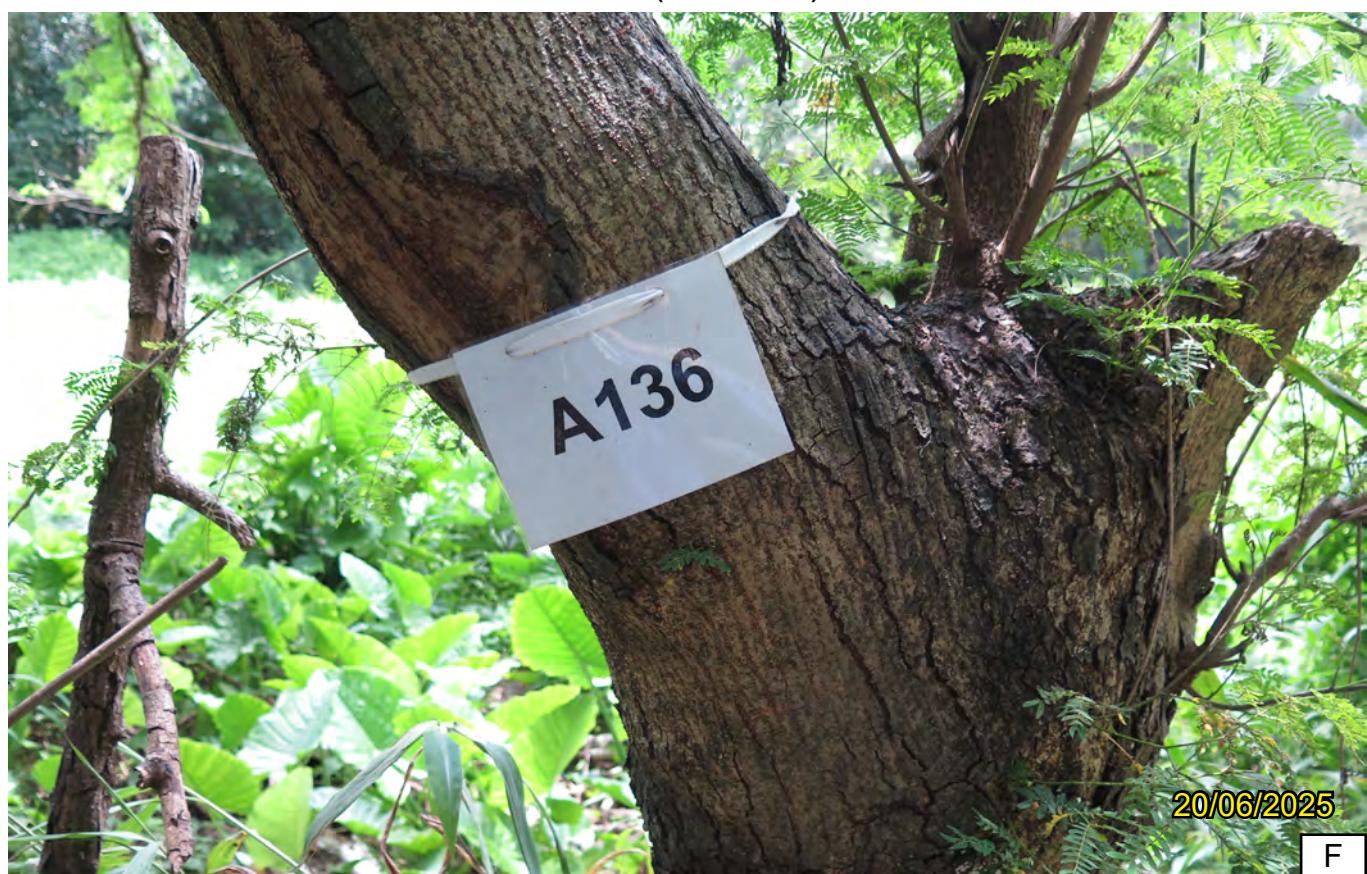
A136 (DEFECT)

| Tree ID | Photo No. | Tree Species | | | | | Top of soil level above root collar (mPD) | Form | | | Health Condition | | | Structural Condition | | | Anticipated Survival Rate after Transplanting | | | Location | | Proposed Treatment | | | Justification | Remarks | | | |
|---|---|---|---|---|---|---|---|---|---|---|---|---|---|---|---|---|---|---|---|---|---|---|---|---|---|---|--|---|--|
| A136 | A136 | <i>Leucaena leucocephala</i> | 銀合歡 | 300 | 5 | 5 | 31.12 | | 1 | | 1 | | | 1 | | | | 1 | 1 | | | | Not listed | | | 1 | B,E | main trunk broken, imbalance form, epicormics on trunk, bending | |
