**Proposed House Development at  
Tuen Mun Town Lot No. 550 (TMTL 550),  
Tuen Mun, N.T.**

**Landscape Proposal  
with  
Tree Survey Report**

**July 2025**

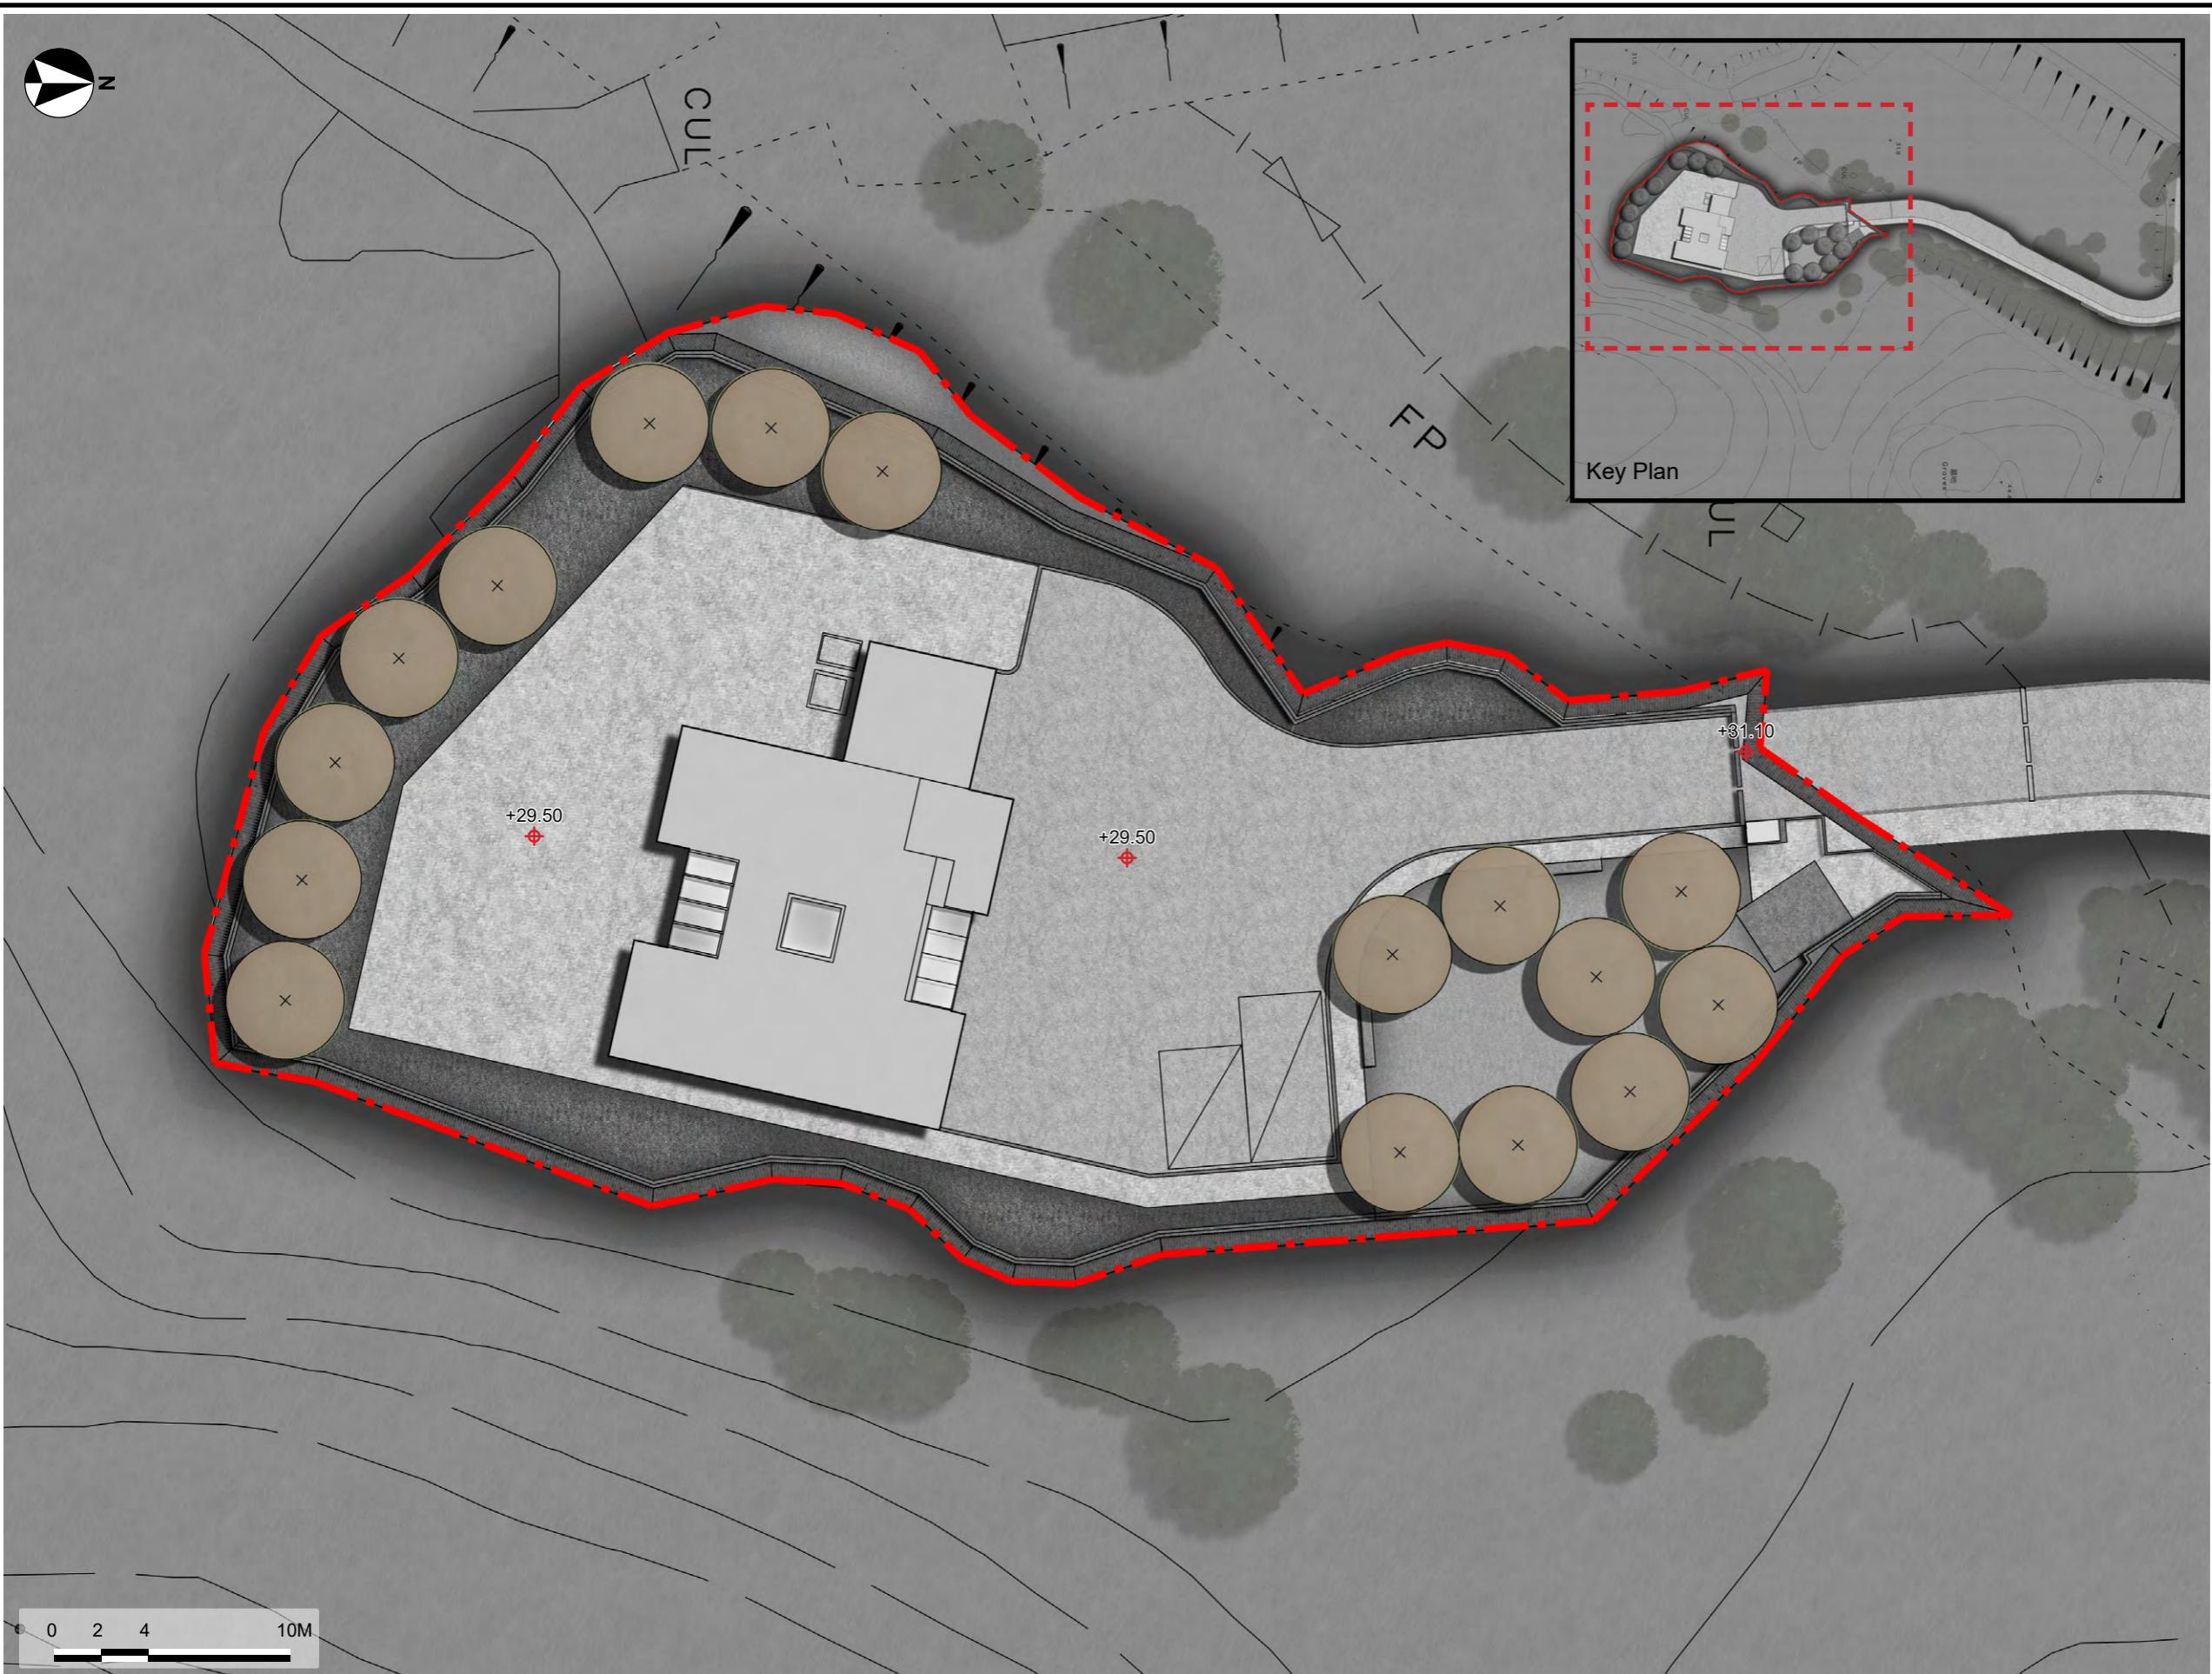
New Tree Planting Proposal

- 5.1 As described above, the loss of existing trees will be replaced by broadleaf/evergreen/ornamental trees creating a good quality residential landscape that would enhance the visual amenity of the local context, benefiting both the future residents, pedestrians and their neighbourhoods. The New Tree Planting Concept is presented in **Appendix V**. The planting proposal has sought to:
