**Proposed Temporary Place of Recreation, Sports or Culture (Hobby Farm and Fishing Ground),  
Holiday Camp, Barbecue Site and Animal Boarding Establishment with Ancillary Facilities and  
Associated Filling of Land for a Period of 3 Years in "Agriculture" Zone,  
Various Lots in D.D.135 and Adjoining Government Land, Pak Nai, Yuen Long, New Territories**

**(S.16 Planning Application No. A/YL-PN/91)**

**Responses-to-Comments**

**Various Lots in D.D. 135 And Adjoining Government Land, Pak Nai, Yuen Long, New Territories**

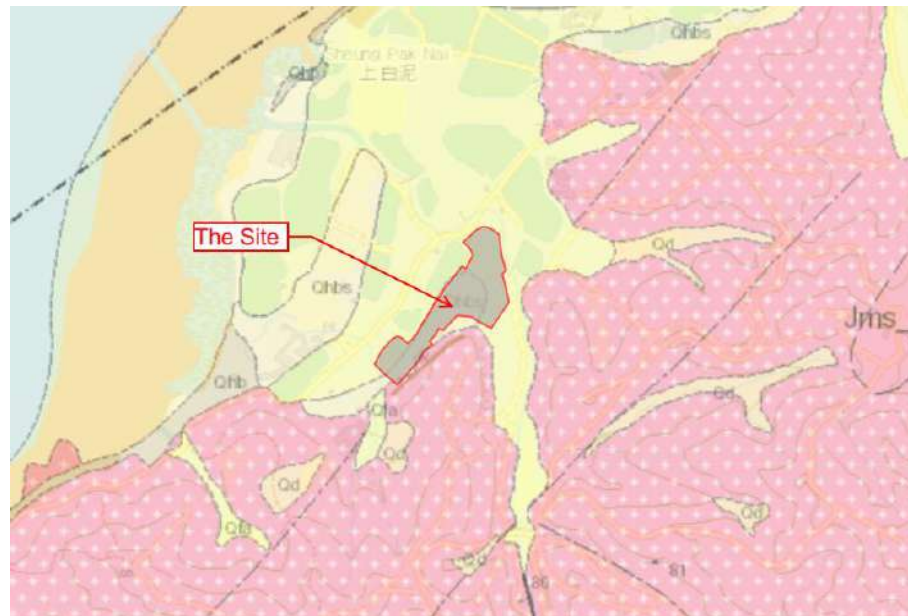
Figure 1 – Solid and Superficial Geology in the vicinity of the Site

- 4.1 According to the 1:20000 scale geological map published by the Geotechnical control Office (Sheet 3:HGM20 Series: Edition 1 - 1991), the site is underlain by DEBRIS FLOW DEPOSITS (Figure 1). Part print of geological map is enclosed in **Appendix D**.

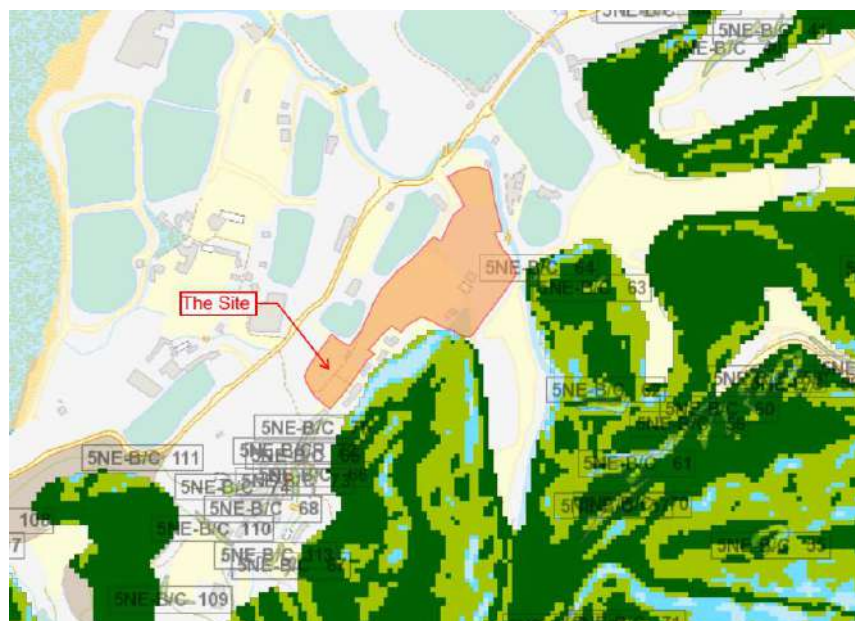
Figure 2 – Extract from Natural Terrain Landslide Inventory Map

- 4.8 According to the Natural Terrain Landslide Inventory Map, no Relict Landslide or Recent Landslide is found in the vicinity of the Site (Figure 2). The map is enclosed in **Appendix F** for easy reference.

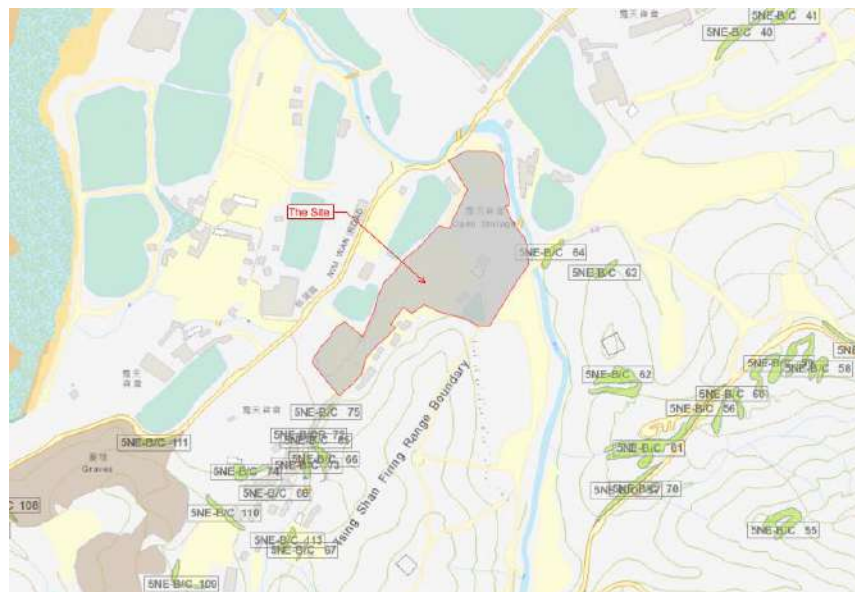
Figure 3 – Extract from Natural Terrain Landslide Inventory Map

| Feature No. | Max. Height (m) | Length (m) | Face Angle (°) |
|---|---|---|---|
| 5NE-B/C 64 | 5 | 50 | 40 |
| 5NE-B/C 75 | 6.2 | 25 | 60 |

- 5.3 According to the Slope Maintenance Responsibility Information System (SMRIS), there are two existing features in close proximity to the Site. The feature is listed as follow:

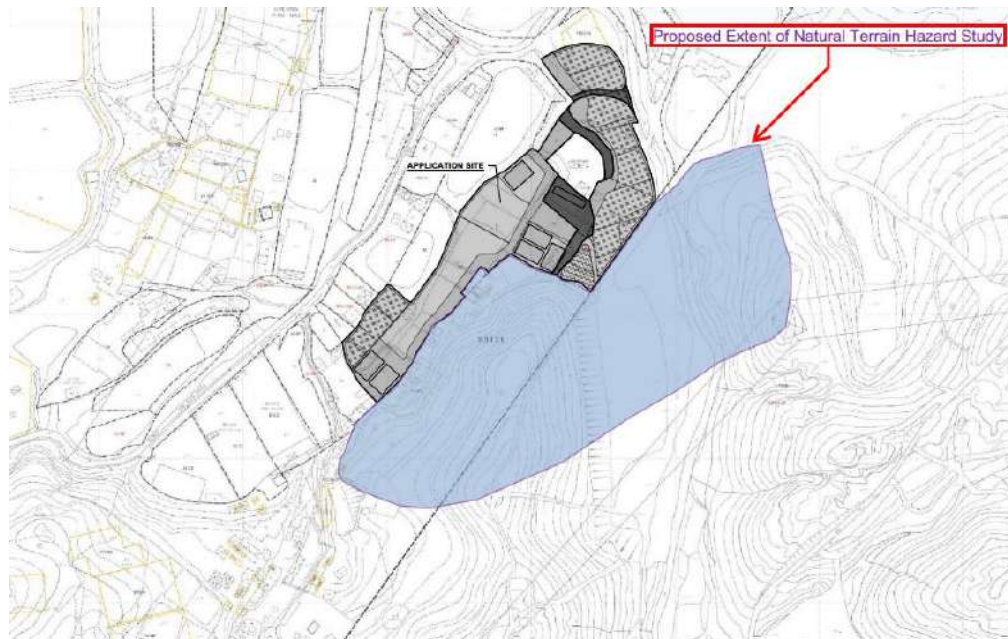
*Figure 4 – The Proposed Extent of Natural Terrain Hazard Study*

- 7.1 There is no natural terrain within the subject Site. The natural terrain is located at the Southeast side of the Site. Nature terrain hazard study would be conducted and to carry out any necessary mitigation measures as part of the proposed development. The proposed extent of natural terrain hazard study is highlighted under Figure 4 below and attached in Appendix H. However, the actual extent will be subjected to final layout and activity zone of the academy
