Annex V
Tree Survey

**Tree Survey Report
of
Various Lots in D.D. 112 and Adjoining
Government Land, Shek Kong, Yuen Long, New
Territories**

Report Date: 25th June 2025

PROPOSED TEMPORARY WAREHOUSE AND OPEN STORAGE OF CONSTRUCTION MATERIALS, MACHINERY AND VEHICLES AND ASSOCIATED FILLING OF LAND FOR A PERIOD OF 3 YEARS

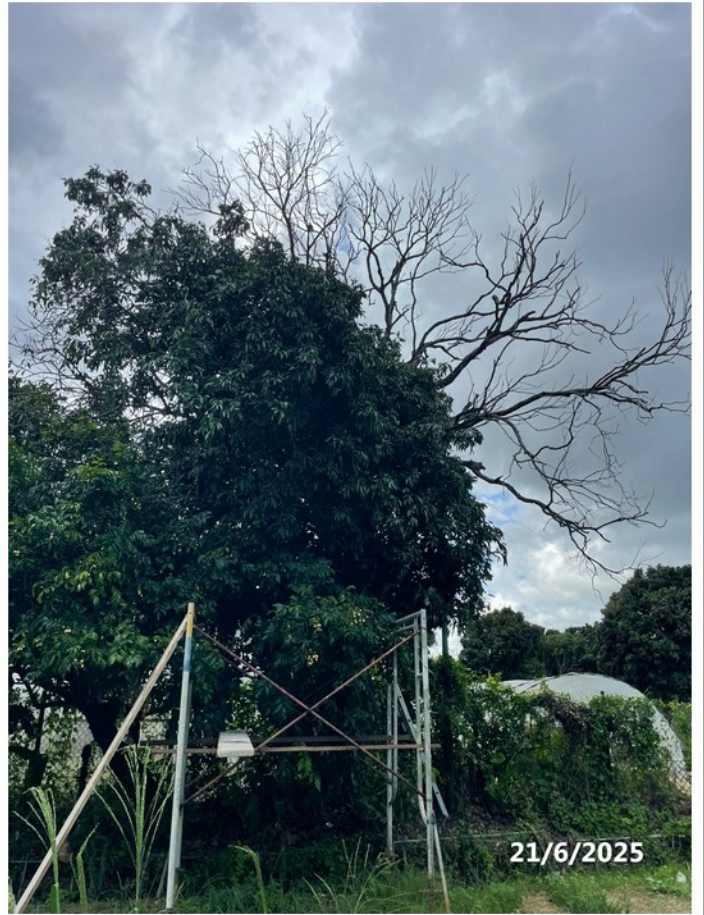
T8 (1)

T08	<i>Litchi chinensis</i>	荔枝	9	396	7	P	P	L	Dieback, Exposed dead wood	
T09	<i>Bridelia tomentosa</i>	土密樹	7	287	7	F	P	M	Co-dominant trunks, Included bark, Dieback	
T10	<i>Dimocarpus longan</i>	龍眼	6	192	6	F	F	M	Wound, Imbalance crown	
T11	<i>Dimocarpus longan</i>	龍眼	6	211	6	F	P	M	Co-dominant branches,	
T12	<i>Dimocarpus longan</i>	龍眼	5	121	3	F	P	M	Wound, Co-dominant branches, Included bark	
T13	<i>Dimocarpus longan</i>	龍眼	6	306	7	F	P	M	Co-dominant branches, Included bark, Dieback	
T14	<i>Citrus maxima</i>	柚	7	150	5	p	P	L	Bending, Co-dominant branches,Included bark	
T15	<i>Dimocarpus longan</i>	龍眼	6	167	7	F	P	M	climber, Co-dominant branches, Included bark	
T16	<i>Dimocarpus longan</i>	龍眼	7	177	6	F	P	M	Climber, Co-dominant branches, Included bark	
T17	<i>Dimocarpus longan</i>	龍眼	7	147	6	F	P	M	Climber, Co-dominant trunks, Included bark	
T18	<i>Litchi chinensis</i>	荔枝	8	329	6	F	P	M	Climber, Co-dominant branches, Included bark, Dieback, Wound, Imbalance crown

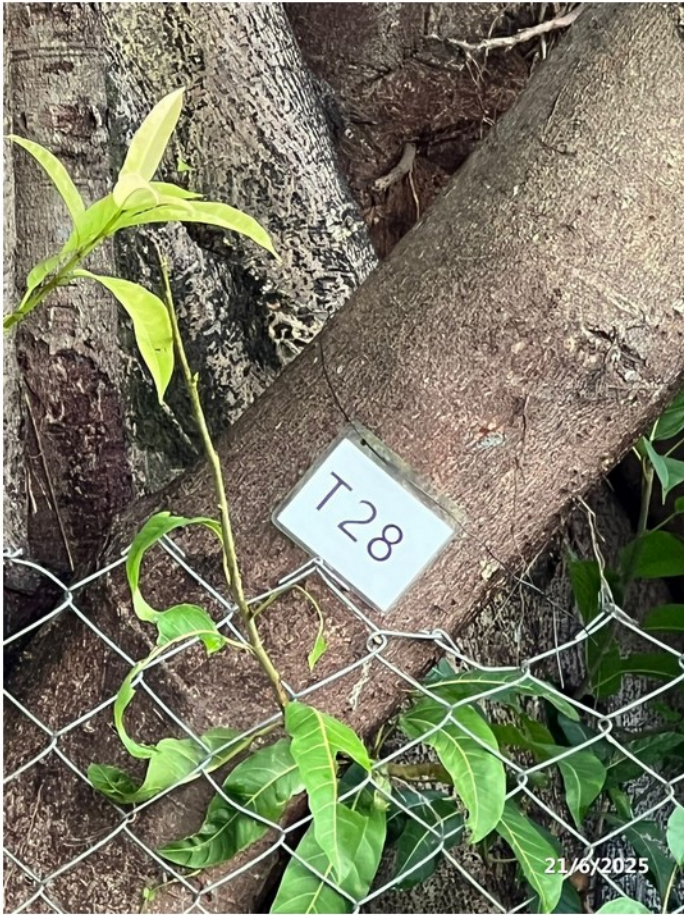
T28 (1)

Most of the observed trees were fruit tree. The dominant species is *Dimocarpus logan* (龍眼). Overall health condition was found fair. However, structural defects were commonly found. Co-dominant branches or trunks with included bark were observed. A strangler plants (*Ficus* sp.) was observed on T25, the trunks was found compressed by strangler plants. One of the dominant trunk of T28 was found dead.

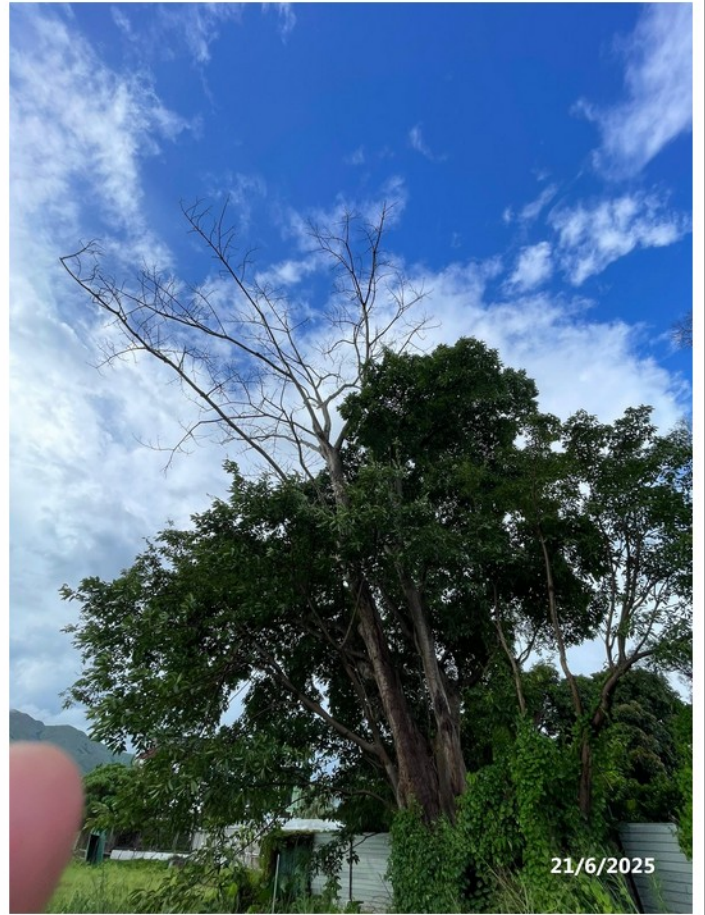
T19	<i>Dimocarpus longan</i>	龍眼	7	187	6	F	P	M	Climber, Co-dominant branches, Included bark	
T20	<i>Artocarpus heterophyllus</i>	菠蘿蜜	9	192	6	F	P	M	Climber, Co-dominant branches, Included bark	
T21	<i>Dimocarpus longan</i>	龍眼	8	217	6	F	P	M	Climber, Co-dominant branches, Included bark	
T22	<i>Dimocarpus longan</i>	龍眼	6	206	4	F	P	M	Dieback, Co-dominant branches, Included bark	
T23	<i>Dimocarpus longan</i>	龍眼	7	369	5	F	P	M	Co-dominant branches, Included bark, Climber	
T24	<i>Melaleuca leucadendra</i>	白千層	13	543	6	P	P	L	Dieback, Co-dominant branches, Restricted root	
T25	<i>Melaleuca leucadendra</i>	白千層	12	627	7	P	P	L	Dieback, Ficus, Restricted root, Co-dominant branches,	
T26	<i>Acacia confusa</i>	台灣相思	10	319	7	P	F	M	Dieback,	
T27	<i>Acacia confusa</i>	台灣相思	6	334	5	F	P	M	Dieback, Exposed dead wood, Wound	
T28	<i>Ficus virens</i>	大葉榕	20	1200	12	P	P	L	Dead trunk, Co-dominant trunks, Included bark, Climber
