**PROPOSED TEMPORARY OPEN STORAGE OF CONSTRUCTION MATERIALS AND CONSTRUCTION MACHINERIES WITH ANCILLARY FACILITIES AND ASSOCIATED FILLING OF LAND FOR A PERIOD OF 3 YEARS AT VARIOUS LOTS IN D.D. 106, SHEK KONG, YUEN LONG, NEW TERRITORIES**

Drainage Proposal - LAYOUT

**Tree Survey Report  
of  
Various Lots in D.D. 106, Shek Kong, Yuen Long,  
New Territories**

drawing title.  
LANDSCAPE PROPOSAL

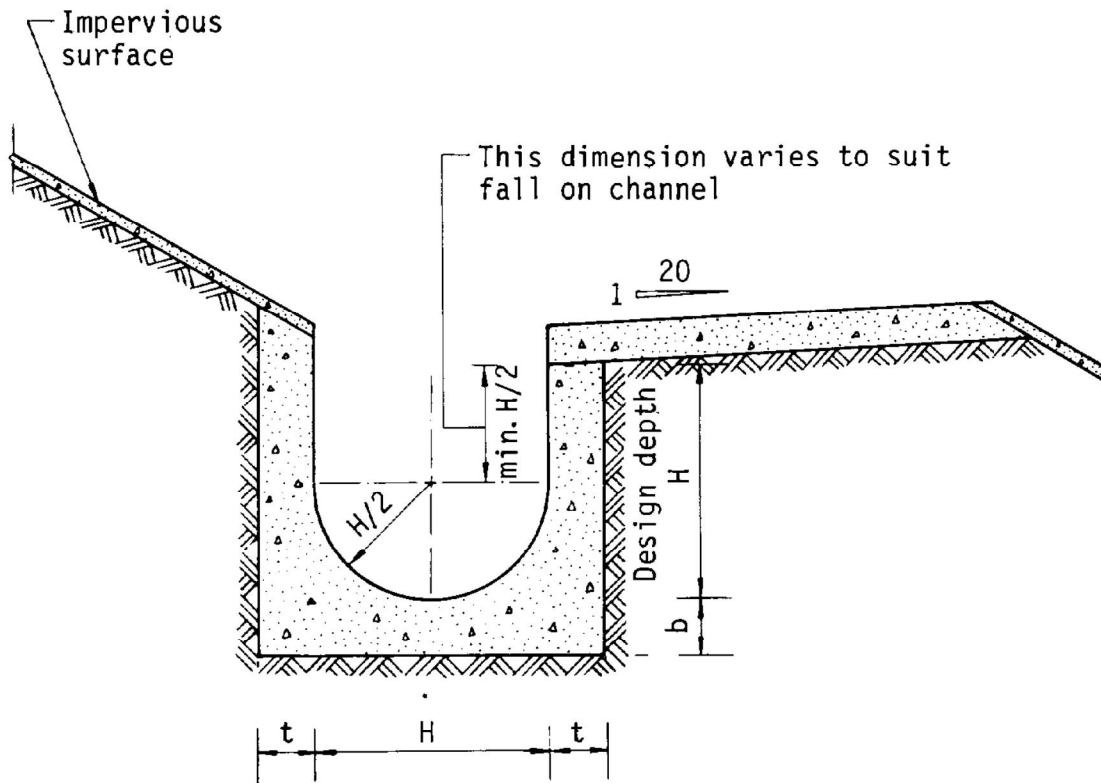
Figure 8.11 - Typical U-channel Details

Dimensions of U - channel

| Nominal size of channel H (mm) | Thickness t (mm) | Thickness b (mm) |
| 225 to 600 | 150 | 150 |
| 675 to 1200 | 175 | 225 |

2. Catchpit and UC follows Typical Details of Geotechnical Manual for Slope Fig.8.10 and Fig.8.11 respectively.

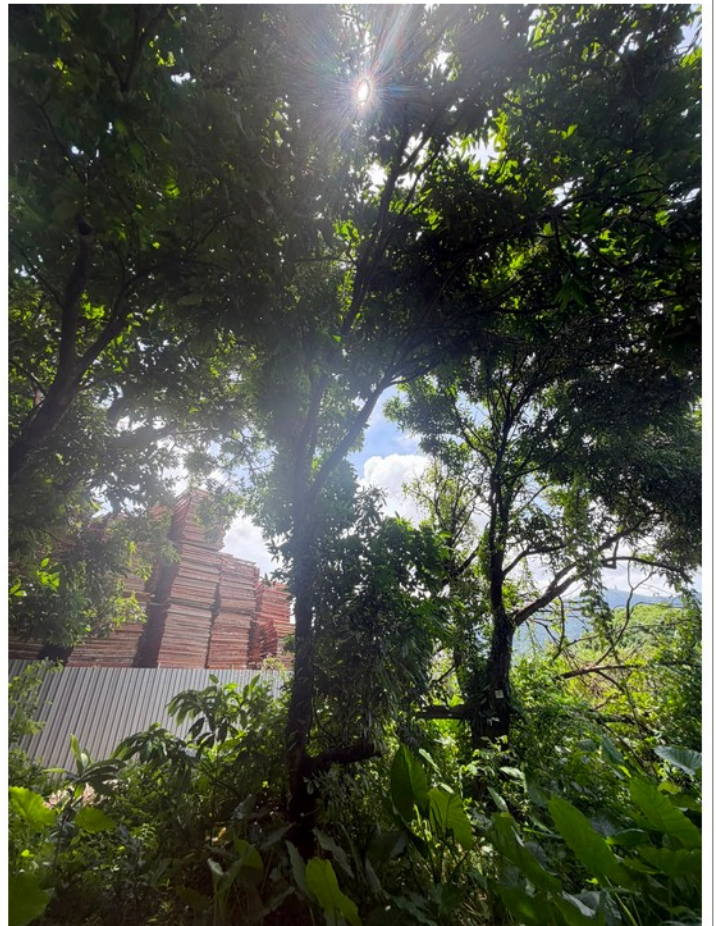
T12 (1)

| Tree No. | Species: | | Size | | | Status | | Amenity<br>Value<br>(High,<br>Medium,<br>Low) | Observable Defects /Damages of Trees | Remarks: |
|---|---|---|---|---|---|---|---|---|---|---|
| T12 | <i>Dimocarpus longan</i> | 龍眼 | 9 | 440 | 7 | F | F | L | Cavity, Decay, Wound | |

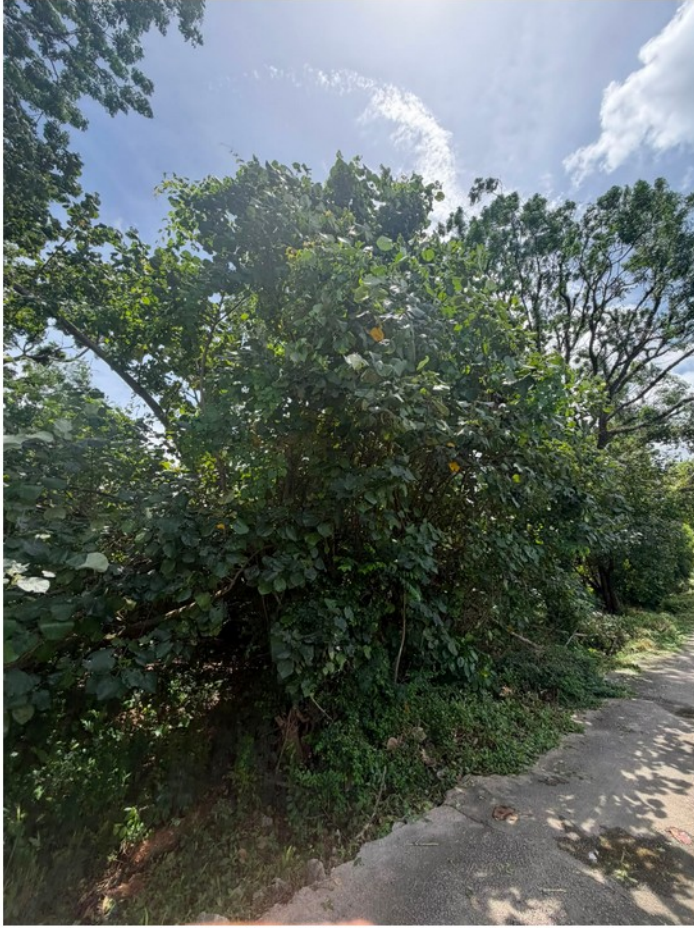
T17 (1)

| Tree No. | Species: | | Size | | | Status | | Amenity<br>Value<br>(High,<br>Medium,<br>Low) | Observable Defects /Damages of Trees | Remarks: |
|---|---|---|---|---|---|---|---|---|---|---|
| T17 | <i>Hibiscus tiliaceus</i> L. | 黃槿 | 6 | 353 | 6 | F | P | L | Broken branch, Exposed dead wood | |

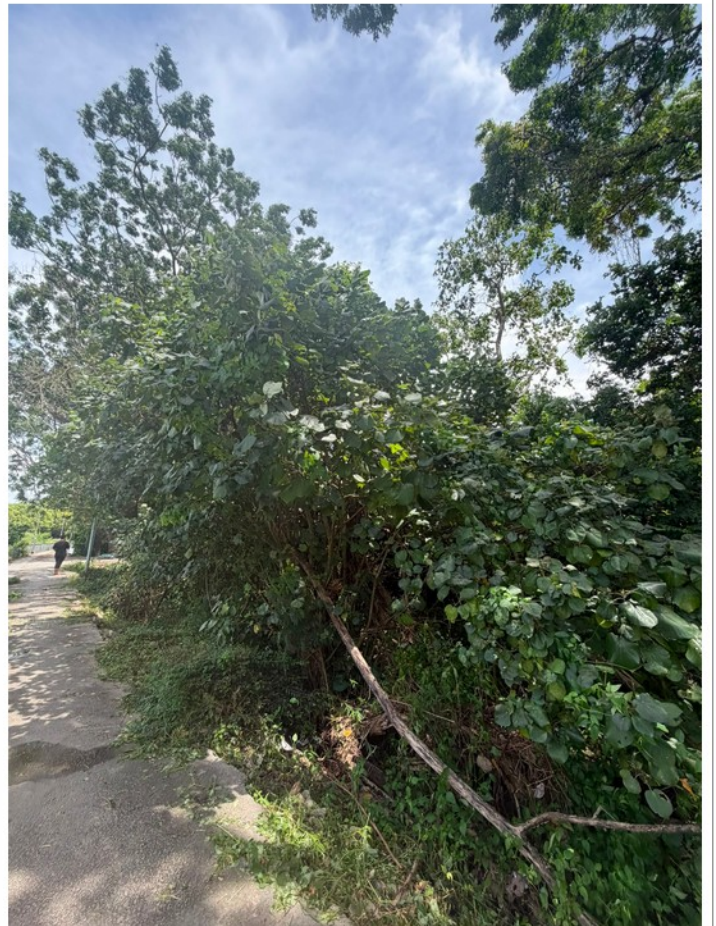
T18 (1)

| Tree No. | Species: | | Size | | | Status | | Amenity<br>Value<br>(High,<br>Medium,<br>Low) | Observable Defects /Damages of Trees | Remarks: |
|---|---|---|---|---|---|---|---|---|---|---|
| T18 | <i>Hibiscus tiliaceus</i> L. | 黃槿 | 6 | 360 | 6 | F | P | L | Broken branch, Exposed dead wood | |
