### **DRAINAGE PROPOSAL**

Ref Nº : DH/138

Application No.: TPB/A/YL-TT/753

#### Drainage Proposal for Temporary Office and Private Vehicle Park

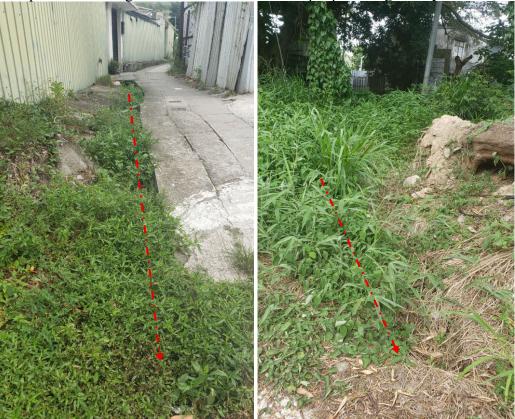
The existing drainage system is directly discharging the stormwater into the nullah (see above R-C Point ii), the existing village drains is working adequately for years and has

no report on flooding after interviewed the local people living nearby.

The existing village drains functioning well and Lands Department has Term Contractor to clear the ditch and drains frequently.

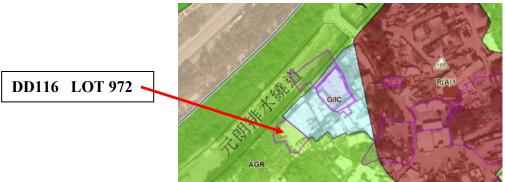
Picture 1 Map of Land Uses

Two sides around the subject is the agriculture lands as shown in green color in *Picture 1* with Lots 973, 974 and 982 respectively with a high ground are now being used as storage sites, the temporary structures.

The other side of the subject is the proposed governmental development project as shown in blue color in *Picture 1*.

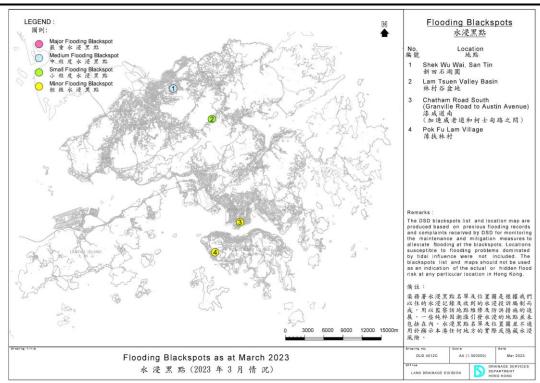
Picture 2: the Flooding Blackspot

The said premise with total area less than one (1) hectare and which is not within the flood area (or so called the 'Blackspot') in the history (refer to *Picture 2* below).

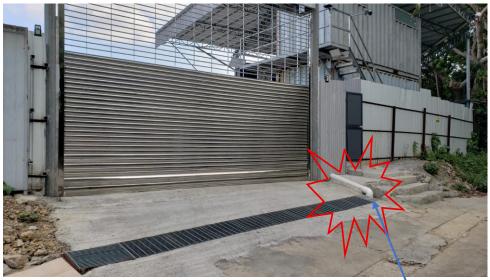
Photo 3: existing 300mm open channel The outlet non-standard catchpit was modified in May 2025

Overland flow from adjacent lots has been observed that there is no obstruction

by the existing hoarding.

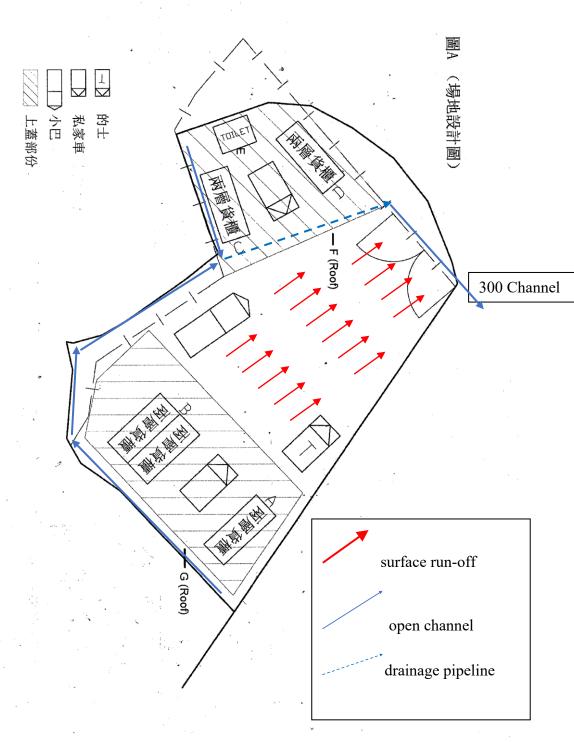
**Drawing No. 04 Direction of Surface Run-Off**

**Drawing No.04** shows the downstream alignment of existing 300mm open channel facilitating the surface water runs off to the existing 300mm open channel before ends up at the natural countryside channel surrounding.

The flow direction of surface runoff is shown on **Drawing No.04** that the existing concrete pavement profile provides a smooth water runoff into the existing U-channel and then the catchpit. Therefore, the pavement surface has to be well maintained and no broken or damages to be occurred during the rainy season.

The area has existing level with almost 8m approximately above sea level that is **providing a free surface run-off** to the existing 300mm U-Channel (refer to Drawing No. 04), stormwater in the area is to be collected by an existing 300mm U-channel before discharging to the existing roadside catchpit then onto the existing nullah which was constructed in 2002 under DSD Project **DC/2002/06** The Construction of Yuen Long Bypass Floodway.

The surface run-off without obstruction from **Point B** onto **Points G**, **B and L** before get into Manhole named **Point M** then fully discharge onto the nullah (the surface run-off is shown on Drawing No. 4 in red arrows).

- 1. The flow direction of the open channel has been indicated clearly on **Drawing** No. 04, the surface water run off is in gradient of 1:200 or greater;
- 2. No right angle or greater (90-degree angle) of the open channel has been observed on site;
- 3. The 300mm surface channel around the site discharges the surface water into the existing U-channel accordingly without disturbing the overall water run-off;
- 4. The overall setting out of the drainage system on the site has been constructed by previous owner but not this owner regardingly;

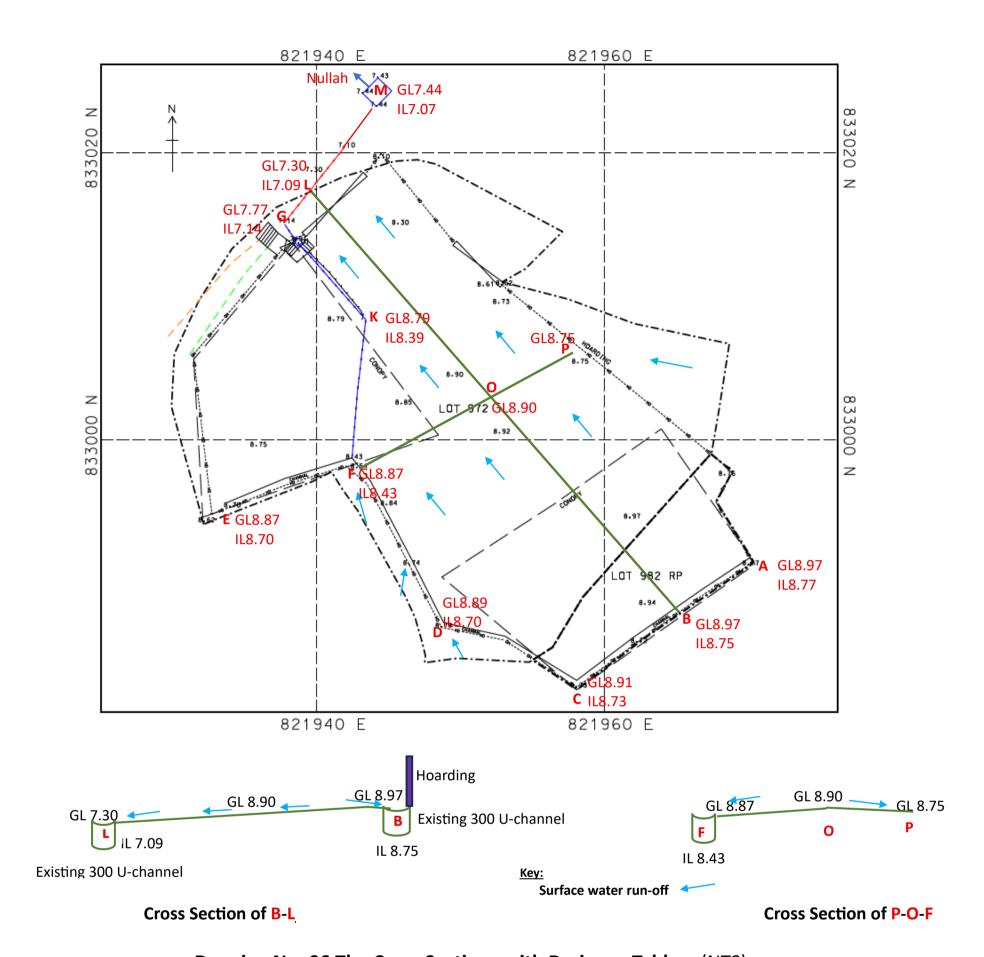
**Drawing No. 06 The Cross Sections with Drainage Table** (NTS)

Points		Upstream		Downstream		Length (m)	Domosile	Doon one ible Doute
		GL (mPD)	IL (mPD)	GL (mPD)	IL (mPD)	(Approximately)	Remark	Responsible Party
А	В	8.97	8.77	8.97	8.75	6.0	Open Chennel	Owner
В	С	8.97	8.75	8.91	8.73	14.4	Open Chennel	Owner
С	D	8.91	8.73	8.89	8.70	10.0	Open Chennel	Owner
0	Р	8.90	-	8.75	-	7.2	Surface Runoff	Owner
0	F	8.90	-	8.87	8.43	9.0	Surface Runoff	Owner
Е	F	8.87	8.70	8.87	8.43	9.6	Open Chennel	Owner
D	F	8.89	8.70	8.87	8.43	13.0	Open Chennel	Owner
F (Inlet)	К	8.87	8.43	8.79	8.39	9.2	300 uPVC Pipe	Owner
K	G (Catchpit)	8.79	8.39	7.77	7.14	8.6	300 uPVC Pipe	Owner
G	L	7.77	7.14	7.30	7.09	3.6	Cover Grating Channel	Owner
В	L	8.97	8.75	7.30	7.09	38.0	Surface Runoff	Owner
L	M (Manhole)	7.30	7.09	7.44	7.07	6.8	Covered Chennel	Lands/DSD
М	Nullah	7.44	7.07	-	-	3.2	Underground Pipeline	DSD

- i) Technical Note No.1 issued December 2024 has been used as a reference guideline for this drainage proposal.
- ii) Please refer to **Drawing No. 6** of the overall Drainage Plan.

The gradients and sizes of the existing drainage facilities are also shown on the drainage plan; the existing gradient is 1:24 approximately towards the existing nullah.

- iii) The cover levels and invert levels of the existing u-channels and modified catchpit are as shown on the drainage plan on **Drawing No.s 6 and 7**.
- iv) **Drawing No. 6,** the Drainage Plan shows the full alignment with Invert Levels and existing Ground Levels from **points A to B, C, D, F (and from E to F), K, G, L, M** then to the final discharge point of the nullah.

ix) The cross-sectional details of the existing 300mm u-channel and the catchpit are shown on **Drawing No.s 6 and 7** respectively for reference.

The existing 300mm u-channel is shown on Drawing No. 6 with yellow color, the rainwater runs along the existing u-channel from **Point A** to **Point F** will be collected into the existing 300mm uPVC pipeline from **Point F** to **Point G** before discharged into the new constructed sand trap.

The stormwater continues to run through the existing 300mm u-channel onto the manhole namely **Pont M** before fully discharge onto the nullah.

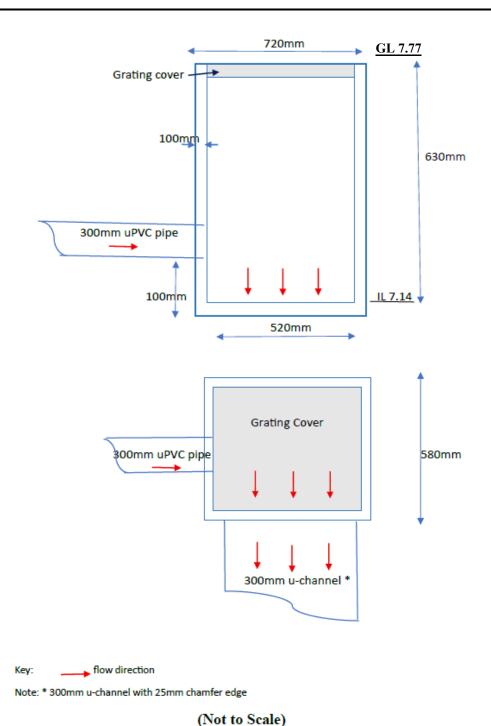
Drawing No. 7 Modification of Non-standard Catchpit at Point G

The nonstandard catchpit was modified as on 28 May 2025 as shown on **Drawing No.** 7

- vi) Please note that no site formation was carried out in the history, therefore no construction of wall / structural hoarding is under this application at all. So, it is confirmed that there is no site formation/levelling works to be carried out under this application.
- vii) Yes, Photo E indicated a nonstandard catchpit which was constructed by previous land owner.

<u>Instruction was given to the new owner to modify the catchpit early May 2025</u>. Below please find the modification of the said catchpit:

6. The non-standard sand trap at **Point G** has been modified accordingly in May 2025 to suit the request of DSD's comment.

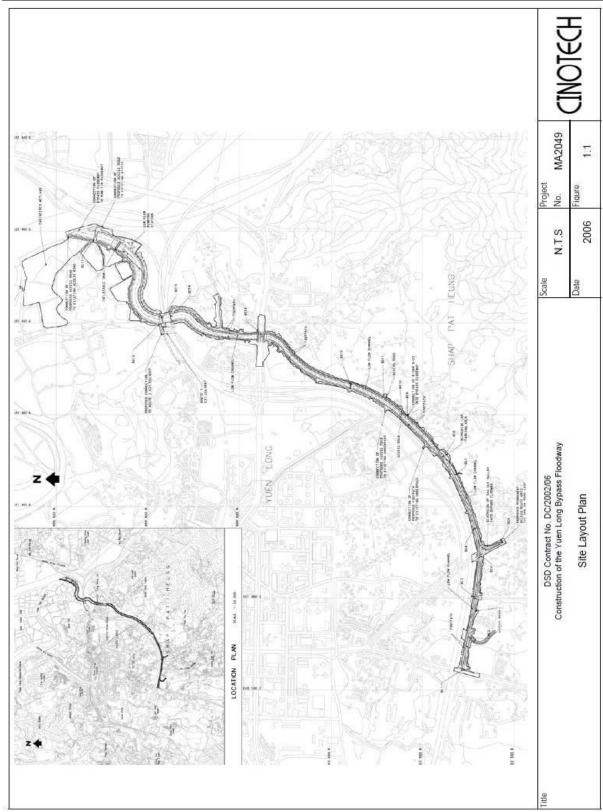
Drawing No. 08 Yuen Long Bypass Floodway (DC/2022/06)

The existing Yuen Long Bypass Floodway takes the capacity of water runoff from the site as shown in **Drawing No. 8** herewith.

The photos show the drainage system is part of the Yuen Long Bypass Floodway (DC/2022/06) which is to collect the stormwater runoff from the premise.\
