# **Proposed Residential Development(s) with Retail, Public Vehicle Park and Social Welfare Facilities at Various Lots in D.D. 11 and Adjoining Government Land, Fung Yuen, Tai Po, New Territories**

## **Land Contamination Assessment**

Report No.:  
**22608-C1**

Date:  
**26 September 2025**

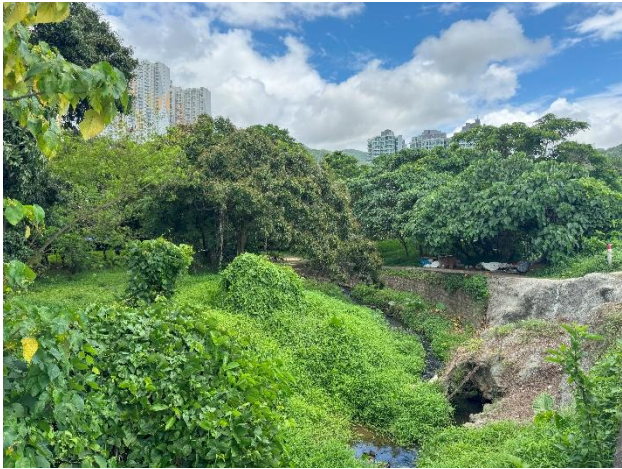
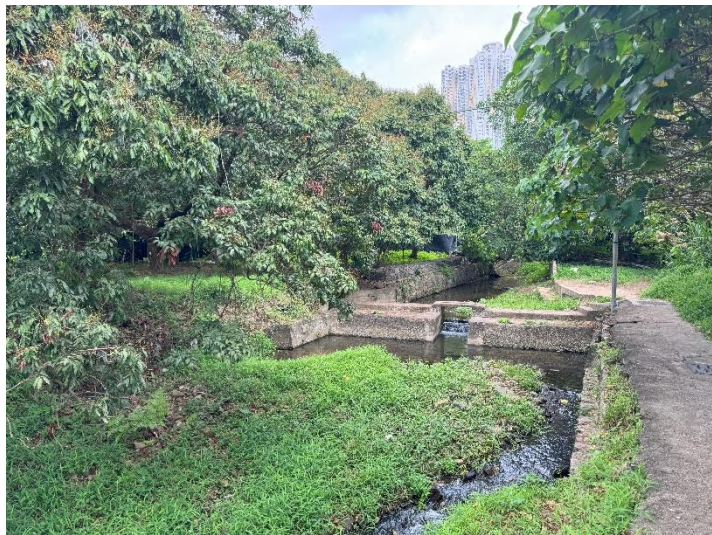
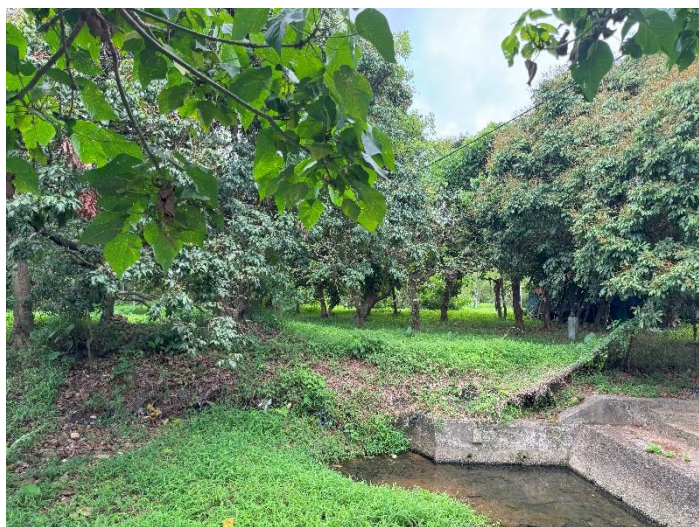
TITLE:  
**Photographs taken on Site  
(Plates 1 – 3)**

**Observation:**  
Area (A) was mainly vegetated and landscaped, which were in clean condition. No sign of contamination.

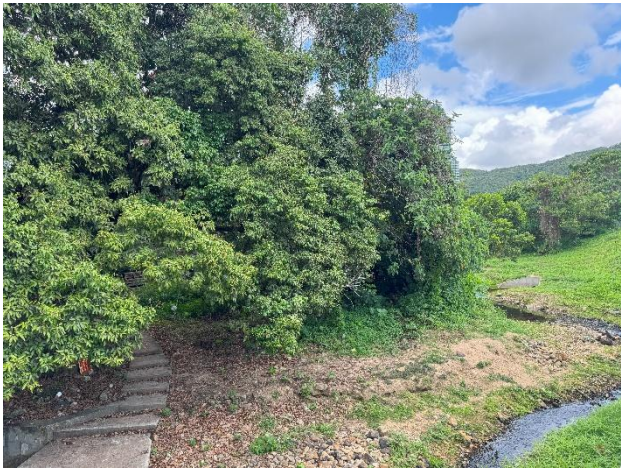
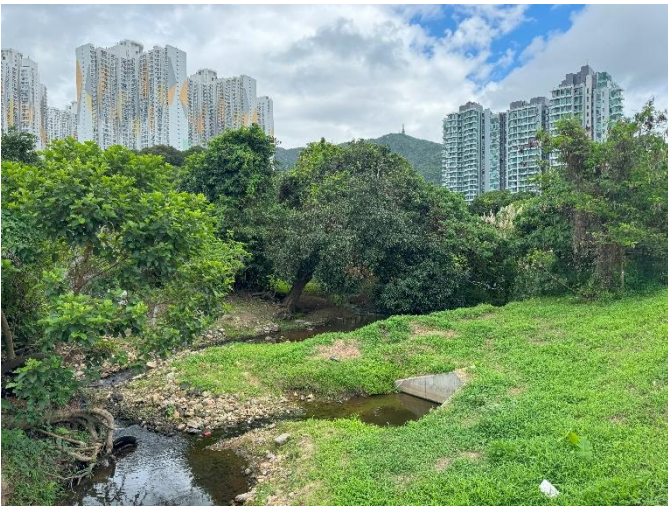
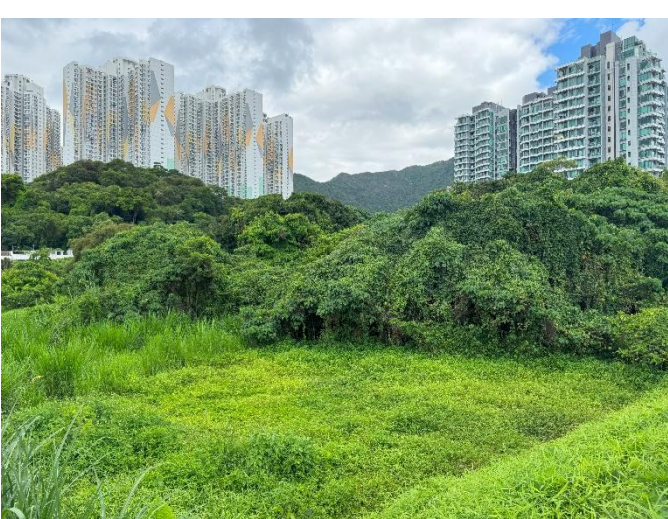
TITLE:  
**Photographs taken on Site  
(Plates 4 – 6)**

**Observation:**  
Area (A) was mainly vegetated and landscaped, which were in clean condition. No sign of contamination.

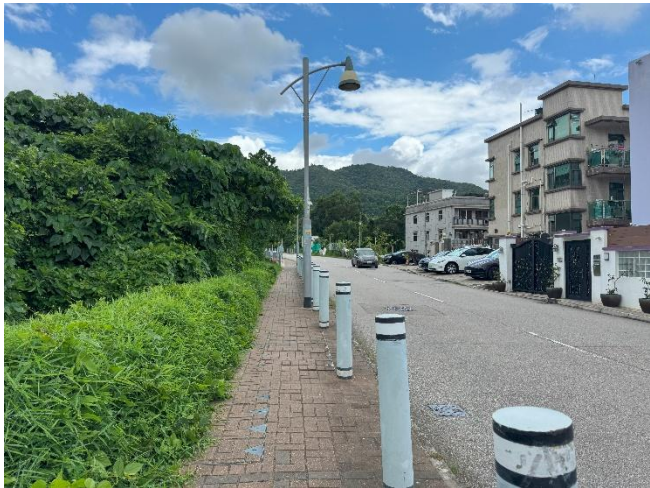
Plate 7 – Photo taken on 7<sup>th</sup> April 2025 :-

**Observation:**  
Area (A) was mainly vegetated and landscaped, which were in clean condition. No sign of contamination.

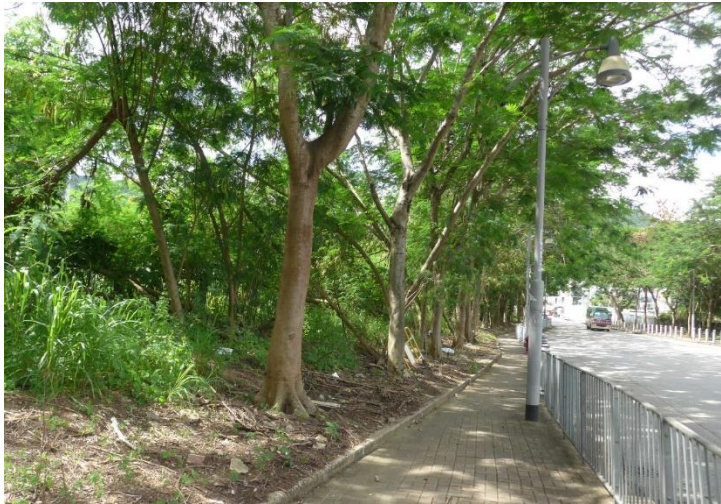
Plate 8 – Photo taken on 7<sup>th</sup> April 2025 :-

**Observation:**  
Area (B) was mainly vacant and covered by vegetation, which were in clean condition. No sign of contamination.

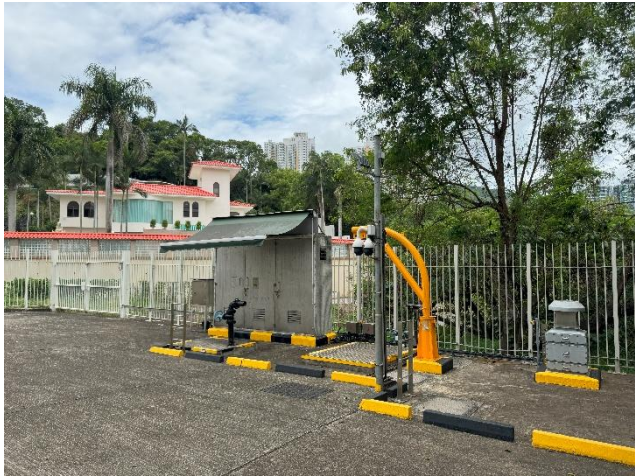
Plate 9 – Photo taken on 7<sup>th</sup> April 2025 :-

**Observation:**  
Southern part of Area (B) was occupied by the Tin Sam Sewage Pumping Station, which was paved and in a clean condition. No sign of contamination.

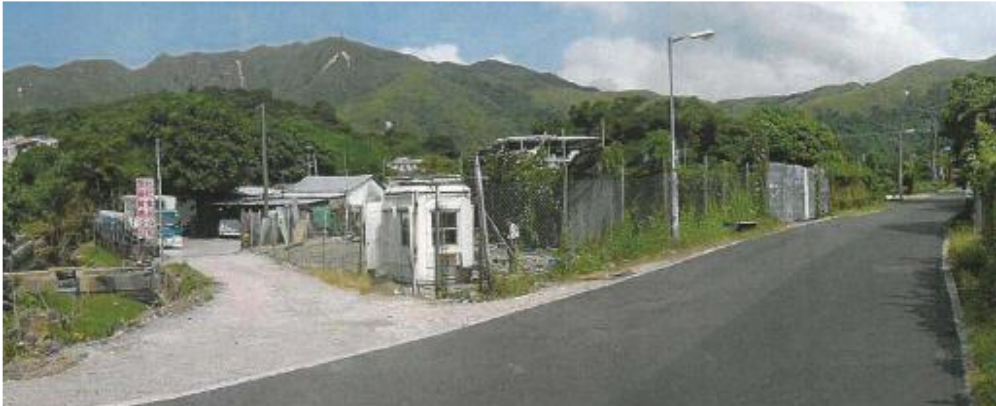
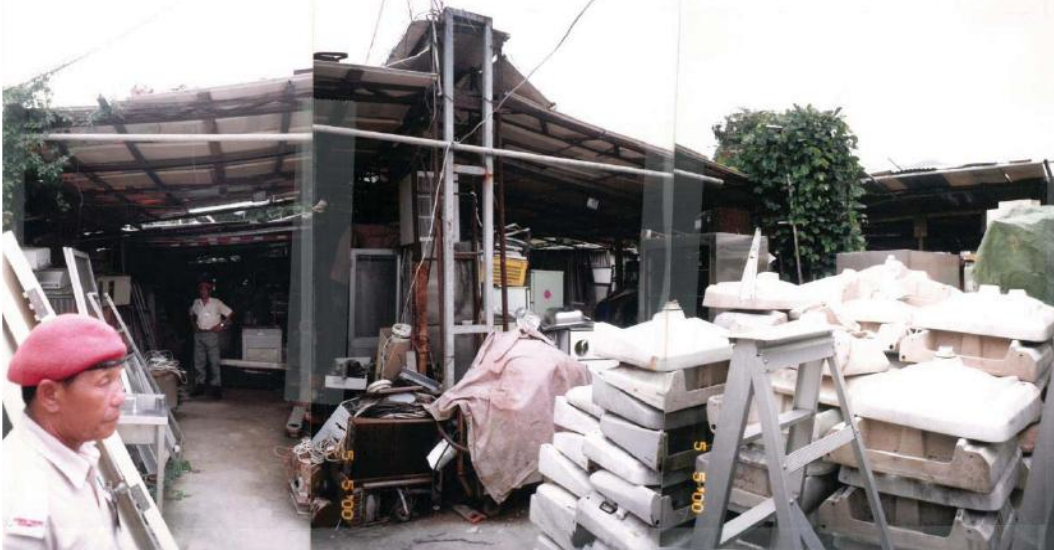
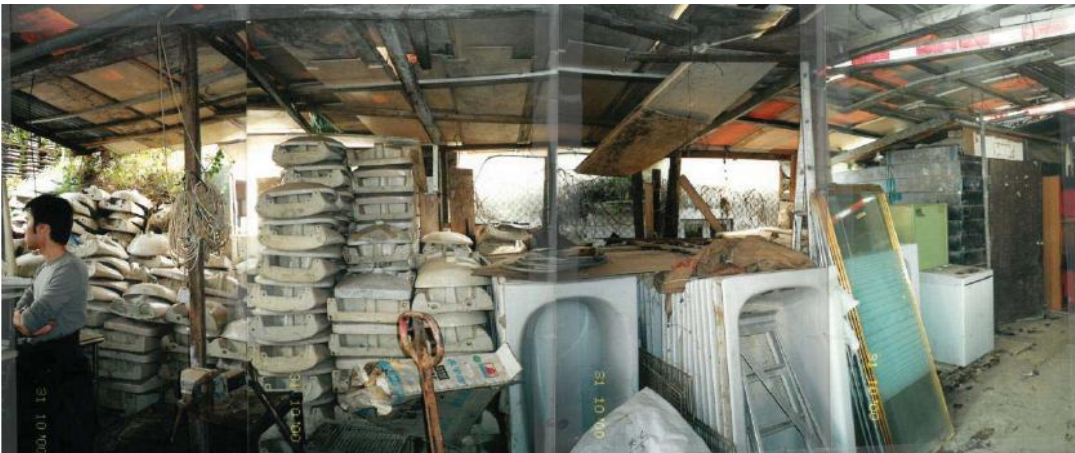
**Photographs taken on Site  
(Plates 10 – 12)**

Eastern tip of Area (A) had been temporarily used for storage of kitchenware, no potential contamination activity and equipment were identified.

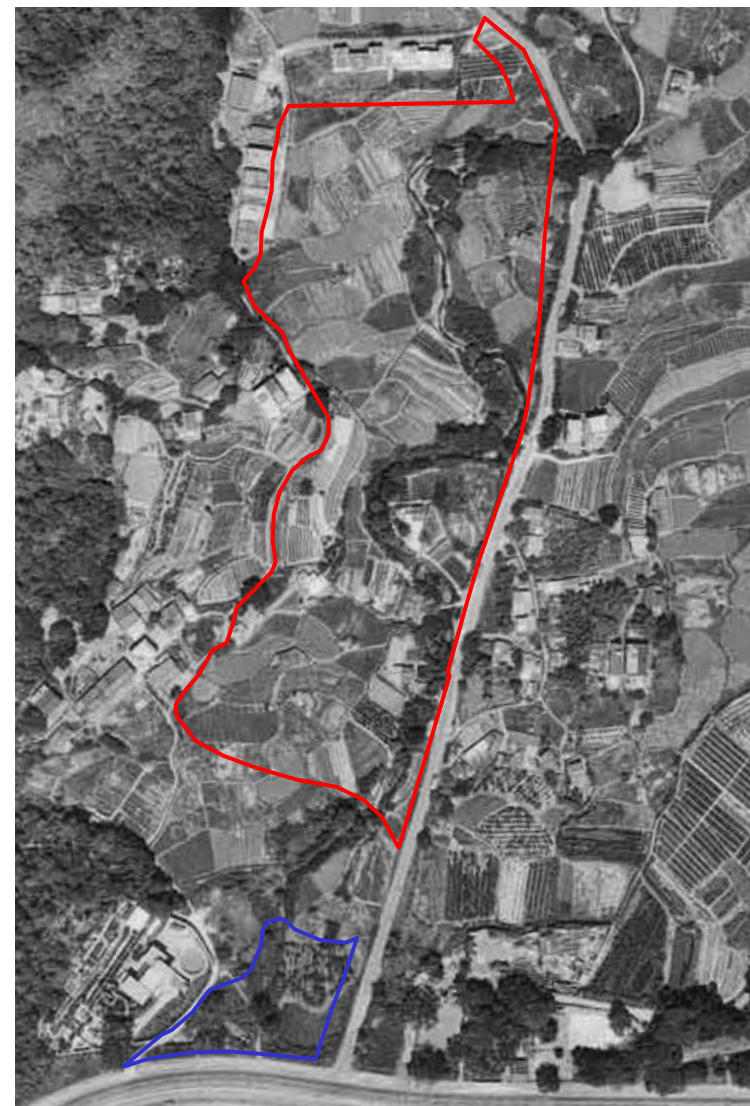
Year 1986 (ref: A06202, height: 4000ft)  
 Area (A) – The site was still used as farmland with agricultural use. Fung Yuen Road and nearby village houses were established.  
 Area (B) – The site was still used as farmland with agricultural use.

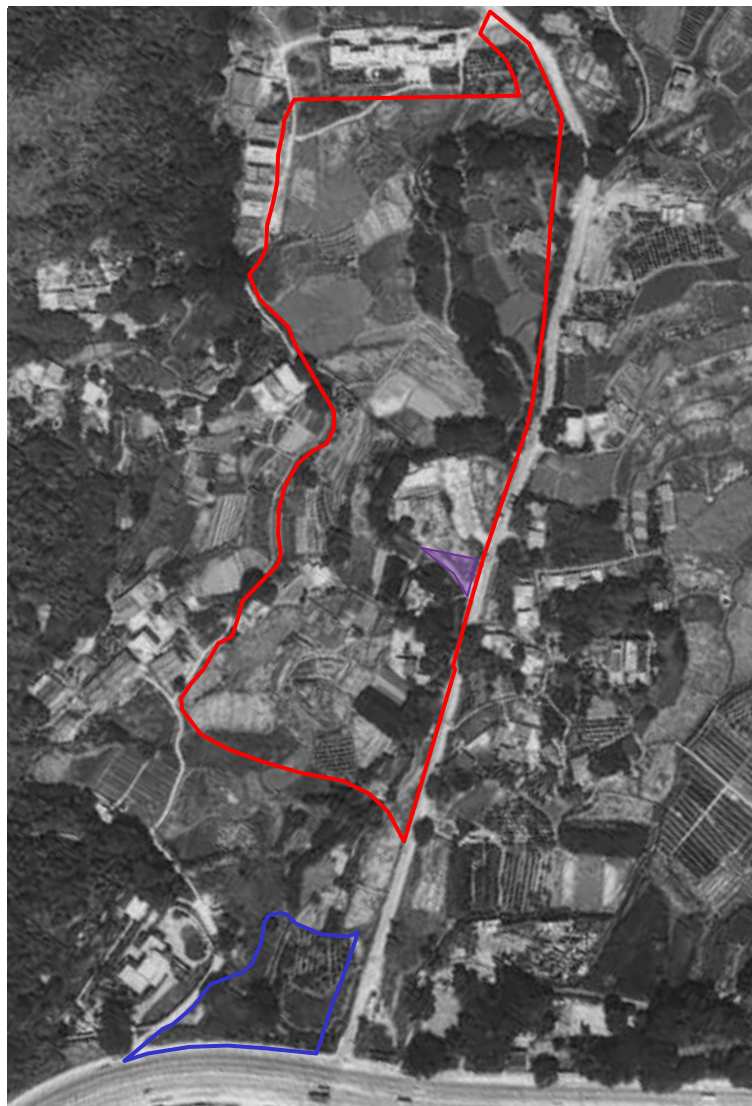
Year 1989 (ref: A18095, height: 4000ft)

Area (A) – A tiny portion located at the eastern tip of the site was used as a temporary storage of kitchenware. Other locations of the site had no significant changes, which was agricultural use.  
Area (B) – The site was still used as farmland with agricultural use.

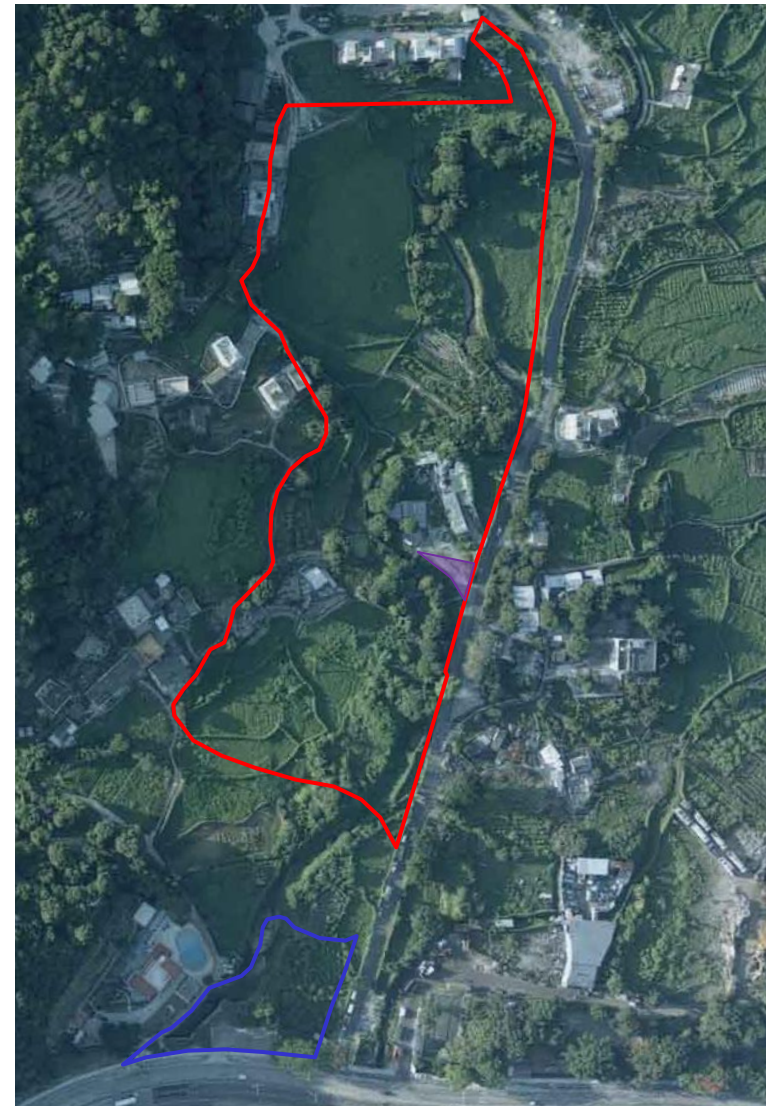
Year 2002 (ref: CW40616, height: 3000ft)

Area (A) – A tiny portion located at the eastern tip of the site was used as a temporary storage of kitchenware. Other locations of the site had no significant changes, which was agricultural use.  
Area (B) – Southern part of the site remained occupied by the Tin Sam Sewage Pumping Station. Other locations of the site remained vegetated.

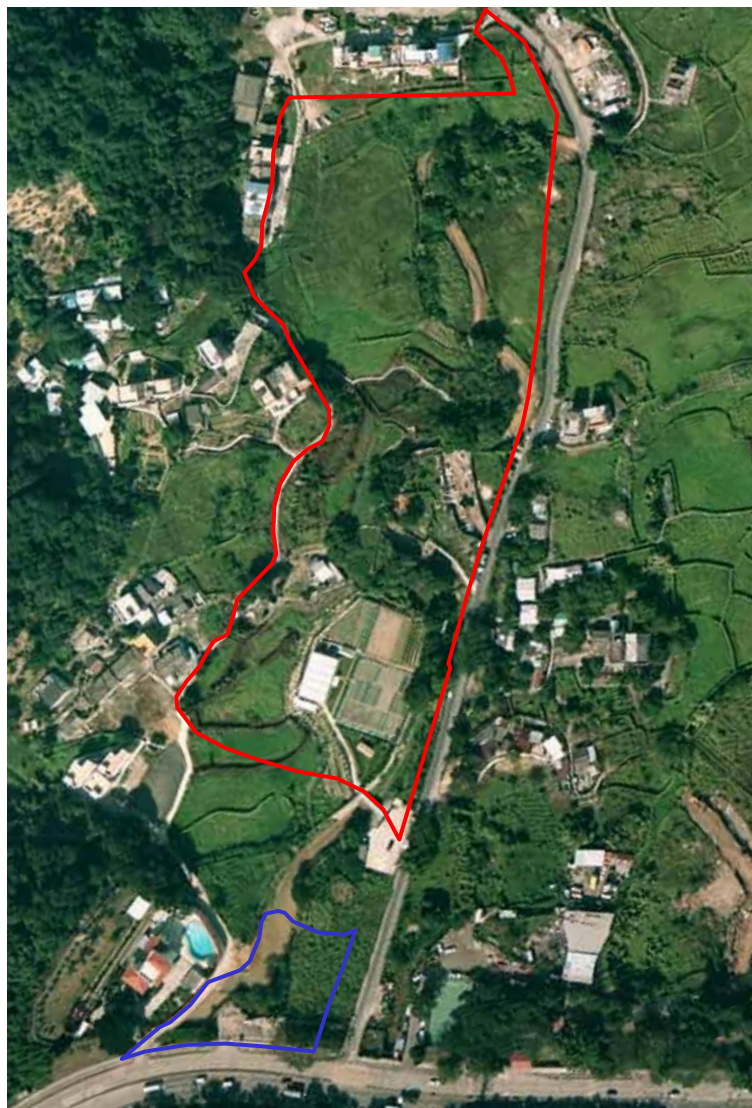
Year 2003 (ref: CW52202, height: 4000ft)

Area (A) – The site was vegetated and landscaped. The central part of the site was agricultural use.

Area (B) – Southern part of the site remained occupied by the Tin Sam Sewage Pumping Station.  
Other locations of the site remained vegetated.

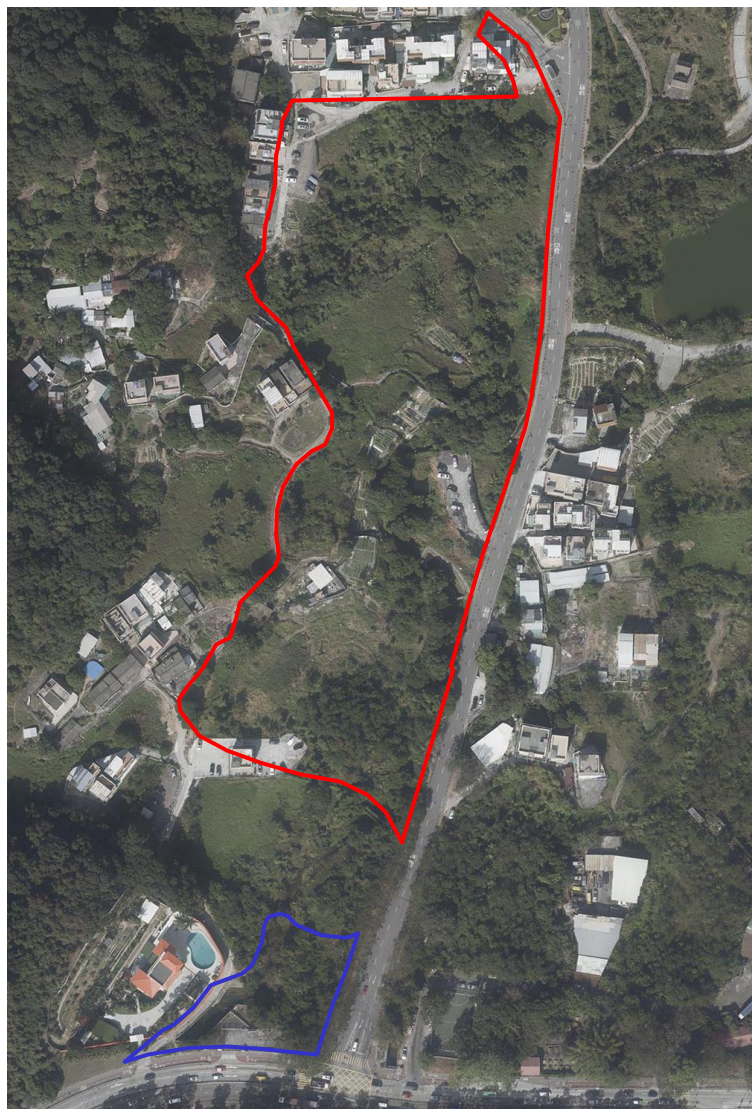
Year 2018 (ref: E033517C, height: 6900ft)

Area (A) – The site was vegetated and landscaped. A tiny portion of northeastern corner was the village houses.

Area (B) – Southern part of the site remained occupied by the Tin Sam Sewage Pumping Station. Other locations of the site remained vegetated.

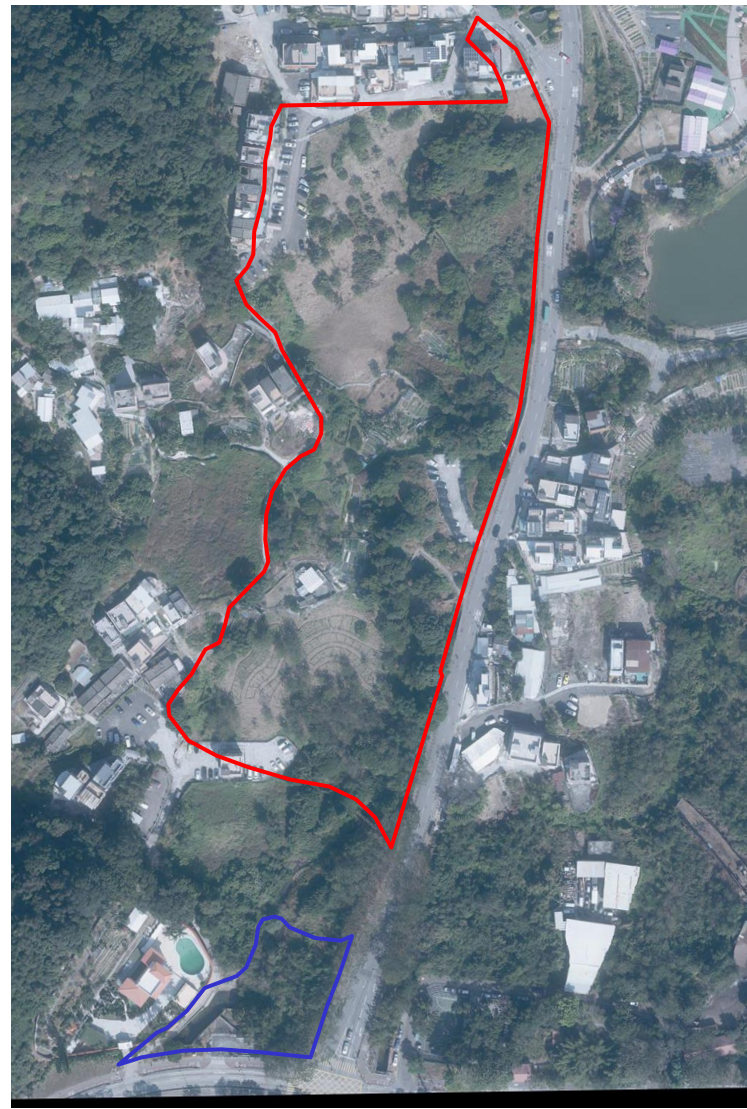
Year 2021 (ref: E126460C, height: 6900ft)

Area (A) – The site was vegetated and landscaped. A tiny portion of northeastern corner was the village houses.

Area (B) – Southern part of the site remained occupied by the Tin Sam Sewage Pumping Station. Other locations of the site remained vegetated.

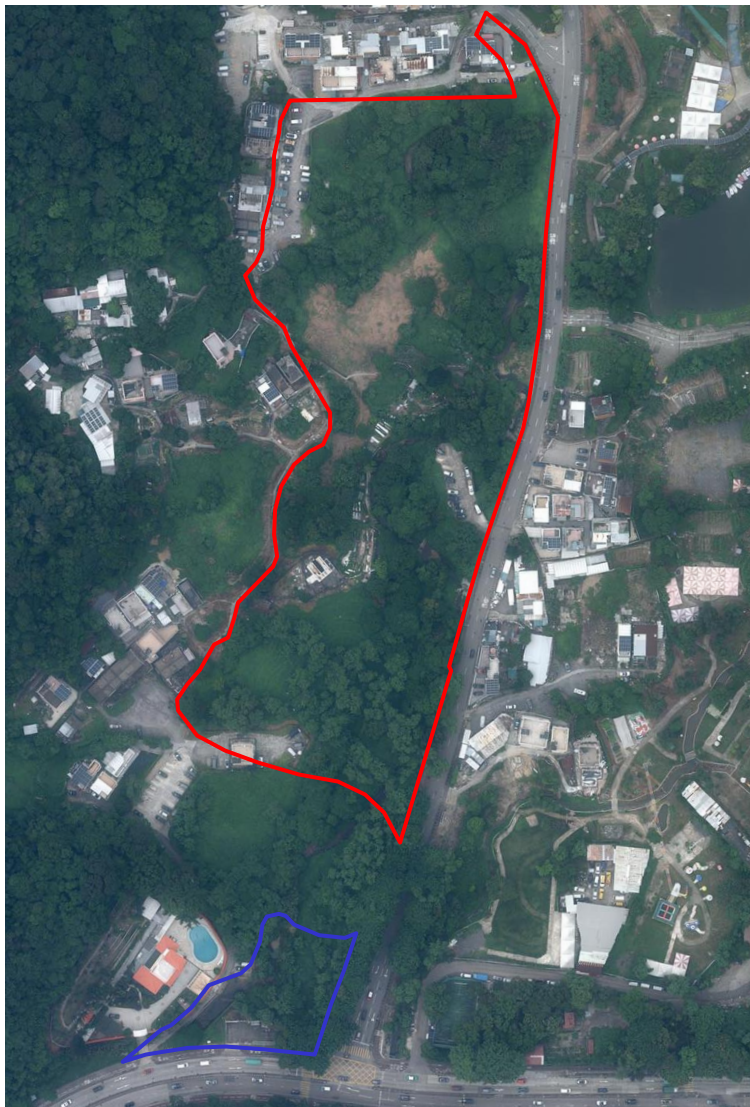
Year 2024 (ref: E228303C, height: 6900ft)

Area (A) – The site was vegetated and landscaped. A tiny portion of northeastern corner was the village houses.

Area (B) – Southern part of the site remained occupied by the Tin Sam Sewage Pumping Station. Other locations of the site remained vegetated.
