AGREEMENT NO.CE51/2018 (CE)
SITE FORMATION & INFRASTRUCTURE WORKS
FOR PUBLIC HOUSING DEVELOPMENT AT
TSING YI ROAD WEST.
TSING YI
FEASIBILITY STUDY

## <u>申述地點航攝照片</u> AERIAL PHOTO OF REPRESENTATION SITE

就青衣分區計劃大綱草圖編號S/TY/31 提出的申述個案編號R1至R5277及 相關意見編號C1至C1627作出考慮 CONSIDERATION OF REPRESENTATIONS No. R1 TO R5277 AND RELATED COMMENTS No. C1 TO C1627 TO THE DRAFT TSING YI OUTLINE ZONING PLAN No. S/TY/31

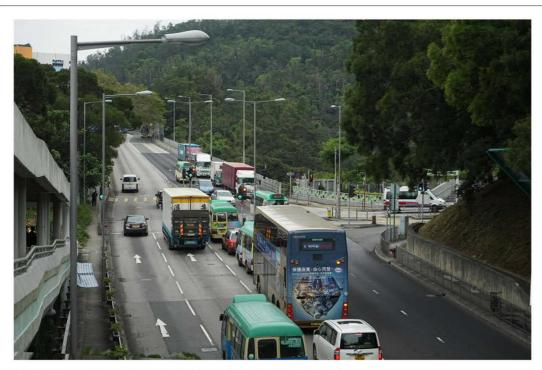
VP1 - Existing View taken at footbridge by Tsing Yi Road West Park

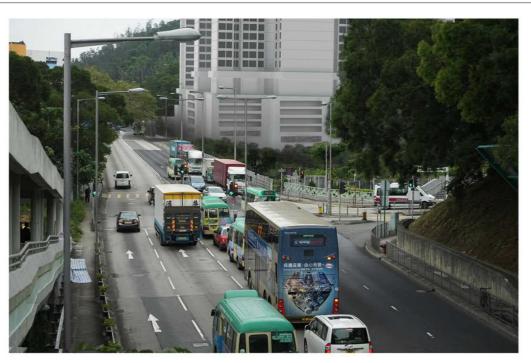
VP1 - Photomontage without Mitigation Measures

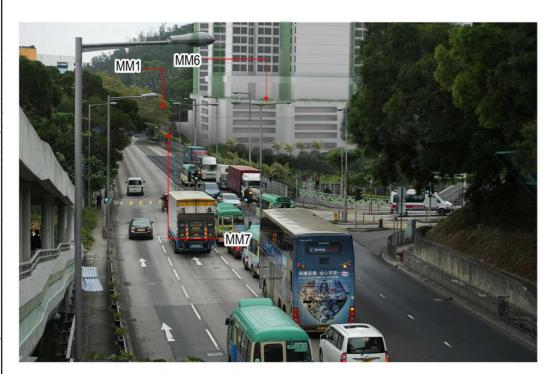
MM1 Preservation of existing vegetation

MM6 Landscape treatment within

developement

MM7 Buffer planting

VP1 - Photomontage with Mitigation Measures

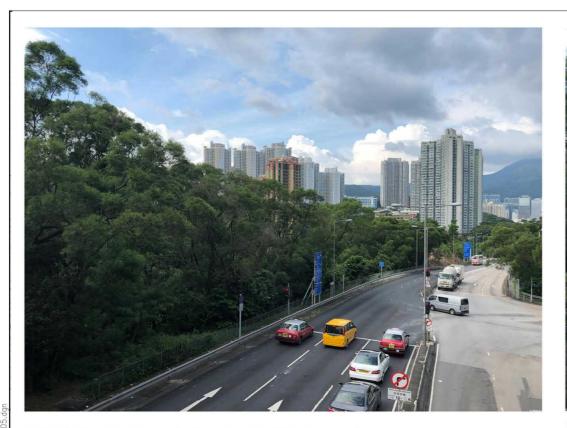
VP2 - Existing View taken at footbridge by Tsing Wah Playground

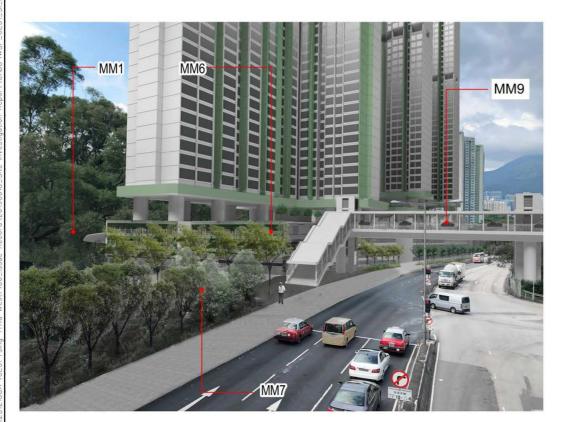
VP2 - Photomontage with Mitigation Measures

MM1 Preservation of existing vegetation

MM6 Landscape treatment within

developement

MM7 Buffer planting

Planting on footbridge

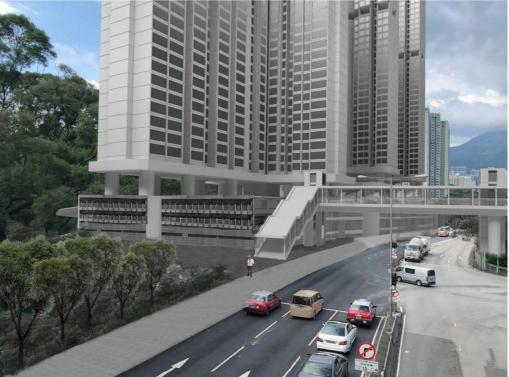
VP2 - Photomontage without Mitigation Measures

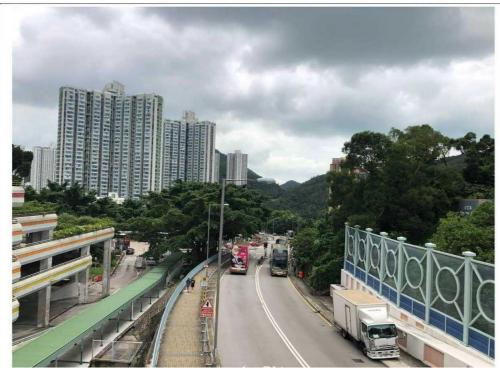
VP3 - Existing View taken at footbridge by Liu To Road

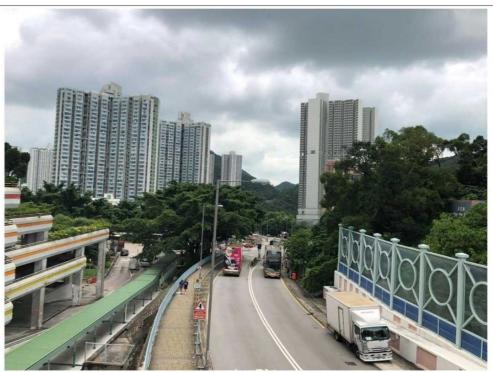
VP3 - Photomontage without Mitigation Measures

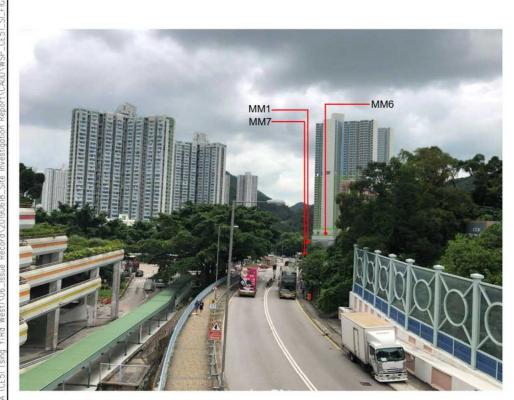
MM1 Preservation of existing vegetation

MM6 Landscape treatment within

developement

MM7 Buffer planting

VP3 - Photomontage with Mitigation Measures

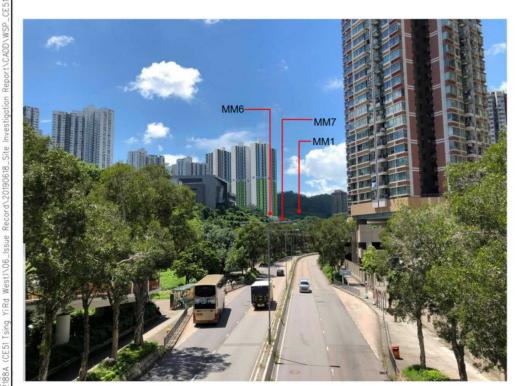
MM1 Preservatgion of existing vegetation

MM6 Landscape treatment within

developement
MM7 Buffer planting

VP4 - Photomontage with Mitigation Measures

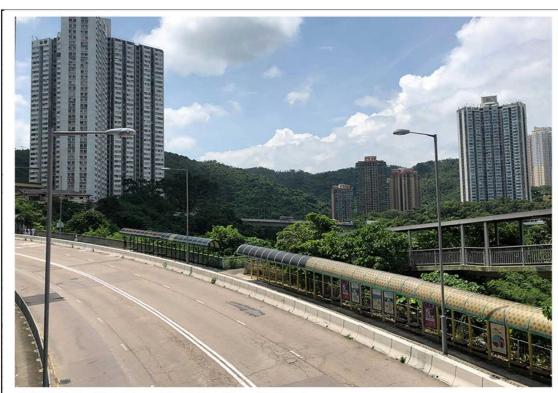
VP5 - Existing View taken at footbridge Chung Mei Road

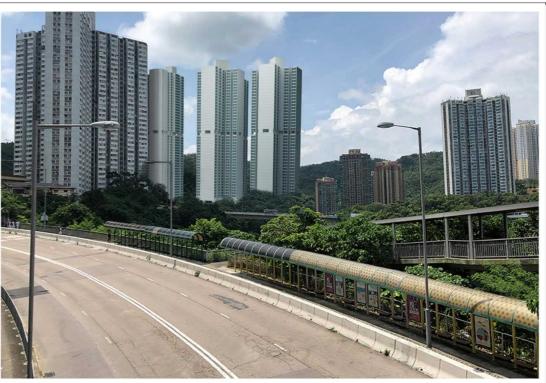
VP5 - Photomontage without Mitigation Measures

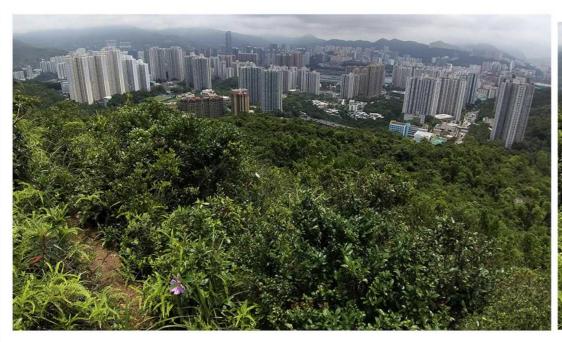
VP6 - Existing View taken at Tsing Yi Nature Trails

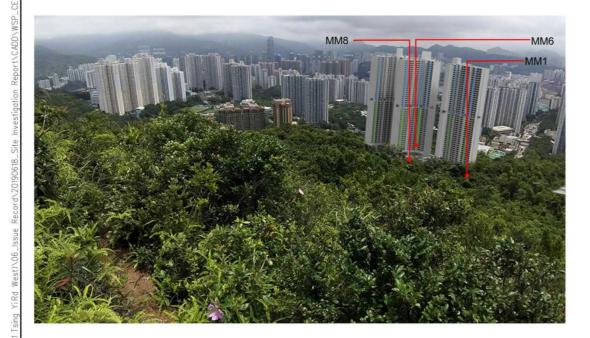
VP6 - Photomontage with Mitigation Measures

MM1 Preservation of existing vegetation

MM6 Landscape treatment within

developement

MM8 Woodland mix tree and shrub

planting

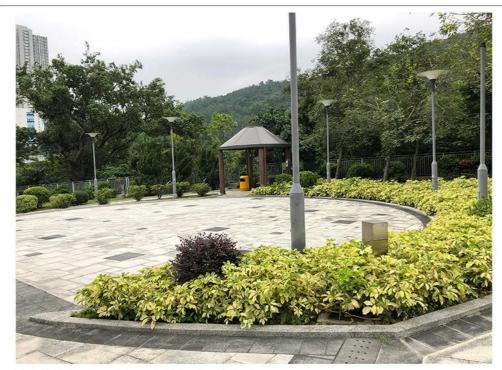
VP7 - Existing View taken at Liu To Road Garden

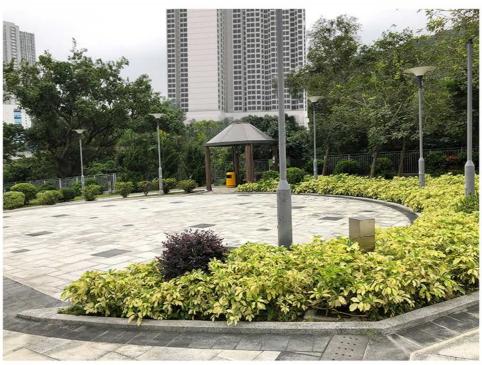
VP7 - Photomontage without Mitigation Measures

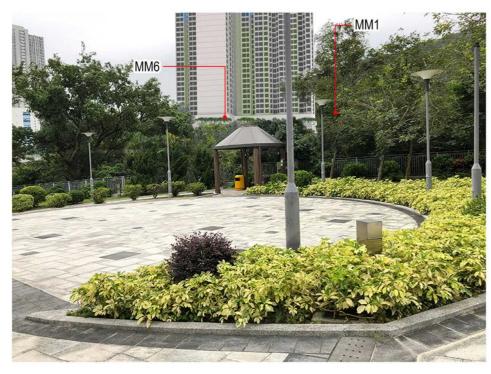
VP7 - Photomontage with Mitigation Measures

MM1 Preservation of existing vegetation

MM6 Landscape treatment within developement

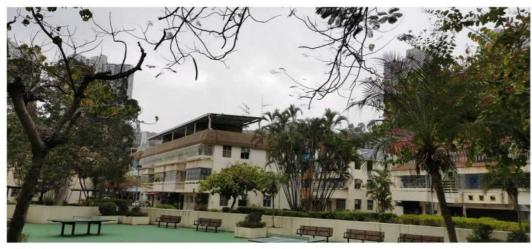
VP8 - Existing View taken of Tai Wong Ha Playground

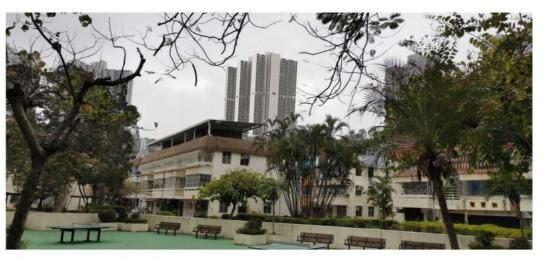
VP8 - Photomontage without Mitigation Measures

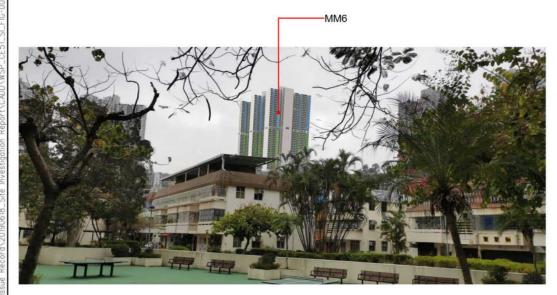
MM6 Landscape treatment within development

VP8 - Photomontage with Mitigation Measures

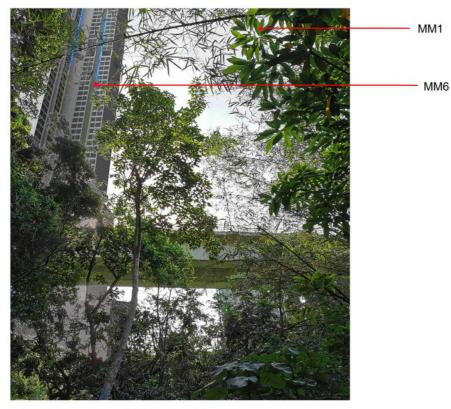
VP9 - Photomontage with Mitigation Measures

MM1 Preservation of existing vegetation

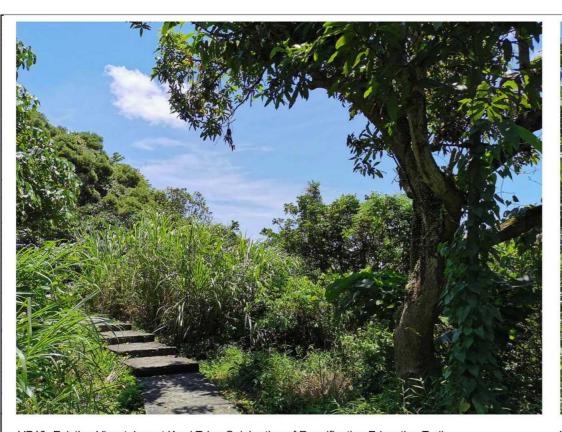
VP10- Existing View taken at Kwai Tsing Celebration of Reunification Education Trail

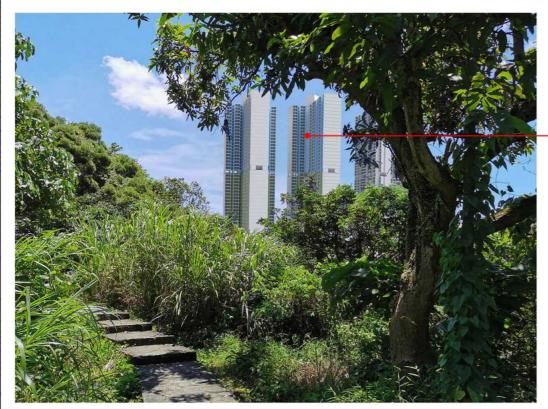
MM6 Landscape treatment within development

VP10 - Photomontage with Mitigation Measures

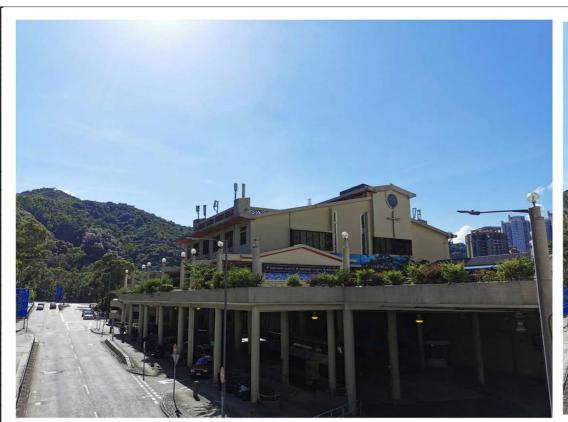
VP11- Existing View taken at Ching Hong Road

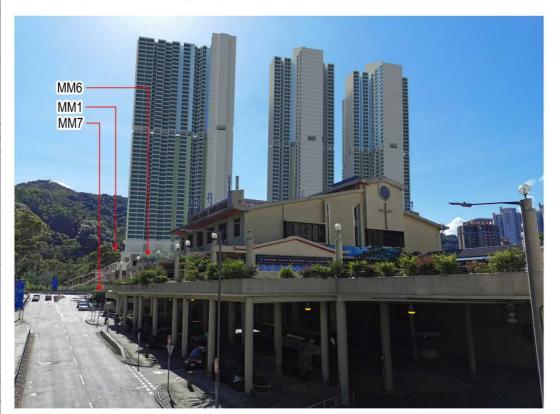
VP11 - Photomontage with Mitigation Measures

MM1 Preservation of existing vegetation MM6 Landscape treatment within developement MM7 Buffer planting

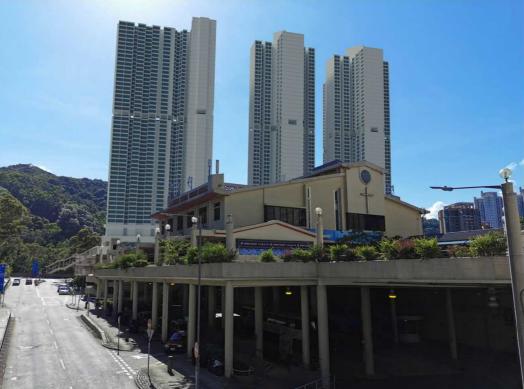
VP11 - Photomontage without Mitigation Measures

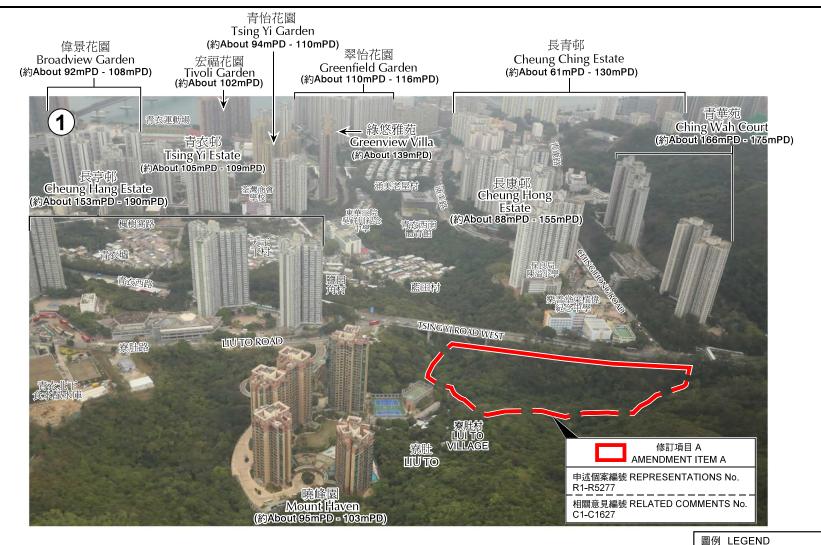
圖PLAN H-4a

現有住用建築物高度(在主水平基準上若干米) EXISTING BUILDING HEIGHT OF DOMESTIC BUILDING BLOCKS (IN METRES ABOVE PRINCIPAL DATUM)

## SITE PHOTO OF REPRESENTATION SITE

本圖於2022年3月1日擬備,所根據的 資料為攝於2021年3月3日的實地照片 PLAN PREPARED ON 1.3.2022 BASED ON SITE PHOTO TAKEN ON 3.3.2021

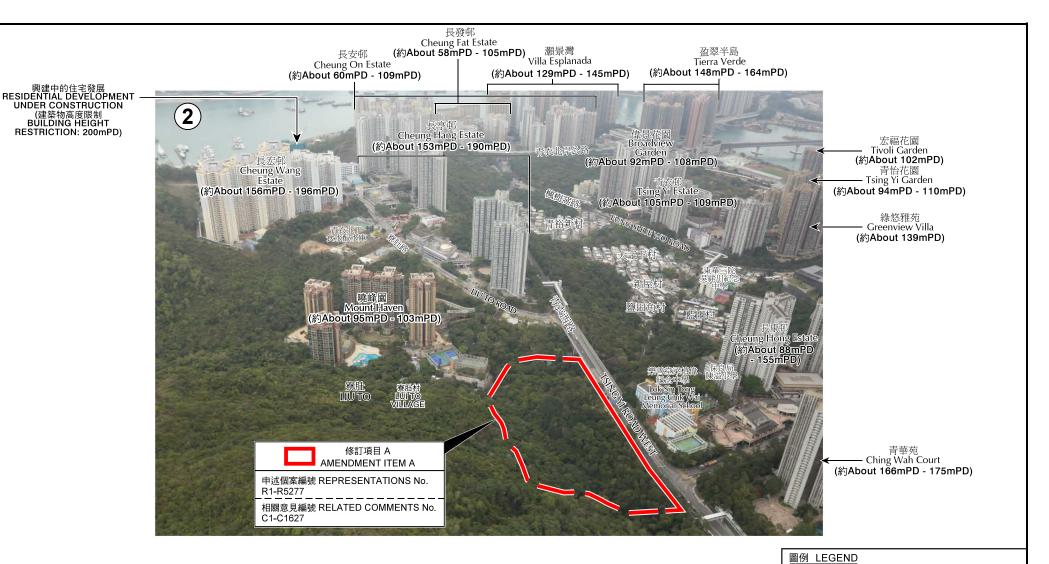
圖 PLAN H-4b

## SITE PHOTO OF REPRESENTATION SITE

現有住用建築物高度(在主水平基準上若干米) EXISTING BUILDING HEIGHT OF DOMESTIC BUILDING BLOCKS (IN METRES ABOVE PRINCIPAL DATUM)

本圖於2022年3月1日擬備,所根據的 資料為攝於2021年3月3日的實地照片 PLAN PREPARED ON 1.3.2022 BASED ON SITE PHOTO TAKEN ON 3.3.2021
