**APPLICATION FOR PERMISSION
UNDER SECTION 16 OF
THE TOWN PLANNING ORDINANCE
(CAP. 131)**

This report would present a Geotechnical Planning Review Report (GPRR) of the site to support of the current planning application (application no. A/YL-LFS/426). No foundation, site formation, building works, or works which involve significant excavation works would be involved in this application.

PROJECT: TEMPORARY LOGISTICS CENTRE WITH ANCILLARY OFFICE AND PARKING OF VEHICLES FOR PERIOD OF 3 YEARS

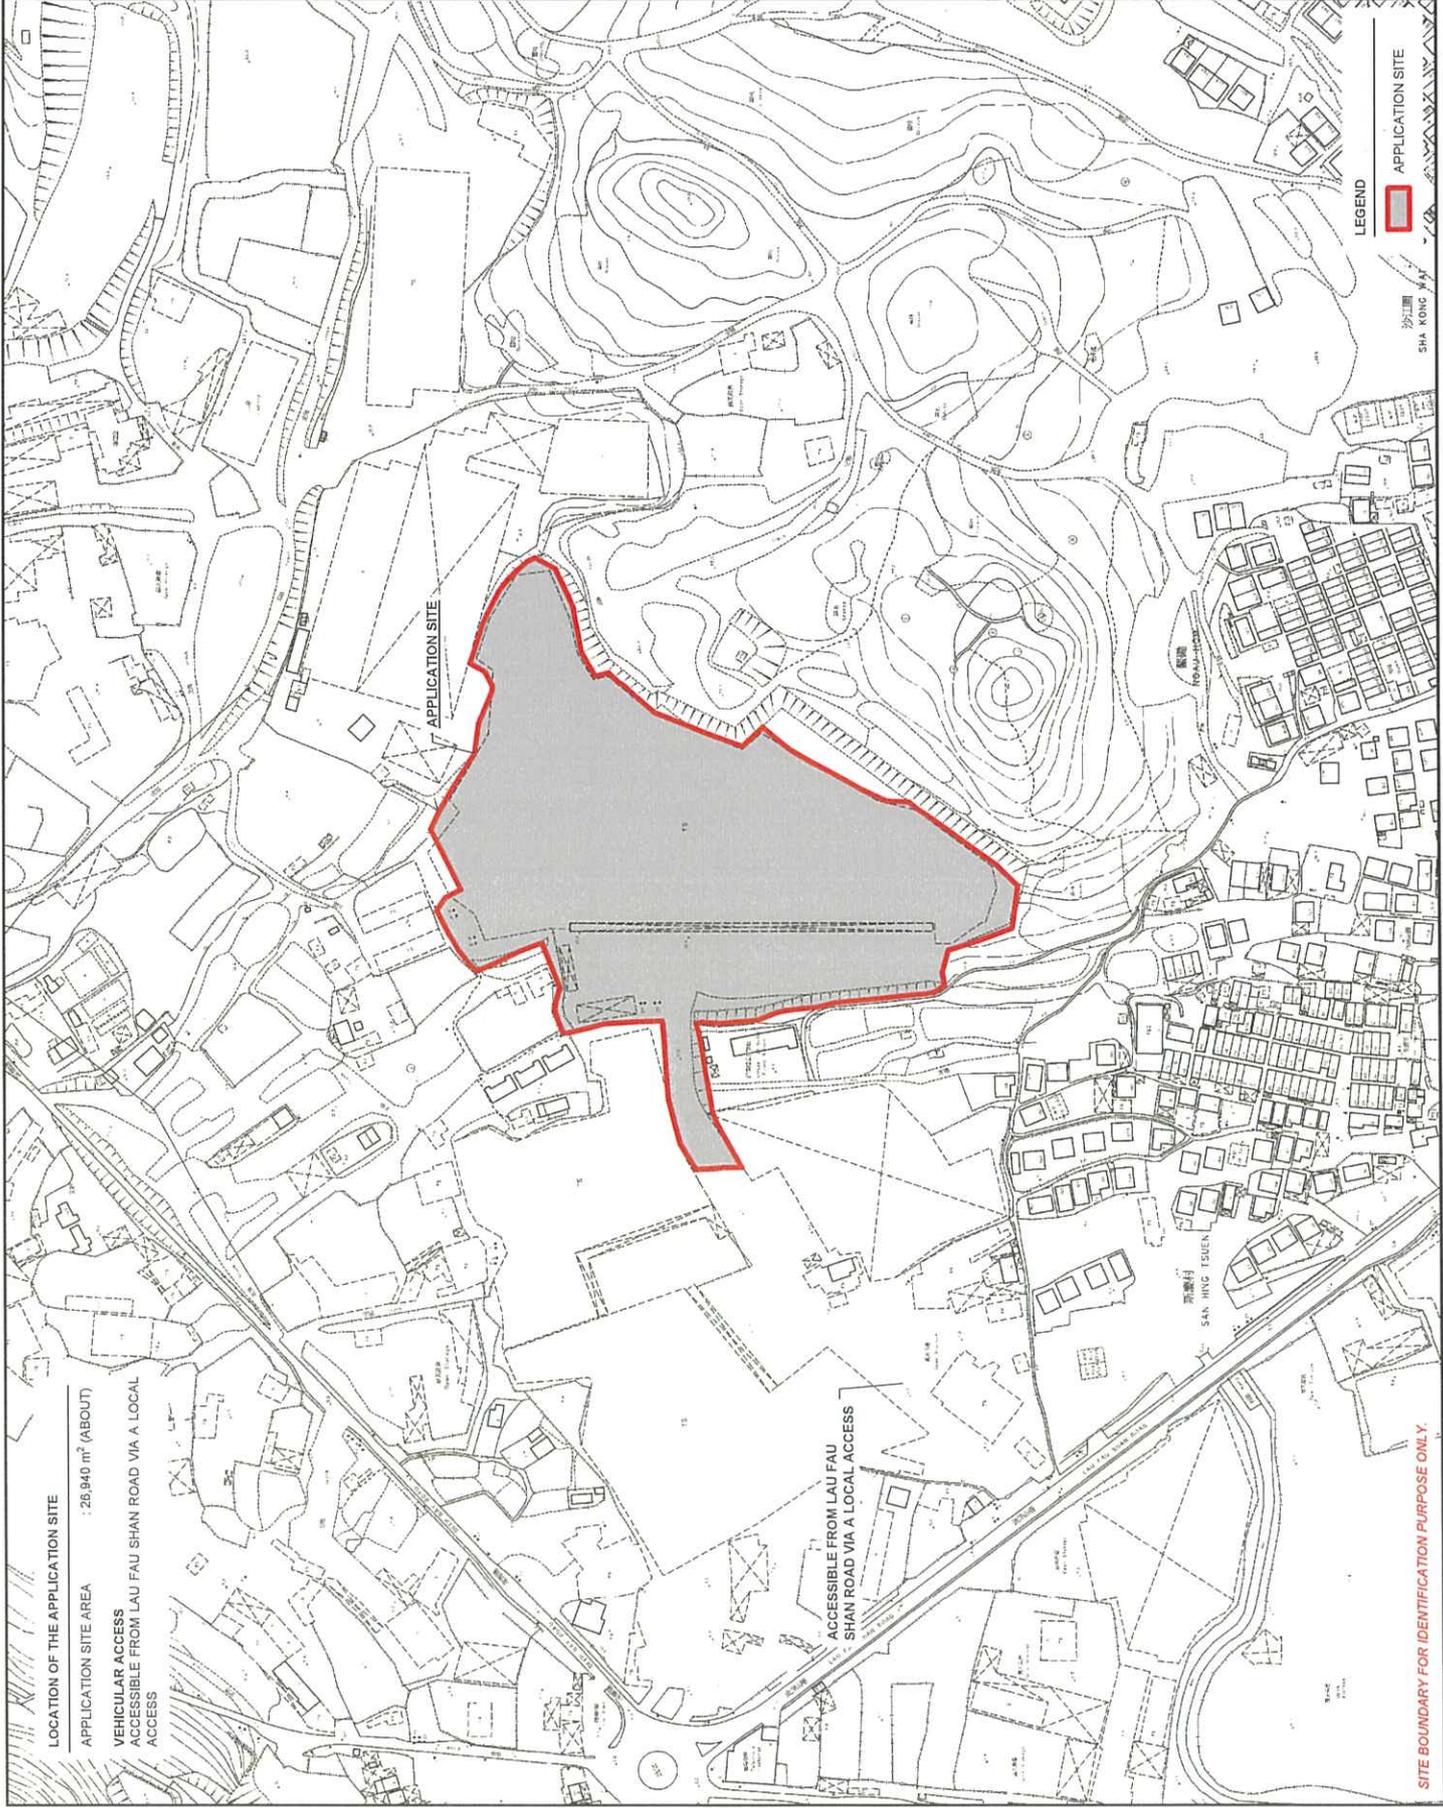
DWG TITLE	LOCATION PLAN
DWG NO.	PLAN 1
VER.	001

LOCATION OF THE APPLICATION SITE
APPLICATION SITE AREA : 26,940 m² (ABOUT)
VEHICULAR ACCESS ACCESSIBLE FROM LAU FAU SHAN ROAD VIA A LOCAL ACCESS

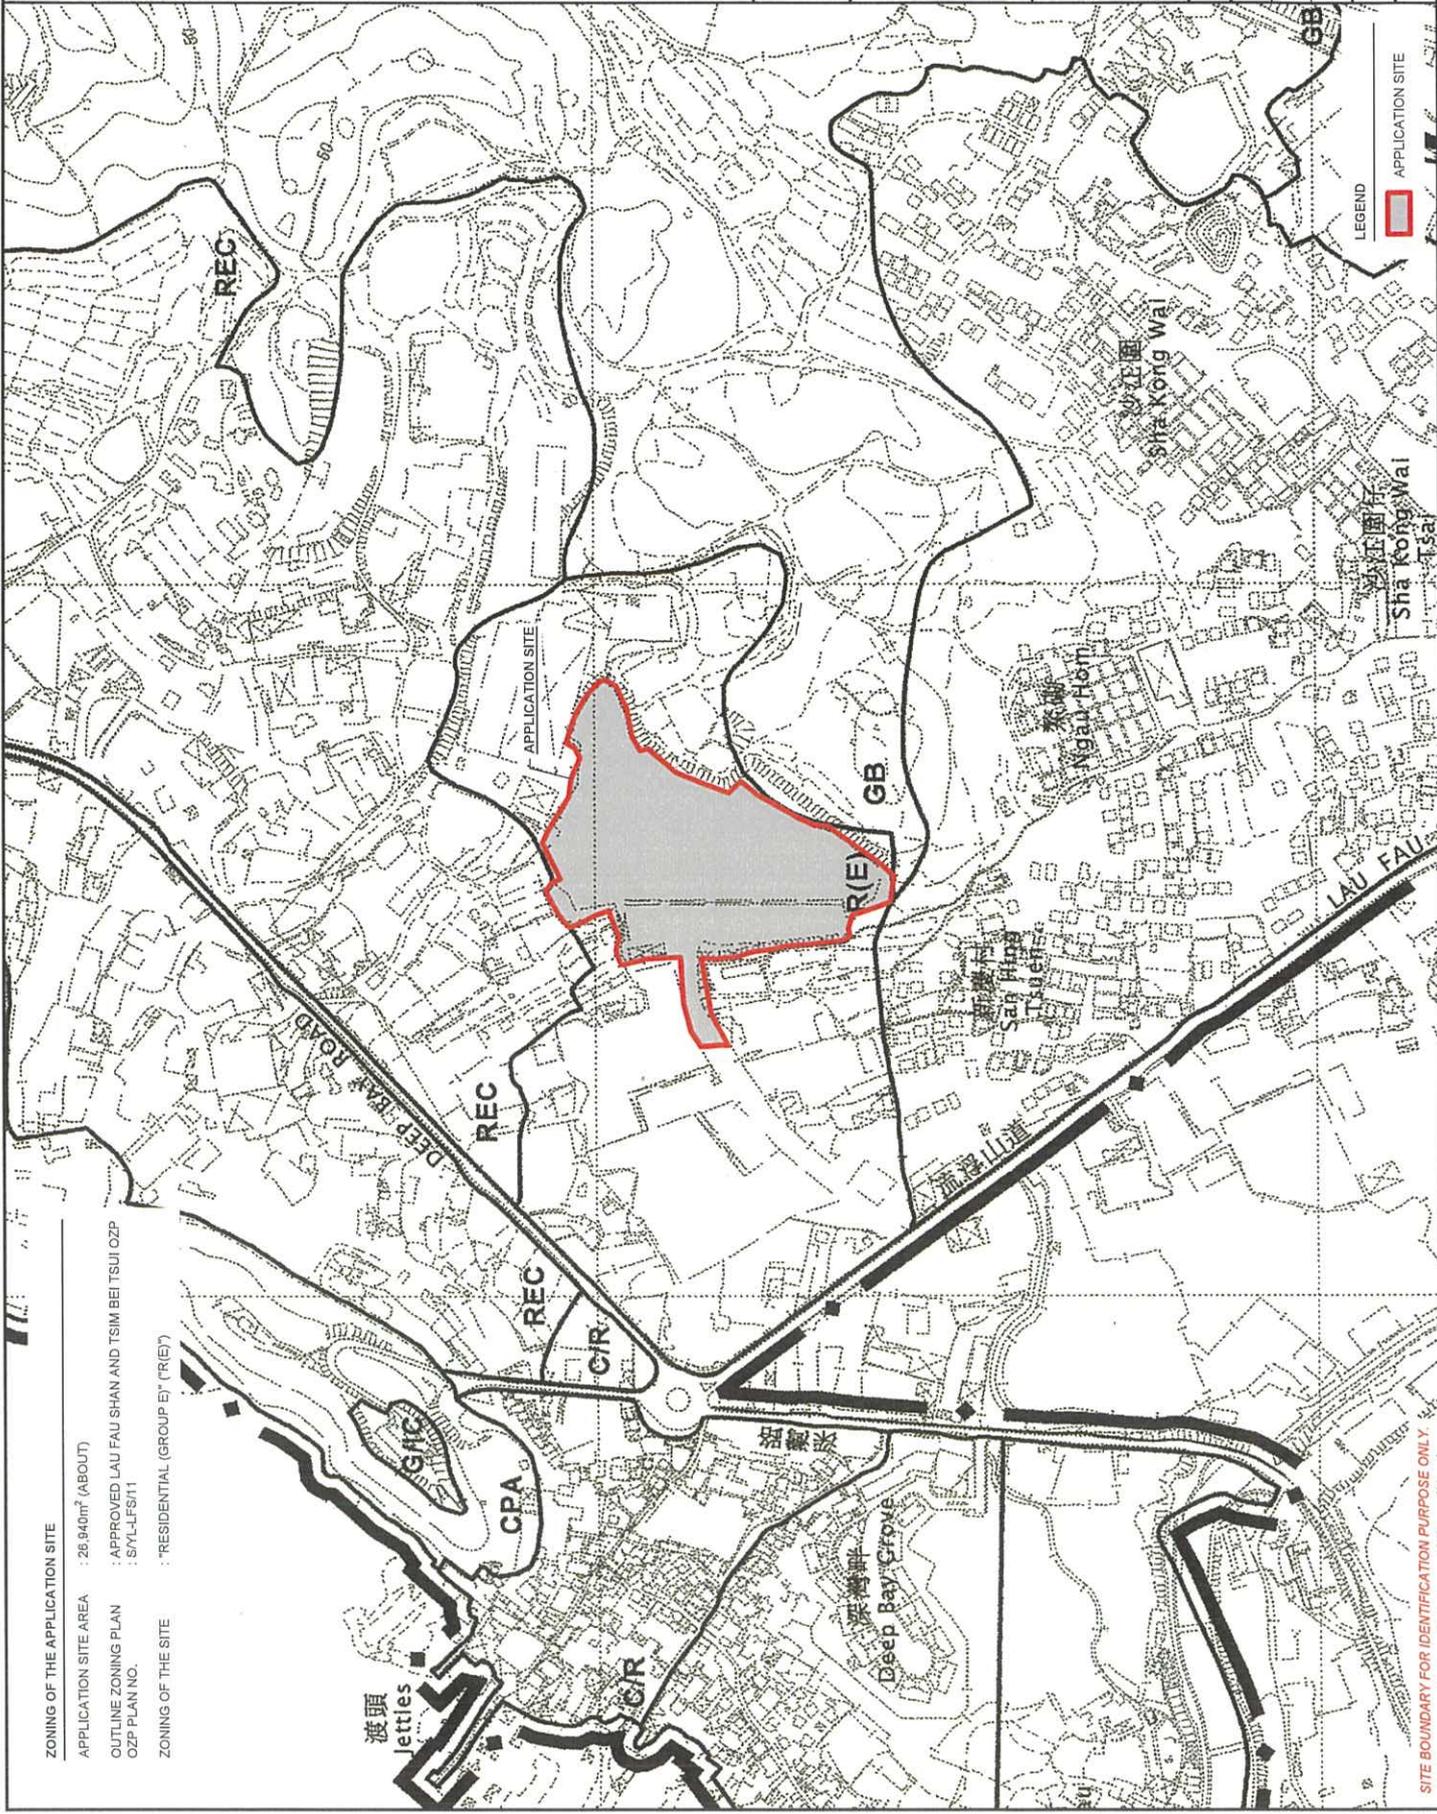
ZONING OF THE APPLICATION SITE
 APPLICATION SITE AREA : 26,940m² (ABOUT)
 OUTLINE ZONING PLAN : APPROVED LAU FAU SHAN AND TSM BEI TSUI OZP
 OZP PLAN NO. : SYLL/PS/11
 ZONING OF THE SITE : RESIDENTIAL (GROUP B) (R(E)7)

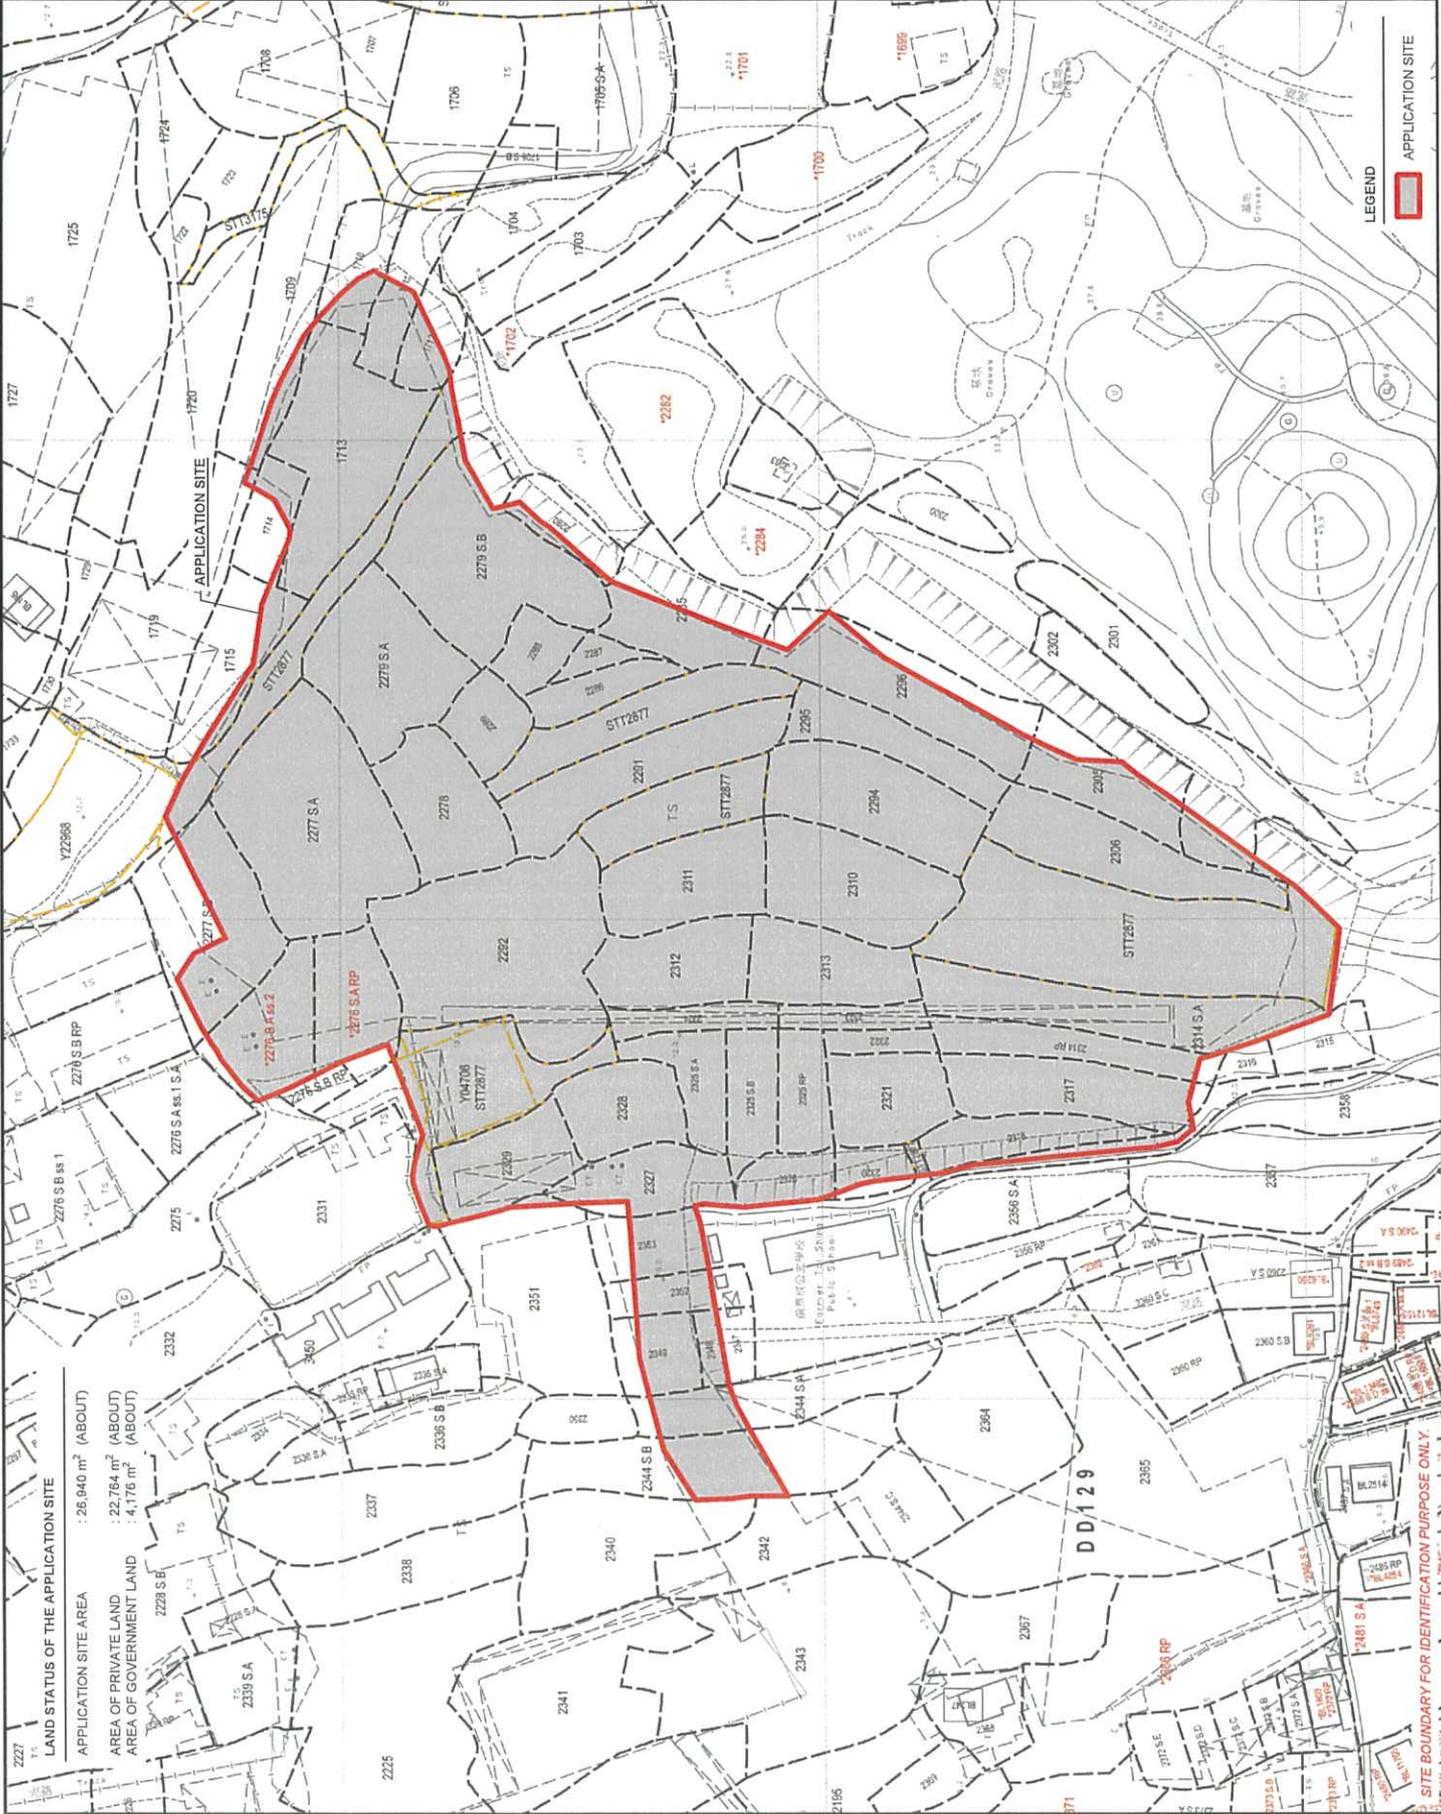
DWG. TITLE:	LAND STATUS OF THE SITE
DWG. NO.:	PLAN 3
VER.:	001

LAND STATUS OF THE APPLICATION SITE	: 26,940 m ² (ABOUT)
APPLICATION SITE AREA	: 22,784 m ² (ABOUT)
AREA OF PRIVATE LAND	: 4,176 m ² (ABOUT)
AREA OF GOVERNMENT LAND

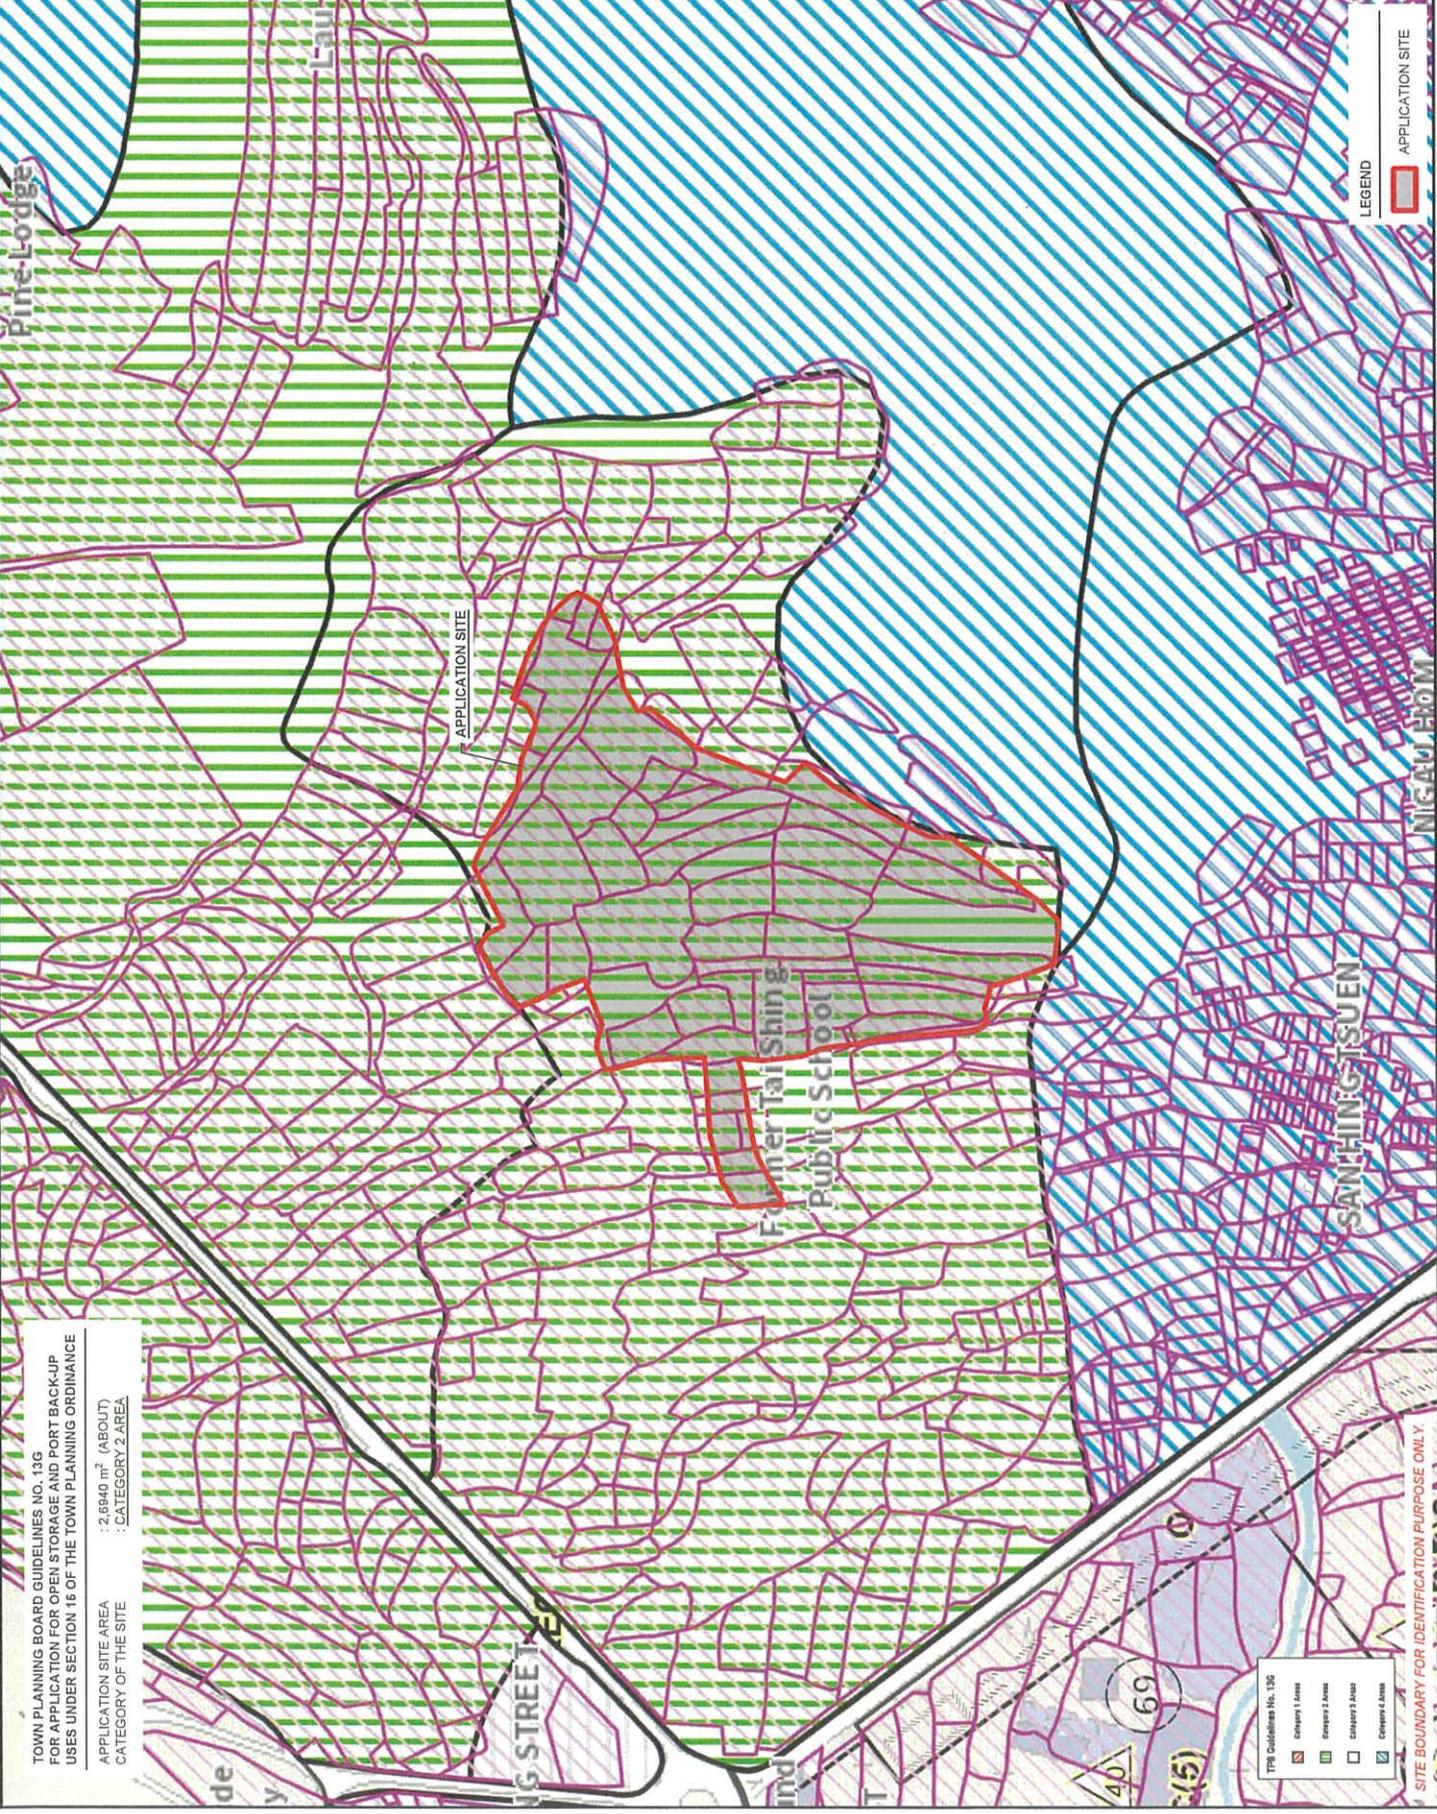
DOC. TITLE	TPB PG-No. 13G
DOC. NO.	PLAN 4
VER.	001

TOWN PLANNING BOARD GUIDELINES NO. 13G
 FOR APPLICATION FOR OPEN STORAGE AND PORT BACK-UP
 USES UNDER SECTION 16 OF THE TOWN PLANNING ORDINANCE

APPLICATION SITE AREA : 2,6940 m² (ABOUT)
 CATEGORY OF THE SITE : CATEGORY 2 AREA

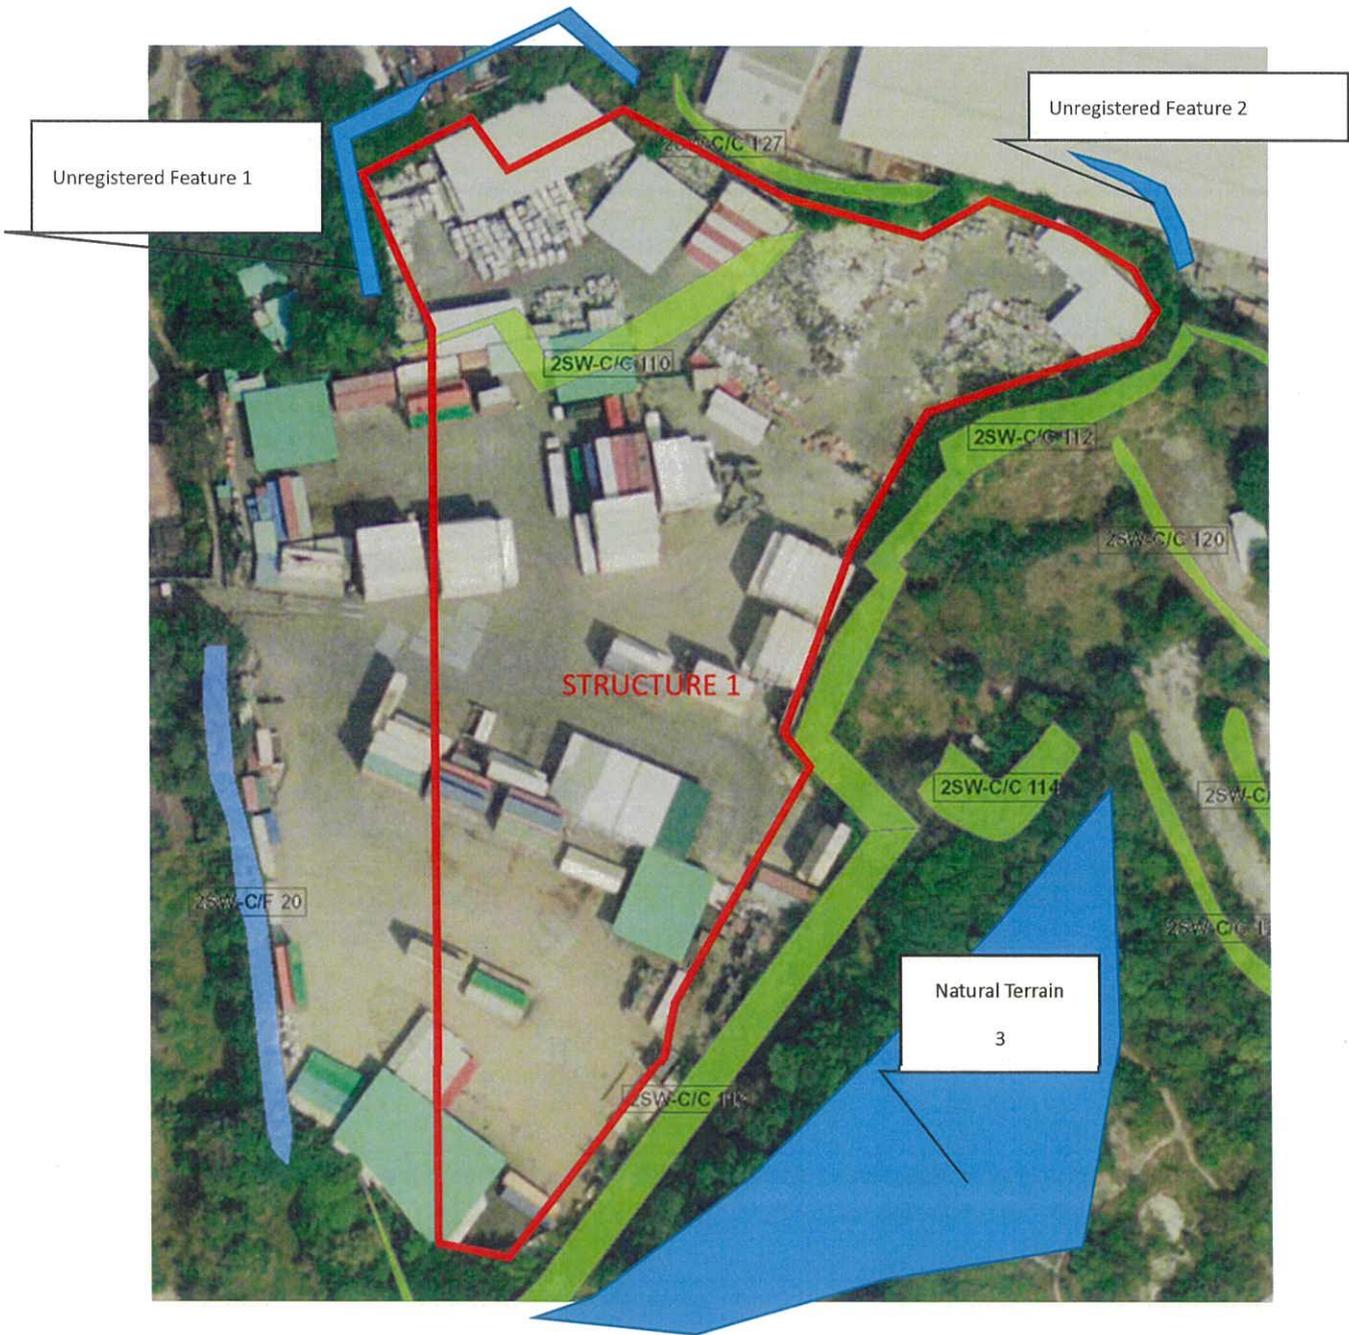
Figure 2.1 Layout and Feature location plan

Figure 2.2 Aerial Photo showing the site and the features

There are 5 registered features in the vicinity of the proposed development. The locations of the features are shown in **Figure 2**. SIS reports and SIMAR reports indicating the location of the feature and their maintenance responsibility are attached in **Appendix A** for easy reference. No record of slope instability can be found.

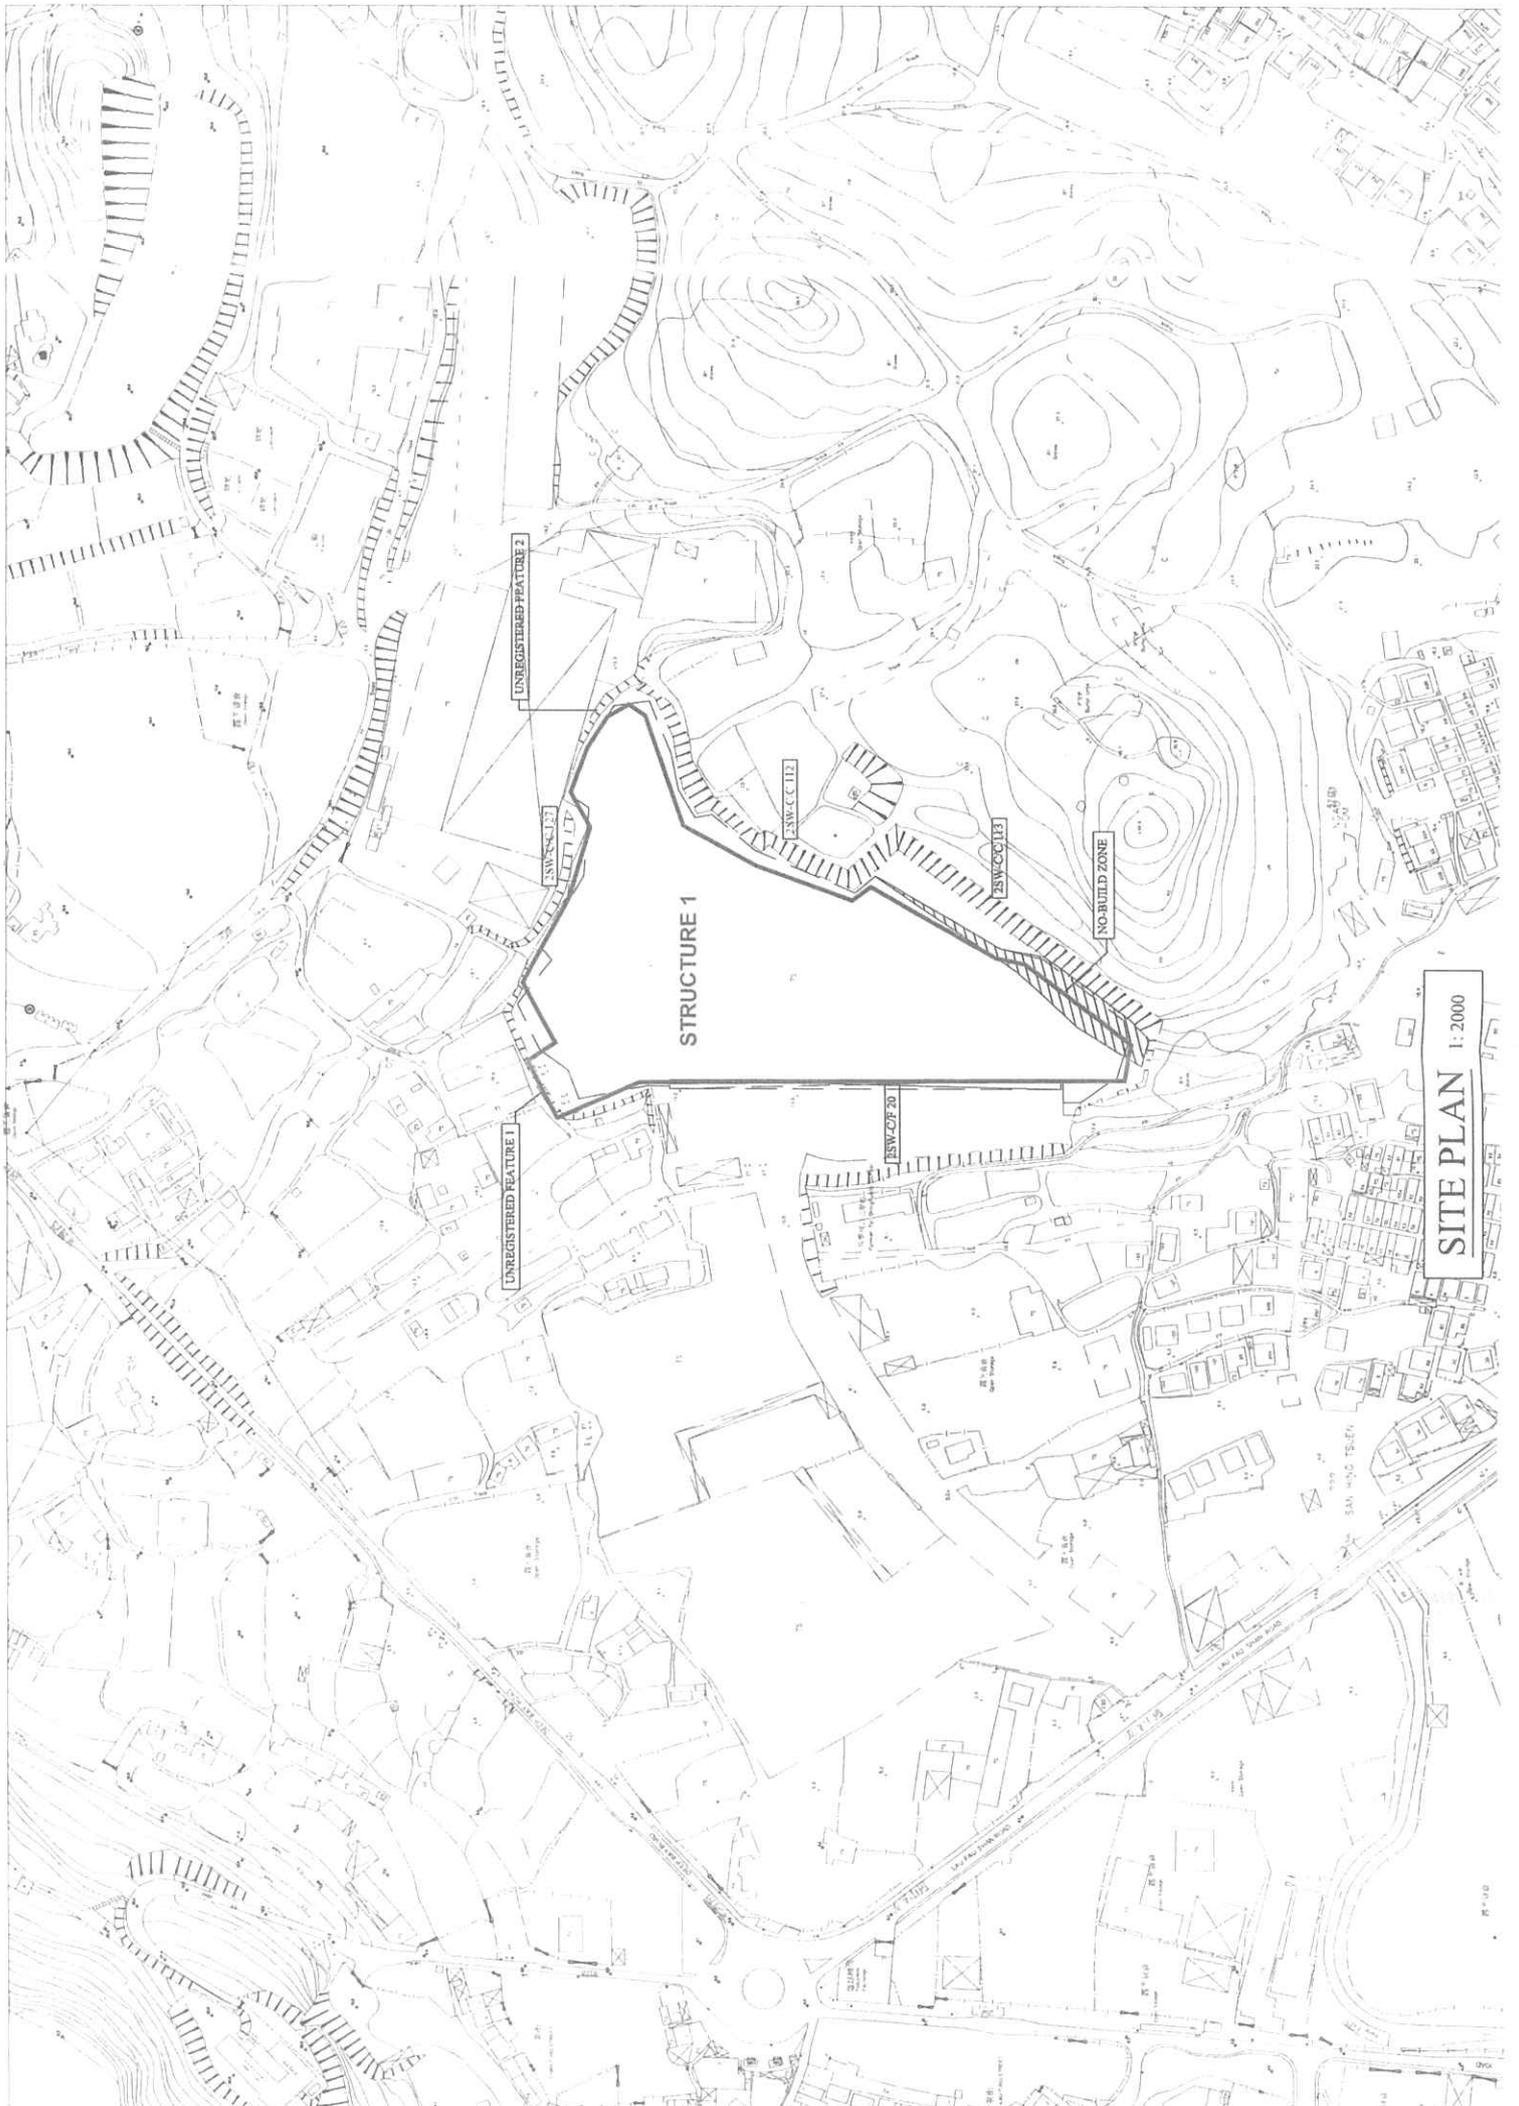
Figure 2.3 1:2000 scale layout plan showing the geotechnical features (including the locations of the unregistered natural slopes) and the 'no-build' zone

SITE PLAN
1:2000

Other than the registered geotechnical features, there are 2 unregistered features found within the vicinity of the site.

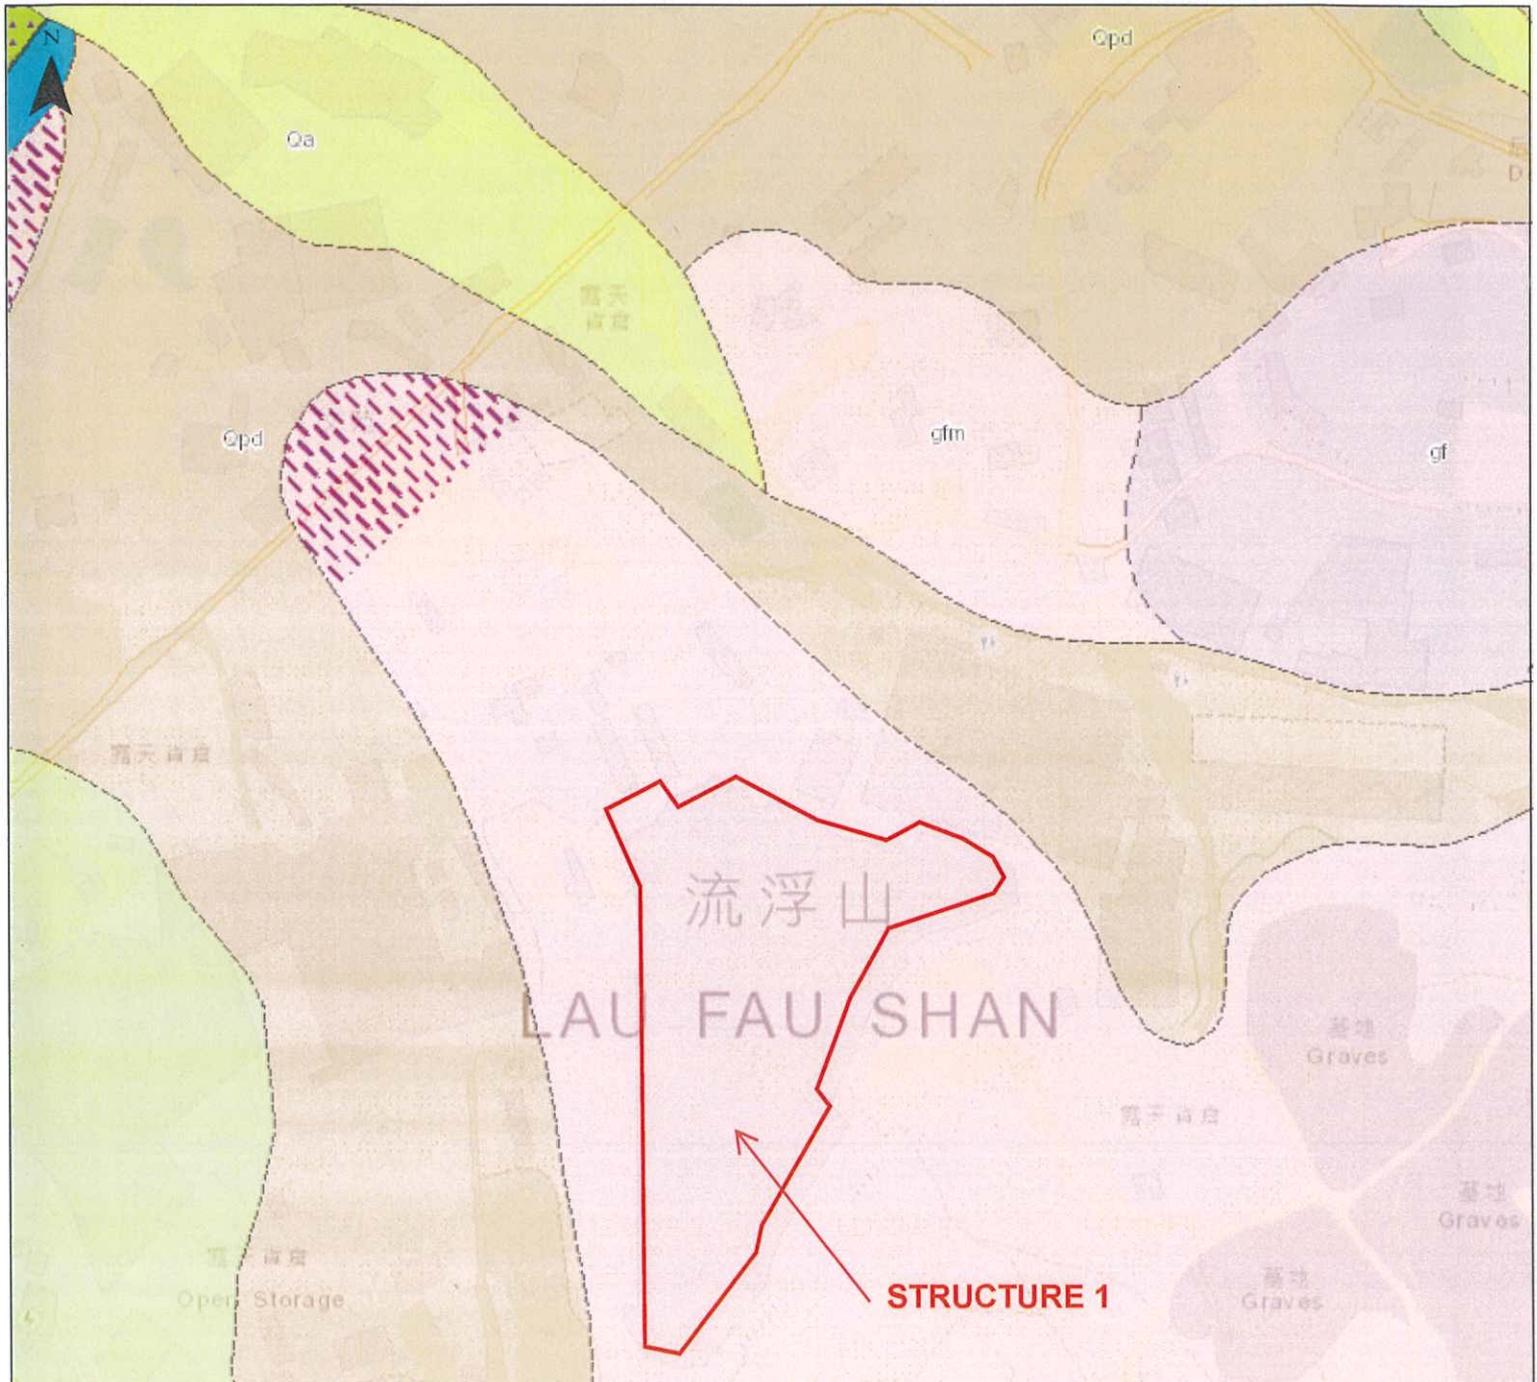
Figure 3

Hong Kong Geological Map Sheet 2 (Part Plan of
1:20,000)

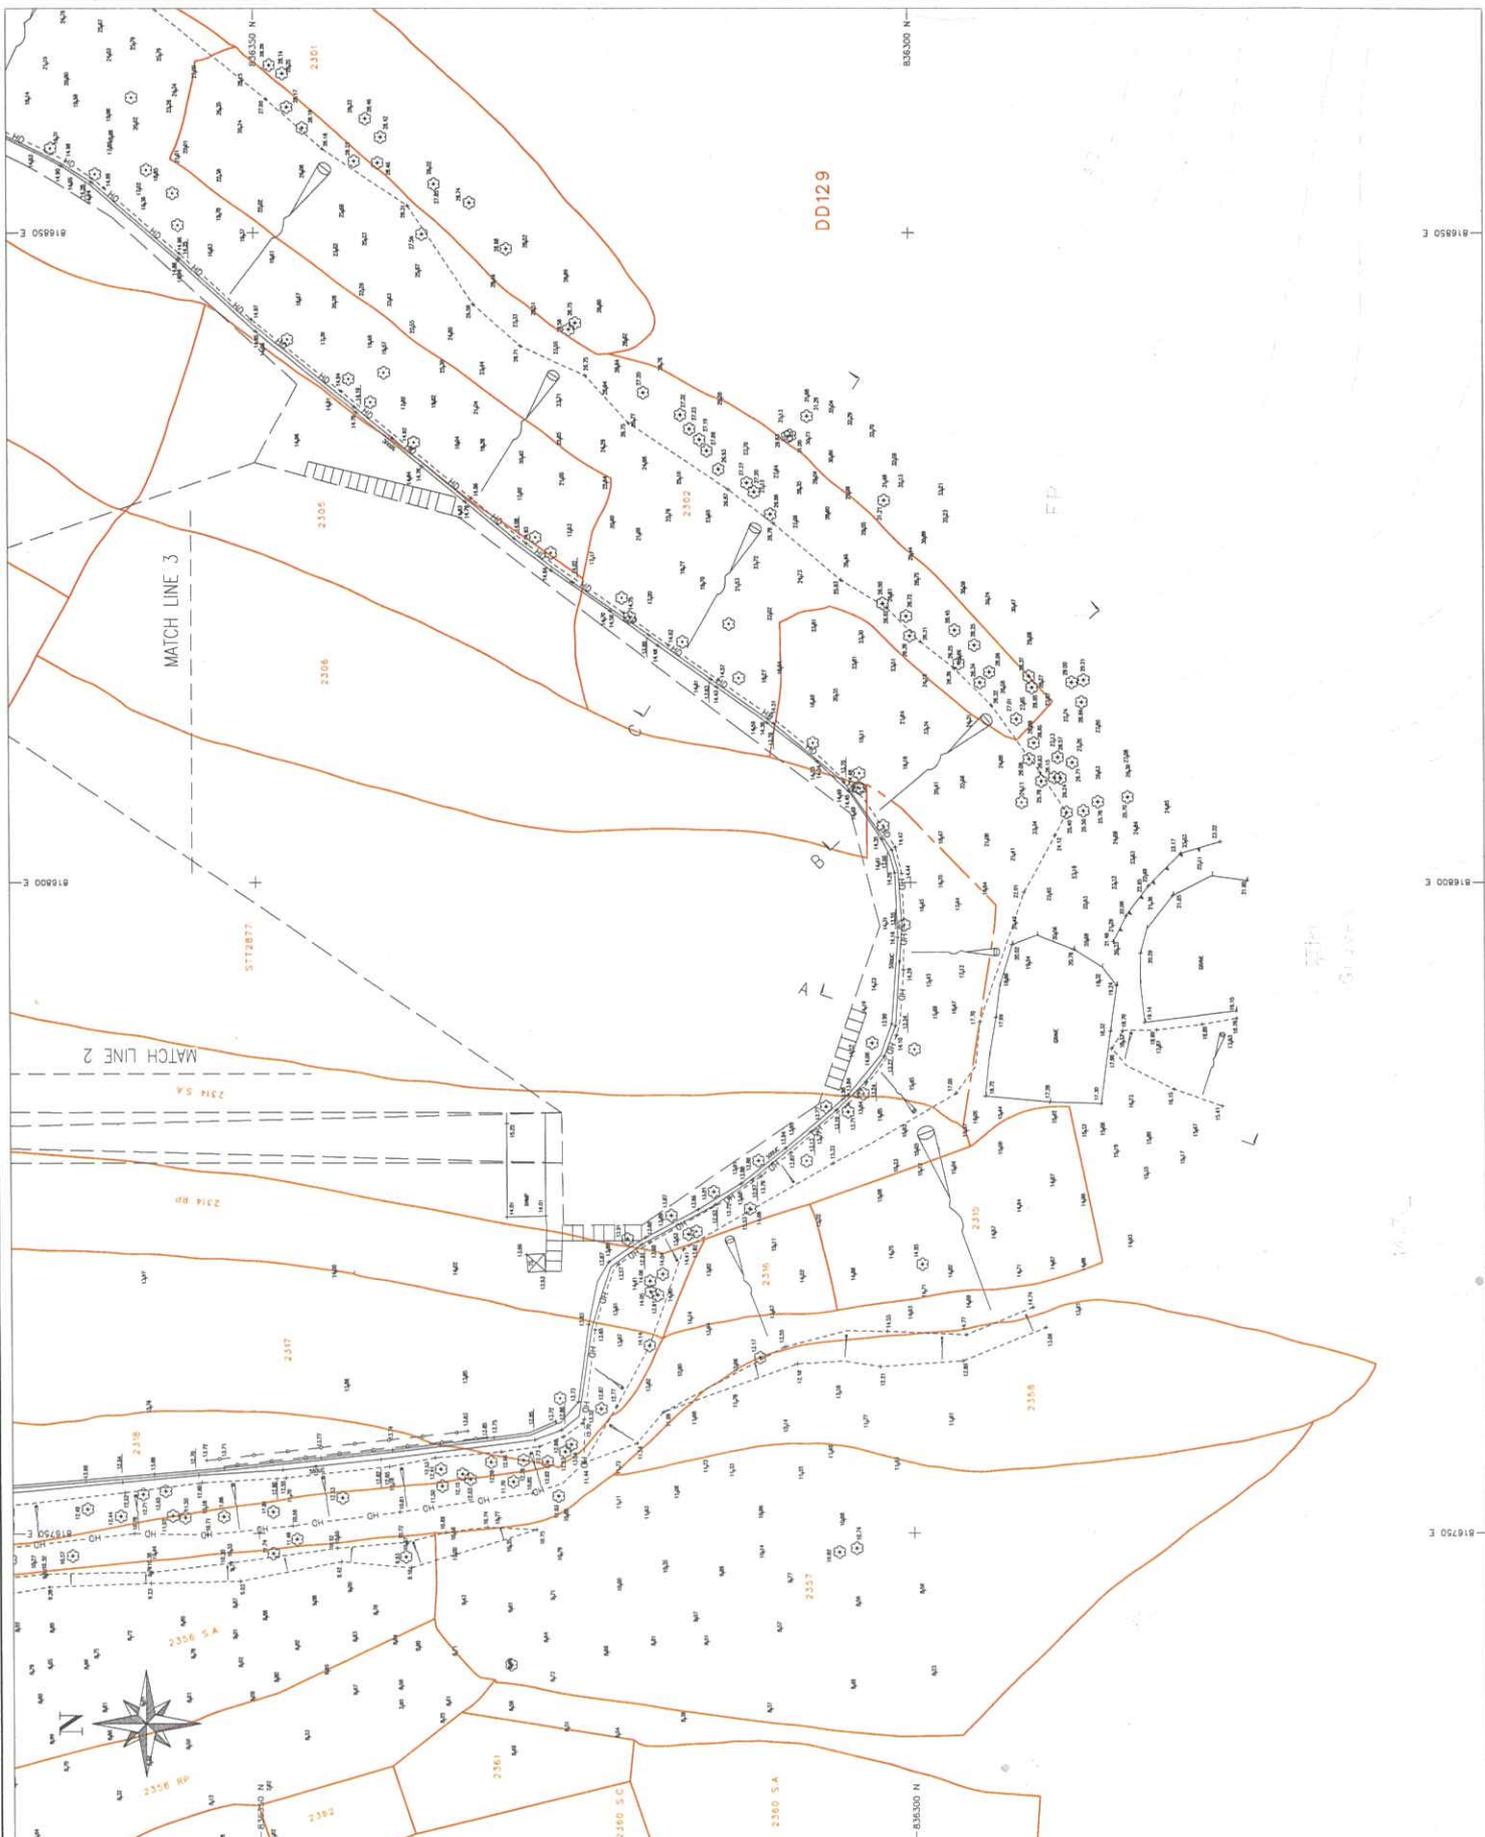
Figure 2.3 Survey Plan

--- 10 ---	HORING
---	EXISTING FENCING
---	EXISTING WALL
---	REINFORCING WALL
---	FOOT WALK
---	FOOT WALK MANHOLE
---	TELEPHONE CHAMBER
---	MANHOLE (UNCENTRED)
---	SOAK POST
---	ROAD SIGN BOARD / NOTICE BOARD
---	LAMP POST
---	TELEPHONE POST
---	ELECTRIC POLE
---	TREE
---	CATCHPIPE
---	TEMPORARY STRUCTURE
---	GATE
---	STEPS
---	WATER LEADS
---	SEWER TRANSFORMER
---	BOLLARD
---	ELECTRIC PIT
---	LOT BOUNDARY (For identification only)
---	LICENSE BOUNDARY (For identification only)
---	SECTION MARK
