**APPLICATION FOR PERMISSION
UNDER SECTION 16 OF
THE TOWN PLANNING ORDINANCE
(CAP. 131)**

This report would present a Geotechnical Planning Review Report (GPRR) of the site to support of the current planning application (application no. A/YL-LFS/426). No foundation, site formation, building works, or works which involve significant excavation works would be involved in this application.

PROJECT: TEMPORARY LOGISTICS CENTRE WITH ANCILLARY OFFICE AND PARKING OF VEHICLES FOR PERIOD OF 3 YEARS

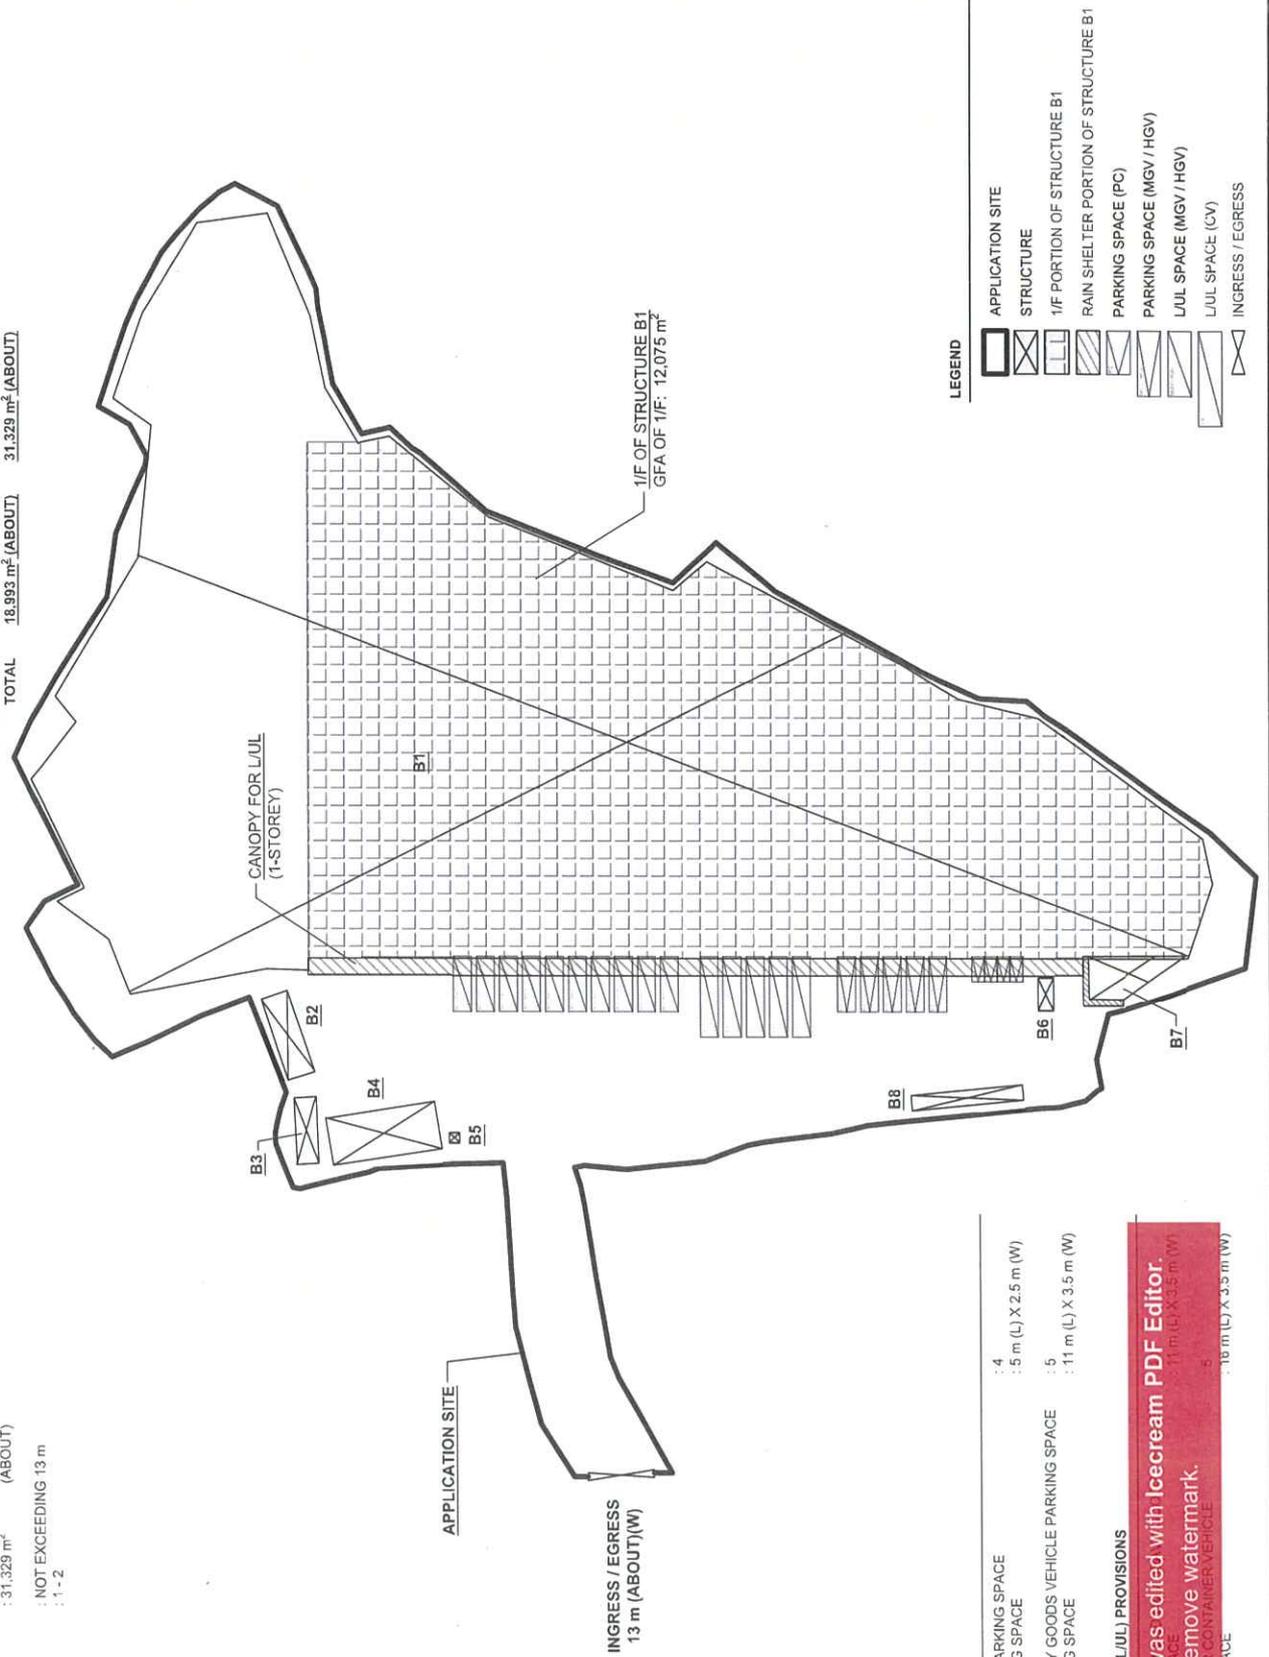
STRUCTURE	USE	COVERED AREA	GROSS FLOOR AREA	BUILDING HEIGHT
B1	WAREHOUSE FOR LOGISTICS USE AND RAIN SHELTER FOR LUL ACTIVITIES	18,517 m ² (ABOUT)	30,592 m ² (ABOUT)	NOT EXCEEDING 13 m (ABOUT)(2-STOREY)
B2	TOILET	54 m ² (ABOUT)	54 m ² (ABOUT)	3.5 m (ABOUT)(1-STOREY)
B3	WATER TANK AND PUMP ROOM	50 m ² (ABOUT)	50 m ² (ABOUT)	5 m (ABOUT)(1-STOREY)
B4	ANCILLARY OFFICE	150 m ² (ABOUT)	300 m ² (ABOUT)	6.5 m (ABOUT)(2-STOREY)
B5	GUARD ROOM	4 m ² (ABOUT)	4 m ² (ABOUT)	3.5 m (ABOUT)(1-STOREY)
B6	TOILET	20 m ² (ABOUT)	20 m ² (ABOUT)	3 m (ABOUT)(1-STOREY)
B7	SITE OFFICE AND RAIN SHELTER	131 m ² (ABOUT)	242 m ² (ABOUT)	NOT EXCEEDING 8 m (ABOUT)(2-STOREY)
B8	WASHROOM	67 m ² (ABOUT)	67 m ² (ABOUT)	3.5 m (ABOUT)(1-STOREY)
TOTAL		18,993 m² (ABOUT)	31,329 m² (ABOUT)

[Symbol]	APPLICATION SITE
[Symbol]	STRUCTURE
[Symbol]	1/1F PORTION OF STRUCTURE B1
[Symbol]	RAIN SHELTER PORTION OF STRUCTURE B1
[Symbol]	PARKING SPACE (PC)
[Symbol]	PARKING SPACE (MGV / HGV)
[Symbol]	LUL SPACE (MGV / HGV)
[Symbol]	LUL SPACE (CV)
[Symbol]	INGRESS / EGRESS

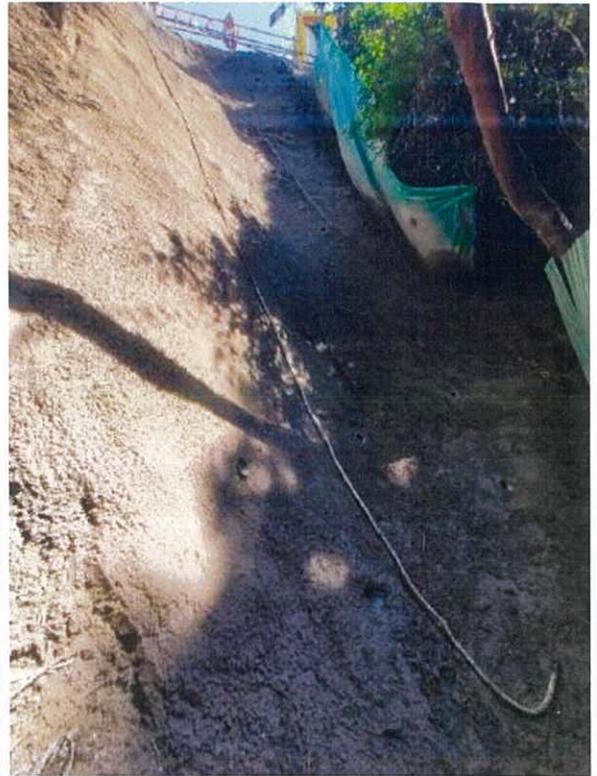
Slope feature no. 2SW-C/C113

The feature is currently undergoing further study, if deemed necessary, design and submission of slope strengthening works would be carried out, and consent would be sought.

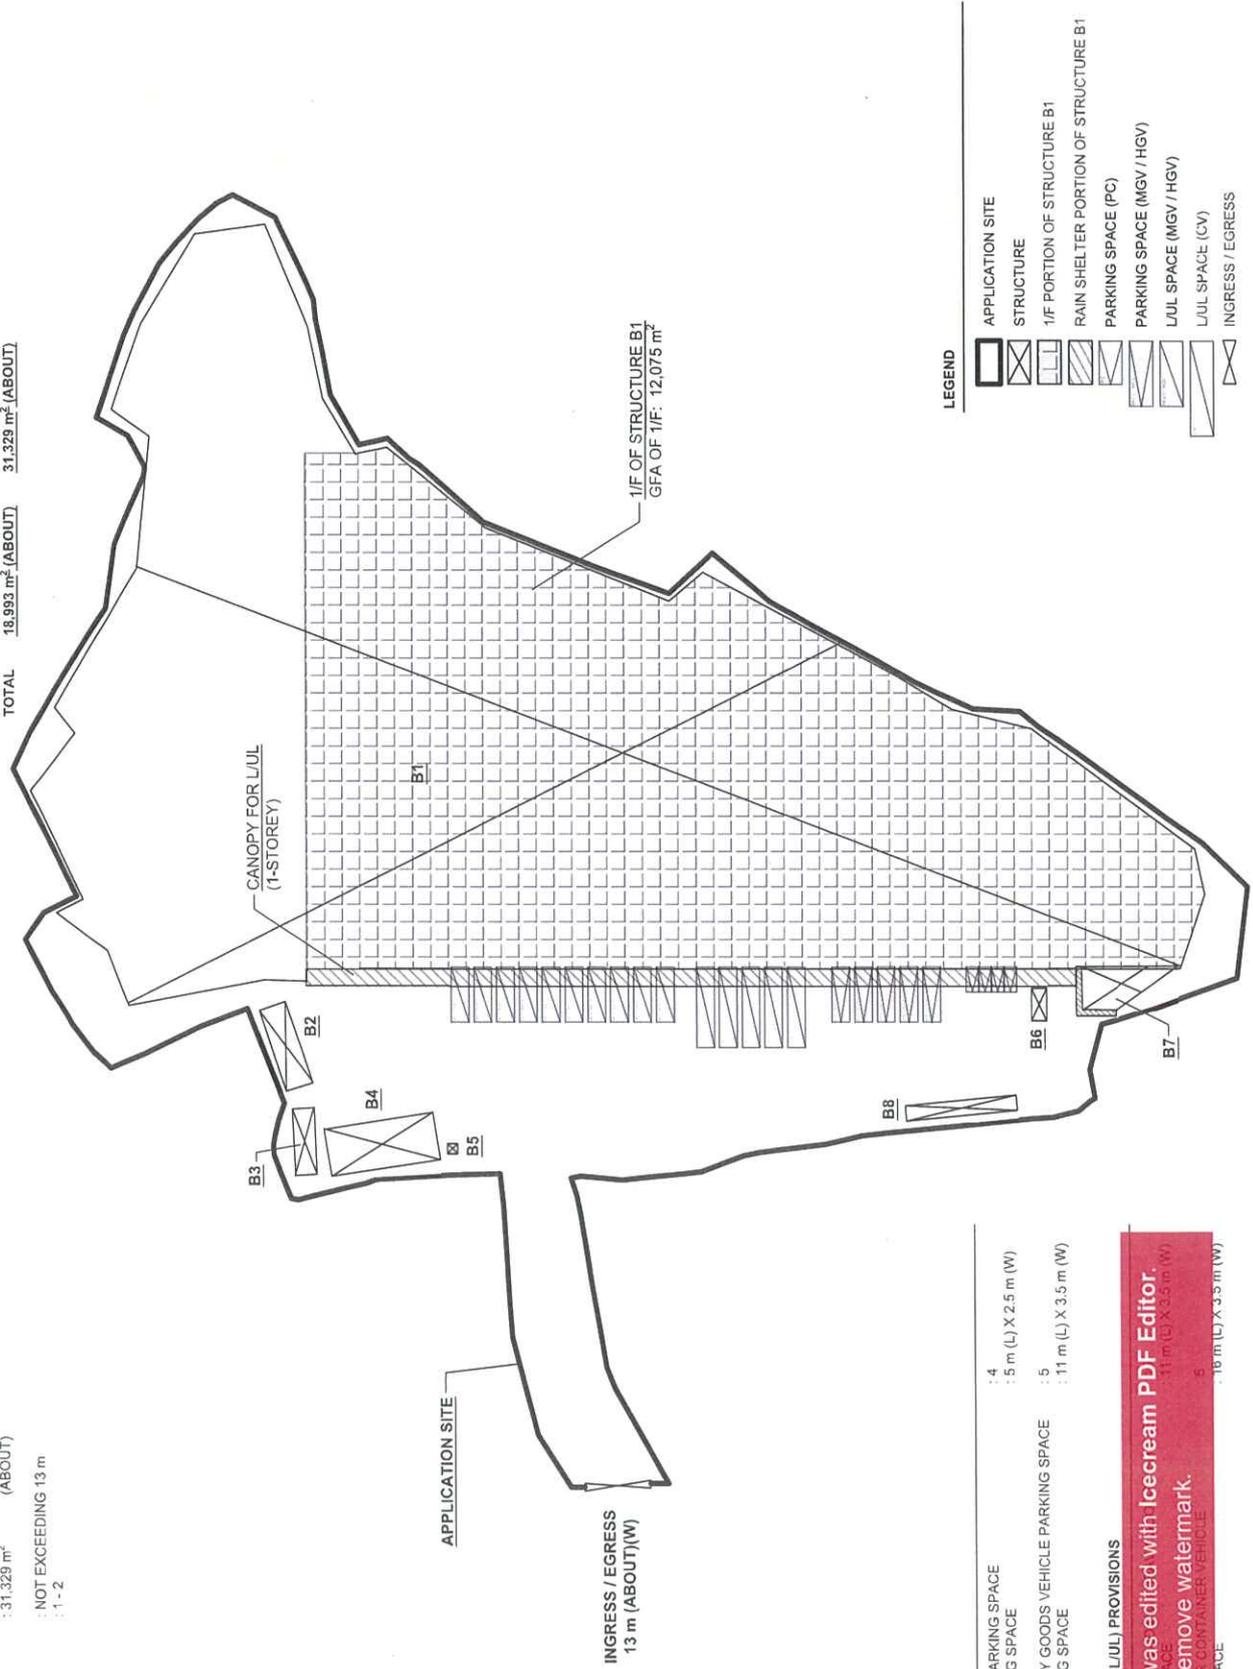
STRUCTURE	USE	COVERED AREA	GROSS FLOOR AREA	BUILDING HEIGHT
B1	WAREHOUSE FOR LOGISTICS USE AND RAIN SHELTER FOR L/U/L ACTIVITIES	18,517 m ² (ABOUT)	30,592 m ² (ABOUT)	NOT EXCEEDING 13 m (ABOUT)(2-STOREY)
B2	TOILET	54 m ² (ABOUT)	54 m ² (ABOUT)	3.5 m (ABOUT)(1-STOREY)
B3	WATER TANK AND PUMP ROOM	50 m ² (ABOUT)	50 m ² (ABOUT)	5 m (ABOUT)(1-STOREY)
B4	ANCILLARY OFFICE	150 m ² (ABOUT)	300 m ² (ABOUT)	6.5 m (ABOUT)(2-STOREY)
B5	GUARD ROOM	4 m ² (ABOUT)	4 m ² (ABOUT)	3.5 m (ABOUT)(1-STOREY)
B6	TOILET	20 m ² (ABOUT)	20 m ² (ABOUT)	3 m (ABOUT)(1-STOREY)
B7	SITE OFFICE AND RAIN SHELTER	131 m ² (ABOUT)	242 m ² (ABOUT)	NOT EXCEEDING 8 m (ABOUT)(2-STOREY)
B8	WASHROOM	67 m ² (ABOUT)	67 m ² (ABOUT)	3.5 m (ABOUT)(1-STOREY)
TOTAL		18,993 m² (ABOUT)	31,329 m² (ABOUT)

DEVELOPMENT PARAMETERS	
APPLICATION SITE AREA	: 26,940 m ² (ABOUT)
COVERED AREA	: 18,993 m ² (ABOUT)
UNCOVERED AREA	: 7,947 m ² (ABOUT)
PLOT RATIO	: 1.2 (ABOUT)
SITE COVERAGE	: 71% (ABOUT)
NO. OF STRUCTURE	: 8 (NOT APPLICABLE)
DOMESTIC GFA	: 31,329 m ² (ABOUT)
NON-DOMESTIC GFA	: 31,329 m ² (ABOUT)
TOTAL GFA	: 31,329 m ² (ABOUT)
BUILDING HEIGHT	: NOT EXCEEDING 13 m
NO. OF STOREY	: 1 - 2
