**APPLICATION FOR PERMISSION  
UNDER SECTION 16 OF  
THE TOWN PLANNING ORDINANCE  
(CAP. 131)**

As requested, we would like to supplement the replacement page(s) of the Supporting Planning Statement, the Indicative Architecture Scheme, and the Application Form for your kind consideration.

We hereby submit a Consolidated Supporting Planning Statement ("Consolidated SPS") together with the replacement pages of application form to facilitate the consideration of the captioned Planning Application by TPB. The Consolidated SPS contains the latest version of the development scheme and technical assessments that had been previously submitted to TPB under various Further Information ("F.I.") submissions. Hence, the attached Consolidated SPS would supersede the various F.I.s submitted on 13 November 2025, 19 November 2025 and 17 December 2025. We also confirm that information included in the attached Consolidated SPS had been previously submitted during the course of the Planning Application and does not contain any new information.

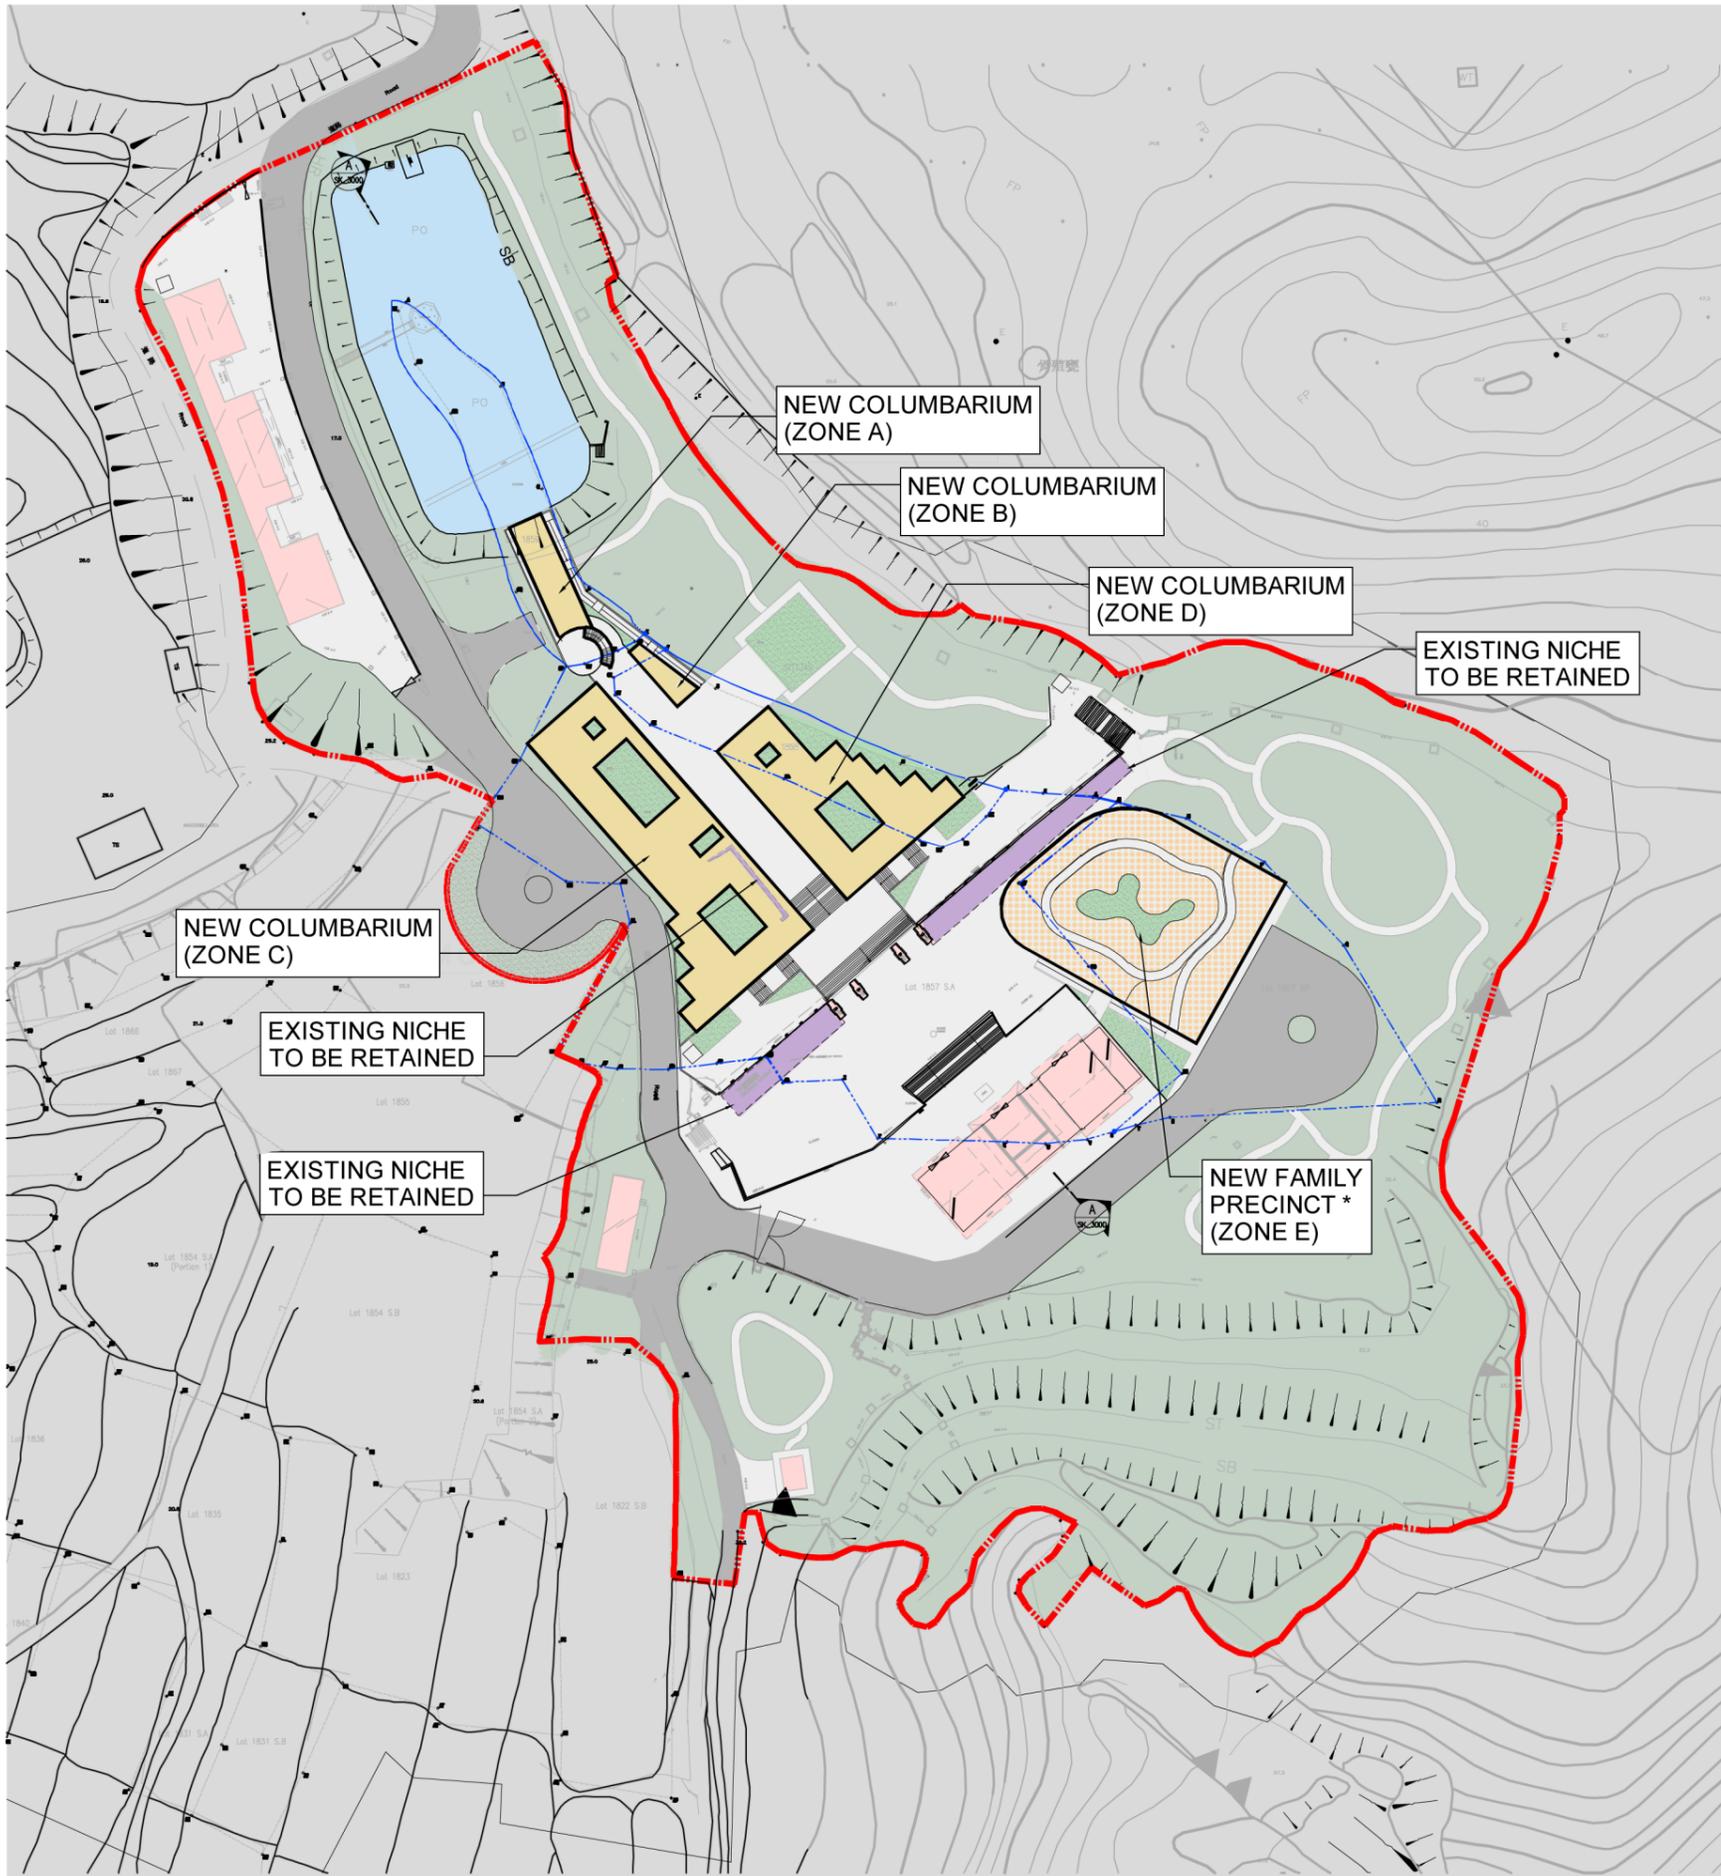
NICHE CALCULATION:

- 1. NEW COLUMBARIUM (ZONE A) (QUAD) = 228 No.s
- 2. NEW COLUMBARIUM (ZONE B) (QUAD) = 84 No.s
- 3. NEW COLUMBARIUM (ZONE C) (QUAD) = 200 No.s
- 3. NEW COLUMBARIUM (ZONE C) (DOUBLE) = 1104 No.s
- 4. NEW COLUMBARIUM (ZONE D) (DOUBLE) = 1720 No.s
- 5. NEW COLUMBARIUM (ZONE E) (QUAD) = 488 No.s

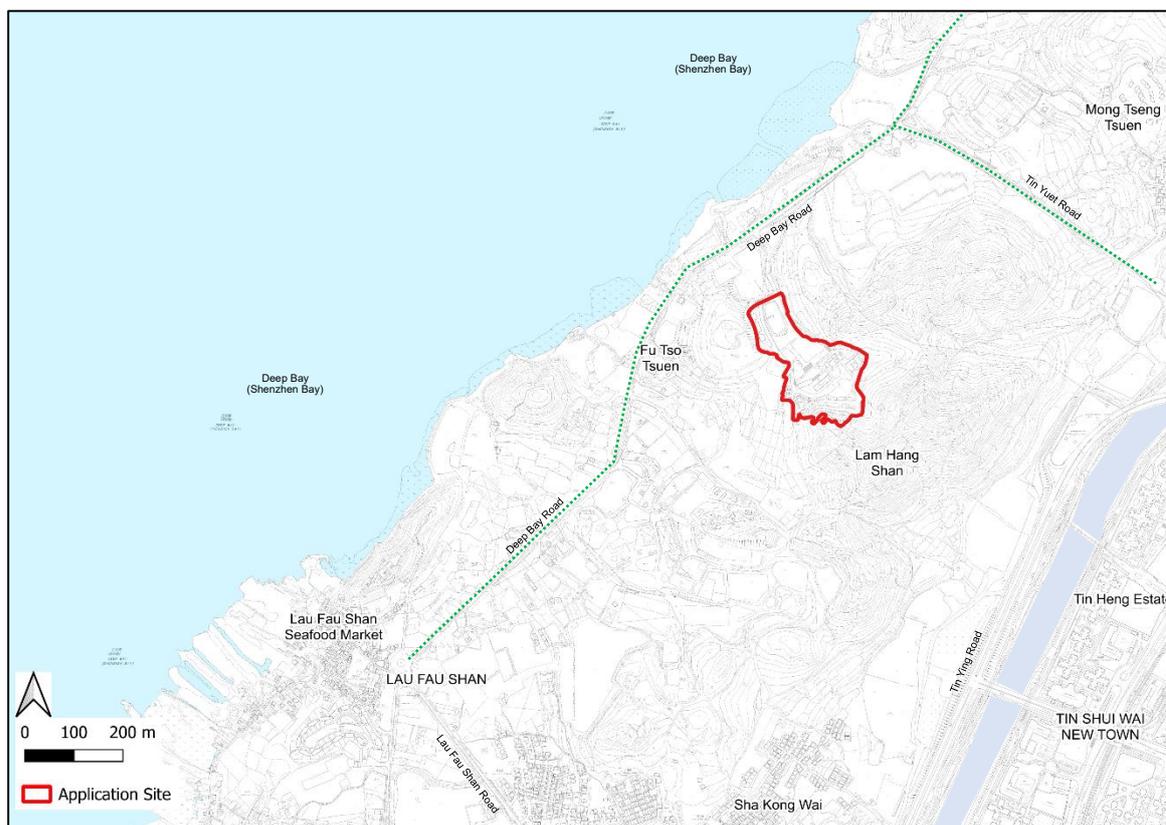
**Figure 2.1: Site Location Plan**

2.1.2 The Site has a total area of about 32,554.56m<sup>2</sup>. The existing site level rises gradually from north to south, ranging from 16.1 mPD to 31.8 mPD.

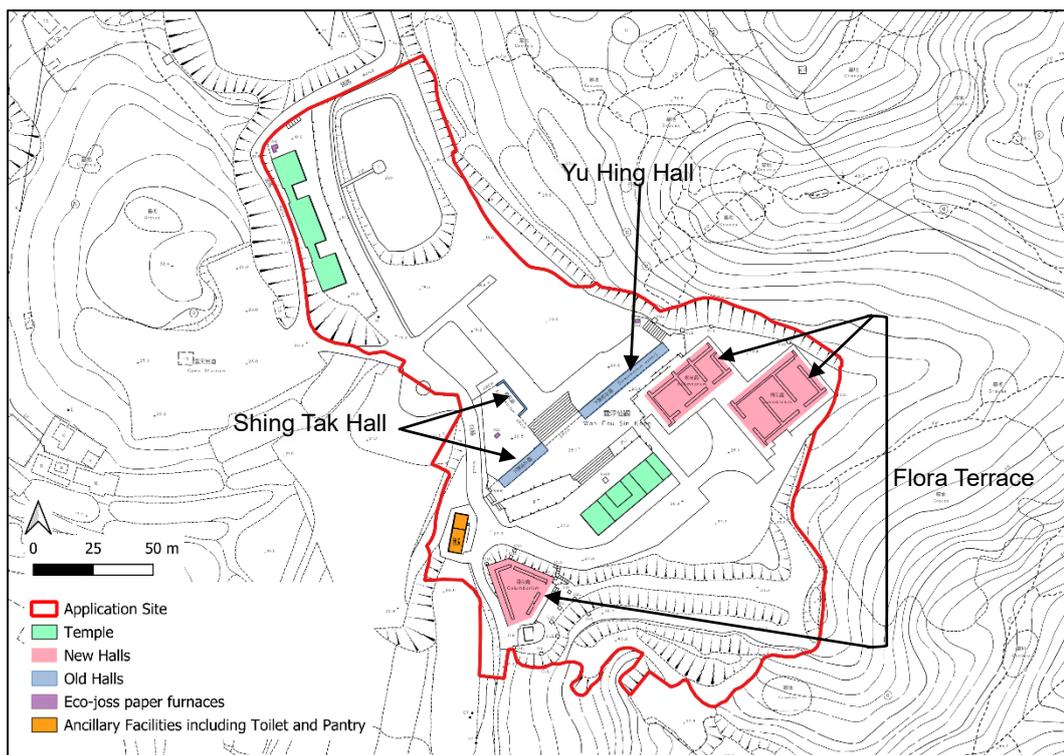
**Figure 2.2: Existing Uses of the Site**

2.2.1 The Site is currently occupied by Wan Fau Sin Koon (the “Koon”), used for temple and columbarium purposes. In the southern part of the Site are the main temple with the New Halls (including Columbarium Block A and B). An ancillary block containing facilities (including toilet and pantry) and Columbarium Block C of the New Halls are also located in the area. The northern part of the Site contains the Old Halls- Shing Tak Hall and Yu Hing Hall, along with a lake, pavilion, and another newly built temple.

<b>Old Halls (Shing Tak Hall and Yu Hing Hall)</b>	<b>New Halls (Flora Terrace)</b>	<b>Total</b>
Pre-cut off sold niches	6,576	/	6,576
Unsold Niches	1,824	2,000	3,824
		<b>GRAND TOTAL</b>	<b>10,400</b>

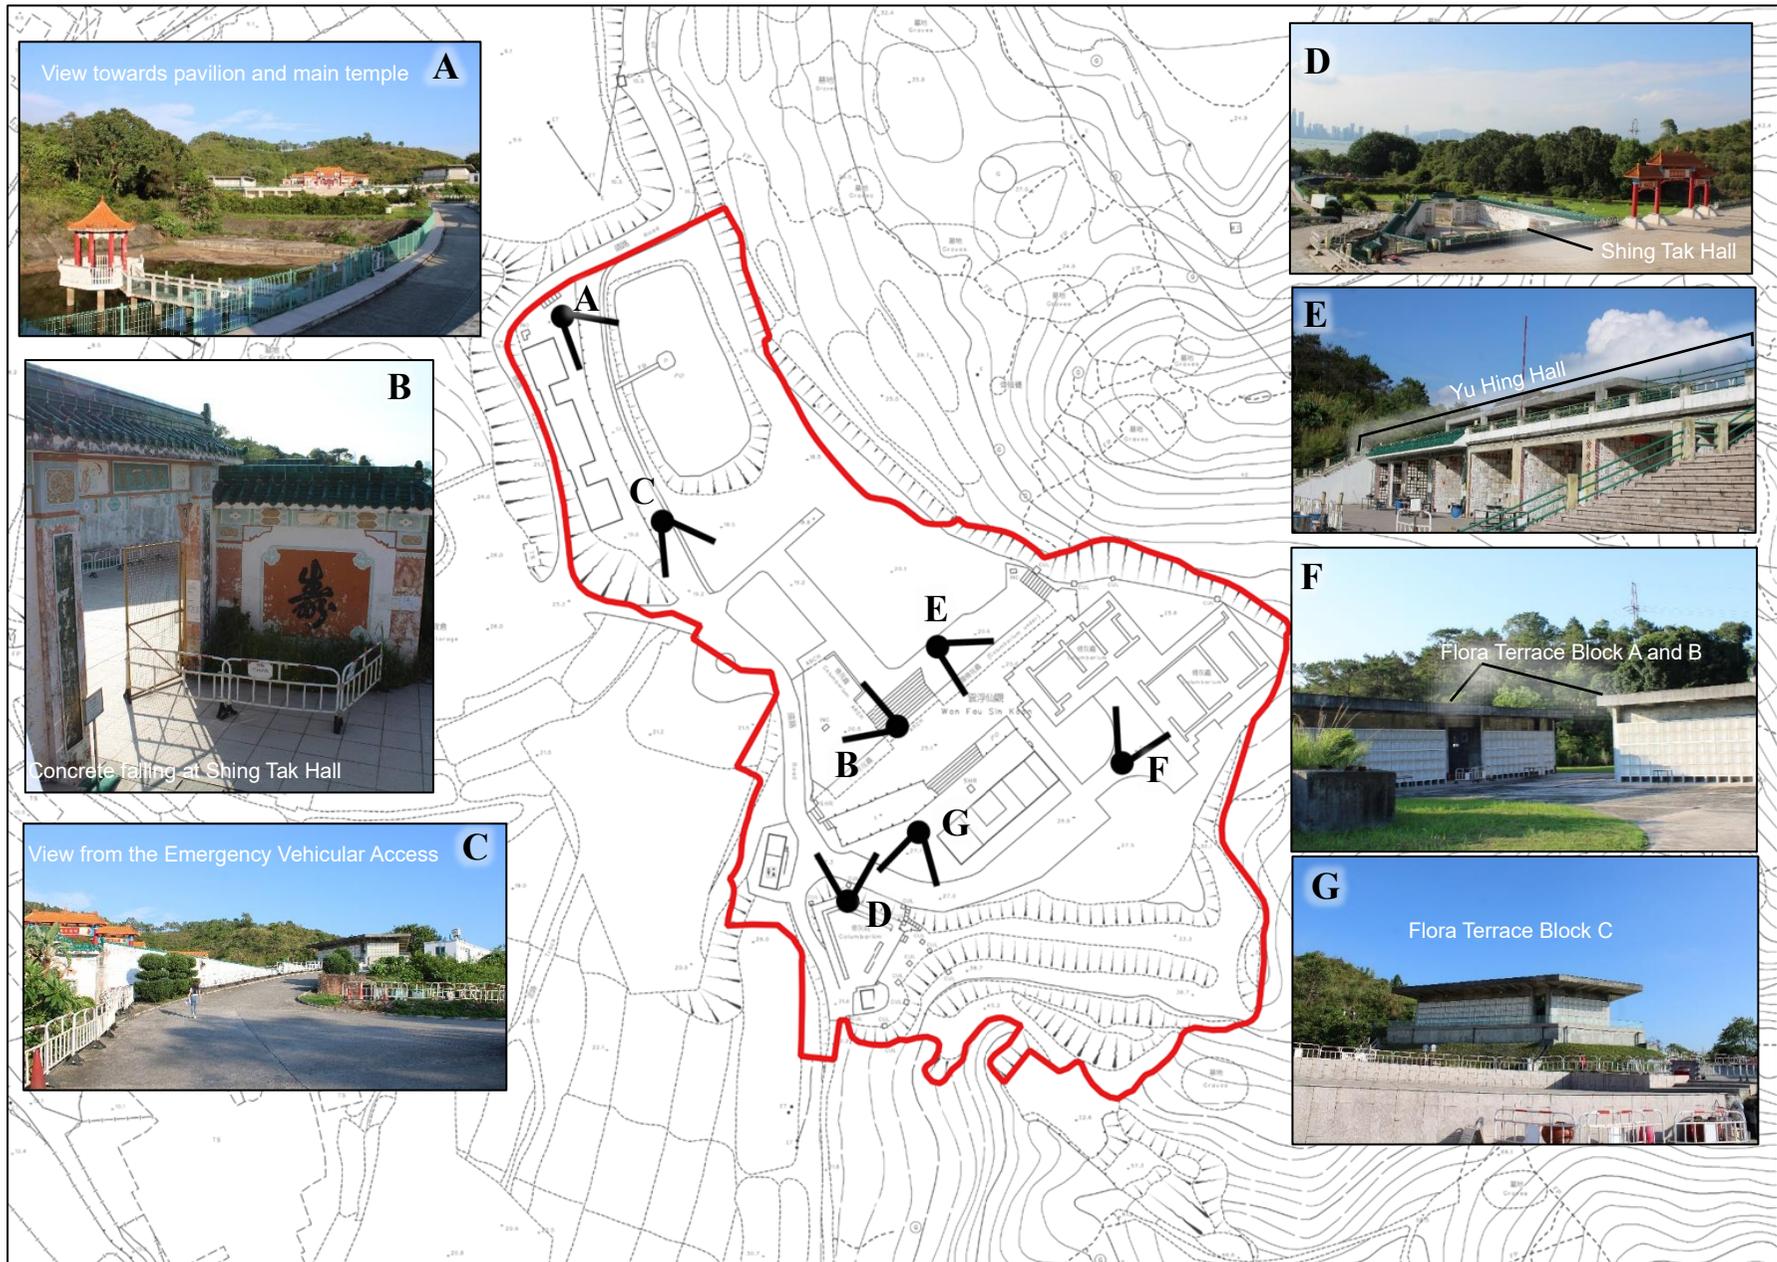
**Figure 2.3: Existing Condition of the Site**

2.2.3 The Site has been operated as temple and columbarium since 1983. The Koon was commented by the local stakeholders and villagers as a renowned temple and representative attraction in Lau Fau Shan. However, there is a lack of weather proof area for an ash interment ceremony, ancestor worship ceremony, family members to prepare joss-paper and other offerings, and senior family members to take a rest. Besides, if more weather-proof facilities can be provided within the Site, it will be more welcomed by the local villagers and visitors. Moreover, the condition of the existing columbarium halls has gradually deteriorated and become dilapidated over time. As shown in **Figure 2.3**, the concrete spalling is visible on Shing Tak Hall, as well as the color of the façade is also tarnished.

<p><u>Existing Conditions</u></p> <p>The existing columbarium (old halls) structures within the Application Site are found to be deteriorating, with concrete falling and a lack of weather-proof areas such as decent sheltered/resting places.</p>	<p>The Applicant is planning to uplift and revamp the conditions of the existing facilities of the Koon, including the columbarium (old hall) structures, to address the comments from current customers and the local stakeholders for better services and an improved environment for the ash interment ceremony and ancestor worship ceremony.</p>

5.5.1 The existing Old halls (esp. the Shing Tak Hall) are deteriorating with the falling of concrete and the tarnishing of the color on the façade. The Site also has no weather-proof facilities such as decent sheltered/resting places within the existing New Halls. The proposed amendments would pose an opportunity to revamp and uplift the condition of the Koon. It is also an opportunity to relocate the unsold niches from the New Halls to the private lots. The Applicant intends to provide better services and sheltered spaces with an improved environment for the ash interment ceremony and ancestor worship ceremony in their new columbarium design. More importantly, there is no increase in the originally approved built over area after the proposed amendments.

The Site has been operated as temple and columbarium since 1983. The Koon was commented by the local stakeholders and villagers as a renowned temple and representative attraction in Lau Fau Shan. However, there is a lack of weather proof area for an ash interment ceremony, ancestor worship ceremony, family members to prepare joss-paper and other offerings, and senior family members to take a rest. Besides, if more weather-proof facilities can be provided within the Site, it will be more welcomed by the local villagers and visitors. Moreover, the condition of the existing columbarium halls has gradually deteriorated and become dilapidated over time. The concrete spalling is visible on the roof of the Shing Tak Hall, as well as the color of the façade is also tarnished.

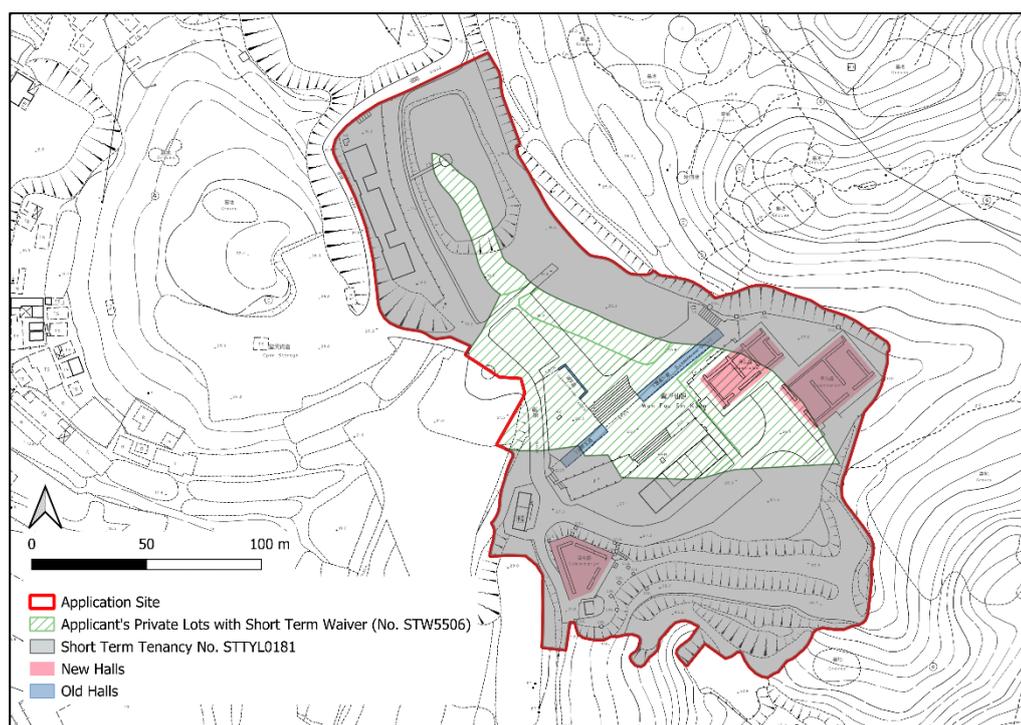
**Figure 2.5: Land Status**

2.4.2 The Koon (or the temple and columbarium uses on the Site) is currently permitted by way of a STW and a STT both commenced on 8 May 2023 for **a term of 7 years until 7 May 2030**. The operation of the columbarium is permitted by a Private Columbarium License (“Licence”) for the same terms as the STT and the STW.

2.4.3 Under the conditions of STT, the built-over area for temple use shall not exceed 1,100 square metres, and for the columbarium use shall not exceed 1,270 square meters. Not more than 2,961 niches should be provided within the STT. While the conditions of STW stipulate that the built-over area for temple use shall not exceed 460 square meters, and for columbarium use shall not exceed 660 square meters. Not more than 7,439 niches should be provided within the STW. Both the STT and STW allow for a total of not more than 10,400 niches to be provided within the Koon. In addition, the existing temple and the Pai Lau shall not exceed 8.2m and 9.6m above ground level respectively while other buildings or structures erected shall not exceed 6.9m above ground level.

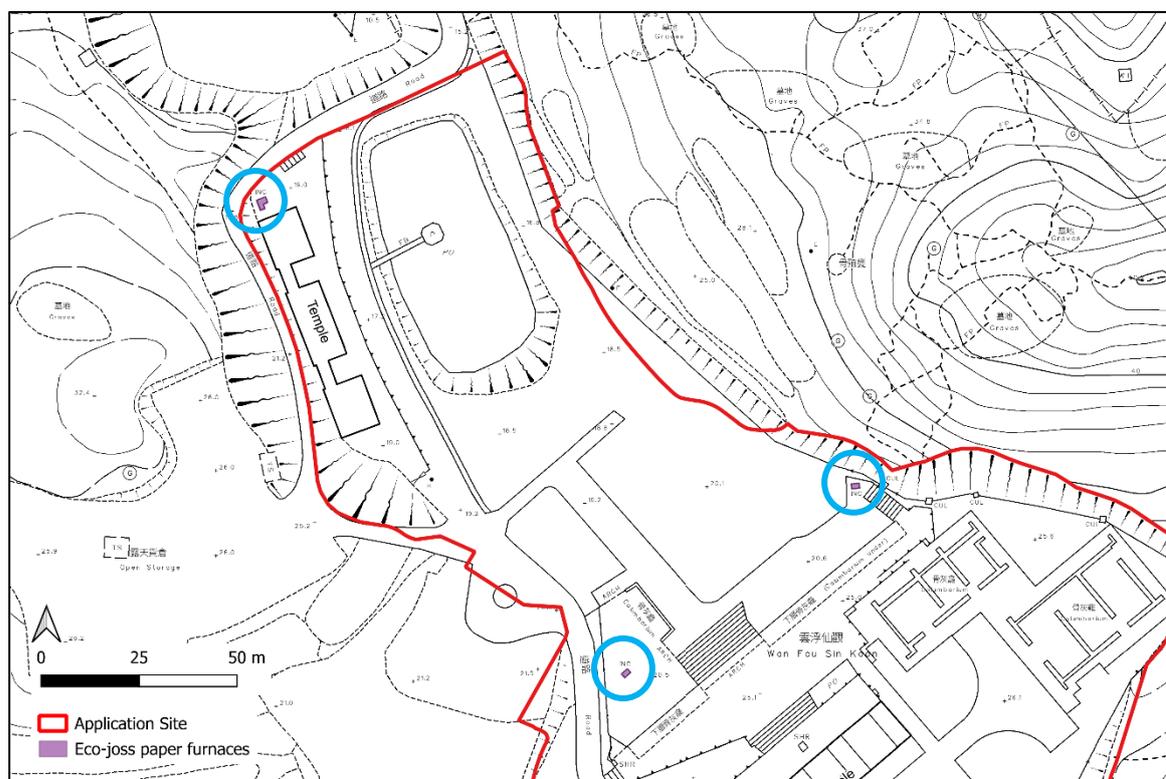
**Figure 3.3: Location of Eco-Joss Paper Furnaces**

4.7.7 Besides that, the existing 3 nos. of eco-joss paper furnaces will be operated by the trained operator(s) to ensure all visitors are only allowed to use the eco-joss paper furnaces. This is also to comply with Condition No. 29 set out by PCLB.

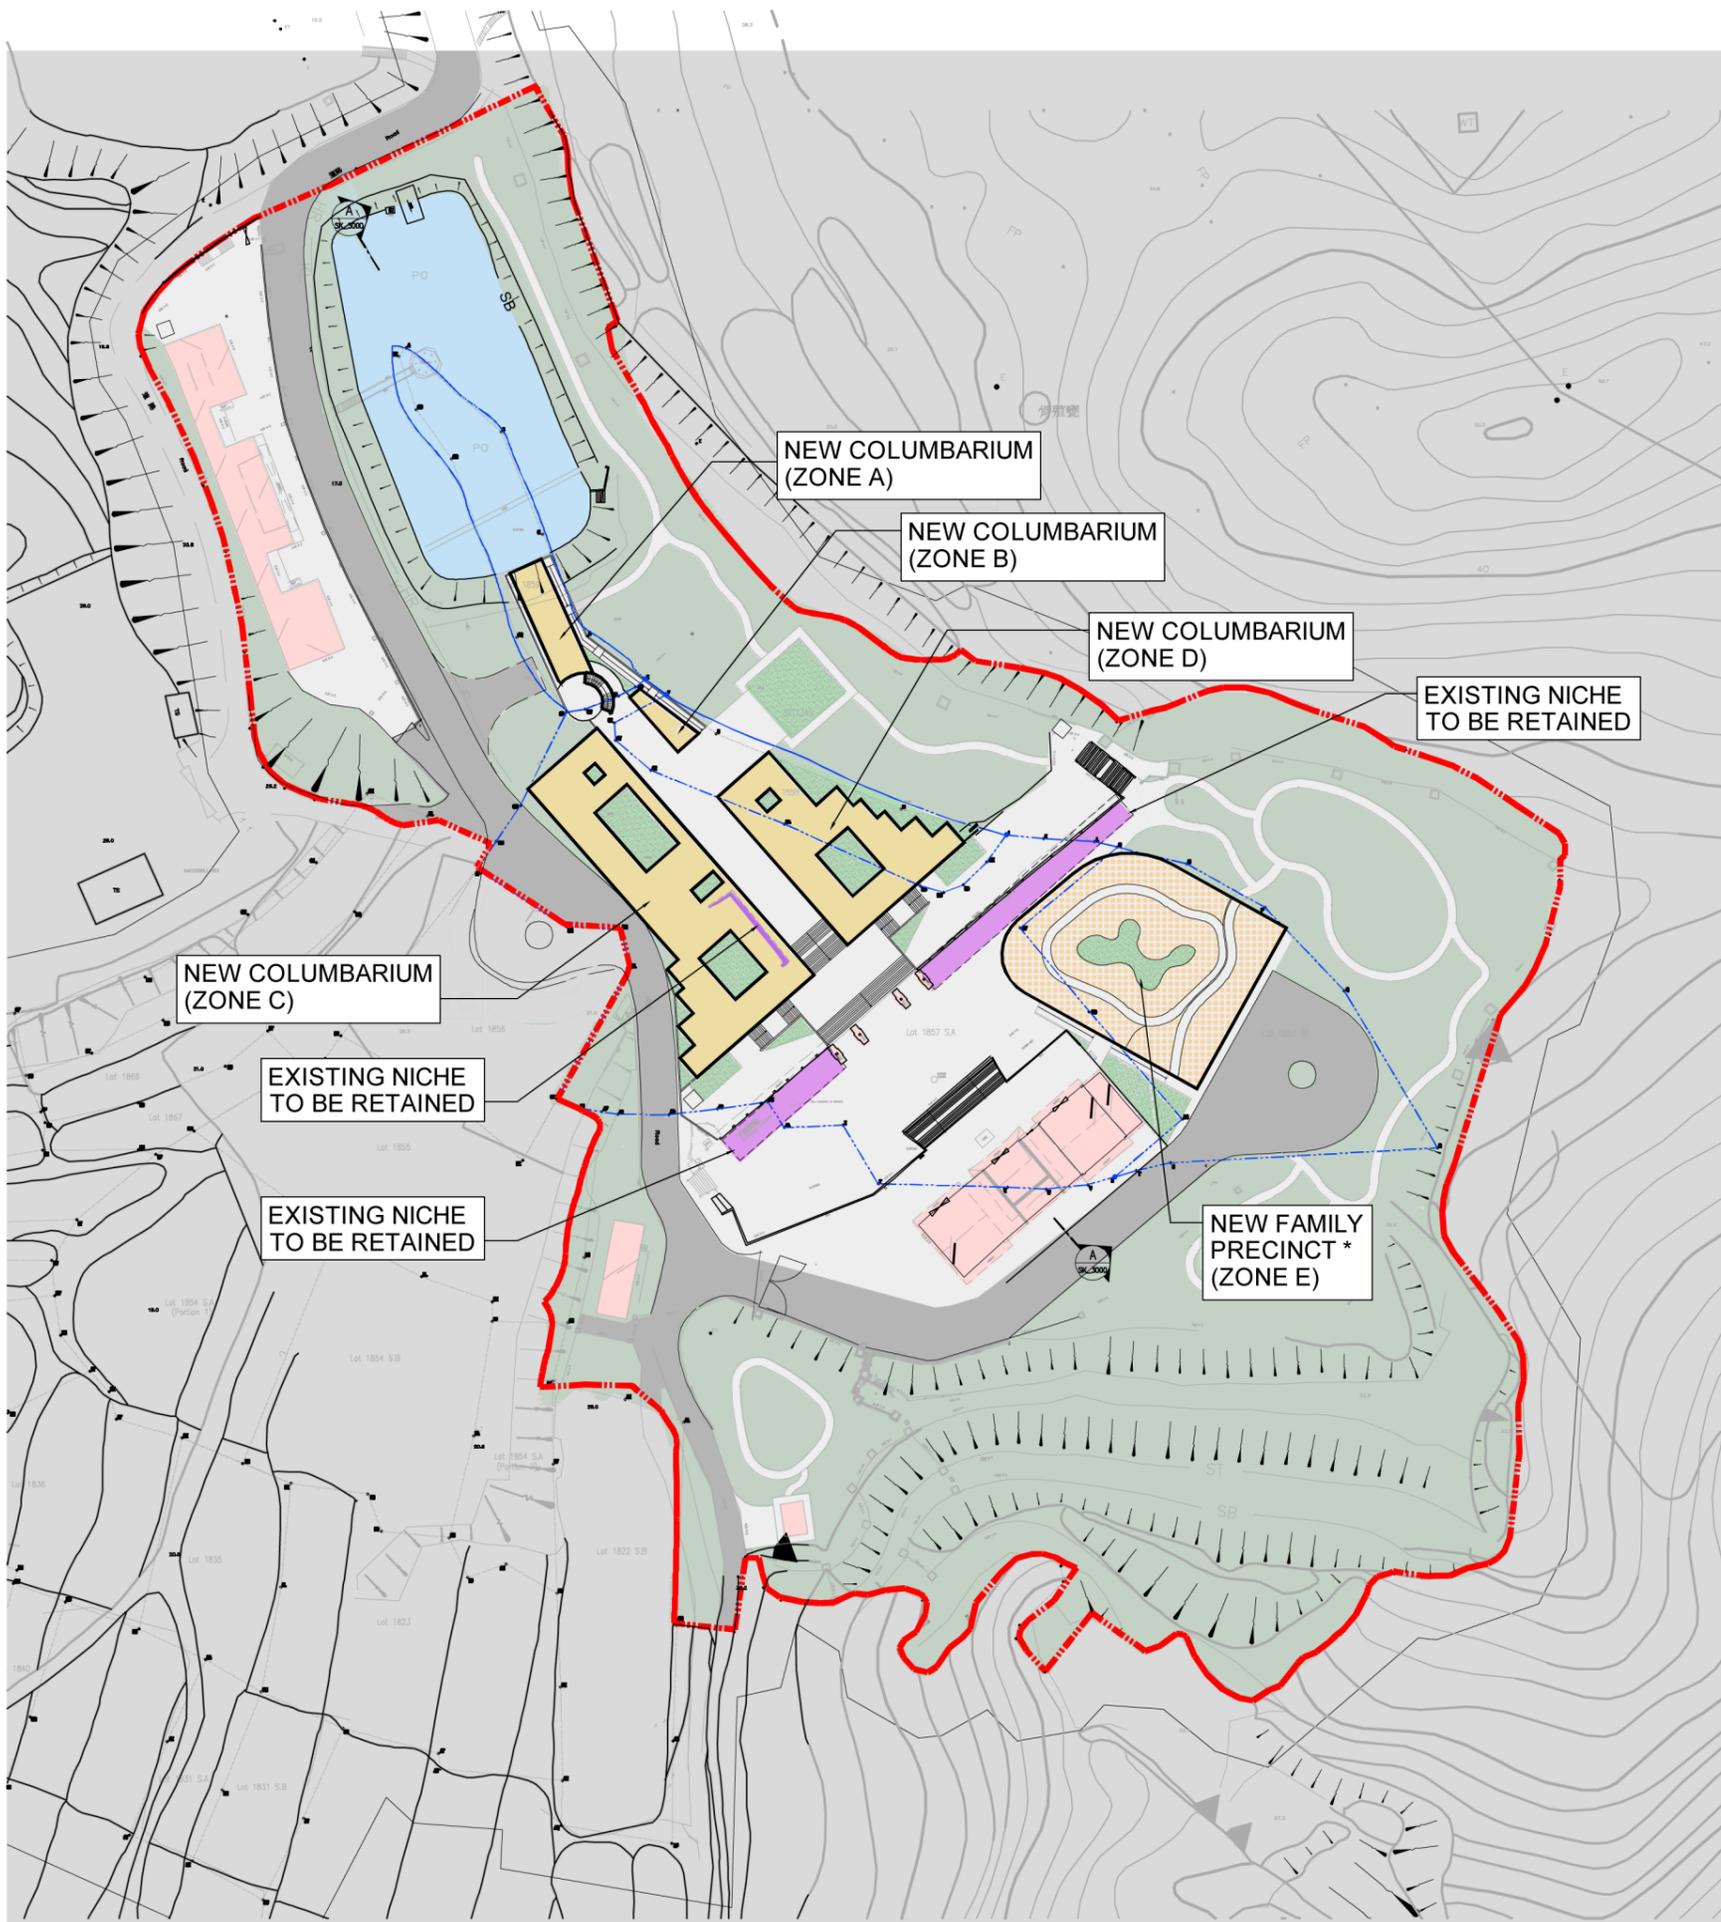
Schematic Architectural Drawings

NICHE CALCULATION:

1.	NEW COLUMBARIUM (ZONE A) (QUAD)	= 228 No.s
2.	NEW COLUMBARIUM (ZONE B) (QUAD)	= 84 No.s
3.	NEW COLUMBARIUM (ZONE C) (QUAD)	= 200 No.s
3.	NEW COLUMBARIUM (ZONE C) (DOUBLE)	= 1104 No.s
4.	NEW COLUMBARIUM (ZONE D) (DOUBLE)	= 1720 No.s
5.	NEW COLUMBARIUM (ZONE E) (QUAD)	= 488 No.s

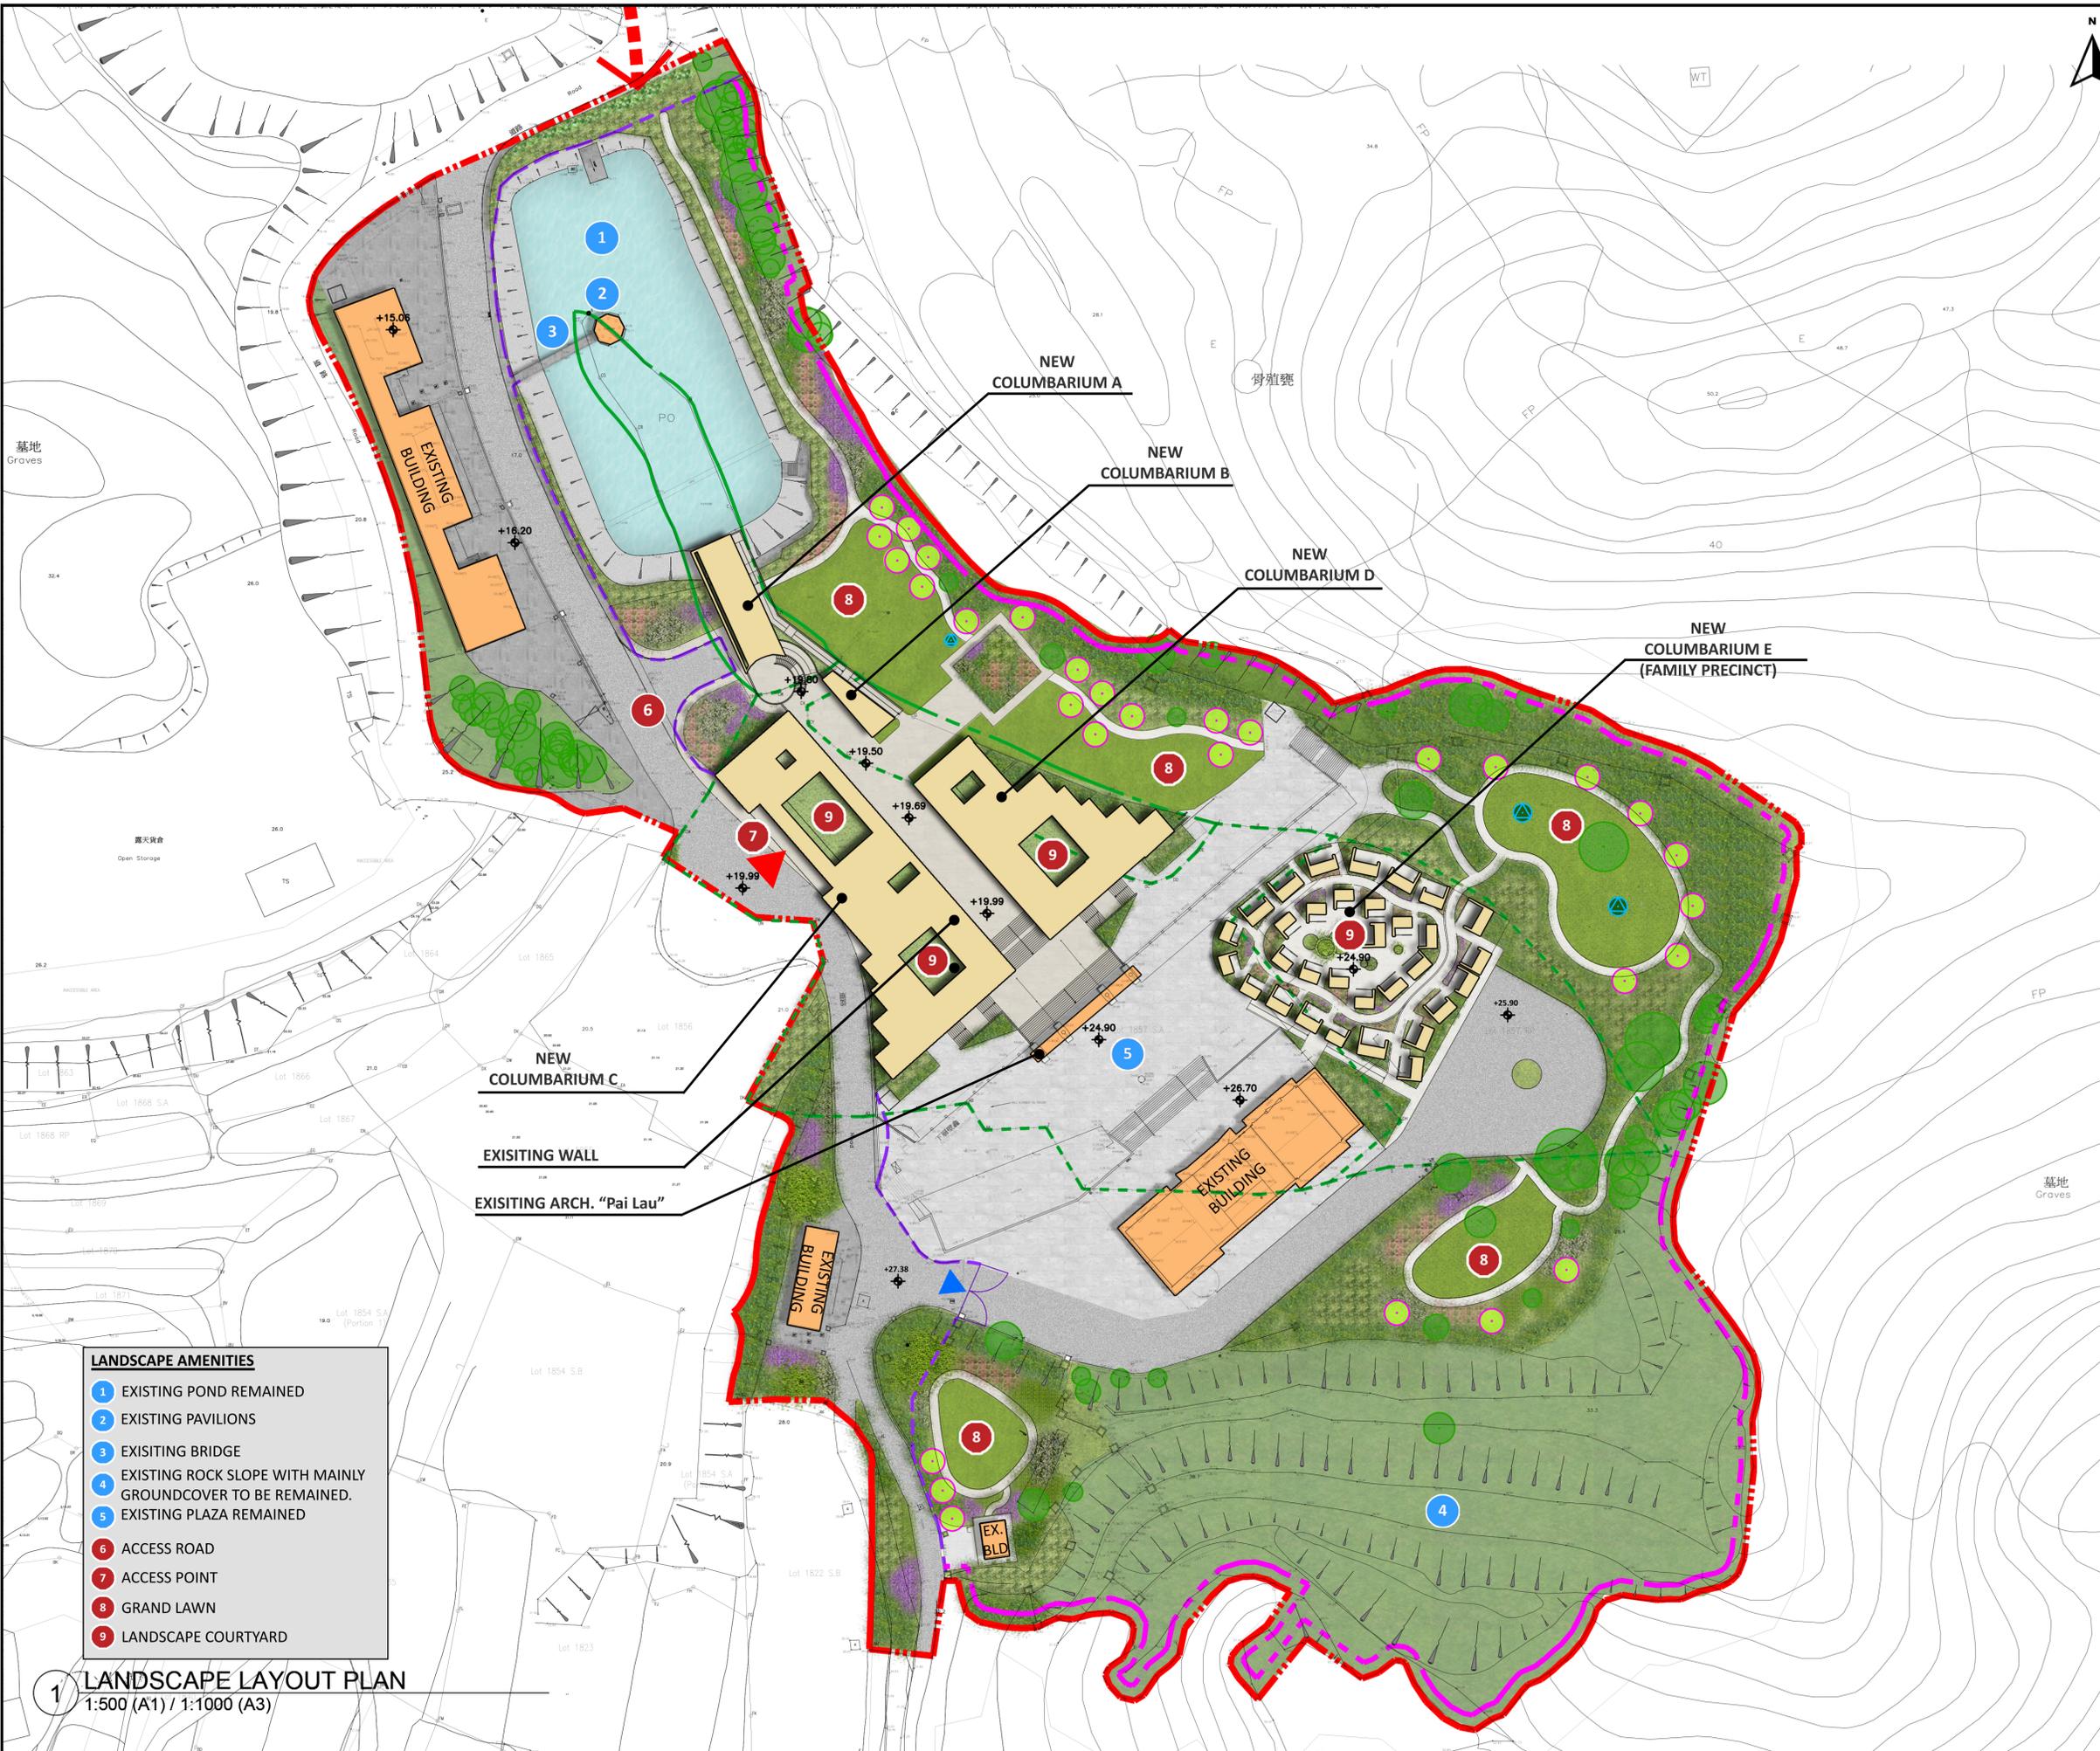
**1 LANDSCAPE LAYOUT PLAN**  
 1:500 (A1) / 1:1000 (A3)

- LANDSCAPE AMENITIES**
- 1 EXISTING POND REMAINED
  - 2 EXISTING PAVILIONS
  - 3 EXISTING BRIDGE
  - 4 EXISTING ROCK SLOPE WITH MAINLY GROUNDCOVER TO BE REMAINED.
  - 5 EXISTING PLAZA REMAINED
  - 6 ACCESS ROAD
  - 7 ACCESS POINT
  - 8 GRAND LAWN
  - 9 LANDSCAPE COURTYARD

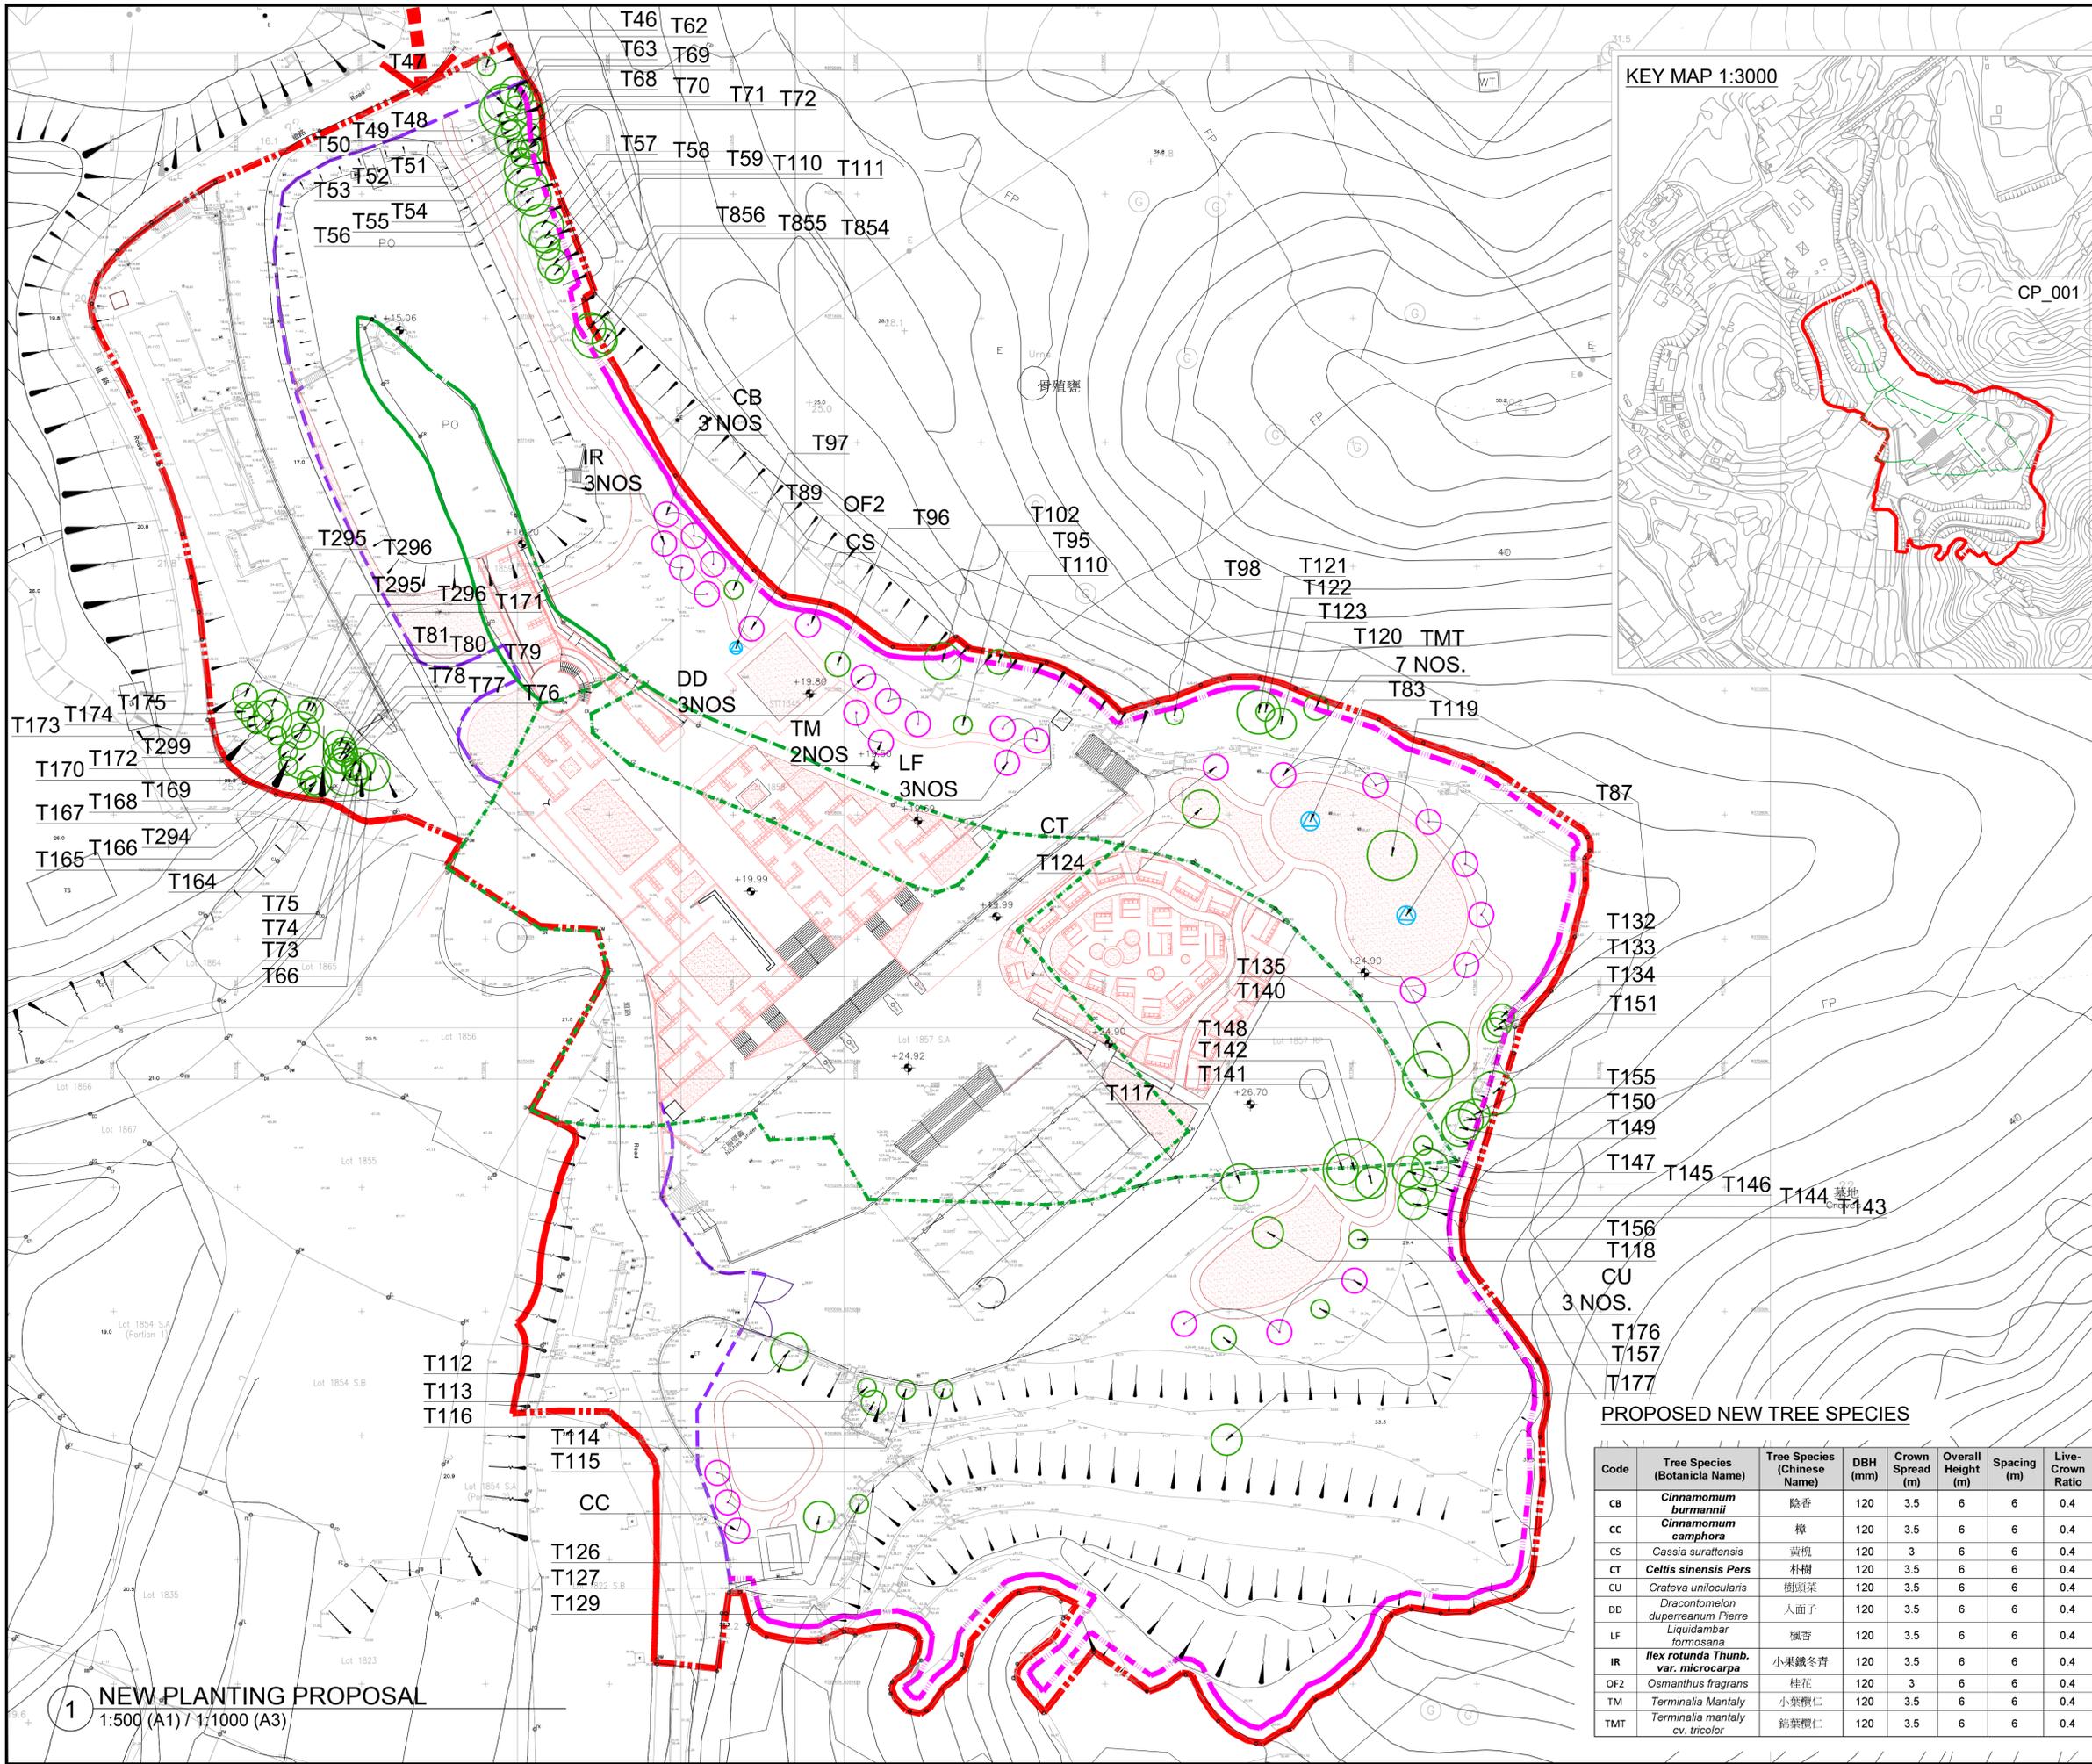
**1 TREE TREATMENT PLAN**  
 1:500 (A1) / 1:1000 (A3)

- LEGEND**
- APPLICATION SITE
  - APPLICANT'S PRIVATE LOTS WITH S.T.W
  - PROPOSED DEVELOPMENT
  - SOLID FENCE WALL
  - CHAIN LINK FENCE
  - XX.XX EXISTING LEVEL
  - +XX.XX PROPOSED LEVEL
  - Txx TREE NUMBER
  - RETAINED TREE
  - Txx TREE NUMBER
  - TRANSPLANTED TREE
  - XX TREE CODE
  - NEW TREE

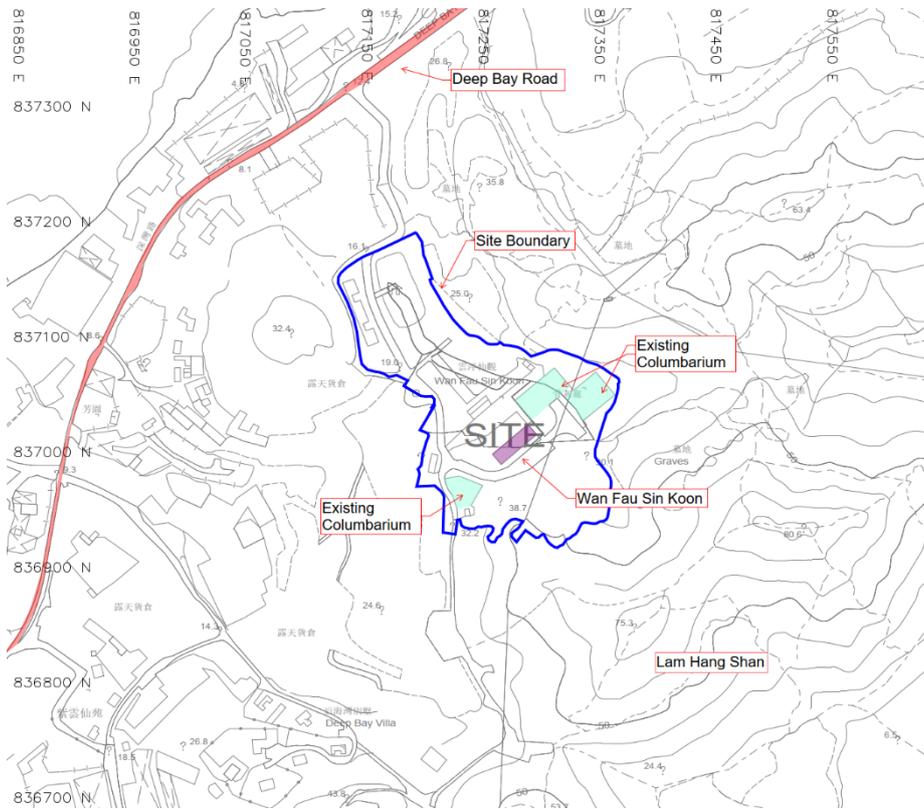
**Figure 2.2 Site Location Layout Plan with adjacent Buildings/roads**

The topography of the site is at the level varying from about +48mPD (Lam Hang Shan Side) at Southern Site Boundary to +16mPD (Deep Bay Road Side) inside the Site Boundary.
