**APPLICATION FOR PERMISSION  
UNDER SECTION 16 OF  
THE TOWN PLANNING ORDINANCE  
(CAP. 131)**

As requested, we would like to supplement the replacement page(s) of the Supporting Planning Statement, the Indicative Architecture Scheme, and the Application Form for your kind consideration.

We hereby submit a Consolidated Supporting Planning Statement ("Consolidated SPS") together with the replacement pages of application form to facilitate the consideration of the captioned Planning Application by TPB. The Consolidated SPS contains the latest version of the development scheme and technical assessments that had been previously submitted to TPB under various Further Information ("F.I.") submissions. Hence, the attached Consolidated SPS would supersede the various F.I.s submitted on 13 November 2025, 19 November 2025 and 17 December 2025. We also confirm that information included in the attached Consolidated SPS had been previously submitted during the course of the Planning Application and does not contain any new information.

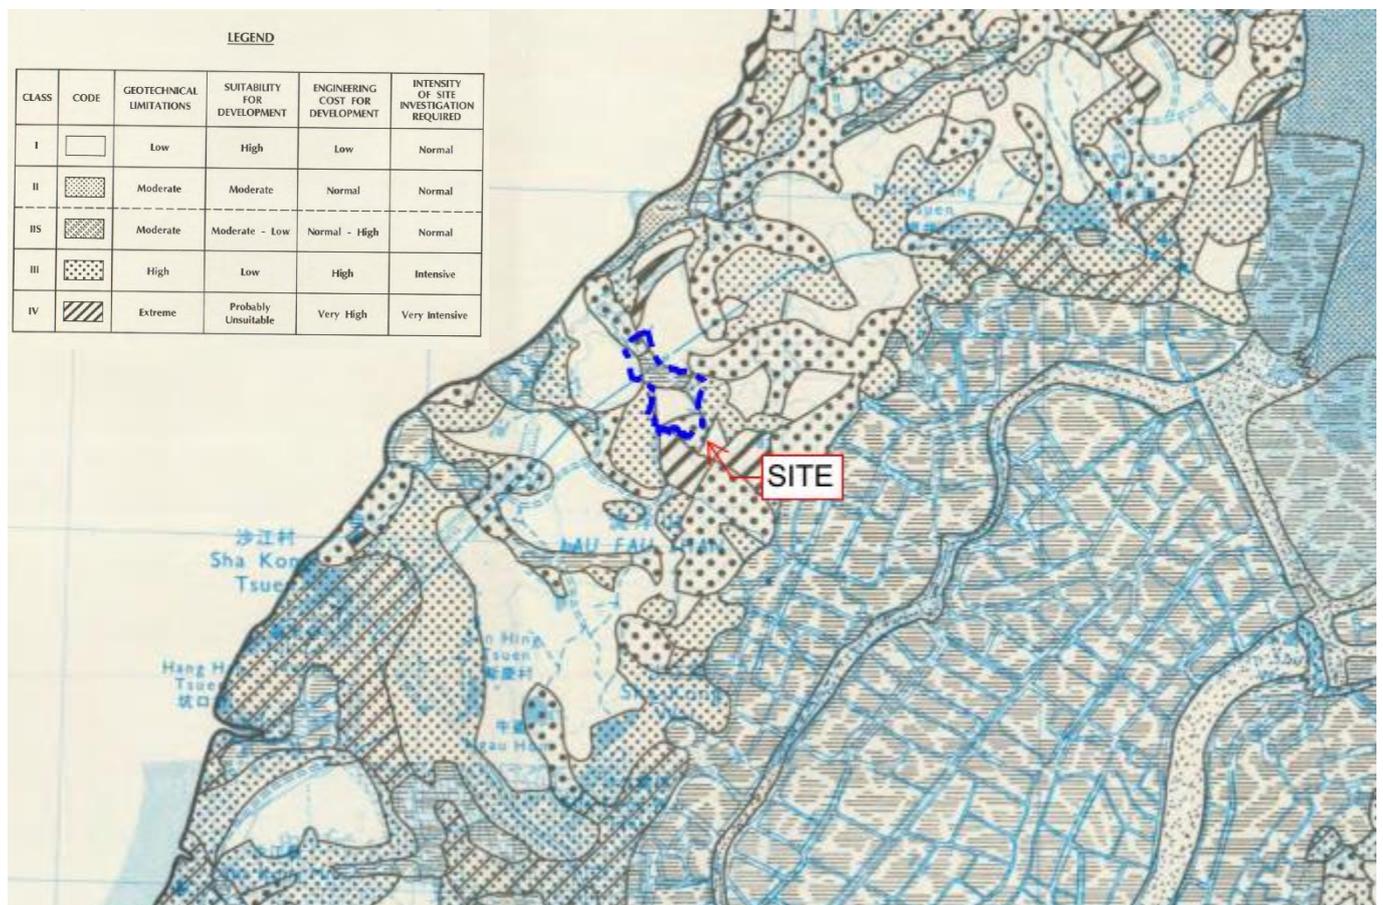
**Figure 3.2 Part Plan of the GLUM – North West New Territories**

In accordance with the Geotechnical Land Use Map (GLUM) (Ref. No. GASP/20/1/1 2nd Edition) in Geotechnical Area Studies Programme (GASP) Report IV – Hong Kong and Kowloon (1987) issued by CEDD, the terrain in proposed site can be classified as Class I to III. (low to high geotechnical limitations). With reference to cl. 4.1.3 of the report, GLUM Class III terrain is expected to require High geotechnical investigation, and the costs associated with site investigation, site formation, foundation and drainage work will probably be high for the north part of site and lower cost for the south part. Part plan of the relevant GLUM is presented in below and provided in **Figure 3.2**.

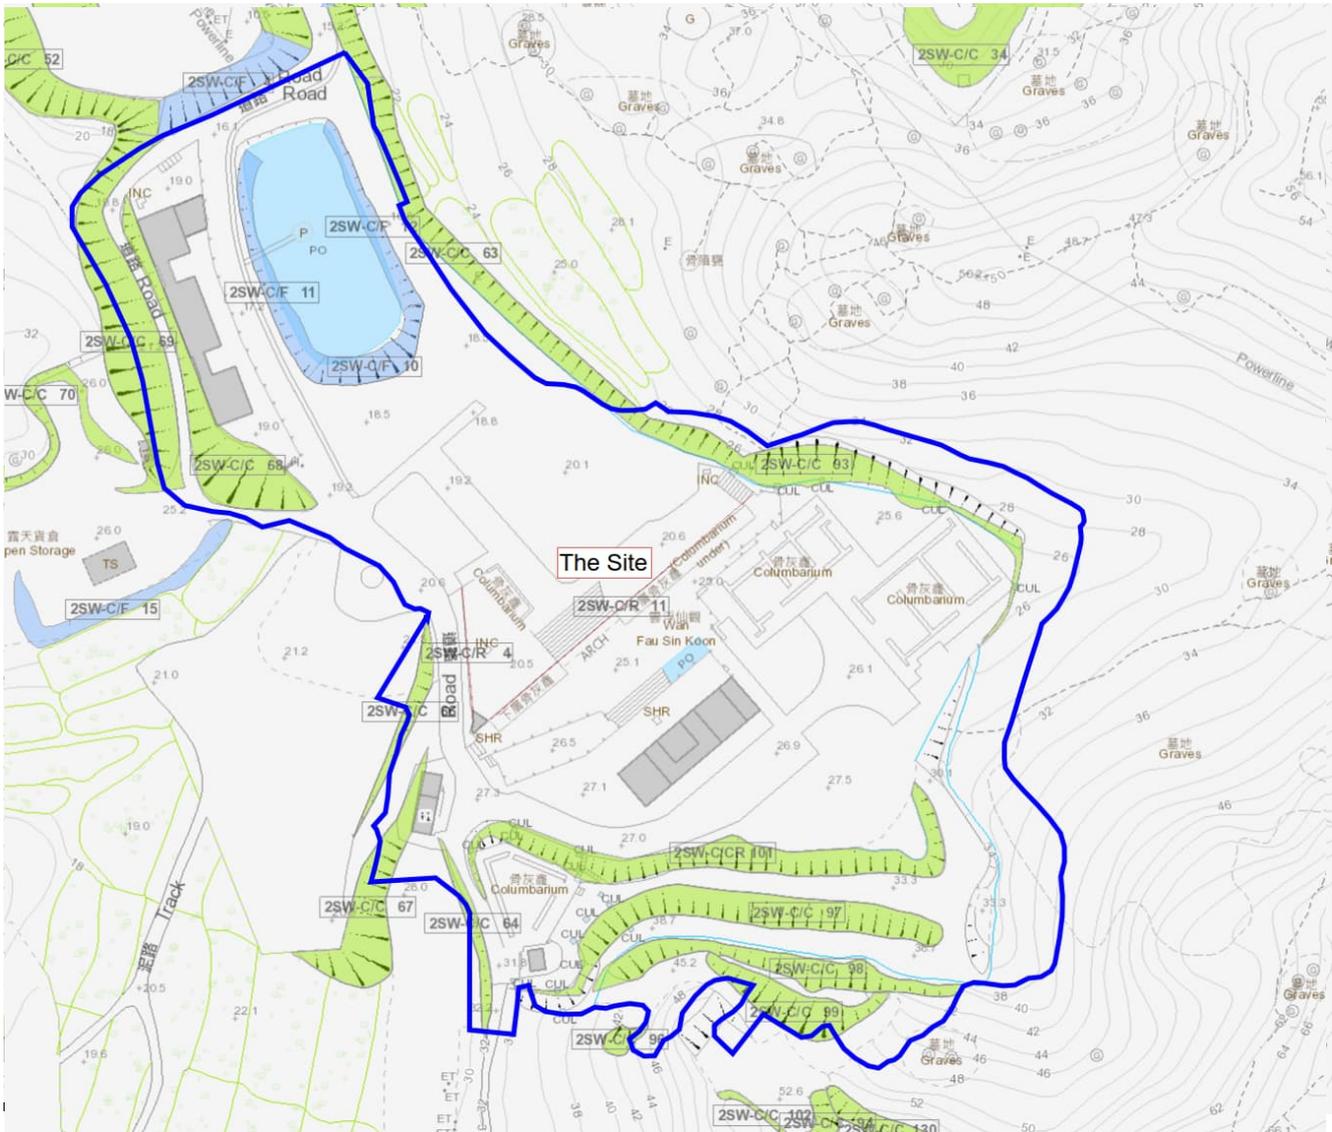
**Figure 3.3 Location plan of Registered Features**

There are 22 registered slope features within or in the vicinity of the proposed site. The location of these features is shown on attached **Figure 3.3**. Records of registered slope features, maintenance responsible lot/party, and stability statement or upgrading works are summarized in **Table 3.1**. Relevant information on the existing slopes and retaining walls feature retrieved from Slope Information System (SIS) is enclosed in **Appendix A**.

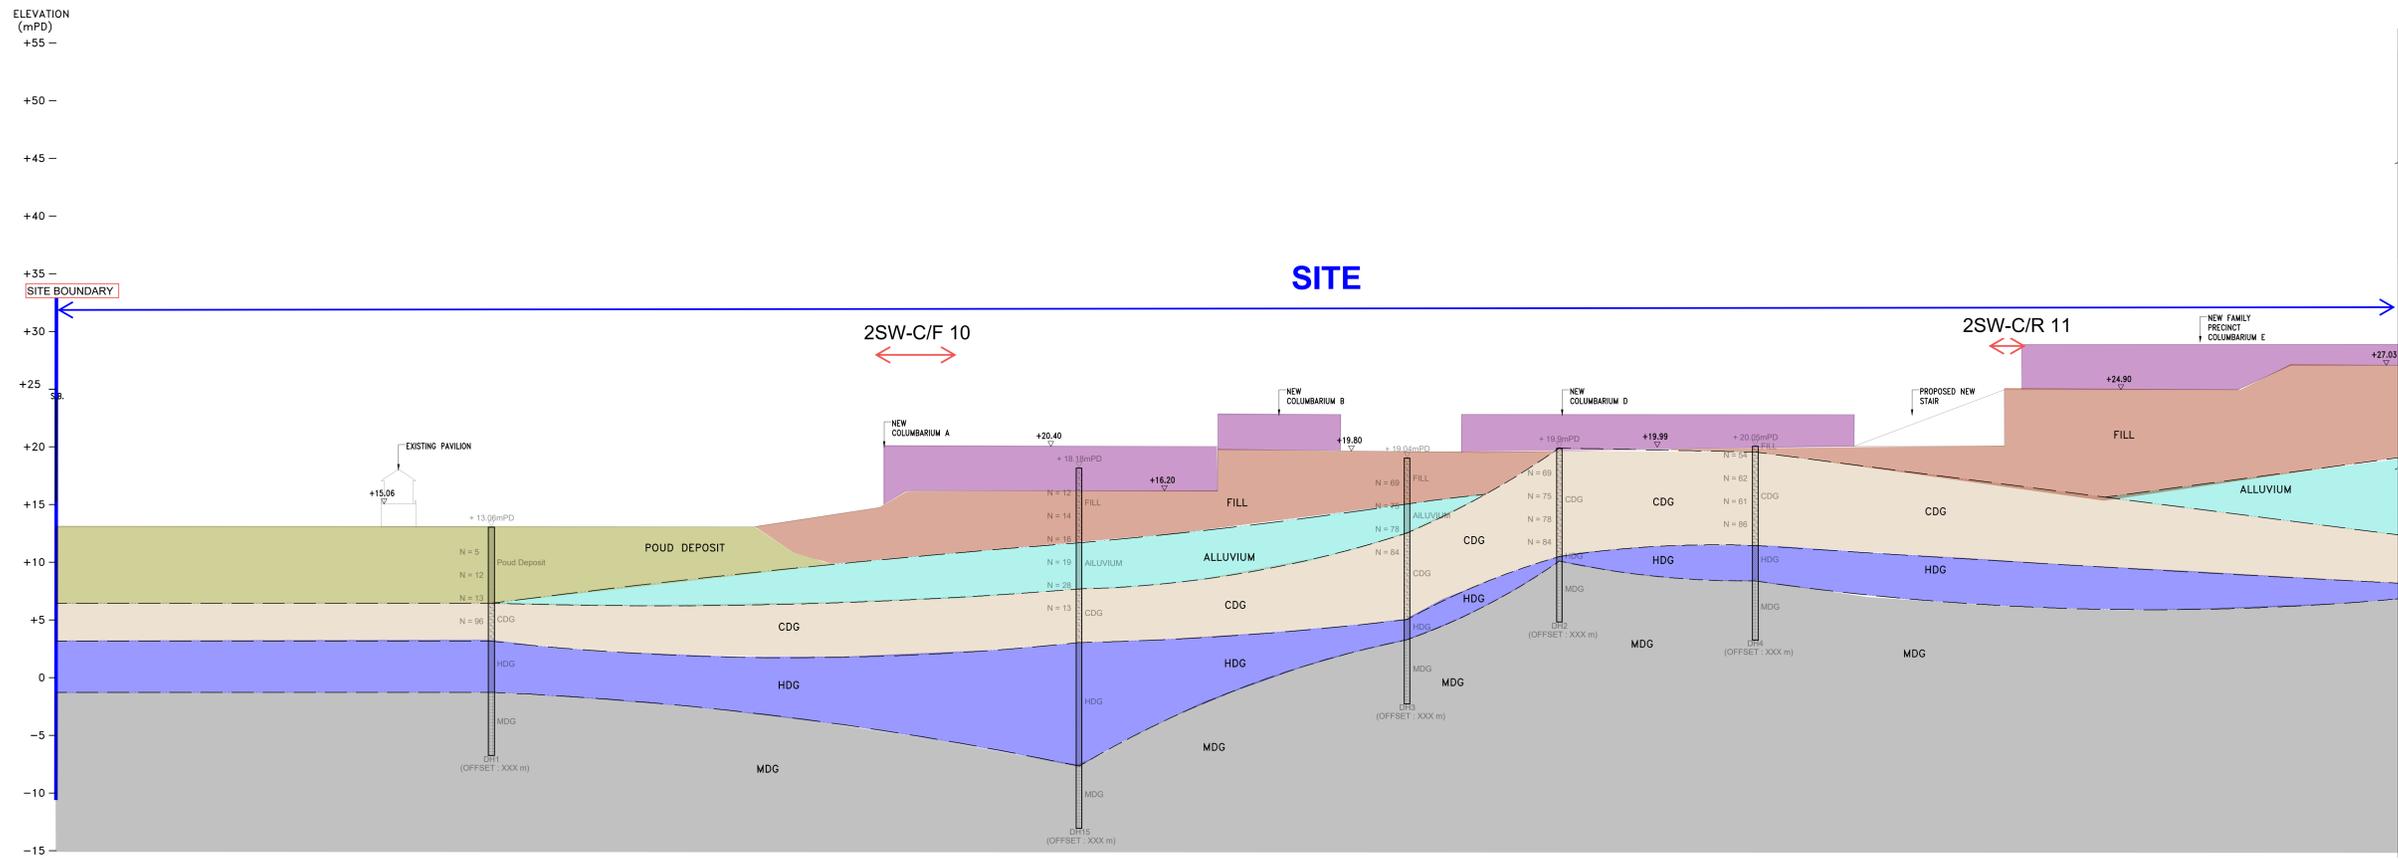
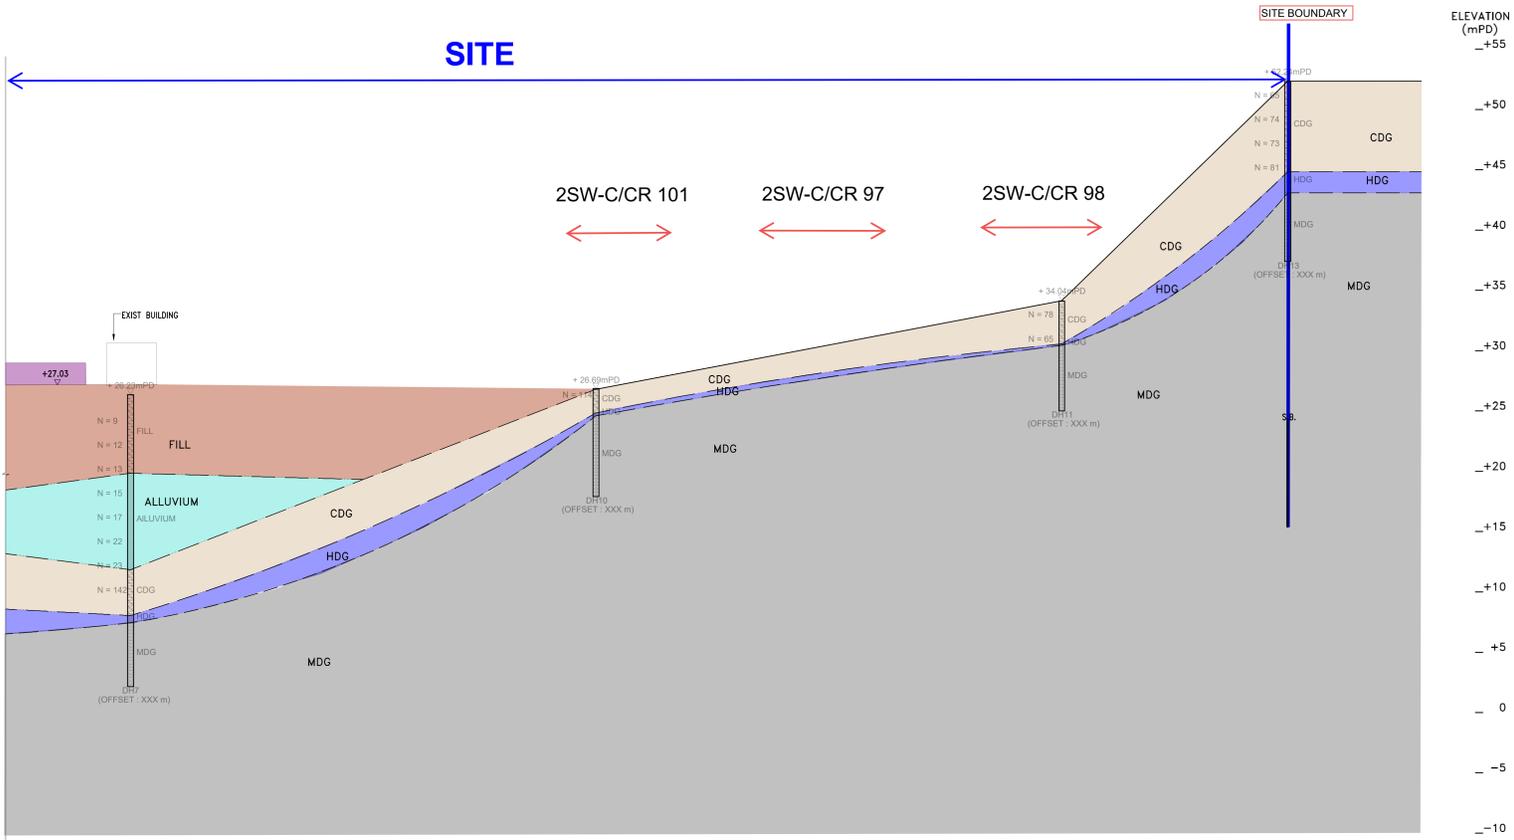
Based on the available information, the preliminary typical geological section showing soil / rock profile is shown in **Figure 3.4**. The tentative grade III rockhead level varies from about -7 mPD to +44 mPD.

<span style="display:inline-block; width:15px; height:10px; background-color: #90EE90; border: 1px solid black;"></span>	POND DEPOSIT
<span style="display:inline-block; width:15px; height:10px; background-color: #D2691E; border: 1px solid black;"></span>	FILL
<span style="display:inline-block; width:15px; height:10px; background-color: #7FFFD4; border: 1px solid black;"></span>	ALLUVIUM
<span style="display:inline-block; width:15px; height:10px; background-color: #F5DEB3; border: 1px solid black;"></span>	CDG
<span style="display:inline-block; width:15px; height:10px; background-color: #6495ED; border: 1px solid black;"></span>	HDG
<span style="display:inline-block; width:15px; height:10px; background-color: #A9A9A9; border: 1px solid black;"></span>	MDG
<span style="display:inline-block; width:15px; height:10px; background-color: #800080; border: 1px solid black;"></span>	NEW COLUMBARIUM

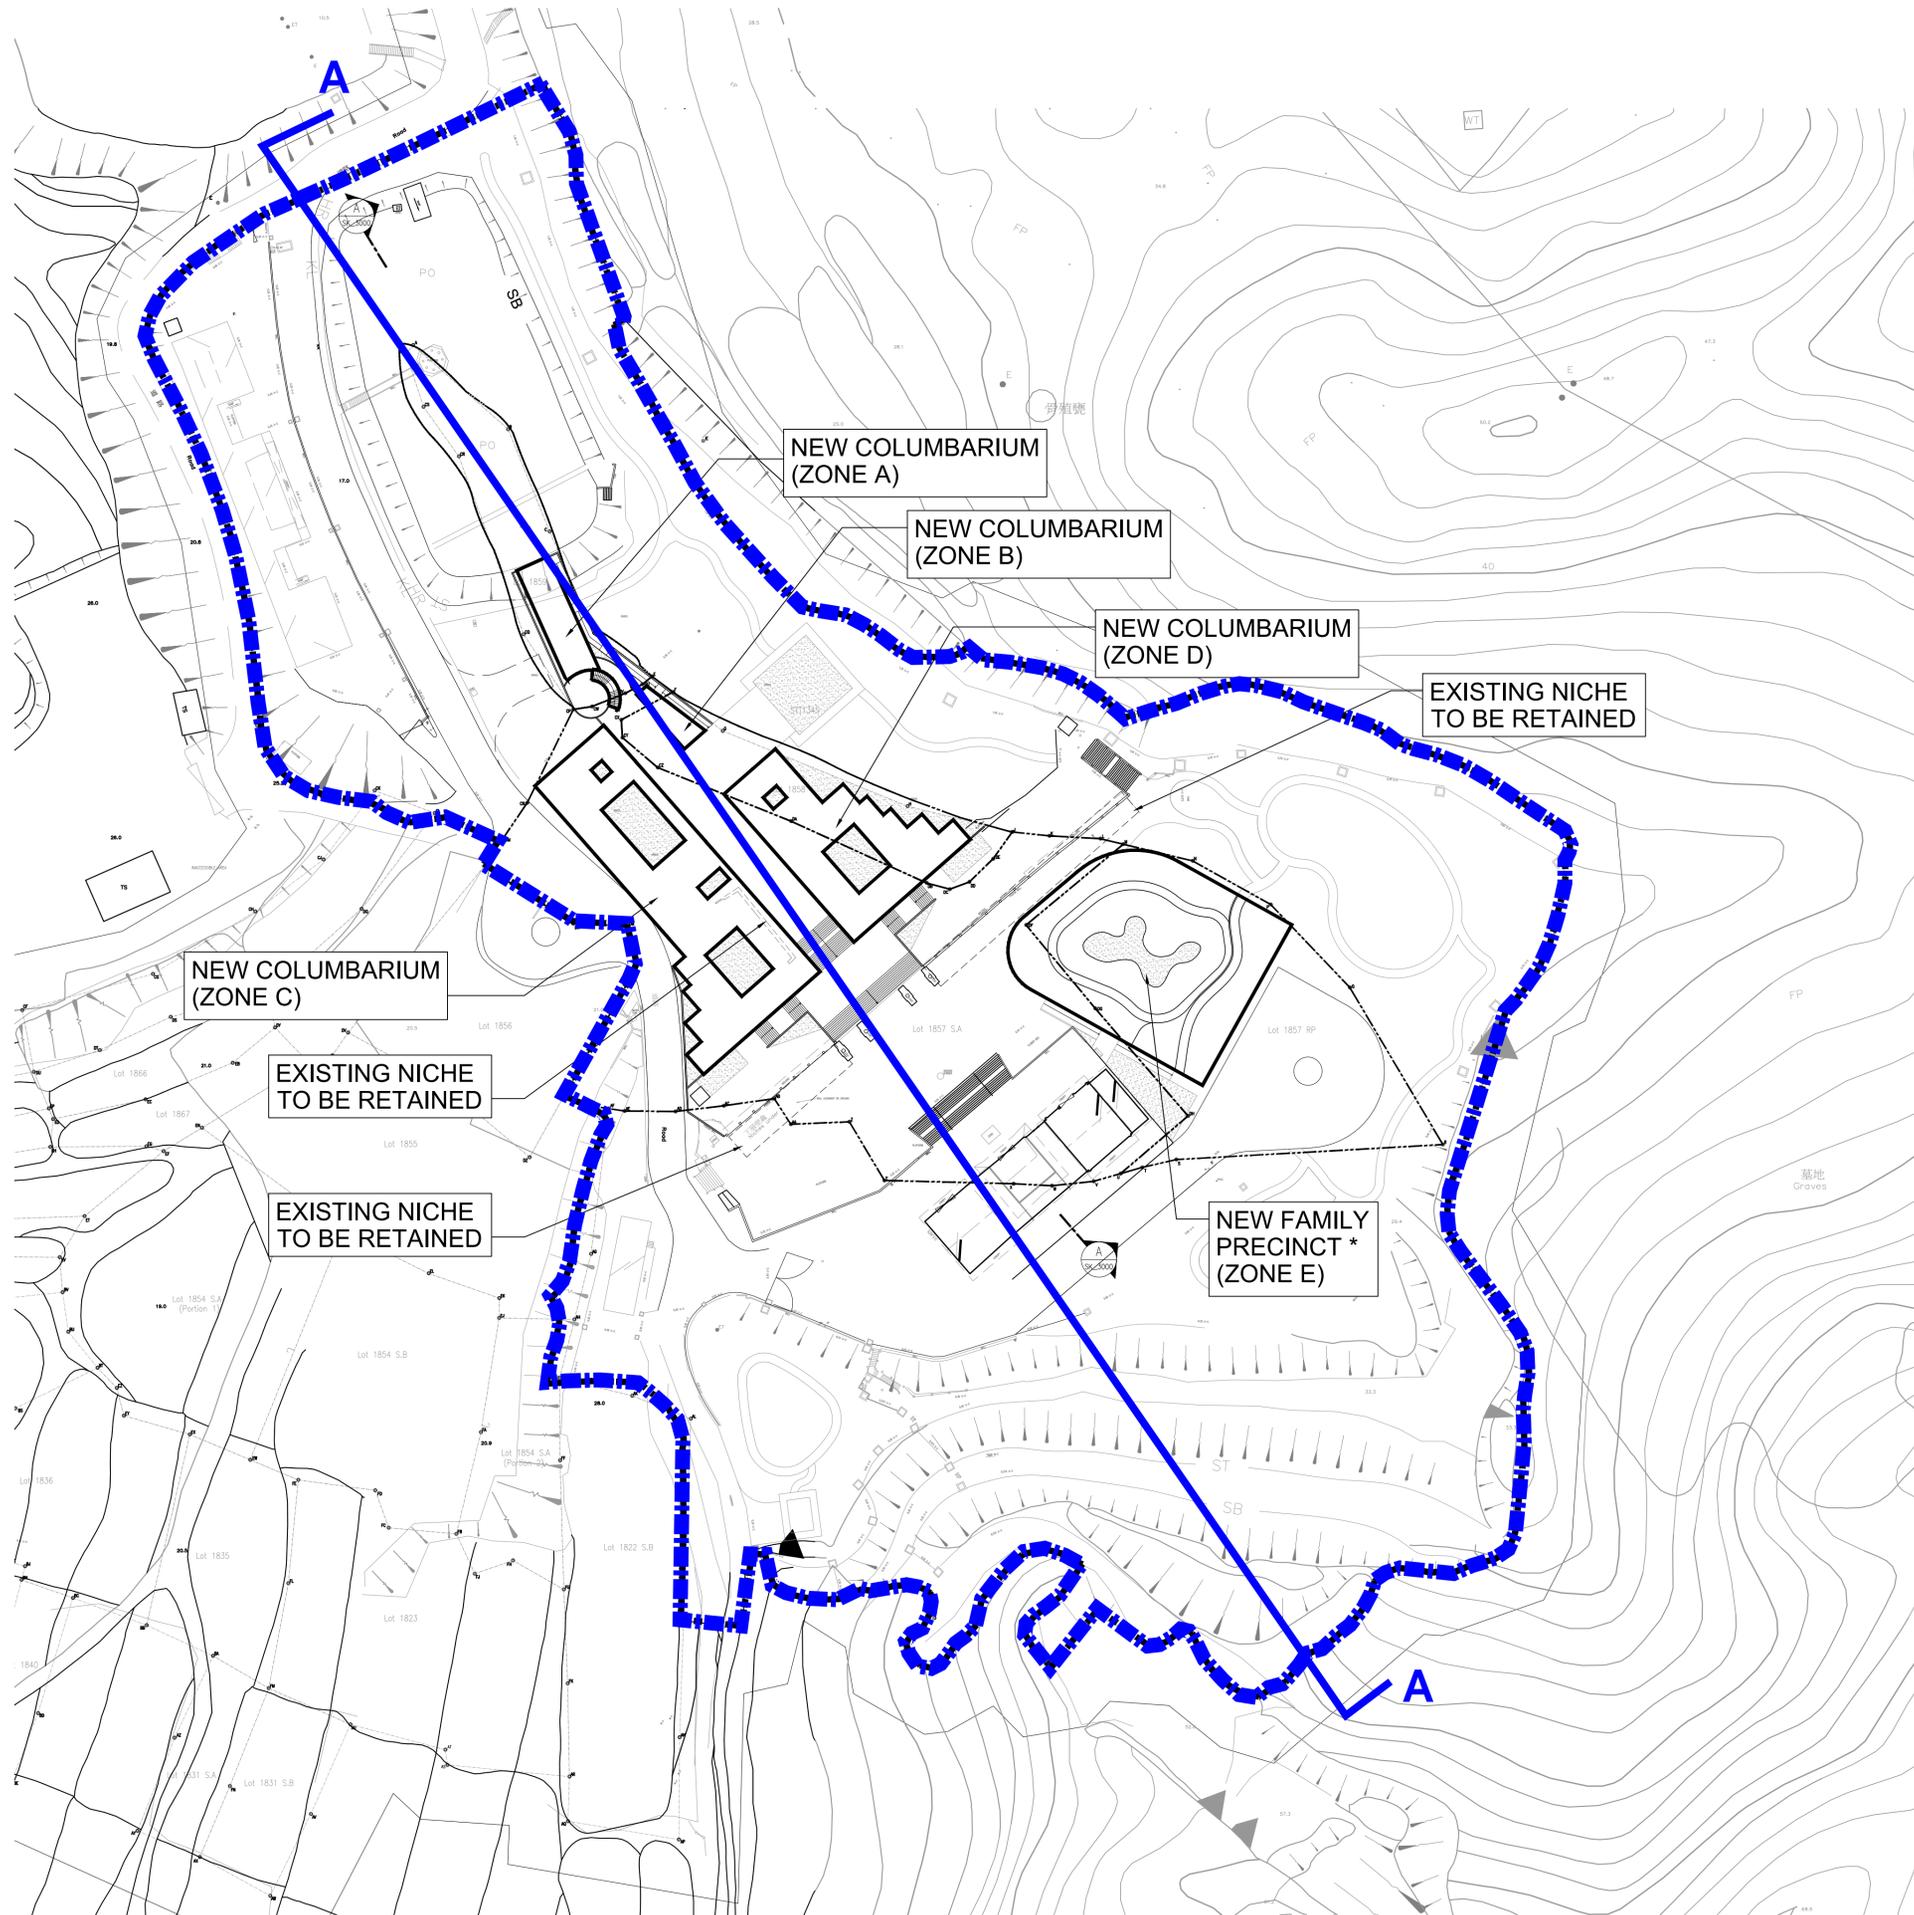
NICHE CALCULATION:

- 1. NEW COLUMBARIUM (ZONE A) (QUAD) = 228 No.s
- 2. NEW COLUMBARIUM (ZONE B) (QUAD) = 84 No.s
- 3. NEW COLUMBARIUM (ZONE C) (QUAD) = 200 No.s
- 3. NEW COLUMBARIUM (ZONE C) (DOUBLE) = 1104 No.s
- 4. NEW COLUMBARIUM (ZONE D) (DOUBLE) = 1720 No.s
- 5. NEW COLUMBARIUM (ZONE E) (QUAD) = 488 No.s

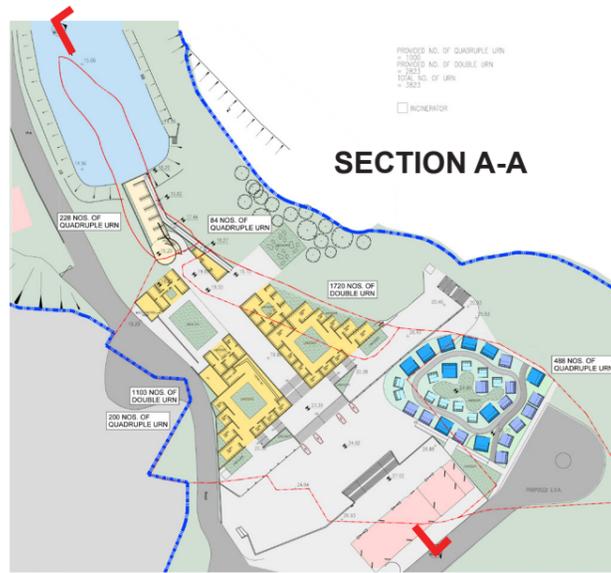
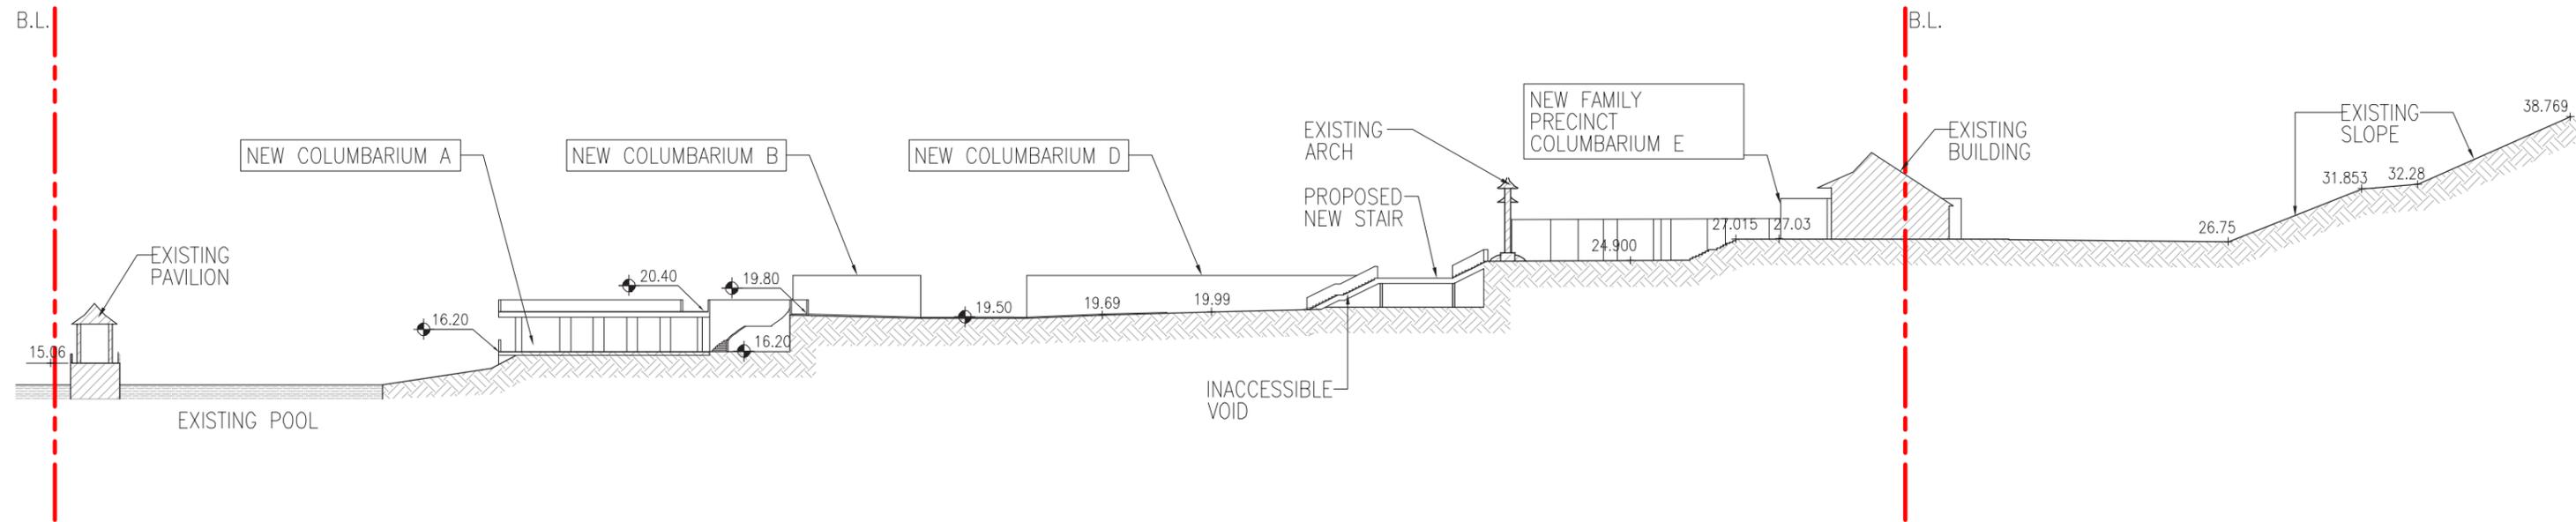
# SECTION A-A

SECTION  
 1:600@A3  
 Aedas
