**Geotechnical Planning Review Report**

**Proposed Development  
at various Lots in D.D.41  
Sha Tau Kok, New Territories**

**GEOTECHNICAL PLANNING REVIEW REPORT**

November 2025

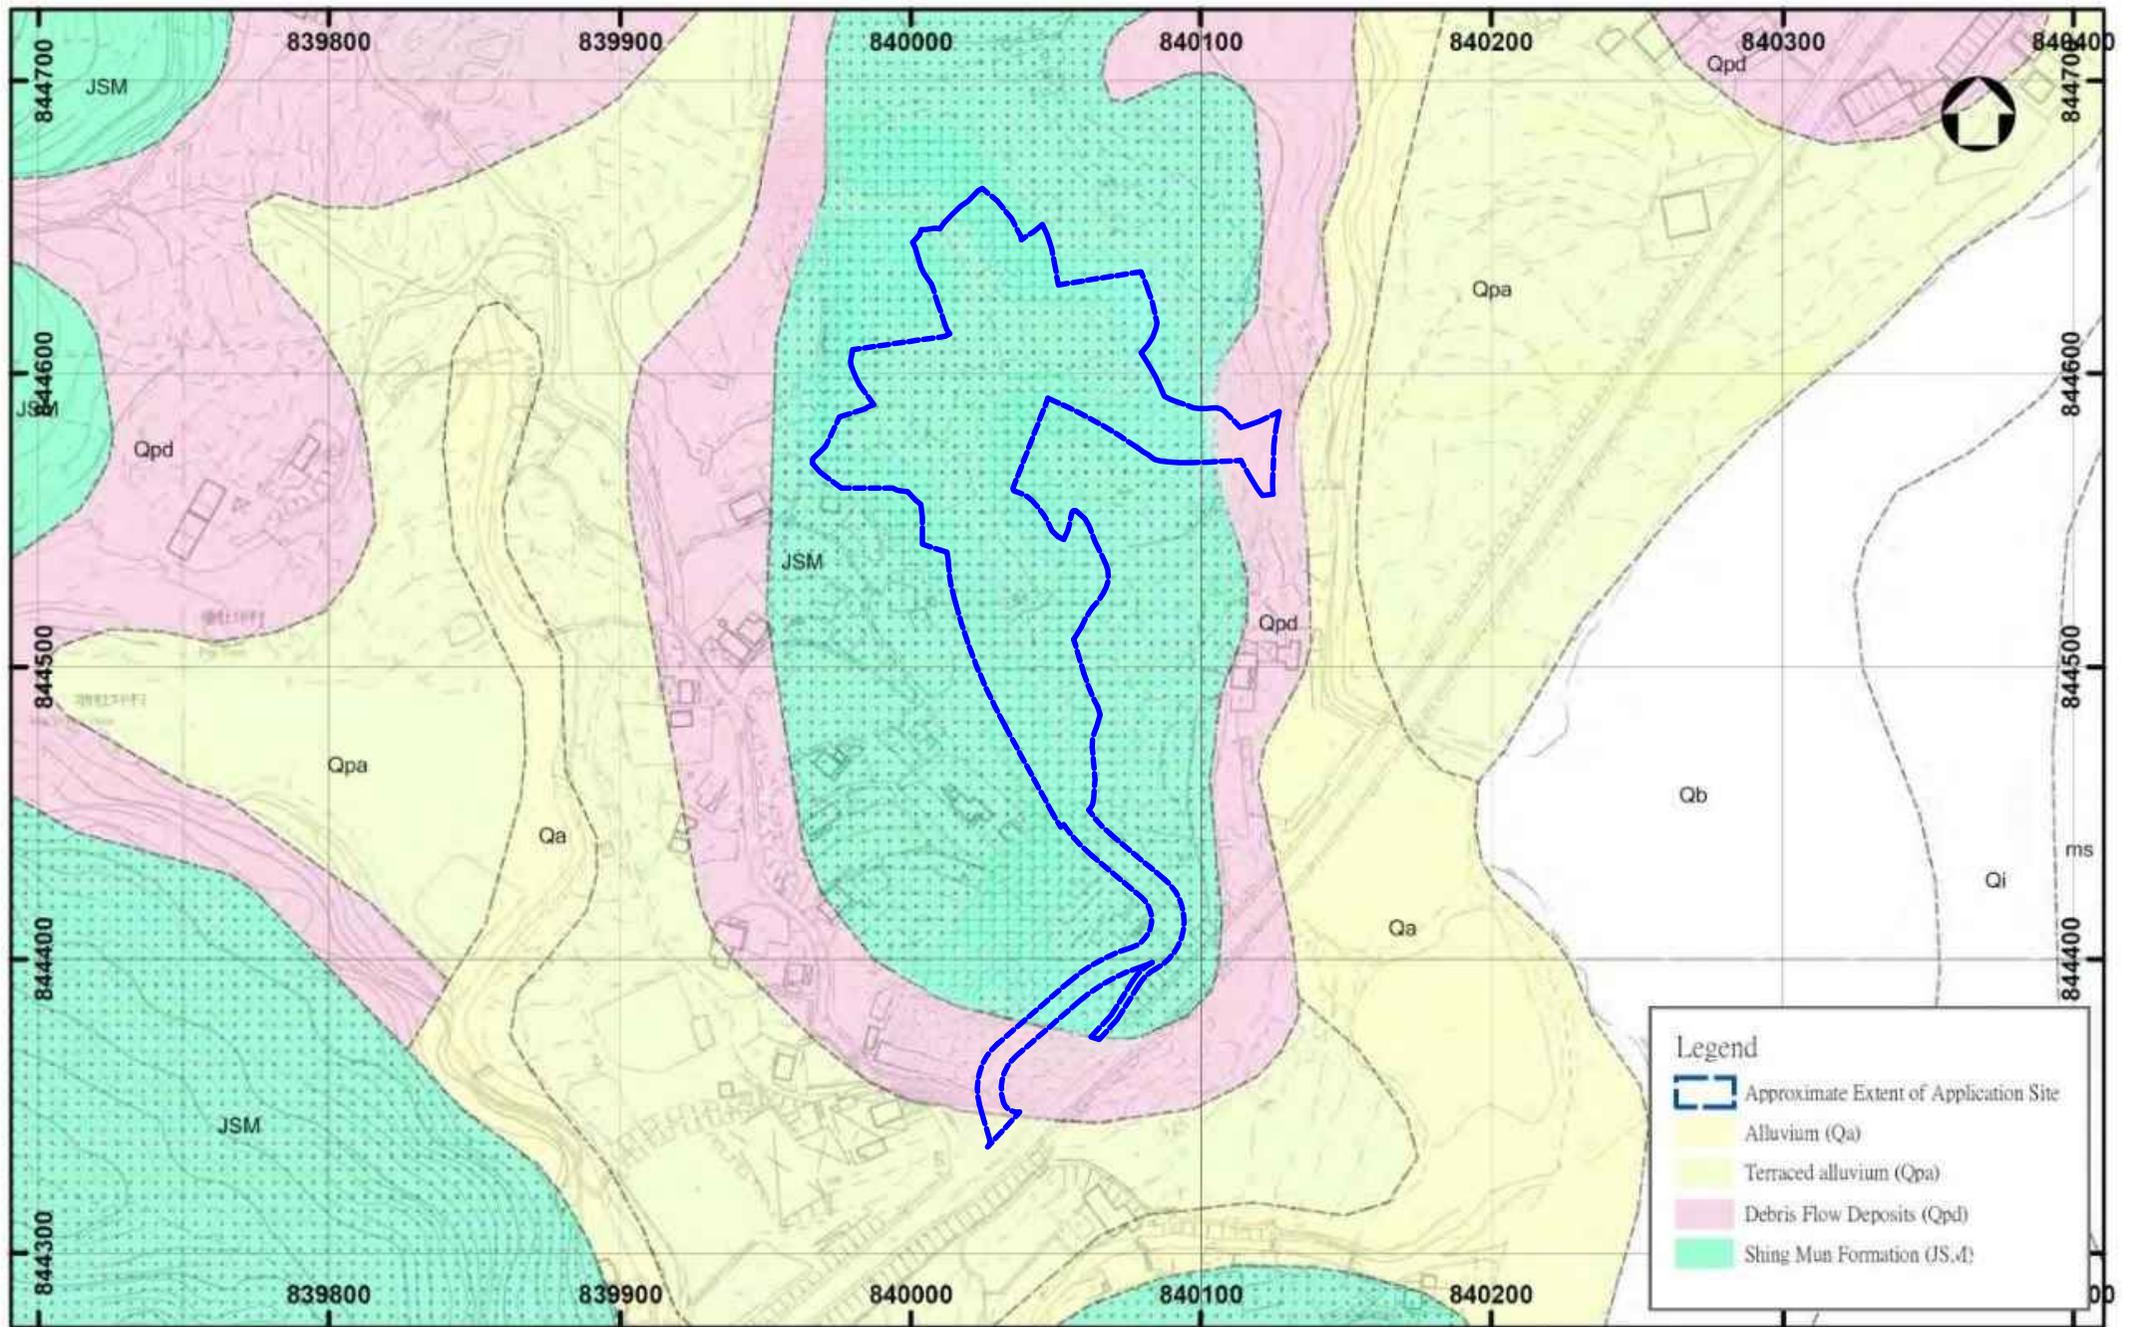
**Figure 3**  
Geological Map

The geology of the Study Area is shown on the Hong Kong Geological Survey (HKGS) Map Sheet 3 (Sheung Shui), 1:20,000-scale HGM20 series. The local geology of the Study Area is presented in Figure 3 and described below.

The 1:20,000 scale geological maps indicated that regional area around the Site is underlain by undivided fine ash to coarse ash tuffs, tuff-breccia and tuffite (JSM) of the Shing Mun Formation.

Entire Site are surrounded by Quaternary debris flow deposits/colluvium (Qpd).

No fault or photolineament has been recorded within or in the vicinity of the Site.

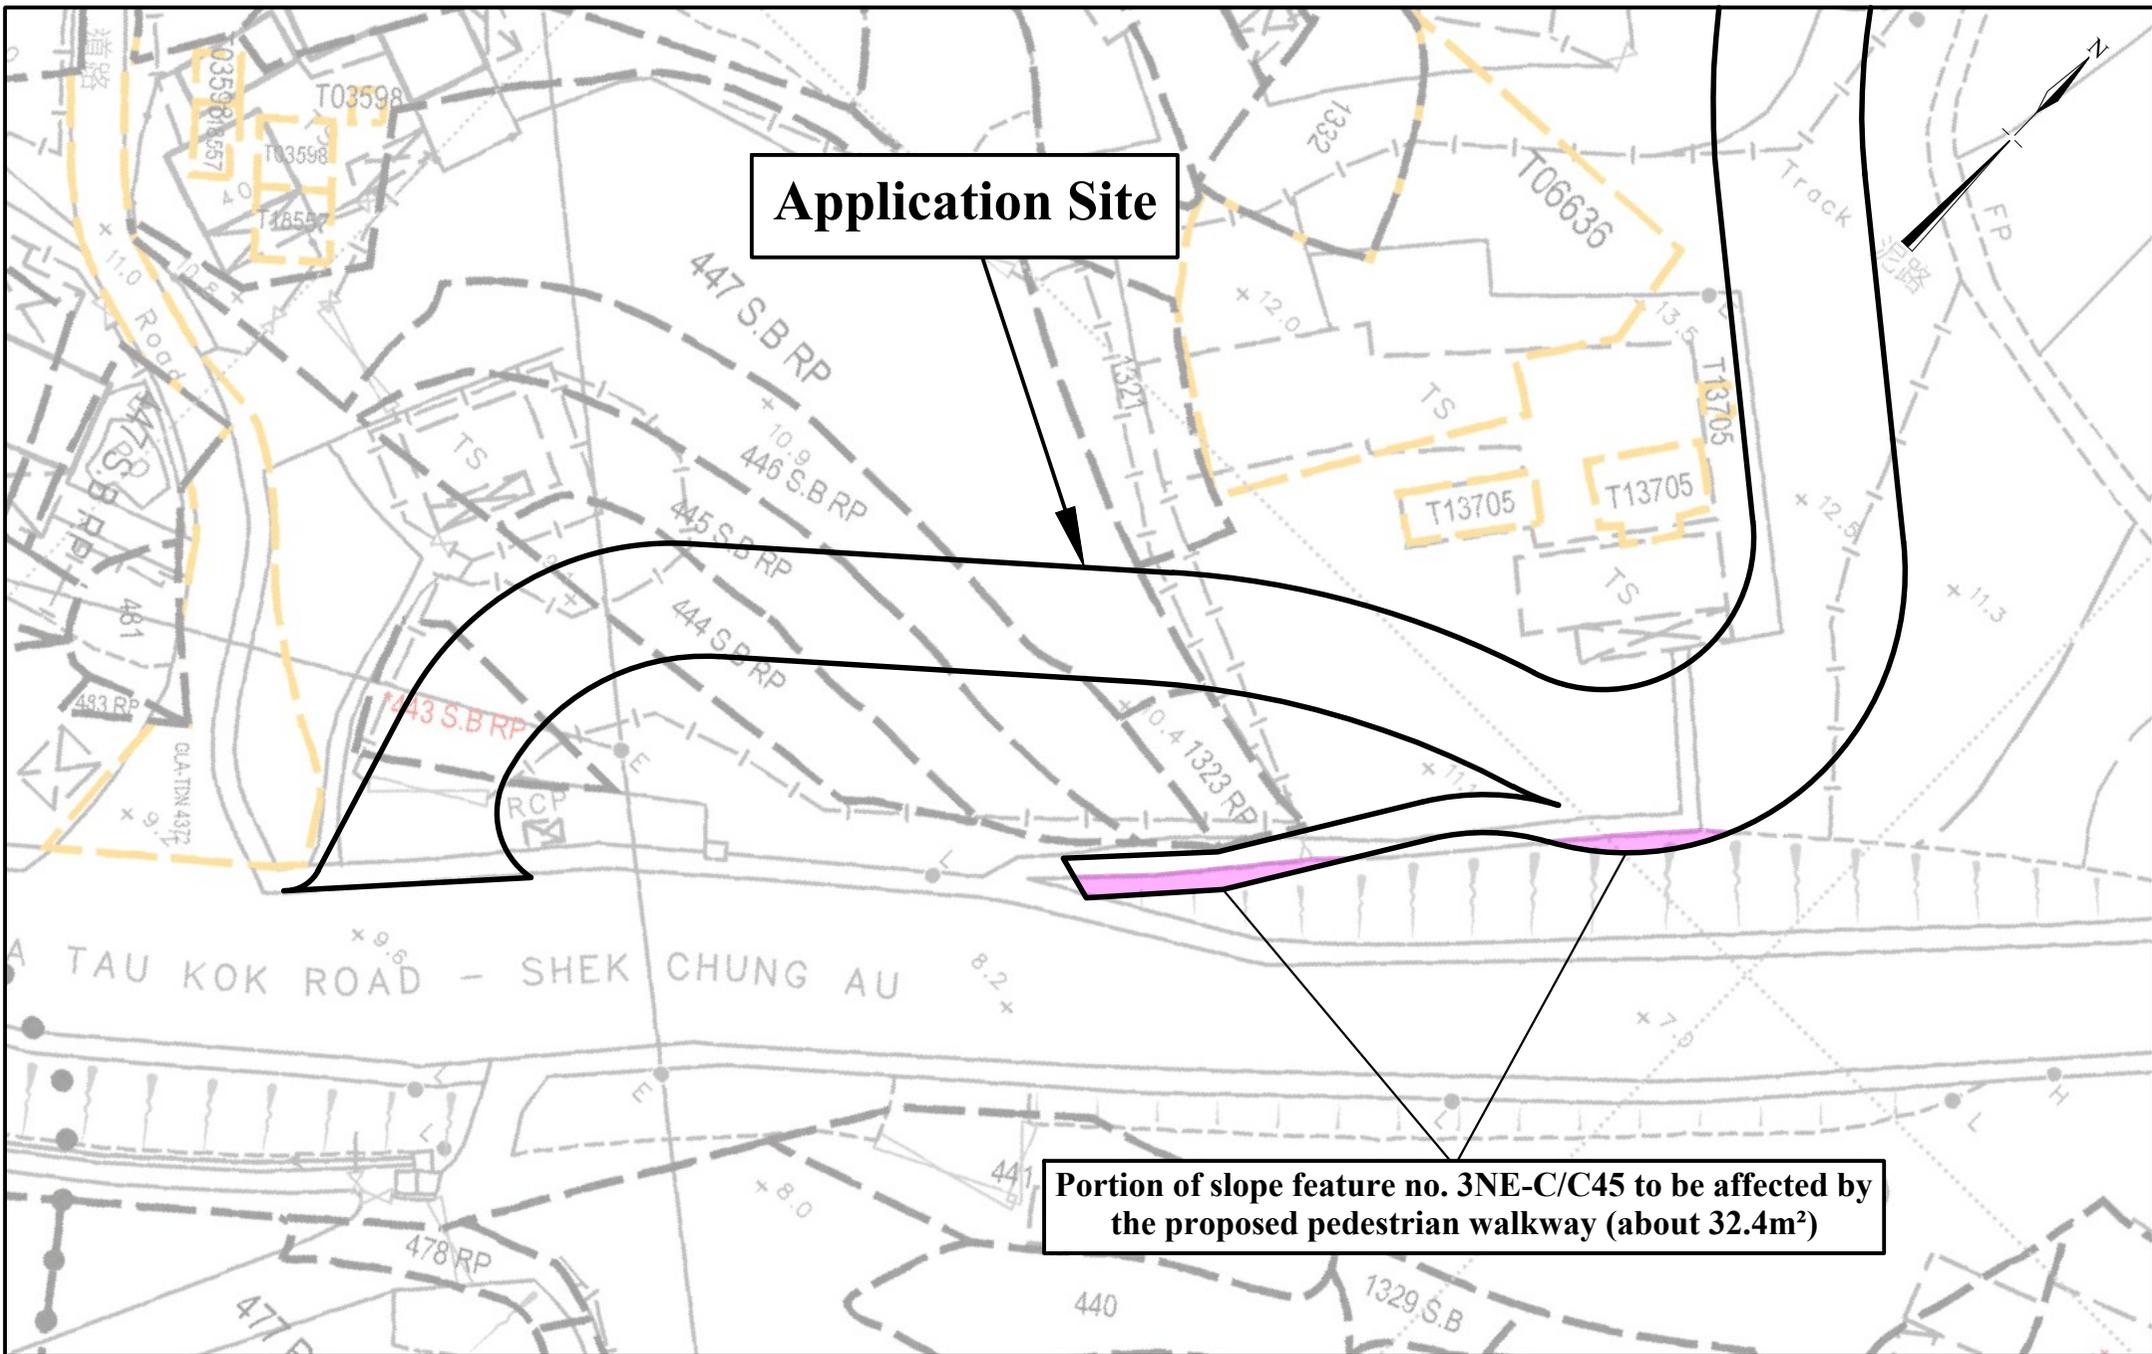
## **Figure 4**

Portion of Slope Feature No. 3NE-C/C45 affected by the Proposed Pedestrian Walkway

**Portion of slope feature no. 3NE-C/C45 to be affected by the proposed pedestrian walkway (about 32.4m²)**

According to the details of proposed pedestrian walkway (see Figure 4), portion of the slopes shall be cut for the construction of the proposed pedestrian walkway. Overall stability assessment for the Feature shall be checked to ensure the Feature will not affect the proposed works, or vice versa. Adequate upgrading measures (e.g. installation of soil nails or replacement of existing soil with cement soil / no-fines concrete and / or mass concrete) shall be provided if the feature cannot fulfill the current engineering standard.

Portion of the slope Feature 3NE-C/C45 to be affected by the proposed pedestrian walkway is presented in Figure 4.

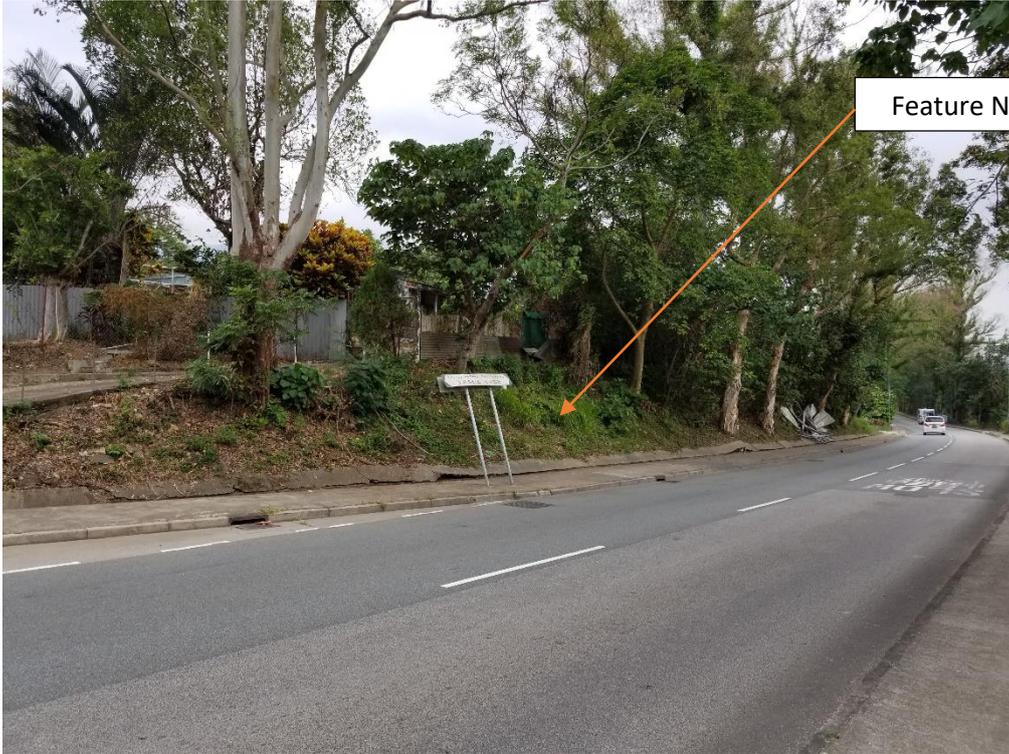
**Photo E**

General View of the Southern Portion of Feature No. 3NE-C/C45, Looking North

The Feature is a cut slope situated due south east of the site. The full slope is about 80m long. The maximum height of the slope is 3m with an average slope angle of 30°. An existing road with moderate traffic density is situated in the slope toe. An existing footpath with low traffic density is situated on slope crest with reference to the SMRIS as retrieved from Lands Department (see Appendix B), the lot owners or parties listed below are responsible for maintenance for this Feature:

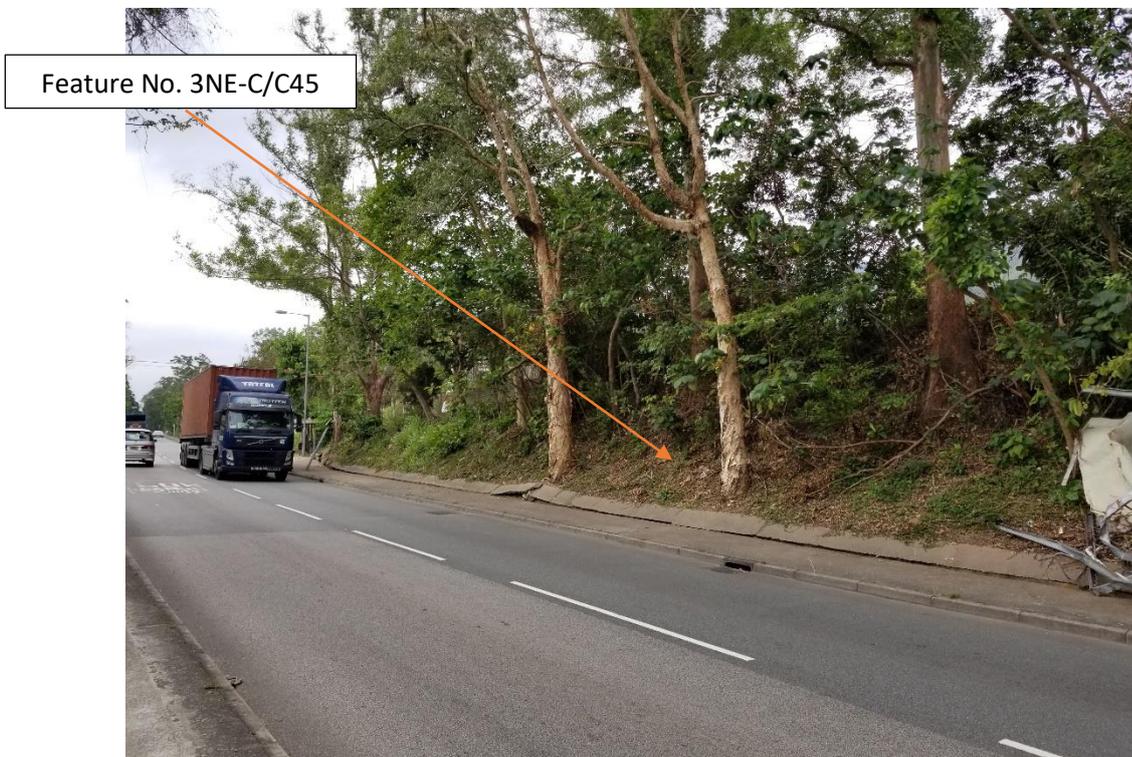
**Photo F**

General View of the Northern Portion of Feature No. 3NE-C/C45, Looking West

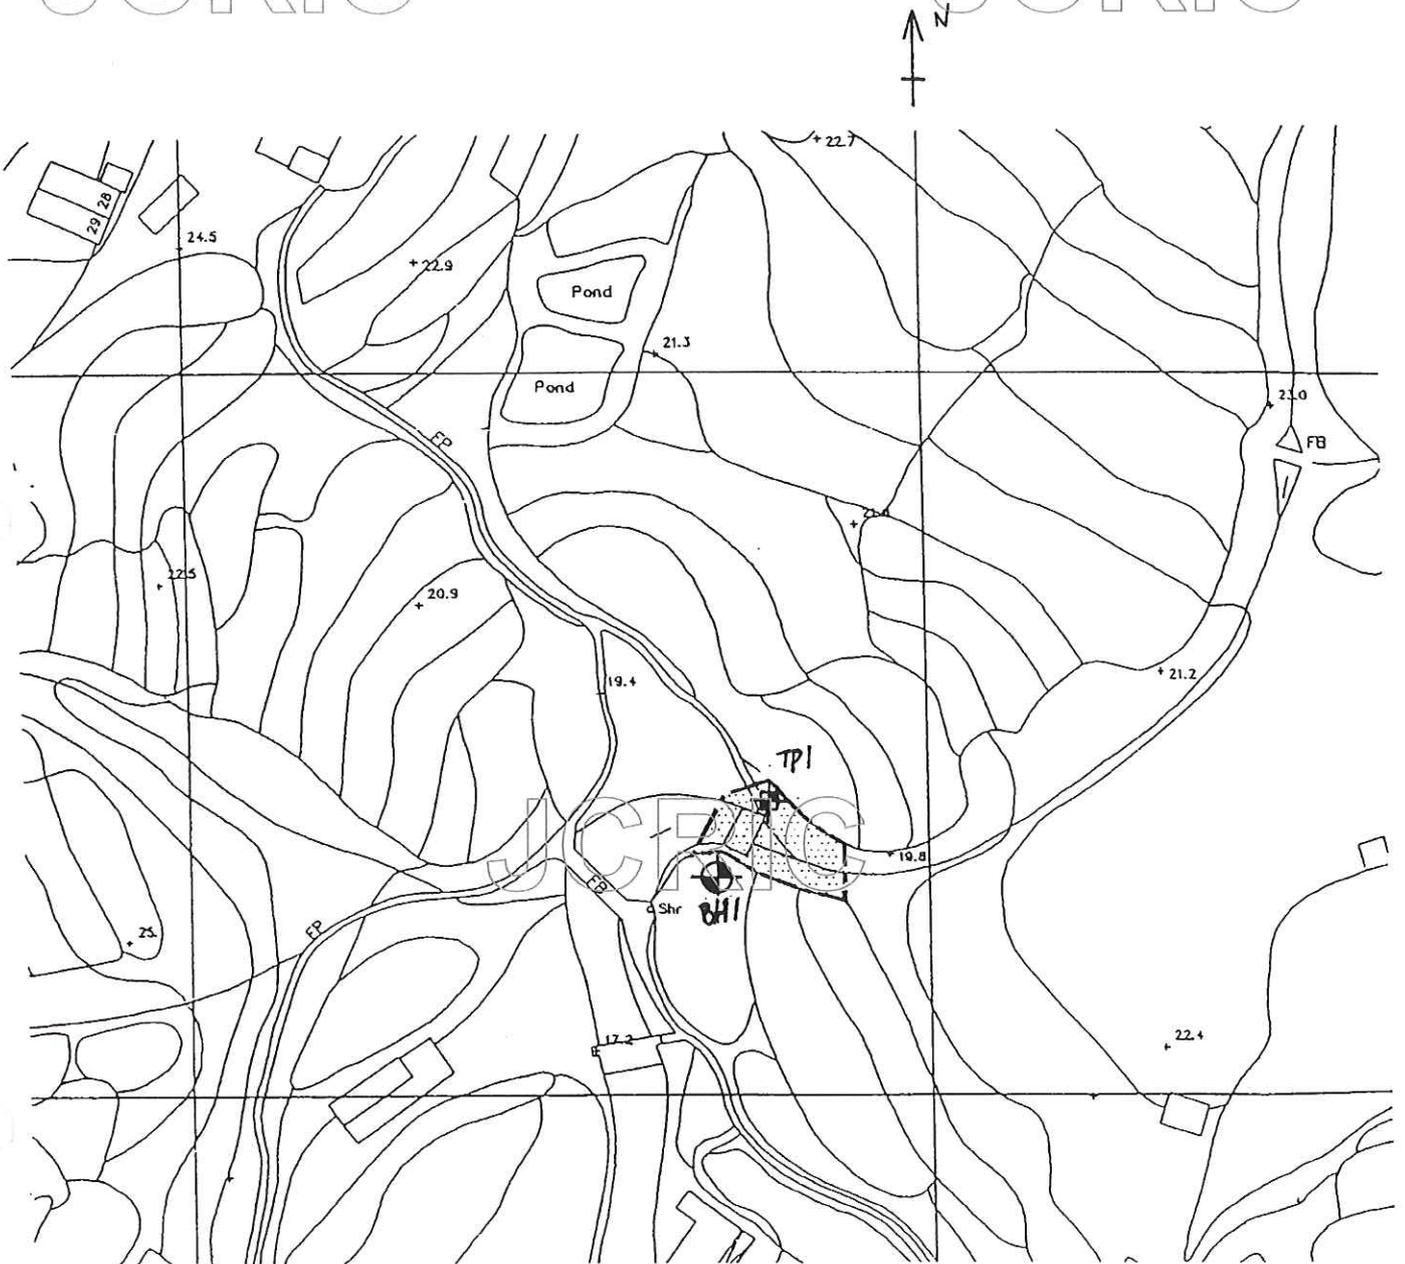
Figure 2

DRILLHOLE & TRIAL PIT LOCATIONS

Ground investigation was carried out at distance about 45m at the northwestern end of the site under the project, namely "RPIS Minor Rural Improvement", prepared by Enpack (Hong Kong) Limited in August 1996. The borehole and trial pit records indicated that the site comprises alluvium overlying completely decomposed tuff (COT) (see Appendix D).
