**APPLICATION FOR PERMISSION
UNDER SECTION 16 OF
THE TOWN PLANNING ORDINANCE
(CAP. 131)**

For Official Use Only 請勿填寫此欄	Application No. 申請編號	A/NE-KLH/663
	Date Received 收到日期	11 FEB 2026

PROJECT :
 PROPOSED TEMPORARY PLACE OF RECREATION, SPORTS OR CULTURE (HBBY FARM) WITH AUXILIARY FACILITIES AND ASSOCIATED TENURE OF LAND FOR A PERIOD OF 5 YEARS AT LOT NOS. 86, 90, 91(PART), 92(PART), 103(PART), 147(PART), 148 SA(PART), 148 SB(PART), 149(PART), 150 SA, 151 SA(PART), 153(PART), 572 SA(PART), 572 SB(PART), 572 BB(PART) AND 576(PART) IN D.D. 16, T.M. 90, NEW TERRORIES.

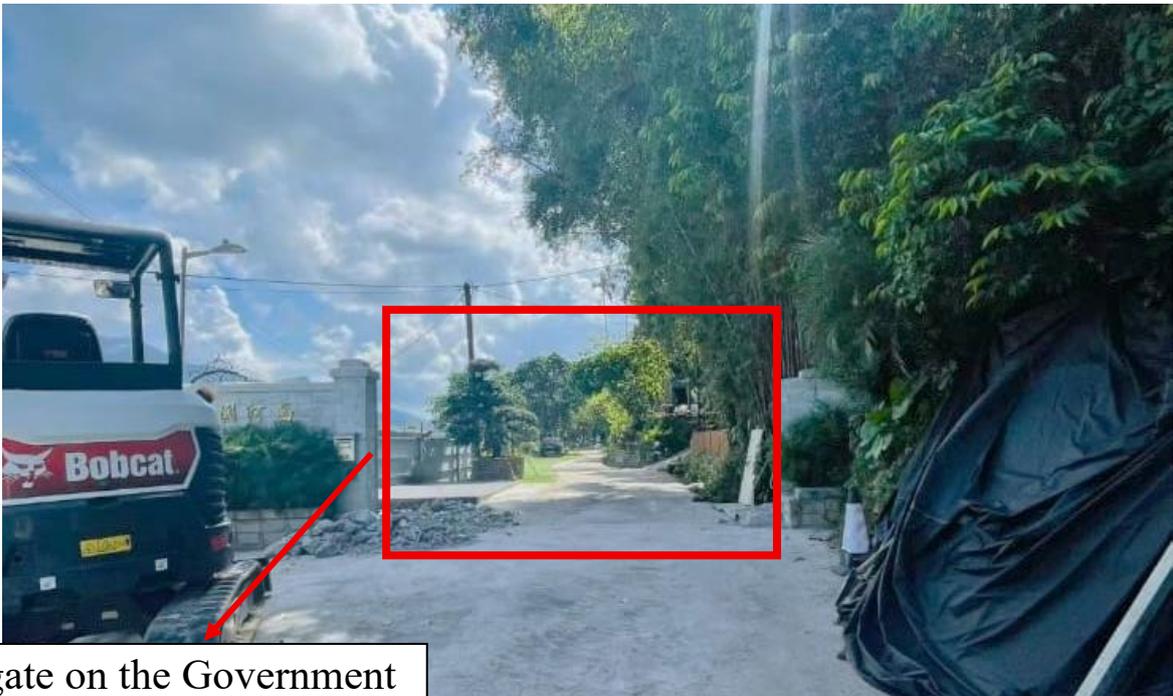
Site photo after the gate is removed

The gate on the Government land has been removed.

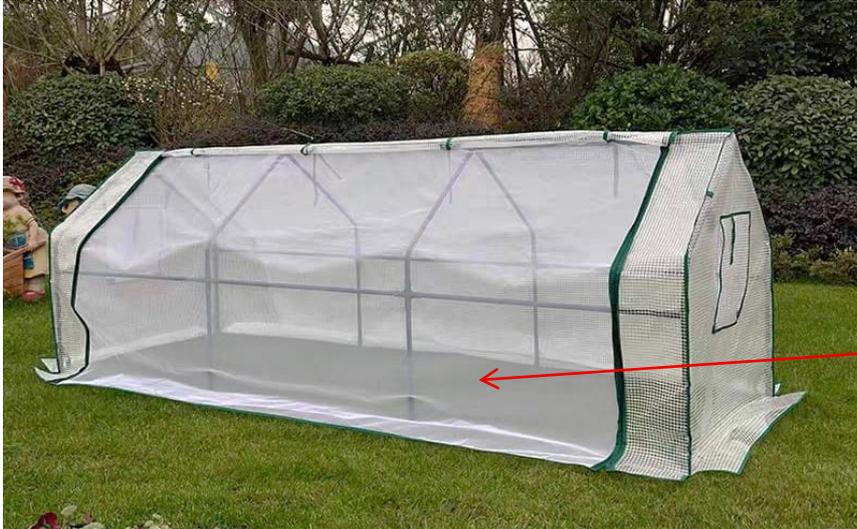
Raised beds will be placed inside the waterproof cover.

- Regular monitoring will ensure soil remains compacted, preventing loose soil from being washed away.
- On rainy days, the raised beds will be covered with waterproof covers to prevent water and soil leakage from the raised beds (see pictures below). As such, no pollution or contamination of the WGG is expected.

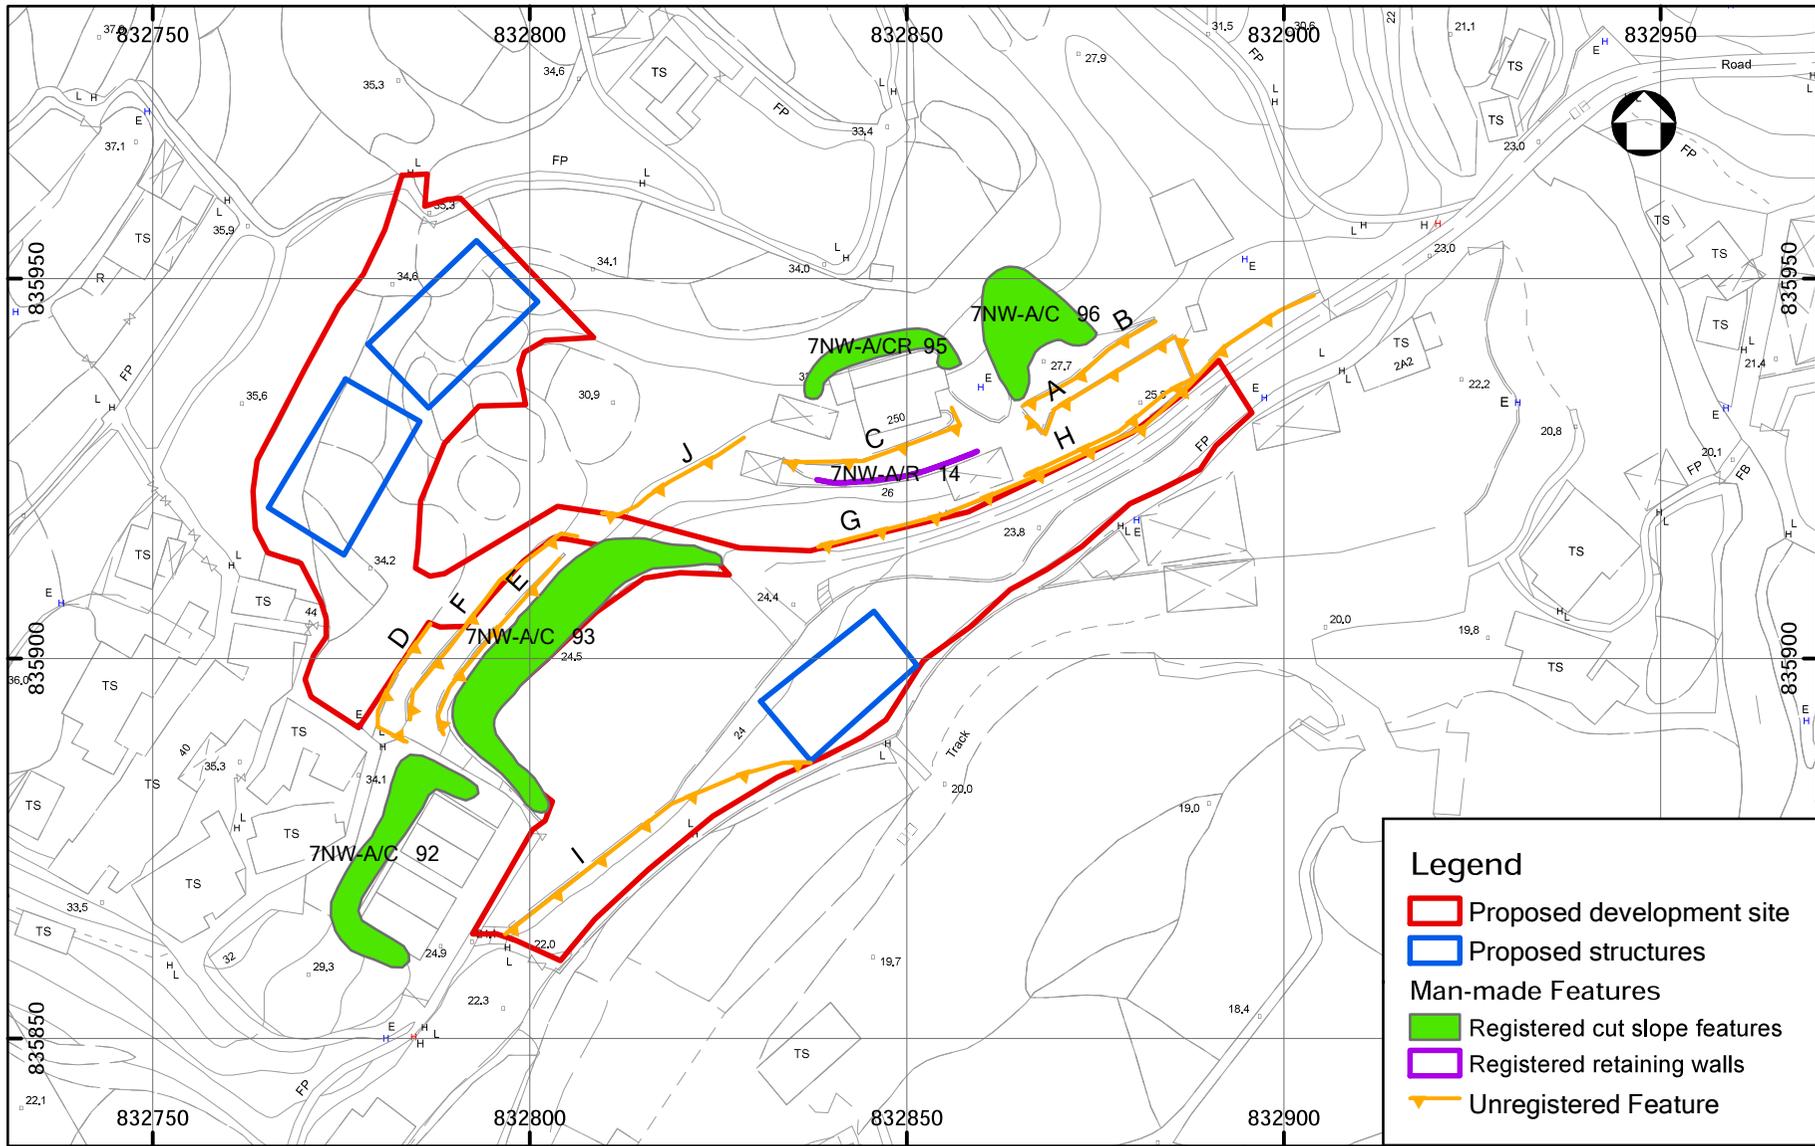
FIGURE NO :
FIGURE 3

- Proposed development site
- Proposed structures
- Man-made Features**
- Registered cut slope features
- Registered retaining walls
- Unregistered Feature

B (Photo L)	Rubble wall	21	0.65	90	Cracks and losing mortar
C (Photo M)	Rubble wall	26	1.10	90	No sign of distress
D (Photo N)	Soil cut slope	20	2.80	75	Bared surface
E (Photo O)	Rubble wall	29	2.10	80	Minor collapse of rubble wall
F (Photo P)	Masonry wall	35	2.20	85	No sign of distress
G (Photo Q)	Rubble and masonry wall	76	1.15	90	No sign of distress
H (Photo R)	Rubble wall	31	1.40	85	No sign of distress
I (Photo S)	Masonry wall	47	2.20	80	No sign of distress
J (Photo T)	Rubble wall	22	1.95	90	Cracks and losing mortar

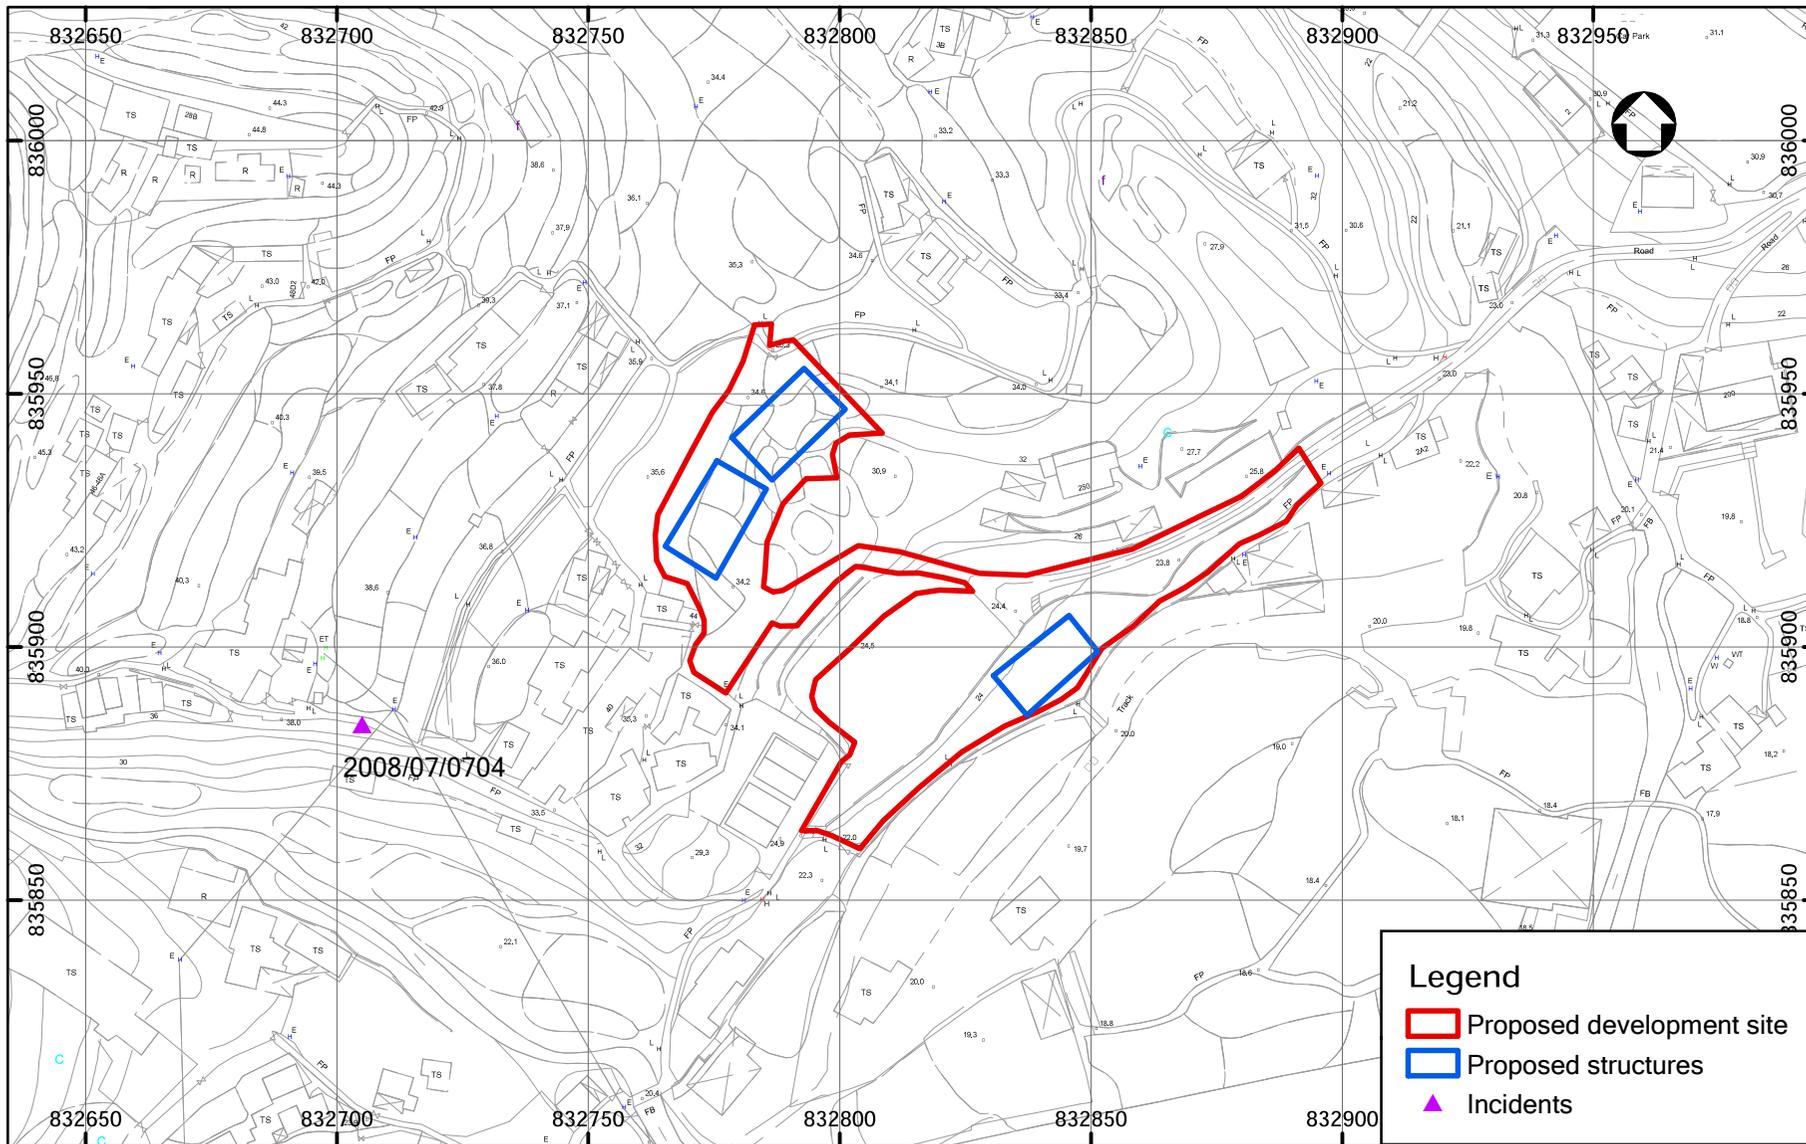
FIGURE NO :
FIGURE 5

- Proposed development site
- Proposed structures
- ▲ Incidents

GCO/GEO Incident No.	Report Date	Location of Failure	Approx. Failure Volume (m ³)	Possible Cause of Failure
2008/07/0704 (about 64m to the west of the Site)	2008/07/10	7NW-A/C97	3.0	Washout

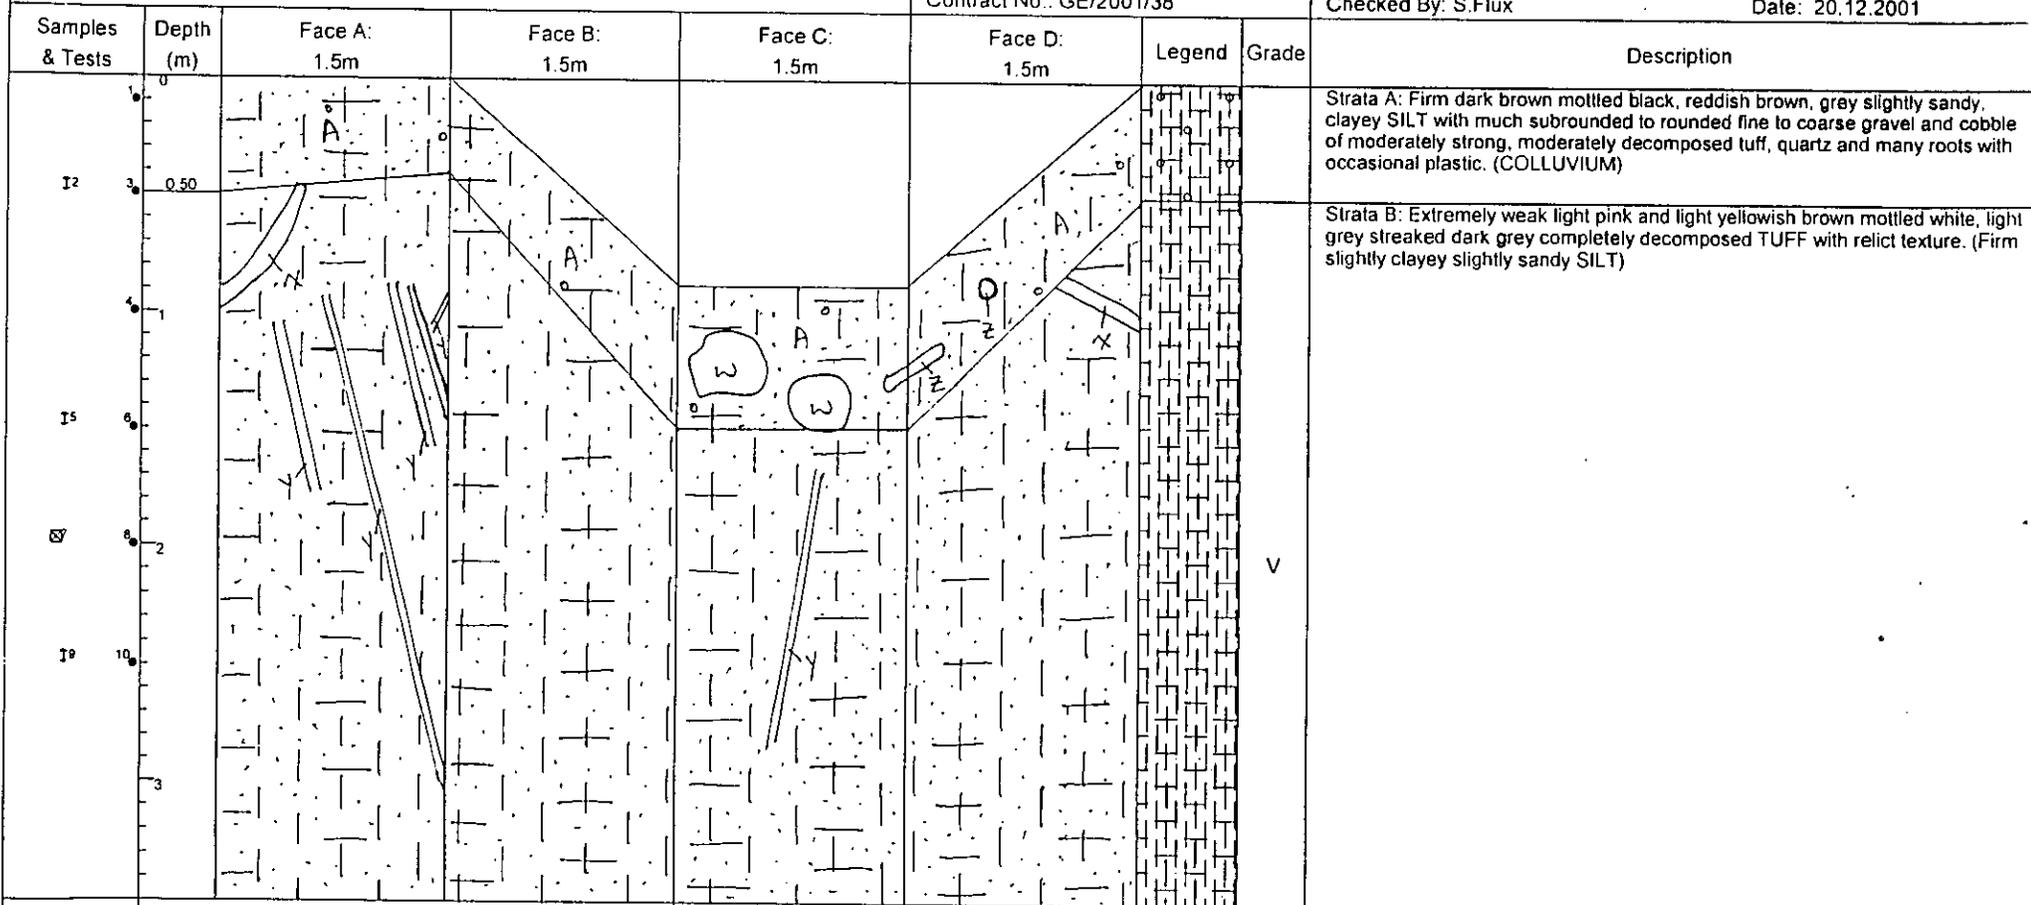
Symbol	Samples/Tests/Water	Plan (Not to Scale)	Remarks
•	Small Disturbed Sample		Trial pit terminated at 3.60m. Groundwater not encountered. Sides stable, shoring installed. 2 No. GCO probe tests were carried out prior to excavation. *Indicates qualitative assessment only. Depth of samples and termination refers to mid point of face B.
I	Bulk Disturbed Sample		
■	Undisturbed Horizontal Sample(U100/U76)		
▬	Undisturbed Vertical Sample(U100/U76)		
⊠	Block Sample		
v	In-situ Density Test		
▲	Water Sample		
↕	Seepage

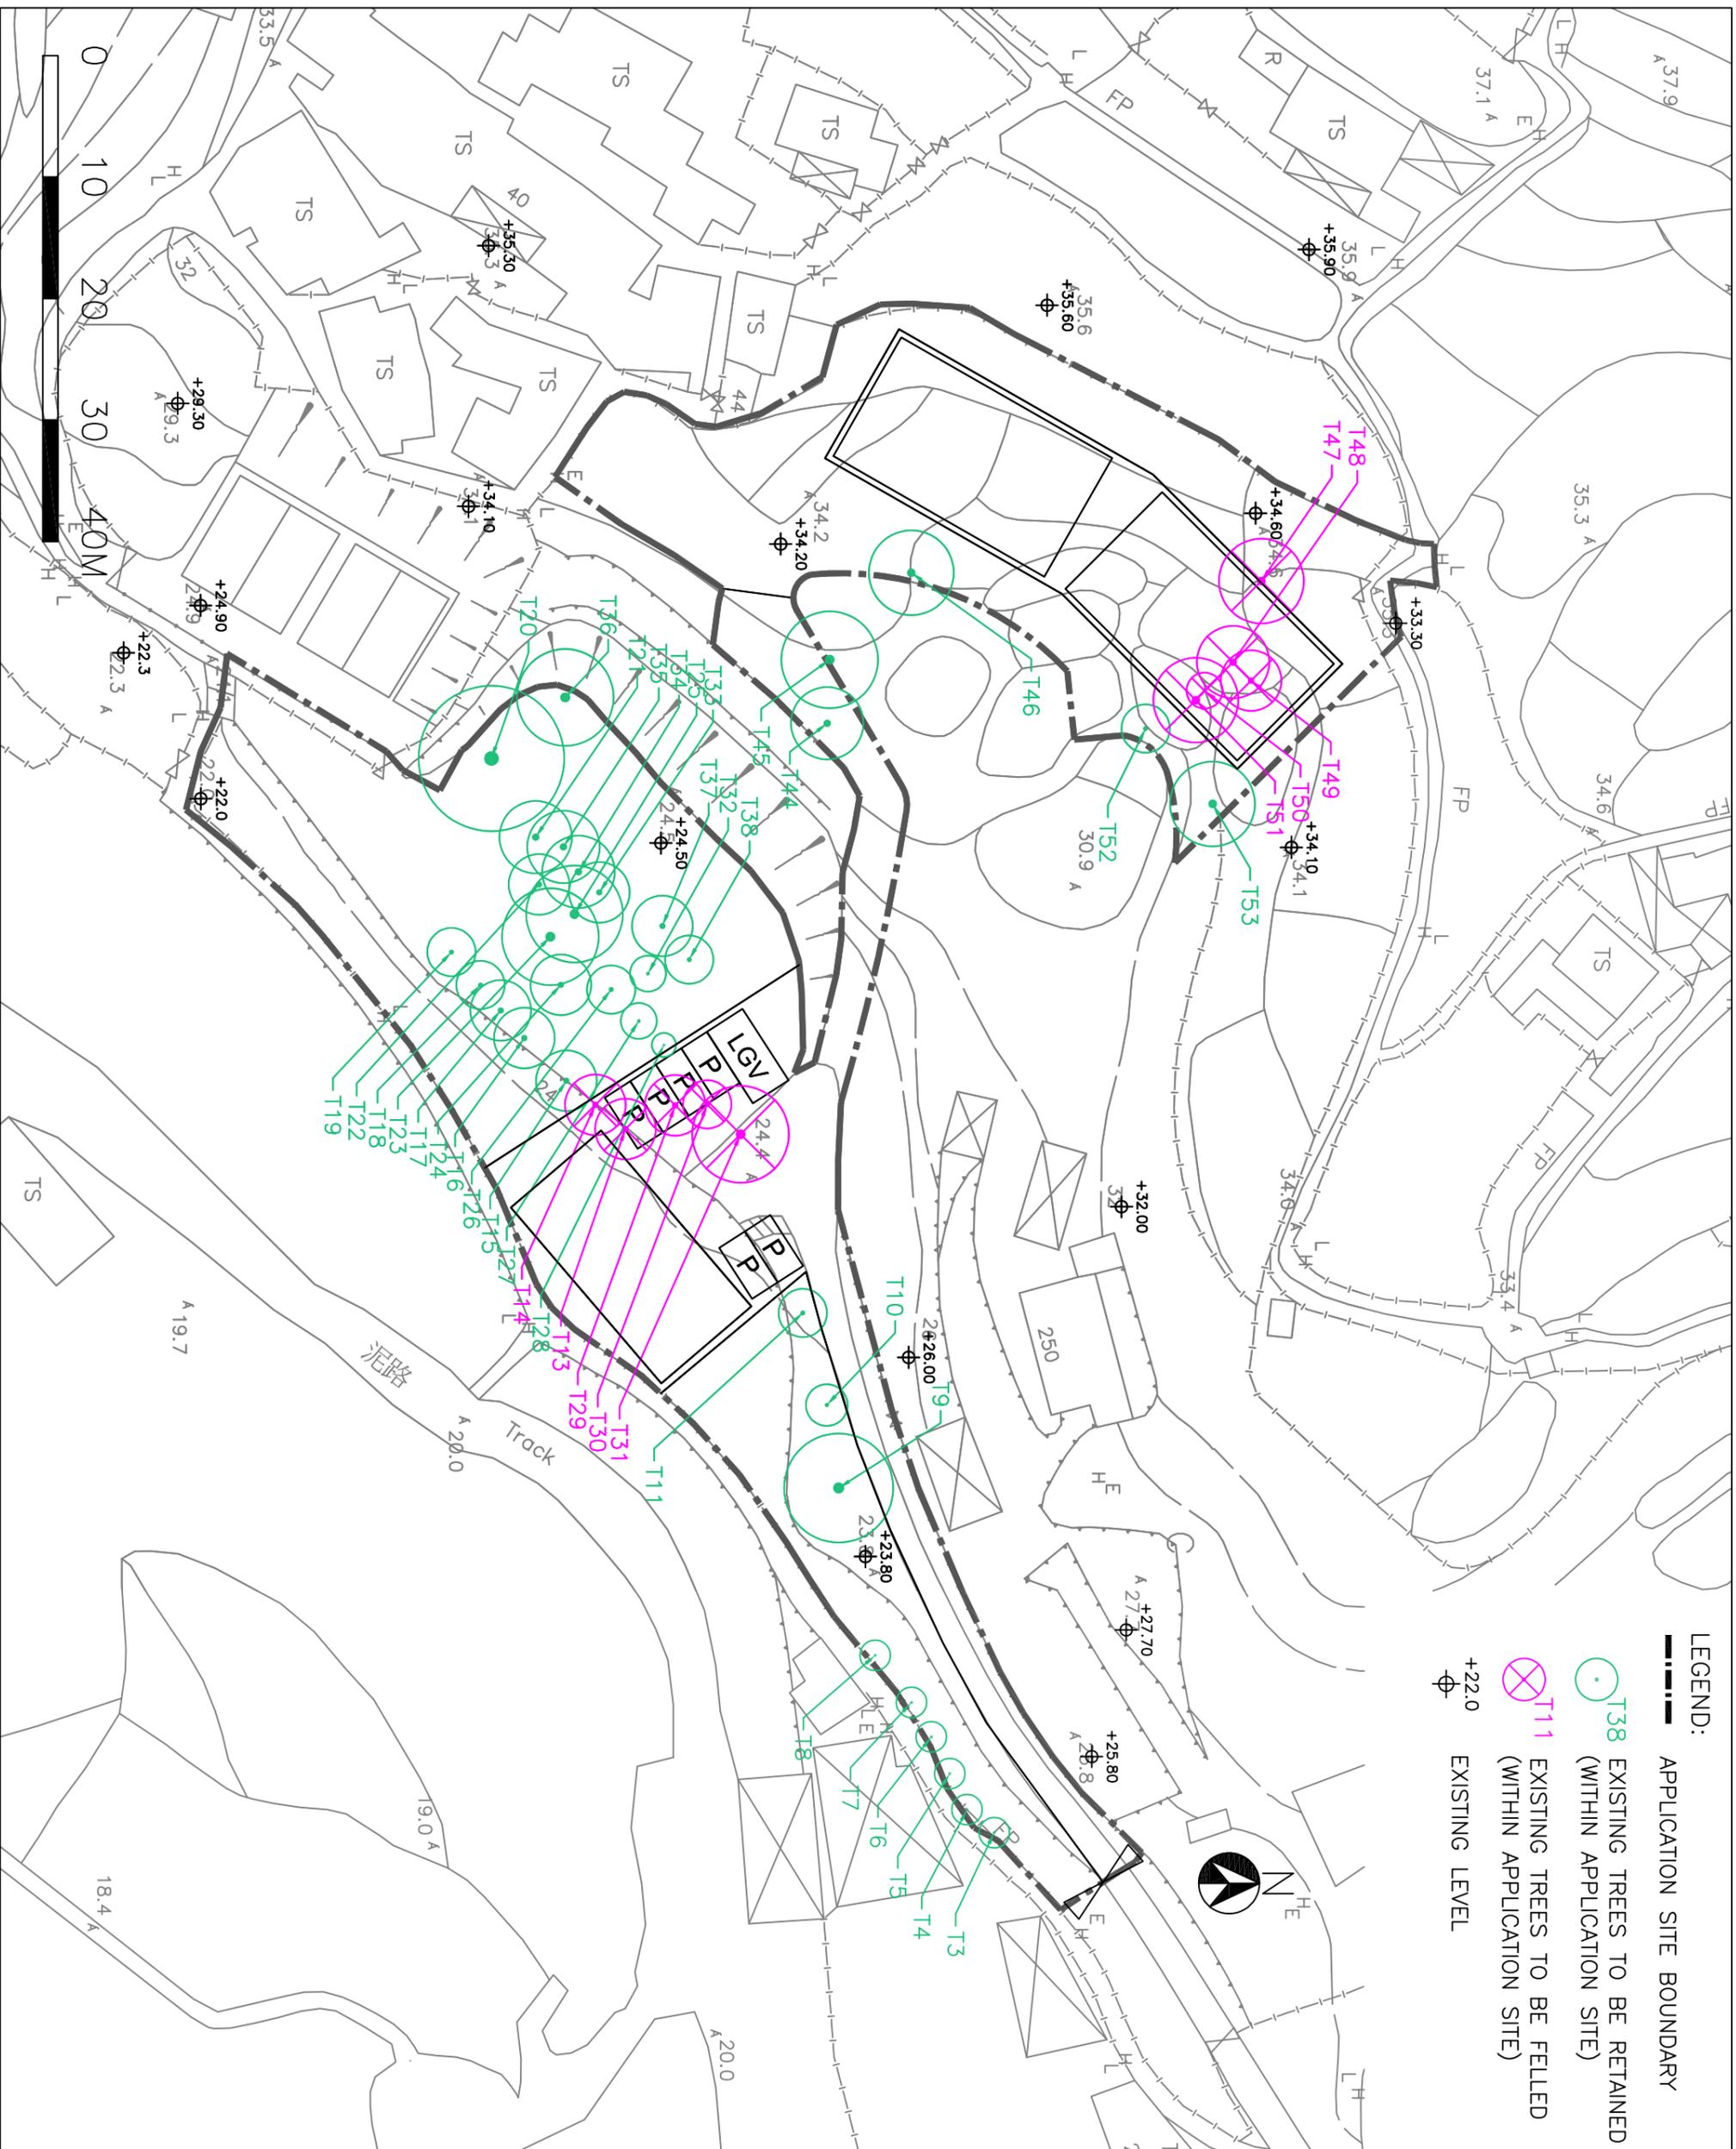
Tree Survey Plan

- LEGEND:**
- APPLICATION SITE BOUNDARY
 - T38 EXISTING TREES TO BE RETAINED (WITHIN APPLICATION SITE)
 - ⊗ T11 EXISTING TREES TO BE FELLED (WITHIN APPLICATION SITE)
 - ⊕ +22.0 EXISTING LEVEL

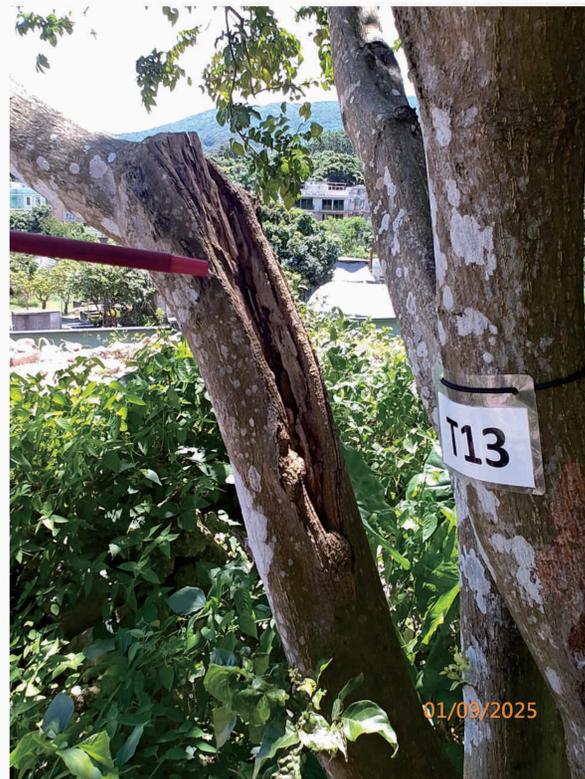
T13 - Decay in Trunk (F)

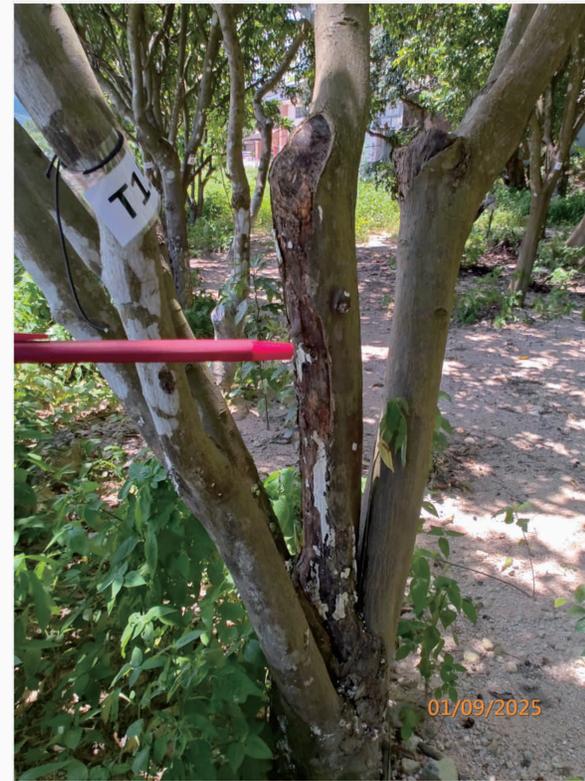
T15 - Decay in Trunk (R)

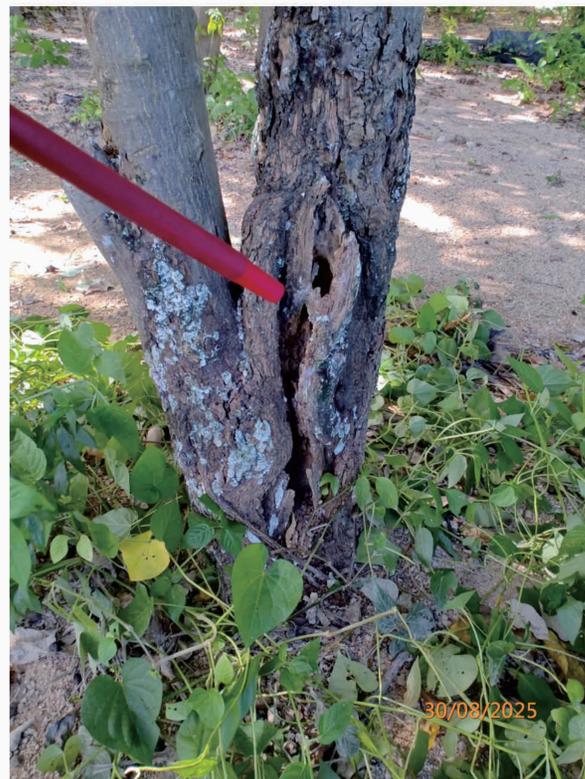
T16 - Decay in Trunk Base (R)

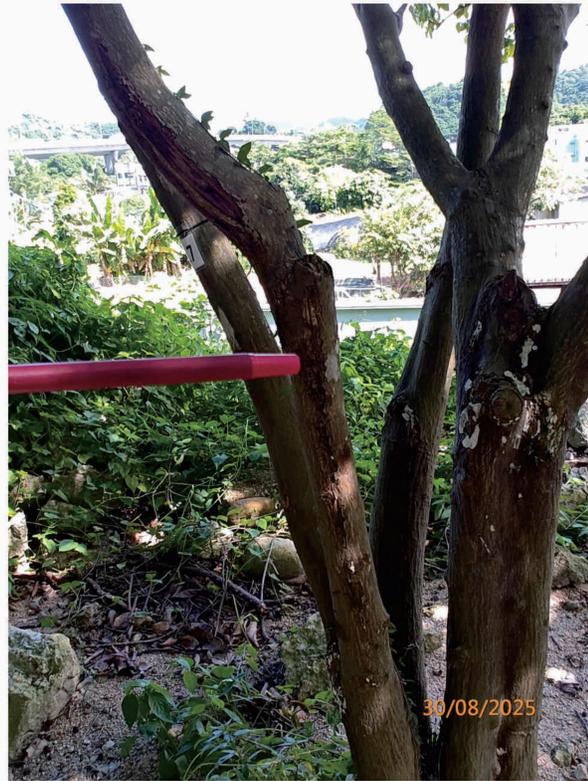
T17 - Decay in Trunk (R)

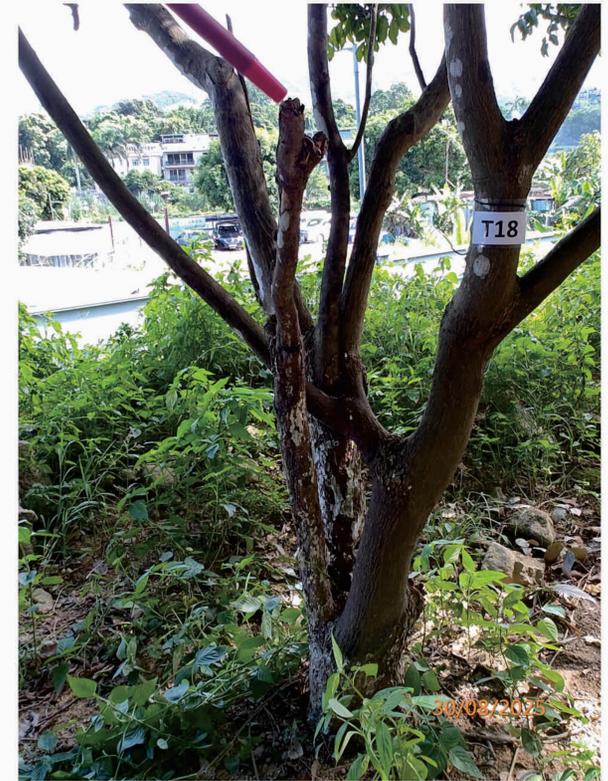
T18 - Decay Trunk (R)

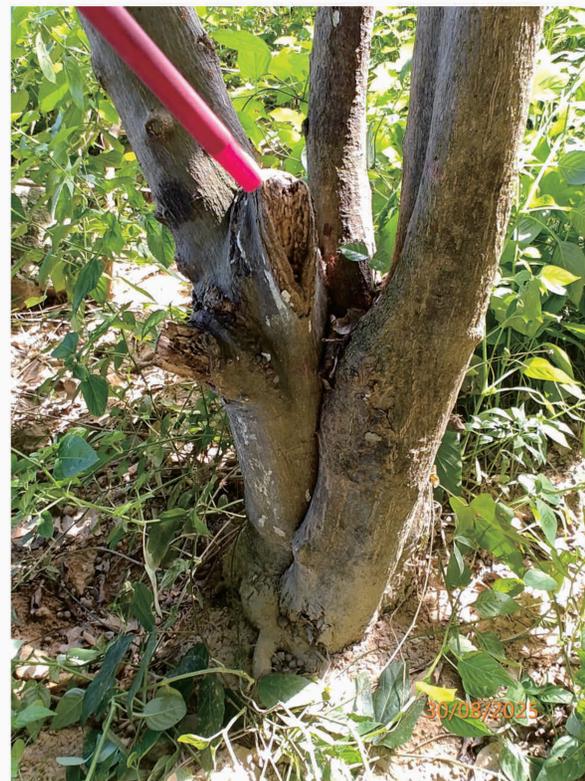
T19 - Decay in Trunk (R)

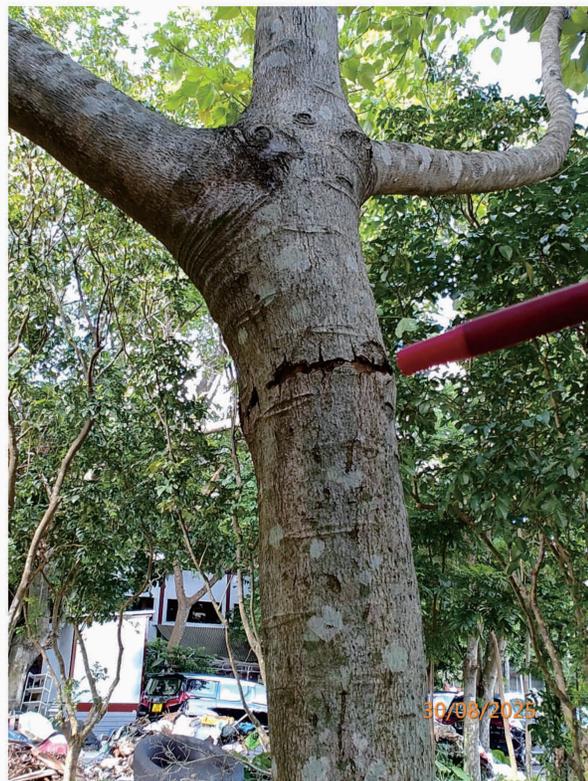
T25 - Abnormal Bark Crack on Trunk (R)

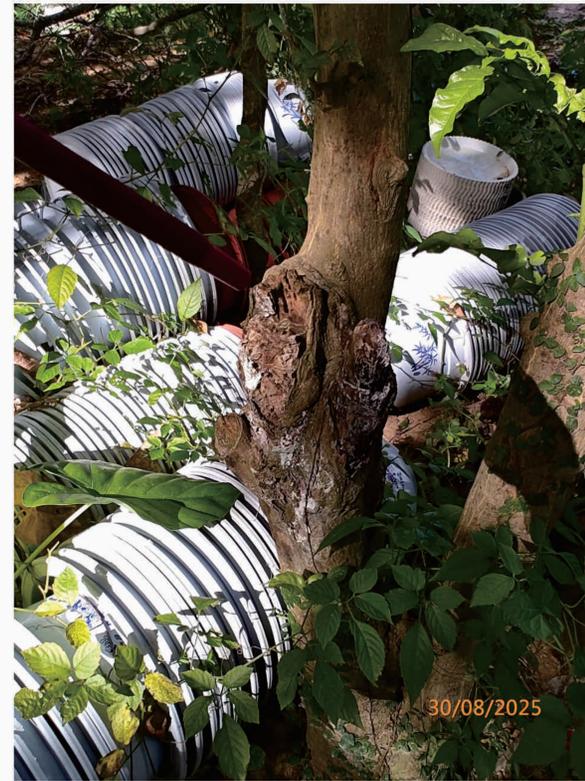
T27 - Decay in Trunk (R)

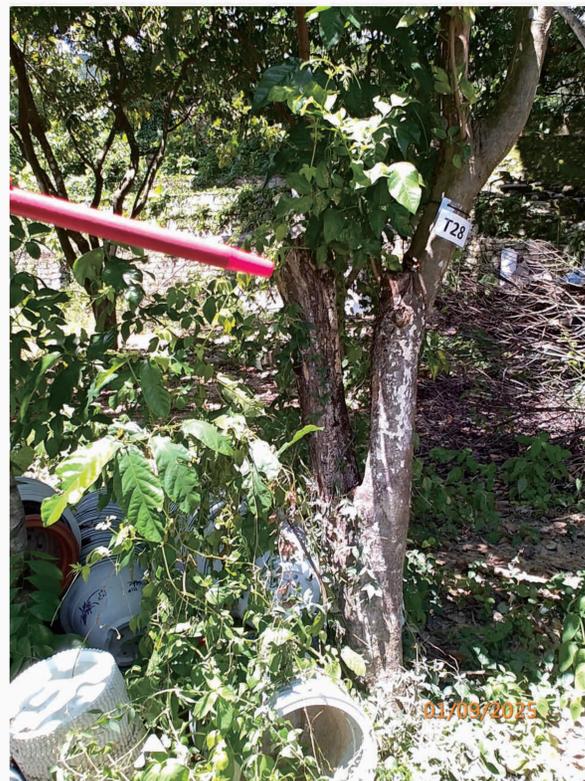
T28 - Decay Trunk (R)

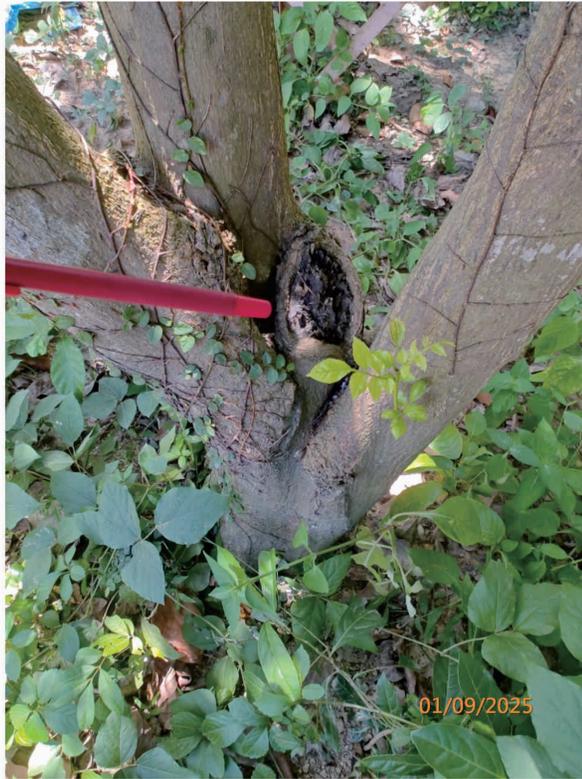
T29 - Decay in Trunk Base (F)

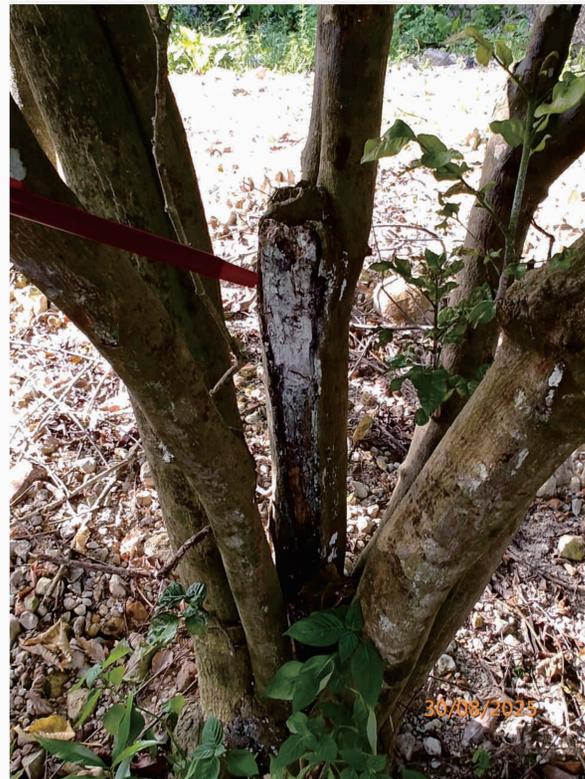
T34 - Decay in Trunk (R)

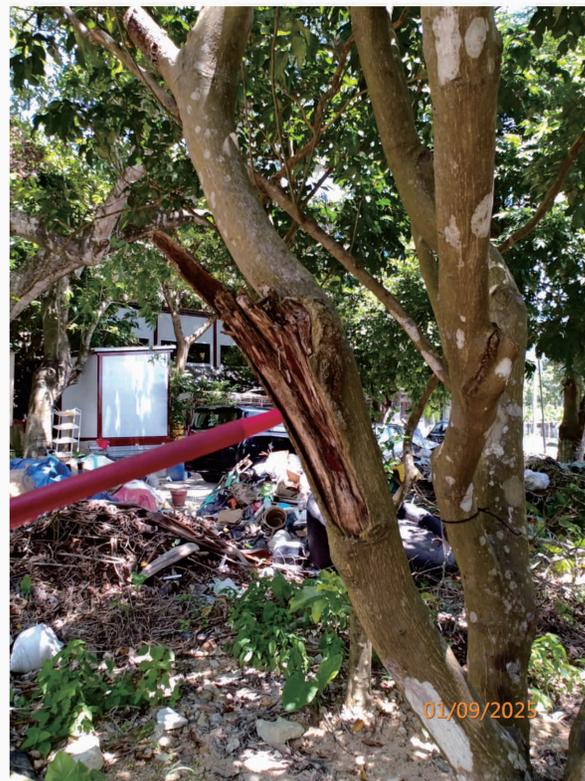
T37 - Heartwood Damaged at Branch (R)

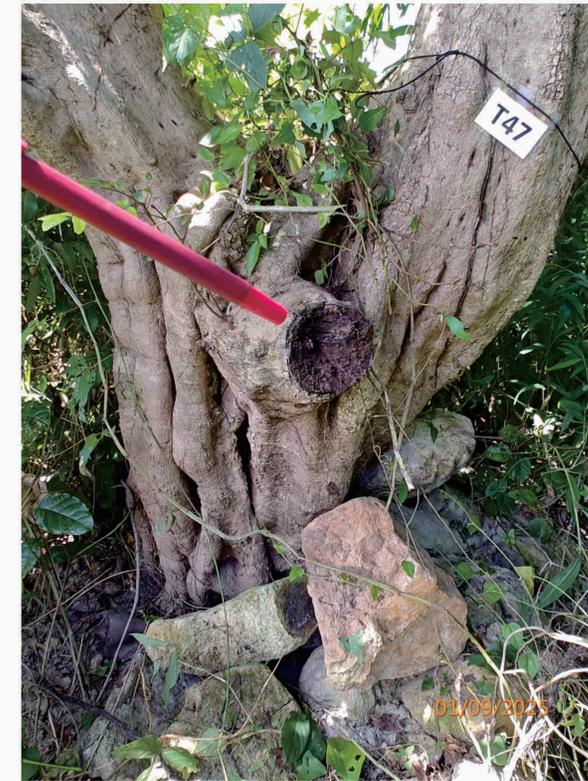
T47 - Decay in Trunk (F)

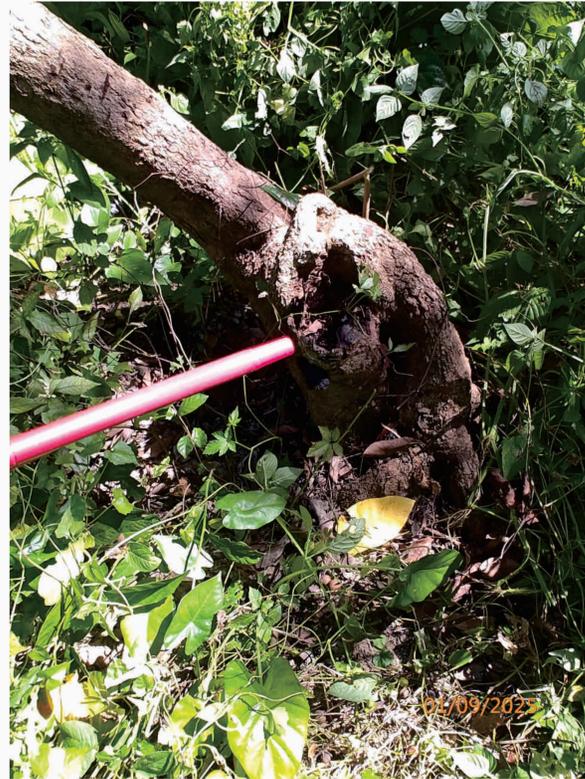
T52 - Decay in Trunk Base (R)
