**Re : Application for Permission Under Section 16 (application no. A\_YL-KTN\_1207)**  
**Proposed House in “Residential (Group D)” Zone at**  
**Lot 787 in D.D.110, Kam Tin Road, Shek Kong San Tsuen, Yuen Long.**

**PROPOSED HOUSE IN RESIDENTIAL (GROUP D) ZONE AT  
LOT. NO. 787 IN D.D. 110, KAM TIN ROAD, SHEK KONG SAN  
TSUEN, YUEN LONG**

**QUALITATIVE ENVIRONMENTAL ASSESSMENT**

Document No. **R10070\_V1.0**

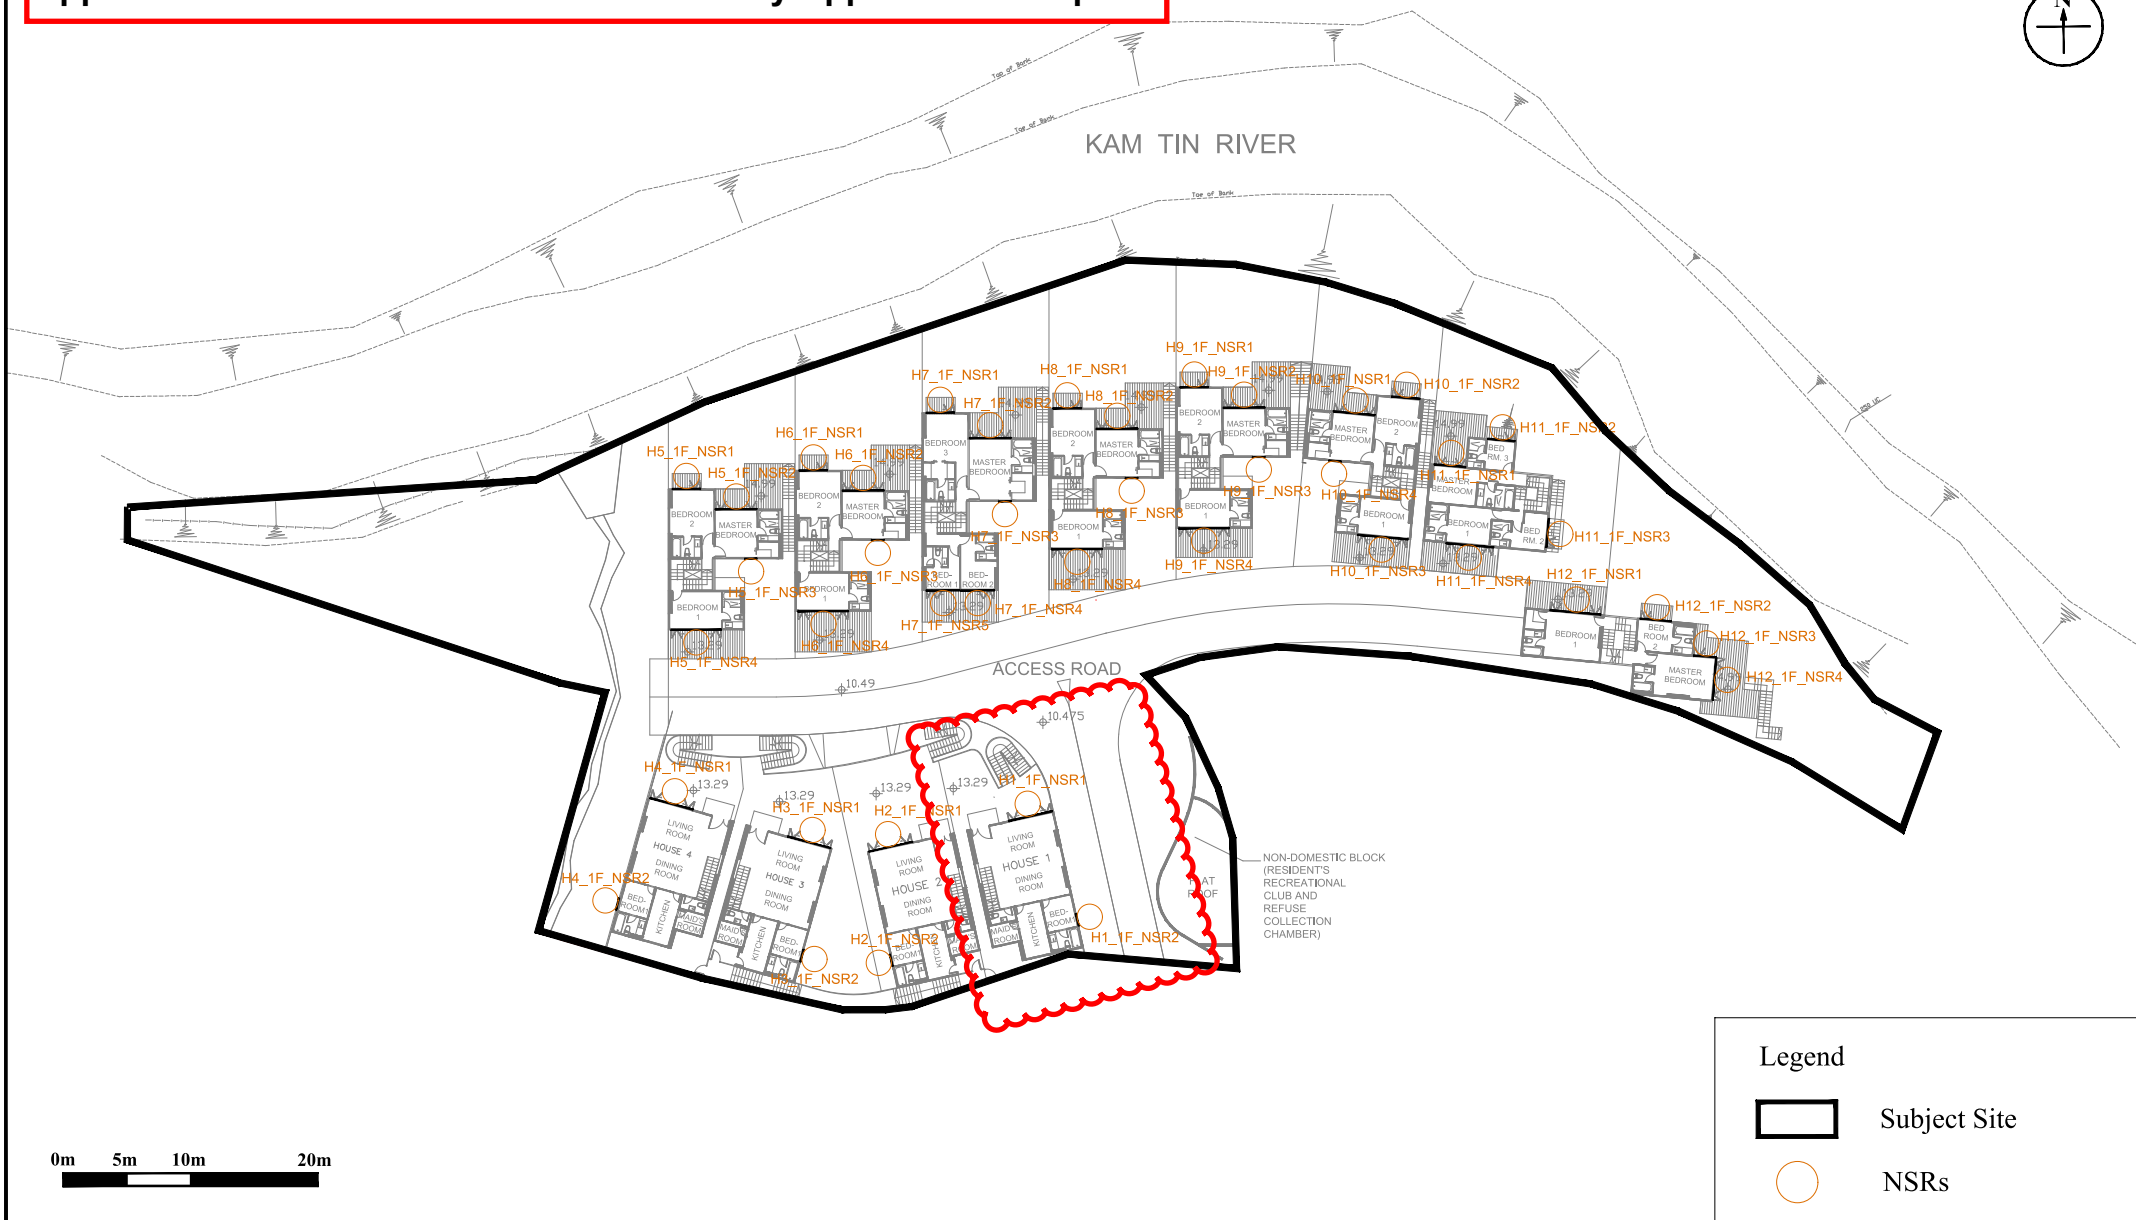
**Figure:** 5b

**Title:** Location of Selected Representative Noise Sensitive Receivers for Road Traffic Noise Impact Assessment 1/F)

- 2.1.2 The approved traffic noise assessment focuses on evaluating the impact of road traffic noise on Noise Sensitive Receivers (NSRs). The assessment used the U.K. Department of Transport's procedure "Calculation of Road Traffic Noise" (CRTN) to predict hourly L10(1-hour) noise levels at selected representative NSRs. The predicted noise levels were compared to the Hong Kong Planning Standards and Guidelines (HKPSG), which recommend a maximum noise level of 70 dB(A) for road traffic noise at typical facades of new dwellings.

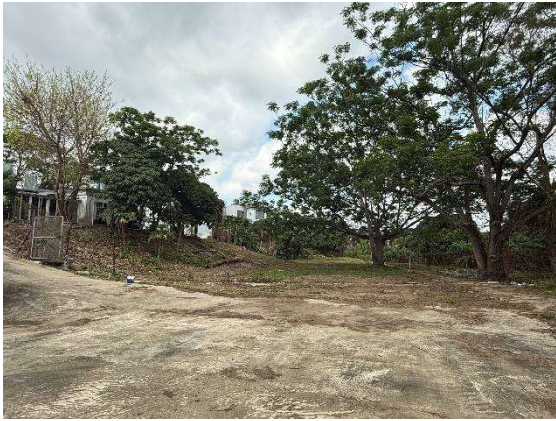
Photo 7:  
West: Vacant with natural vegetation

- 3.3.9 The western, northern and eastern portions of the Subject Site (with lower ground level) was mainly vacant, covered with natural vegetation and trees (Photos 7 to 9). One temporary structure for storage of construction materials / equipment / tool (e.g. empty cage, used timber, empty containers, tarpaulin sheets, tiles, etc.) was observed at the south-eastern portion of Subject Site (Photos 10 to 13). At the eastern side adjacent to the temporary structure, temporary storage of steel bars and tiles were observed (Photos 14 and 15). The areas at and adjacent to such temporary structure

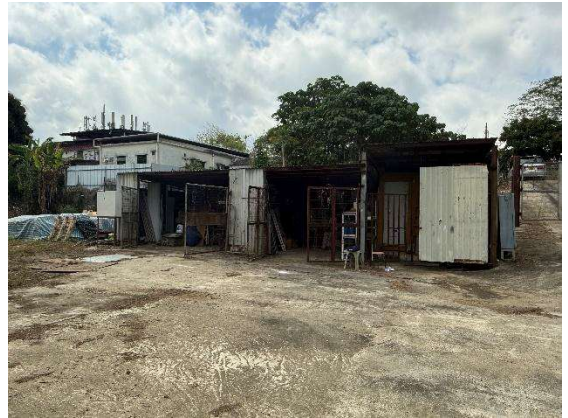
Photo 10:  
South East: Temporary structure for storage of construction  
equipment and material

are paved with concrete ground. The concrete ground was in good condition. Same as the information provided by the Project Proponent, only construction materials / equipment / tool for the construction use were found within and adjacent to this temporary structure, and no chemicals, chemical wastes and fuels was observed within and adjacent to the temporary structures. The Project Proponent also advised that no maintenance and repairing activities had never conducted there.

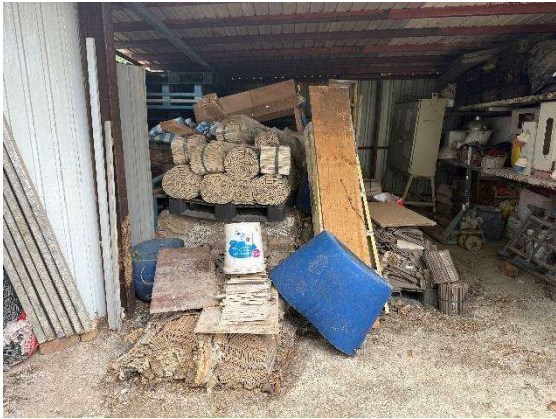
Photo 13:  
Temporary storage of construction materials including used  
timber, empty containers, tarpaulin sheets, tiles within the  
temporary structure

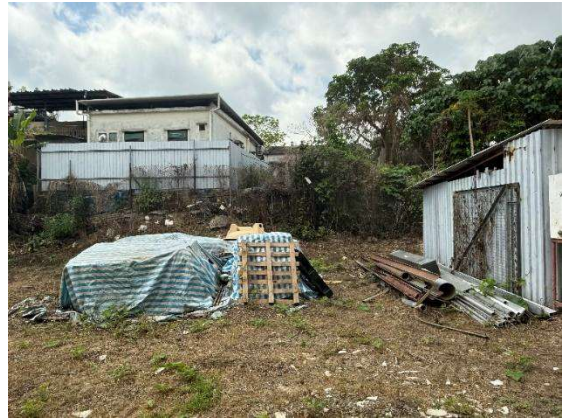
Photo 14:  
Temporary storage of steel bars and tiles

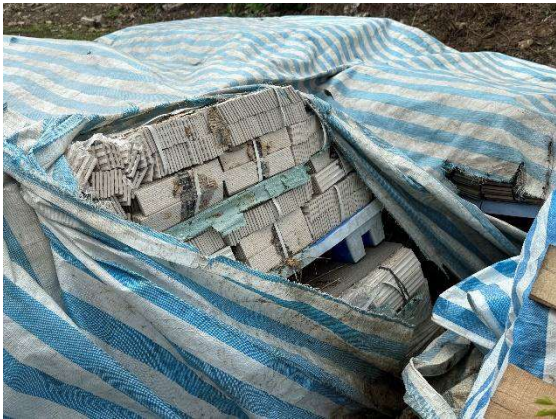
Photo 15:  
Temporary storage of tiles
