**Re : Application for Permission Under Section 16 (application no. A\_YL-KTN\_1207)**  
**Proposed House in "Residential (Group D)" Zone at**  
**Lot 787 in D.D.110, Kam Tin Road, Shek Kong San Tsuen, Yuen Long.**

Proposed House in Residential (Group D) Zone at Lot No. 787 in D.D.110, Kam Tin Road, Shek Kong San Tsuen, Yuen Long  
Submission of Qualitative Environmental Assessment (EA) Report

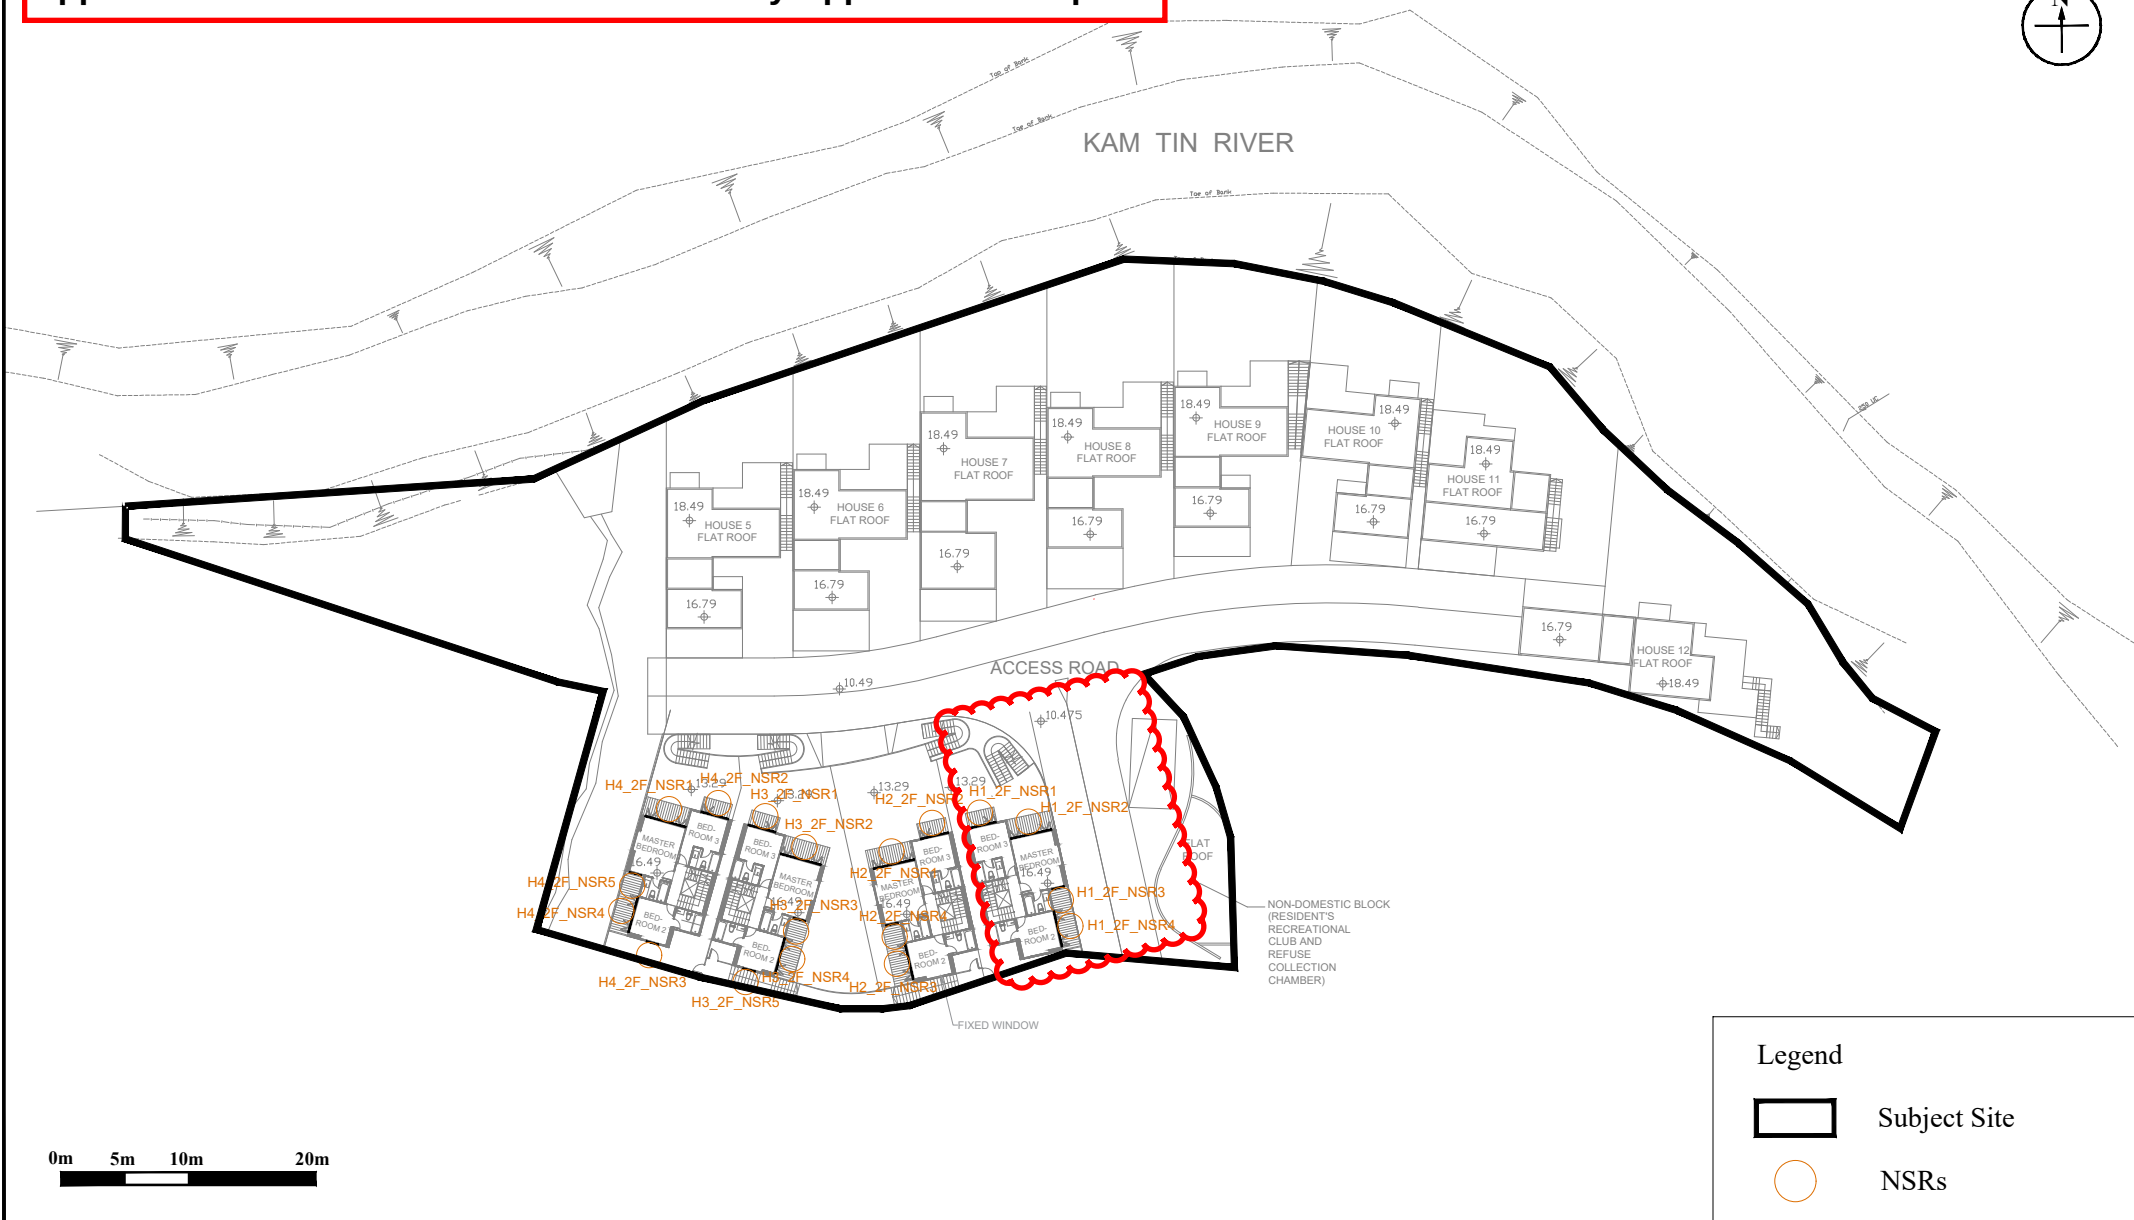
**Figure:** 5c

**Title:** Location of Selected Representative Noise Sensitive Receivers for Road Traffic Noise Impact Assessment 2/F)

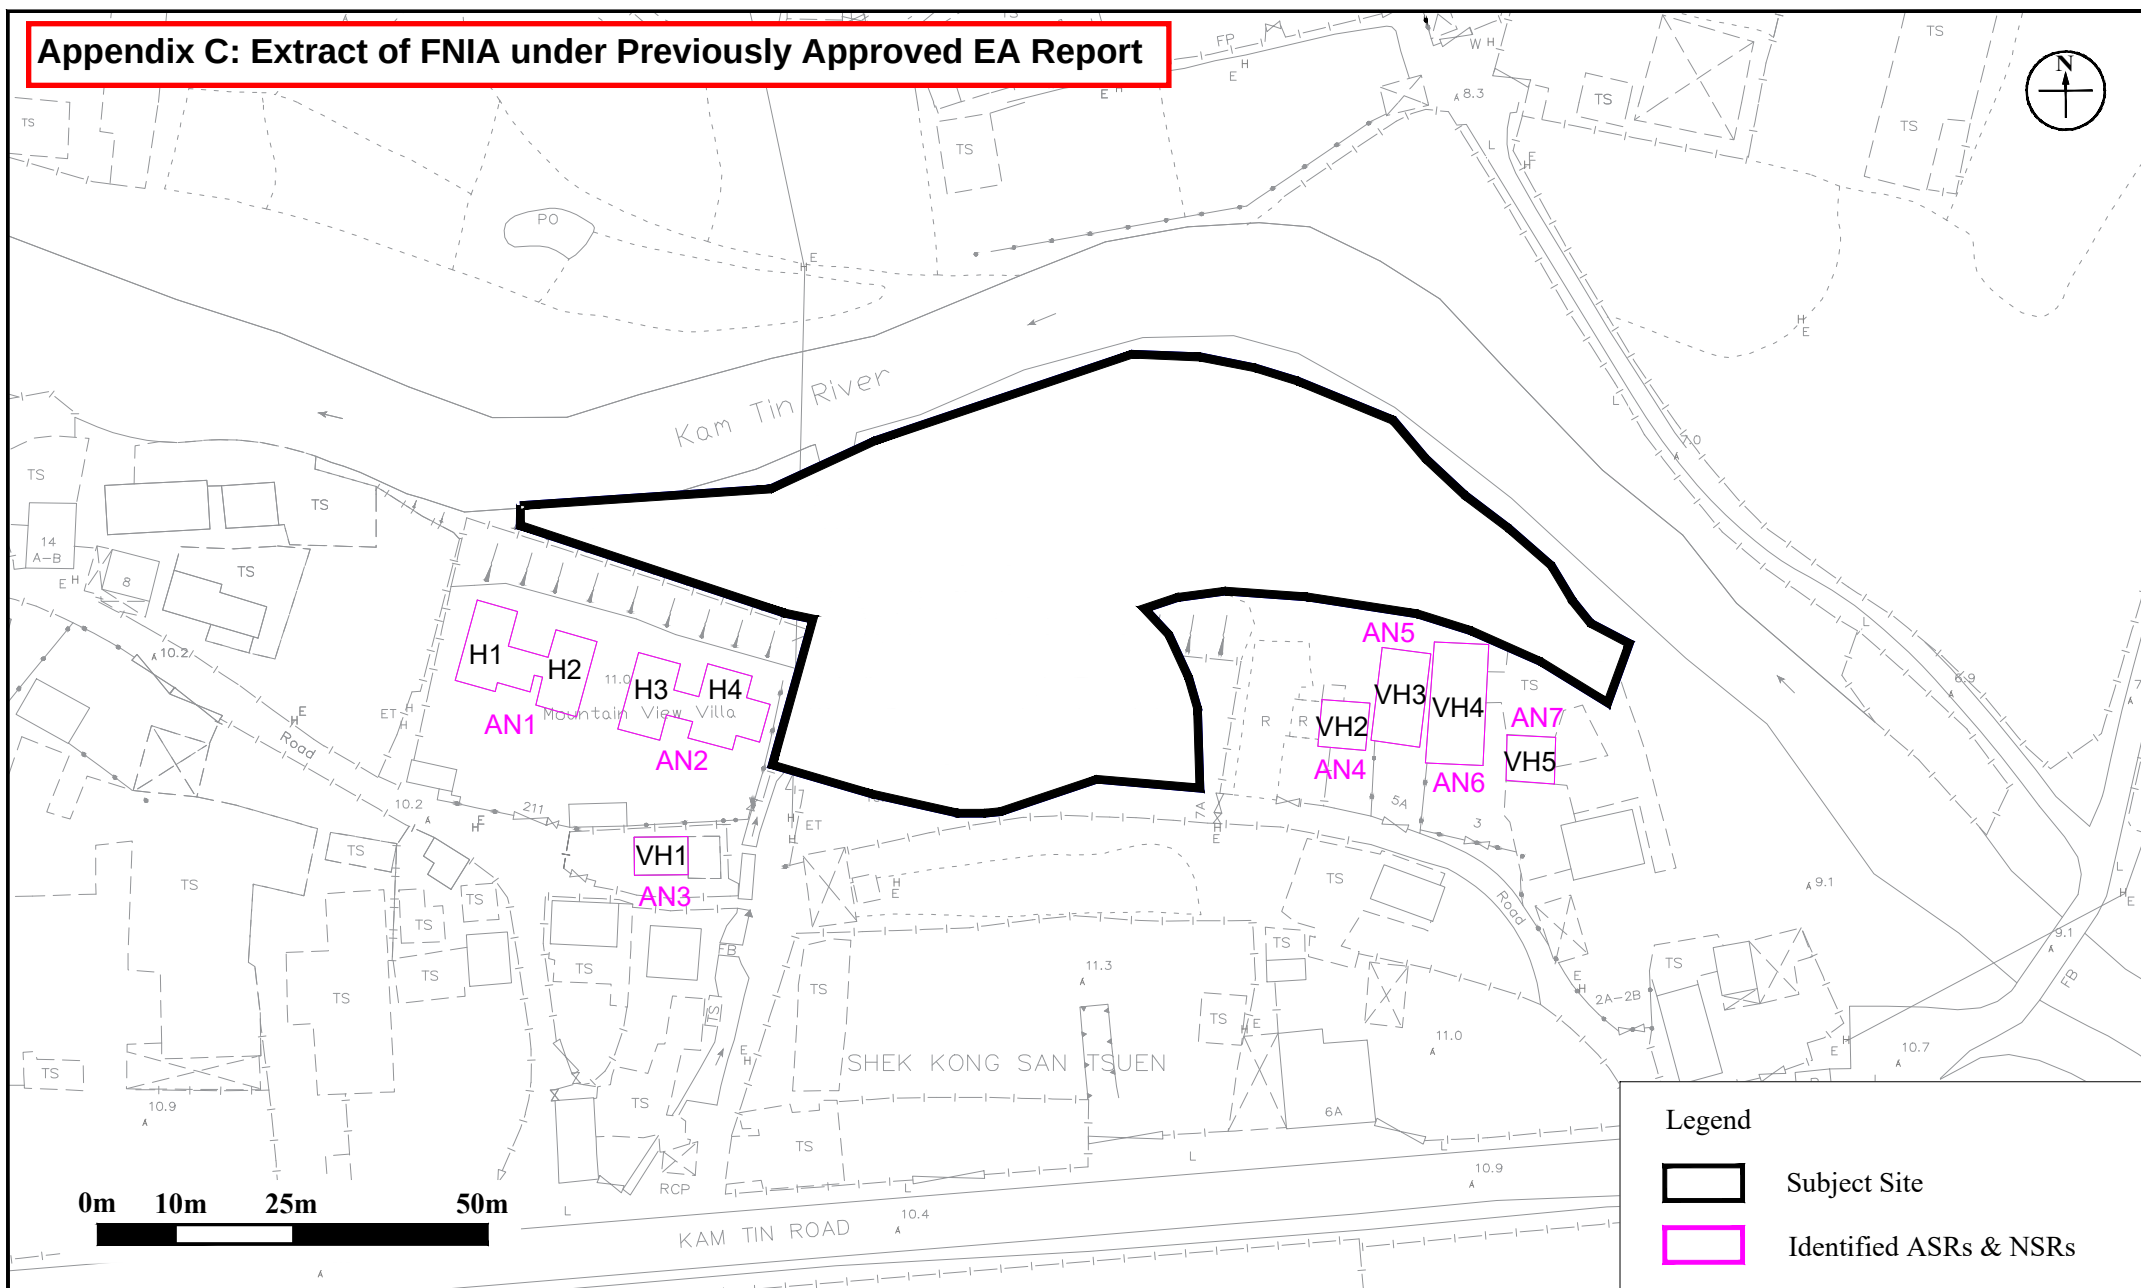
**Figure: 4**

**Title:** Identified Air & Noise Sensitive Receivers in Vicinity of Subject Site

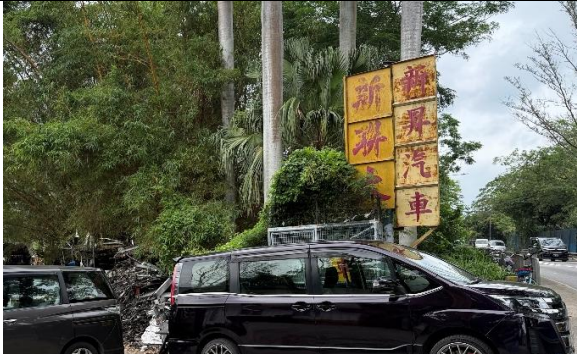
| <p>1. 新聯汽車零件有限公司. Warehouse and storage area of car parts was observed on-site. (S1)</p> | <p>2. 新聯汽車零件有限公司. The warehouse was used to store car parts and Forklift was observed on-site. (S1)</p> |

| ID | Name | Nature of Business | Description of As-observed Activities |
|---|---|---|---|
| S1 | 新聯汽車零件有限公司 | Vehicle repair & dismantling workshop | Storage of dismantled vehicle; No other activities observed. |

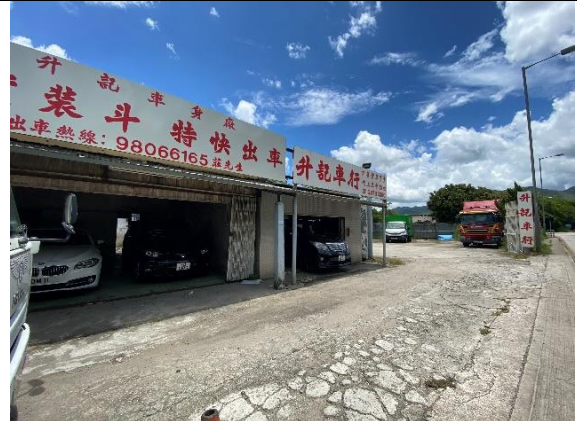
| <p>3. 升記車行 . Warehouse and storage area of car parts was observed on-site. (S2)</p> | <p>4. 合成汽車服務. Car service was provided. (S3)</p> |

| ID | Name | Nature of Business | Description of As-observed Activities |
|---|---|---|---|
| S2 | 升記車行 | Vehicle repair & dismantling workshop | Storage of dismantled vehicle; No other activities observed. |

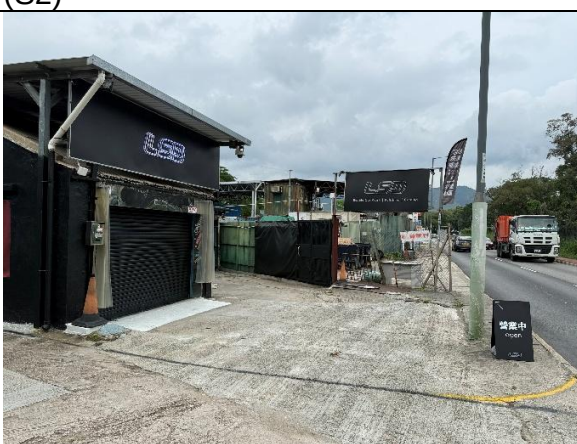
| <p>5. LSD Car retail shop with car parking on-site. No noisy activity nor equipment was observed. (S4)</p> | <p>6. Top Torque Car retail shop with car parking on-site. No noisy activity nor equipment was observed. (S5)</p> |

| ID | Name | Nature of Business | Description of As-observed Activities |
|---|---|---|---|
| S4 | Formerly 雄才汽車服務中心 (2021) now LSD (2026) | Vehicle dismantling workshop | No activities observed. |

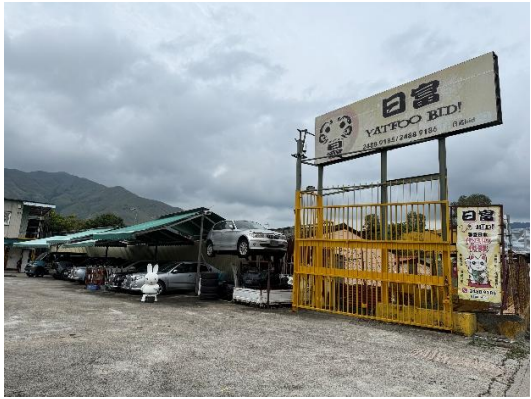
| <p>7. 日富汽車零件. Retail shop of car parts. No noisy activity nor equipment was observed. (S6)</p> | <p>8. Unnamed open storage. No noisy activity nor equipment was observed. (S7)</p> |

| ID | Name | Nature of Business | Description of As-observed Activities |
|---|---|---|---|
| S6 | 日富汽車零件 | Vehicle repair & selling | No activities observed. |

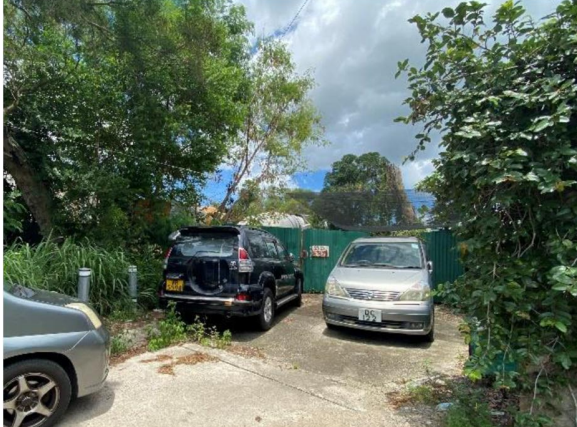
| <p>9. Unnamed vehicle maintenance and repair workshop. No noisy activity nor equipment was observed. (S8)</p> | <p>高記貨倉 . Open storage. No noisy activity nor equipment was observed. (S9)</p> |

| ID | Name | Nature of Business | Description of As-observed Activities |
|---|---|---|---|
| S8 | Unnamed vehicle maintenance and repair workshop | Vehicle repair workshop | Open parking. No other activities observed. |

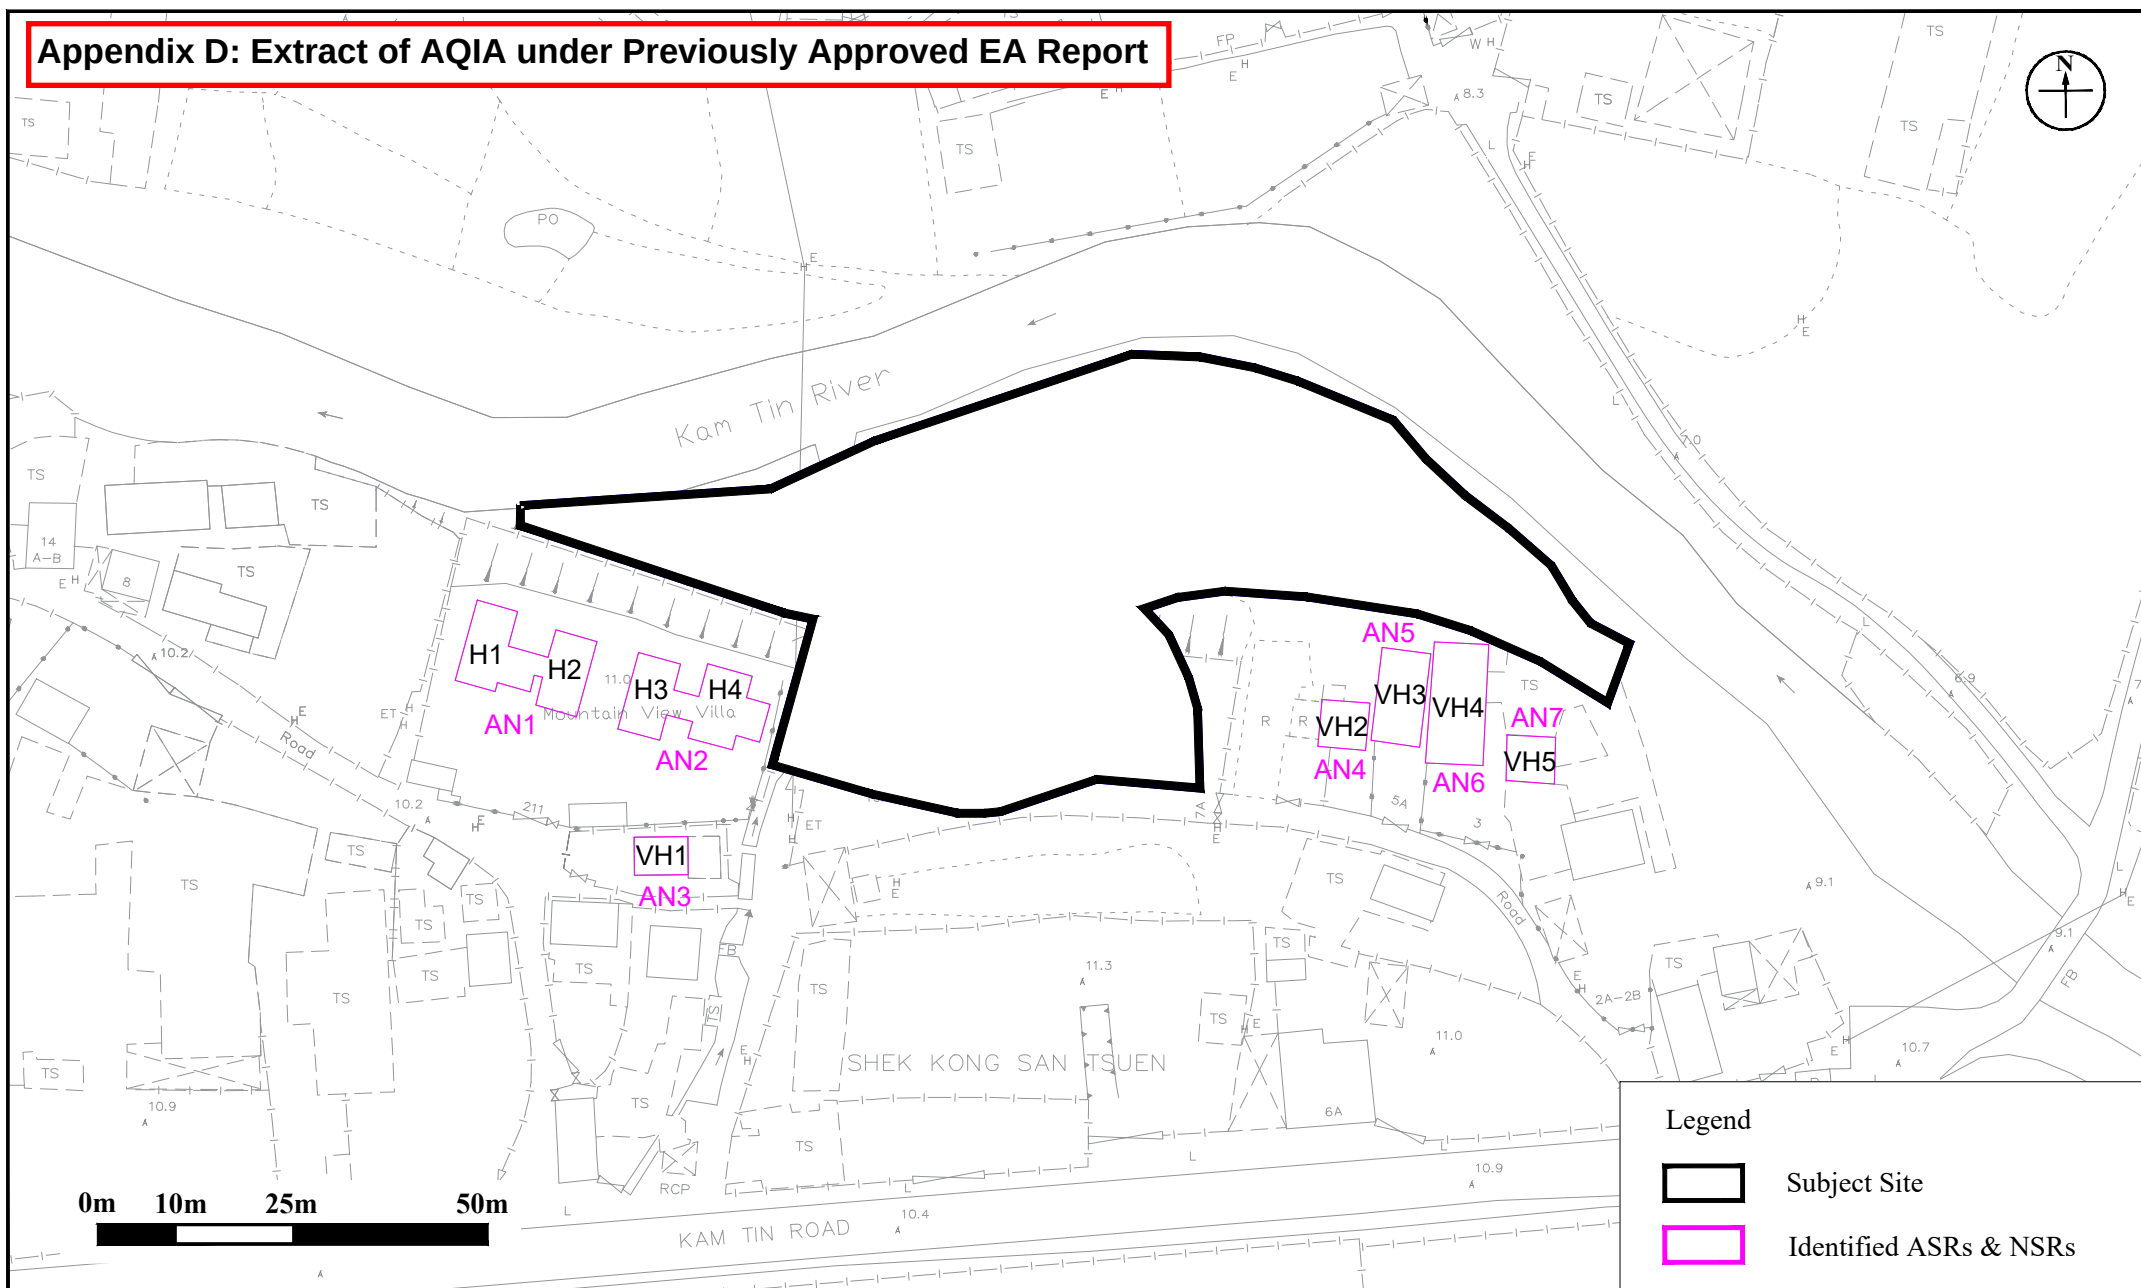
**Figure:** 4

**Title:** Identified Air & Noise Sensitive Receivers in Vicinity of Subject Site

3.1.9 Overall, the assessment concludes that no significant air quality impacts are anticipated from the development under normal conditions. There are a number of existing village houses located within close proximity to the Application Site, which are considered as Representative Air Sensitive Receivers (ASRs). These ASRs are identified at the existing (i) Mountain View Villa, (ii) Shek Kong San Tsuen (see Appendix E). Table 3-1 below summarises the representative ASRs.

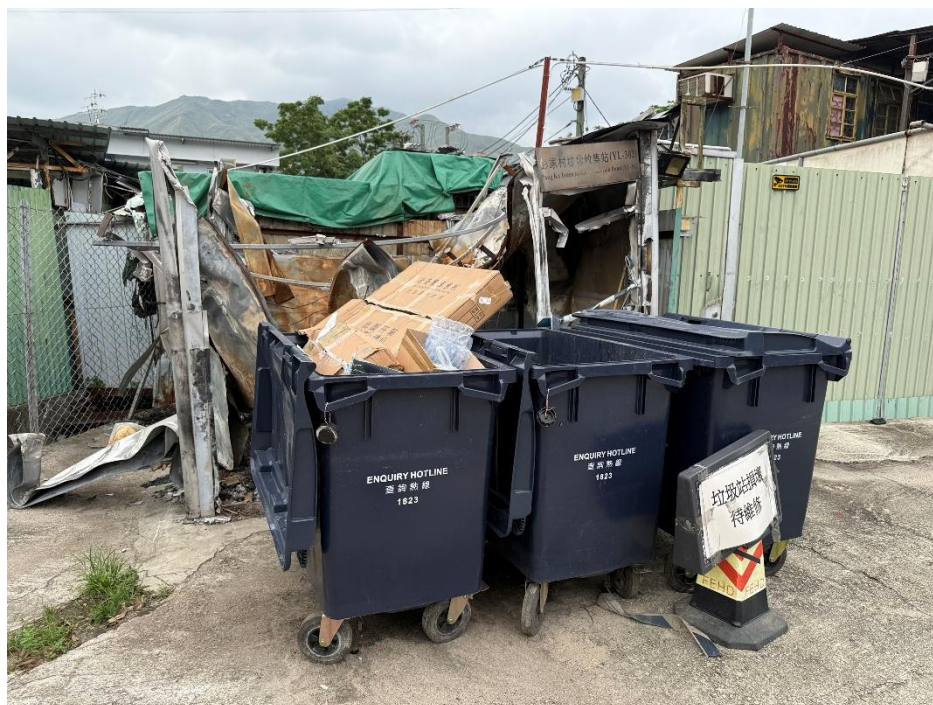
Odour Detected? No  
Remarks: No odour was detected along the inspection route. The previous RCP with sensor-operated openings was damaged. A temporary replacement of the RCP is provided at the same location.

3.1.2 Based on field surveys from July 2021 and May 2026, one refuse collection point (RCP) at Kam Tin Road is located away about 60m at the southwest from the Subject Site. This RCP is considered as potential odour source for the Application Site. Other than the RCP, there is no air pollution source identified in the vicinity of the Application Site. Also, there is no odour and fluff observed.

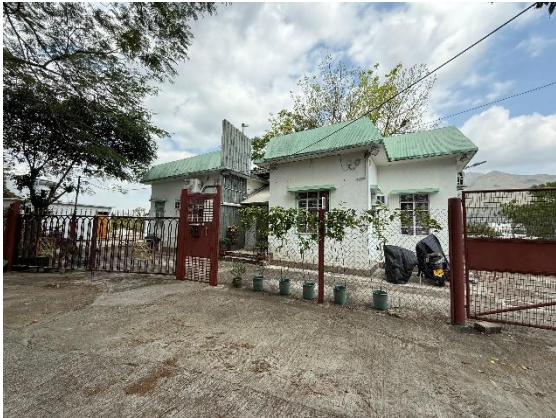
Photo 1:  
South: Existing residential house

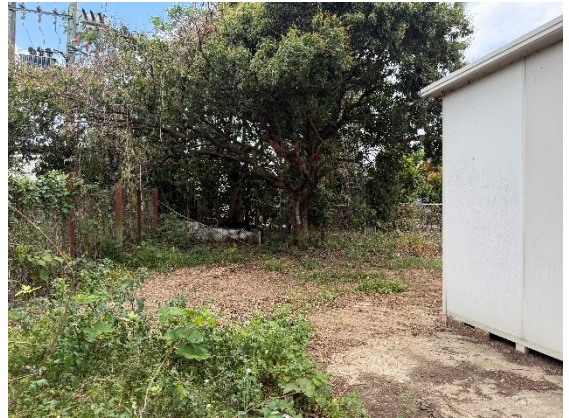
Photo 2:  
South: Open yard at the existing residential house

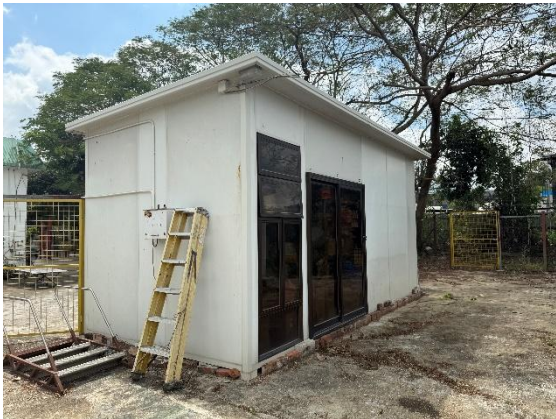
Photo 3:  
South: Temporary structure at western side of the existing residential house for domestic storage

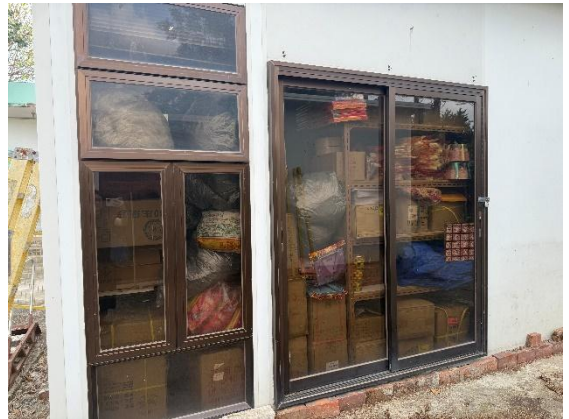
Photo 4:  
South: Temporary structure at western side of the existing residential house for domestic storage

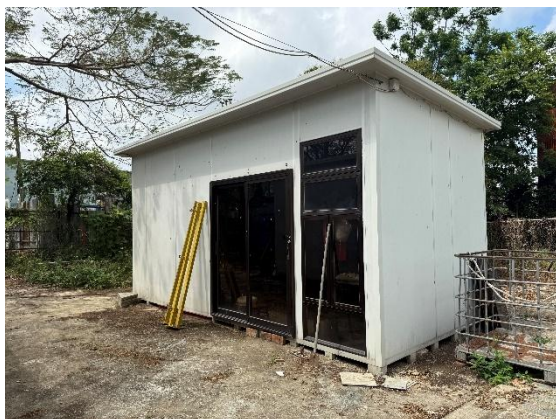
Photo 5:  
South: Temporary structure at western side of the existing residential house for domestic use

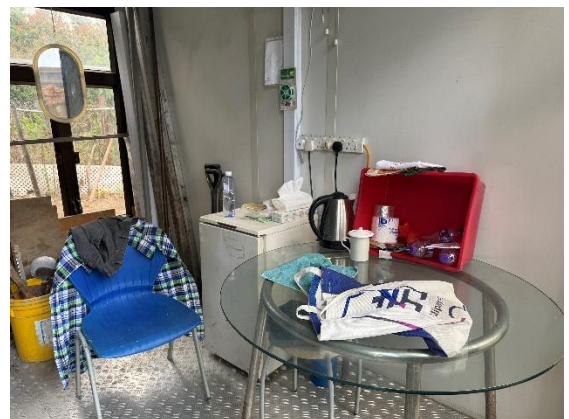
Photo 6:  
South: Temporary structure at western side of the existing residential house for domestic use

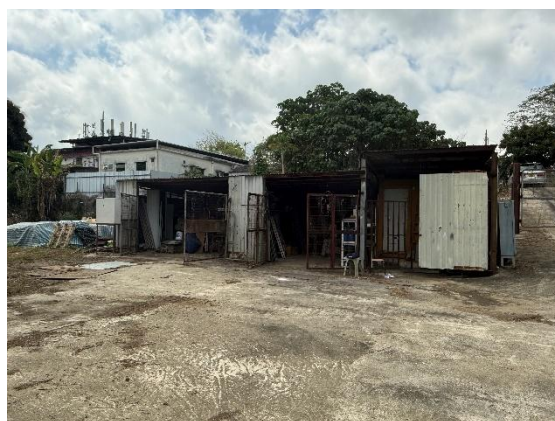
Photo 10:  
South East: Temporary structure for storage of construction  
equipment and material

- 3.3.9 The western, northern and eastern portions of the Subject Site (with lower ground level) was mainly vacant, covered with natural vegetation and trees (Photos 7 to 9). One temporary structure for storage of construction materials / equipment / tool (e.g. empty cage, used timber, empty containers, tarpaulin sheets, tiles, etc.) was observed at the south-eastern portion of Subject Site (Photos 10 to 13). At the eastern side adjacent to the temporary structure, temporary storage of steel bars and tiles were observed (Photos 14 and 15). The areas at and adjacent to such temporary structure

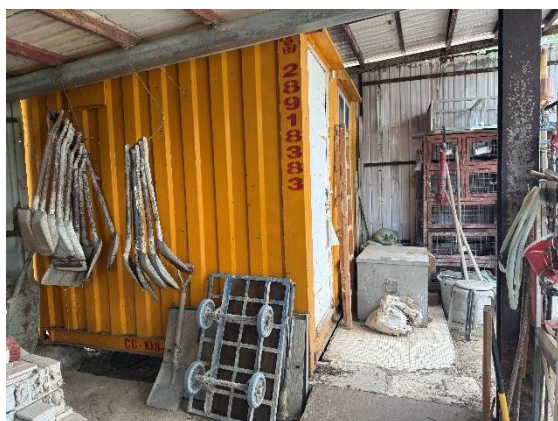
Photo 11:  
One container office and temporary storage of empty cage,  
equipment / tools within the temporary structure

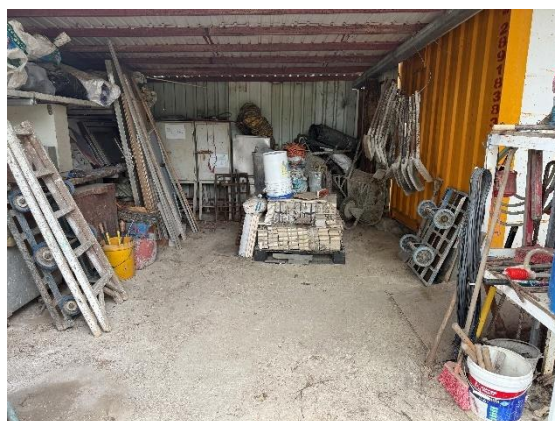
Photo 12:  
Temporary storage of construction equipment / tools within the  
temporary structure

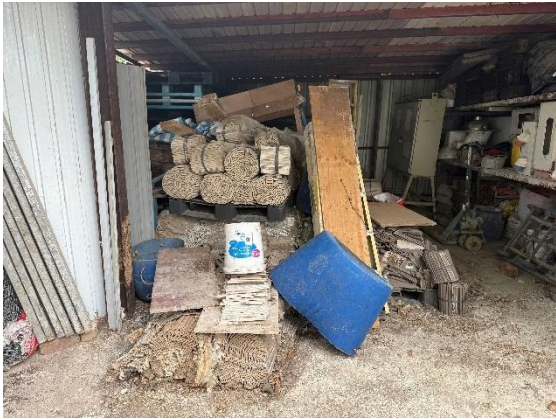
Photo 13:  
Temporary storage of construction materials including used  
timber, empty containers, tarpaulin sheets, tiles within the  
temporary structure

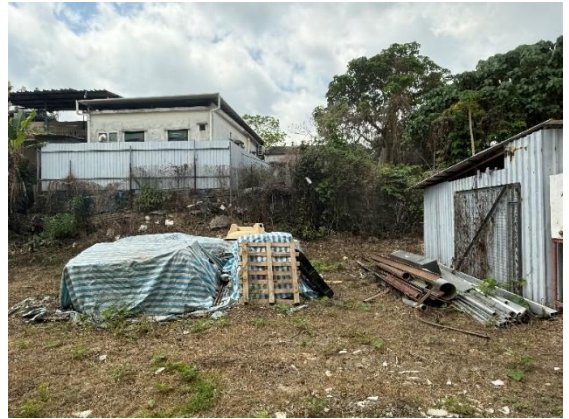
Photo 14:  
Temporary storage of steel bars and tiles

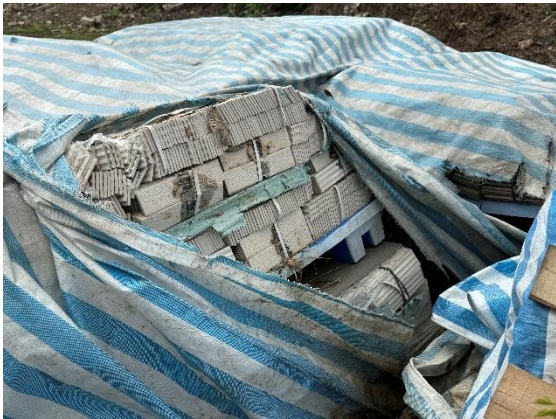
Photo 15:  
Temporary storage of tiles
