APPLICATION FOR PERMISSION
UNDER SECTION 16 OF
THE TOWN PLANNING ORDINANCE
(CAP.131)

DIMENSION PLAN OF PROPOSED SMALL HOUSE ON GOVERNMENT LAND IN D.D.28

GPRR FOR PLANNING APPLICATION OF NTEH
NEAR TO LOT 607 IN DD28, TAI PO

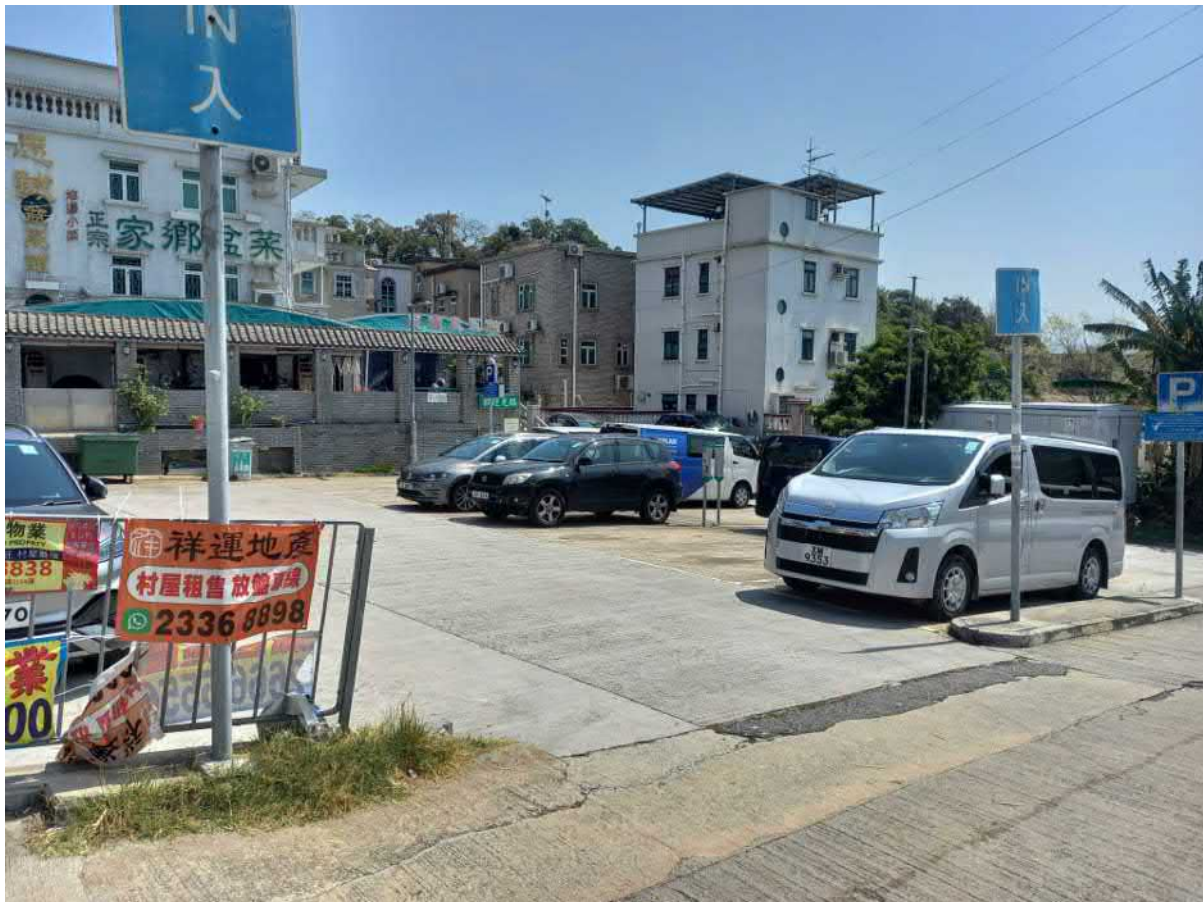
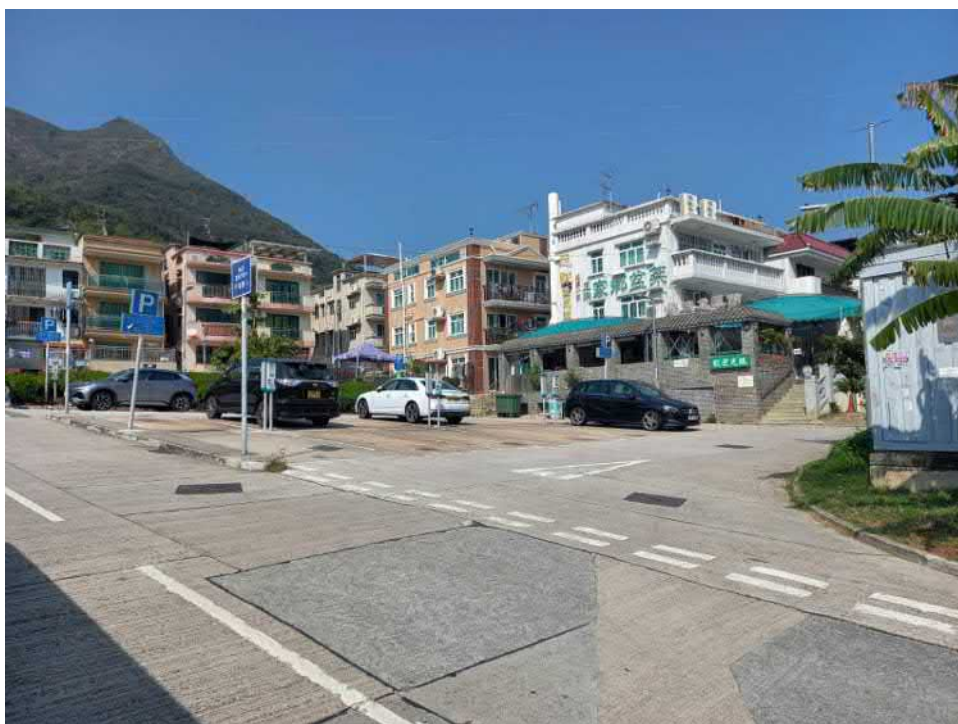
Carpark near the entrance of Tai Mei Tuk Village:

Regarding the comments from the Transport Department, I have attached two photos below, which showed at least 3 empty parking lots in the carpark near the entrance of Tai Mei Tuk Village at night (around 2100 hours on weekdays), which provided sufficient parking space to accommodate the parking issue. On the other hand, I believe the illegal parking issue is due to the visitors who come to Tai Mei Tuk Village during the weekend, which is not likely to bring a long term adverse inference to the local parking issue.

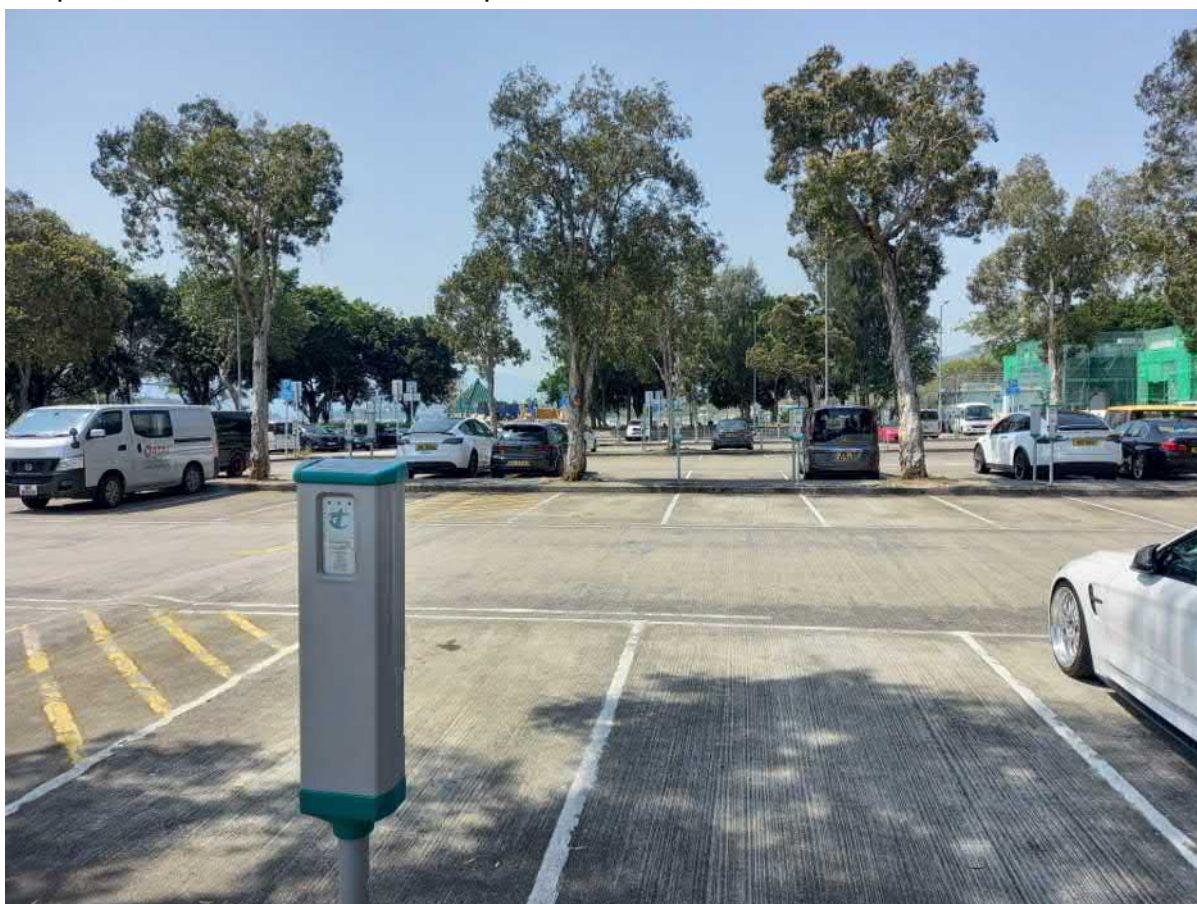
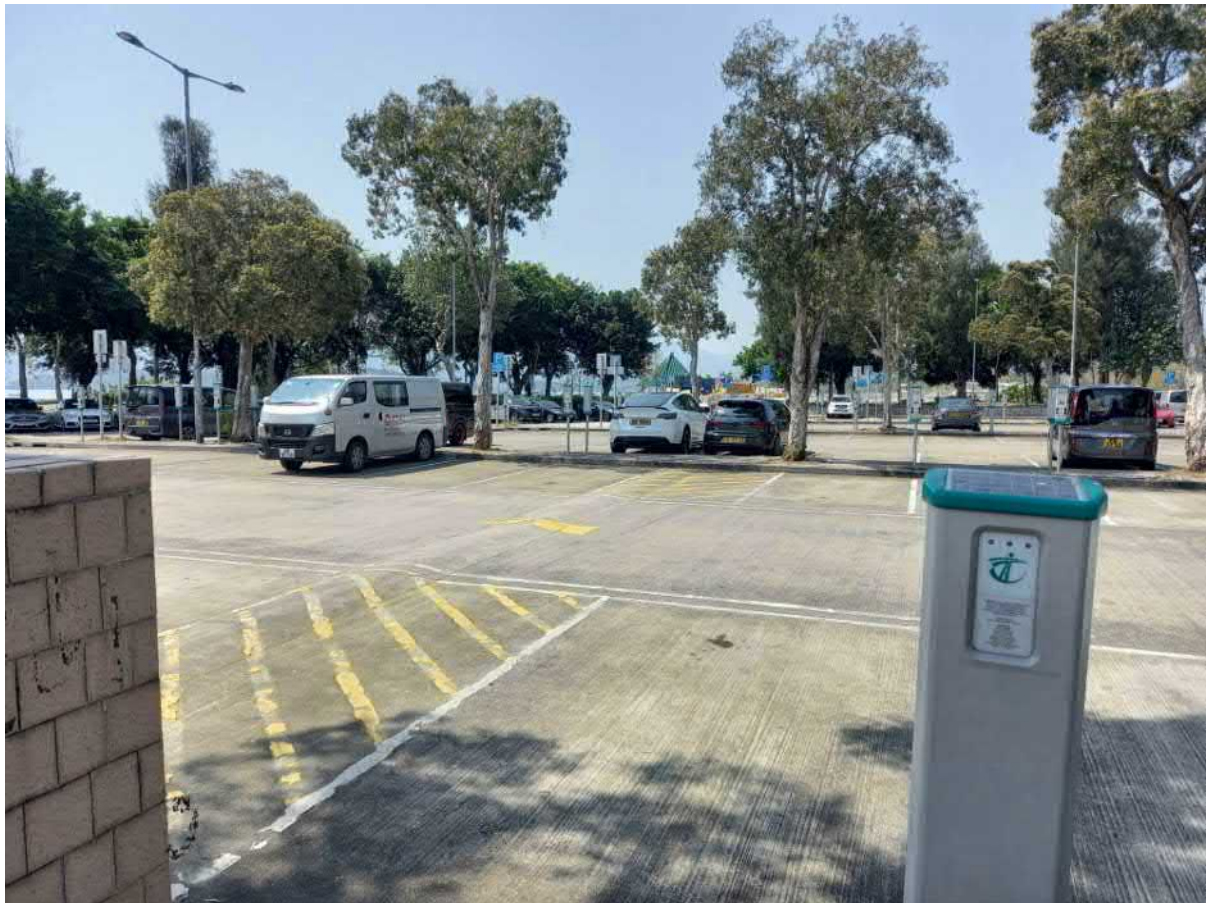
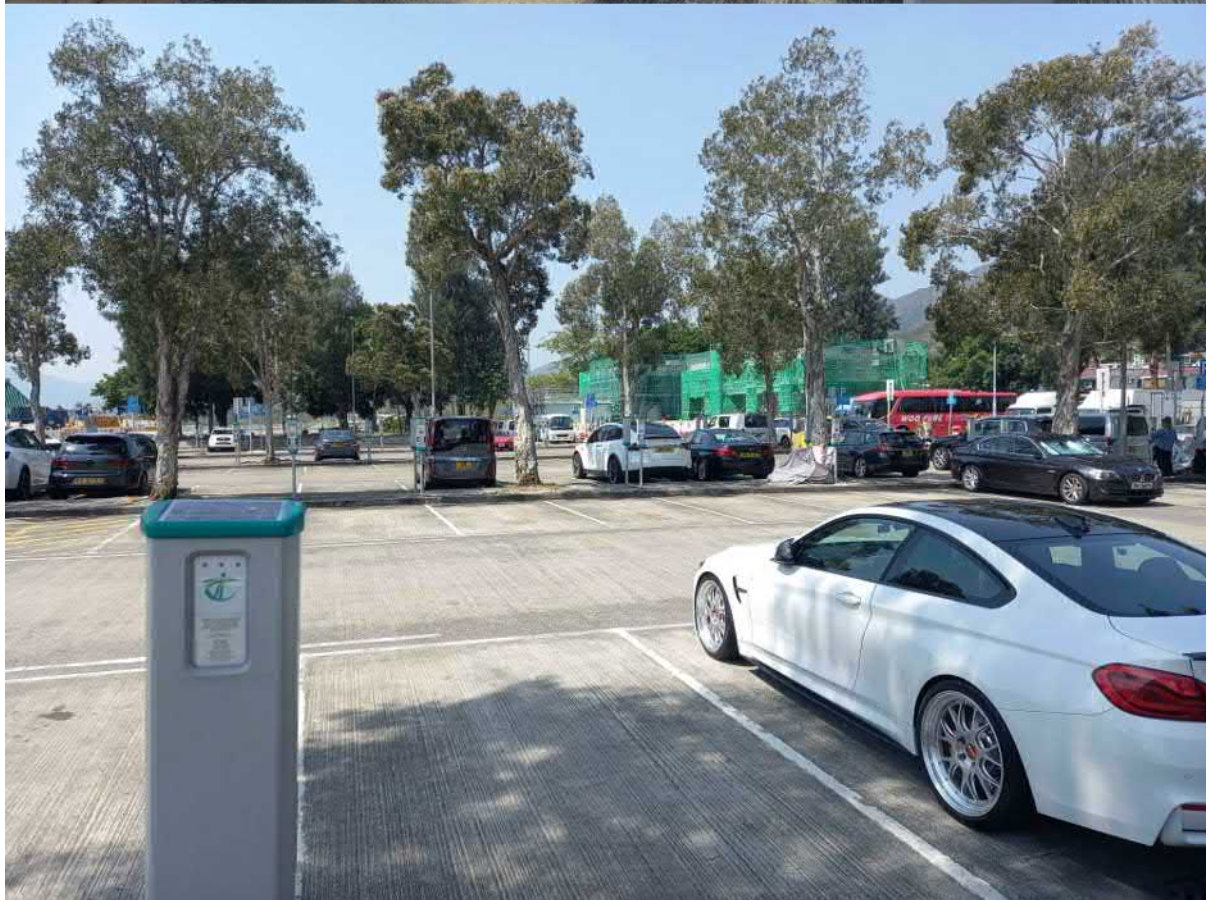
Carpark near Tai Mei Tuk bus stop:

Regarding the carpark near Tai Mei Tuk Bus Terminus, the carpark is actually **within 3-minute walking distance** from the Tai Mei Tuk Village, which is definitely a reasonable distance for the villagers of Tai Mei Tuk village to park their car therein. In fact, some of the locals parked their cars in that carpark, which provided a large amount of parking space within a reasonable walking distance and solved the parking demand nearby. A photo is attached which showered plenty of empty parking lots at night (around 2100 hours).

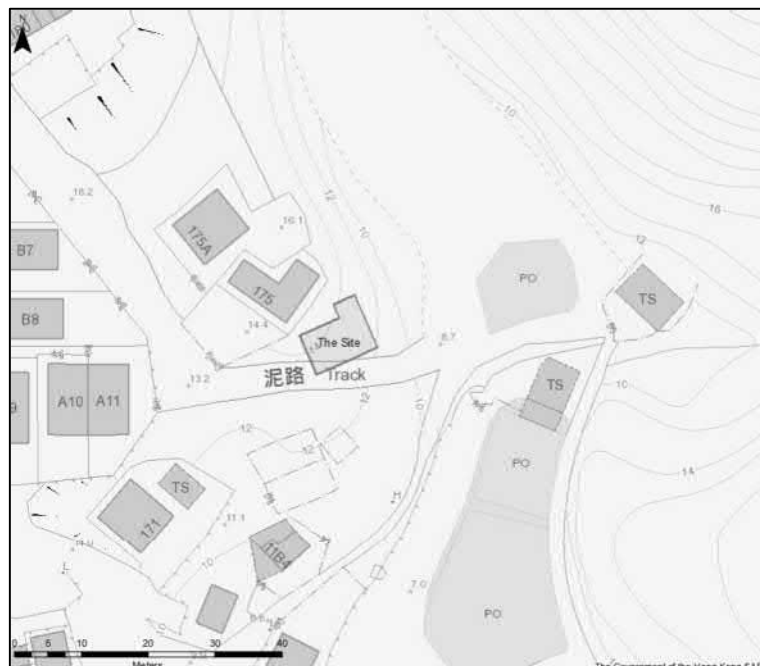
Fig.1 Location Plan

The proposed lot for the project in question is perfectly shaped for the proposed NTEH, and the site is currently vacant. It is situated on a sloping ground that ranges from 15.98 mPD to 13mPD.

Fig.1 and **Fig.2** below shows the location of the project site and the lots near to the site.

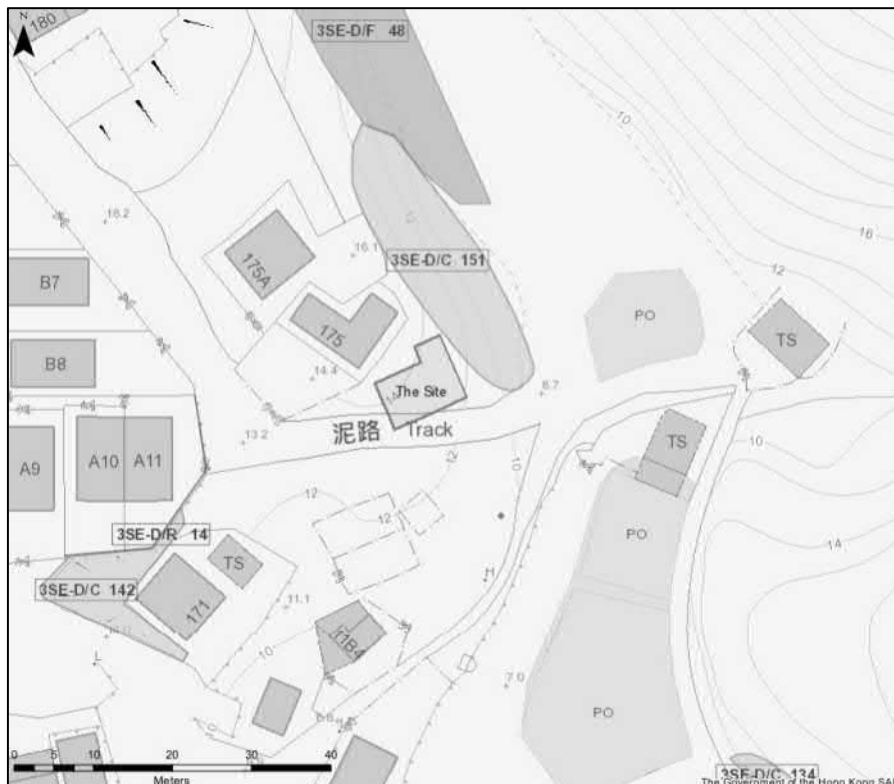
According to the Slope Information System, there are four registered features are within the area of 50m away from the proposed Site. The registered feature layout plan is presented in the **Fig.3** below.

A brief description on these geotechnical features is given as follows. The information of these features extracted from GEO is presented in **Appendix A**.

The close proximity between feature 3SE-D/C151 and the proposed site warrants a discussion on the potential geotechnical impact of the proposed development on the feature, as well as the likelihood of the development being affected by any failure of the feature. This will be addressed in the following section.

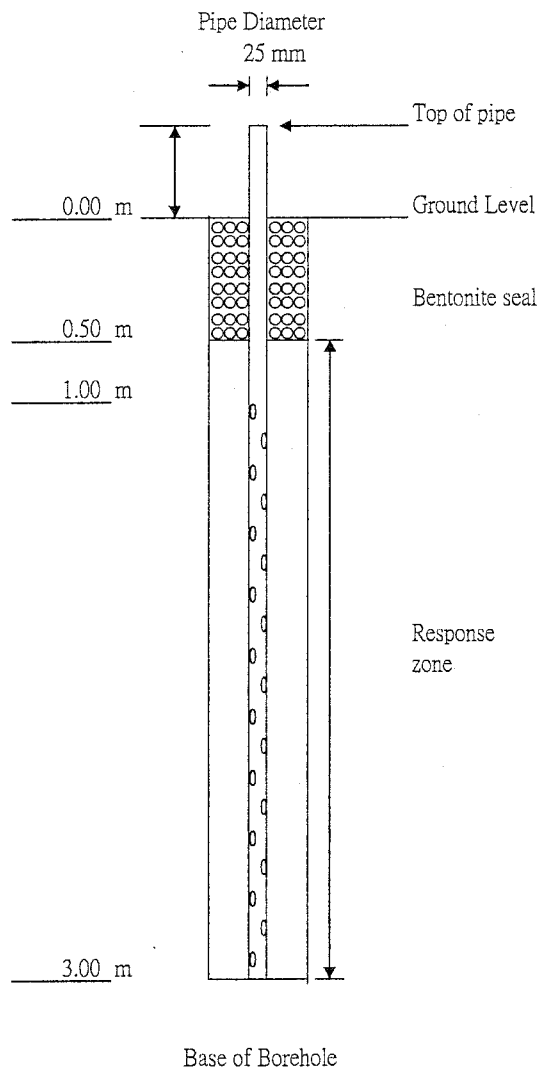
STANDPIPE DETAIL AND RESPONSE TEST RECORD SHEET

Time Elapsed (minutes)	Depth of water from top of pipe (m)
0.00	0.00
0.25	0.33
0.50	0.46
0.75	0.56
1.00	0.66
1.50	0.82
2.00	0.93
3.00	1.01
4.00	1.07
5.00	1.13
6.00	1.19
7.00	1.24
8.00	1.29
9.00	1.34
10.00	1.39
15.00	1.57
20.00	1.73
25.00	1.87
30.00	1.99
45.00	2.25
60.00	2.48

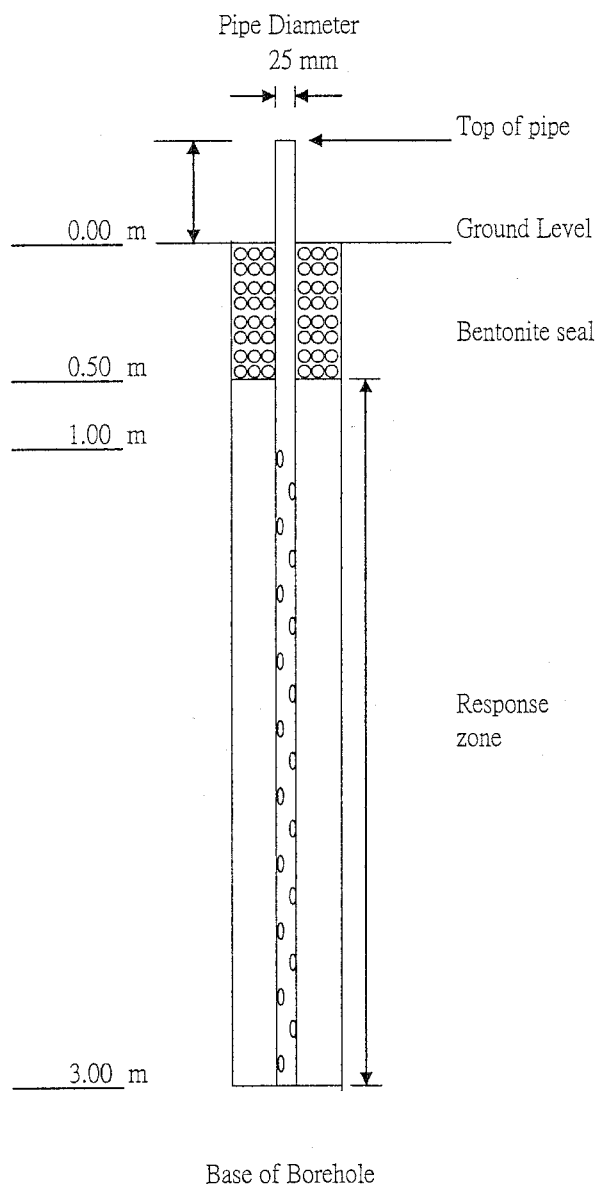
STANDPIPE DETAIL AND RESPONSE TEST RECORD SHEET

Contractor :	Winfield Engineering Co.	Trial Pit No. :	TP 2
Contract No. :		Date of Test :	22-Jul-08
Works Order No. :		Ground Level :	15.03 mPD
Project :	Ground Investigation Works at Lot 768 S.Q & S.R in DD28, Tai Mei Tuk, Tai Po, N.T.	Co-ordinates :	E 842261.74 N 837262.50
Initial Water Level	Dry m below G.L.	Bottom Level of well	12.03 mPD
Tested/Supervised by :	C.M.Tsui

Time Elapsed (minutes)	Depth of water from top of pipe (m)
0.00	0.00
0.25	0.43
0.50	0.62
0.75	0.75
1.00	0.84
1.50	1.00
2.00	1.12
3.00	1.30
4.00	1.47
5.00	1.63
6.00	1.77
7.00	1.89
8.00	1.99
9.00	2.19
10.00	2.28
15.00	2.58
20.00	2.75
25.00	2.86
30.00	2.94
45.00	Dry
60.00	Dry

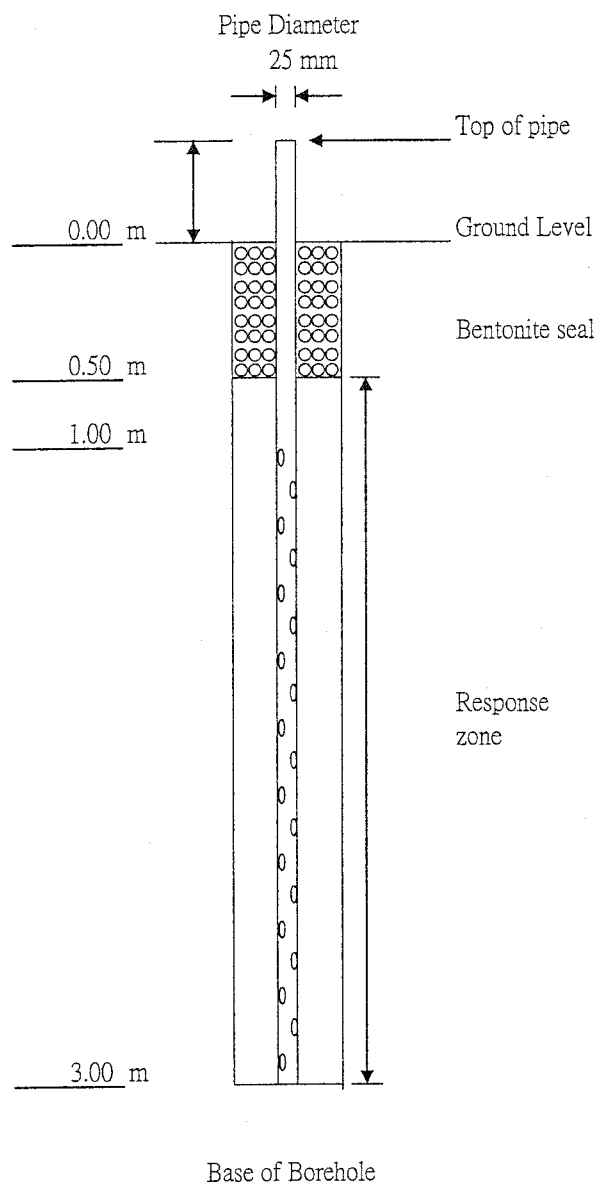
STANDPIPE DETAIL AND RESPONSE TEST RECORD SHEET

Contractor :	Winfield Engineering Co.	Trial Pit No. :	TP 3
Contract No. :		Date of Test :	22-Jul-08
Works Order No. :		Ground Level :	15.51 mPD
Project :	Ground Investigation Works at Lot 768 S.Q & S.R in DD28, Tai Mei Tuk, Tai Po, N.T.	Co-ordinates :	N 842252.48 E 837257.84
Initial Water Level	Dry	Bottom Level of well	12.51 mPD
Tested/Supervised by :	C.M.Tsui

Time Elapsed (minutes)	Depth of water from top of pipe (m)
0.00	0.00
0.25	0.45
0.50	0.69
0.75	0.86
1.00	1.02
1.50	1.22
2.00	1.40
3.00	1.62
4.00	1.78
5.00	1.93
6.00	2.07
7.00	2.16
8.00	2.26
9.00	2.36
10.00	2.46
15.00	2.79
20.00	2.95
25.00	Dry
30.00	Dry
45.00	Dry
60.00	Dry

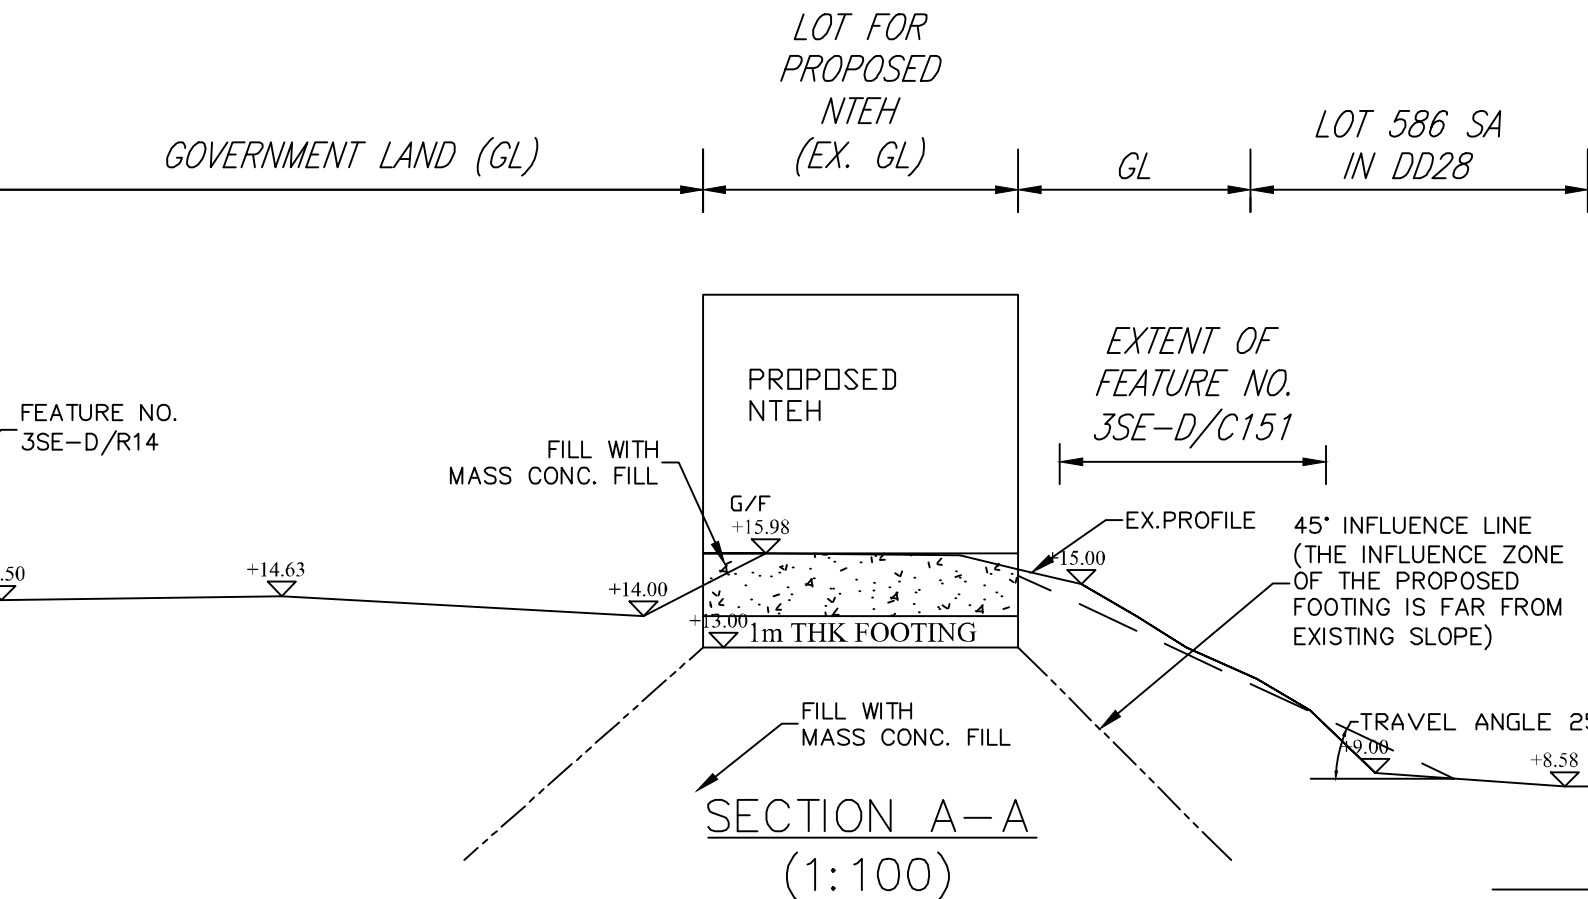
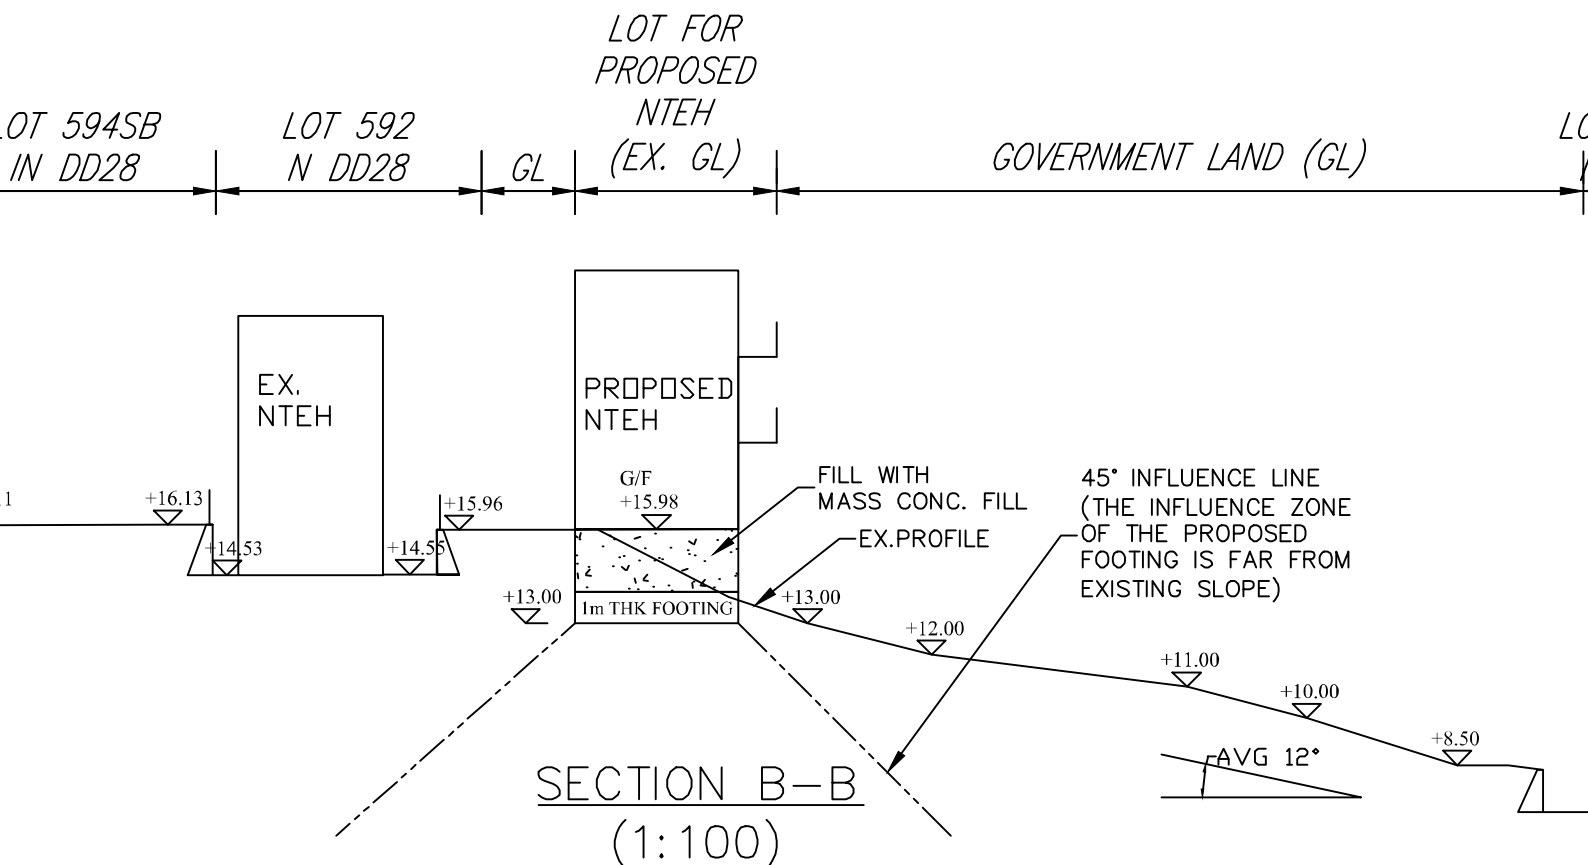
Appendix C
Preliminary Site Formation Design

To prevent any surcharge from the proposed building on the existing feature 3SE-D/C151, the proposed NTEH will be situated on a site formation level of +15.98mPD, with a 1m thick concrete footing at +13.00mPD. We anticipate that the proposed NTEH will not be impacted by any potential failure of 3SE-D/C151 in a view of travel angle.

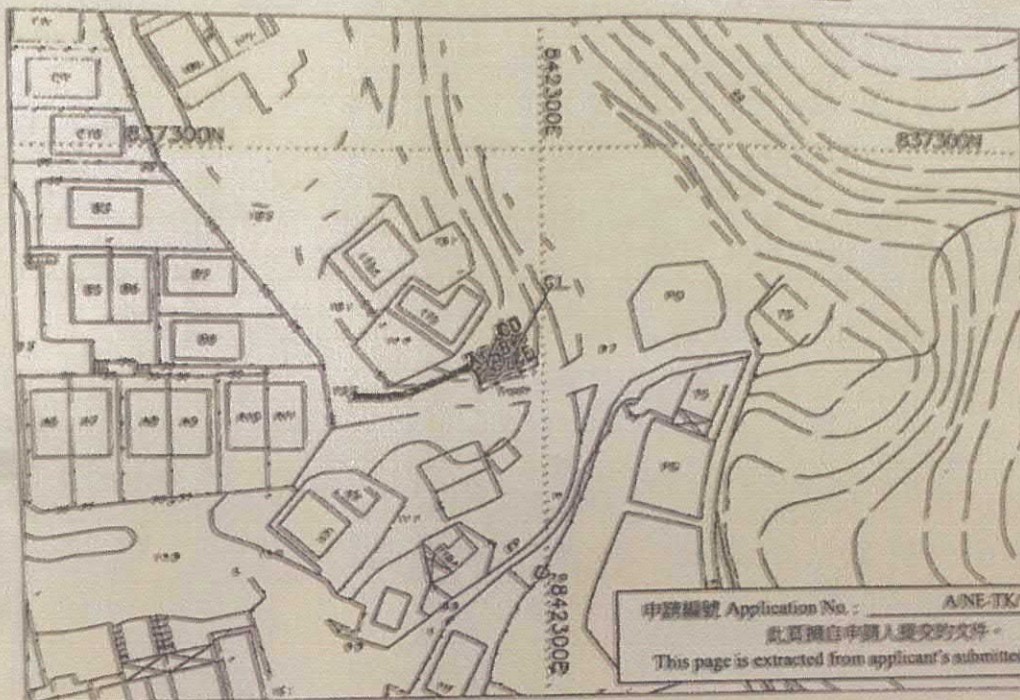
DIMENSION PLAN OF PROPOSED SMALL HOUSE ON GOVERNMENT LAND IN D.D.28

(P) Coloured Pink Area: 59.7 sq.m. (About)
