APPLICATION FOR PERMISSION
UNDER SECTION 16 OF
THE TOWN PLANNING ORDINANCE
(CAP.131)

(a) Full address / location / demarcation district and lot number (if applicable) 詳細地址/地點/丈量約份及地段號碼 (如適用)	Lot No. 45 S.P in D.D. 213, Lung Mei, Sai Kung, N.T. 新界西貢龍尾丈量約份第213約地段第45號P分段
(b) Site area and/or gross floor area involved 涉及的地盤面積及/或總樓面面積	<input checked="" type="checkbox"/> Site area 地盤面積 163.40 sq.m 平方米 <input checked="" type="checkbox"/> About 約 <input checked="" type="checkbox"/> Gross floor area 總樓面面積 195.09 sq.m 平方米 <input type="checkbox"/> About 約
(c) Area of Government land included (if any) 所包括的政府土地面積 (倘有) sq.m 平方米 <input type="checkbox"/> About 約

Natural Terrain Hazard Study Report

BC+S Limited was commissioned to undertake a natural terrain hazard study (NTHS) for a new development of New Territories Exempt Houses (NTEH), Lot 45 S.D, S.O, S.P, S.Q, S.R and S.AH DD213, in Lung Mei Tsuen, Sai Kung.

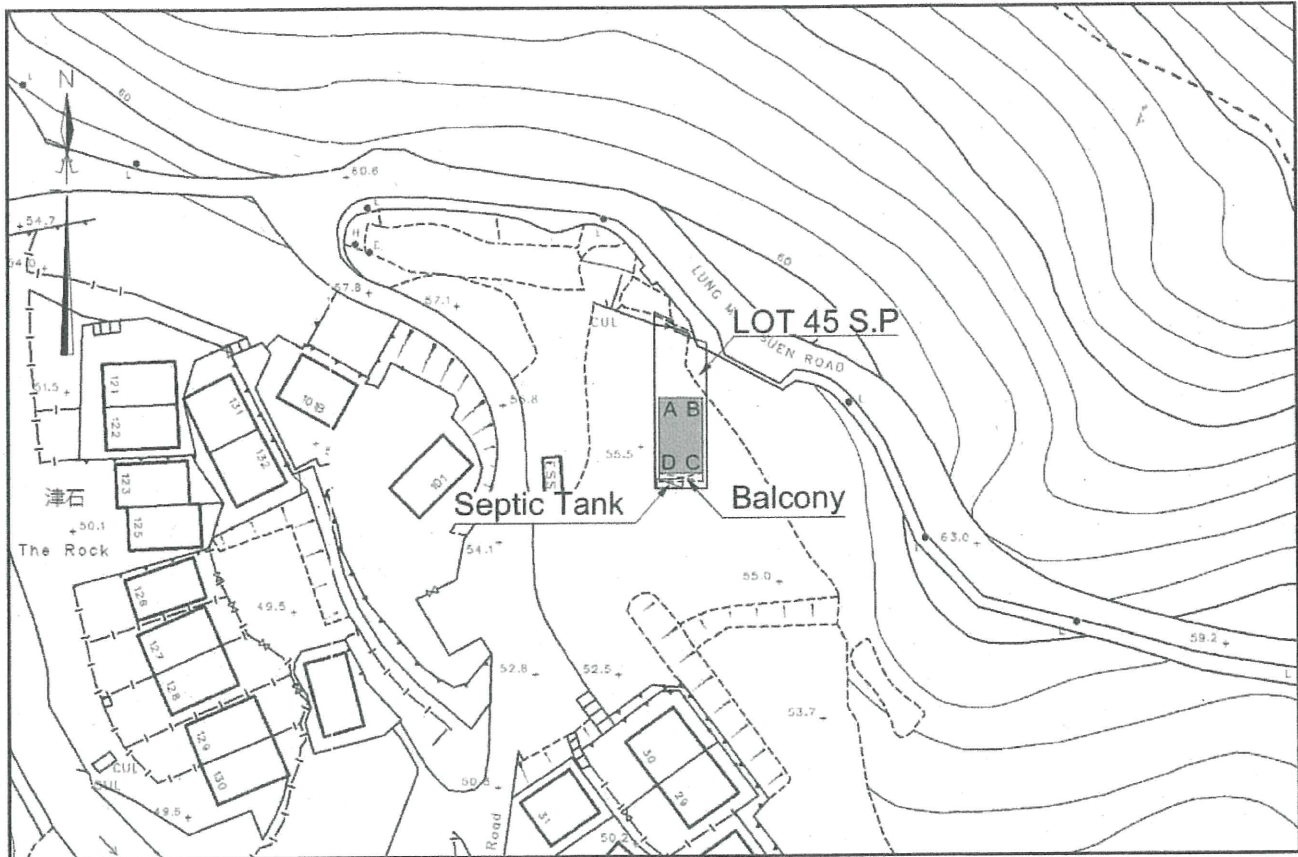
PROPOSED BUILDING LICENCE LOT No. 45 S.P IN D.D. 213

Line	Bearing	Distance(M)	Nothing	Easting	Pt.
A-B	90°00'00"	6.096	828 332. 335	845 796. 492	A
B-C	180°00'00"	10.668	828 332. 335	845 802. 588	B
C-D	270°00'00"	6.096	828 321. 667	845 802. 588	C
D-A	0°00'00"	10.668	828 321. 667	845 796. 492	D

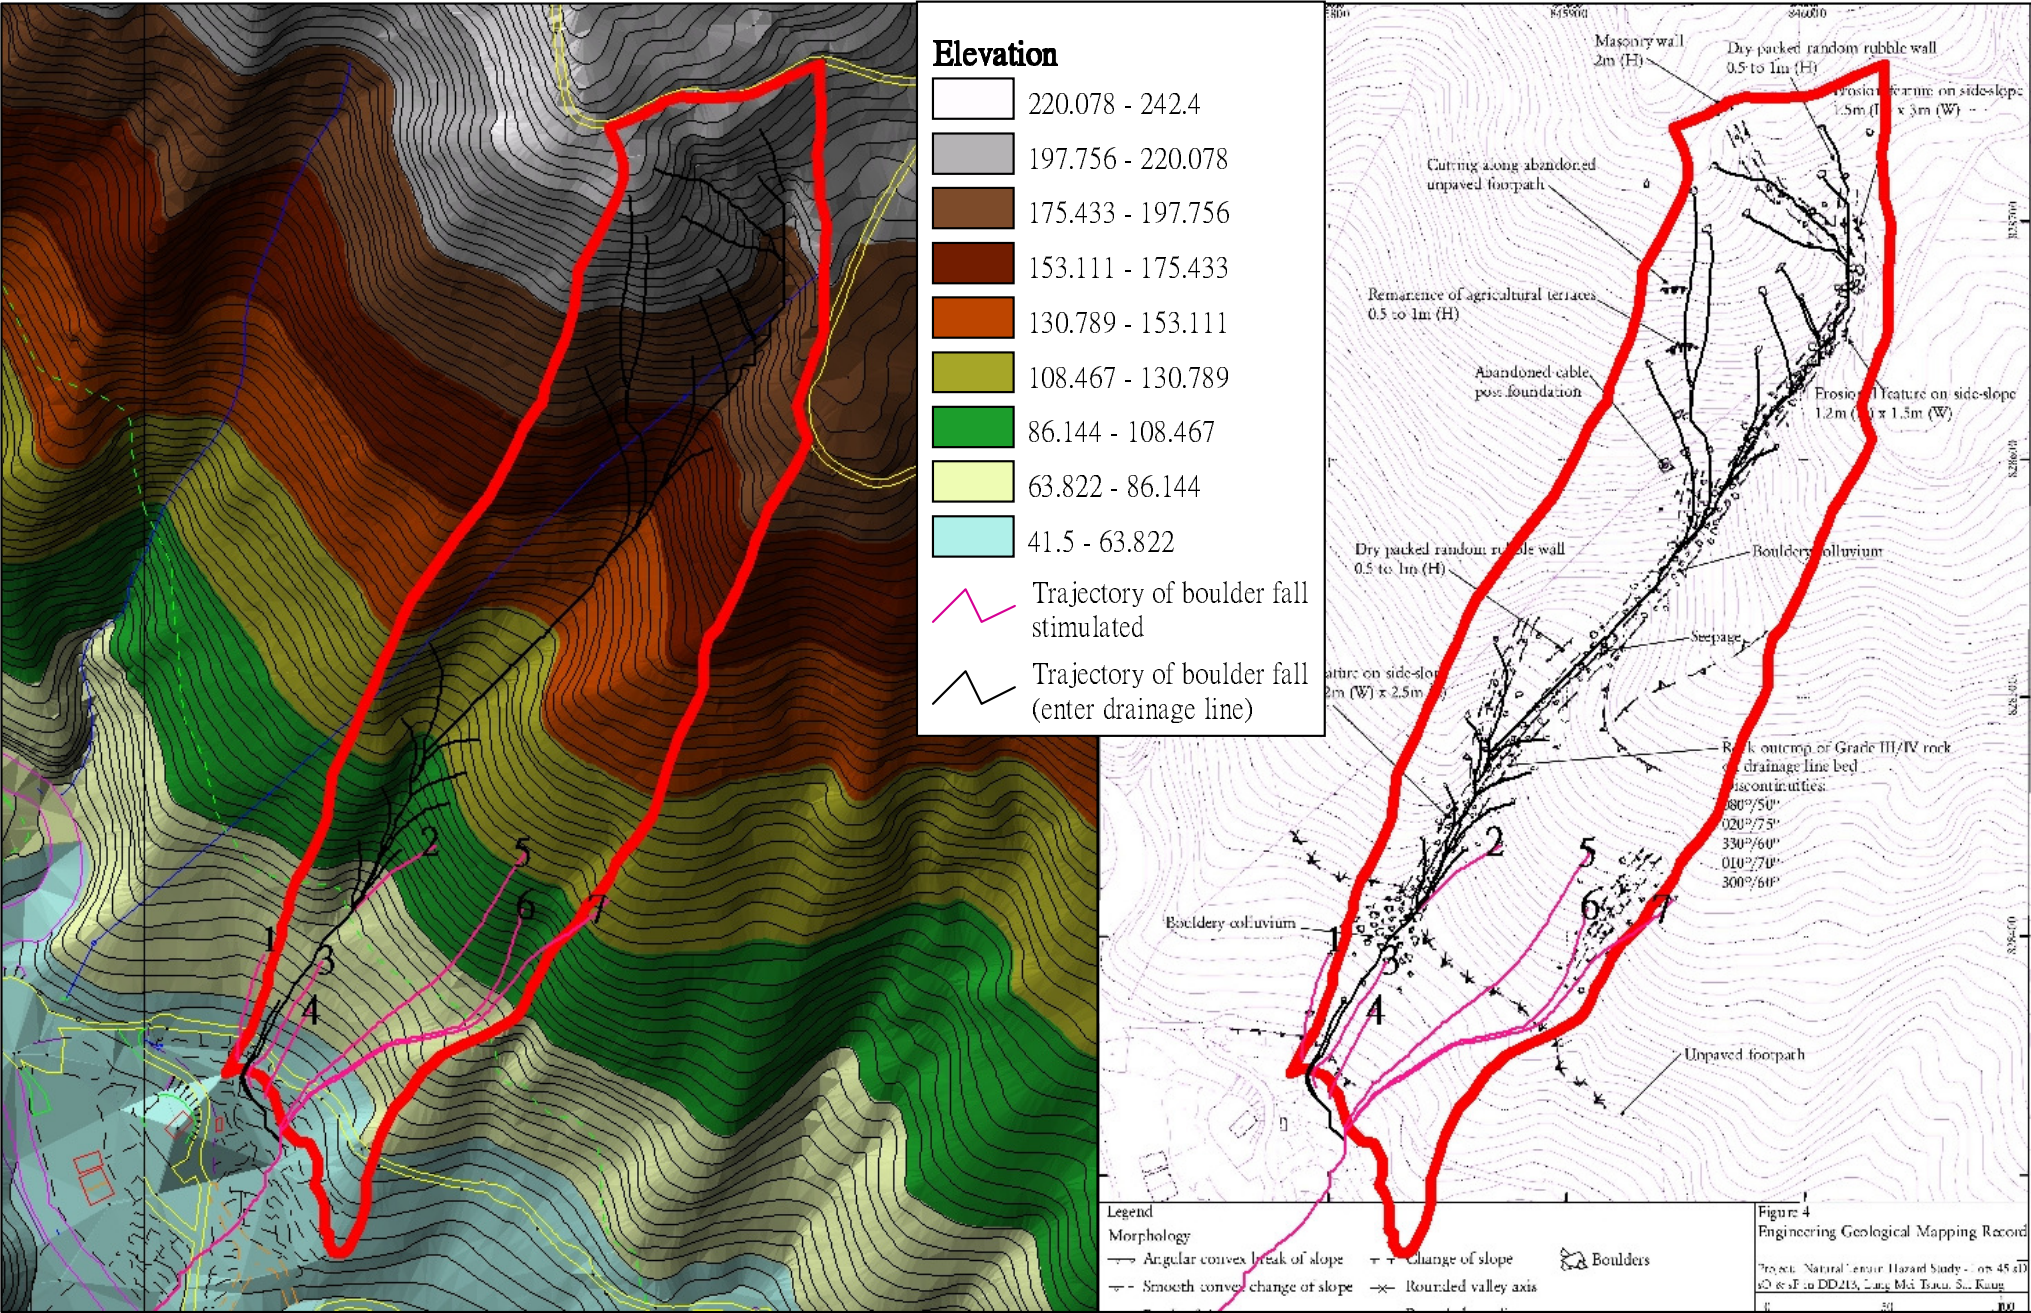
Figure S1 – Trajectories of potential boulder fall

In field mapping, boulders with various sizes ranged from 0.2m to 2.5m were found within the study area. The potential trajectories of these boulders are generated on a digital elevation model developed from 1:1,000 topographic map. The trajectories show that boulders deposited on the upper and middle portions of the middle slope terrain would enter the drainage lines once triggered. Seven boulders on the lower portion of the middle slope terrain and the lower slope terrain have potential trajectories would reach the proposed development. The trajectories are given in Figure S5. Boulder fall hazard assessment of the 7 boulders have been assessed on software CRSP by considering the most unfavourable spherical shape of the boulder with a maximum diameter of 2.5m. The parameters are estimated from field mapping and reference to Chau et al, 1996, which are summarised in Table 6.3. The assessment results are presented in Figures S6 to S12 and summarised in Table 6.3, which show that no boulder would fall in and in the vicinity of the proposed development. Therefore, there was no boulder fall hazard within the study area.

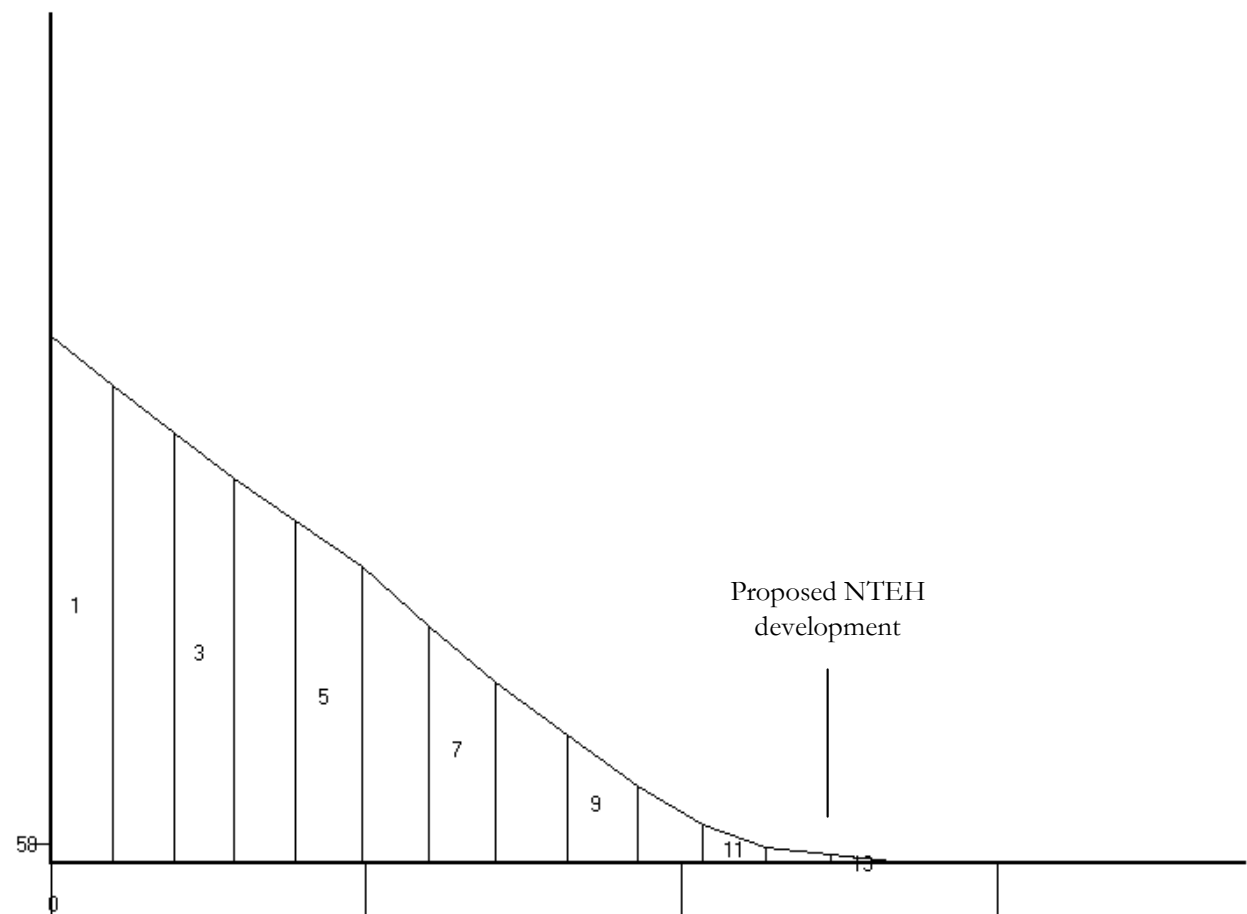
Figure S2 – Trajectory 1

Scale: Each division = 20 metrs

Rocks Left to Roll: 0

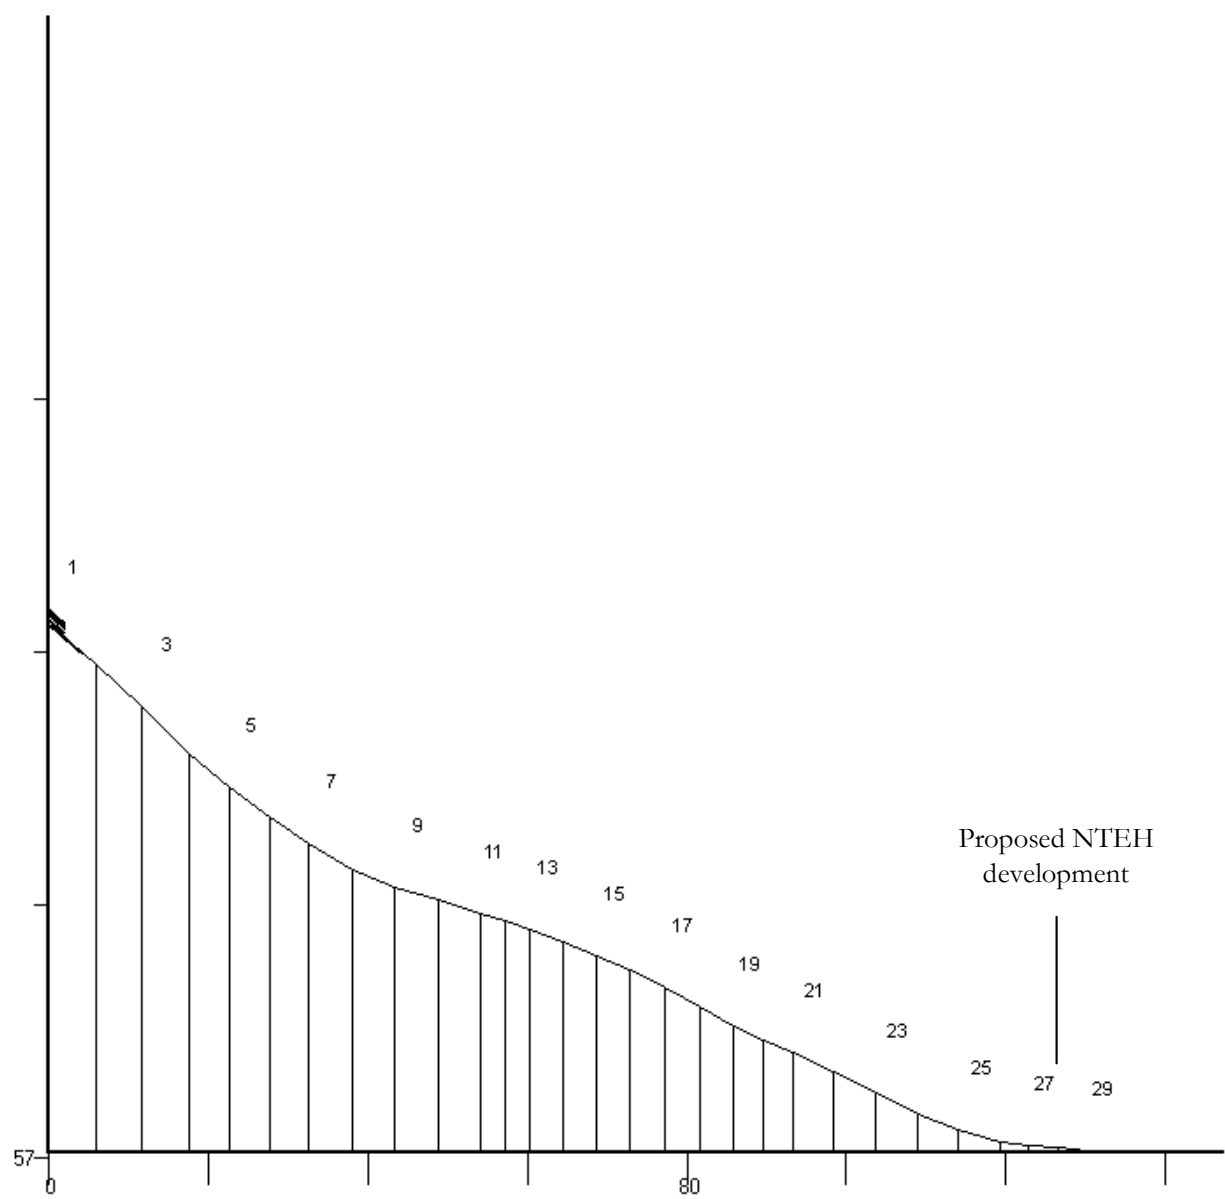
Figure S3 – Trajectory 2

Scale: Each division = 20 metre

Rocks Left to Roll: 0

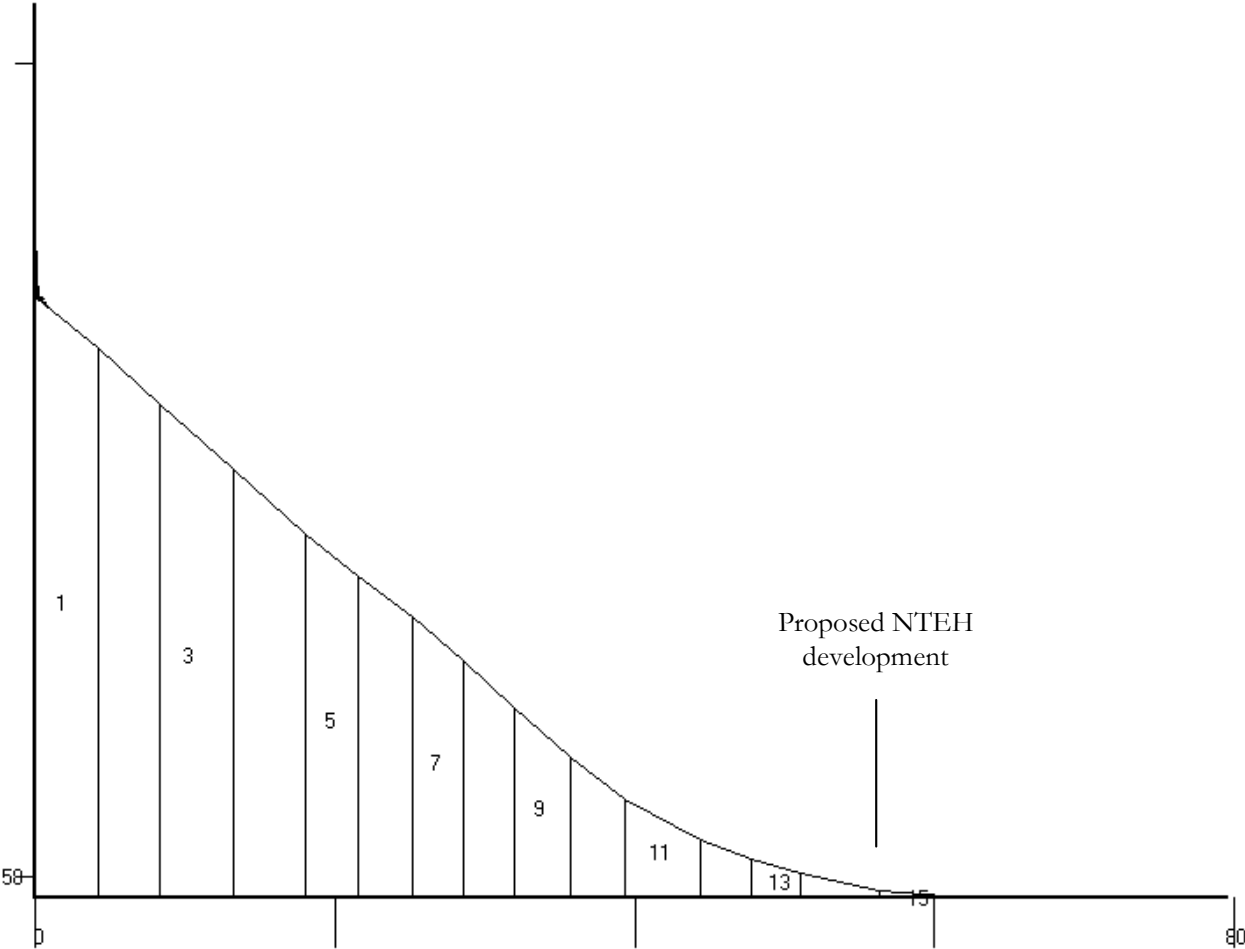
Figure S4 – Trajectory 3

Scale: Each division = 20 metre

Rocks Left to Roll: 0

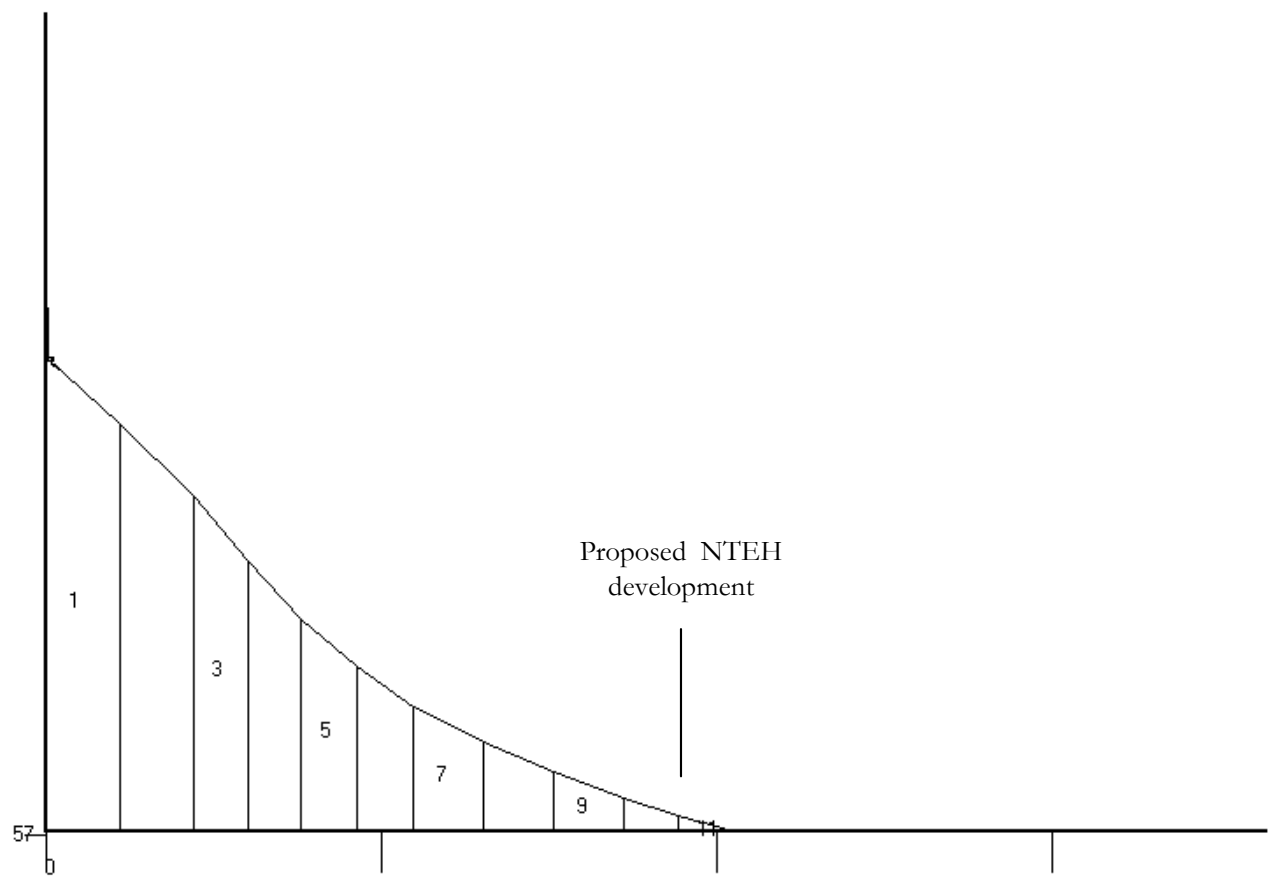
Figure S5 – Trajectory 4

Scale: Each division = 20 metre

Rocks Left to Roll: 0

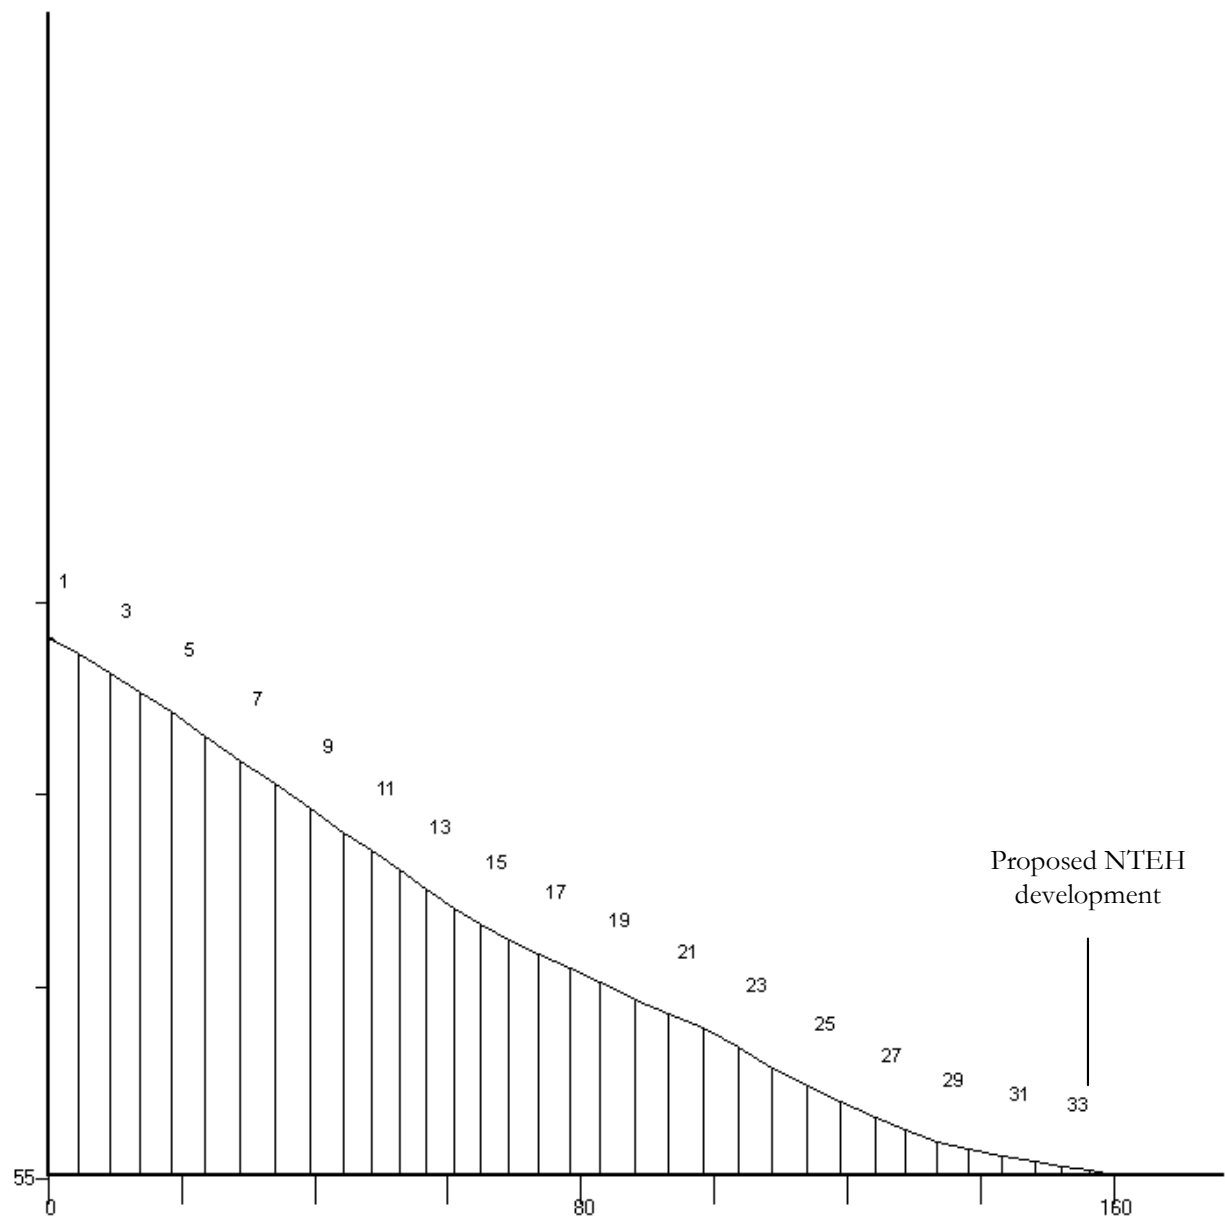
Figure S6 – Trajectory 5

Scale: Each division = 20 metre

Rocks Left to Roll: 0

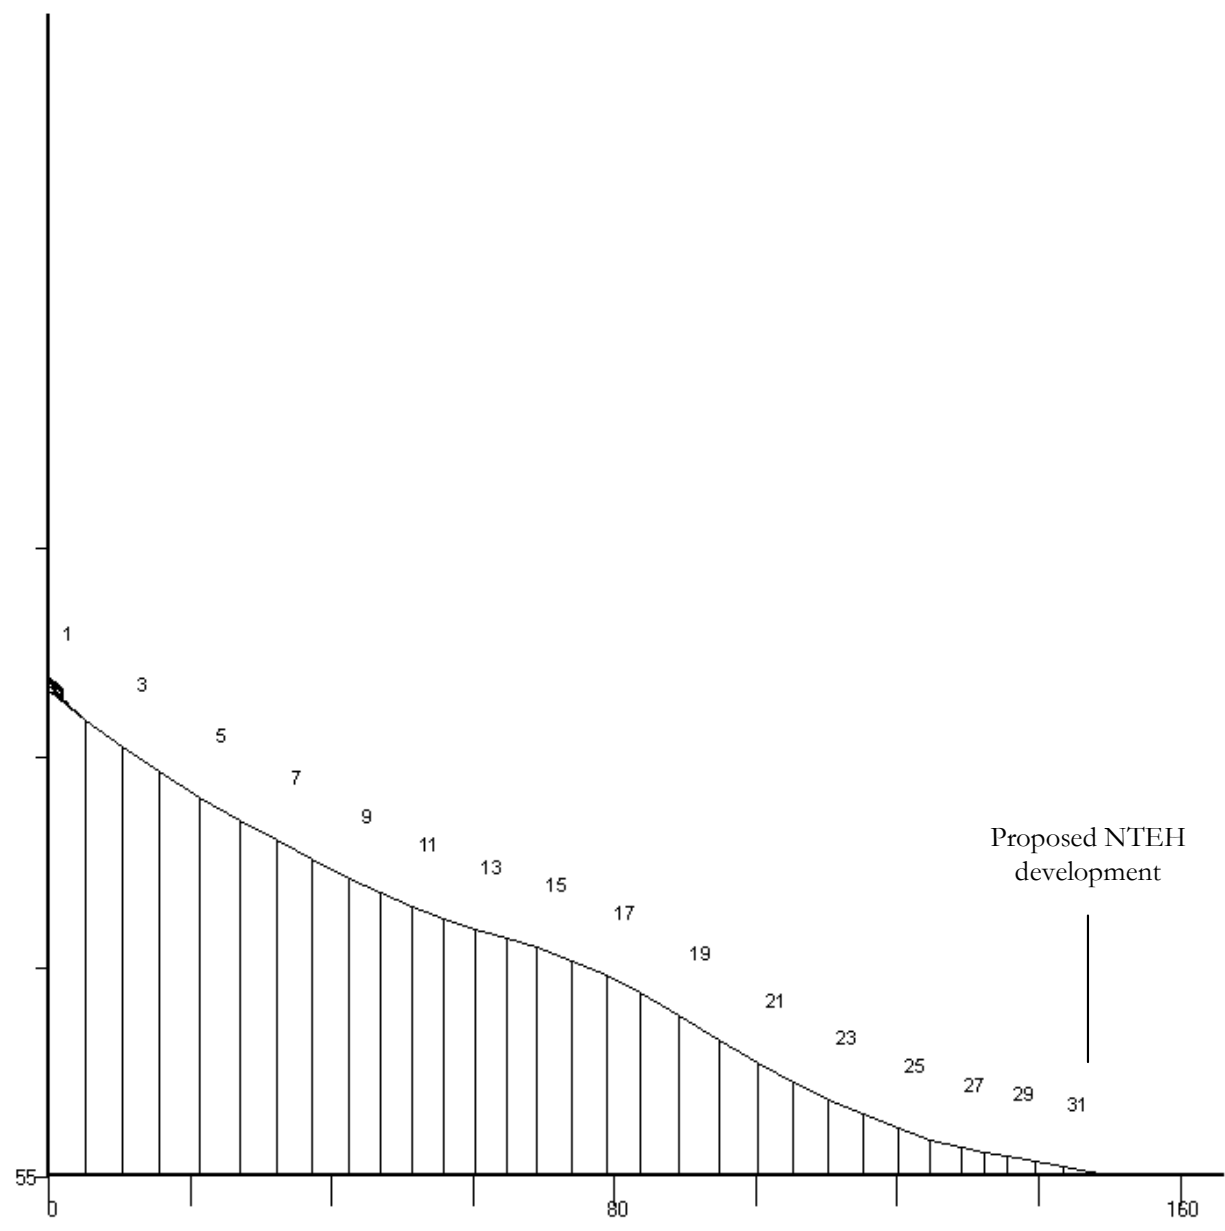
Figure S7 – Trajectory 6

Scale: Each division = 20 metre

Rocks Left to Roll: 0

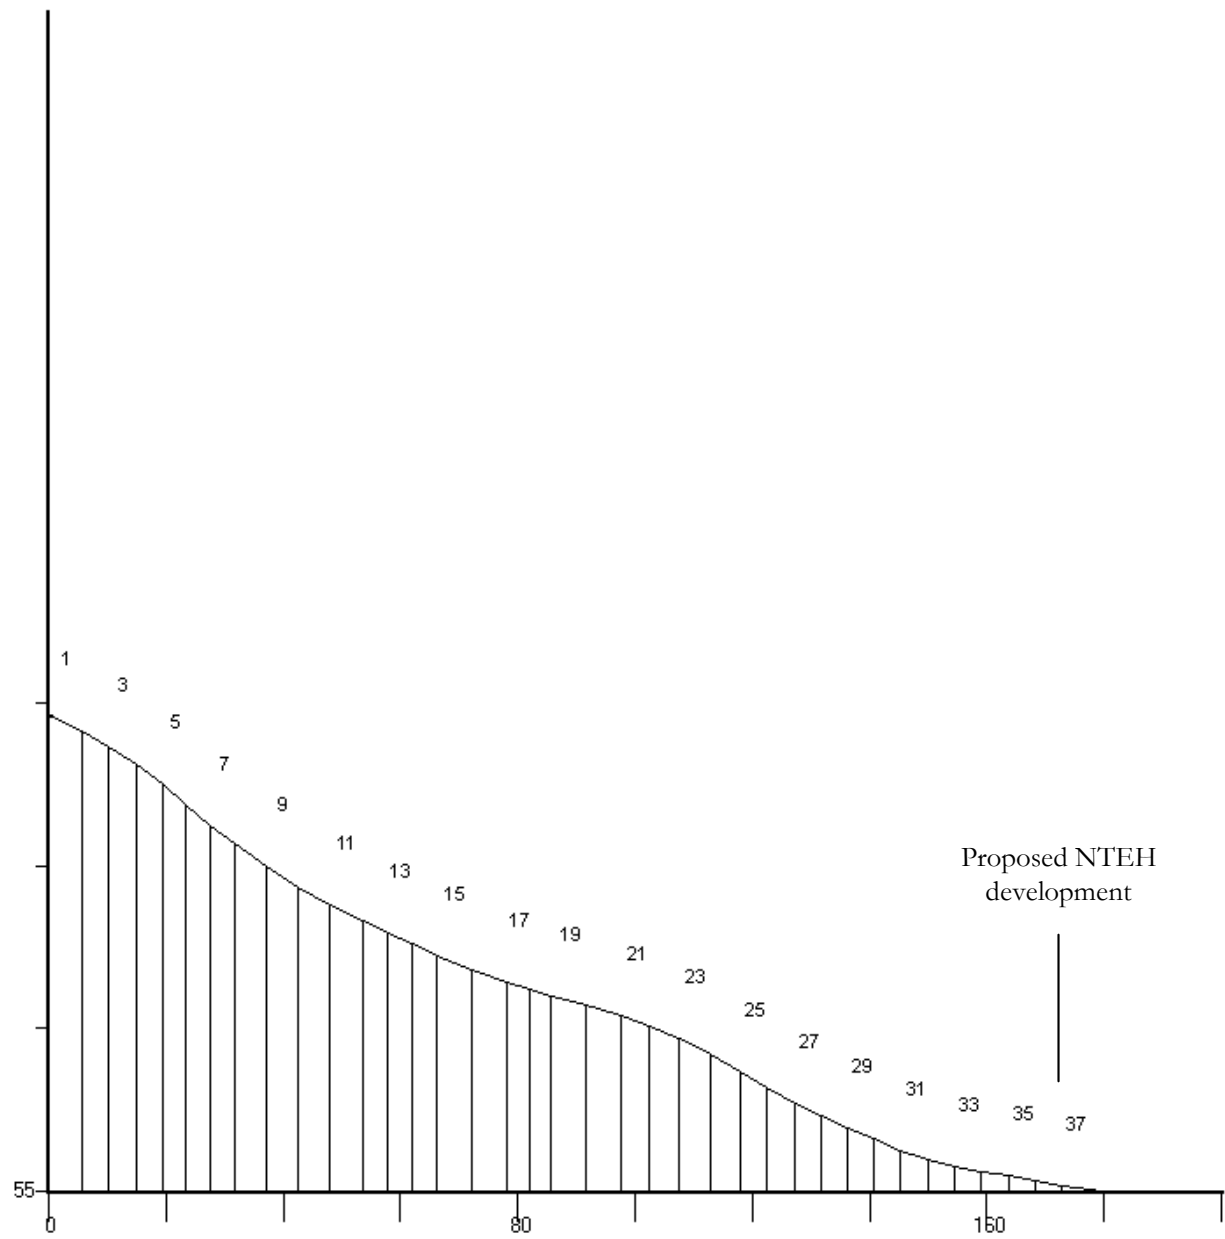
Figure S8 – Trajectory 7

Scale: Each division = 20 metre

Rocks Left to Roll: 0
