### **Tree Preservation and Removal Proposal**

**Proposed Development at  
Fanling Sheung Shui Town Lot No. 245,  
On Kui Street, Fanling, New Territories**

**TREE PRESERVATION AND REMOVAL PROPOSAL  
(PINK AREA)  
RE-SUBMISSION**

**Oriental Landscapes Limited**  
**東方綠化有限公司**

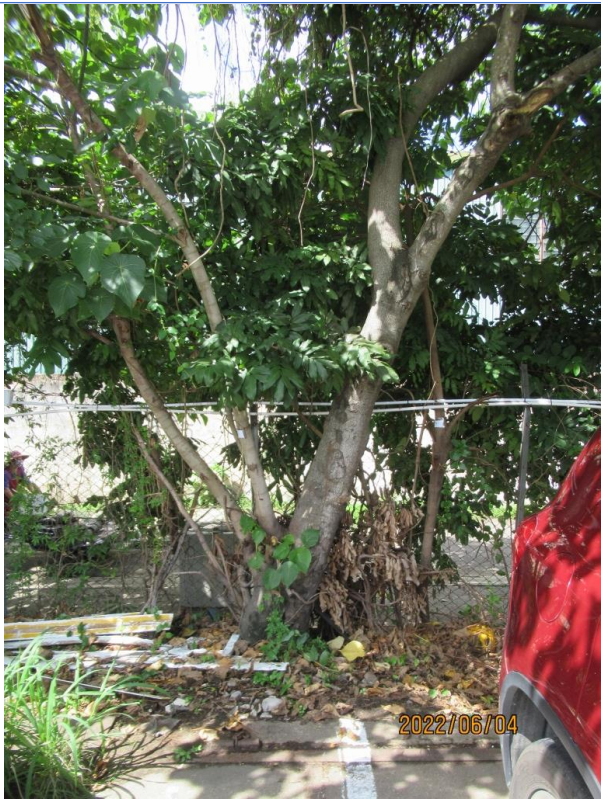
T21 Lower Trunk & Ground Condition - FELL
