# Tree Survey Report

**Date of Survey: 11<sup>th</sup> February 2025**

**Various Lots in D.D. 91 And D.D.100, Lin Tong Mei, Fanling,  
New Territories**

PROJECT  
 PROPOSED TEMPORARY  
 WAREHOUSE (EXCLUDING  
 DANGEROUS GOODS GODOWN)  
 WITH ANCILLARY FACILITIES  
 FOR A PERIOD OF 3 YEARS AND  
 ASSOCIATED FILLING OF LAND

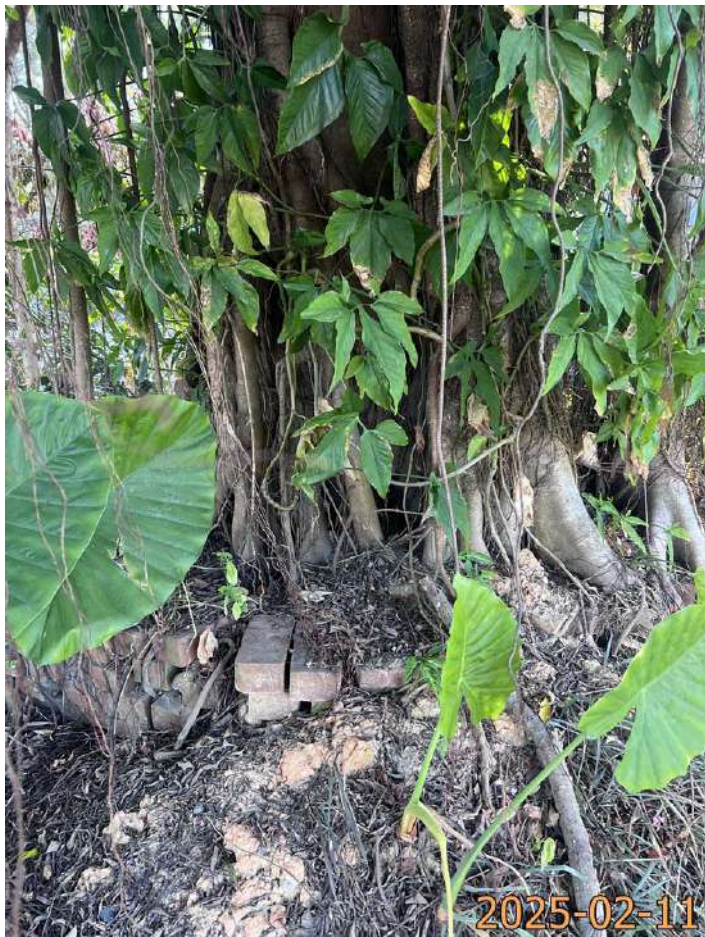
| Tree No. | Tree Species | | Tree Size Measurements | | | Amenity Value | Form | Health Condition | Structural Condition | Suitability for Transplanting | Remarks |
|---|--|---|---|---|---|---|---|---|---|---|--|
| T1 | <i>Ficus microcarpa</i> | 榕樹(細葉榕) | 14.0 | 700 | 11.0 | Low | Fair | Fair | Poor | Low | epiphytic plants, restricted root |

T1 Restricted root

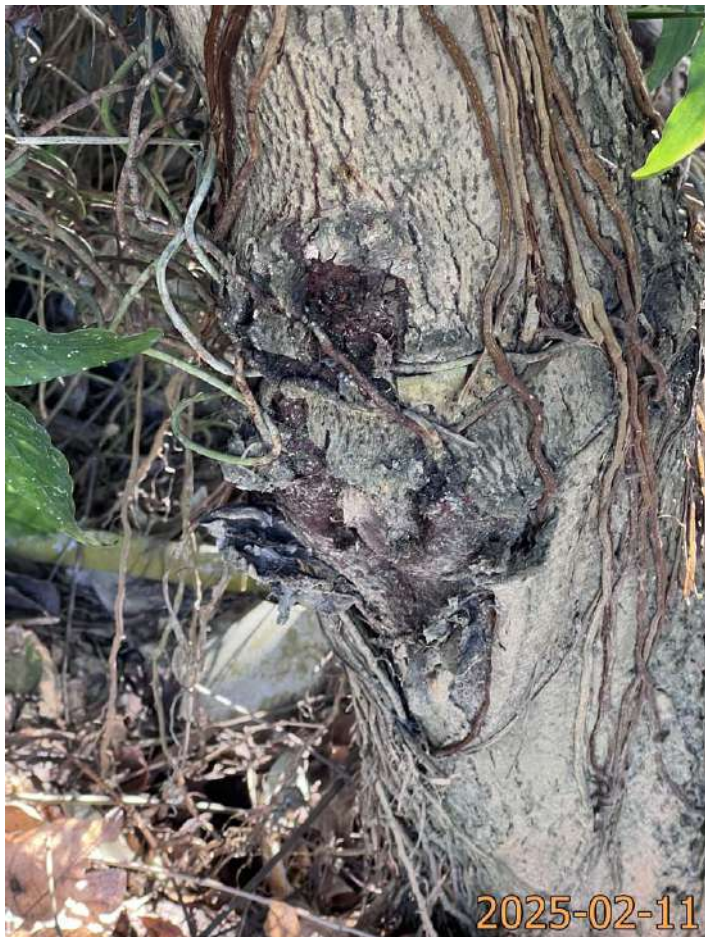
| Tree No. | Tree Species | | Tree Size Measurements | | | Amenity Value | Form | Health Condition | Structural Condition | Suitability for Transplanting | Remarks |
|---|--|---|---|---|---|---|---|---|---|---|--|
| T2 | <i>Sterculia lanceolata</i> | 假蘋婆 | 4.0 | 120 | 2.0 | Low | Fair | Fair | Poor | Low | leaning, wound on branch and trunk, epiphytic plants |

T2 Wound on trunk

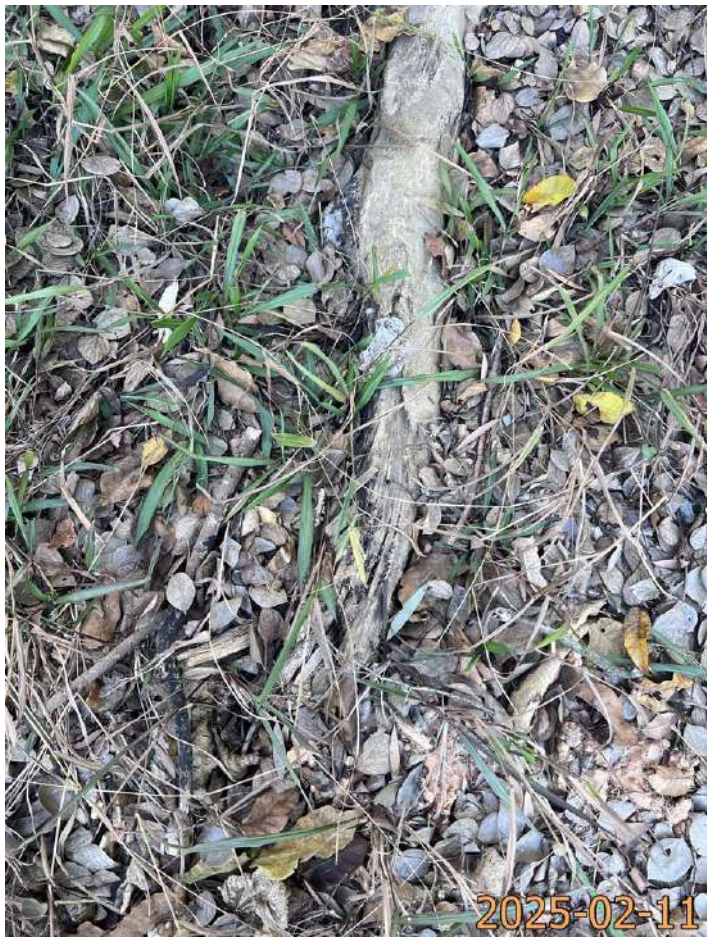
| Tree No. | Tree Species | | Tree Size Measurements | | | Amenity Value | Form | Health Condition | Structural Condition | Suitability for Transplanting | Remarks |
|---|--|---|---|---|---|---|---|---|---|---|--|
| T4 | <i>Celtis sinensis</i> | 朴樹 | 13.0 | 260 | 7.0 | Low | Fair | Fair | Poor | Low | co-dominant stems, exposed dead root, wound on trunk, epiphytic plants |

T4 Exposed dead root

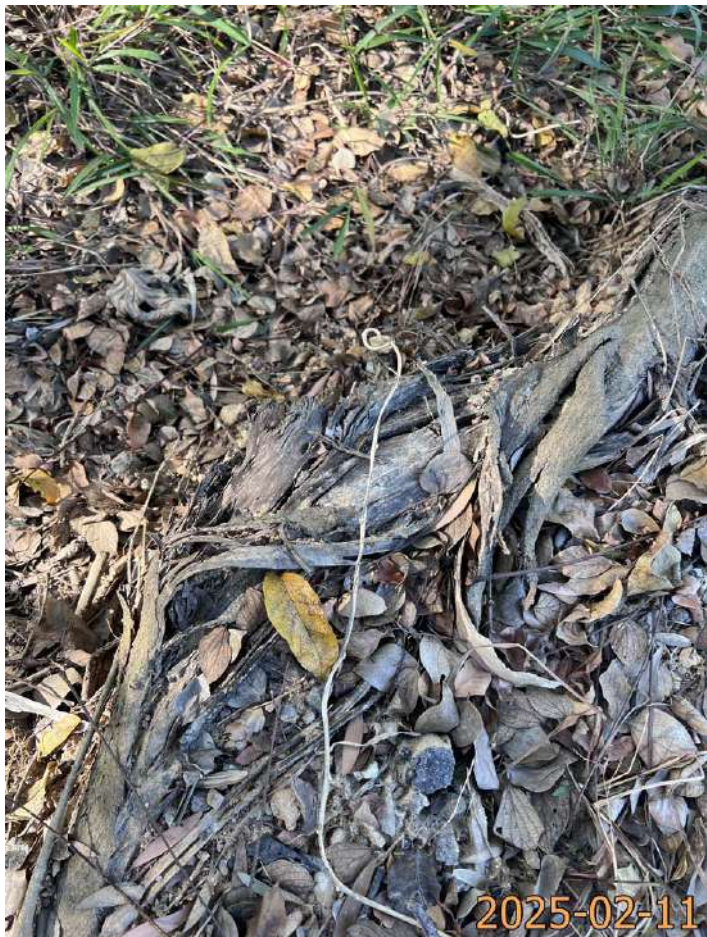
| Tree No. | Tree Species | | Tree Size Measurements | | | Amenity Value | Form | Health Condition | Structural Condition | Suitability for Transplanting | Remarks |
|---|--|---|---|---|---|---|---|---|---|---|--|
| T5 | <i>Chukrasia tabularis</i> | 麻棟 | 13.0 | 320 | 5.0 | Low | Fair | Fair | Poor | Low | dead branch, wound on trunk, exposed dead root |

T5 Exposed dead root

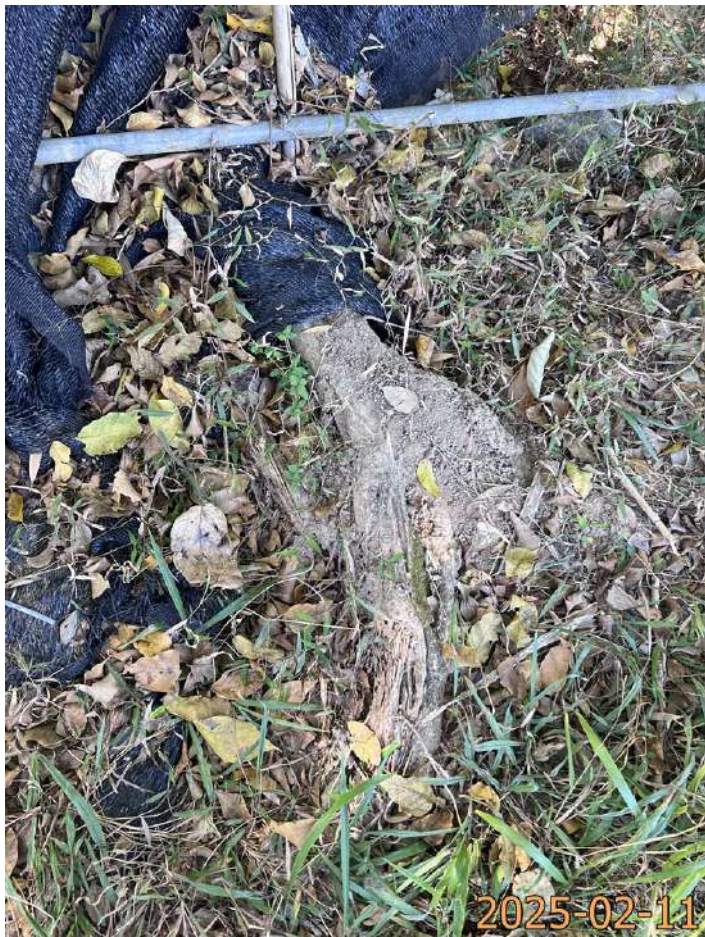
| Tree No. | Tree Species | | Tree Size Measurements | | | Amenity Value | Form | Health Condition | Structural Condition | Suitability for Transplanting | Remarks |
|---|--|---|---|---|---|---|---|---|---|---|--|
| T8 | <i>Ficus benjamina</i> | 垂葉榕 | 9.0 | 250 | 6.0 | Low | Fair | Fair | Poor | Low | exposed dead root |

T8 Exposed dead root

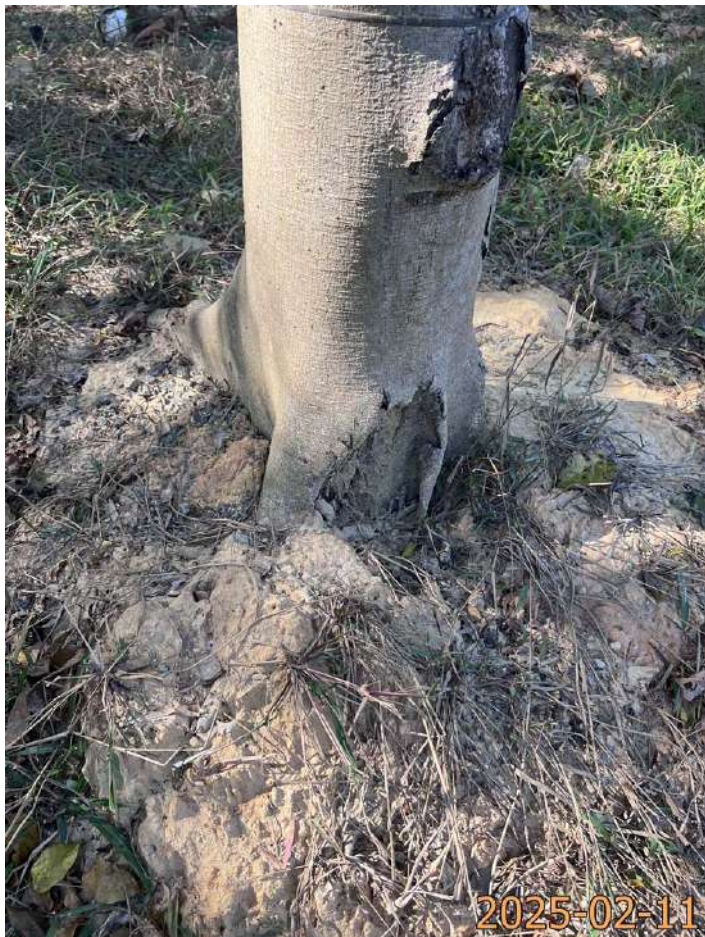
| Tree No. | Tree Species | | Tree Size Measurements | | | Amenity Value | Form | Health Condition | Structural Condition | Suitability for Transplanting | Remarks |
|---|--|---|---|---|---|---|---|---|---|---|--|
| T9 | <i>Ficus variegata</i> | 青果榕 | 9.0 | 240 | 9.0 | Low | Poor | Fair | Poor | Low | wound on trunk, dead stub |

T9 Wound on trunk\_2

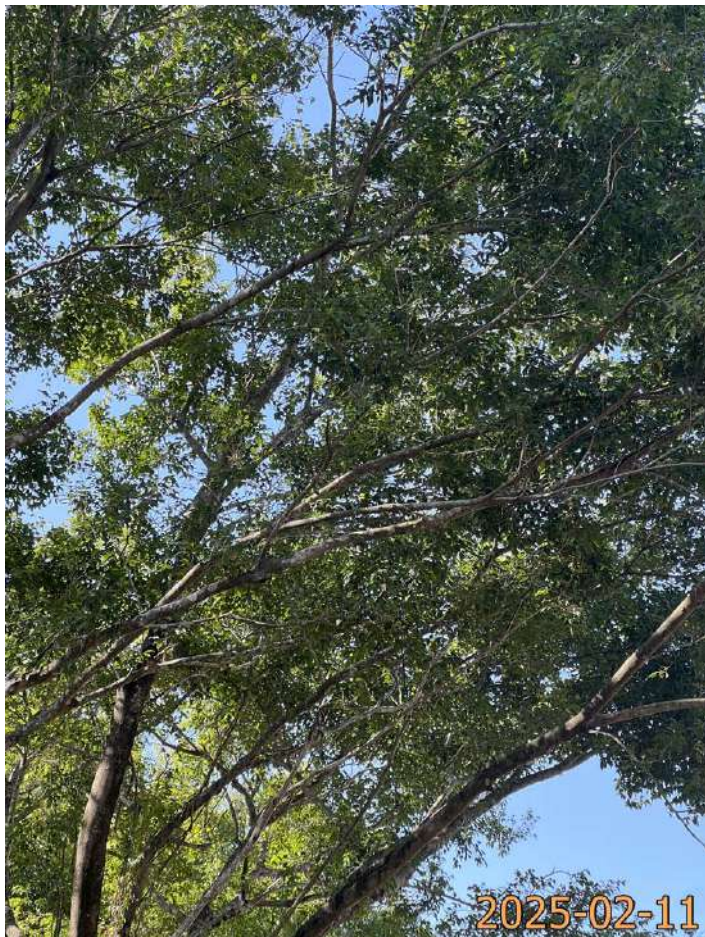
| Tree No. | Tree Species | | Tree Size Measurements | | | Amenity Value | Form | Health Condition | Structural Condition | Suitability for Transplanting | Remarks |
|---|--|---|---|---|---|---|---|---|---|---|--|
| T11 | <i>Ficus benjamina</i> | 垂葉榕 | 12.0 | 420 | 7.0 | Low | Fair | Fair | Poor | Low | cross branches |

T11 Cross branches

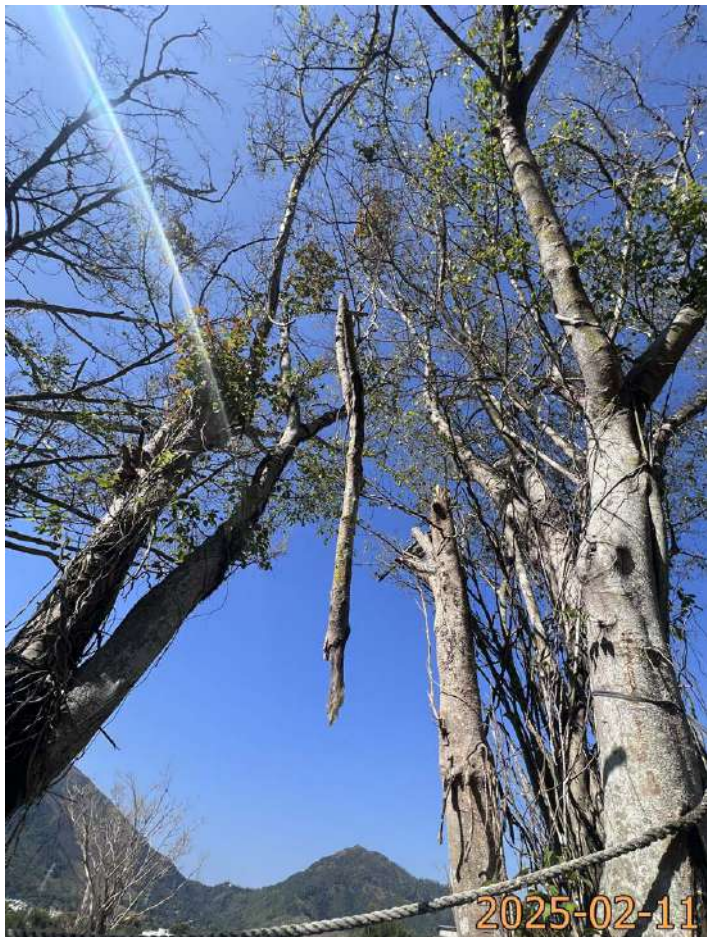
| Tree No. | Tree Species | | Tree Size Measurements | | | Amenity Value | Form | Health Condition | Structural Condition | Suitability for Transplanting | Remarks |
|---|--|---|---|---|---|---|---|---|---|---|--|
| T15 | <i>Ficus benjamina</i> | 垂葉榕 | 11.0 | 500 | 6.0 | Low | Poor | Poor | Poor | Low | dying tree, dieback, dead trunk, hanger, wound on trunk |

T15 Hanger

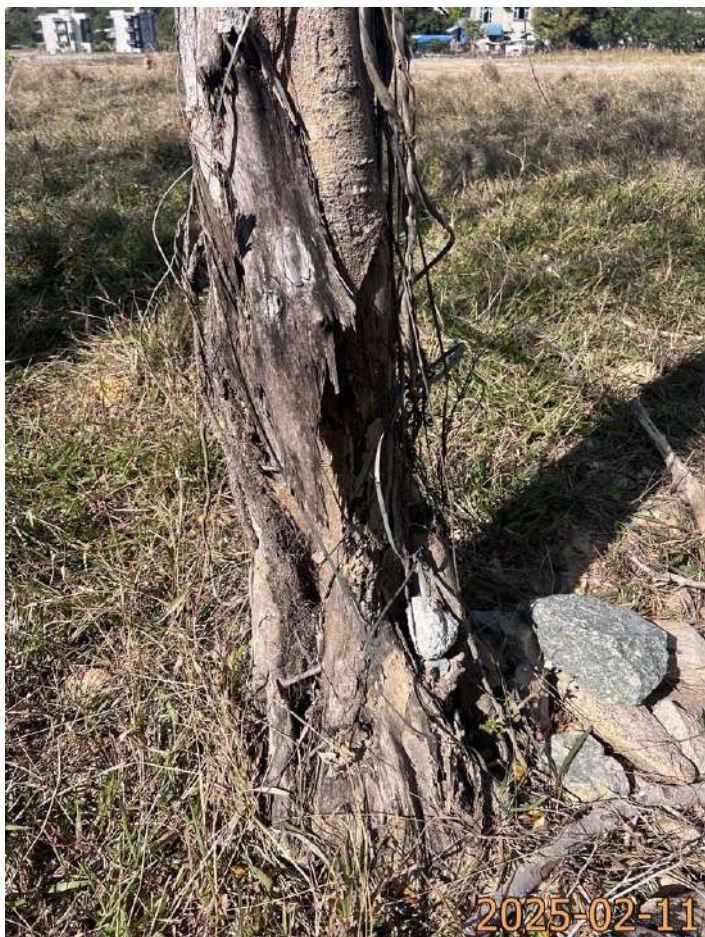
| Tree No. | Tree Species | | Tree Size Measurements | | | Amenity Value | Form | Health Condition | Structural Condition | Suitability for Transplanting | Remarks |
|---|--|---|---|---|---|---|---|---|---|---|--|
| T16 | <i>Ficus benjamina</i> | 垂葉榕 | 11.0 | 280 | 3.0 | Low | Poor | Poor | Poor | Low | dying tree, dieback, dead trunk, wound on trunk with exposed deadwood, trace of termite |

T16 Wound on trunk with exposed deadwood (Trace of

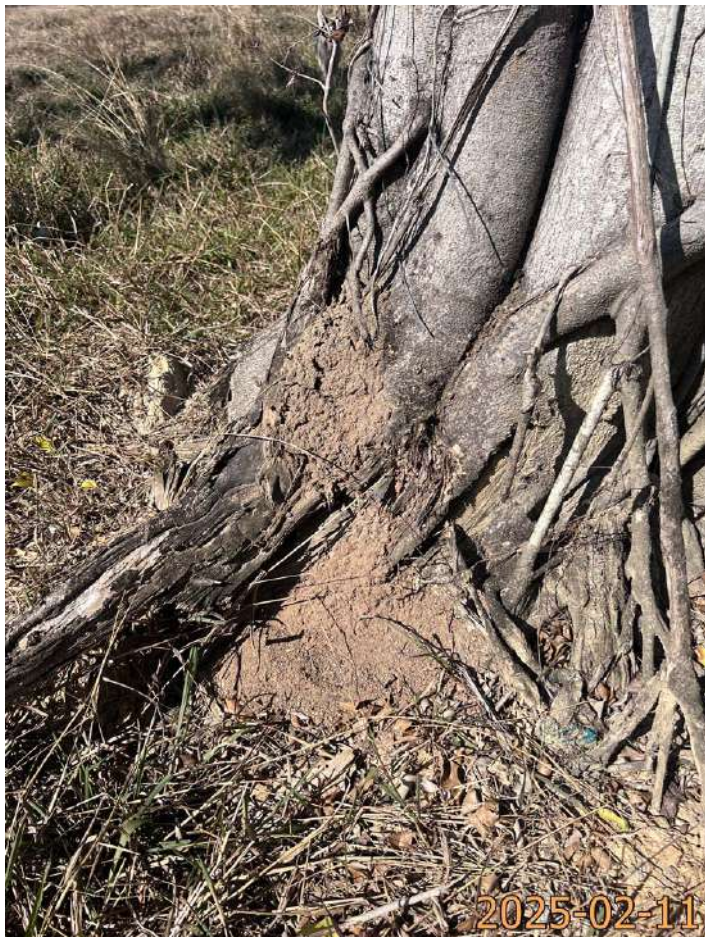
T17 Trace of termite

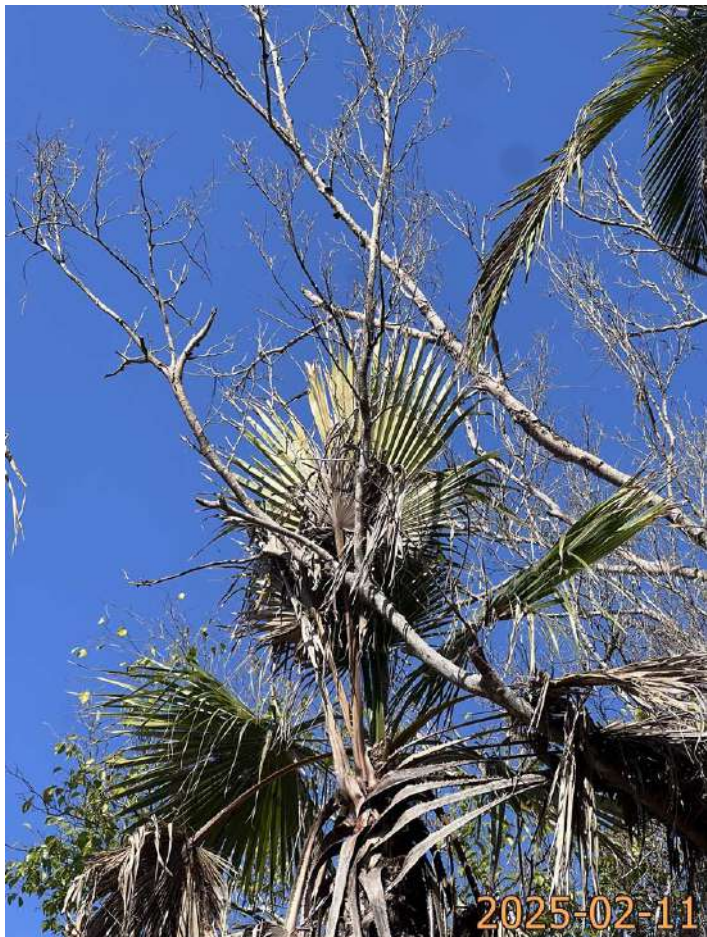
T19 Crown conflict with branch of T17

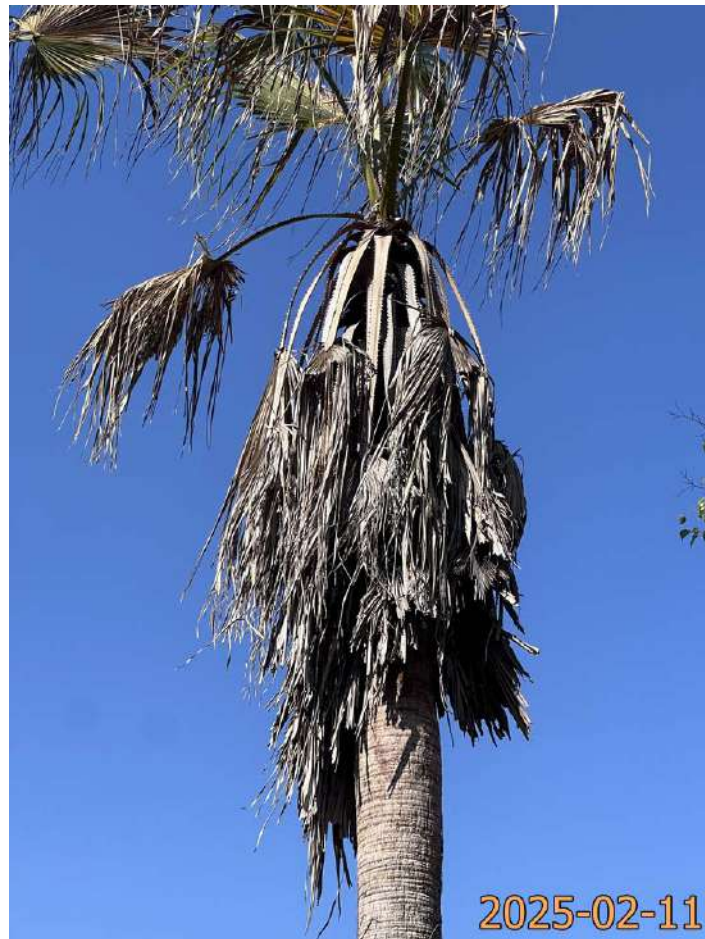
T20 Dead fronds

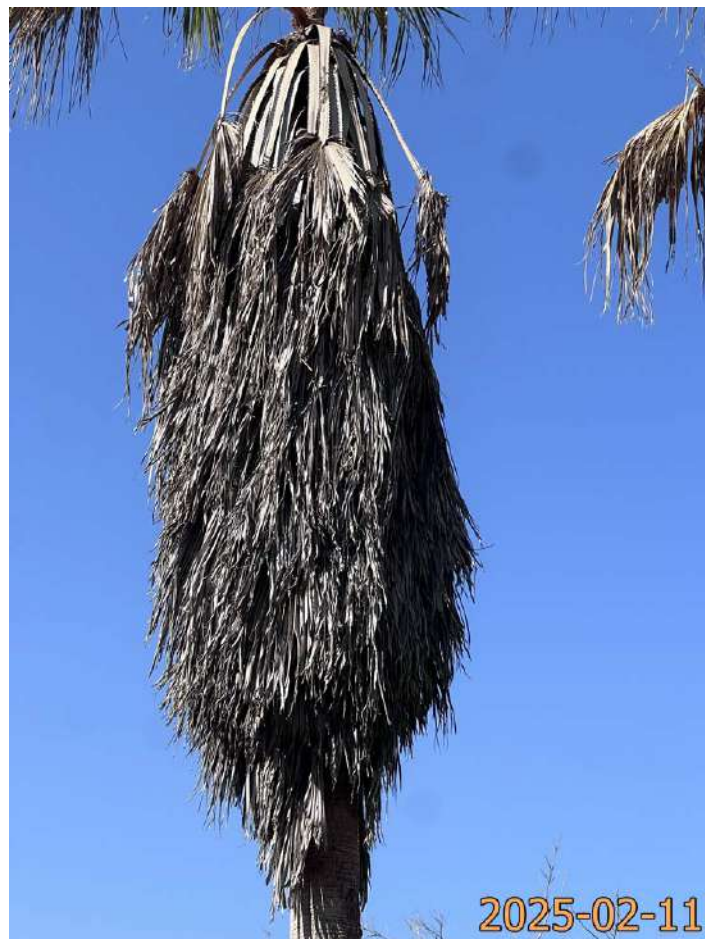
T21 Dead fronds

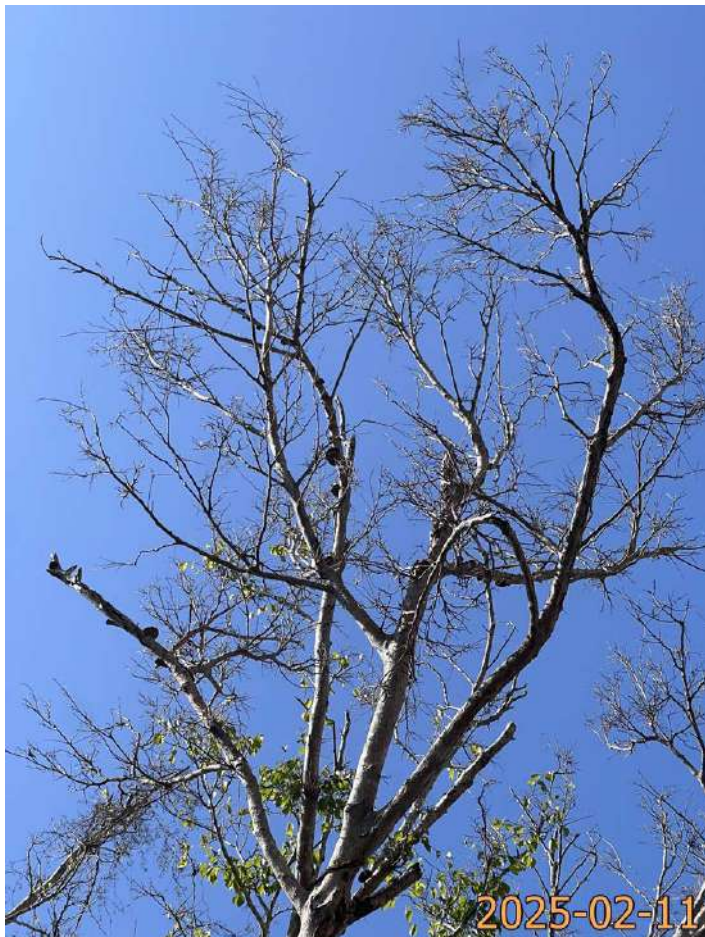
T22 Dieback

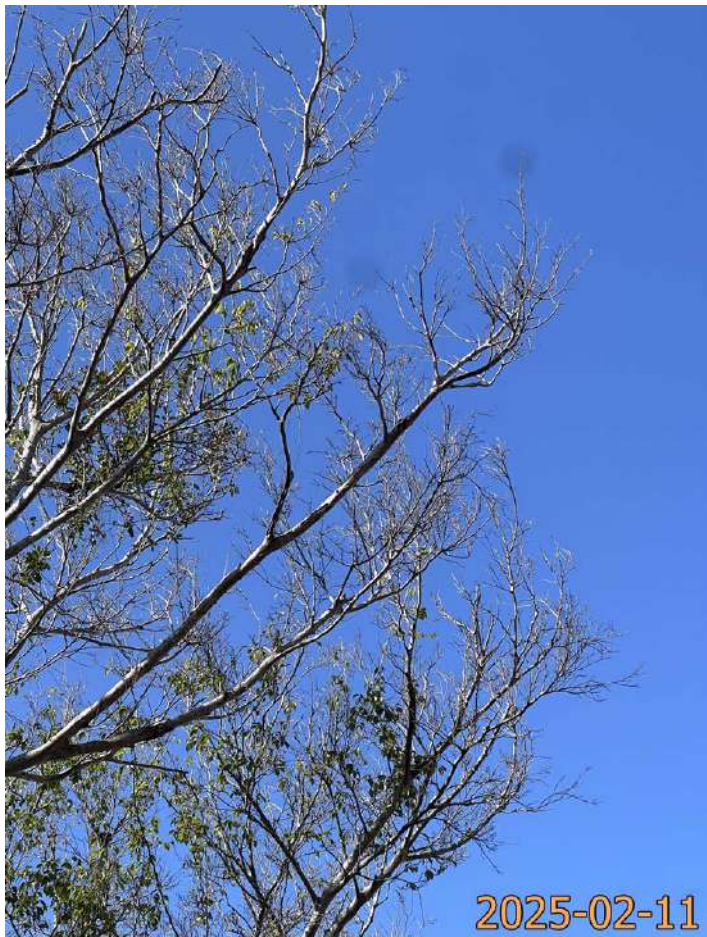
T23 Dieback
