TREE GROUP INSPECTION REPORT FOR

LOT NO. 478 S.A. RP, 479, 487, 484 & 482 IN

D.D. 90

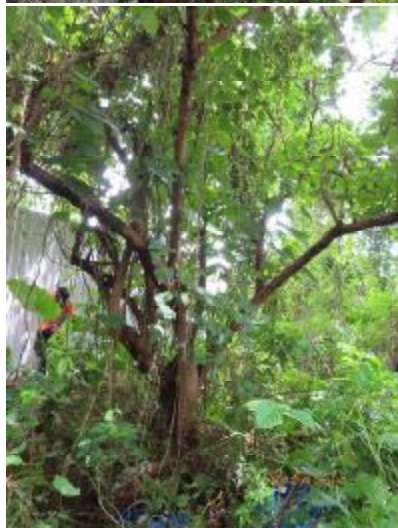
T6	<i>Macaranga tanarius</i> var. tomentosa	血桐	270	5	6	Low	Fair	Fair	Fair	Low	Native	wound (trunk), vine
T7	<i>Leucaena leucocephala</i>	銀合歡	100	7	4	Low	Fair	Fair	Fair	Low	Native	vine
T8	<i>Leucaena leucocephala</i>	銀合歡	376	9	8	Low	Fair	Fair	Fair	Low	Exotic	wound (trunk), restricted root, multi-trunks, vine
T9	<i>Leucaena leucocephala</i>	銀合歡	26	8	7	Low	Fair	Fair	Fair	Low	Exotic	restricted root, vine
T10	<i>Ficus hispida</i>	對葉榕	255	4	5	Low	Fair	Fair	Fair	Low	Native	restricted root, multitrunks, vine
T11	<i>Ficus hispida</i>	對葉榕	100	4	2	Low	Poor	Fair	Poor	Low	Native	wound (trunk), lean, bent (trunk), cracks, vine,
T12	<i>Ficus hispida</i>	對葉榕	194	4	4	Low	Poor	Fair	Poor	Low	Native	lean, codominant trunks, vine
T13	<i>Leucaena leucocephala</i>	銀合歡	270	8	7	Low	Poor	Fair	Poor	Low	Exotic	lean, restricted root, vine
T14	<i>Macaranga tanarius</i> var. tomentosa	血桐	470	7	9	Low	Poor	Fair	Poor	Low	Native	wound (trunk), fungal, cross branches, exposed root, dead branches
