Natural Terrain Hazard Study
(Application number A/SK-CWBS/17)

**Natural Terrain Hazard Study
for Proposed Filling of Land and
Excavation of Land for Permitted 2-Storey on Farm
Domestic Structure at Lot No. 30 (Part)
in D.D. 233, East of Clear Water Bay Road,
Sai Kung,
New Territories**

CHUNG KWOK-FAI, EDWIN
MASc. B Eng C Eng FHKIE
Registered Structural Engineer
Registered Geotechnical Engineer

August 2014

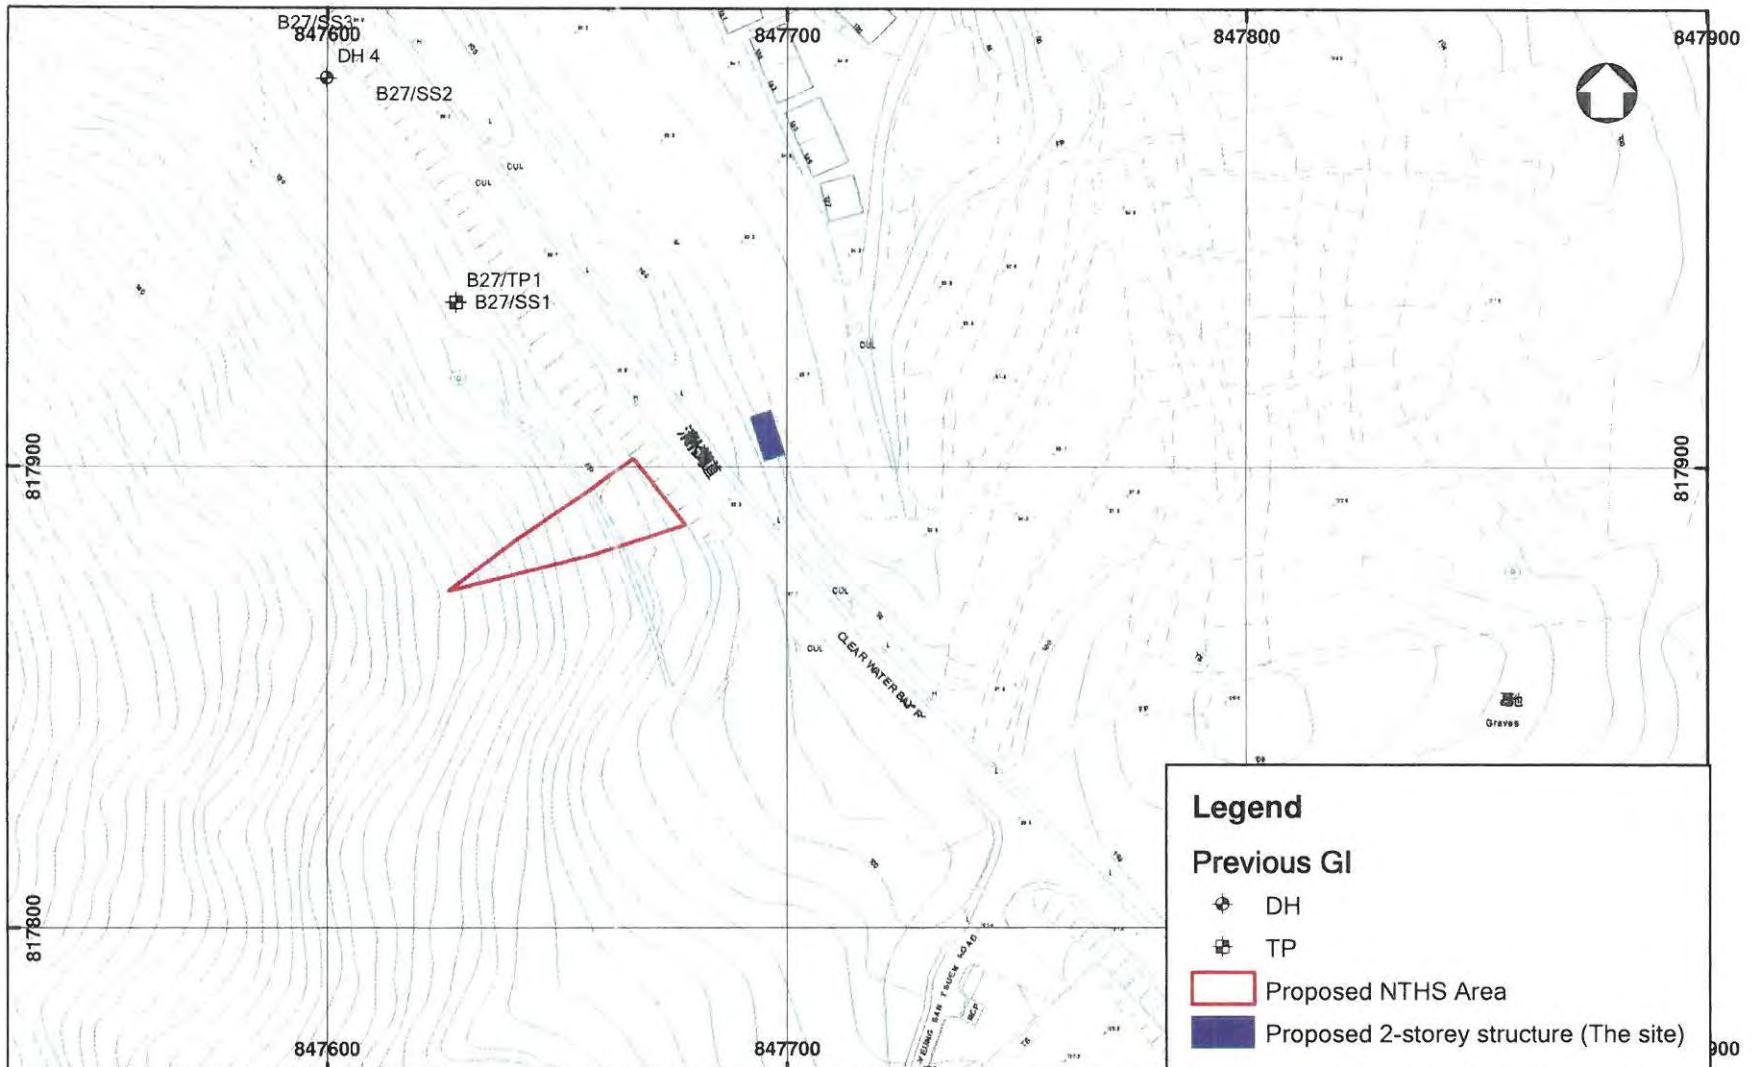
FIGURE NO :
FIGURE 6

There is no previous ground investigation work has been carried out within the Study Area. The nearest trial pit and borehole were located at the crest of the man-made Feature No. 12NW-C/C106 and about 45 m and 100 m to the northwest of the Study Area respectively (Figure 6). Both GI stations indicated about 2.0 m thick colluvium overlying the completely to highly decomposed volcanic rock. The colluvium typically comprises firm, yellowish brown, slightly sandy silty Clay with some gravel and cobbles.

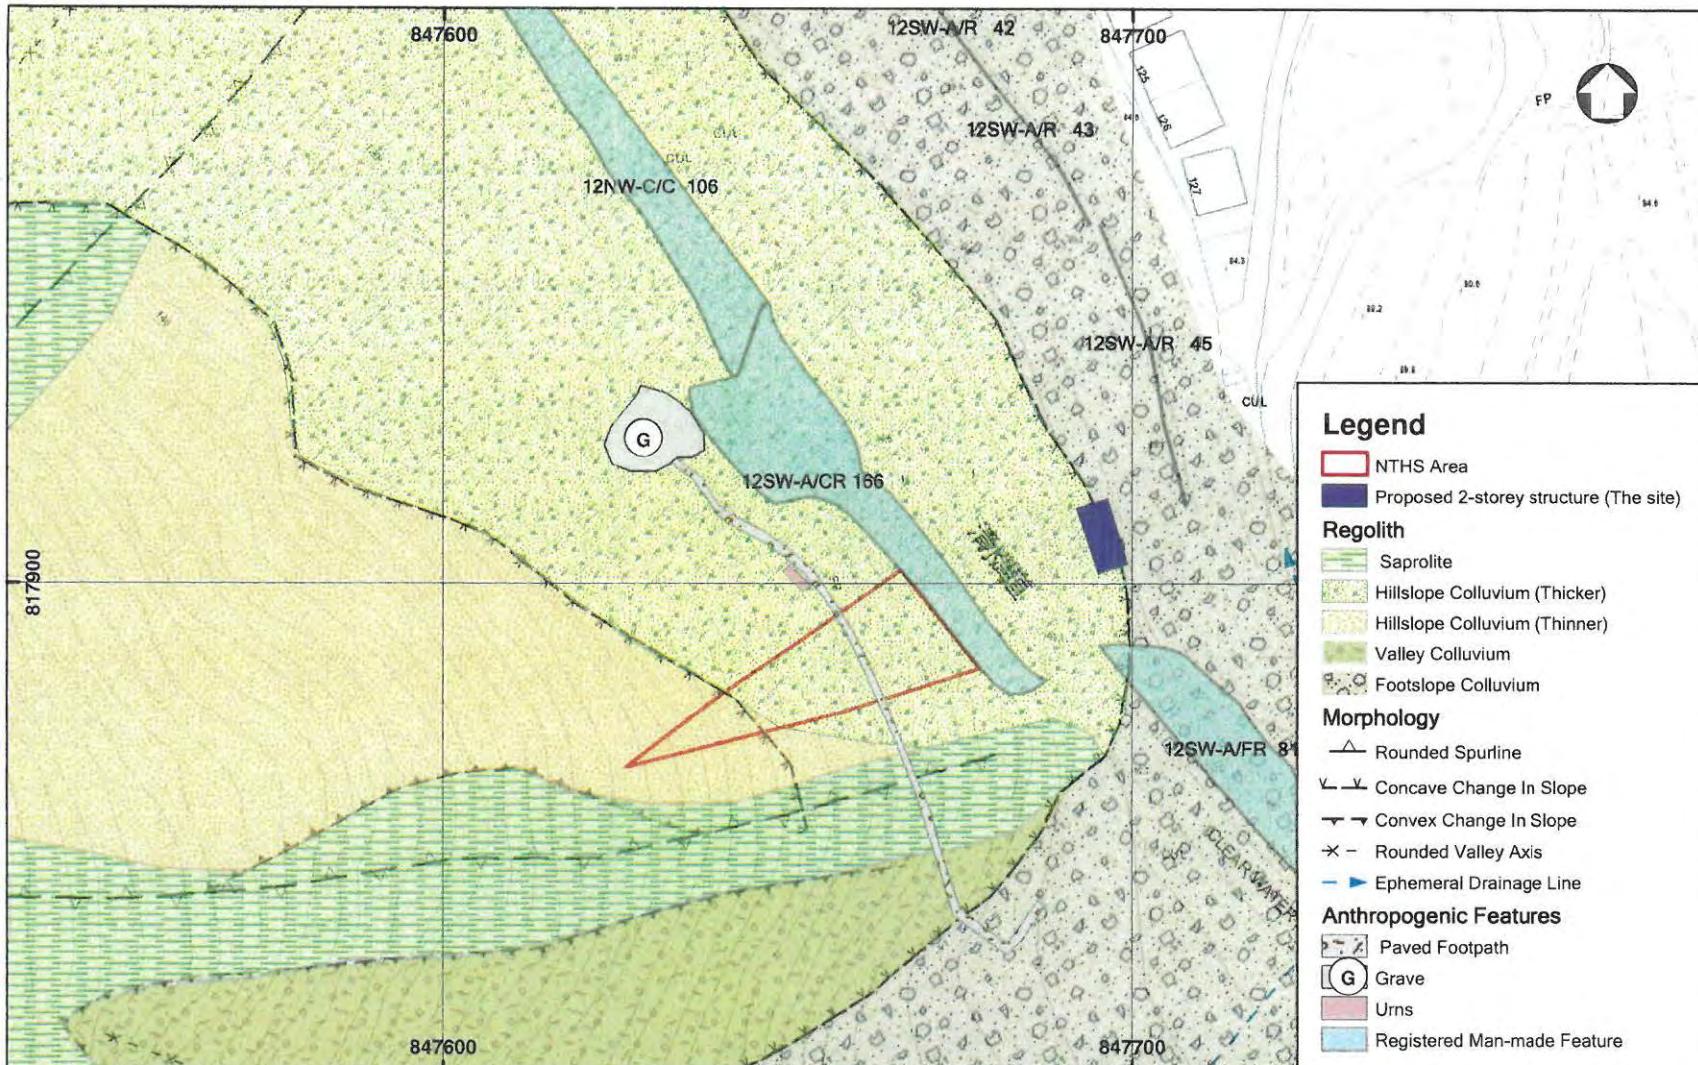
FIGURE NO :
FIGURE 8

Figure 8 illustrates the mapped regolith types within the Study Area which generally include open hillslope colluvium deposit over the entire Study Area.

Majority of the hillslope within the Study Area was covered by open hillslope colluvium which generally consisted of firm, reddish brown dappled grey, slightly sandy, slightly clayey SILT with some subangular fine to coarse gravel and occasional cobbles (Plate 4).

Major anthropogenic features within and in the vicinity of the Study Area include the paved footpath, urns and graves (Plate 8 and 9). The locations of these features are marked in Figure 8.

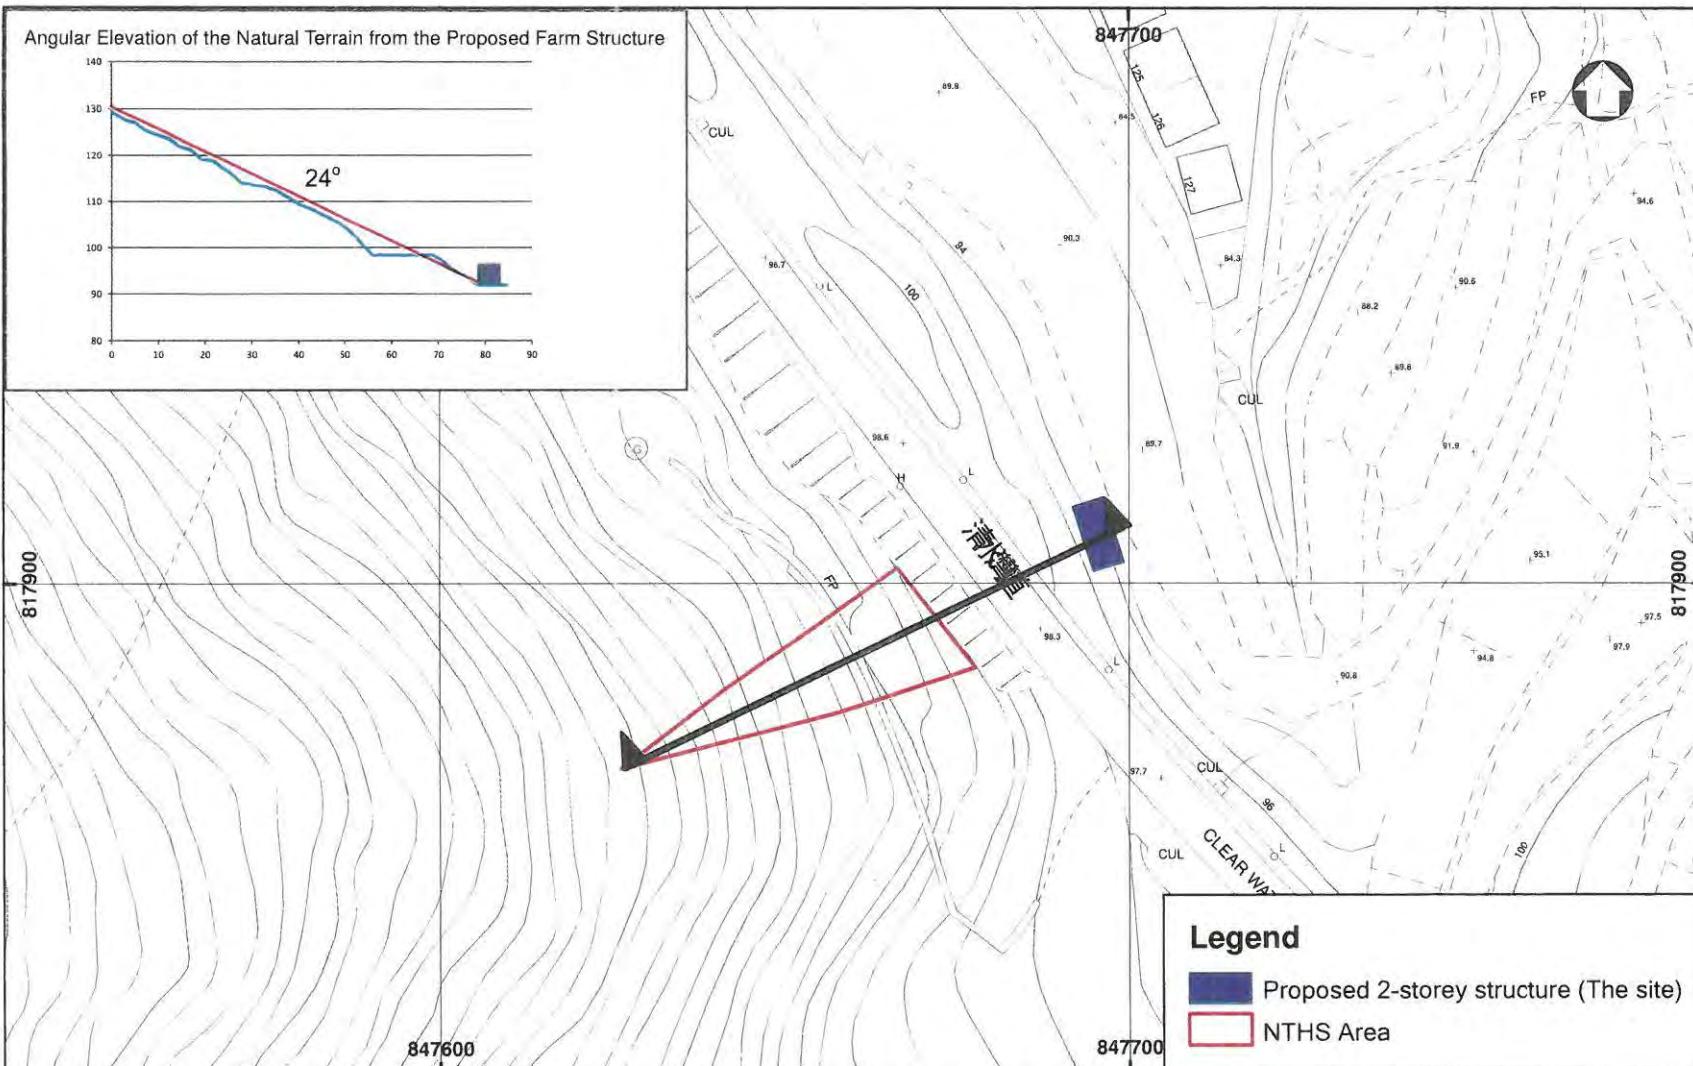
FIGURE NO :
FIGURE 10

Proximity of the Natural Terrain to the proposed domestic farm structure is shown in Figure 10 and detail of the consequence class of the facility at risk is presented in Table 7.2 below.

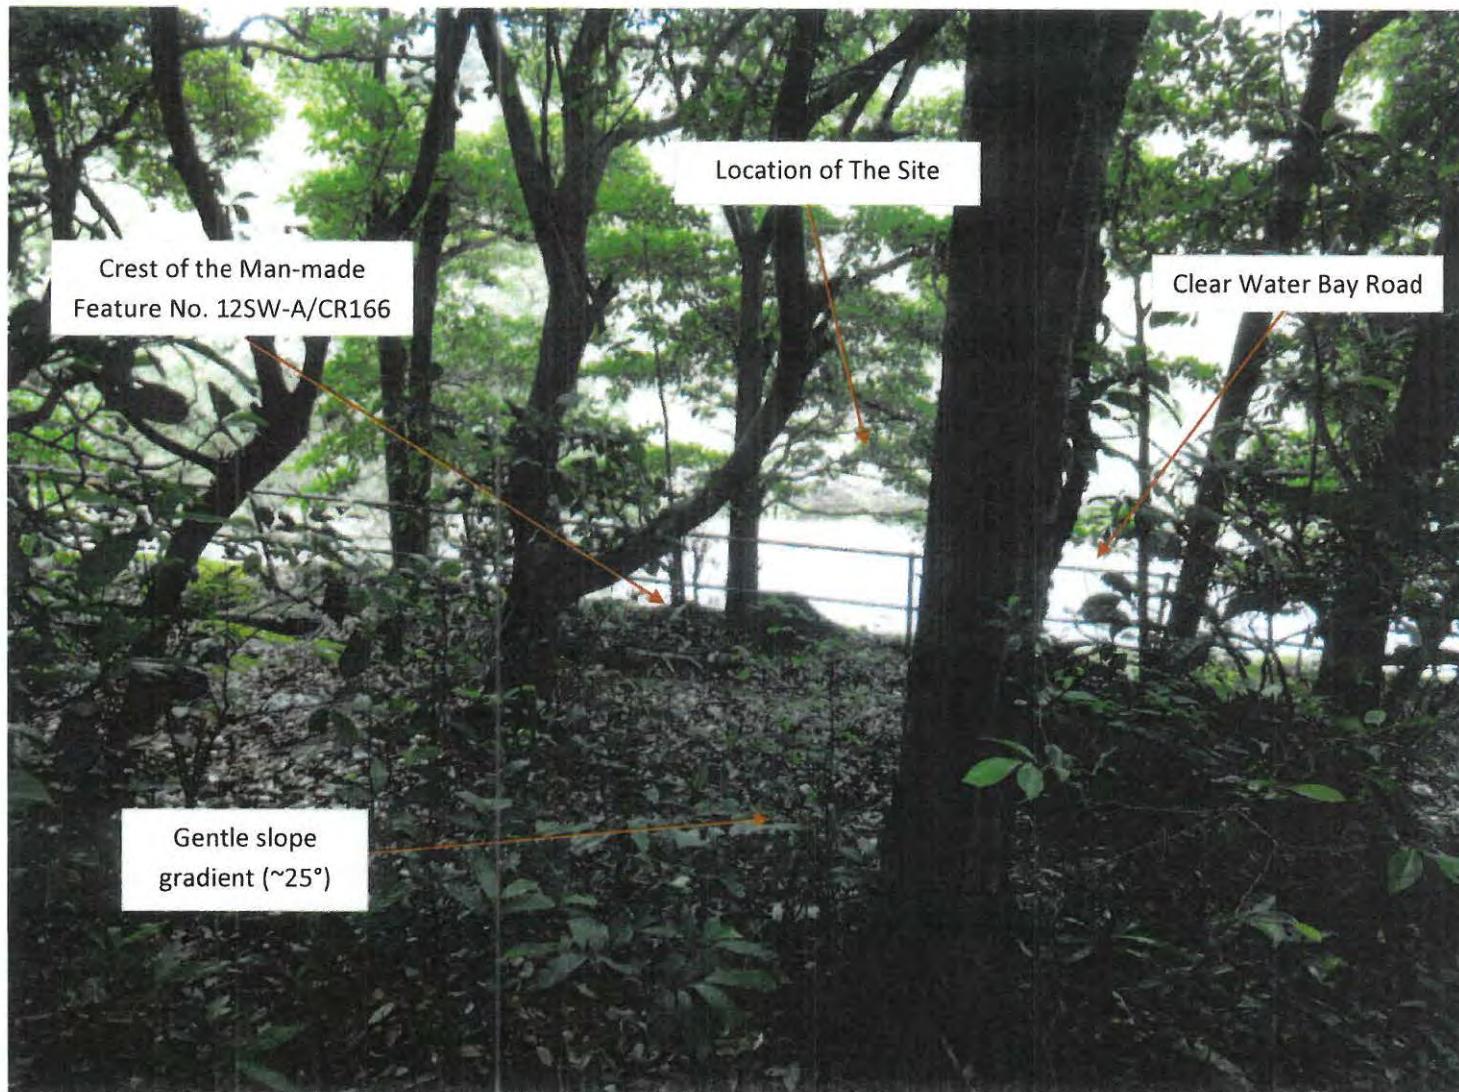
The general slope gradient of the natural terrain within the mid-level and lower portions of the Study Area is about 25° (Plate 5 and 6). While the upper portion of the Study Area is inclined at about 30° (Plate 7).

Plate 5 General view of the gentle slope at the lower portion of the Study Area below the existing paved footpath

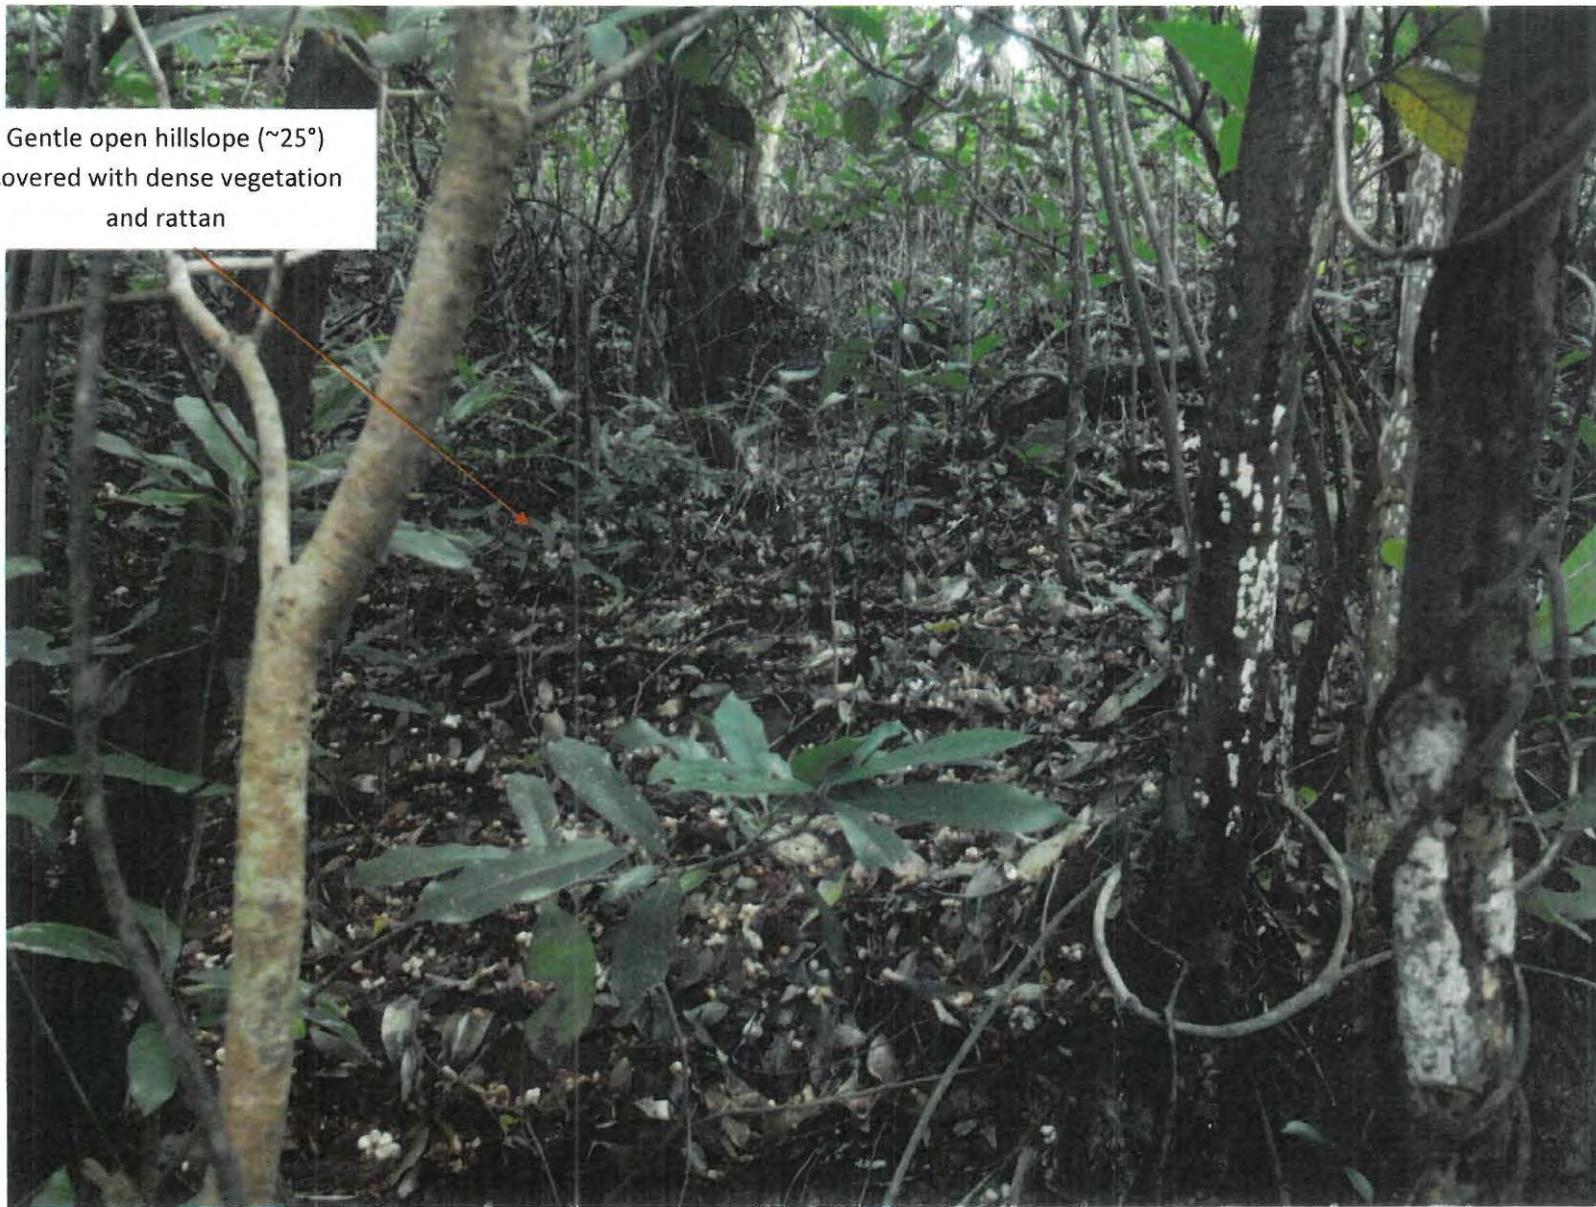
Plate 6 General view of the natural slope at the mid-level of the NTHS area

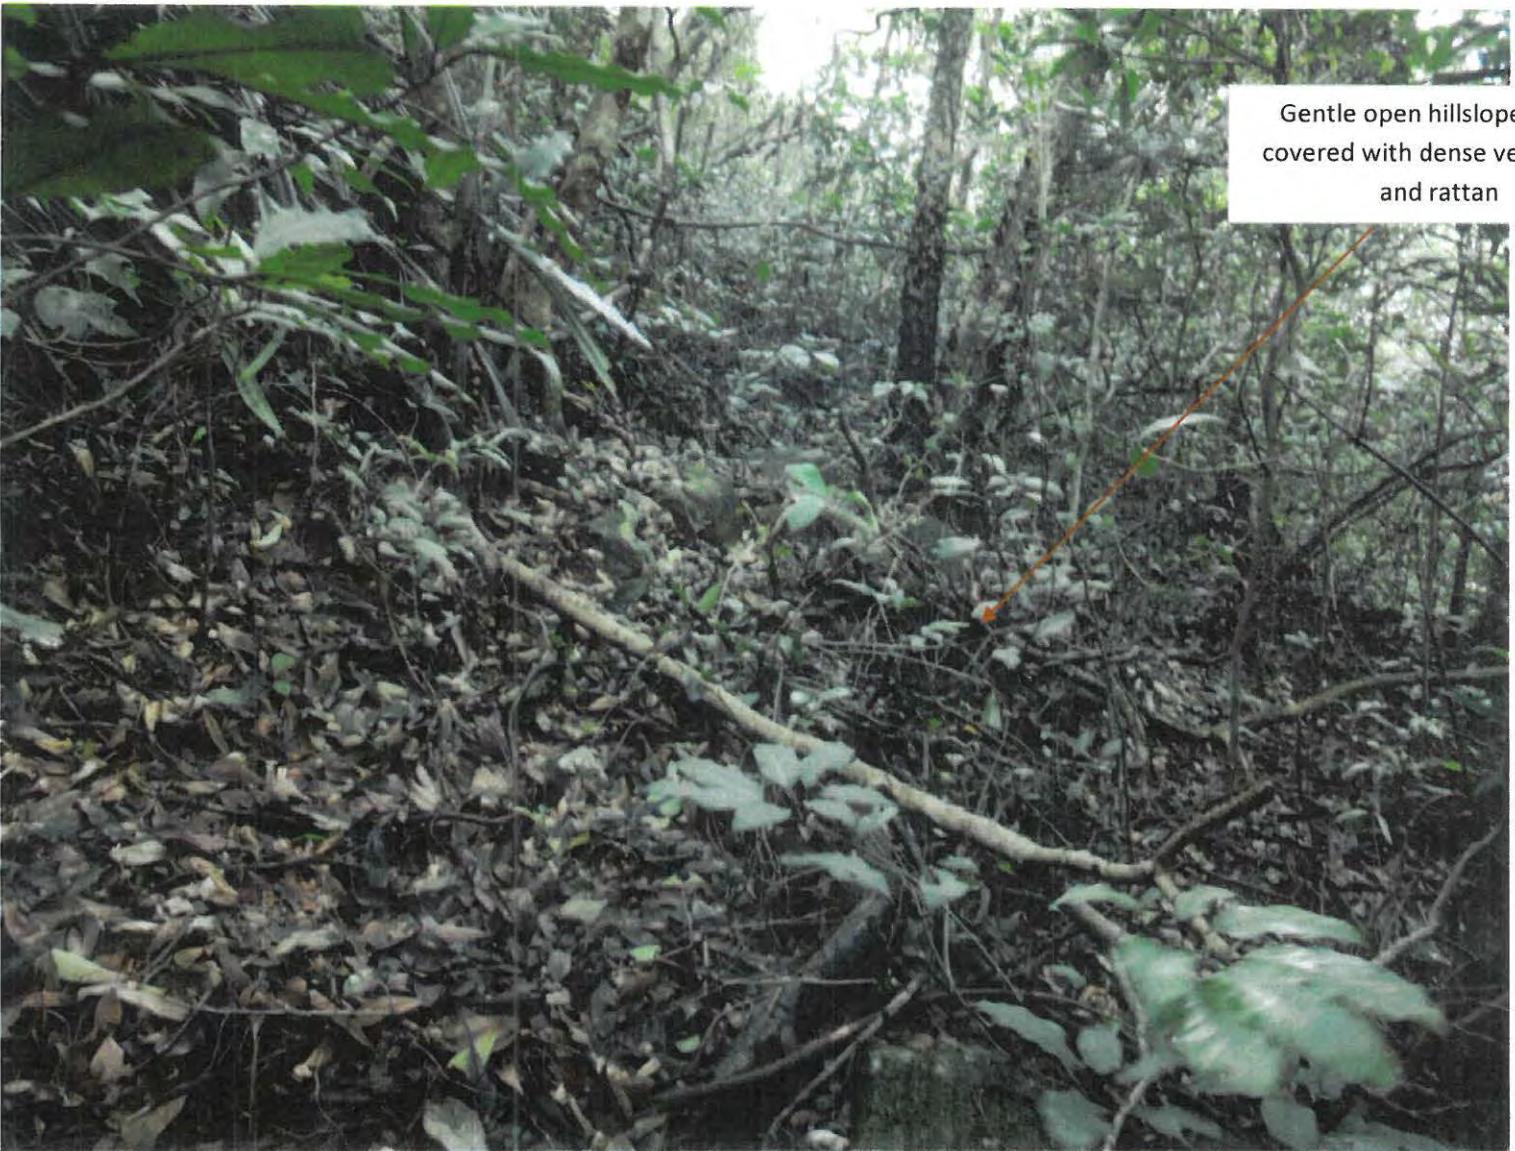
Plate 7 General view of the natural slope at the upper portion of the NTHS area

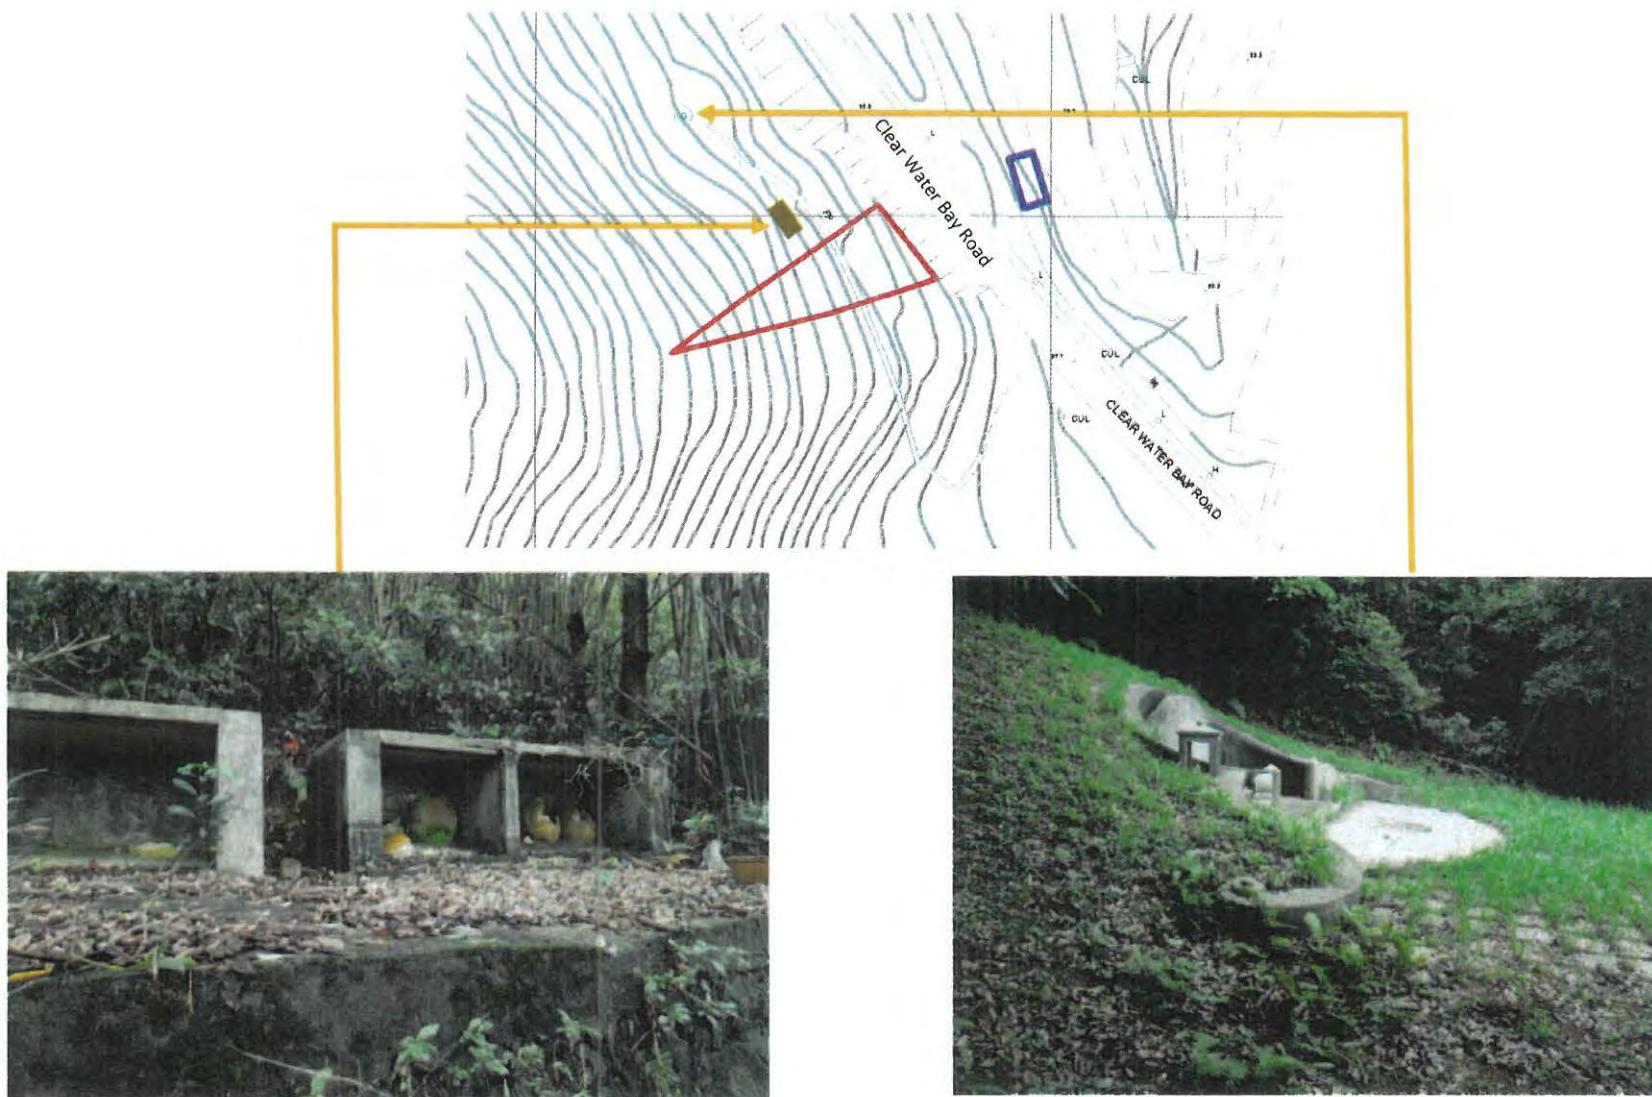
Plate 8 General view of the urns and grave to the northwest of the NTHS area

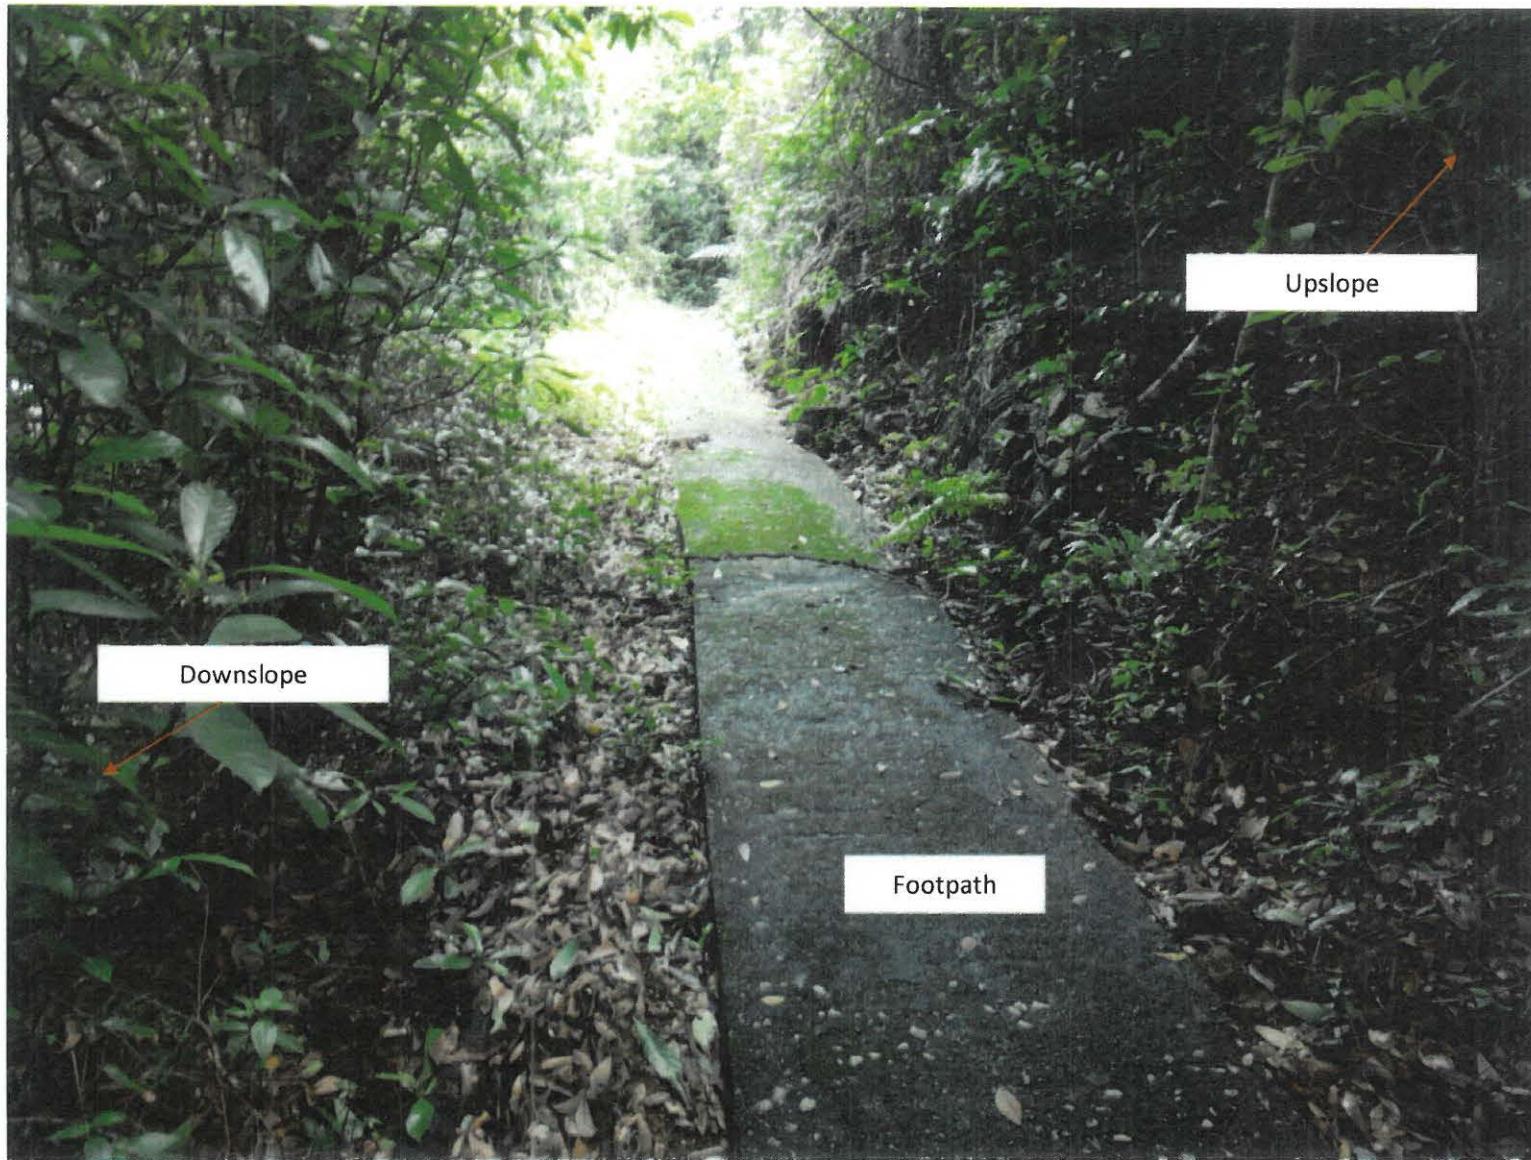
Plate 9 General view of the paved footpath within the lower portion of the Study Area
