Various Lots in D.D. 107, Fung Kat Heung, Kam Tin, Yuen Long, New Territories

(AYL-KTN/1031)  
(Drainage Proposal)

**Proposed Temporary Warehouse (Excluding Dangerous Goods Godown)  
for a Period of Three Years and Associated Filling of Land in "Agriculture" Zone, Various  
Lots in D.D. 107, Fung Kat Heung, Kam Tin, Yuen Long, New Territories**  
**(Application No. A/YL-KTN/1031)**

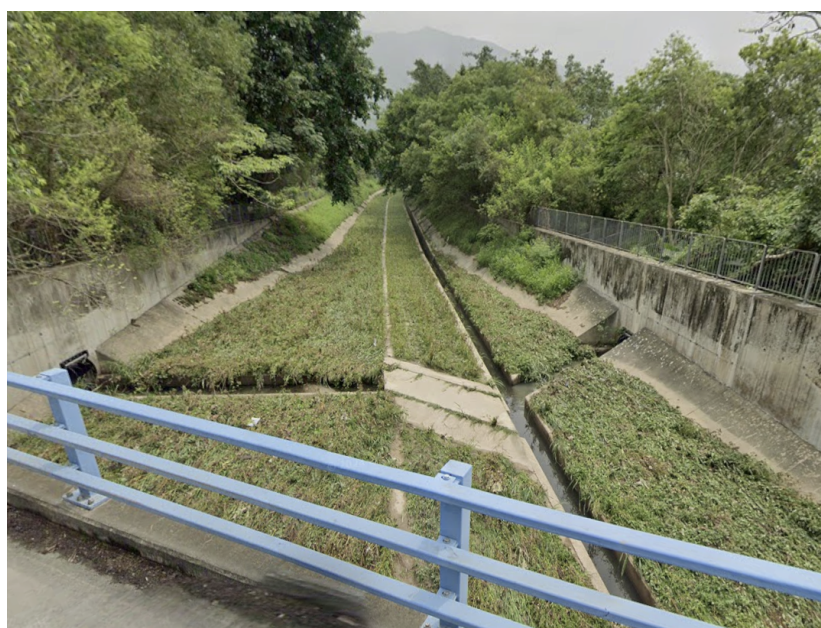
VIEW1: Existing 800UC

As a result, proposed 800UC is suitable for connection between site and existing drainage facility
