Temporary Open Storage of Construction Materials for a Period of 3 Years at Lots 1700 (Part) & 1701 (Part) in D.D. 129, Lau Fau Shan, Yuen Long, N.T.

GEOTECHNICAL PLANNING REVIEW REPORT (GPRR)

**TEMPORARY OPEN STORAGE OF CONSTRUCTION
MATERIALS FOR A PERIOD OF 3 YEARS**

**LOT NO. 1700 (PART) & 1701 (PART) IN D.D. 129,
LAU FAU SHAN, YUEN LONG, N.T.**

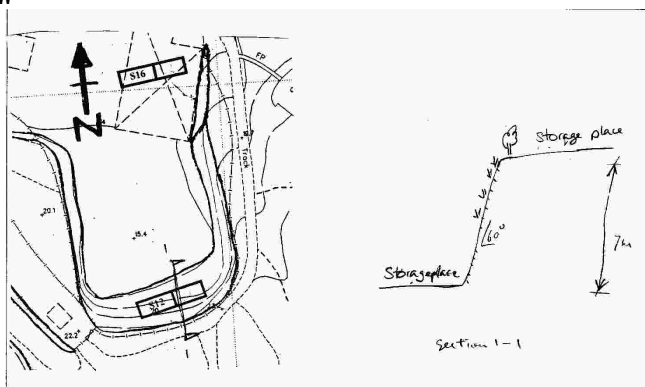
Section No: 1-1
Height (m): N/A
Type of Toe Facility: Non-dangerous goods storage site
Distance from Toe (m): 0
Type of Crest Facility: Road/footpath with low traffic density
Distance from Crest (m): 0
Consequence Category: 3
Engineering Judgement: P
Section No: 2-2
Type of Toe Facility: N/A
Distance from Toe (m): 0
Type of Crest Facility: N/A
Distance from Crest (m): 0
Consequence Category: 3
Engineering Judgement: P

Sign of Seepage:	Slope : No signs of seepage Wall : N/A
Criterion A satisfied:	N
Sign of Distress:	Slope : N/A Wall : N/A
Criterion D satisfied:	N
Non-routine maintenance required:	N
Note:	N/A
Masonry wall / Masonry facing:	N
Note:	N/A
Consequence category (for critical section):	3
Observations:	N/A
Emergency Action Required:	N
Action By:	N/A

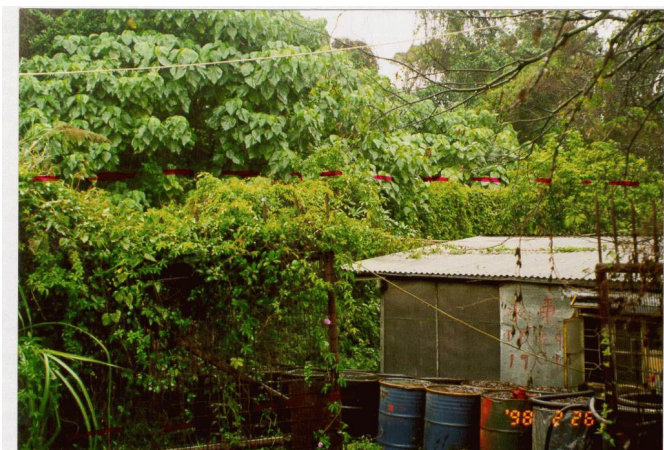
2SW-C/C120

GENERAL VIEW

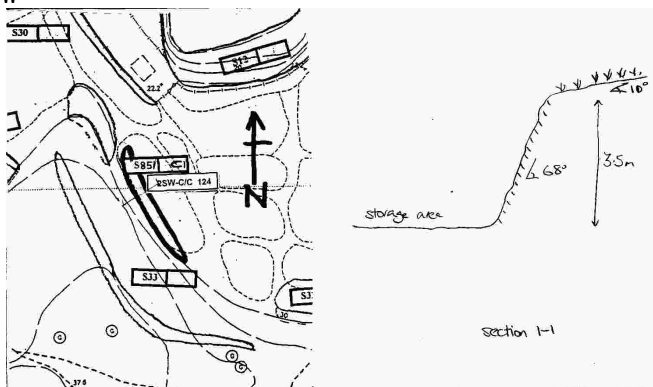
Section No: 1-1
Height (m): N/A
Type of Toe Facility: Non-dangerous goods storage site
Distance from Toe (m): 0
Type of Crest Facility: Undeveloped green belt
Distance from Crest (m): 0
Consequence Category: 3
Engineering Judgement: P
Section No: 2-2
Type of Toe Facility: N/A
Distance from Toe (m): 0
Type of Crest Facility: N/A
Distance from Crest (m): 0
Consequence Category: 3
Engineering Judgement: P
Sign of Seepage: Slope : No signs of seepage
Wall : N/A
Criterion A satisfied: N
Sign of Distress: Slope : Reasonable (near crest, mid-portion)
Wall : N/A
Criterion D satisfied: N
Non-routine maintenance required: N
Note: N/A
Masonry wall / Masonry facing: N
