**Temporary Logistics Centre with Ancillary Office and Parking of Vehicles for a Period of 3 Years  
in "Residential (Group E)" Zone, Various Lots in D.D. 129 and Adjoining Government Land,  
Lau Fau Shan, Yuen Long, New Territories**

**(S.16 Planning Application No. A/YL-LFS/563)**

**Geotechnical Planning Review Report (GPRR)  
for  
Temporary Logistics Centre with  
Ancillary Office and Parking of Vehicles for  
a Period of 3 Years at  
Various Lots in D.D.129 & adjoining Government Land  
Lau Fau Shan, Yuen Long, N.T.  
(Application No. AYL-LFS/563)**

**Ref. No. : LFS002  
10 October 2025**

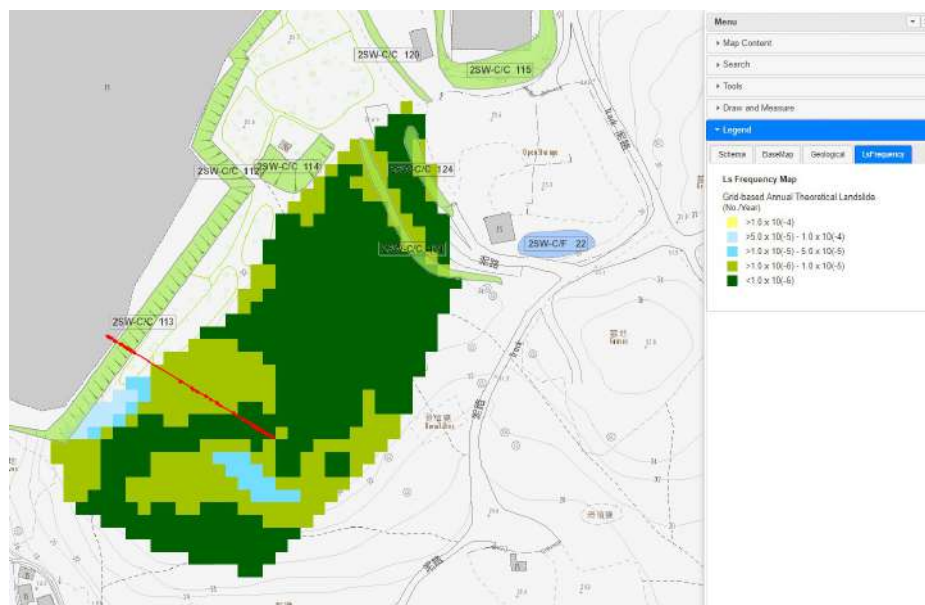
Natural Terrain Feature 3 (Outside boundary of application site)

The feature would not be modified by the extended period of tenancy. The site is located 20m from the toe of the feature and therefore the proposed extended period would not have adverse effect on the stability of geotechnical feature.

The feature has a face angle of 25° without any visible boulders on its surface. Based on the extract of landslide frequency map obtained from the GInfo System from the GIU library of GEO, its annual theoretical landslide is only between  $5.0 \times 10^{-5}$  to  $1.0 \times 10^{-4}$ , which is less likely than a 1 in 1000-year event. Consider the period of land use extension would be 3 years only, the risk of landslide would be minimal.

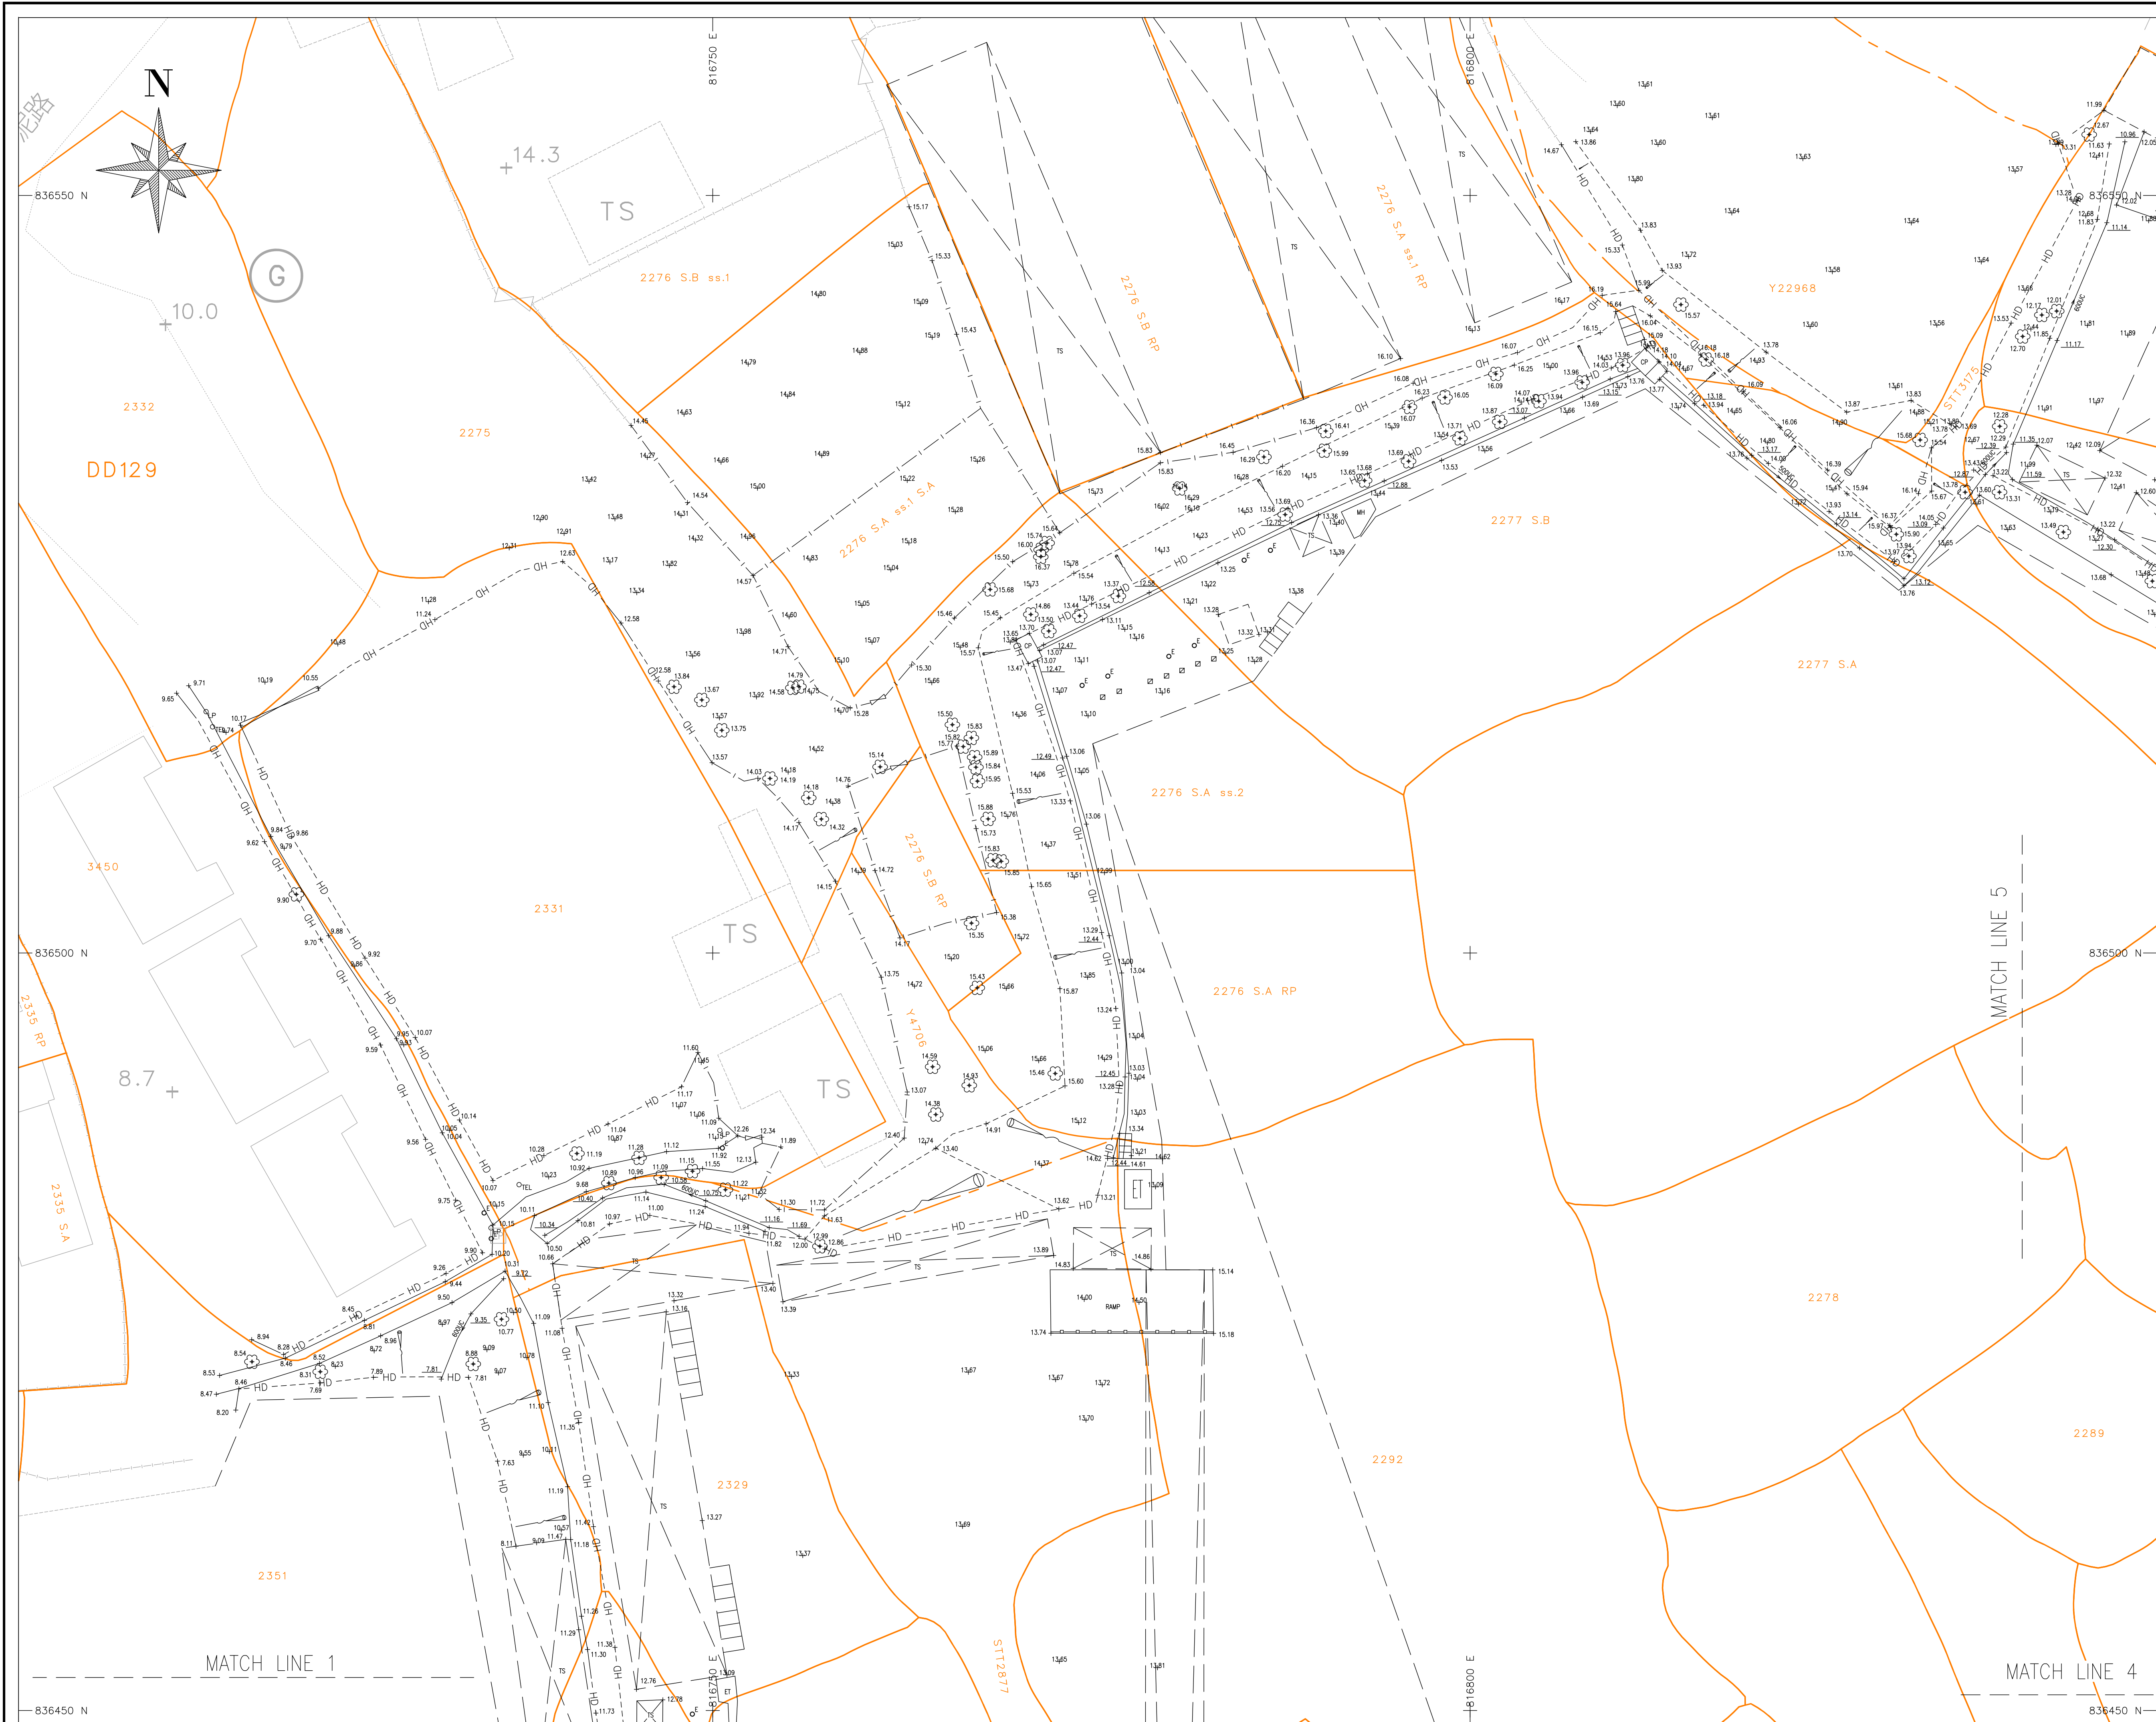
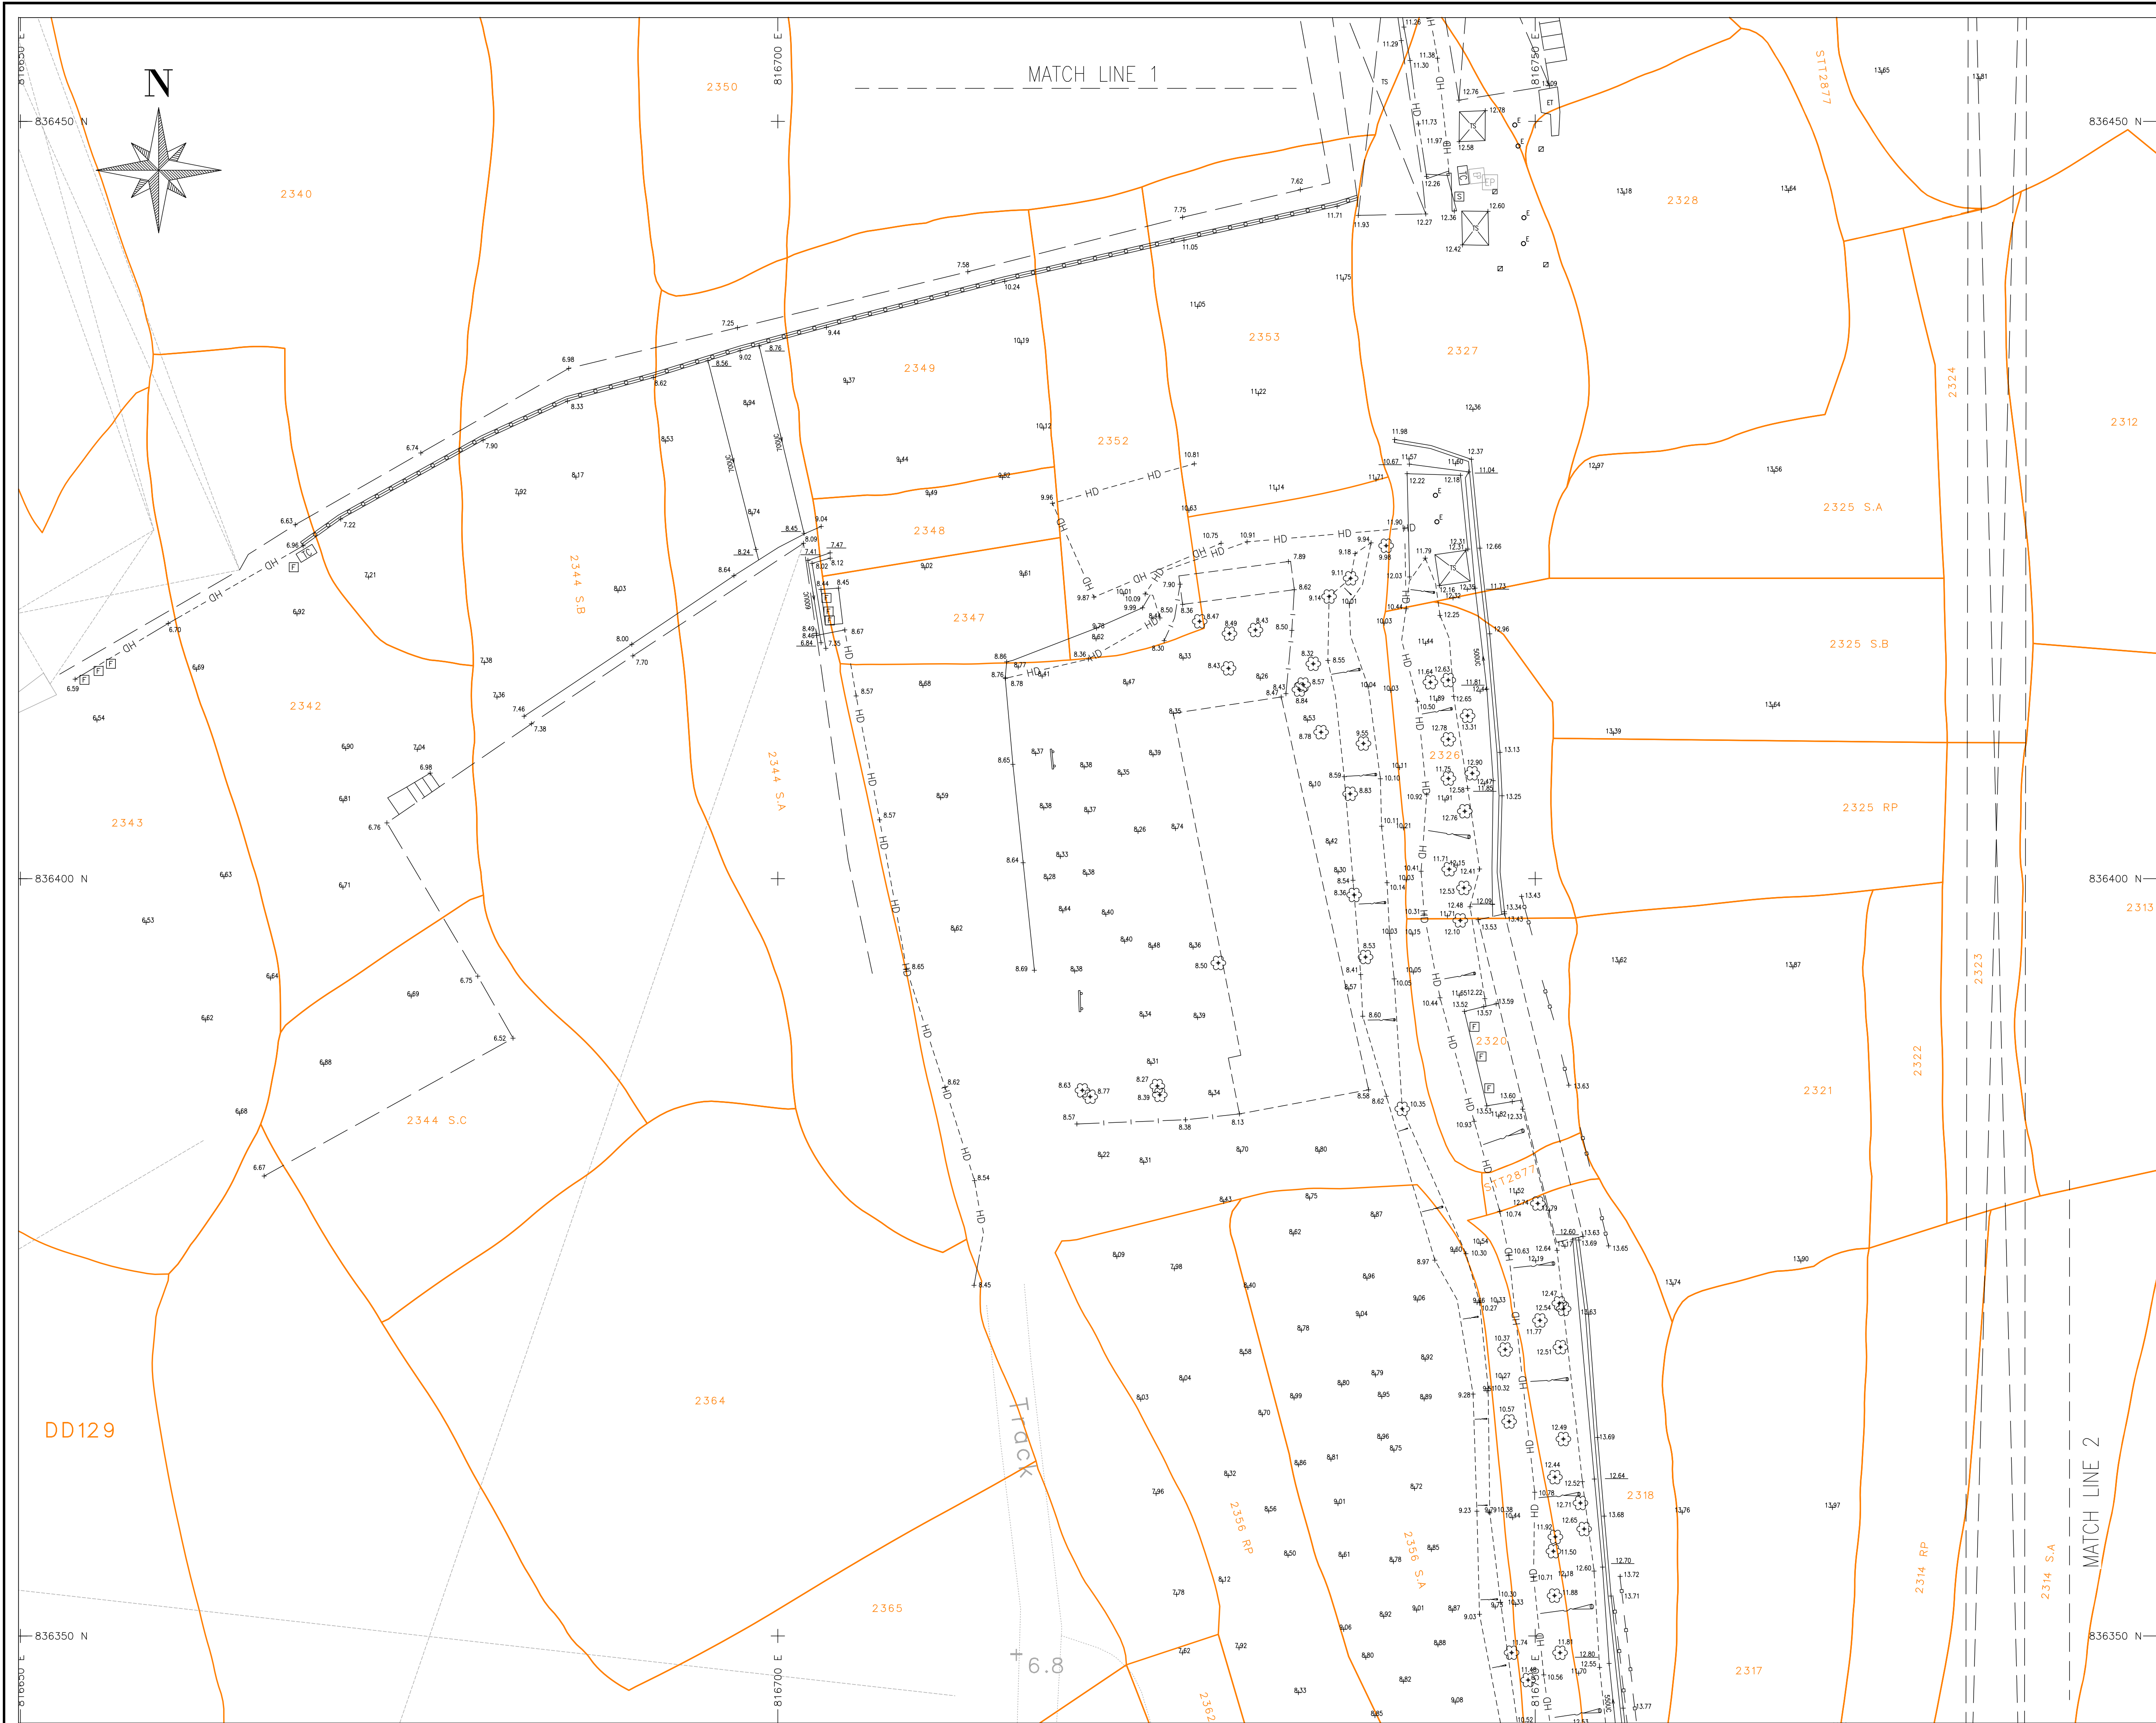
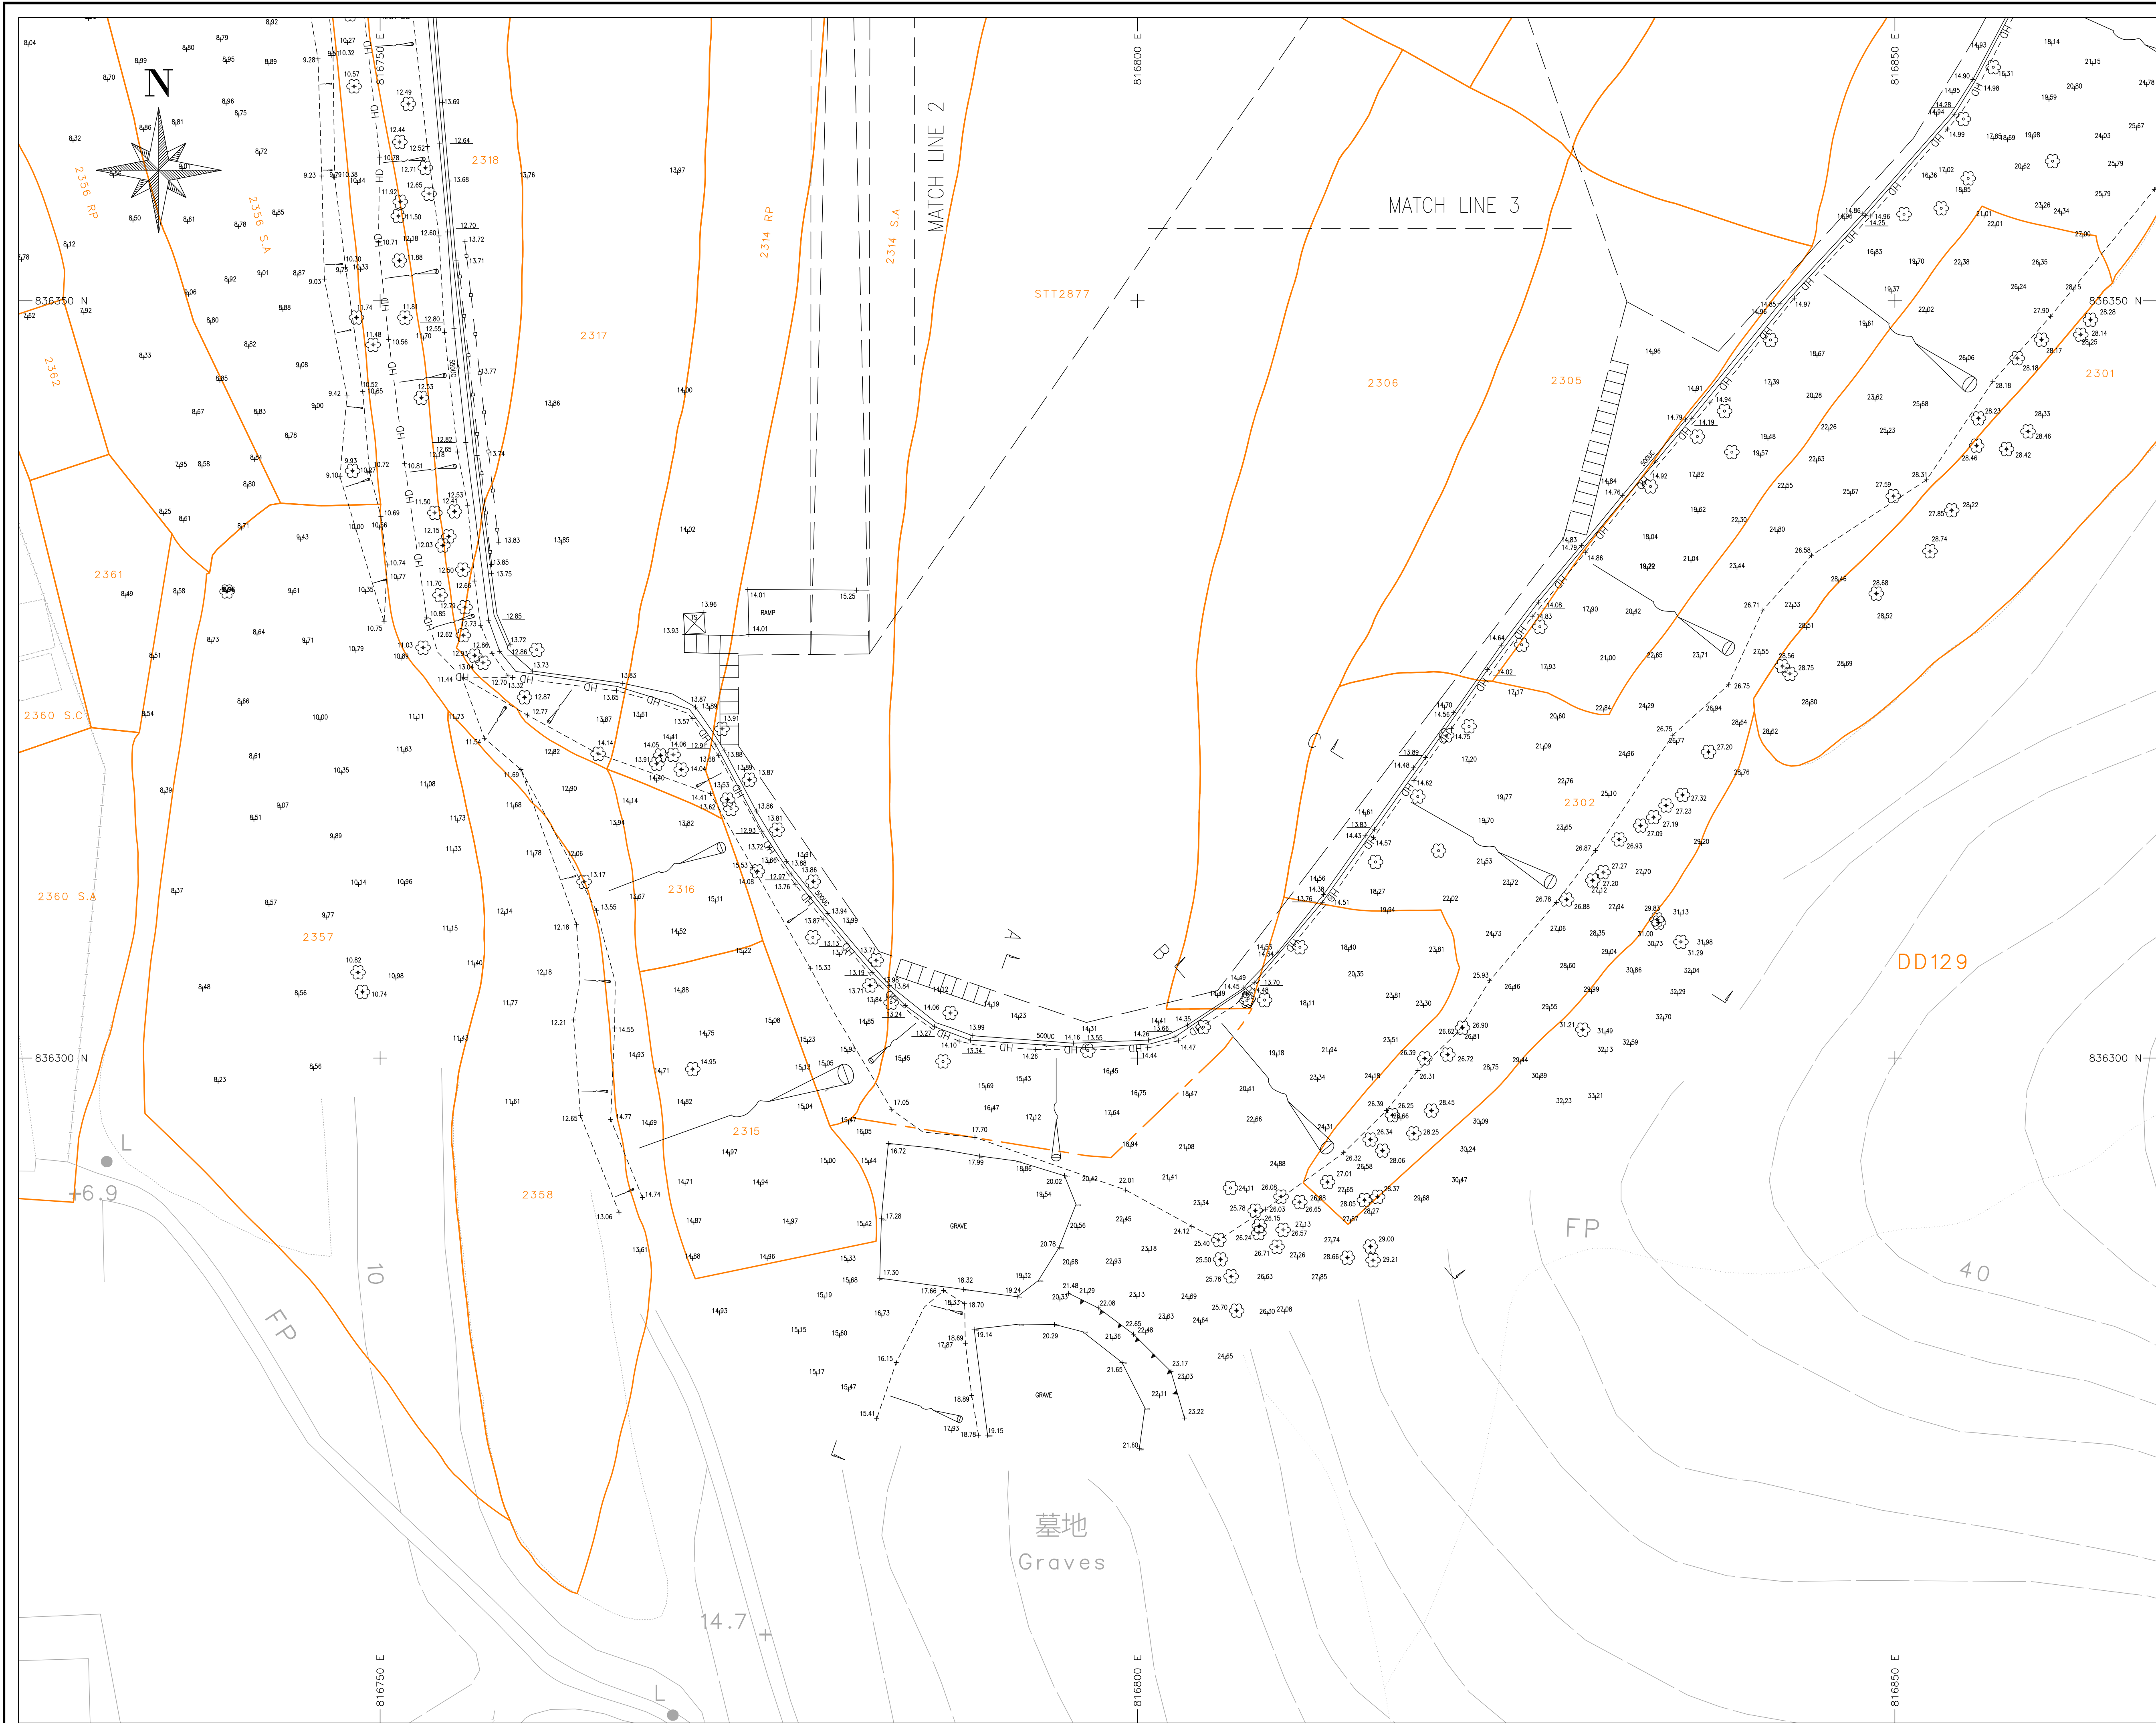
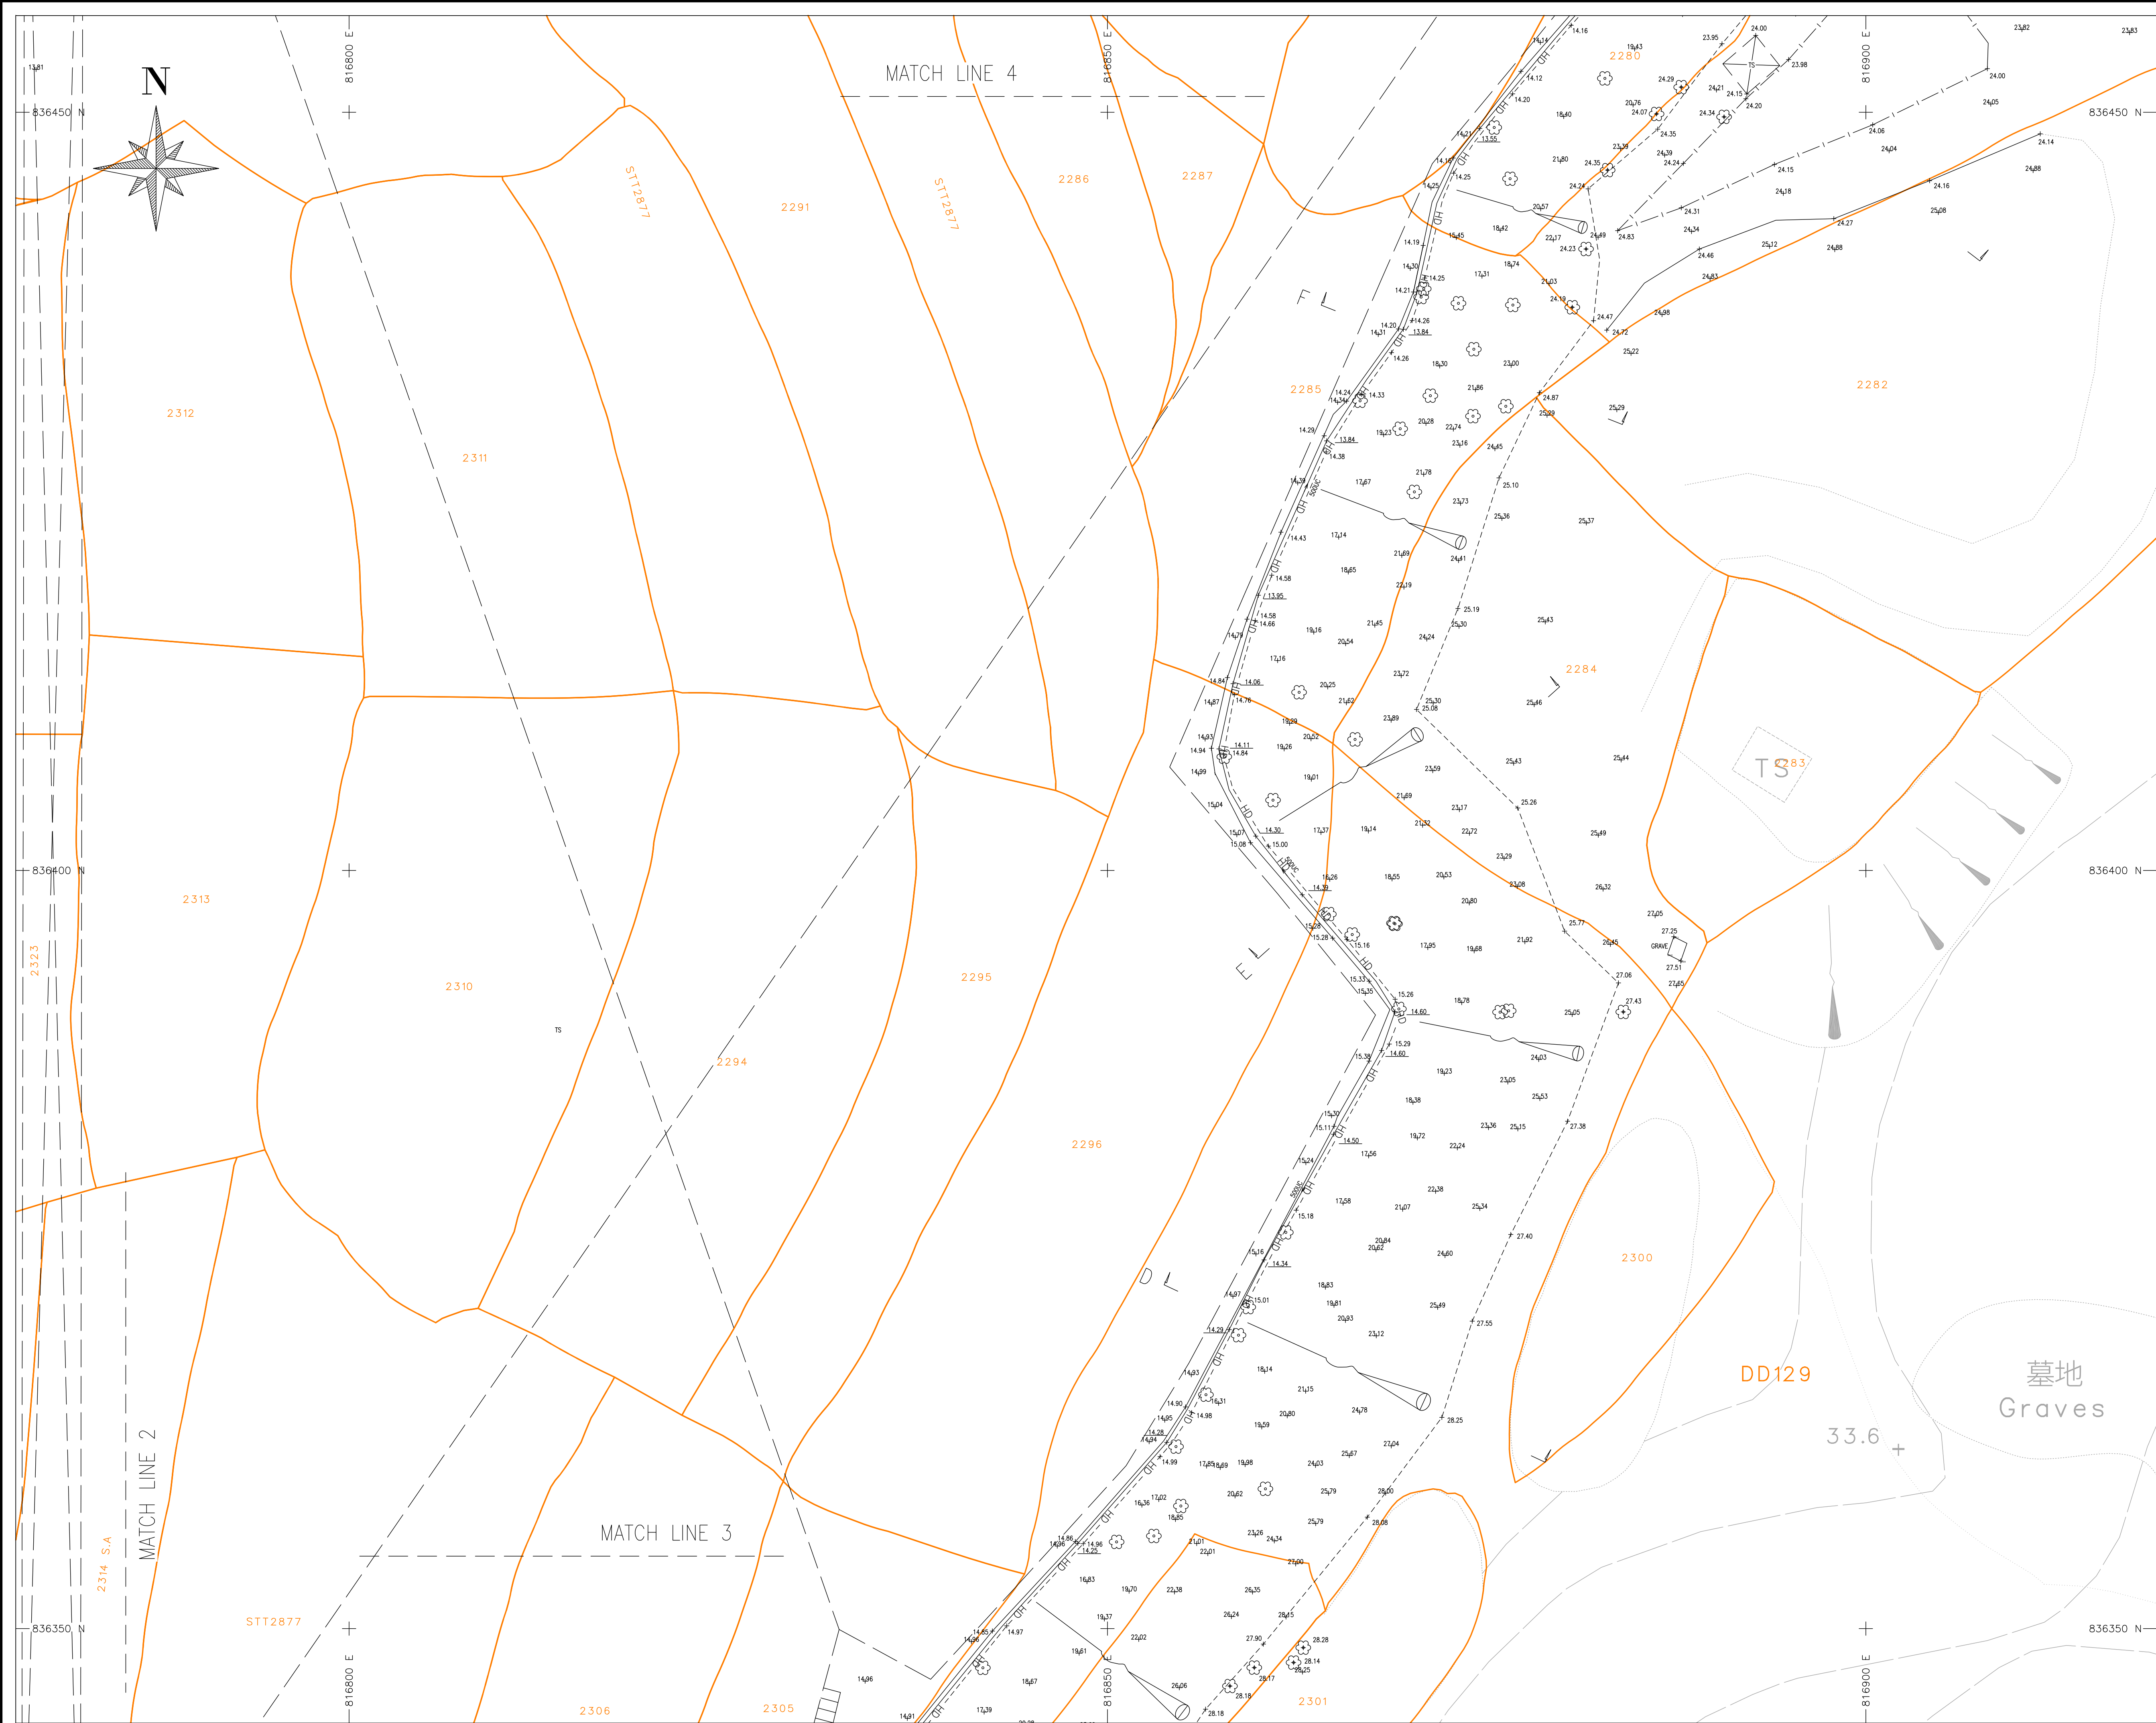
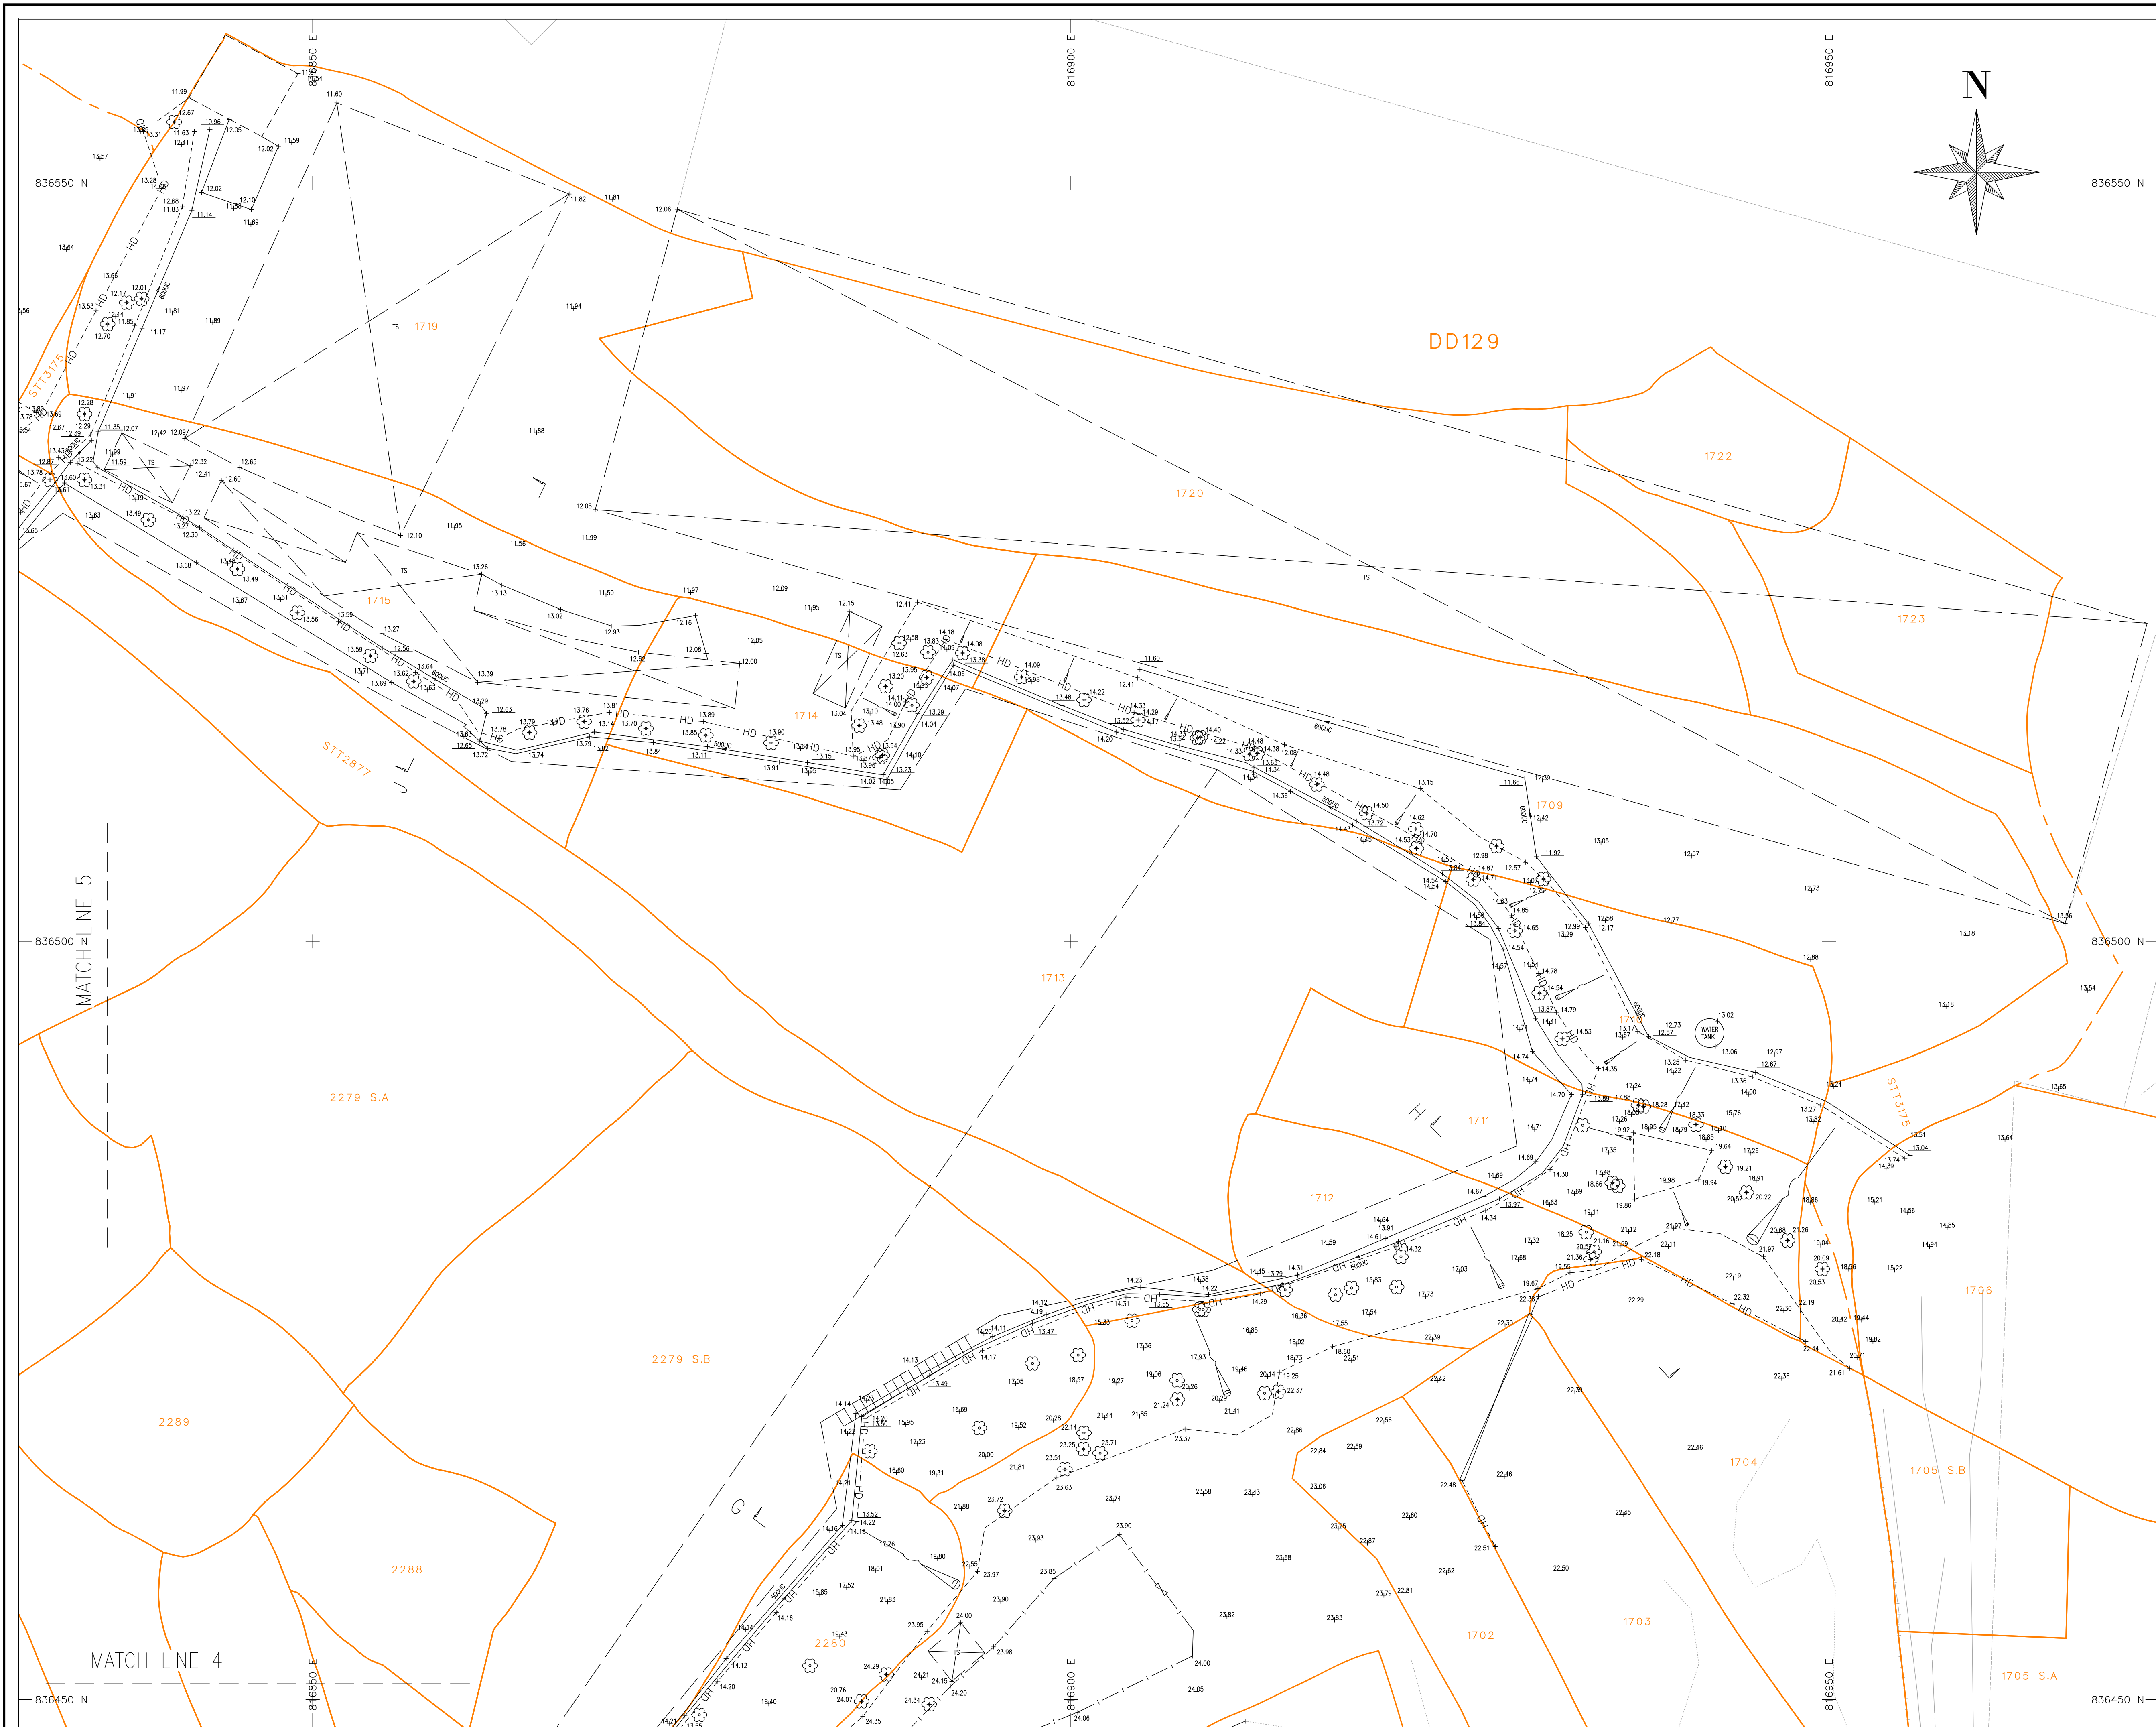
Figure 2.3      Survey Plan

The subject site is located at various lots in D.D.129 and adjoining government land at Lau Fau Shan, Yuen Long, N.T. (level +12mPD to +13mPD). An indication of site location and site layout are shown on **Figures 1** and **2**, respectively. A detail survey plan and sections are as attached in **Figure 2.3**. The site is about triangular on plan. The site is a 1-storey covered storage area since 2016.

After the approval of the 1<sup>st</sup> GPRR report in 2022, the site has been extended slightly towards its southeastern side. (as shown in **Figure 2.3**)

no slope strengthening works were required. **Sections E, F, G, H and J** in **Figure 2.3** illustrate cross sections of this feature.

**Sections A-D** in **Figure 2.3** illustrate cross sections of this feature.

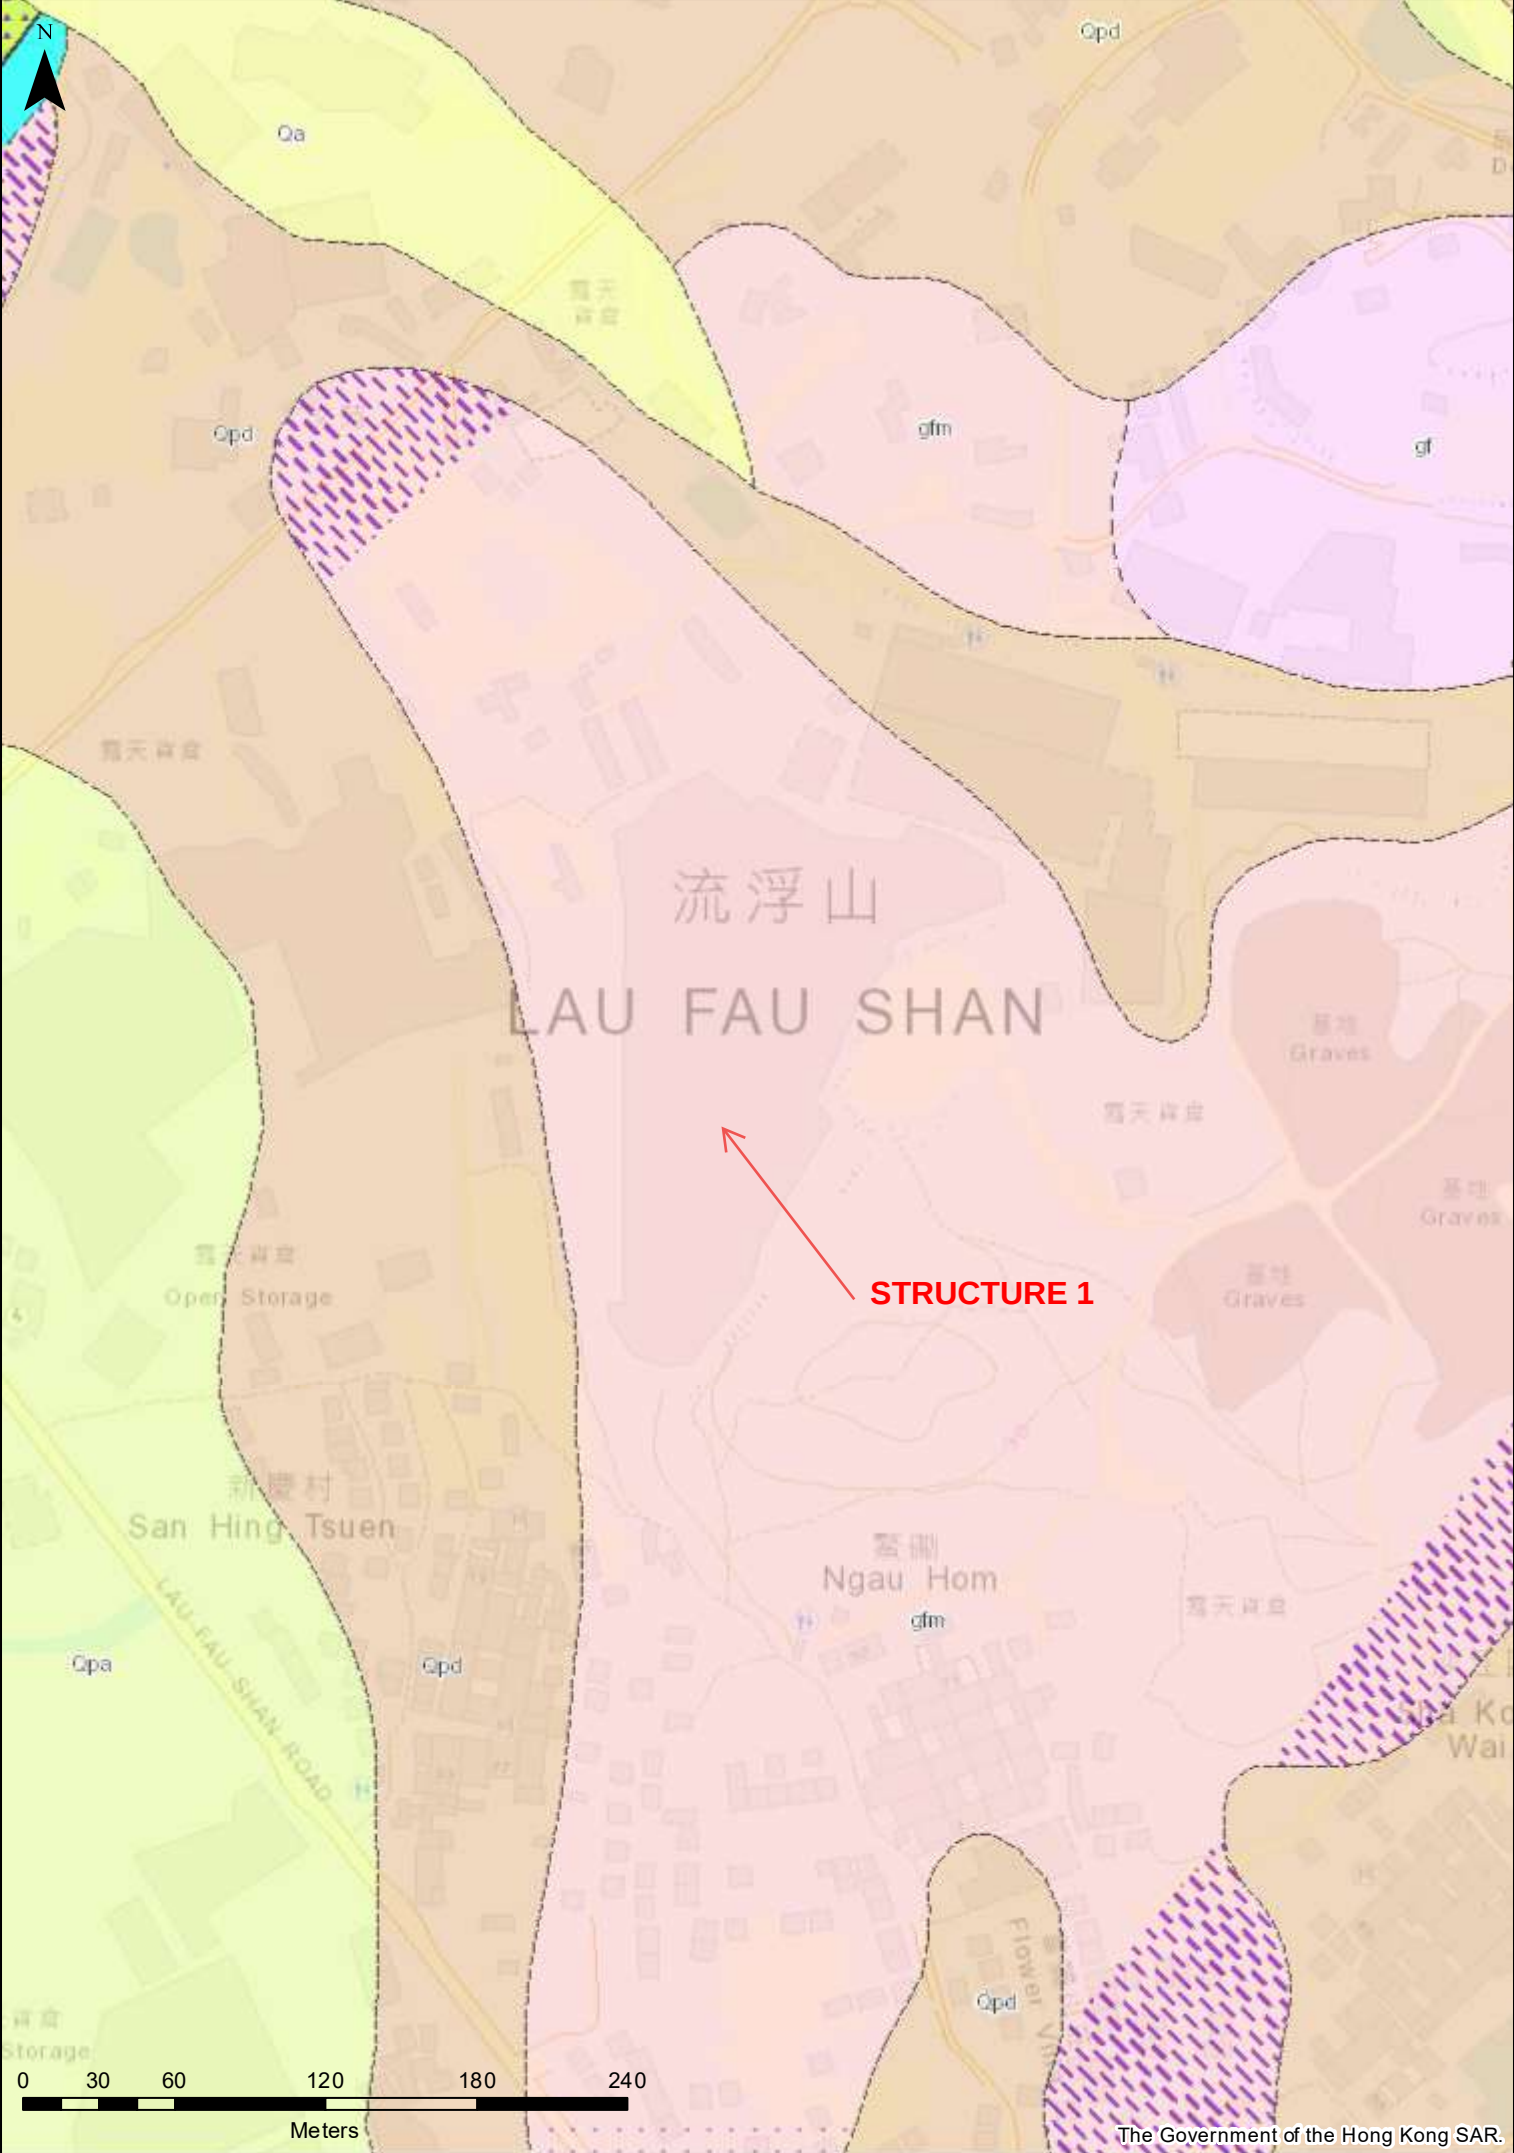
Hong Kong Geological Map Sheet 2 (Part Plan of  
1:20,000)

With reference to the 1:20,000 geological map published by the Geotechnical Control Office, Hong Kong Geological Survey Sheet 2, the site is located within the area of fine- to medium-grained granite (gfm). Therefore, the superficial deposits should be fine- to medium-grained granite. Extract of the Geological Map Sheet is as attached in **Figure 3**.
