Appendix III
Geotechnical Planning Review Report

**Geotechnical Planning Review Report (GPRR)
for
Temporary Logistics Centre with
Ancillary Office and Parking of Vehicle for
a Period of 3 Years at
Various Lots in D.D.129 & adjoining Government Land
Lau Fau Shan, Yuen Long, N.T.
(Application No. A/YL-LFS/426)**

**Ref. No. : LFS002a
17 June 2022**

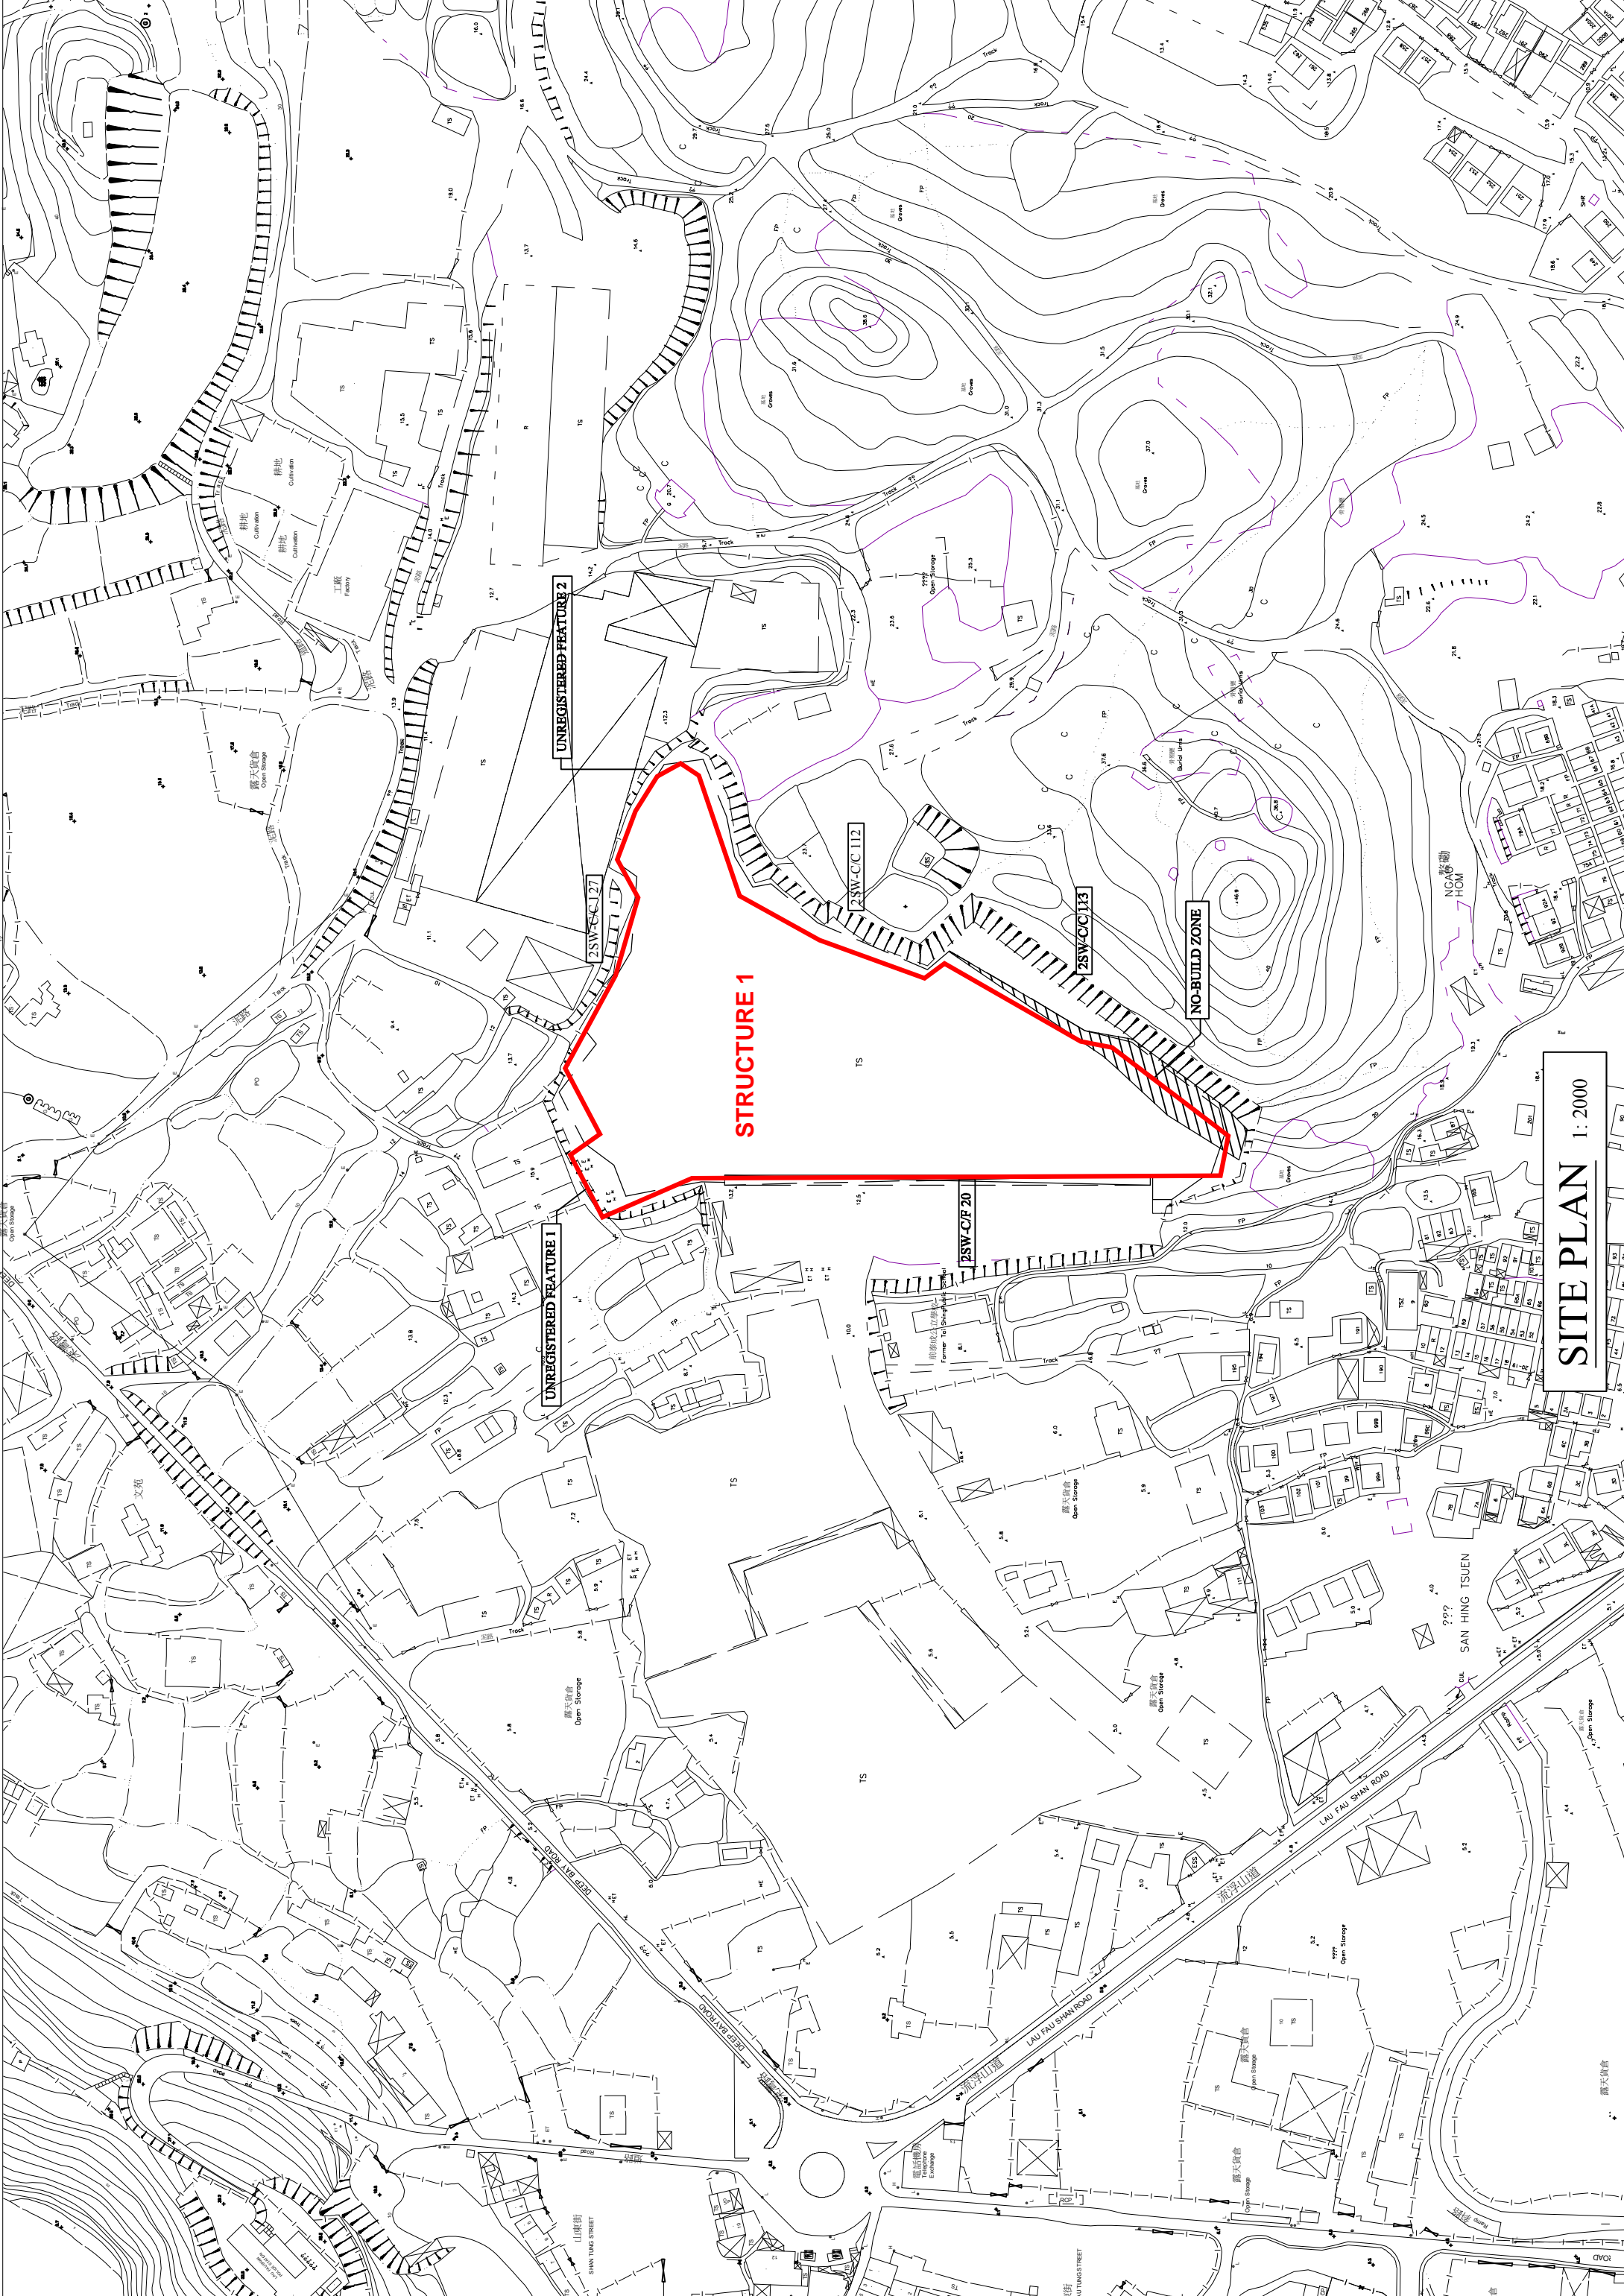
Figure 2.3 1:2000 scale layout plan showing the geotechnical features (including the locations of the unregistered natural slopes) and the 'no-build' zone

UNREGISTERED FEATURE 1

UNREGISTERED FEATURE 2
