**GEOTECHNICAL PLANNING REVIEW REPORT (GPRR)**

**TEMPORARY OPEN STORAGE OF CONSTRUCTION  
MATERIALS FOR A PERIOD OF 3 YEARS**

**LOT NO. 1703 (PART) & 1704 (PART) IN D.D. 129,  
LAU FAU SHAN, YUEN LONG, N.T.**

**Dec 2025**

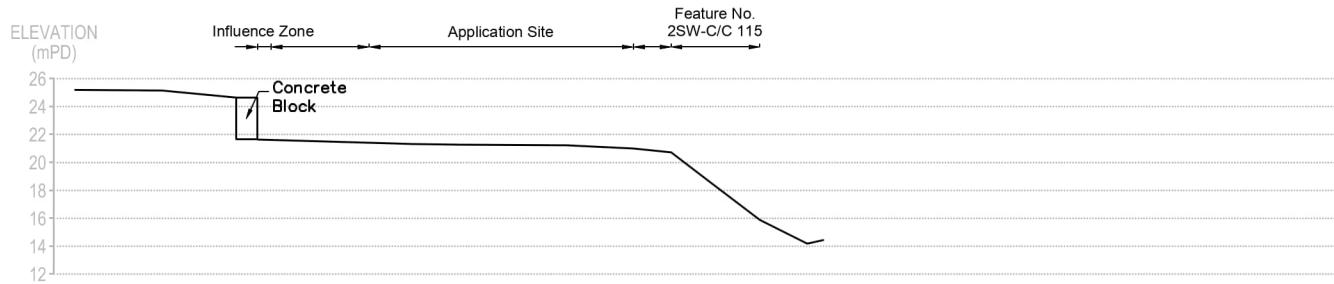
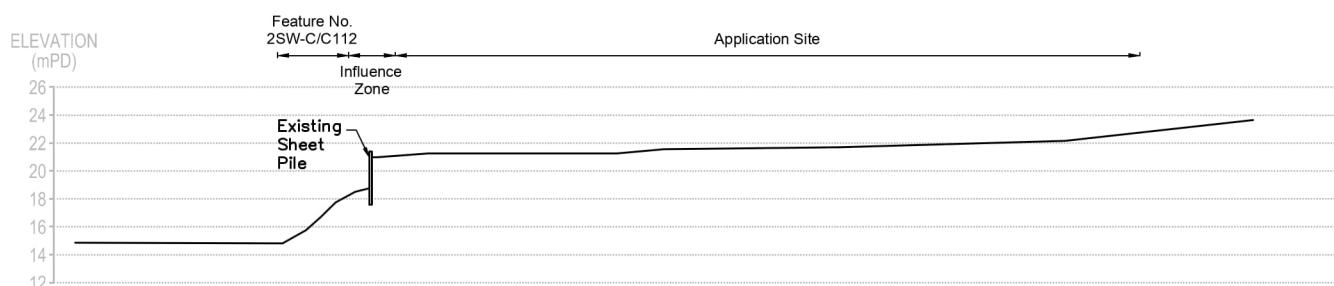
Drawing No.:  
Figure 5

The feature is located at the northwestern side outside the site, the application site is located at the crest of this feature, and no works will be carried out within the crest influence zone of the feature. Although a landslip occurred on 13 August 2025, the location of the landslip is at a sufficient distance from the site location. No other signs of distress or instability were found at the portion adjacent to the site during site reconnaissance; it was concluded that the proposed development is geotechnical feasible provided that the boundary of the application site adjacent to the feature is set back 4m to avoid the crest influence zone.

This is a U-shaped feature which located adjacent to the eastern boundary of the site. Since the proposed development is a temporary open storage area for construction materials without any structure or building constructed on site, and no foundation works, site formation works, building works, or excavation works will be carried out. Hence, the proposed development is considered to be feasible from a geotechnical point of view.
