### Revised Land Contamination Review

**To rezone the Application Site from “Other Specified Uses” annotated “Business” to  
“Residential (Group E) 2” at Lot 316 in D.D. 444 and Kwai Chung Town Lot (KTCL) 146,  
97-107 Wo Yi Hop Road, New Territories**

### **Land Contamination Review**

September 2025

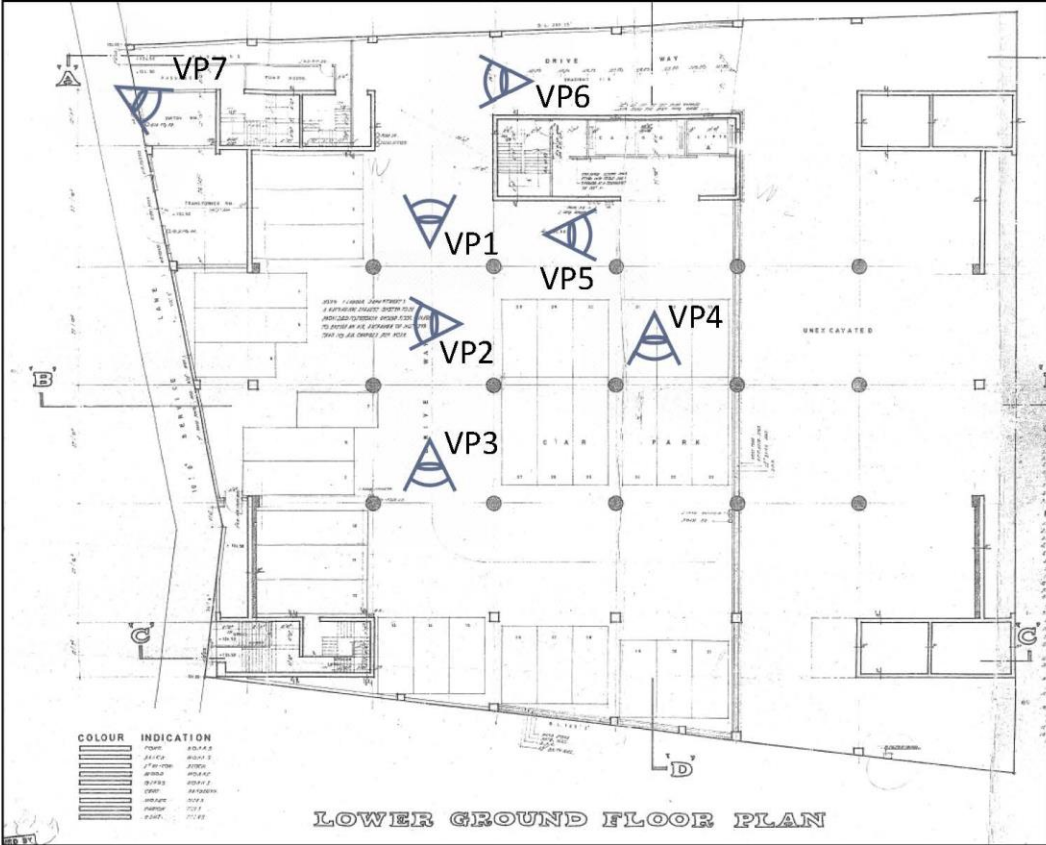
VP6

| V<br>P | Description | Potential Source of Pollution | Evidence of Spillage<br>/Leakage/Pollution | Free from<br>Contamination? |
|---|---|---|---|---|
| 6 | Security box | Concrete walls and ground, and<br>red bucket | No (Red bucket was<br>empty) | Yes |

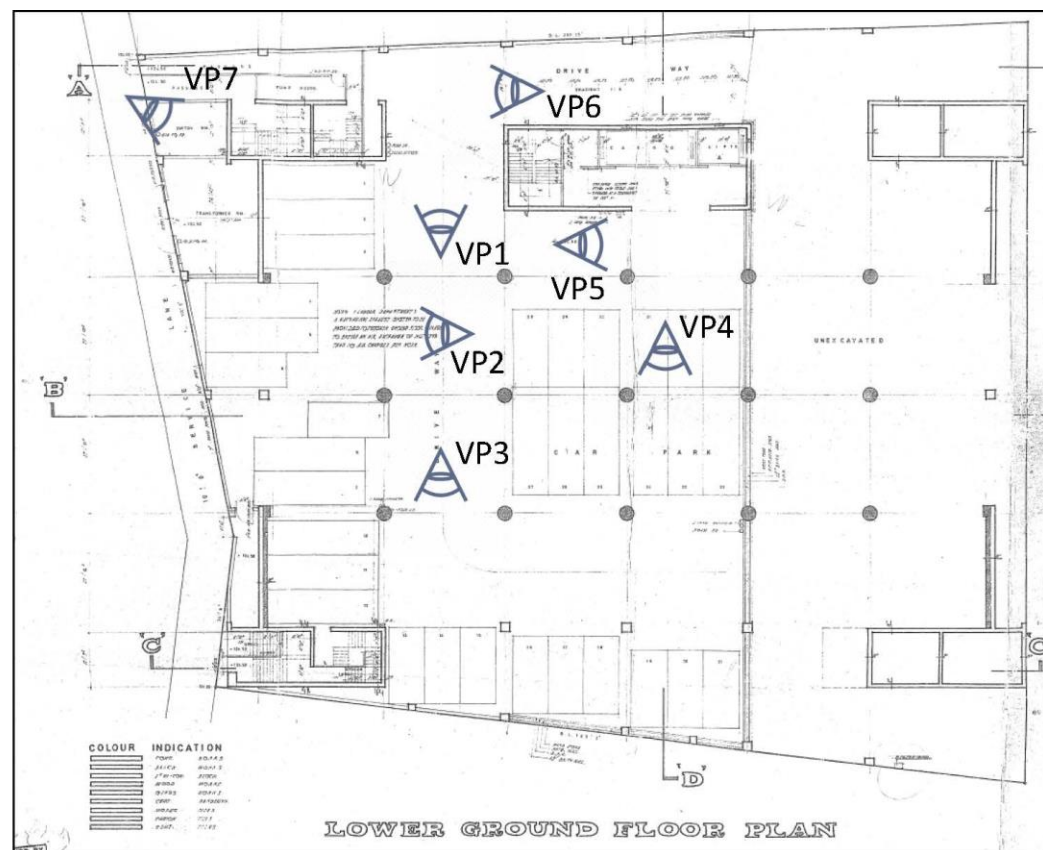
VP7

| V<br>P | Description | Potential Source of Pollution | Evidence of Spillage /Leakage/Pollution | Free from Contamination? |
|---|---|---|---|---|
| 7 | Switch Room | Concrete walls and ground, and electrical switches | No | Yes |
