Proposed Minor Relaxation of Site Coverage Restriction for Permitted House Development in "Residential (Group C) 3" Zone, No. 66 Deep Water Bay Road, Shouson Hill, Hong Kong – S16 Planning Application

Geotechnical Planning Review Report

Document	Verification				CMA
Job title		SECTION 16 PLANNING APPLICATION FOR THE PROPOSED RESIDENTIAL DEVELOPMENT AT NO. 66 DEEP WATER BAY ROAD, SHOUSON HILL, HONG KONG			
5 (20)					DWB66
Document title		GEOTI	ECHNICAL PLANNING F	File reference DWB66/GPRR-01	
Document ref					
Revision	Date	Filename			
			Prepared by	Checked by	Approved by
0	April 2025	Name	Jacky Ip	Thomas Chui	Thomas Oll-
		Signature	7	an	(A-
		Filename			
			Prepared by	Checked by	Approved by
		Name			
		Signature			
		Filename			Management of the Control of the Con
			Prepared by	Checked by	Approved by
		Name			
		Signature			
		Filename			
			Prepared by	Checked by	Approved by
		Name			
		Signature			
AP		RSE		RGE	
Name: Date:		Name: Date:		Name: Date:	
Bato.				120101

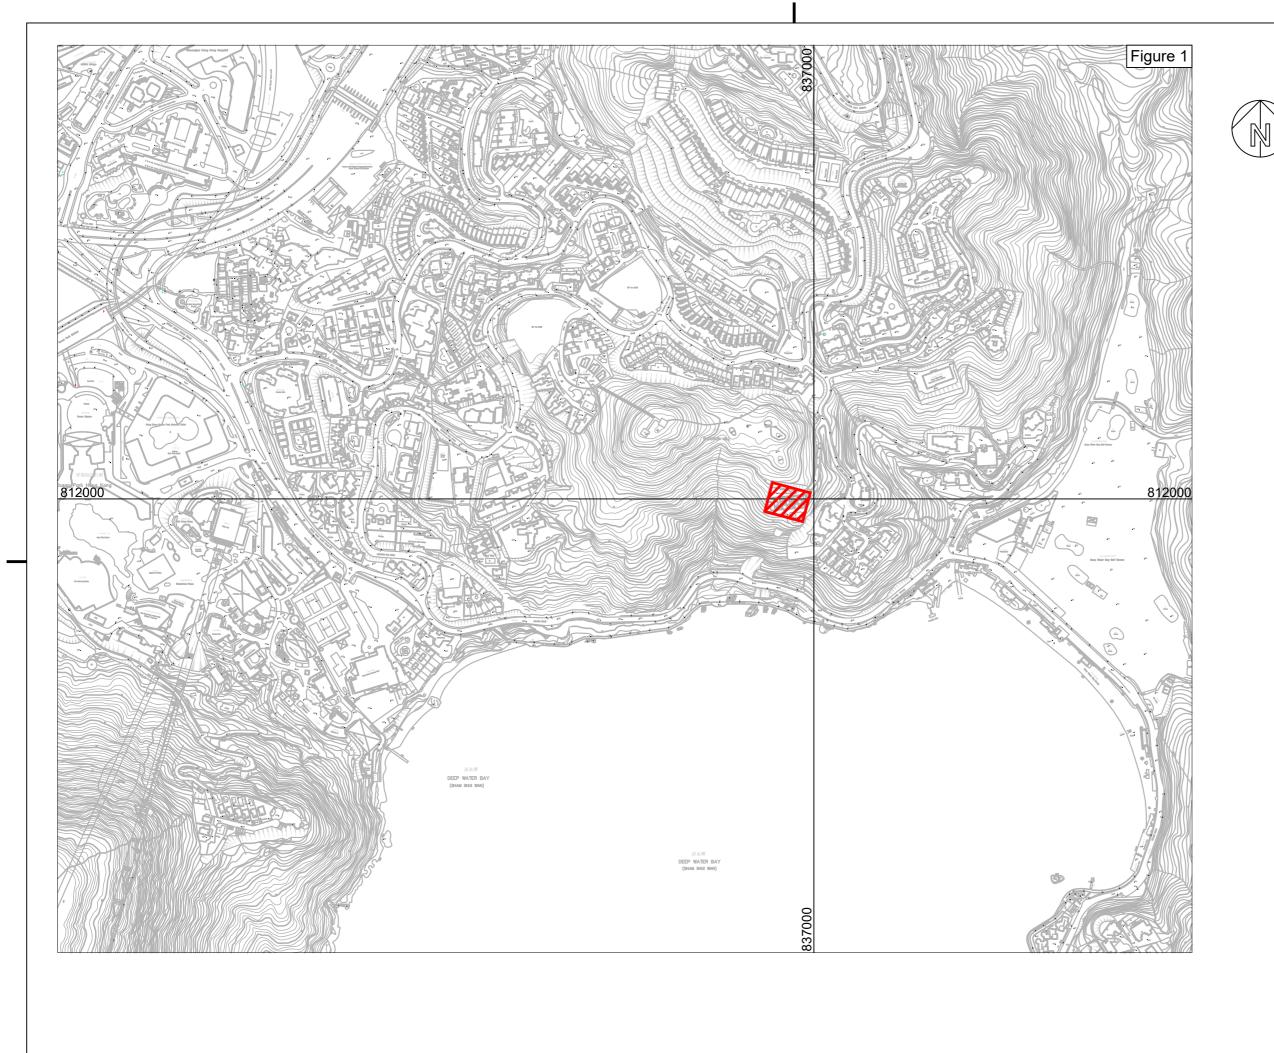
DRG. TITLE			DRG. NO		
SITE LO	OCATION PLAN		F	TIG-01	
SCALE	1:5000 IN A3		DATE	MAY 2025

Figure 1: Site Layout Plan

The site is located at no. 66 Deep Water Bay Road, Shouson Hill. The site is connected to Deep Water Bay road via an access road from the north-east corner of the site. Site photos taken in February 2025 are presented in Appendix A (see Photos 1 to 3). The site location plan is provided in figure no. 1.

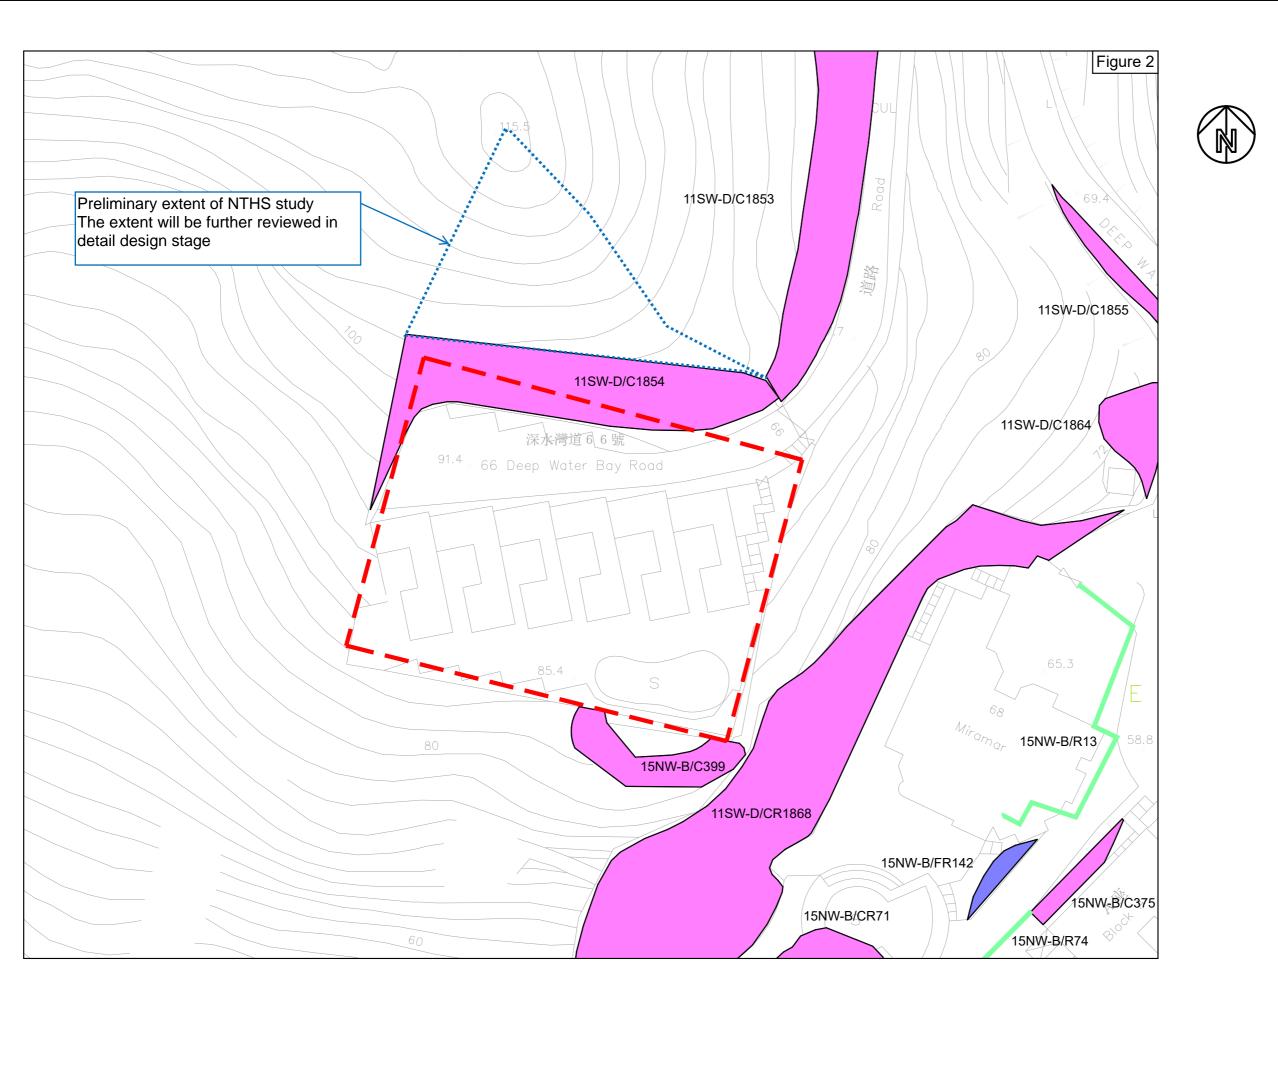
DRG. TITI	E	DRG. NO	
FEATUR	RES LOCATION PLAN	F	1G-02
SCALE	1:500 IN A3	DATE	MAY 202

Figure 2: Feature Location Plan

According to the available SIS records obtained from Geotechnical Engineering Office (GEO), there are 4 existing geotechnical features located in the vicinity of the site. Existing geotechnical feature no. 11SW-D/C1854 is partly lies within the northwestern of the Site. The existing geotechnical feature no. 11SW-D/C1853 is outside lot and located to the west of the existing access road between Deep Water Bay Road and the subject site. Geotechnical feature nos. 15NW-B/C399 and 11SW-D/CR1868 are located immediately outside and about 5m from the southeastern of the site boundary, respectively. The feature location plan is provided in figure no. 2.

Legend: The Application Site Existing Geological Feature Fill Slope Cut Slope Retaining Wall

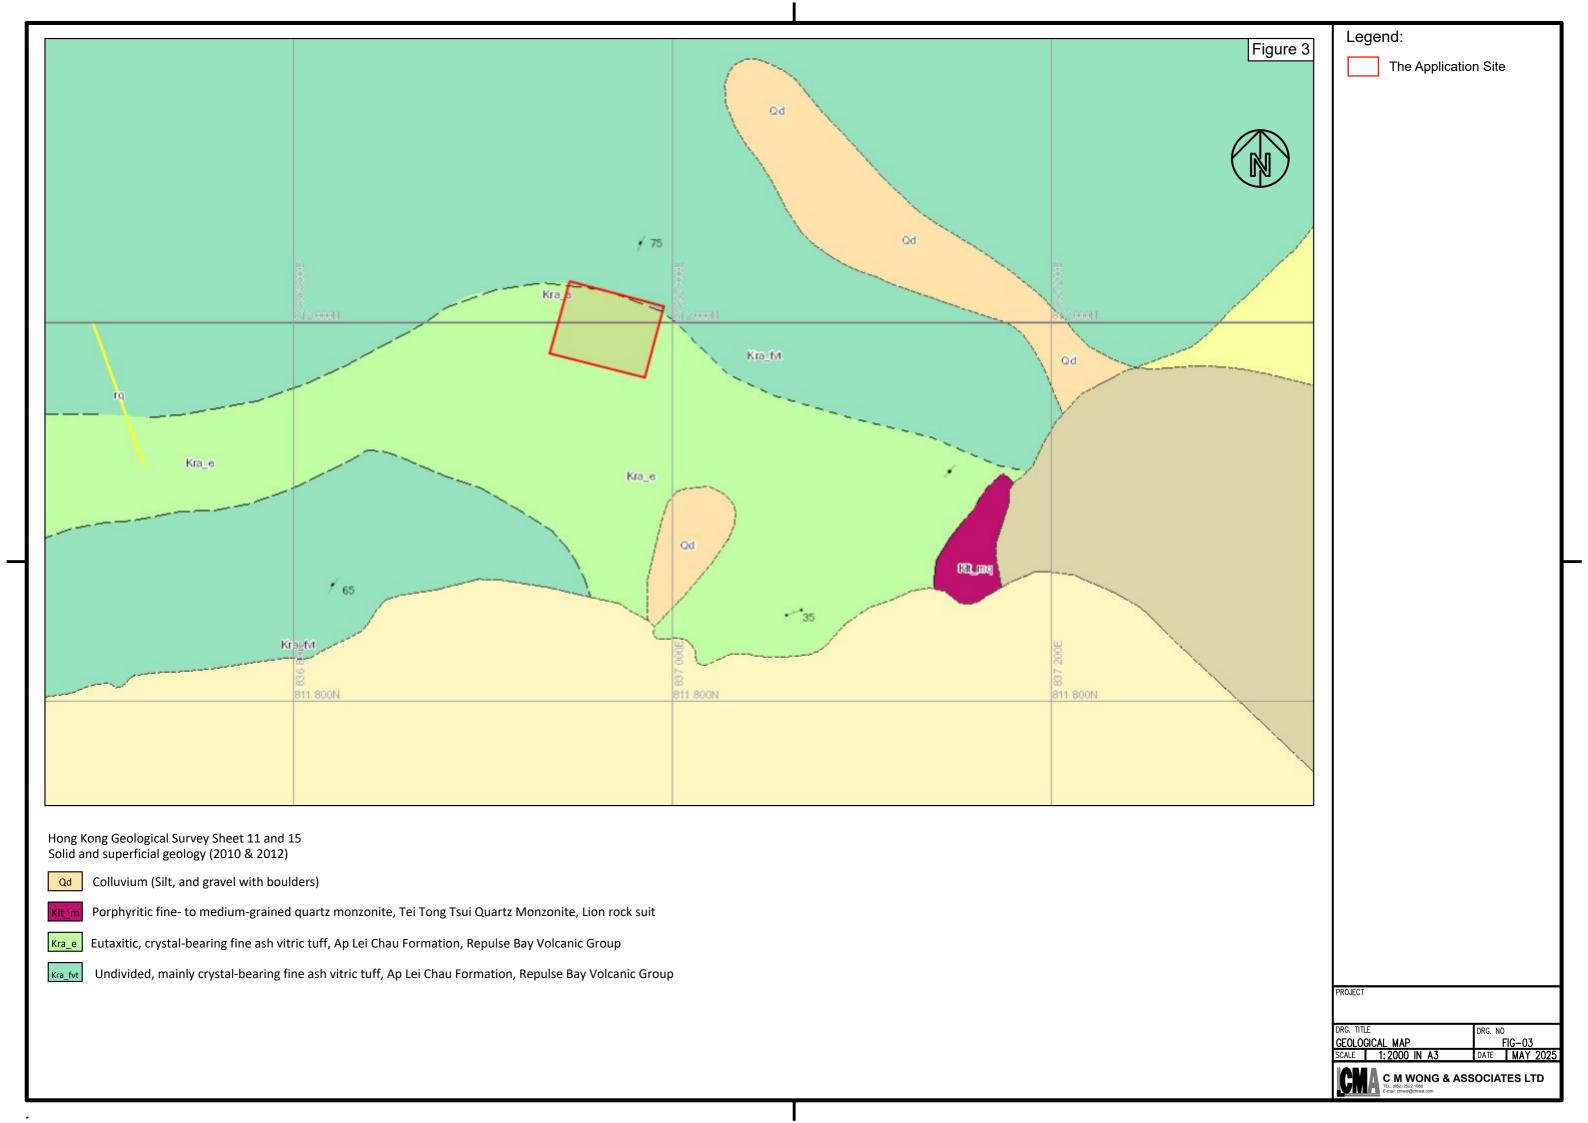
Figure 3: Geological Map

The geology of the Study Area is shown on the Hong Kong Geological Survey (HKGS) Map Sheet 11 & 15, 1:20,000 - scale HGM20 series. The local geology of the Study Area is presented in Figure 3 and described below.

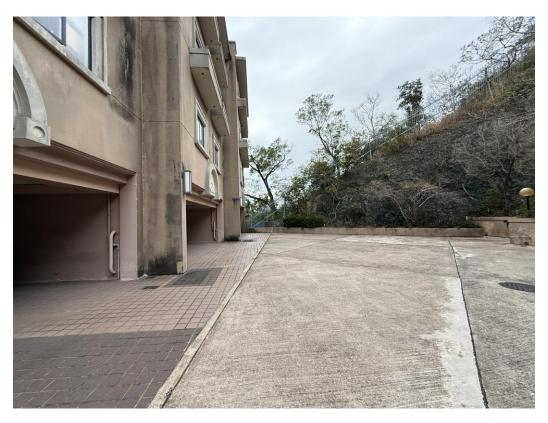
Photo 1: General View of site

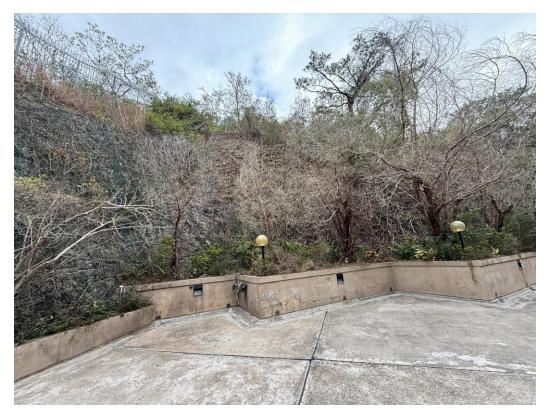
Photo 2: General view of Feature 11SW-D/C1854

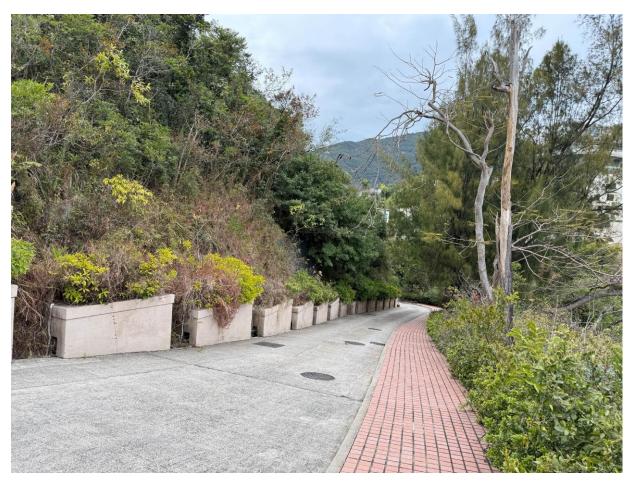
Photo 3: General view of the access road

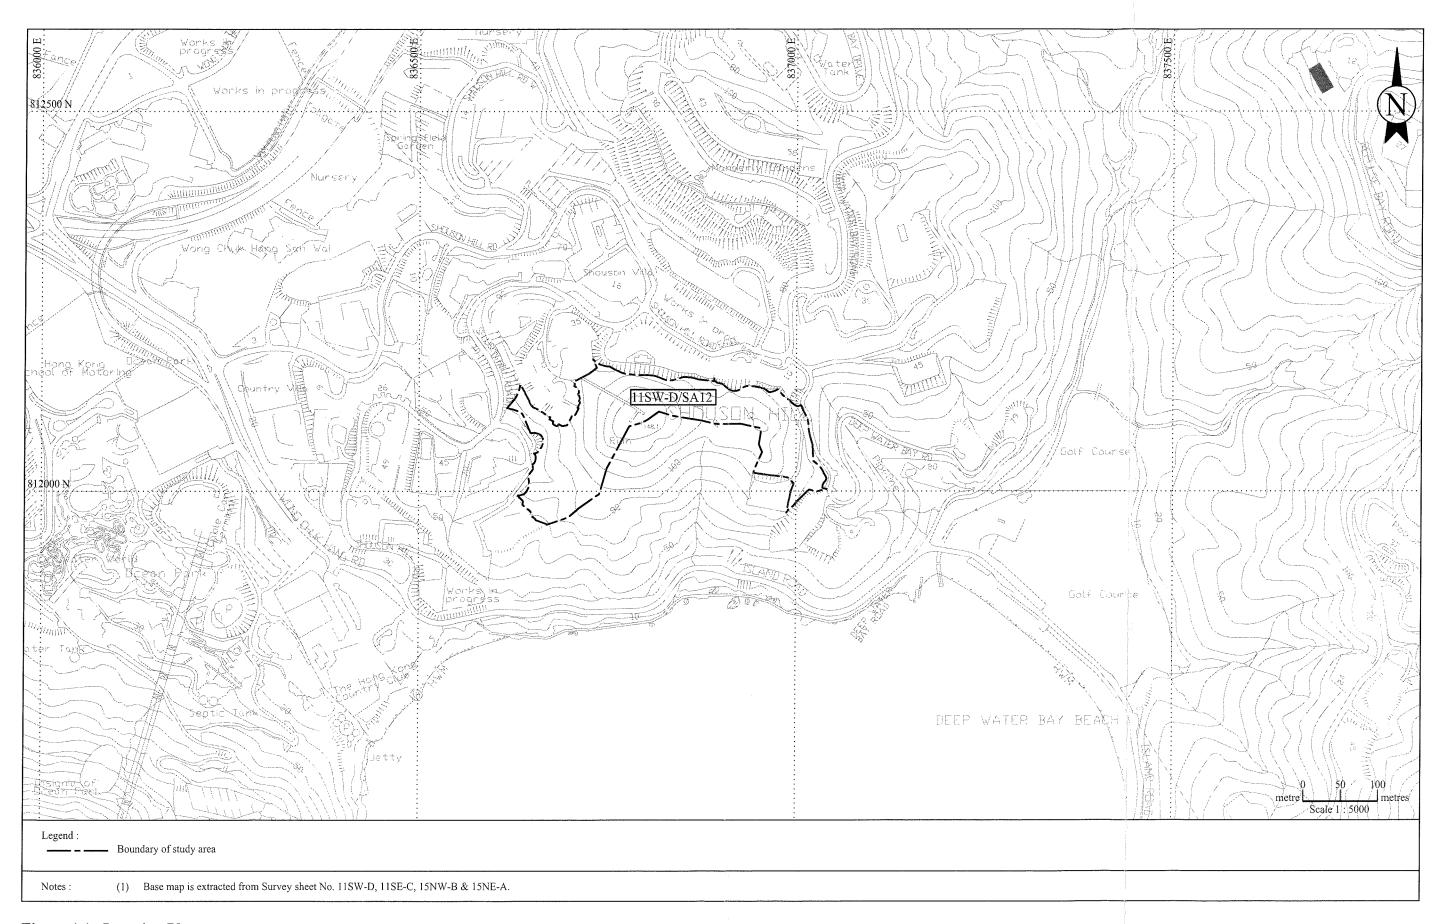
Figure 1.1 Location Plan

A Stage 2(H) Report (S2(H)R 20/2013) was prepared in June 2013, which presented the findings of a review of the potential hazards arising from natural terrain areas within this Study Area. The location and extent of the Study Area are presented in Figure 1.1.

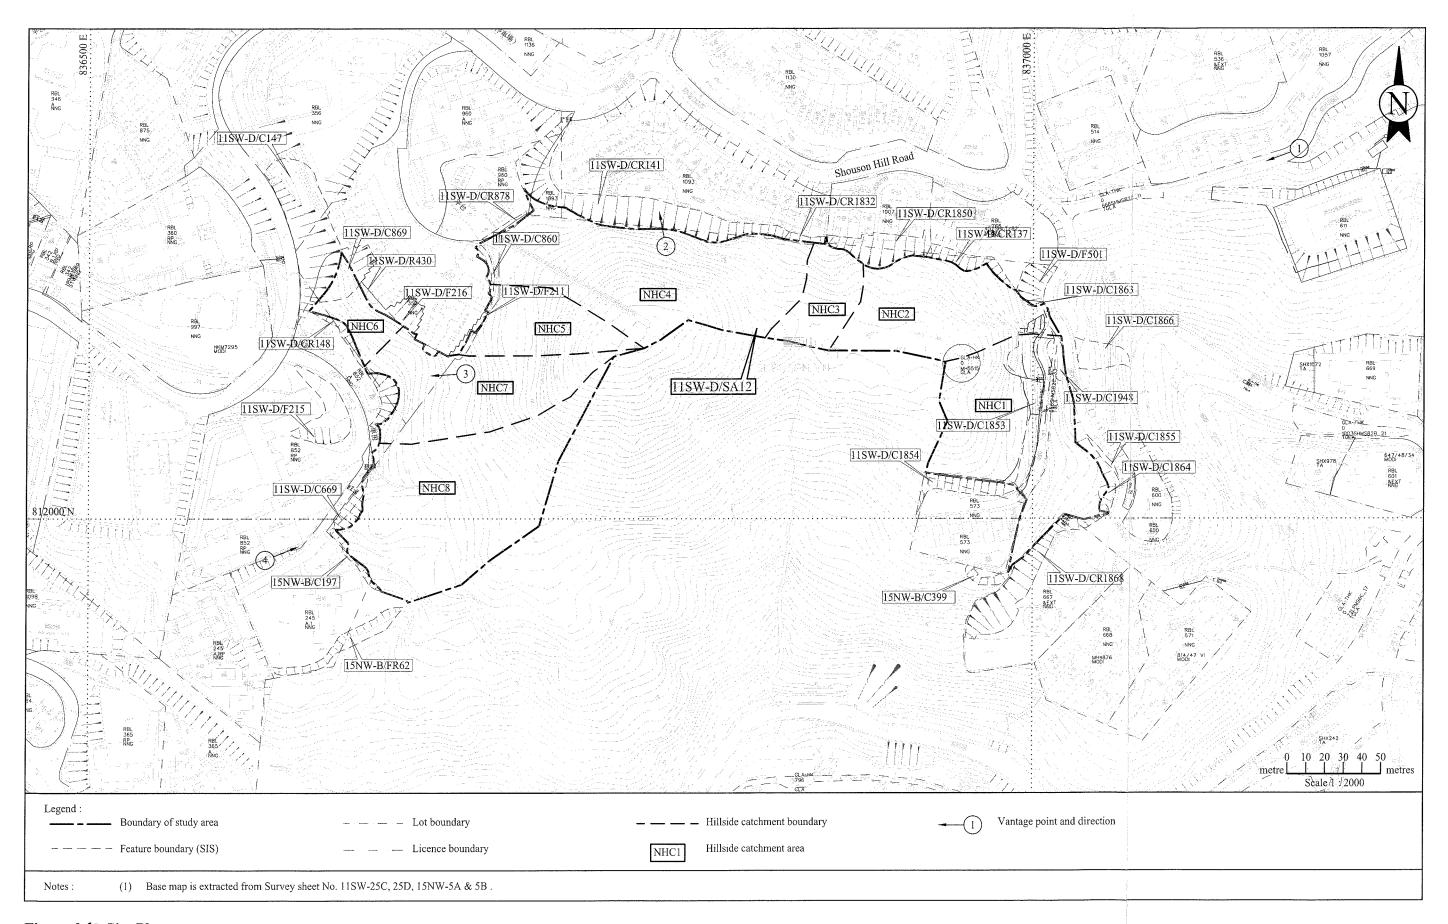
Figure 2.1 Site Plan

Study Area 11SW-D/SA12 is located in the southwestern part of Hong Kong Island just to the north of Deep Water Bay and is essentially natural terrain. It encompasses the steep hillsides to the north, northwest, west, southwest, east and southeast of the east-west trending ridgeline which forms the summit of Shouson Hill. The Study Area is a horse-shoe shaped area of about 3.6 ha in size (Figure 2.1). The Study Area comprises the following eight Natural Hillside Catchments (NHC):

General views of the Study Area are shown in Figures 2.2 to 2.5 and vantage points of the photos are shown in Figure 2.1.

retaining walls in the vicinity of the Study Area are shown in Figure 2.1. Five of them have been checked under previous LPM Stage 2 or Stage 3 studies.
