**Approved Geotechnical Planning Review
Report**

**Proposed Commercial Development
on Inland Lot No.8945, Causeway
Bay, Hong Kong**

Geotechnical Planning Review Report

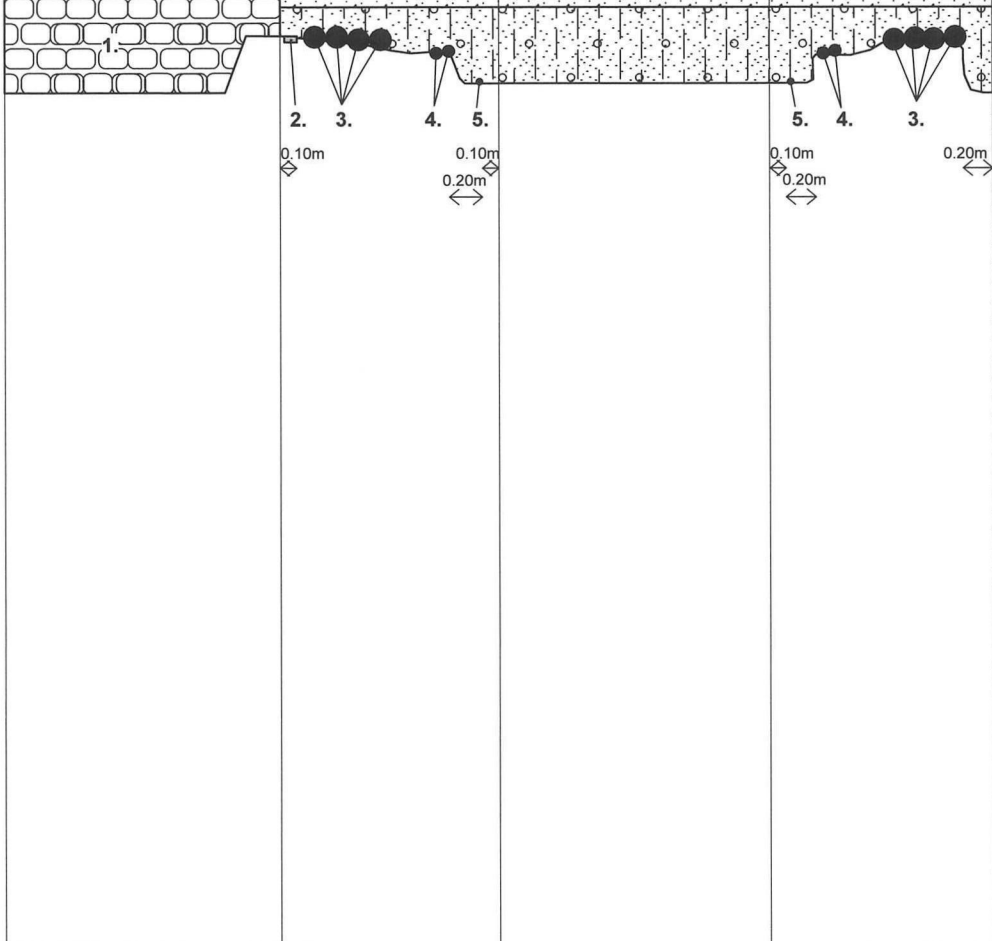
CONTRACT No.	PROJECT NO. J3957		Logged by : M H CHIU Date : 18/01/2022	Co-ordinates : E 837225.73 N 815420.58 Ground Level : + 4.85 mPD	Excavation Dates: 17/01/2022 to 17/01/2022 Backfill Dates: 21/01/2022	TRIAL PIT No. TP05U		
	PROJECT: Ground Investigation Works for the Commercial Development on IL No. 8945, Causeway Bay, Hong Kong			Checked by : K M LO Date : 19/01/2022					
Sample & Tests	Depth (m)	Sketch				Depth (m)	Legend	Grade	Description
		Face A 1.50 m	Face B 1.20 m	Face C 1.50 m	Face B 1.20 m

Grey, CONCRETE surface. 1. Brown, MASONRY WALL. Dense, moist, brown, slightly silty fine to coarse SAND with some subangular fine to coarse gravel sized rock and concrete fragments. (FILL) 2. Grey, CONCRETE block (50mm thick). 3. Black, PVC pipe (Dia. 110mm). (New World) 4. Blue, PVC pipe (Dia. 60mm). (HGC Broadband) 5. Blue, low voltage cable (Dia. 30mm). (Highway) End of trial pit at 0.50m depth. 6. Grey, CONCRETE.

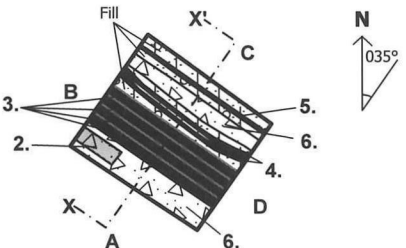
Shoring: No Stability: Stable Water Seepage: No Maximum Depth: 0.50m 1. Small disturbed sample was taken at 0.50m depth.

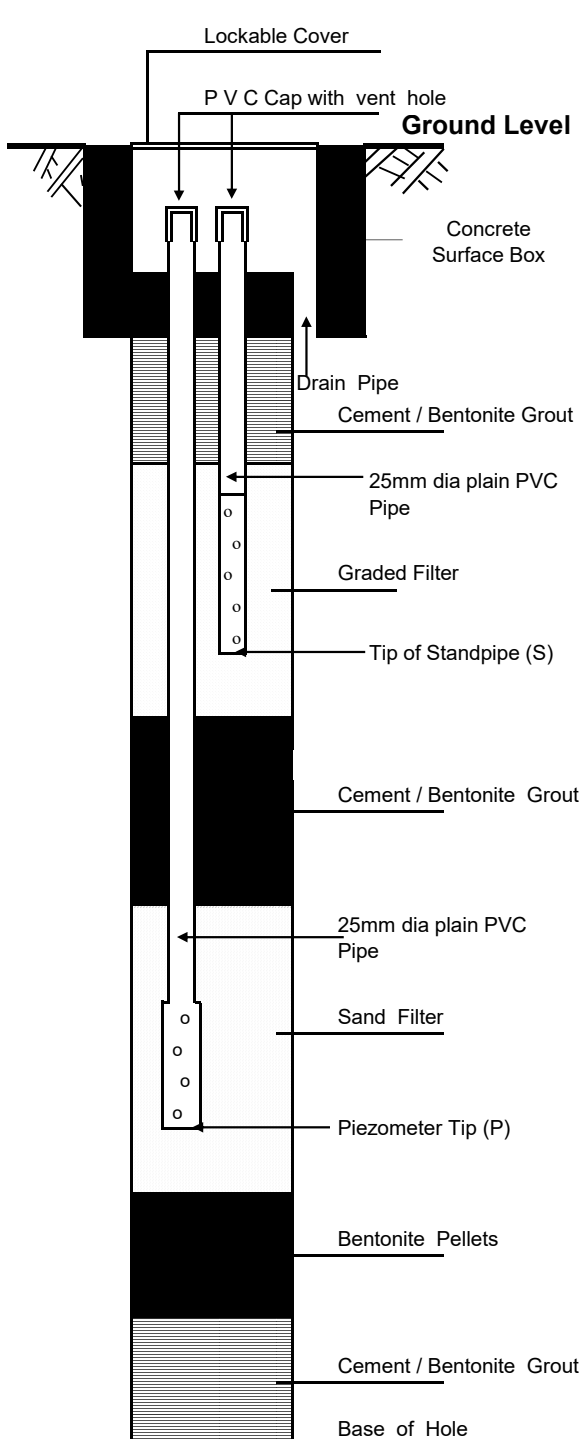
TYSAN FOUNDATION LIMITED		Hole No. : BH10
			Piezometer ID. : P
			Standpipe ID. : S
Contract No. : TC G518		Works Order No. : ASD 012516	Date of test : 02/09/2019
PWP Item No. 286ZX - Construction of the District Court Complex at Project : Caroline Hill Road (Phase 1)			Supervised by : Derek Wong
Co-ordinates : E 837229.63 N 815269.16		Ground Level : +15.07 mPD	Date checked : 03/09/2019
Response Zone of Piezometer : 0.87 mPD to -0.43 mPD		Piezometer (P) Tip Level : 0.07 mPD	Checked by : Peter Chu
Response Zone of Standpipe : 13.07 mPD to 2.07 mPD		Standpipe (S) Tip Level : 2.57 mPD	Dip Meter ID : TSMT-31
Remarks :

STANDPIPE / PIEZOMETER INSTALLATION DETAILS AND GROUNDWATER MONITORING RECORDS									
STANDPIPE		Reduced Level (mPD)	Depth (m)

Date	Depth of G.W.L. (m)								
		15.07	0.00						
03/09/2019	7.52	14.97	0.10						
04/09/2019	7.55								
05/09/2019	7.55	14.77	0.30						
06/09/2019	7.56								
08/09/2019	7.54	13.07	2.00						
09/09/2019	7.55								
10/09/2019	7.56								
PIEZOMETER		2.57	12.50						
		2.07	13.00						
03/09/2019	7.62								
04/09/2019	7.63	0.87	14.20						
05/09/2019	7.65								
06/09/2019	7.65								
08/09/2019	7.66	0.07	15.00						
09/09/2019	7.68	-0.43	15.50						
10/09/2019	7.67								
		-1.43	16.50						
		-40.00	55.07
