# **Geotechnical Planning Review Report for Construction of Horizontal Directional Drilling (HDD) Works Near Discovery Bay Tunnel**

Geotechnical Planning Review | Government Land Near Discovery Bay Tunnel

B220171.023.01 | 15 October 2025

**CLP Power Hong Kong Limited**

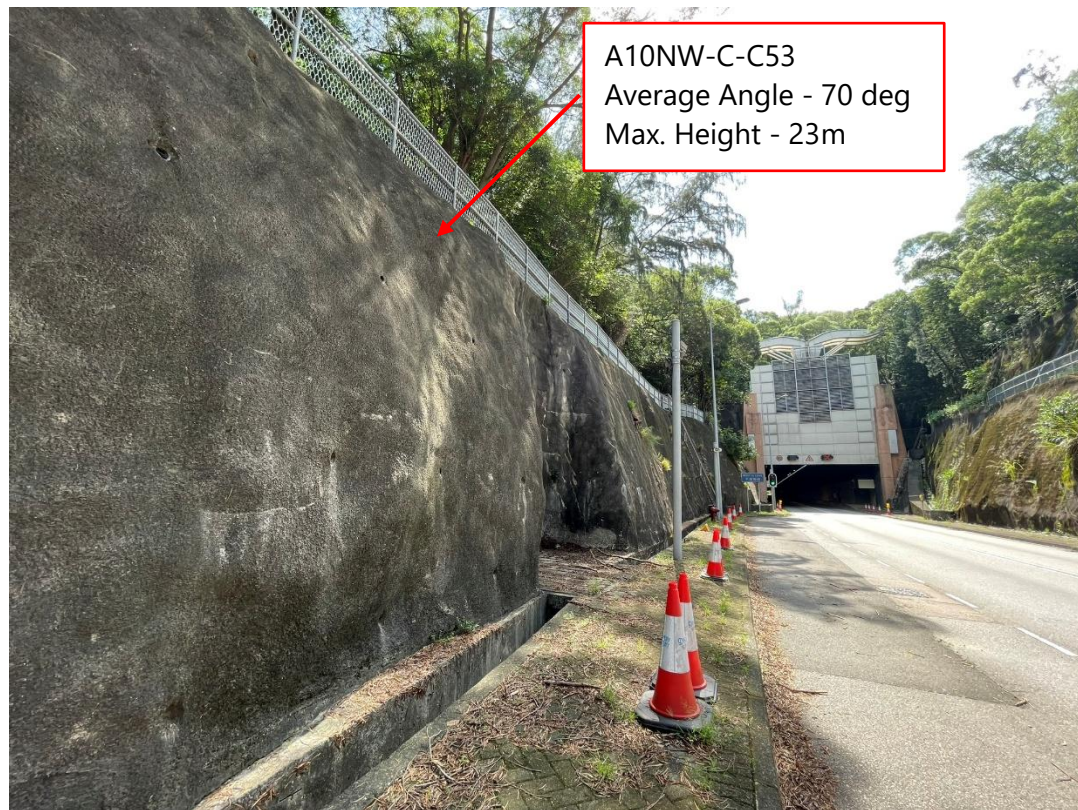
Photo 2: General View of 10NW-C-C53

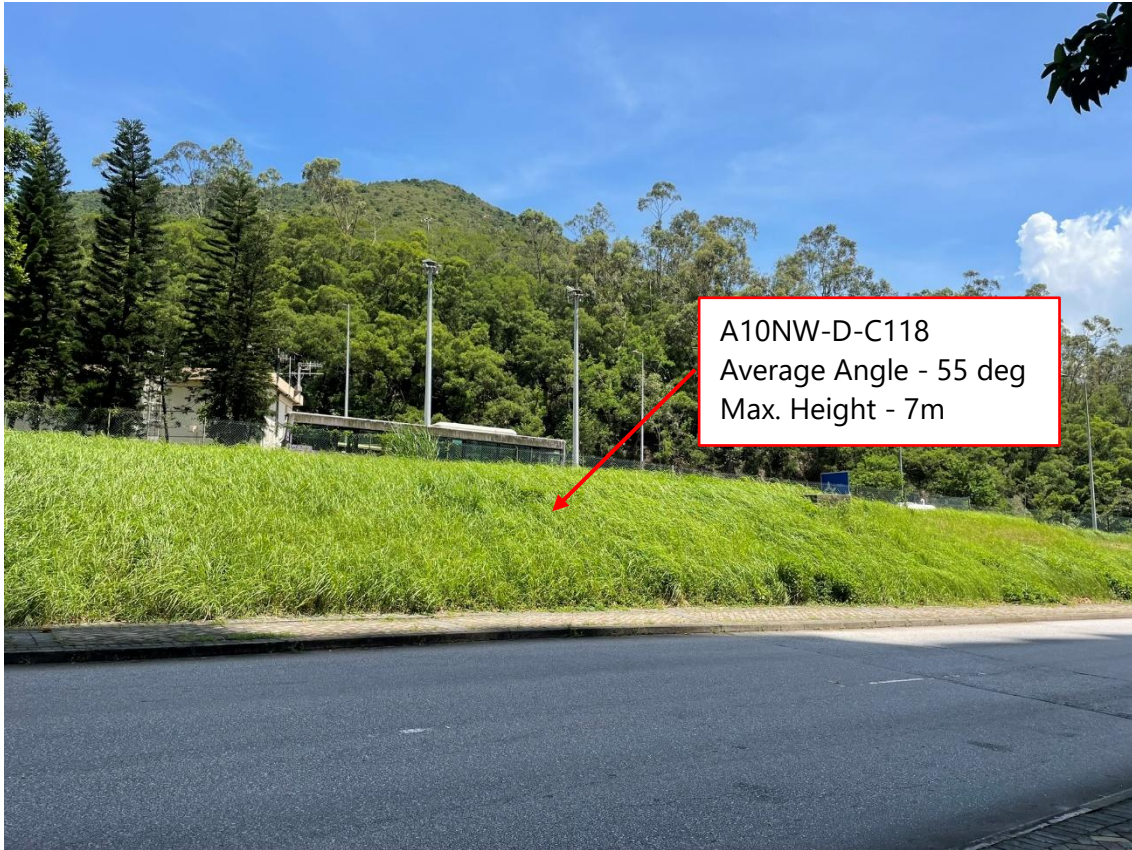
Photo 3: General View of 10NW-D-C118

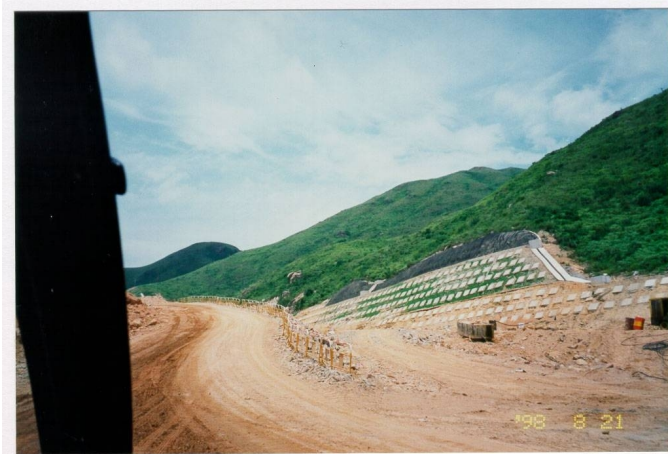
10NW-D/C118

GENERAL VIEW .

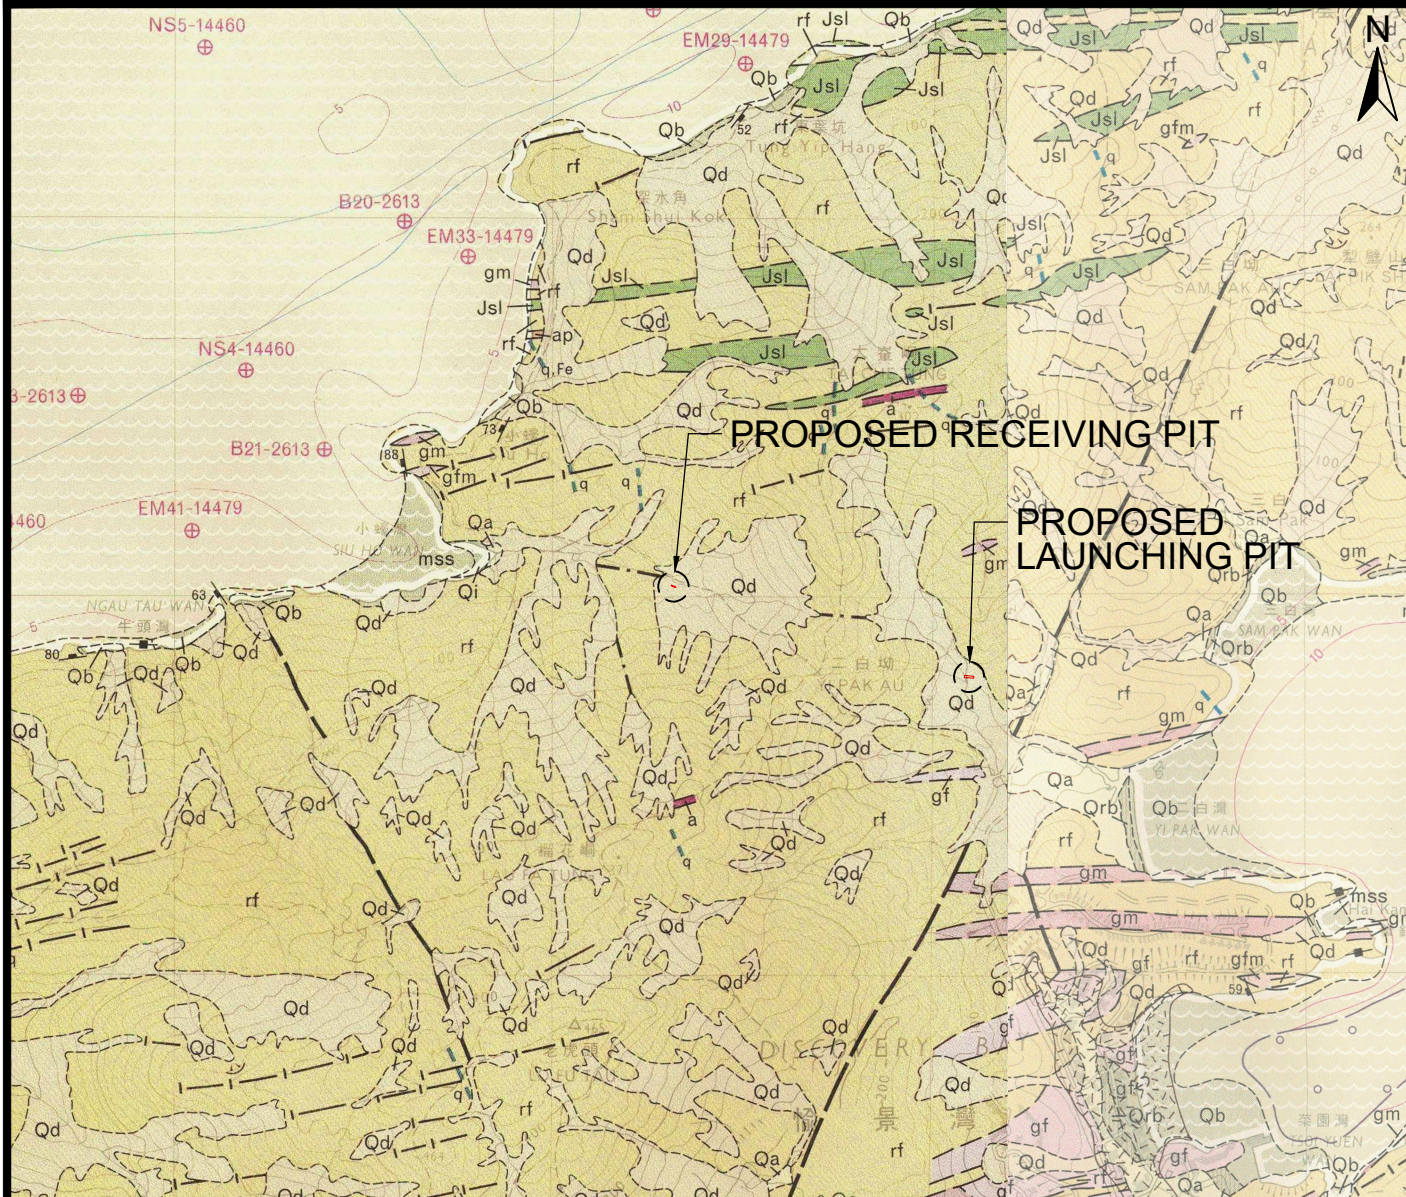
- PROPOSED LAUNCHING PIT / RECEIVING PIT
- GEOLOGICAL BOUNDARY, SUPERFICIAL DEPOSIT
- \* GEOLOGICAL BOUNDARY, SOLID ROCK
- \* FAULT (CROSSMARK INDICATES DOWNTROW SIDE)
- ISOPACH OF HANG HAU FORMATION
- LIMIT OF DUMPED MATERIAL OUTSIDE GAZETTED DUMPING GROUND
- PHOTOGEOLOGICAL LINEAMENT
- JOINTING (INCLINED)
- JOINTING (VERTICAL)
- MINERAL VEIN
- Qb SAND (BEACH DEPOSITS)
- Qd MUD SHOWING ACOUSTIC TURBIDITY (GAS BLANKING)
- Qd SAND, GRAVEL, COBBLES AND BOULDERS IN SILT MATRIX (DEBRIS FLOW DEPOSITS)
- gf FINE-GRAINED GRANITE, <2 MM
- gm MEDIUM-GRAINED GRANITE, 2-6 MM
- ap APLITE
- rf FELDSPARPHYRIC RHYOLITE
