Geotechnical Planning Review Report

Section 16 Planning Application for Proposed Religious Institution
and Columbarium (Partial Redevelopment of Prajna Dhyana Temple)

Section 16 Planning Application

April 2026

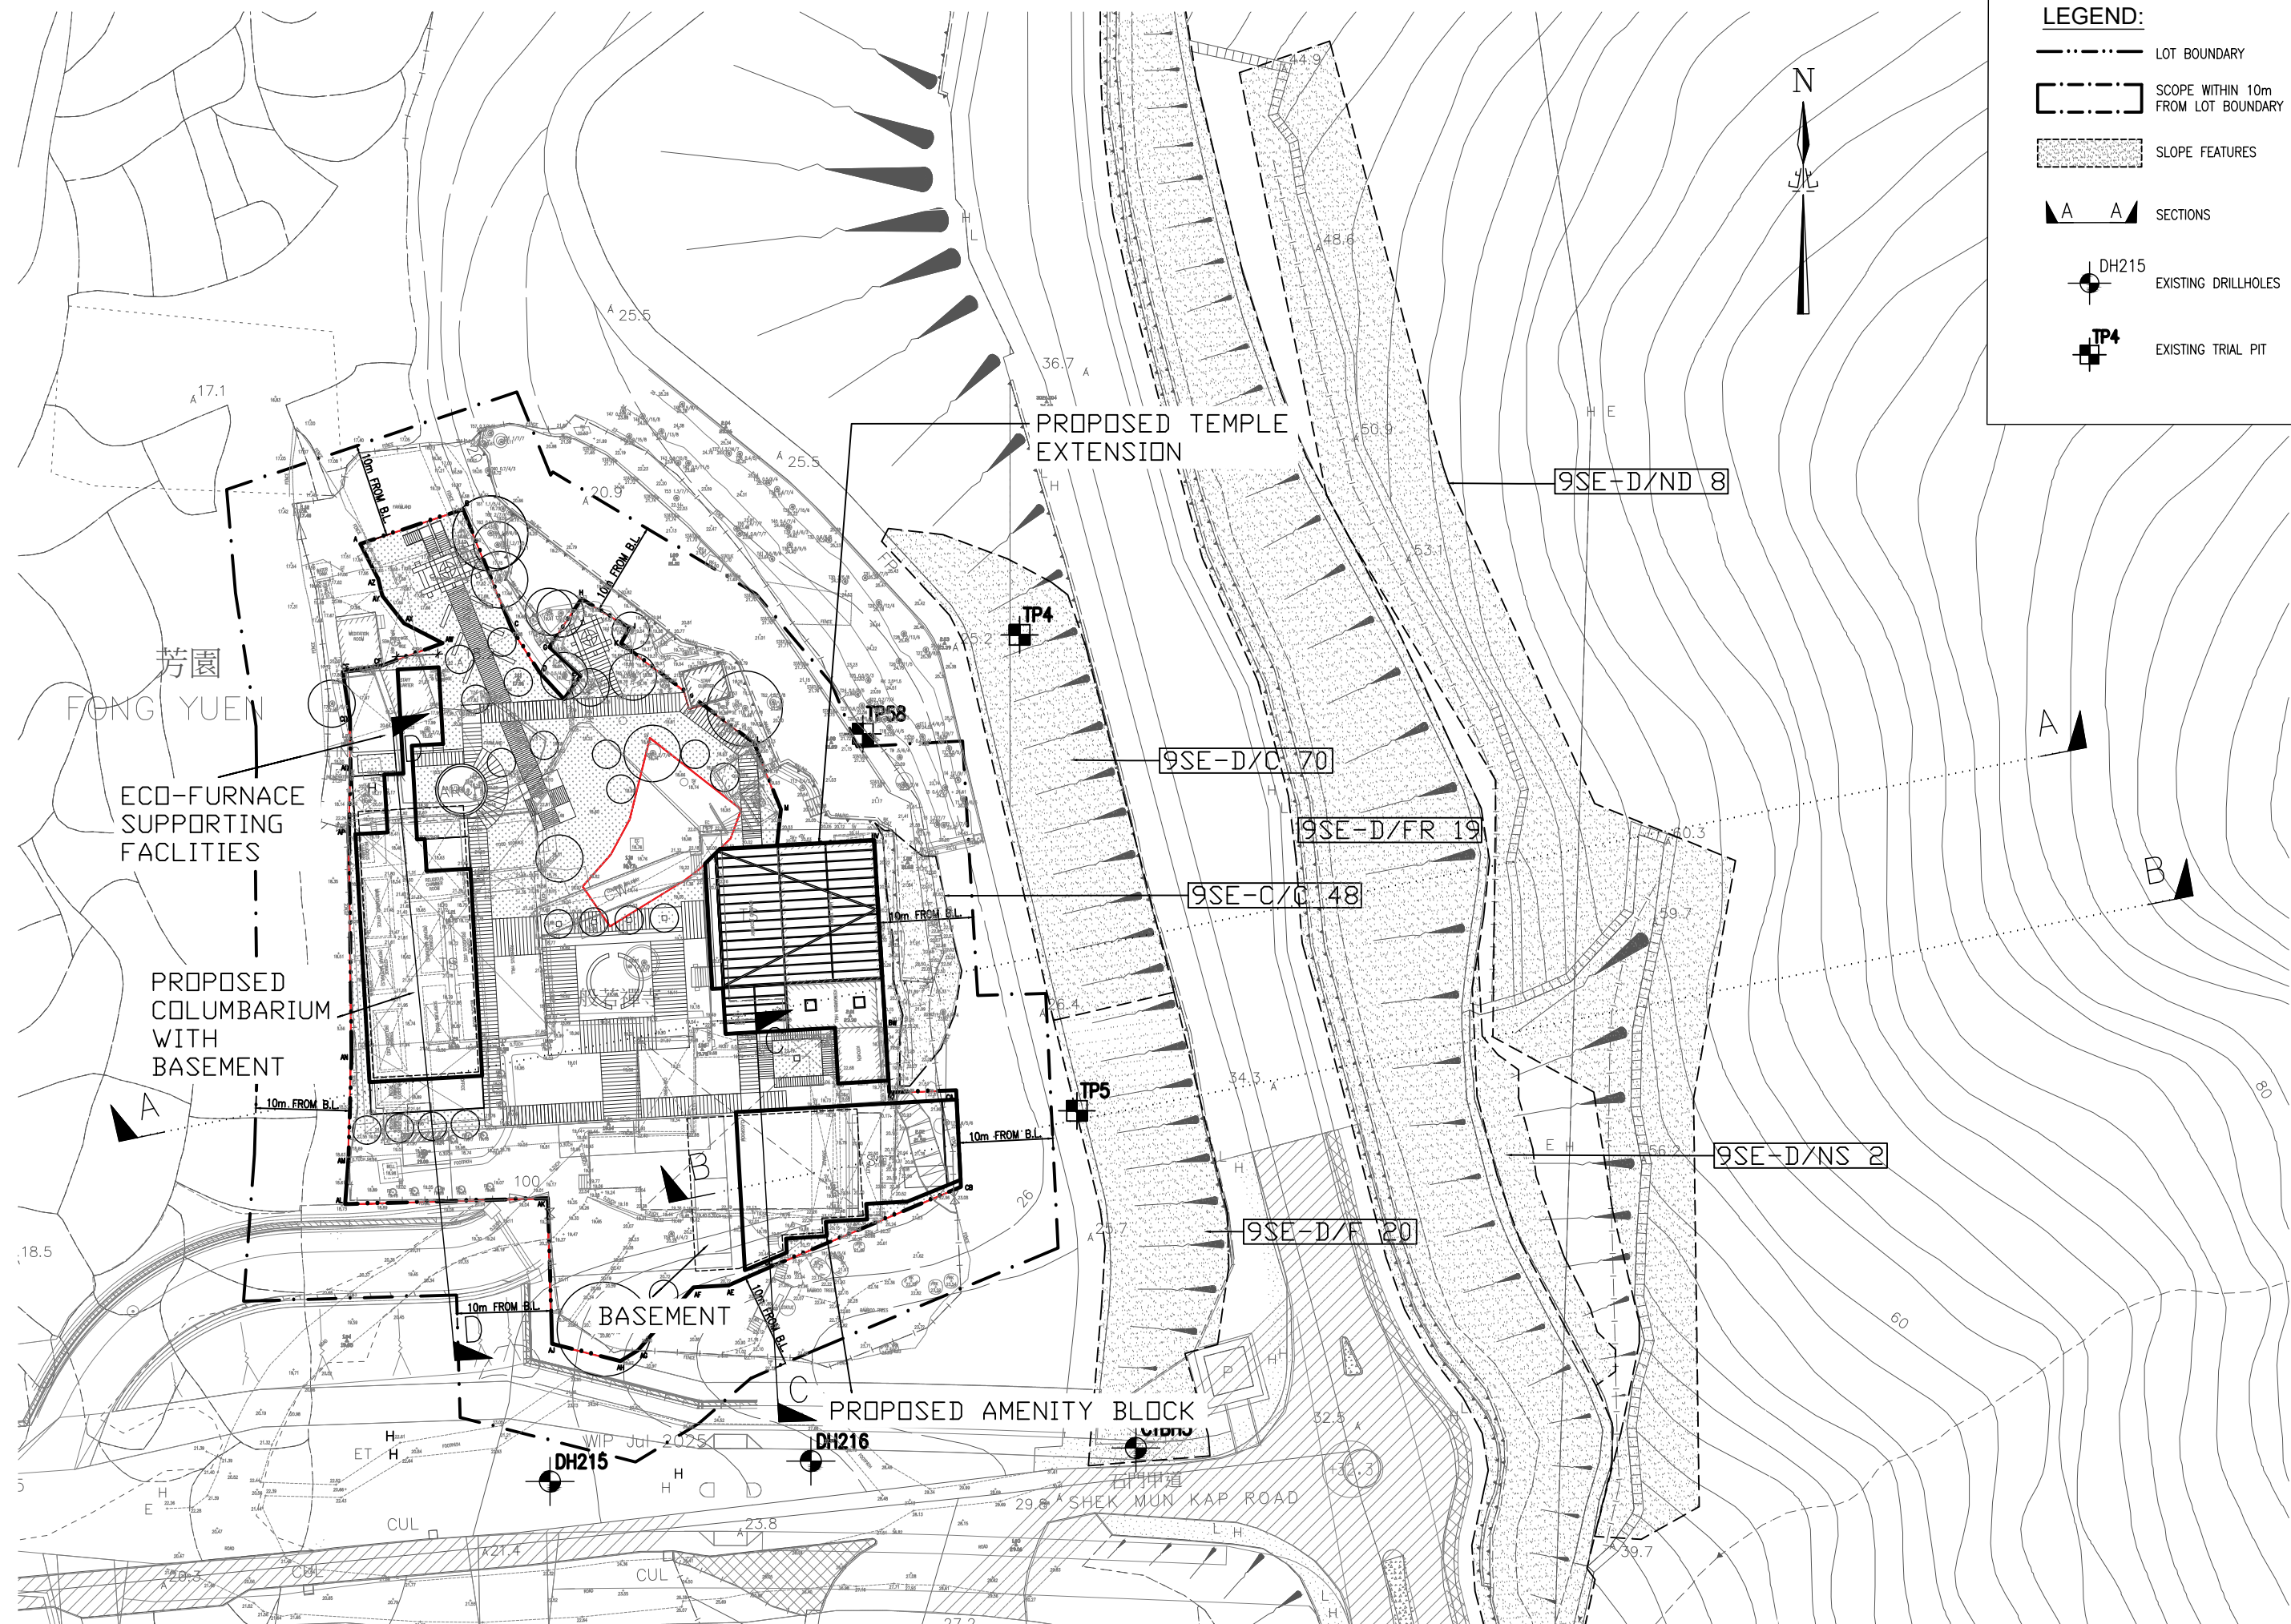
FIGURE 2

Superimposed Development Layout Plan and Geotechnical Cross Section (Figure 2 to 5)

An overall redevelopment layout plan and geological sections are presented as Figure 2 to 4 attached in **Appendix C**.

There is only one registered slope feature 9SE-C/C48 which lies within site boundary as shown in Figure 2. Stability check will be carried out on this Feature, and it will be upgraded to meet current FOS if found necessary. Detailed design submission will be

Proposed Basements are upto 4m deep, as both basements are located close to site boundary, lateral support excavation system is required. Again, all proposed ELS works will be submitted to relevant Government Departments for approval (Fig 2 to 4 refers).
