Geotechnical Assessment Report

Proposed Temporary Shop & Services
(Estate Agent Office)

Lot 431 R.P. in D.D. 10
Lam Kam Road, Lam Tsuen
Tai Po, N.T.

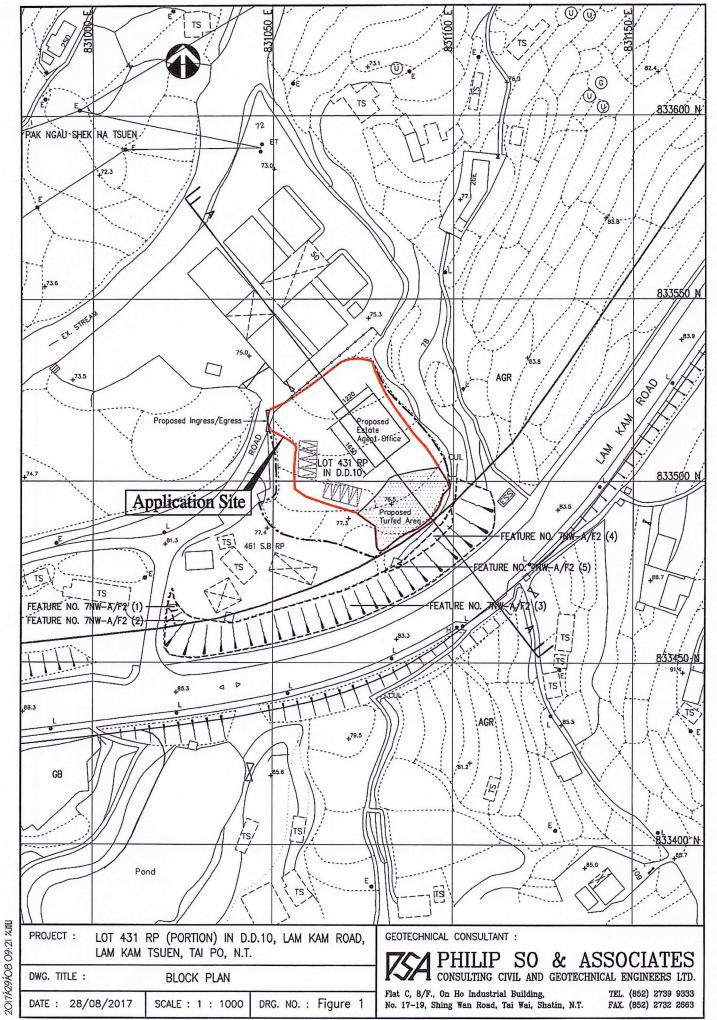
The proposed works involve Temporary Shop & Services (Estate Agent Office) with Ancillary Car Park for Period of 3 Years at Lot 431 R.P. in D.D. 10, Lam Kam Road, Lam Tsuen, Tai Po, N.T. The block plan of the site is given in Figure 1.

With reference to the Block Plan (Figure 1 refers), temporary shop & services (Estate Agent Office) with Ancillary Car Park and turfed area are proposed to be constructed at the subject lot.

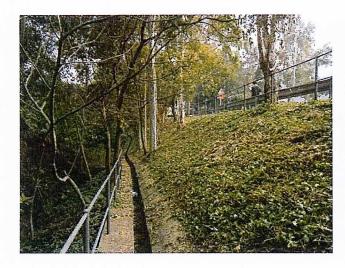
<u>PHOTO</u>

SLOPE PART

(1) Max. Height (m): 8 Length (m): 130 Average Angle (deg): 40

Slope Part (1)

Vegetated: 100

Material Description: Berm: Material type: Soil No. of Berms: 1 Geology: N/A Min. Berm Width (m): 1

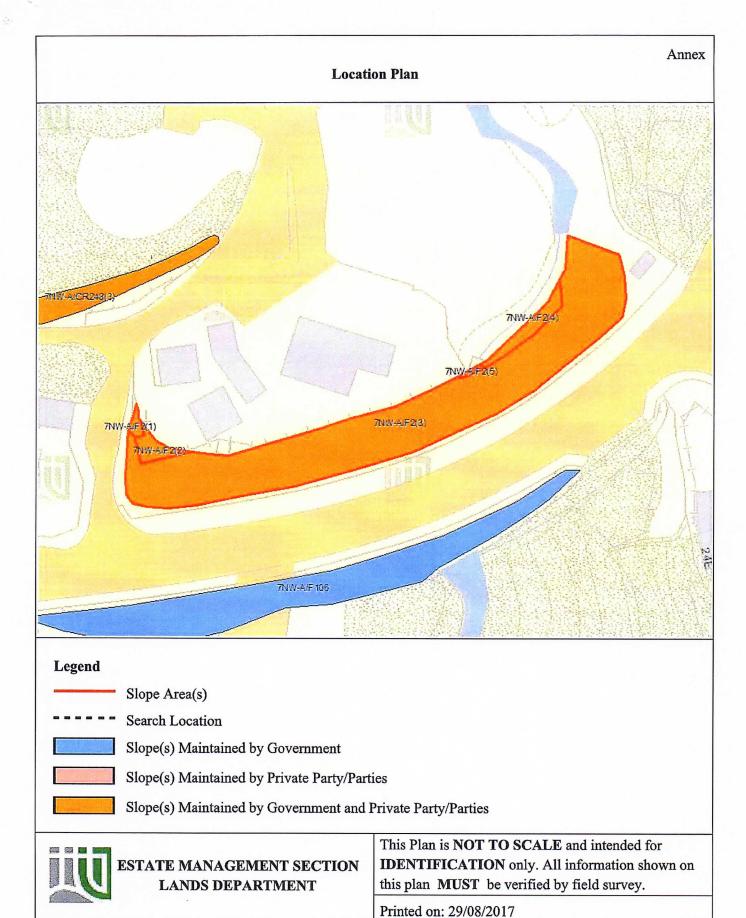
- (i) The location plan in Annex is for identification purposes of slope(s) only.
- (ii) The slope(s) as listed in the Slope Maintenance Responsibility Report may not be shown on the location plan in Annex.
