Application for Permission under Section 16 of The Town Planning Ordinance (Cap.131)  
Proposed Temporary Place of Recreation, Sports or Culture (Hobby Farm) with Ancillary Facilities for a Period of 3  
Years and Associated Filling of Land at Lots 1275 (Part), 1279 (Part), 1280, 1281 (Part), 1282 and 1284 (Part) in D.D. 96,  
Ma Tso Lung, New Territories

Geotechnical Planning Review Report

**March 2026**

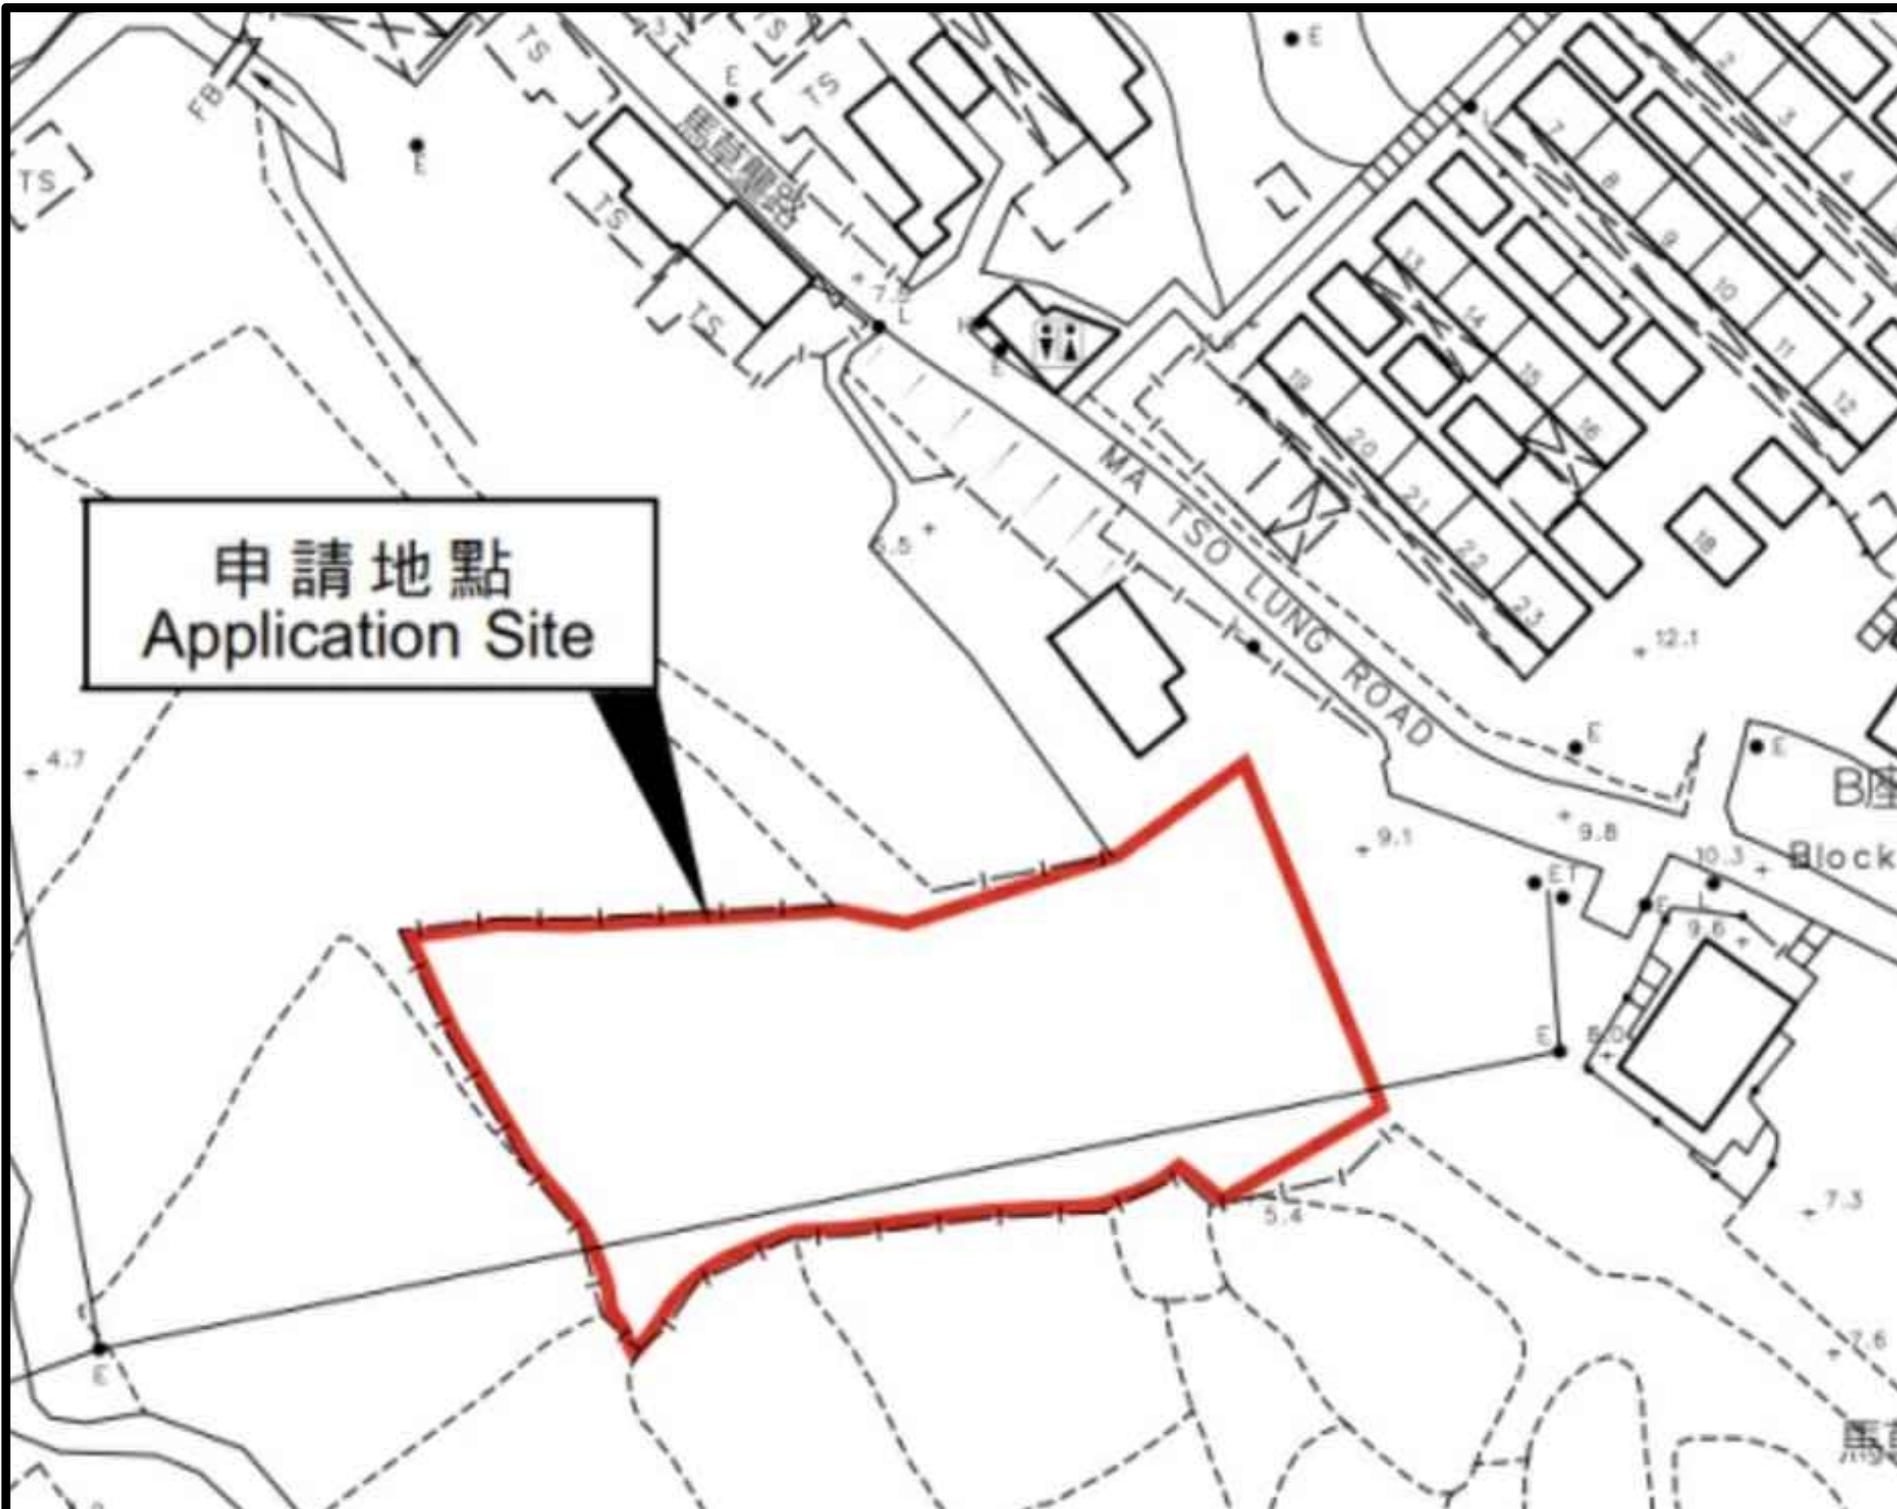
Fig.1

— Site Boundary

Site photos taken in December 2024 are presented in Appendix A (see Photos A to D). General view and close up view of the Site is shown on Photo A, B, C and D. The location plan and the aerial view of the Site is presented in Figures 1 and 2, respectively.

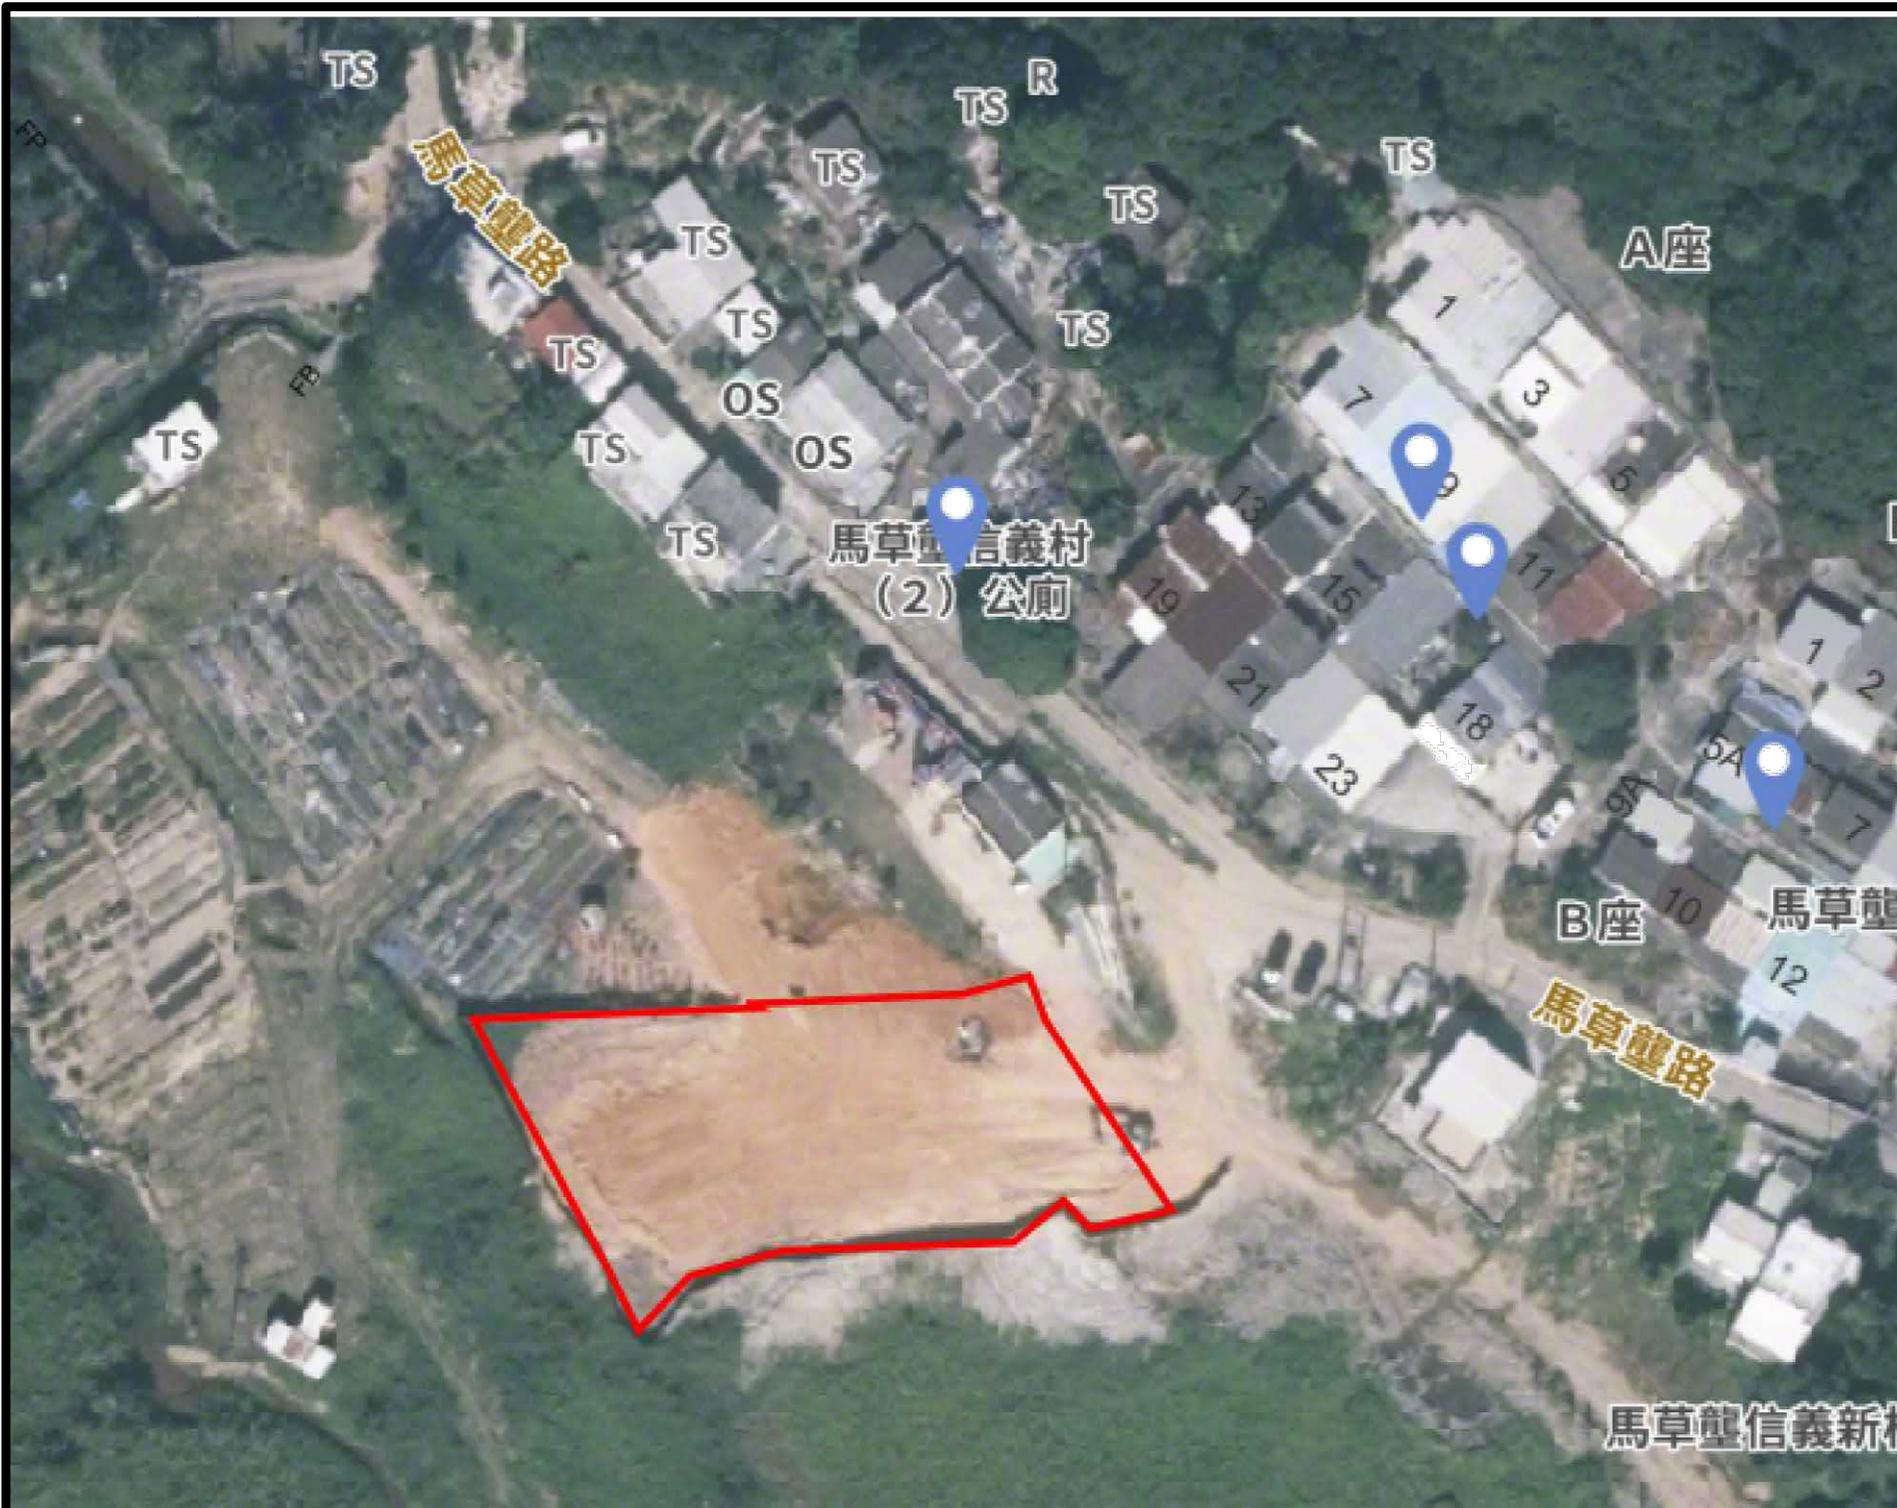
Fig.2

— Site Boundary

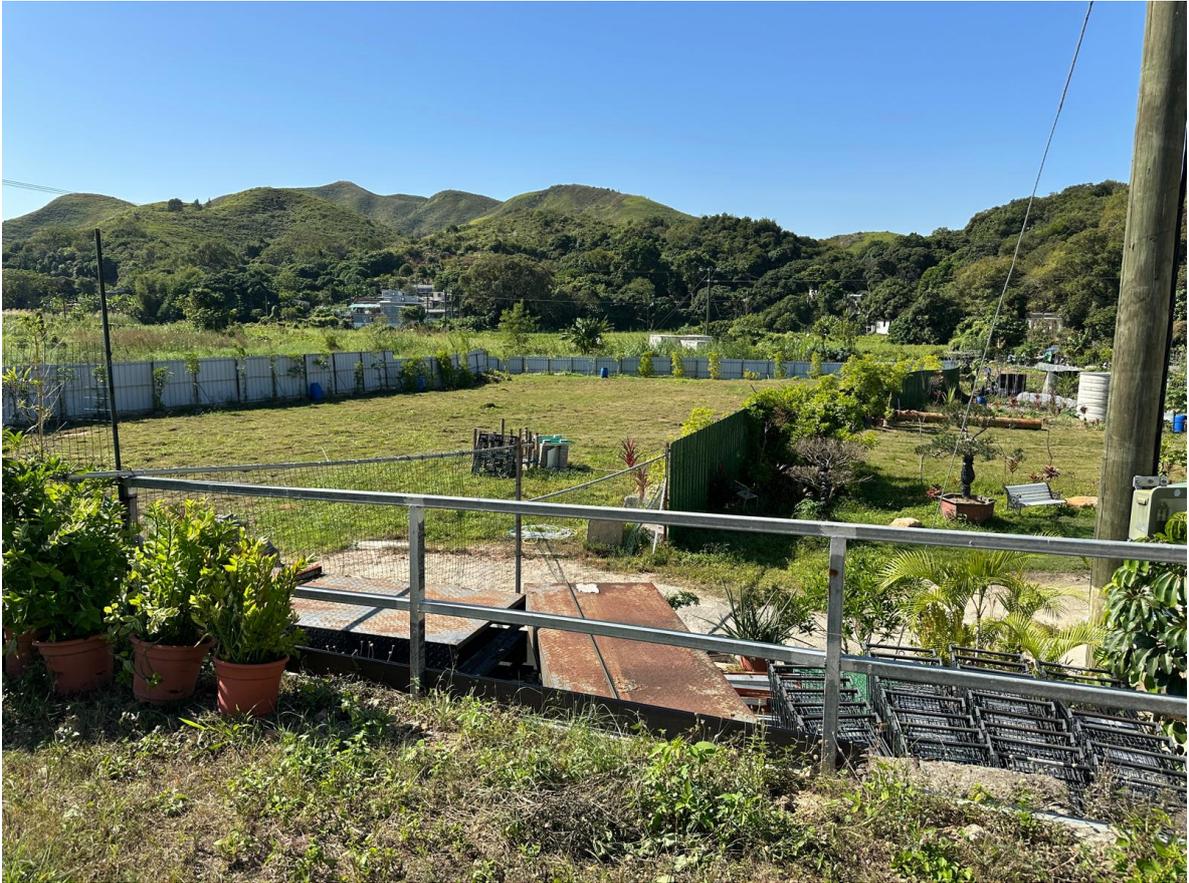
VIEW A SITE VIEW

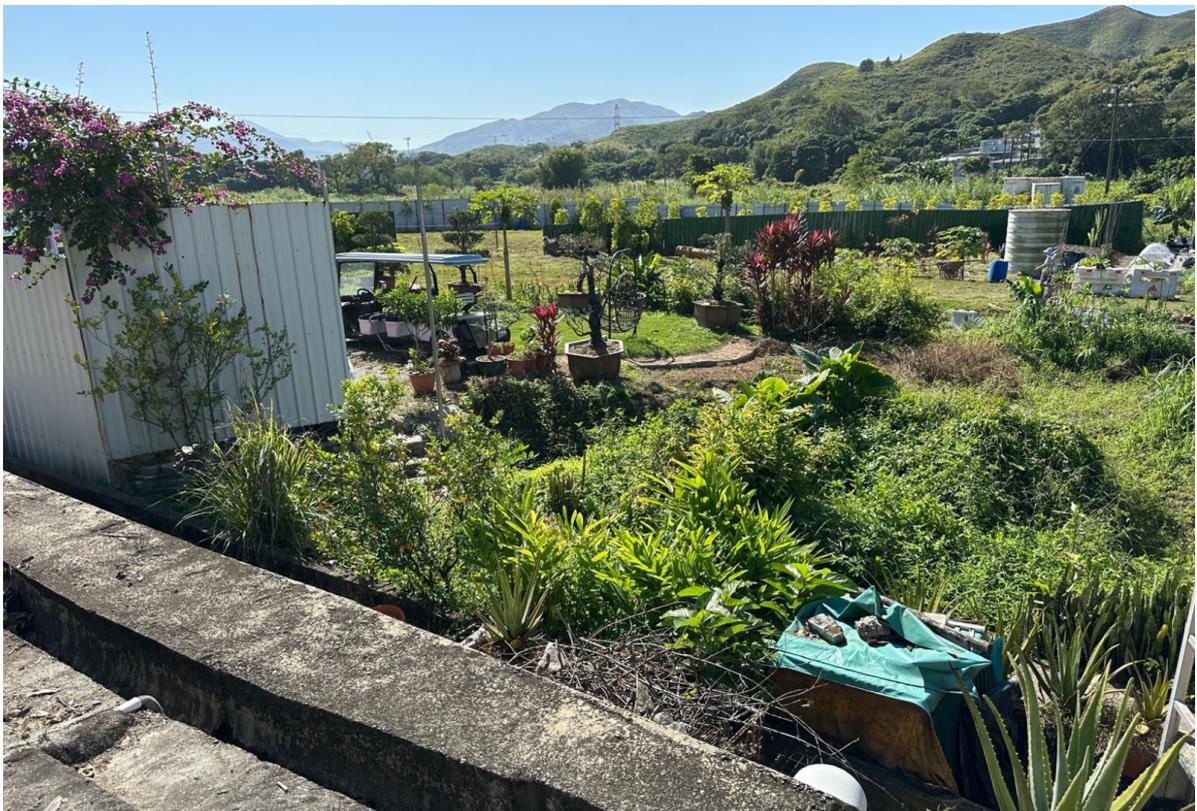
VIEW B SITE VIEW

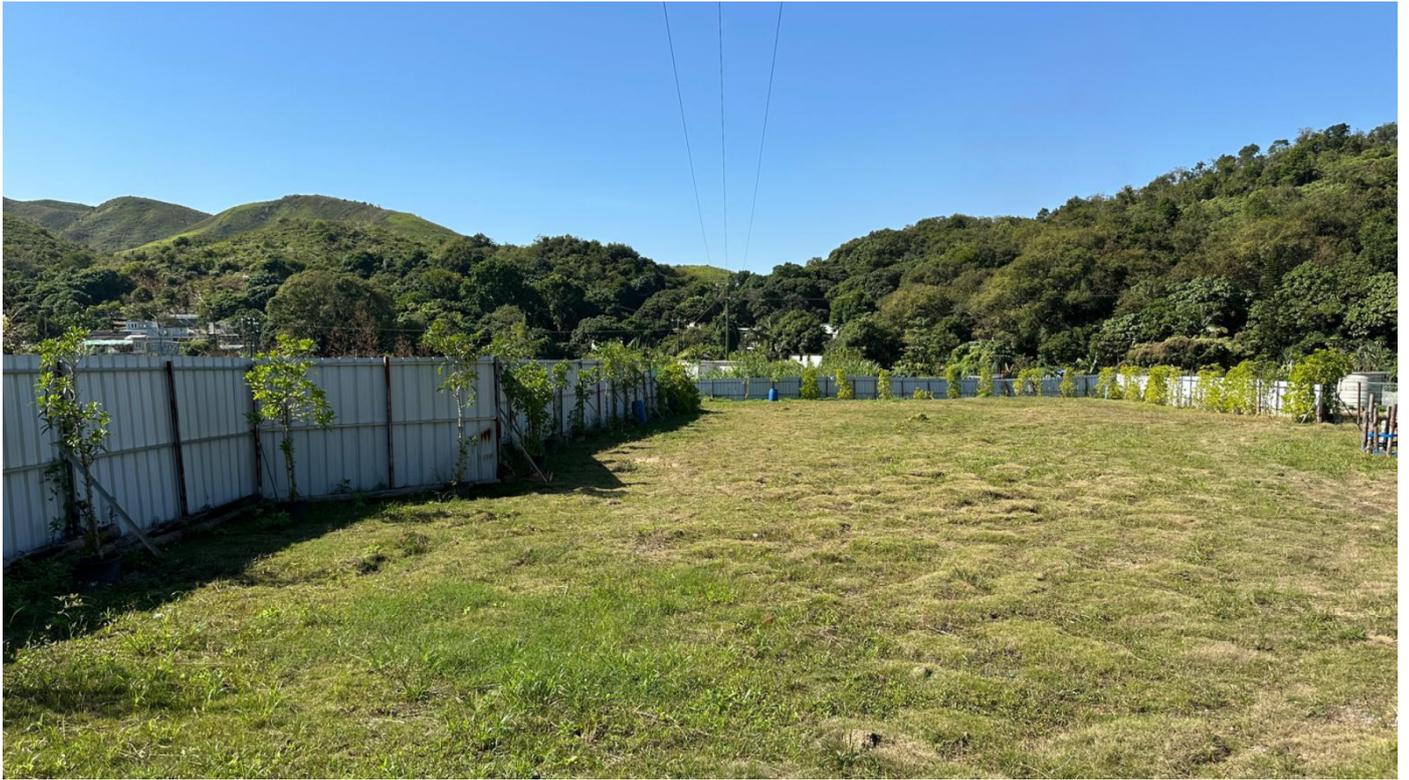
VIEW C SITE VIEW

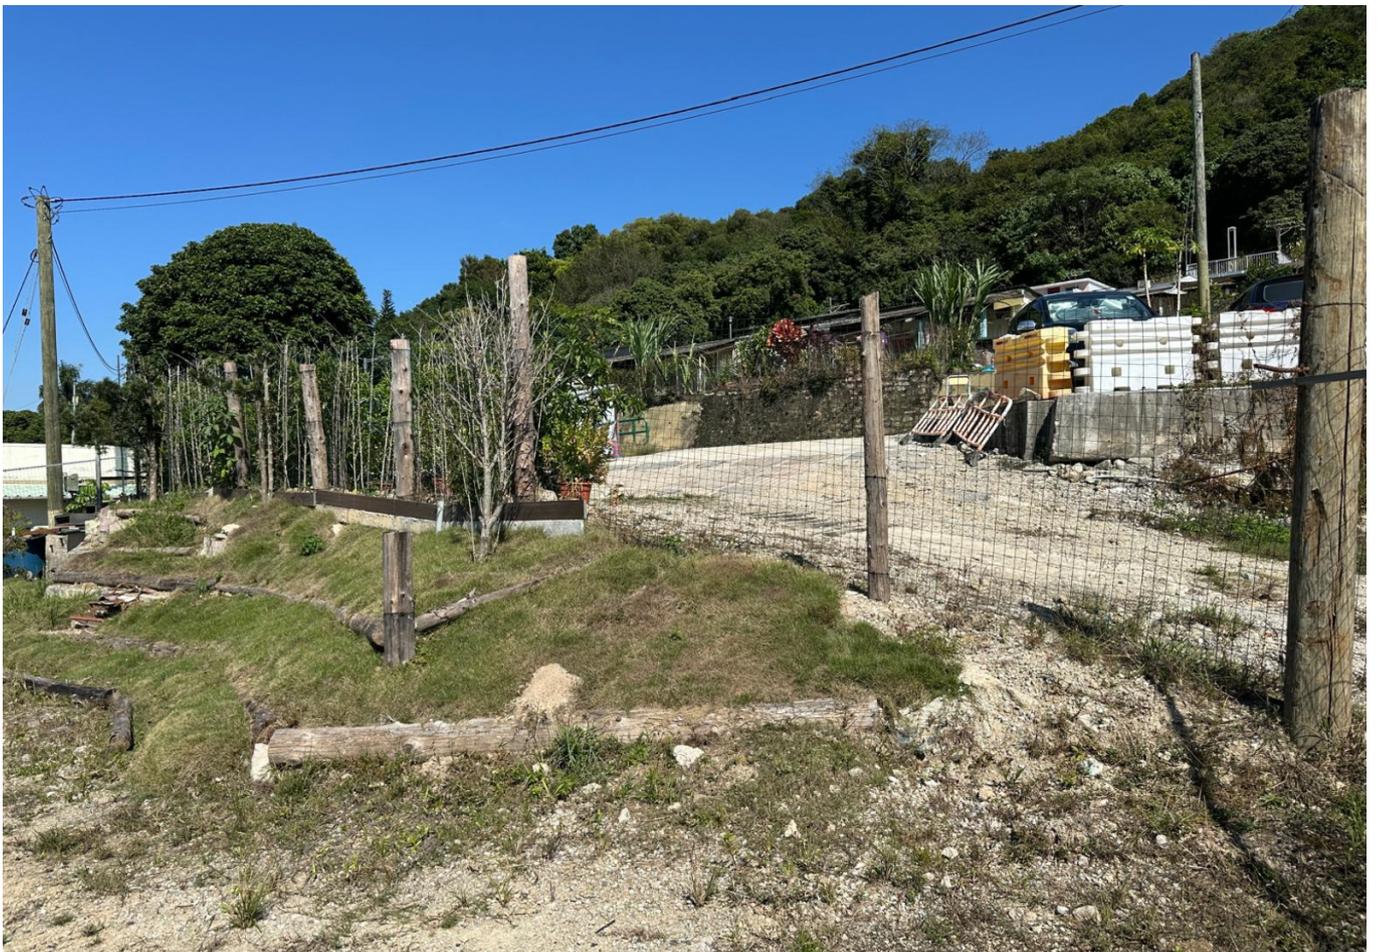
VIEW D1 Entrance of Site

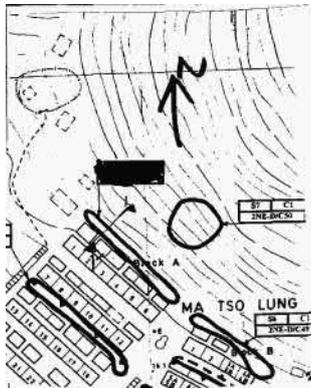
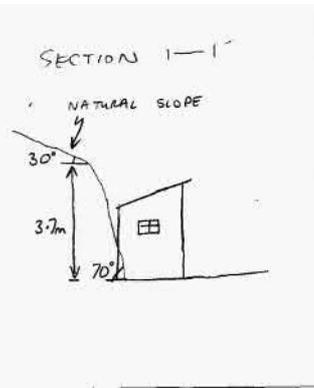
Section No: 1-1  
 Height (m): N/A  
 Type of Toe Facility: Cottage, licensed and squatter area  
 Distance from Toe (m): 0  
 Type of Crest Facility: Undeveloped green belt  
 Distance from Crest (m): 0  
 Consequence Category: 1  
 Engineering Judgement: P  
 Section No: 2-2  
 Type of Toe Facility: N/A  
 Distance from Toe (m): 0  
 Type of Crest Facility: N/A  
 Distance from Crest (m): 0  
 Consequence Category: 1  
 Engineering Judgement: P  
 Sign of Seepage: Slope : No signs of seepage  
 Wall : N/A  
 Criterion A satisfied: N  
 Sign of Distress: Slope : Minor (mid-portion)  
 Wall : N/A  
 Criterion D satisfied: N  
 Non-routine maintenance required: N  
 Note: N/A

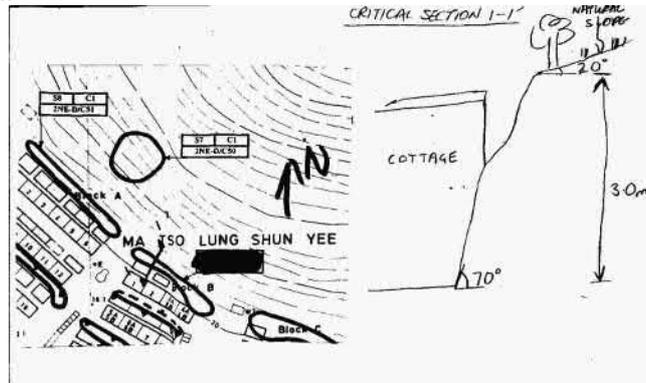
Section No: 1-1  
 Height (m): N/A  
 Type of Toe Facility: Cottage, licensed and squatter area  
 Distance from Toe (m): 0  
 Type of Crest Facility: Undeveloped green belt  
 Distance from Crest (m): 0  
 Consequence Category: 1  
 Engineering Judgement: P  
 Section No: 2-2  
 Type of Toe Facility: N/A  
 Distance from Toe (m): 0  
 Type of Crest Facility: N/A  
 Distance from Crest (m): 0  
 Consequence Category: 1  
 Engineering Judgement: P  
 Sign of Seepage: Slope : Signs of seepage  
 Wall : N/A  
 Criterion A satisfied: N  
 Sign of Distress: Slope : Minor (near crest, mid-portion, at toe)  
 Wall : N/A  
 Criterion D satisfied: N  
 Non-routine maintenance required: N  
 Note: N/A  
 Masonry wall / Masonry facing: N

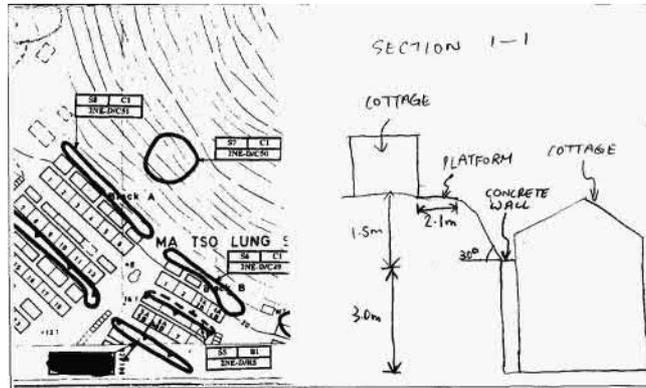
Section No: 1-1  
 Height (m): H1 : 5 , H2 : 3  
 Type of Toe Facility: Cottage, licensed and squatter area  
 Distance from Toe (m): 0  
 Type of Crest Facility: Cottage, licensed and squatter area  
 Distance from Crest (m): 3.5  
 Consequence Category: 1  
 Engineering Judgement: P  
 Section No: 2-2  
 Type of Toe Facility: N/A  
 Distance from Toe (m): N/A  
 Type of Crest Facility: N/A  
 Distance from Crest (m): N/A  
 Consequence Category: 1  
 Engineering Judgement: P  
 Sign of Seepage: Slope : No signs of seepage  
 Wall : Signs of seepage  
 Criterion A satisfied: N  
 Sign of Distress: Slope : N/A  
 Wall : N/A  
 Criterion D satisfied: N

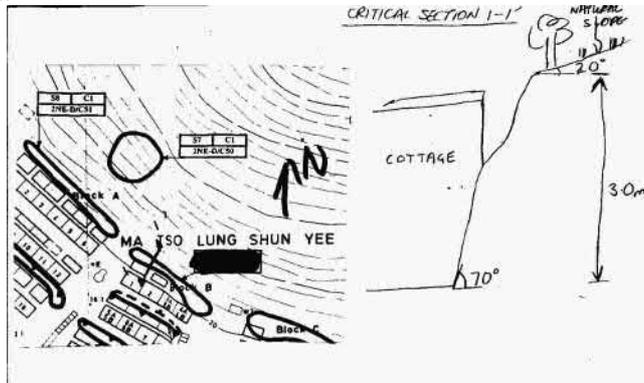
**STAGE 1 STUDY REPORT**

Inspected On: 27-10-1997  
 Weather: Mainly Fine  
 District: MW

Section No: 1-1  
 Height (m): N/A  
 Type of Toe Facility: Cottage, licensed and squatter area  
 Distance from Toe (m): 0  
 Type of Crest Facility: Undeveloped green belt  
 Distance from Crest (m): 0  
 Consequence Category: 1  
 Engineering Judgement: P  
 Section No: 2-2  
 Type of Toe Facility: N/A  
 Distance from Toe (m): 0  
 Type of Crest Facility: N/A  
 Distance from Crest (m): 0  
 Consequence Category: 1  
 Engineering Judgement: P  
 Sign of Seepage: Slope : Signs of seepage  
 Wall : N/A  
 Criterion A satisfied: N  
 Sign of Distress: Slope : Minor (near crest, mid-portion, at toe)  
 Wall : N/A  
 Criterion D satisfied: N  
 Non-routine maintenance required: N  
 Note: N/A  
 Masonry wall / Masonry facing: N

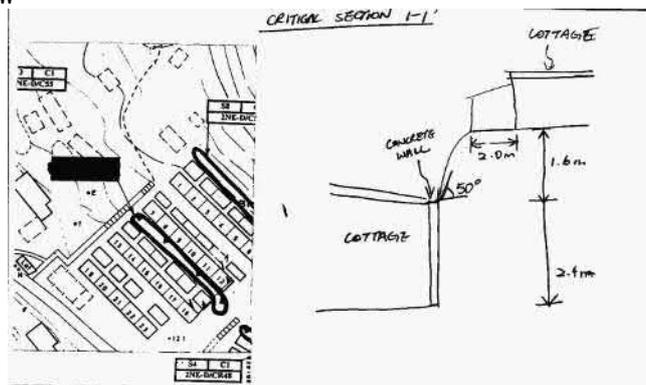
**STAGE 1 STUDY REPORT**

Inspected On: 27-10-1997  
 Weather: Mainly Fine  
 District: MW

Section No: 1-1  
 Height (m): H1 : 2 , H2 : 2  
 Type of Toe Facility: Cottage, licensed and squatter area  
 Distance from Toe (m): 0  
 Type of Crest Facility: Cottage, licensed and squatter area  
 Distance from Crest (m): 2  
 Consequence Category: 1  
 Engineering Judgement: P  
 Section No: 2-2  
 Type of Toe Facility: N/A

Distance from Toe (m):	N/A
Type of Crest Facility:	N/A
Distance from Crest (m):	N/A
Consequence Category:	1
Engineering Judgement:	P
Sign of Seepage:	Slope : No signs of seepage Wall : No sign of seepage
Criterion A satisfied:	N
Sign of Distress:	Slope : N/A Wall : N/A
Criterion D satisfied:	N
Non-routine maintenance required:	N
Note:	N/A
Masonry wall / Masonry facing:	N
Note:	N/A
Consequence category (for critical section):	1
Observations:	N/A
Emergency Action Required:	N
Action By:	N/A

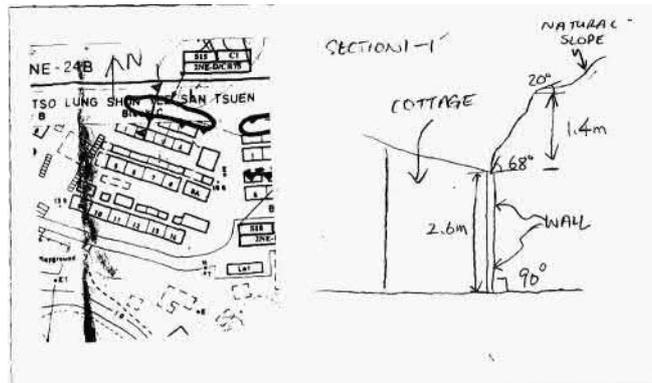
**STAGE 1 STUDY REPORT**

Inspected On: 06-11-1997  
 Weather: Mainly Fine  
 District: MW

Section No: 1-1  
 Height (m): N/A  
 Type of Toe Facility: Cottage, licensed and squatter area  
 Distance from Toe (m): 0  
 Type of Crest Facility: Undeveloped green belt  
 Distance from Crest (m): 0  
 Consequence Category: 1  
 Engineering Judgement: HP

Section No: 2-2  
 Type of Toe Facility: Cottage  
 Distance from Toe (m): 0  
 Type of Crest Facility: Undeveloped green belt  
 Distance from Crest (m): 0  
 Consequence Category: 1  
 Engineering Judgement: HP

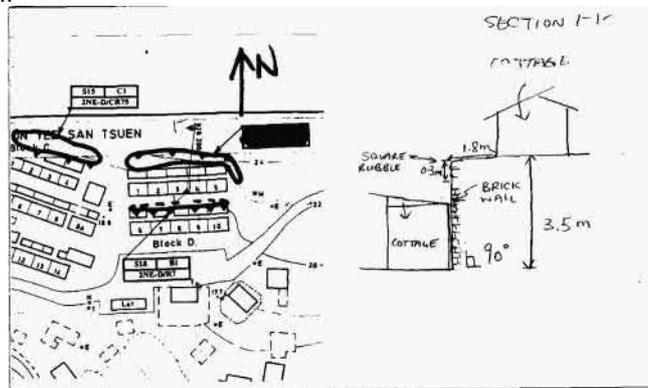
**STAGE 1 STUDY REPORT**

Inspected On: 27-10-1997  
 Weather: Mainly Fine  
 District: MW

Section No: 1-1  
 Height (m): N/A  
 Type of Toe Facility: Cottage, licensed and squatter area  
 Distance from Toe (m): 0  
 Type of Crest Facility: Non-dangerous goods storage site  
 Distance from Crest (m): 1  
 Consequence Category: 1  
 Engineering Judgement: P  
 Section No: 2-2  
 Type of Toe Facility: Cottage  
 Distance from Toe (m): 0  
 Type of Crest Facility: Other lightly-used open space  
 Distance from Crest (m): 0  
 Consequence Category: 1  
 Engineering Judgement: P  
 Sign of Seepage: Slope : No signs of seepage  
 Wall : No sign of seepage  
 Criterion A satisfied: N  
 Sign of Distress: Slope : N/A  
 Wall : N/A  
 Criterion D satisfied: N

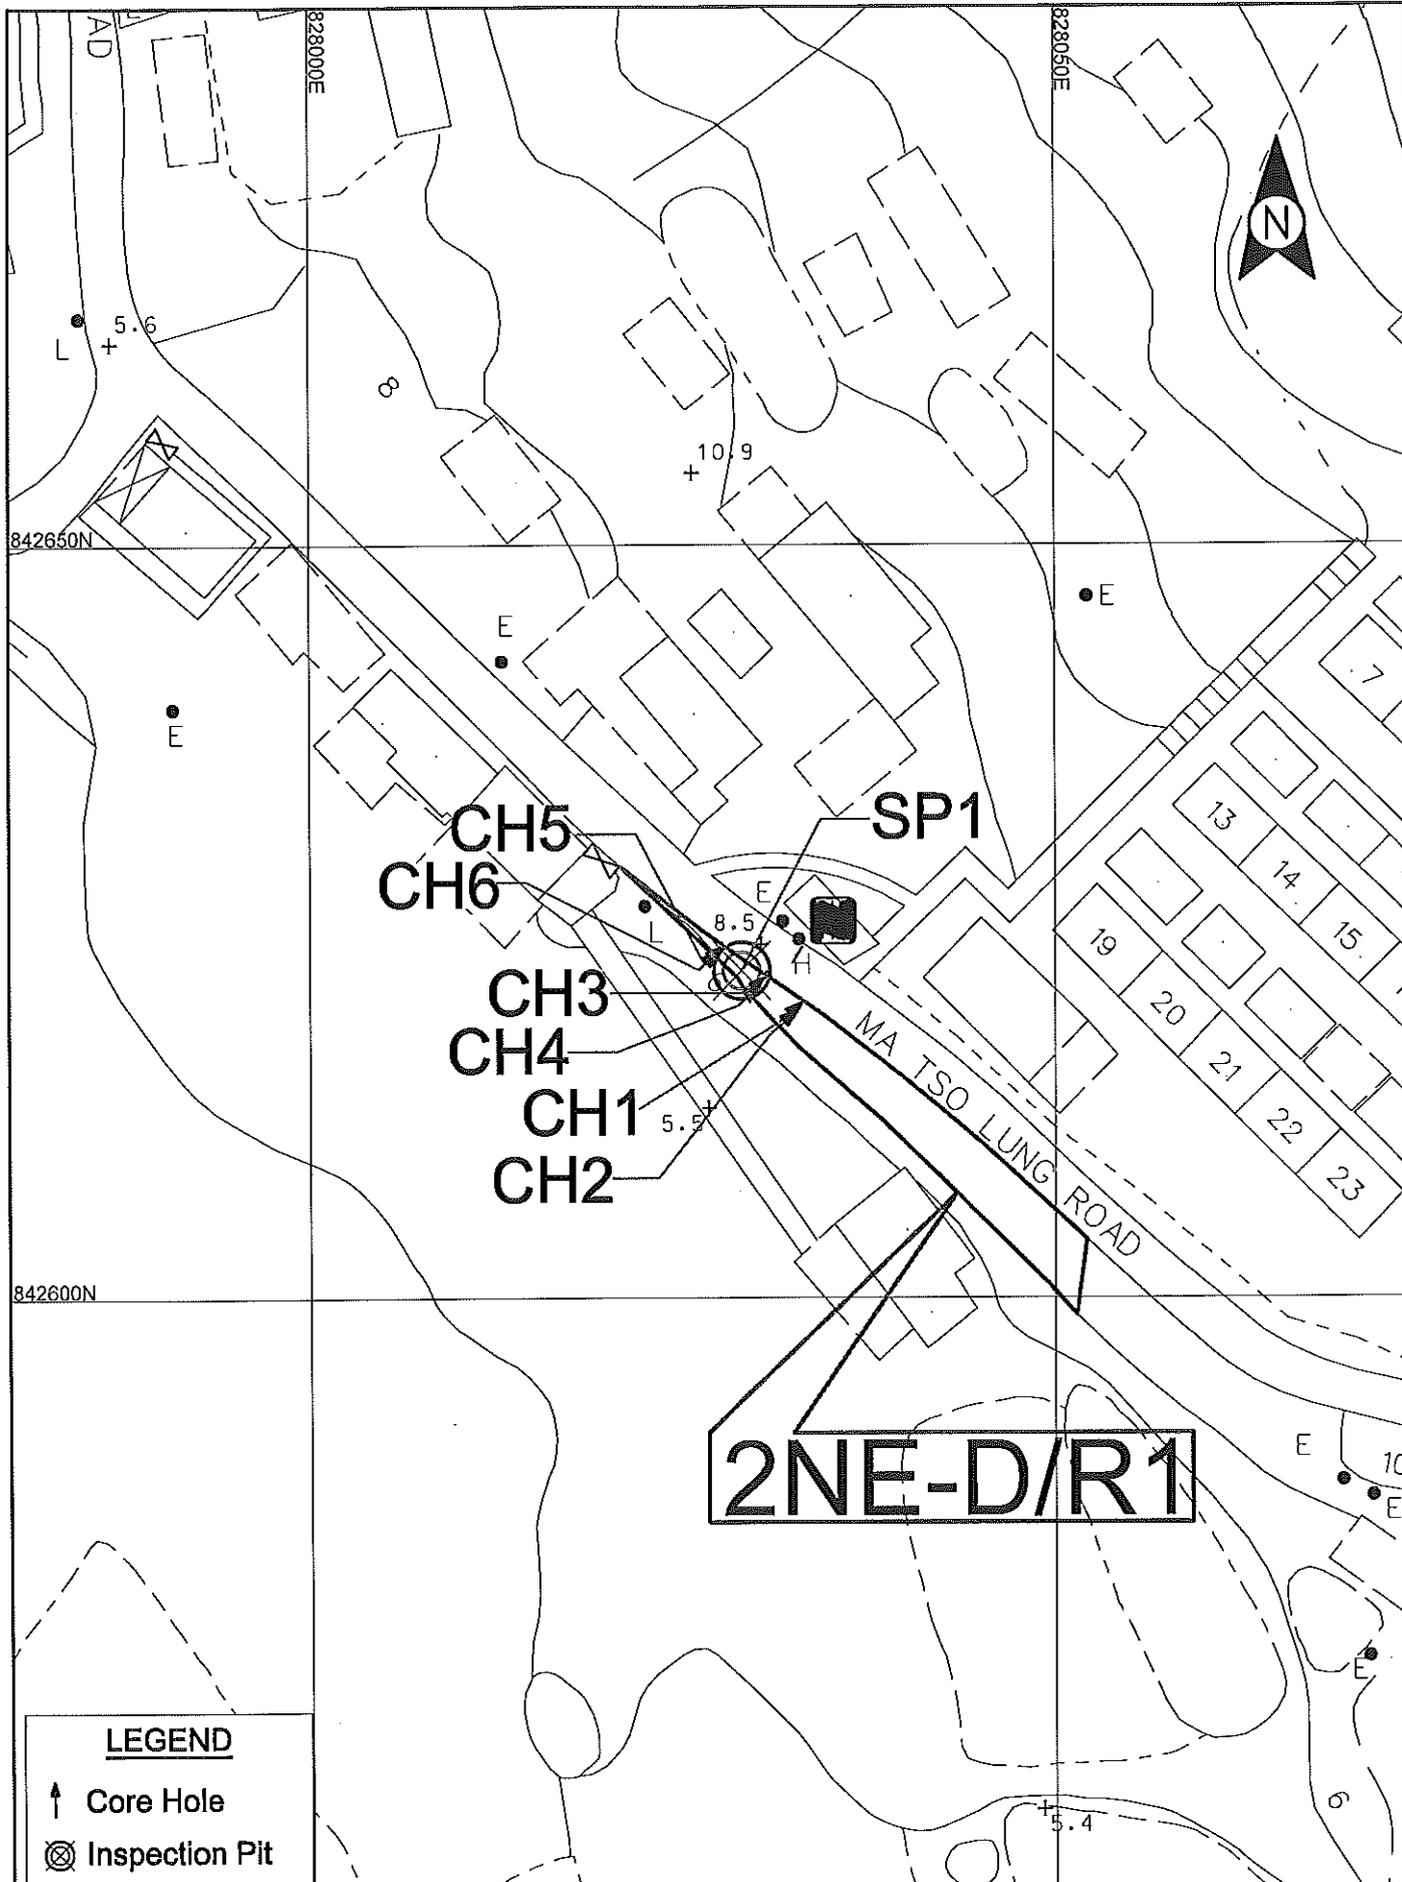
**FIGURE**

<b>LEGEND</b>	
↑	Core Hole
⊗	Inspection Pit

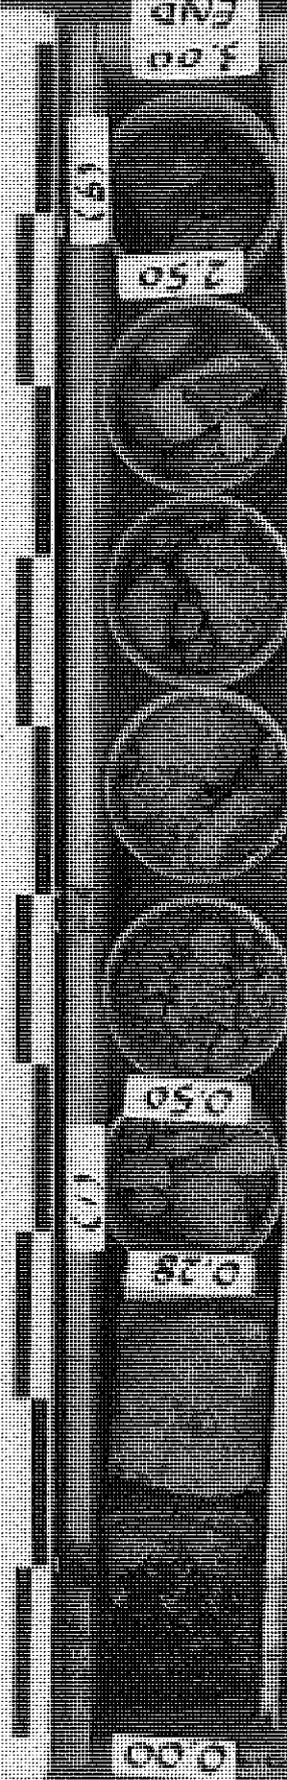
**Date of Photograph:** 5/3/2010

**Job Title:** Agreement No. BA012005  
 Consultancy for the Investigation, Design & Supervision of Slope & Retaining Wall Upgrading Works at Ma Tso Lung Sun Tsuen, Yuen Long, N.T. on Lot No. 1263 in D.D.96 for Portion of Feature No. 2NE-D/R1

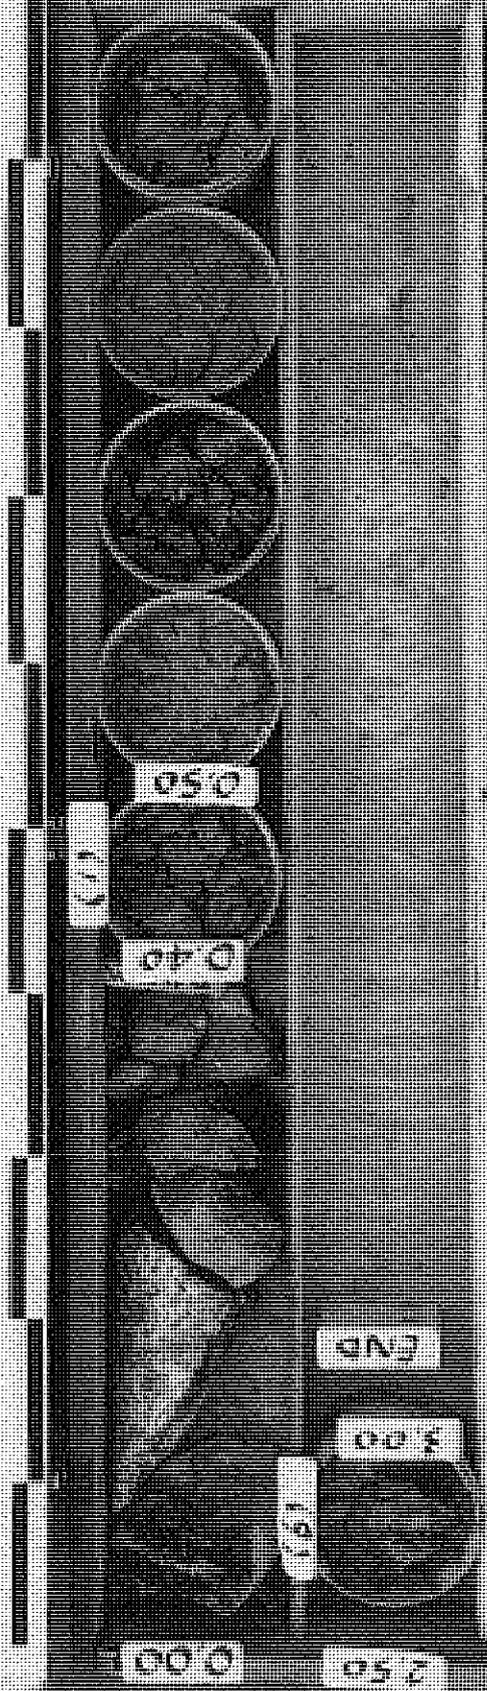
Job Title: Agreement No. BA/01/2006  
 Consultancy for the Investigation, Design  
 & Supervision of Slope & Retaining Wall  
 Upgrading Works at Ma Tso Lung Sun  
 Tsuen, Yuen Long, N.T. on Lot No. 1283 in  
 D.D.96 for Portion of Feature No. 2NE-D/R1

Date of Photograph: 5/3/2010

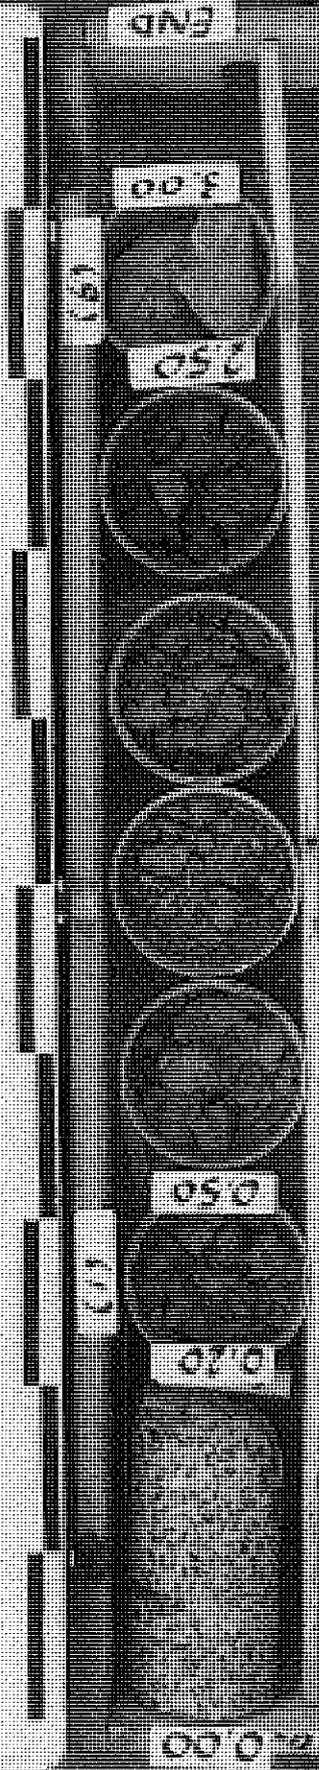
Date of Photograph: 5/3/2010

Job Title: Agreement No. BA/01/2008  
 Consultancy for the Investigation, Design  
 & Supervision of Slope & Retaining Wall  
 Upgrading Works at Ma Tso Lung Sun  
 Tsuen, Yuen Long, N.T. on Lot No. 1283 in  
 D.D.96 for Portion of Feature No. 2NE-D/R1

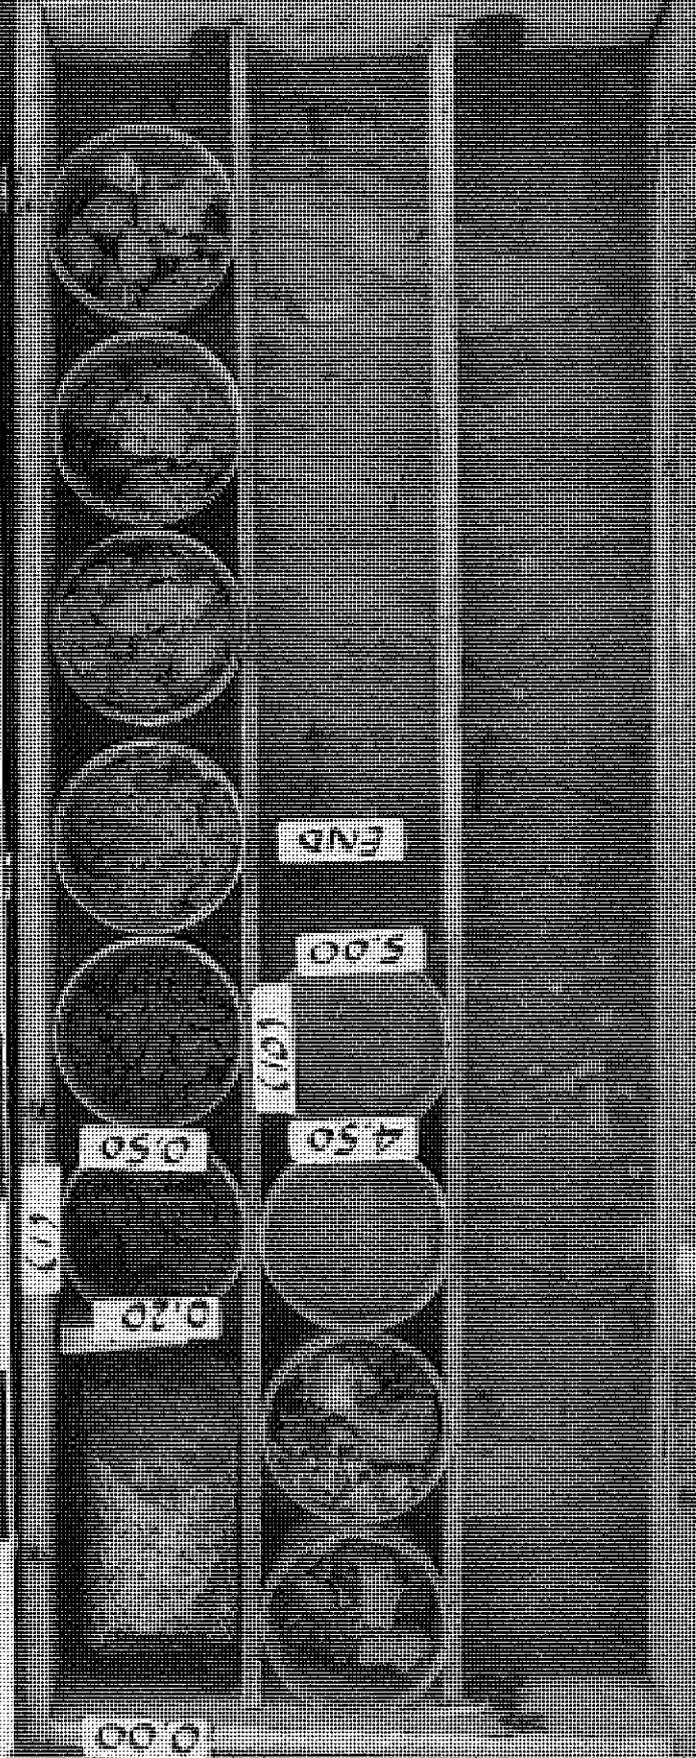
**Date of Photograph : 5/3/2010**

**Job Title : Agreement No. BA/01/2006**  
**Consultancy for the Investigation, Design**  
**& Supervision of Slope & Retaining Wall**  
**Upgrading Works at Ma Tso Lung Sun**  
**Tsuen, Yuen Long, N.T. on Lot No. 1283 in**  
**D.D.96 for Portion of Feature No. 2NE-D/R1**

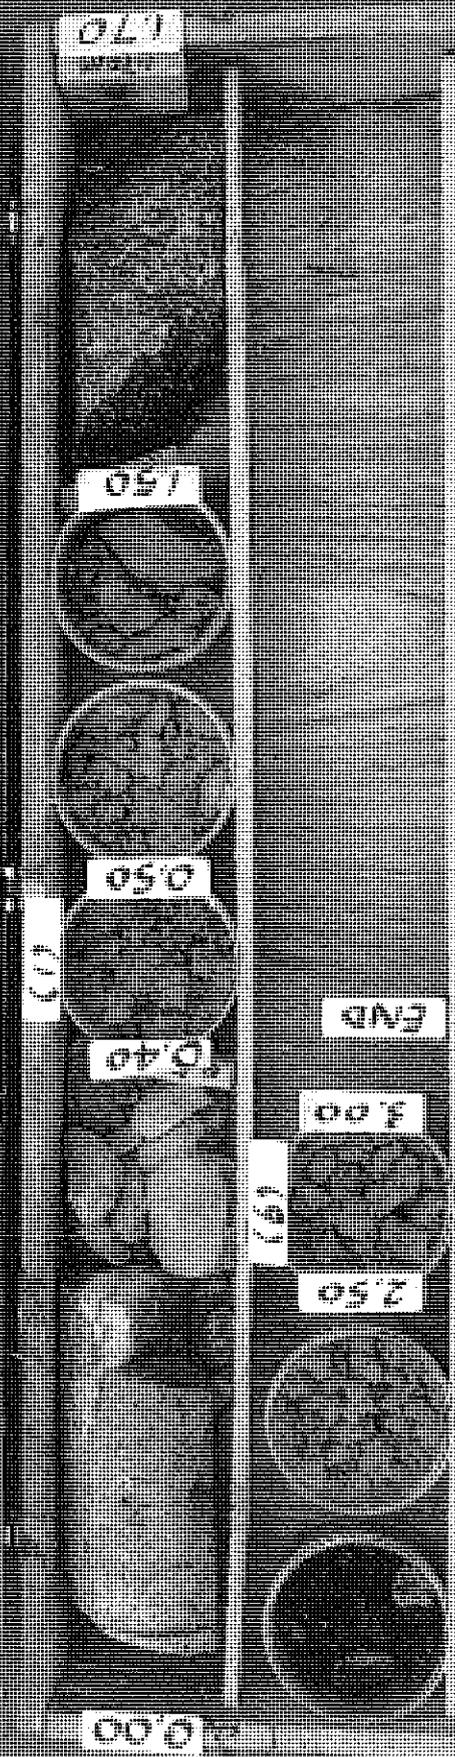
Date of Photograph: 5/3/2010

Consultancy for the Investigation, Design  
 & Supervision of Slope & Retaining Wall  
 Upgrading Works at Ma Tso Lung Sun  
 Tsuen, Yuen Long, N.T. on Lot No. 1283 in  
 D.D.96 for Portion of Feature No. 2NE-D/R1

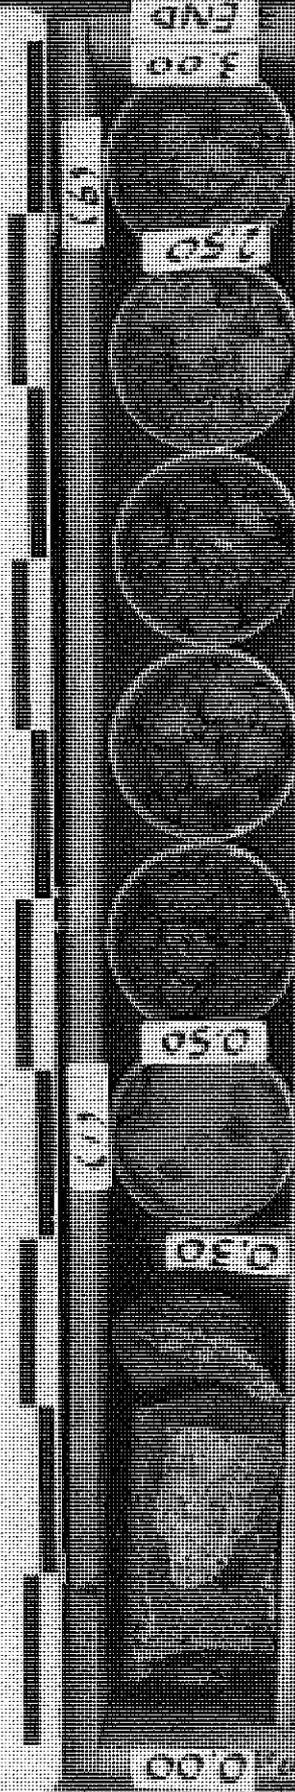
Date of Photograph: 5/3/2010

Job Title: Agreement No. BA/012008  
 Consultancy for the Investigation, Design  
 & Supervision of Slope & Retaining Wall  
 Upgrading Works at Ma Tso Lung Sun  
 Tsuen, Yuen Long, N.T. on Lot No. 1283 in  
 D.D. 96 for Portion of Feature No. 2NE-D/RI
