Application for Permission under Section 16 of The Town Planning Ordinance (Cap.131)  
Proposed Temporary Place of Recreation, Sports or Culture (Hobby Farm) with Ancillary Facilities for a Period of 3  
Years and Associated Filling of Land at Lots 1275 (Part), 1279 (Part), 1280, 1281 (Part), 1282 and 1284 (Part) in D.D. 96,  
Ma Tso Lung, New Territories

Geotechnical Planning Review Report

**March 2026**

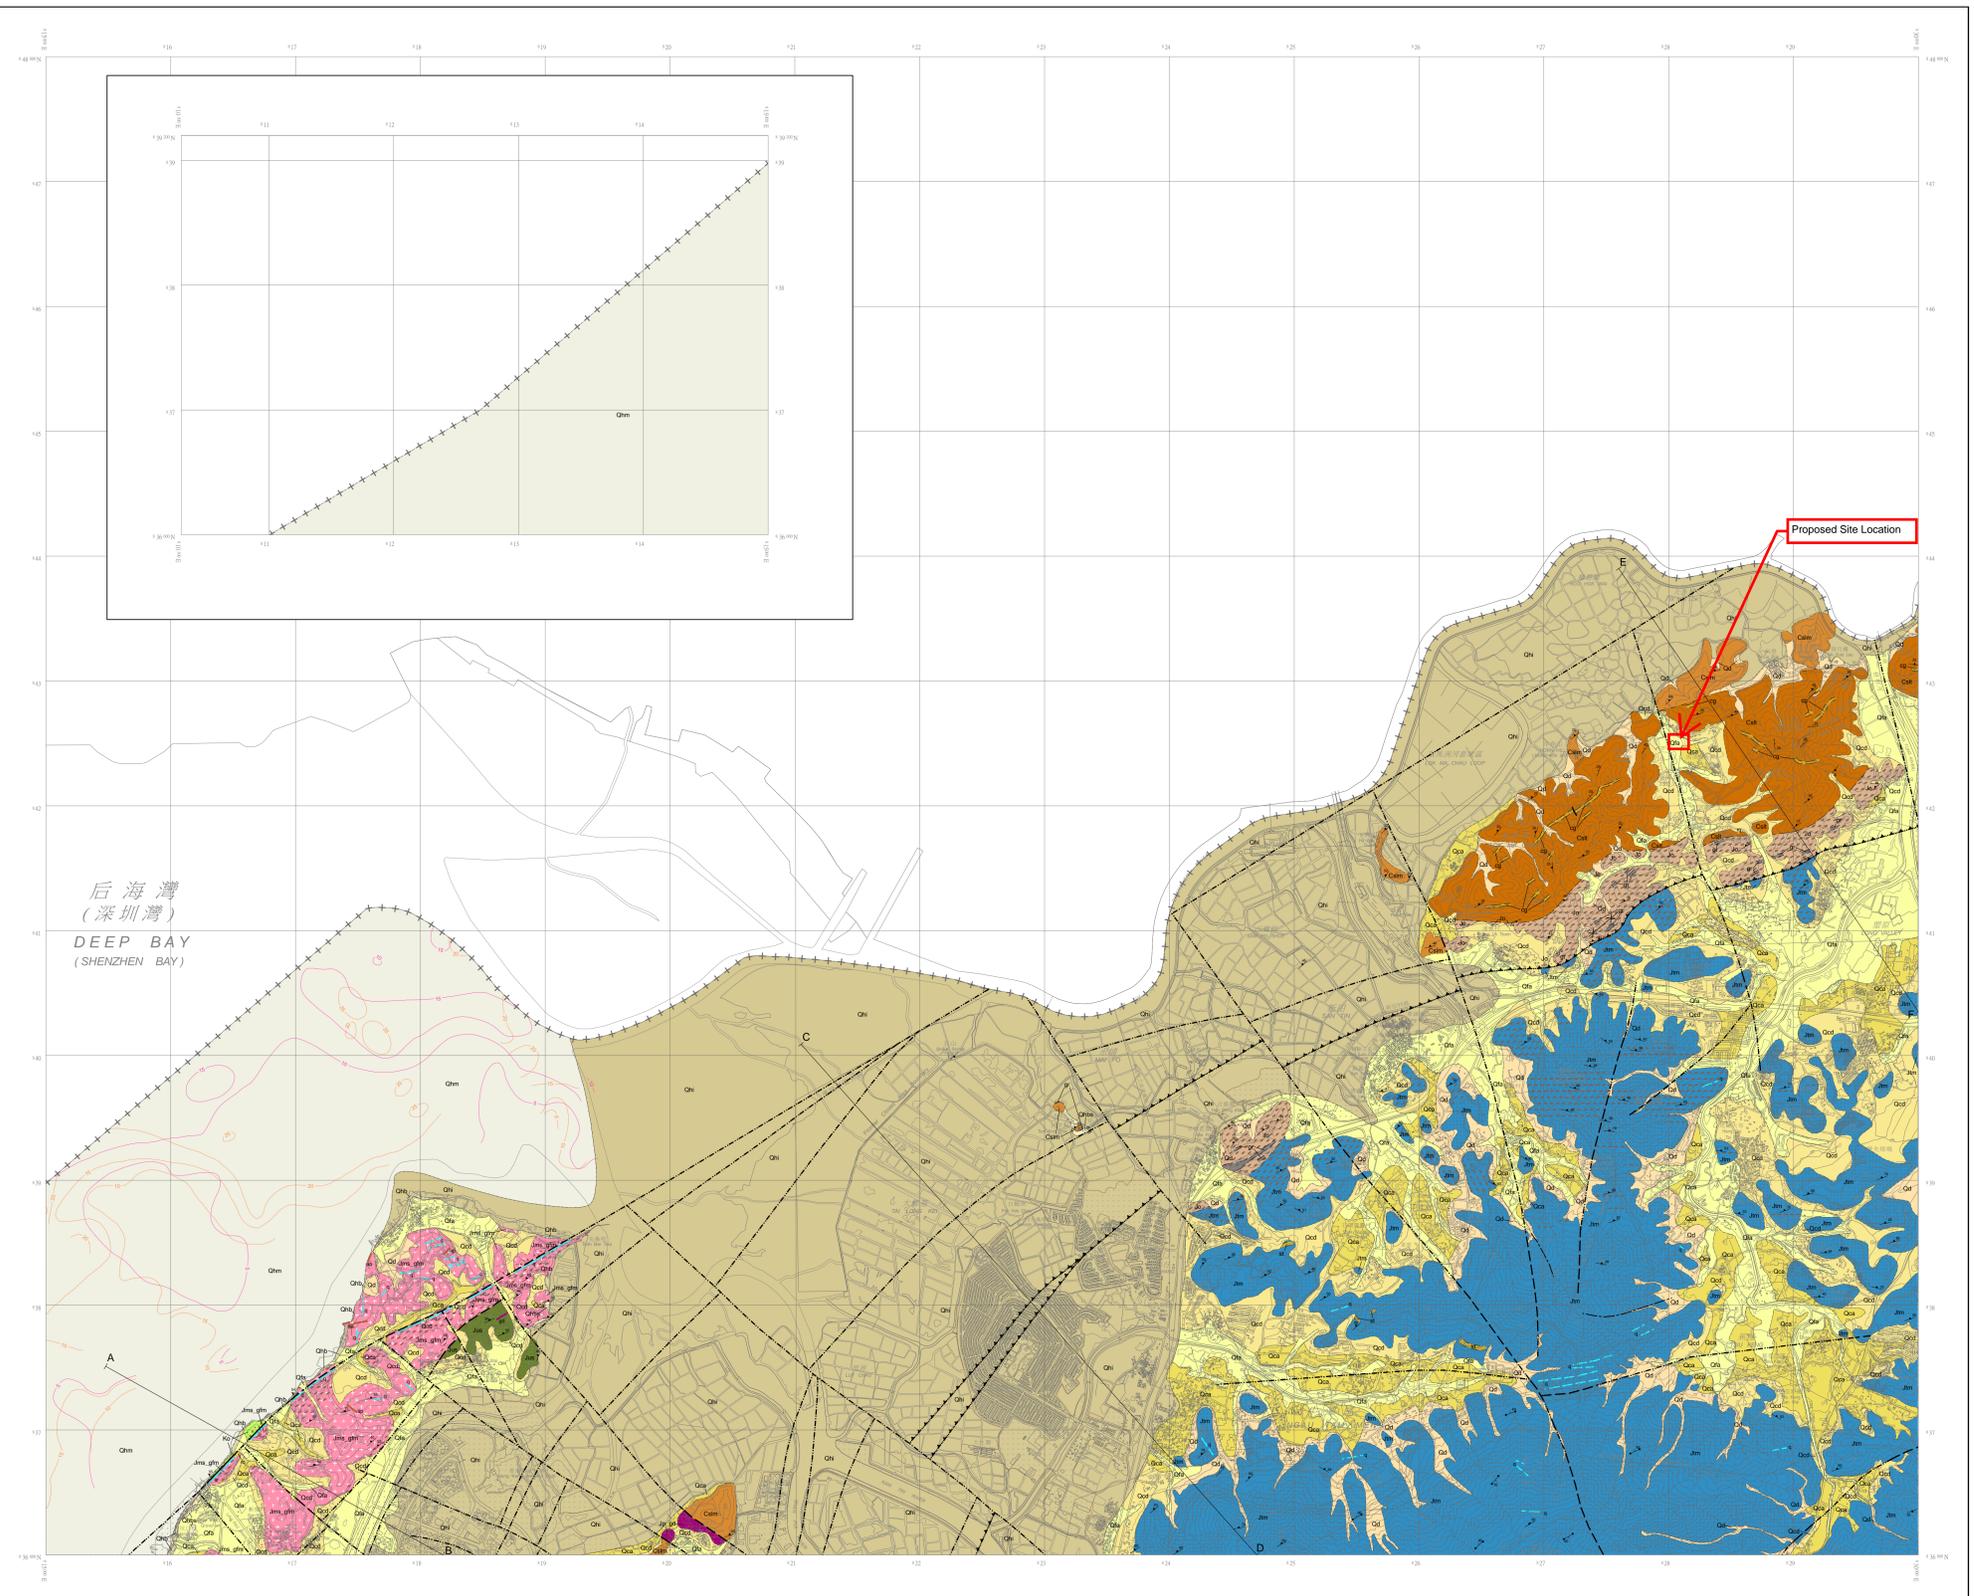
Geotechnical Map

**HONG KONG GEOLOGICAL SURVEY**  
**SAN TIN**  
 Sheet 2  
**SOLID AND SUPERFICIAL GEOLOGY**  
 Series HGM20  
 Scale 1:20 000

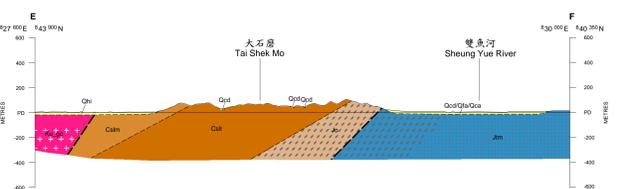
SECTION E-F  
Vertical scale 1:20 000

**GEOLOGICAL CROSS-SECTIONS**

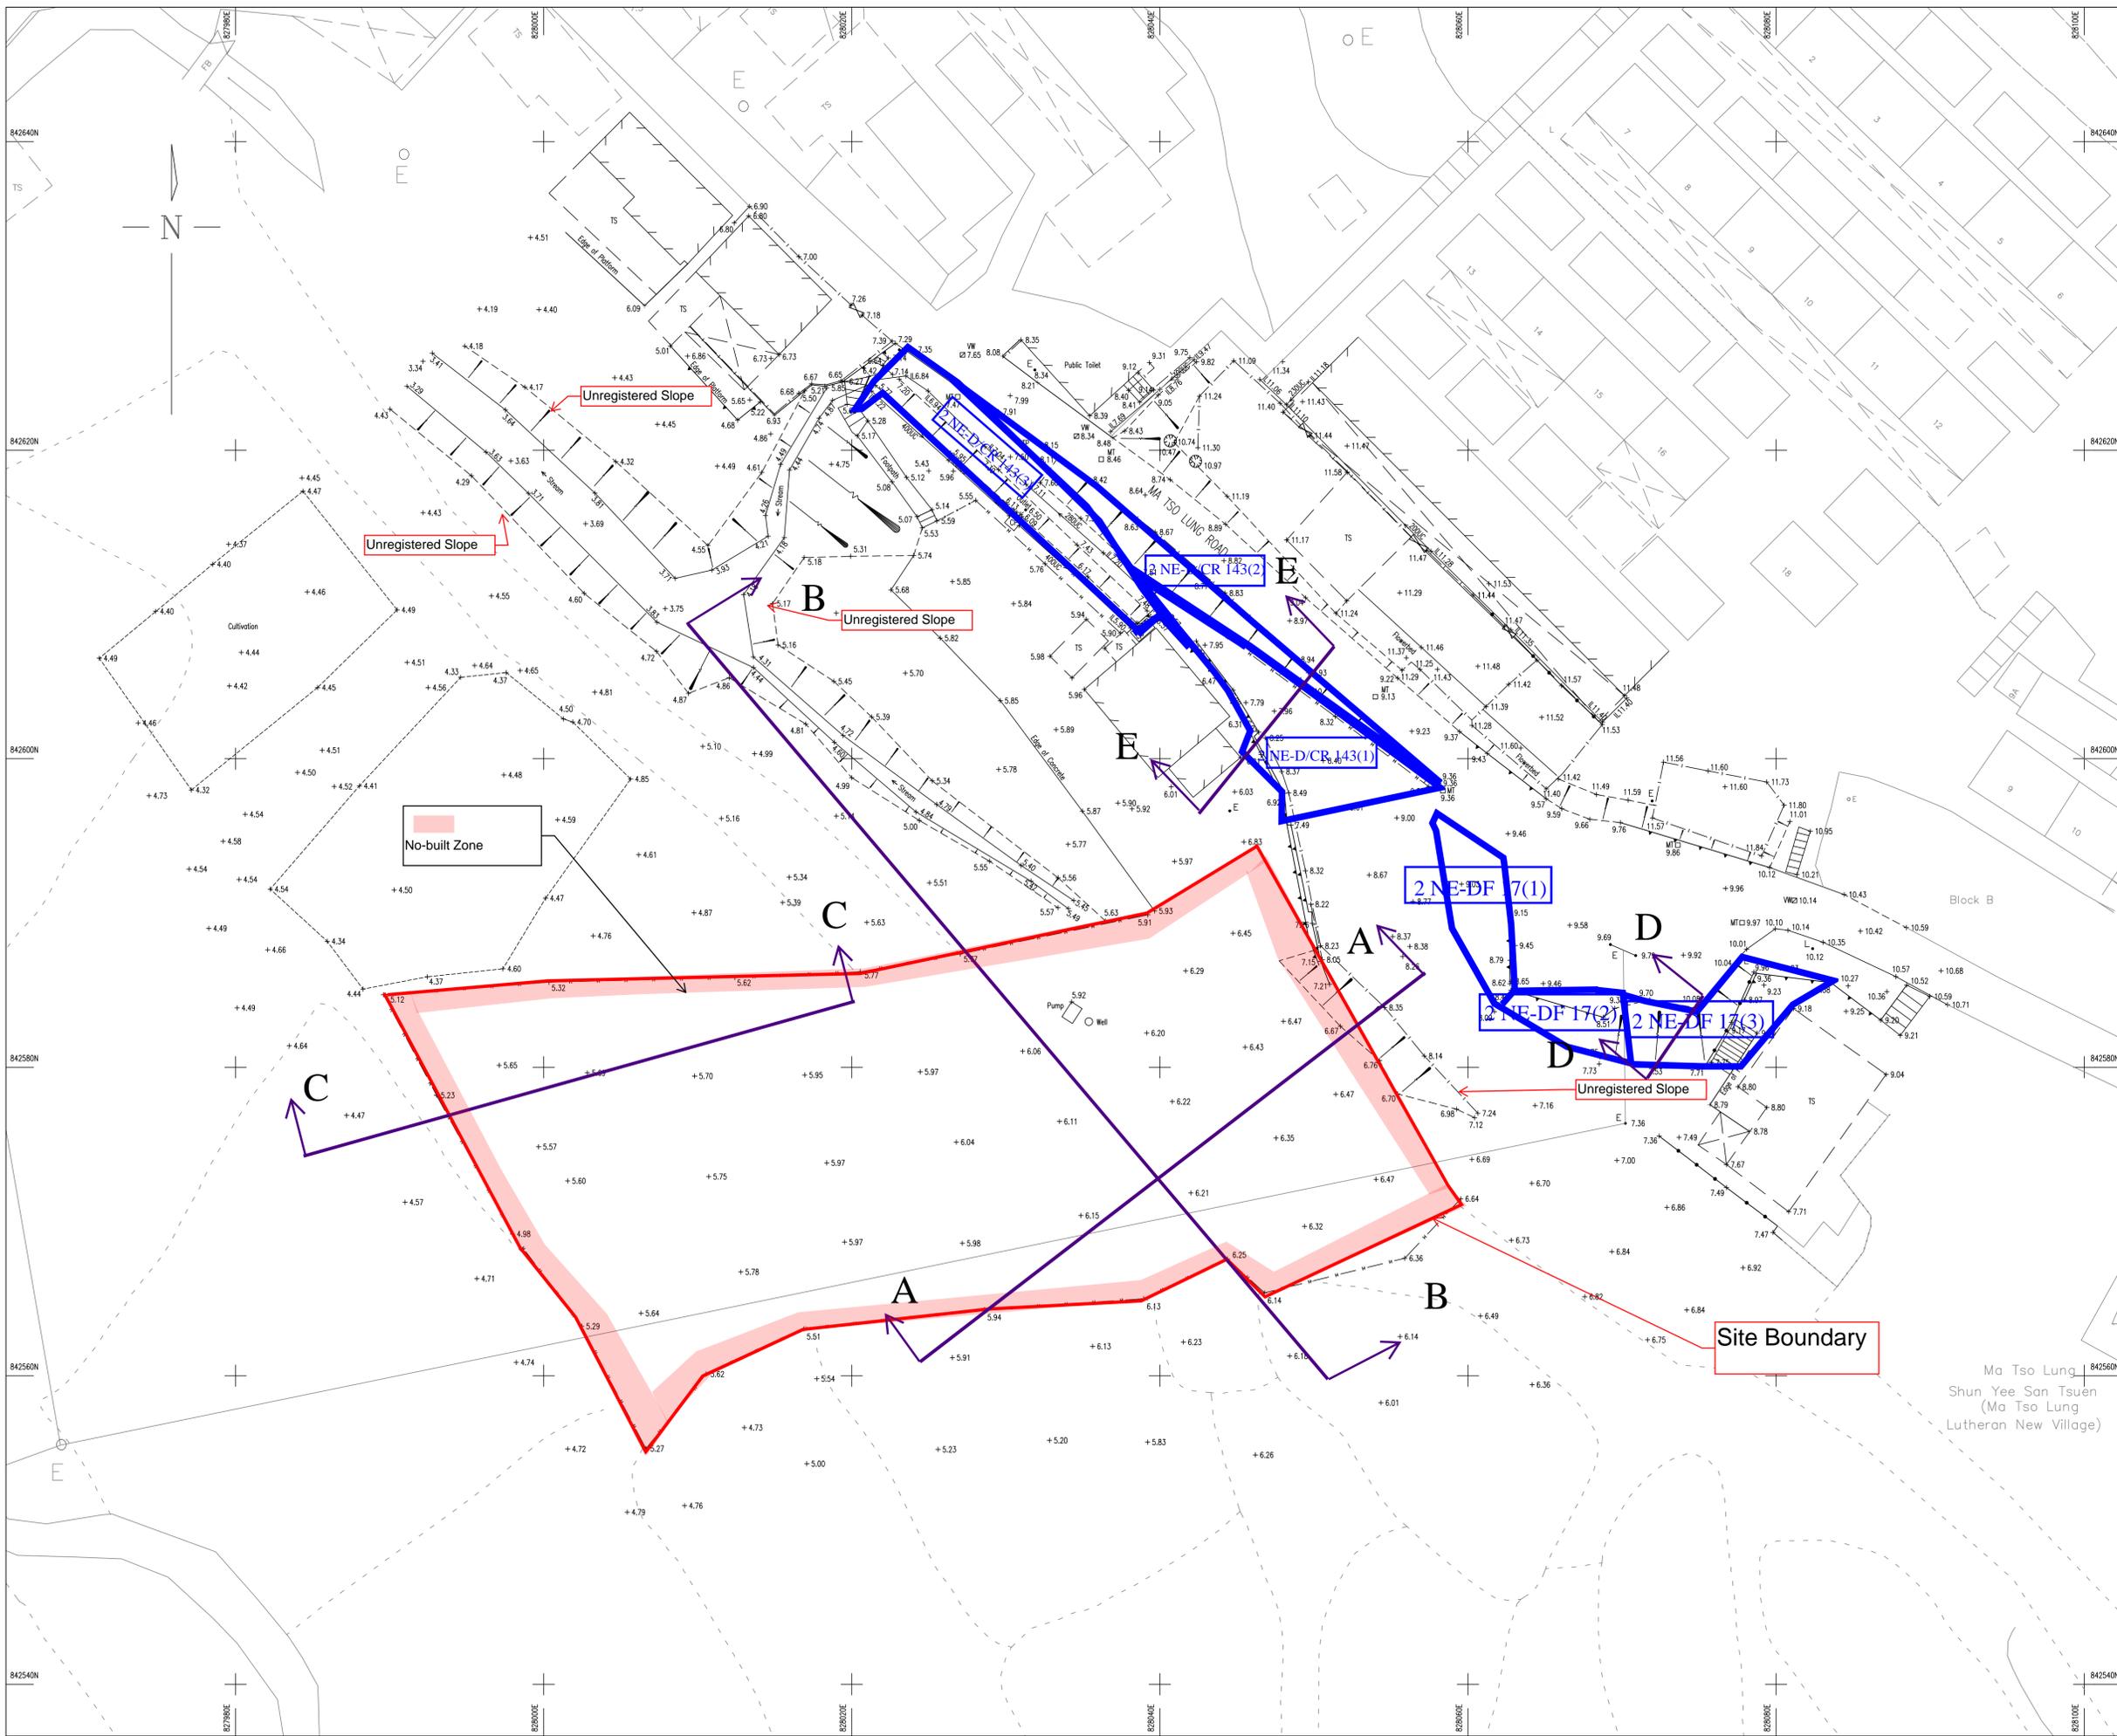
Topographic Survey Plan

NOTES:  
 1. Hong Kong Geodetic Datum 1980  
 2. All levels refer to Principal Datum Hong Kong  
 3. All units are in Metres  
 4. All spot level positions are indicated by the decimal point or a cross.

Drawing No. HPL3431/TS/01	Scale 1:200(A1)
------------------------------	--------------------

The site is a filling land (Approx. 0.2m to 0.5m higher than surrounding ground) at Ma Tso Lung Road, Ma Tso Lung, New Territories. (See Appendix F).

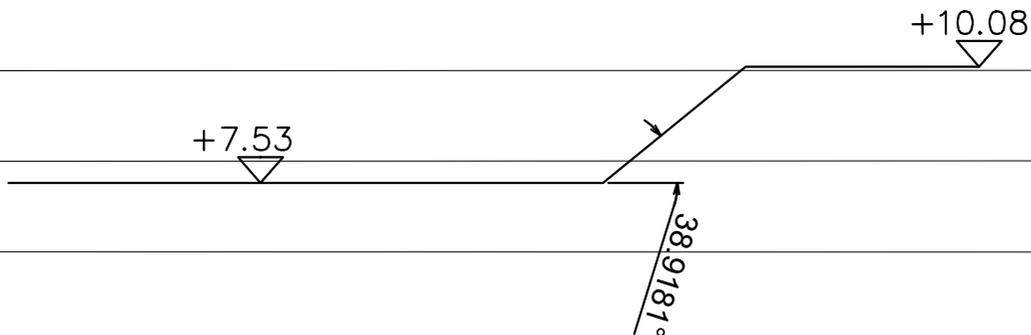
# SECTION D-D

Registered Slope: 2NE-DF/17

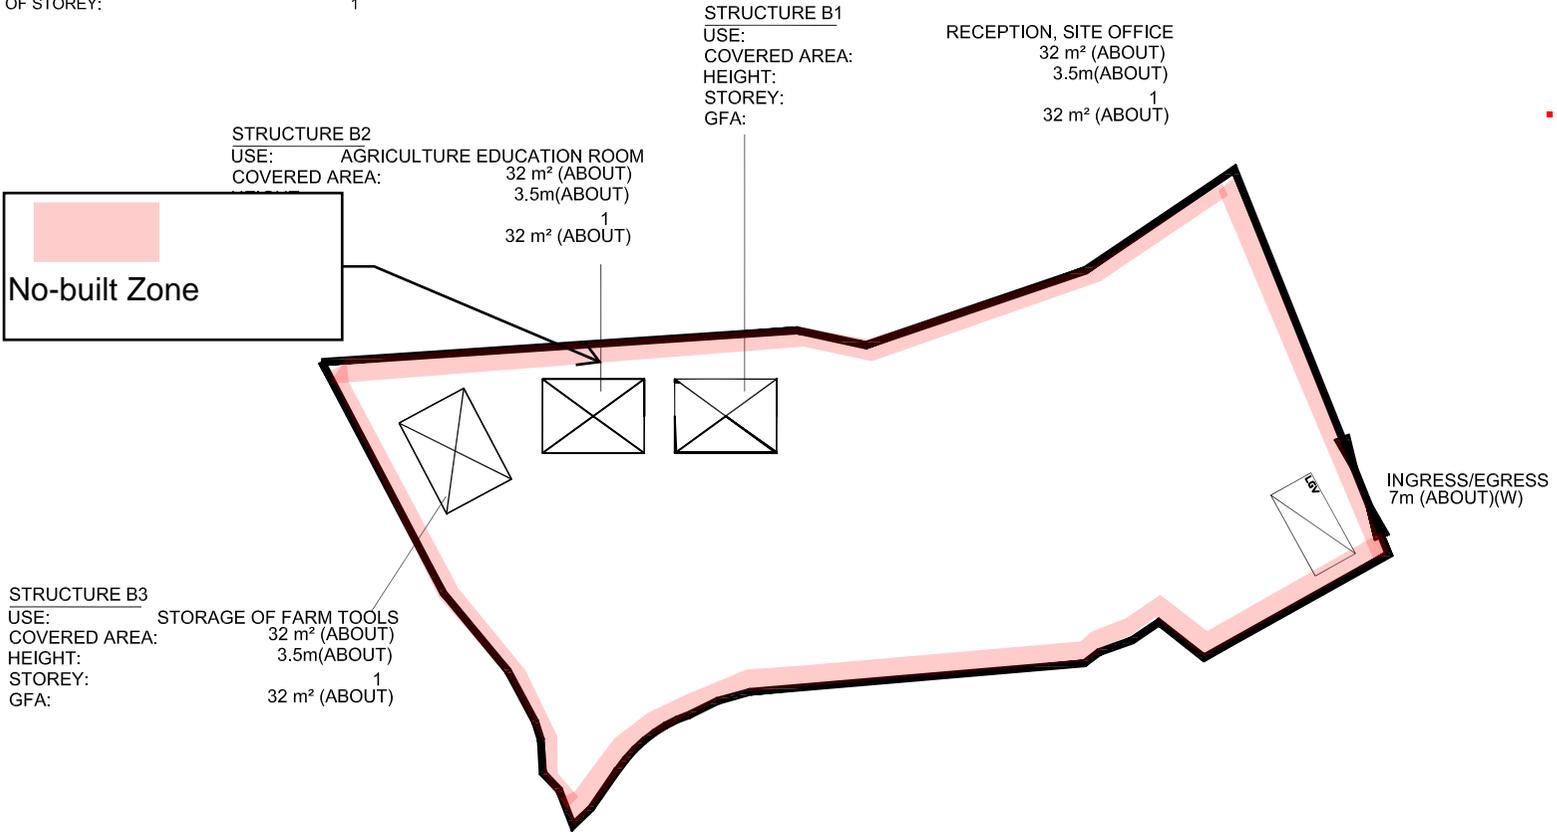
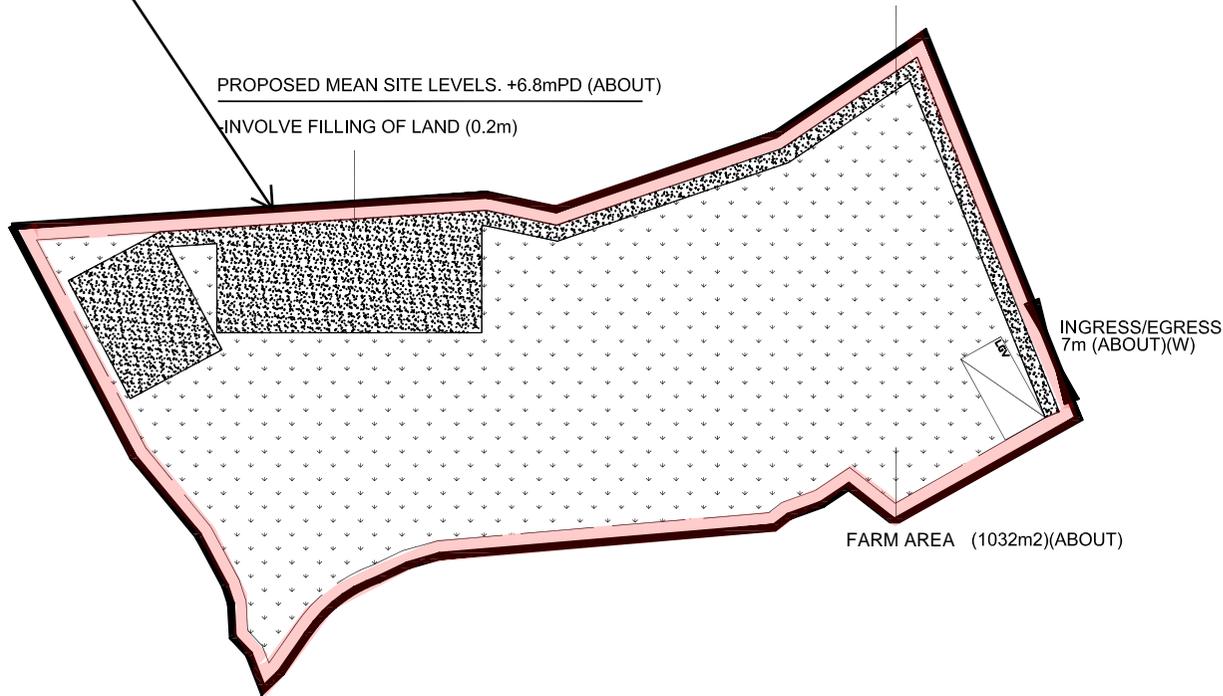
DWG NO. PLAN 2	VER. A-1
-------------------	-------------

STRUCTURE B2  
 USE: AGRICULTURE EDUCATION ROOM  
 COVERED AREA: 32 m<sup>2</sup> (ABOUT)  
 HEIGHT: 3.5m(ABOUT)  
 STOREY: 1  
 GFA: 32 m<sup>2</sup> (ABOUT)

PROPOSED SITE LEVEL OF THE APPLICATION SITE

APPLICATION SITE AREA: 1485 m<sup>2</sup> (ABOUT)  
 HARD PAVED AREA: 245 m<sup>2</sup> (ABOUT)  
 PROPOSED MEAN SITE LEVELS: +6.8 mPD  
 DEPTH OF LAND FILLING: NOT MORE THAN 0.2 m
