**Proposed Temporary Warehouse with Ancillary Facilities for a Period of 3 Years
and Associated Filling of Land in “Residential (Group D)” and “Agriculture” Zones,
Various Lots in D.D. 38 and Adjoining Government Land, Sha Tau Kok, New Territories**

Response-to-Comment

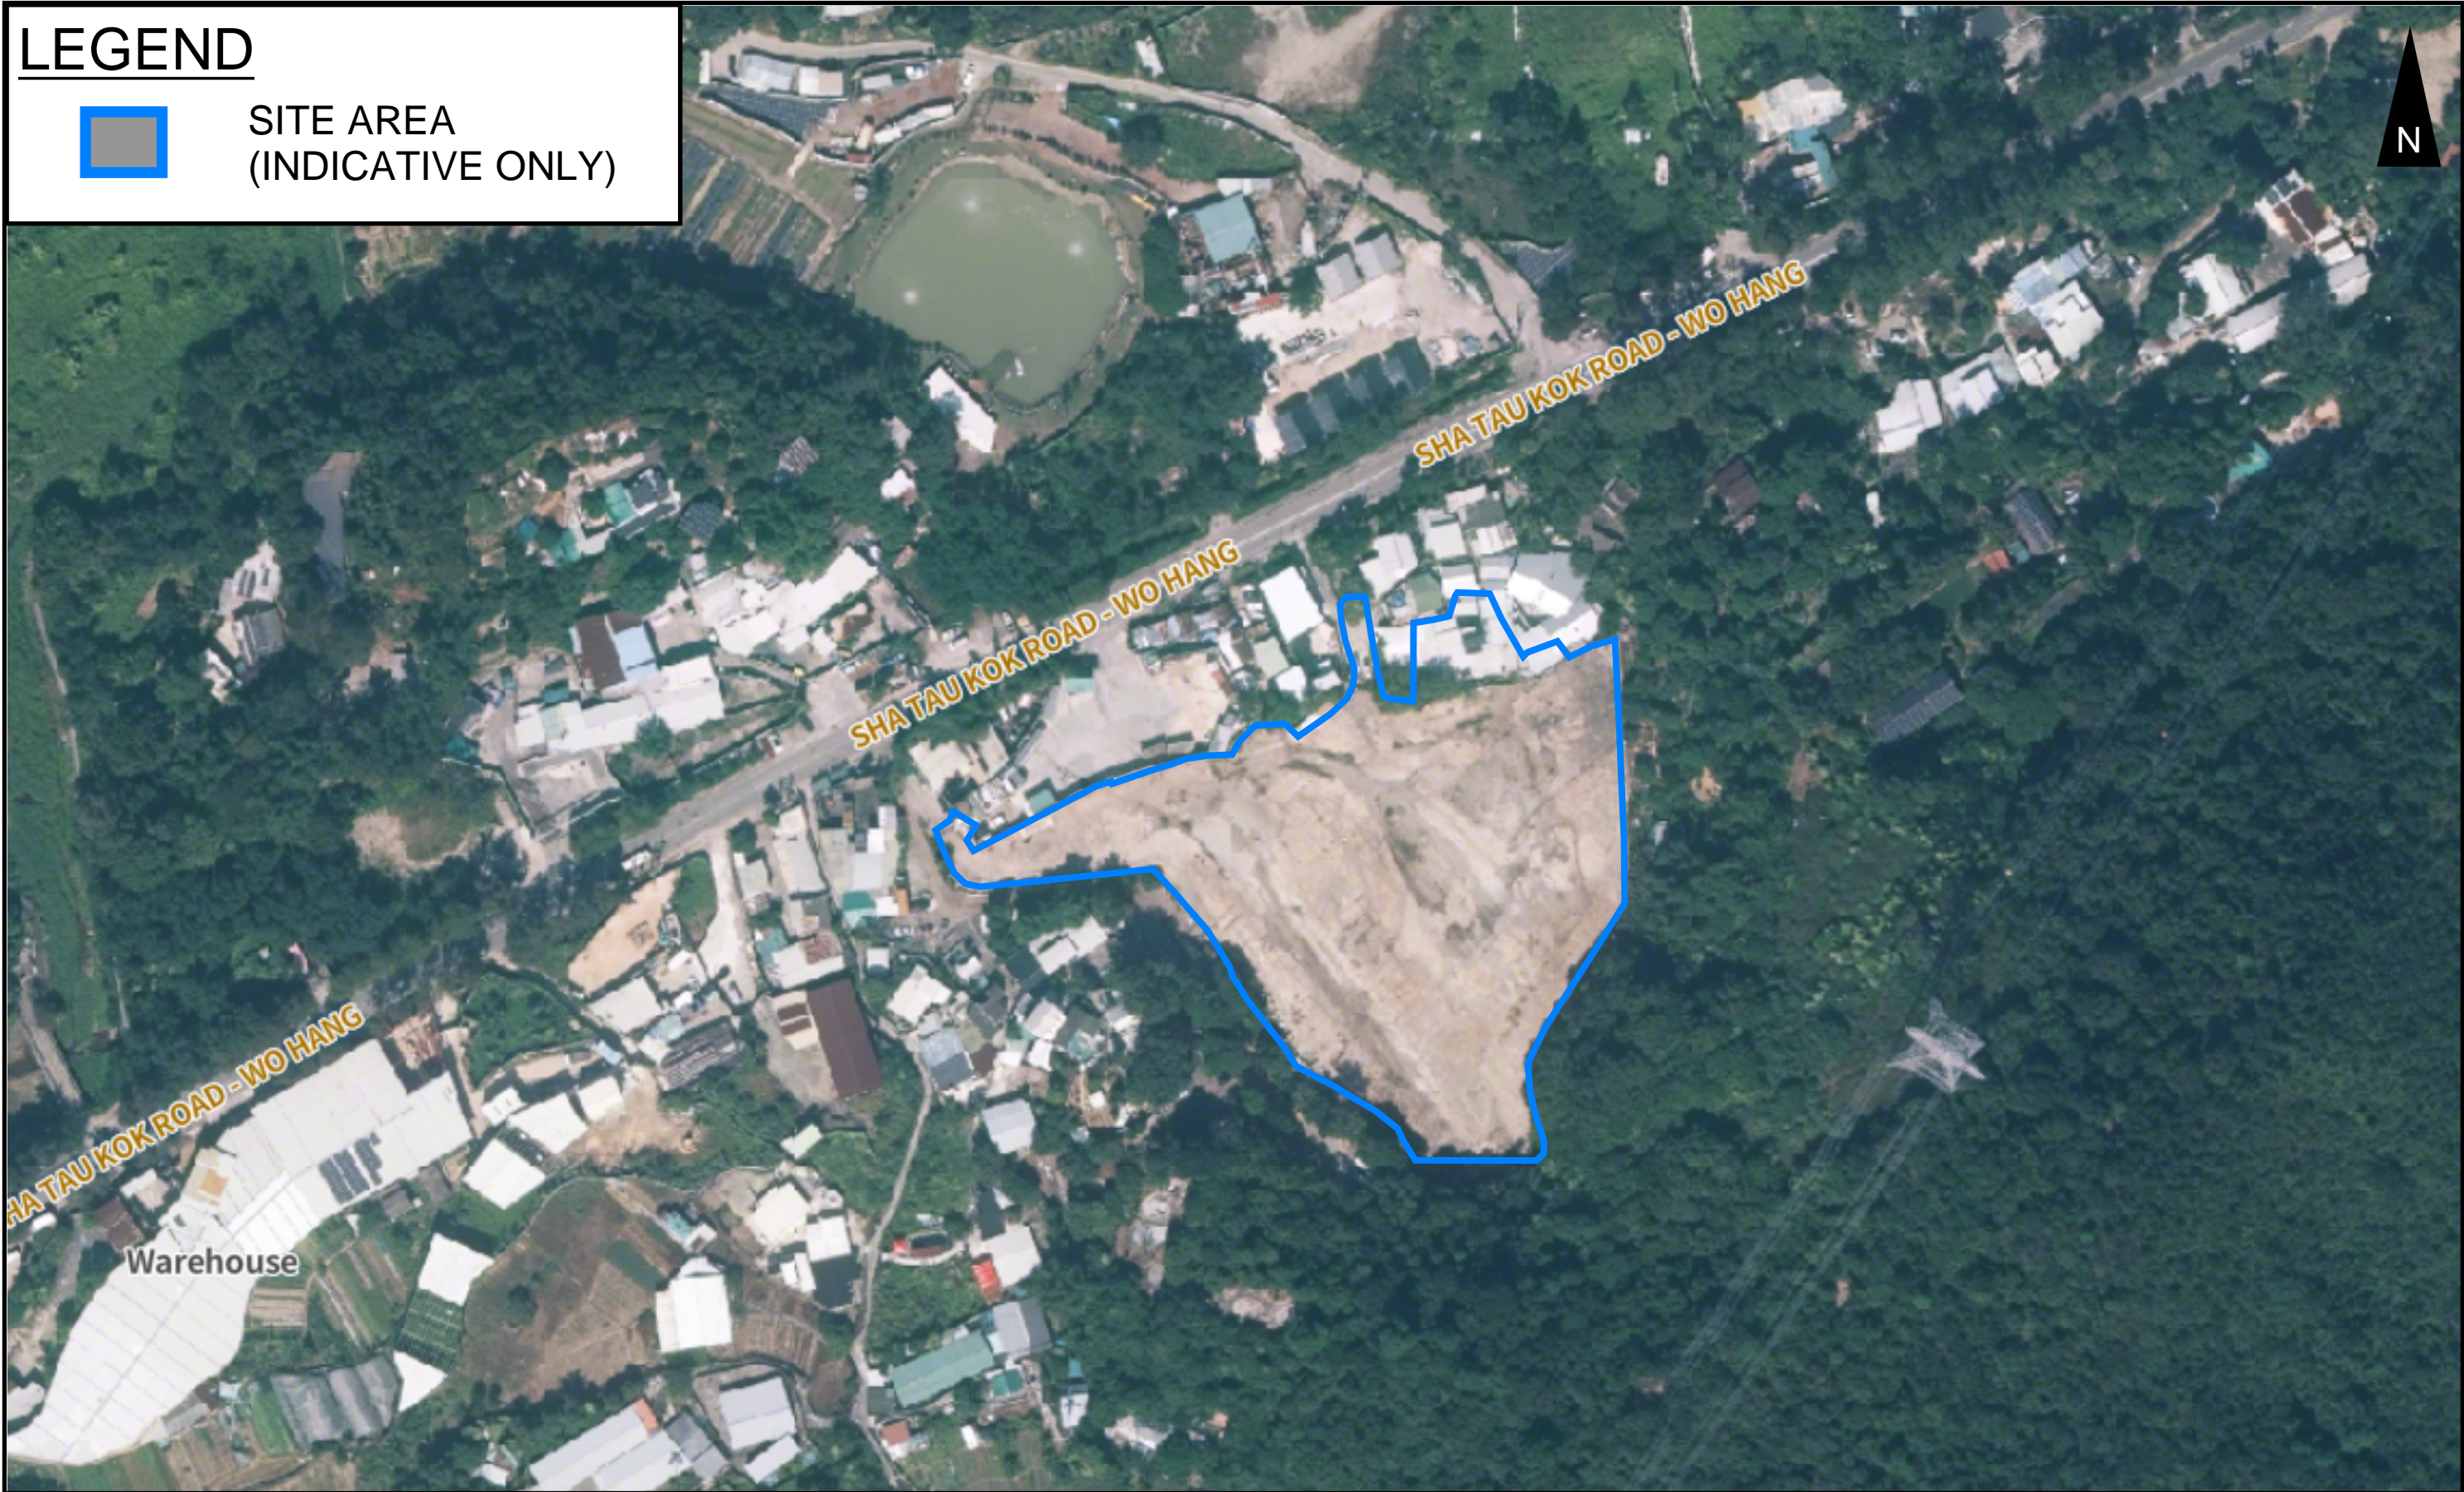
Figure 2 – Aerial Photo

PROJECT: Proposed Temporary Warehouse (Excluding Dangerous Goods Godown) with Ancillary Facilities for a Period of 3 Years and Associate Filling of Land in “Residential (Group D)” and “Agriculture” Zones	TITLE AERIAL PHOTO	FIGURE NUMBER FIGURE 2		
LOCATION: Various Lots in D.D. 38 and Adjoining Government Land, Sha Tau Kok, New Territories		VER	DESCRIPTION	DATE

- 2.1.1 The development site situates beside Sha Tau Kok Road – Wo Hang. It has an area of about 11,698m². The site location plan and aerial photo view are shown in **Figure 1** and **Figure 2** respectively.
- 2.1.2 In general, the site is a flat ground with level various from approx. +28.6 mPD to + 30.7 mPD, gently falling from south to north. The site topography is relatively flat with a natural hillside near the southeast boundary
- 2.1.3 The hillside is covered in dense vegetation and the site area is mostly open area comprising paved area or shallow vegetation.

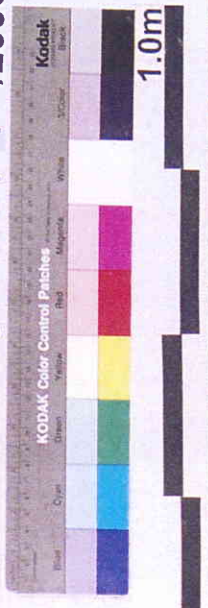
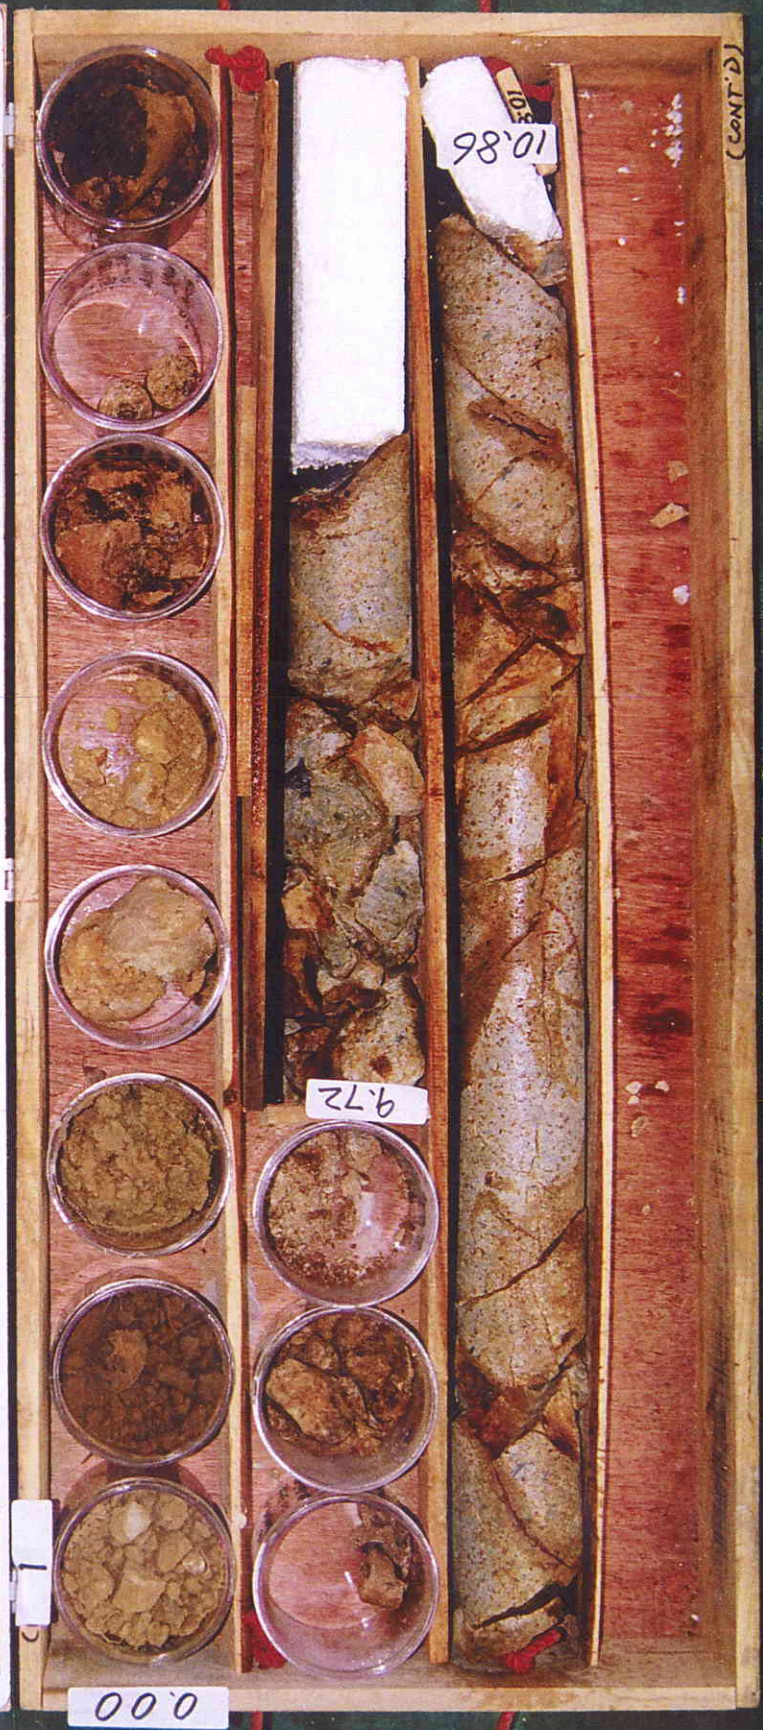
CONTRACT NO.: GE/2003/19
PROJECT: GROUND INVESTIGATION-
NEW TERRITORIES EAST
(TERM CONTRACT)
WORKS ORDER NO.: GE/2003/19.29
LOCATION: AGREEMENT NO. CE 6/2002 (DS)
DRAINAGE IMPROVEMENT IN
NORTHERN NT - PACKAGE C
INVESTIGATION, DESIGN AND
CONSTRUCTION (MAN UK PING)

HOLE NO.: B 20
BOX NO.: 1 OF 3
DEPTH: 0.00 m. TO 10.86 m.
DATE OF PHOTOGRAPH: 22 / 1 /2005

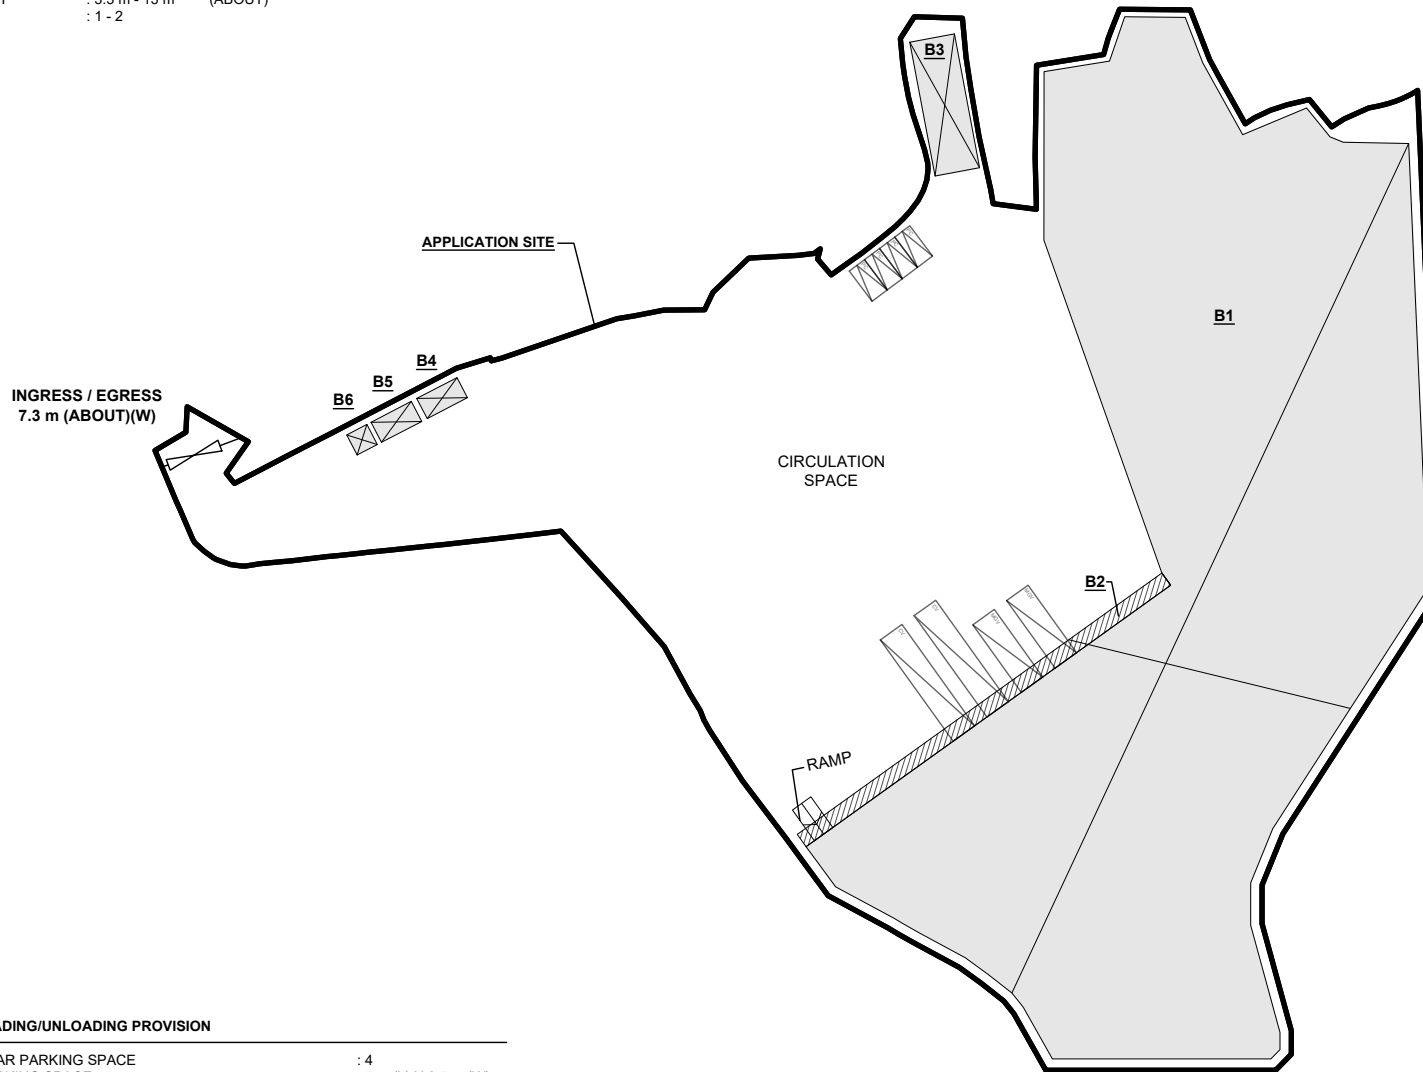
APPLICATION SITE AREA	: 11,698 m ²	(ABOUT)
COVERED AREA	: 5,970 m ²	(ABOUT)
UNCOVERED AREA	: 5,728 m ²	(ABOUT)
PLOT RATIO	: 1.01	(ABOUT)
SITE COVERAGE	: 51 %	(ABOUT)
NO. OF STRUCTURE	: 6	
DOMESTIC GFA	: NOT APPLICABLE	
NON-DOMESTIC GFA	: 11,776 m ²	(ABOUT)
TOTAL GFA	: 11,776 m ²	(ABOUT)
BUILDING HEIGHT	: 3.5 m - 13 m	(ABOUT)
NO. OF STOREY	: 1 - 2

STRUCTURE	USE	COVERED AREA	GROSS FLOOR AREA	BUILDING HEIGHT
B1	WAREHOUSE (EXCL. D.G.G.)	5,698 m ² (ABOUT)	11,396 m ² (ABOUT)	13 m (ABOUT)(2-STOREY)
B2	RAIN SHELTER FOR L/U/L	119 m ² (ABOUT)	119 m ² (ABOUT)	7 m (ABOUT)(1-STOREY)
B3	SITE OFFICE	108 m ² (ABOUT)	216 m ² (ABOUT)	7 m (ABOUT)(2-STOREY)
B4	UTILITIES AND METER ROOM	18 m ² (ABOUT)	18 m ² (ABOUT)	3.5 m (ABOUT)(1-STOREY)
B5	WASHROOM	18 m ² (ABOUT)	18 m ² (ABOUT)	3.5 m (ABOUT)(1-STOREY)
B6	CARETAKER OFFICE	9 m ² (ABOUT)	9 m ² (ABOUT)	3.5 m (ABOUT)(1-STOREY)
TOTAL		5,970 m ² (ABOUT)	11,776 m ² (ABOUT)

NO. OF PRIVATE CAR PARKING SPACE	: 4
DIMENSION OF PARKING SPACE	: 5 m (L) X 2.5 m (W)
NO. OF LOADING/UNLOADING SPACE FOR MEDIUM GOODS VEHICLE	: 2
DIMENSION OF LOADING/UNLOADING SPACE	: 11 m (L) X 3.5 m (W)
NO. OF LOADING/UNLOADING SPACE FOR CONTAINER VEHICLE	: 2
DIMENSION OF LOADING/UNLOADING SPACE	: 16 m (L) X 3.5 m (W)
