寄件者: [REDACTED]  
寄件日期: 2026年09月22日星期二 10:39  
收件者: tpbpd/PLAND  
副本: Belva Yuen King TONG/PLAND  
主旨: A/YL-HTF/1207進一步資料  
附件: HTF1207 GPRR R-to-C 31-8-2026.pdf; 排水建議計劃圖.pdf; 場地設計圖..pdf; A-YL-HTF-1207 GPRR 31-8-2026.pdf

**Project: Proposed Temporary Open Storage of  
Construction Materials and Associated Filling of Land for  
a Period of 3 Years at Lot 129 S.B (Part) in D.D. 128 and  
Adjoining Government Land, Ha Tsuen, Yuen Long  
(A/YL-HTF/1207)**

**Geotechnical Planning Review Report**

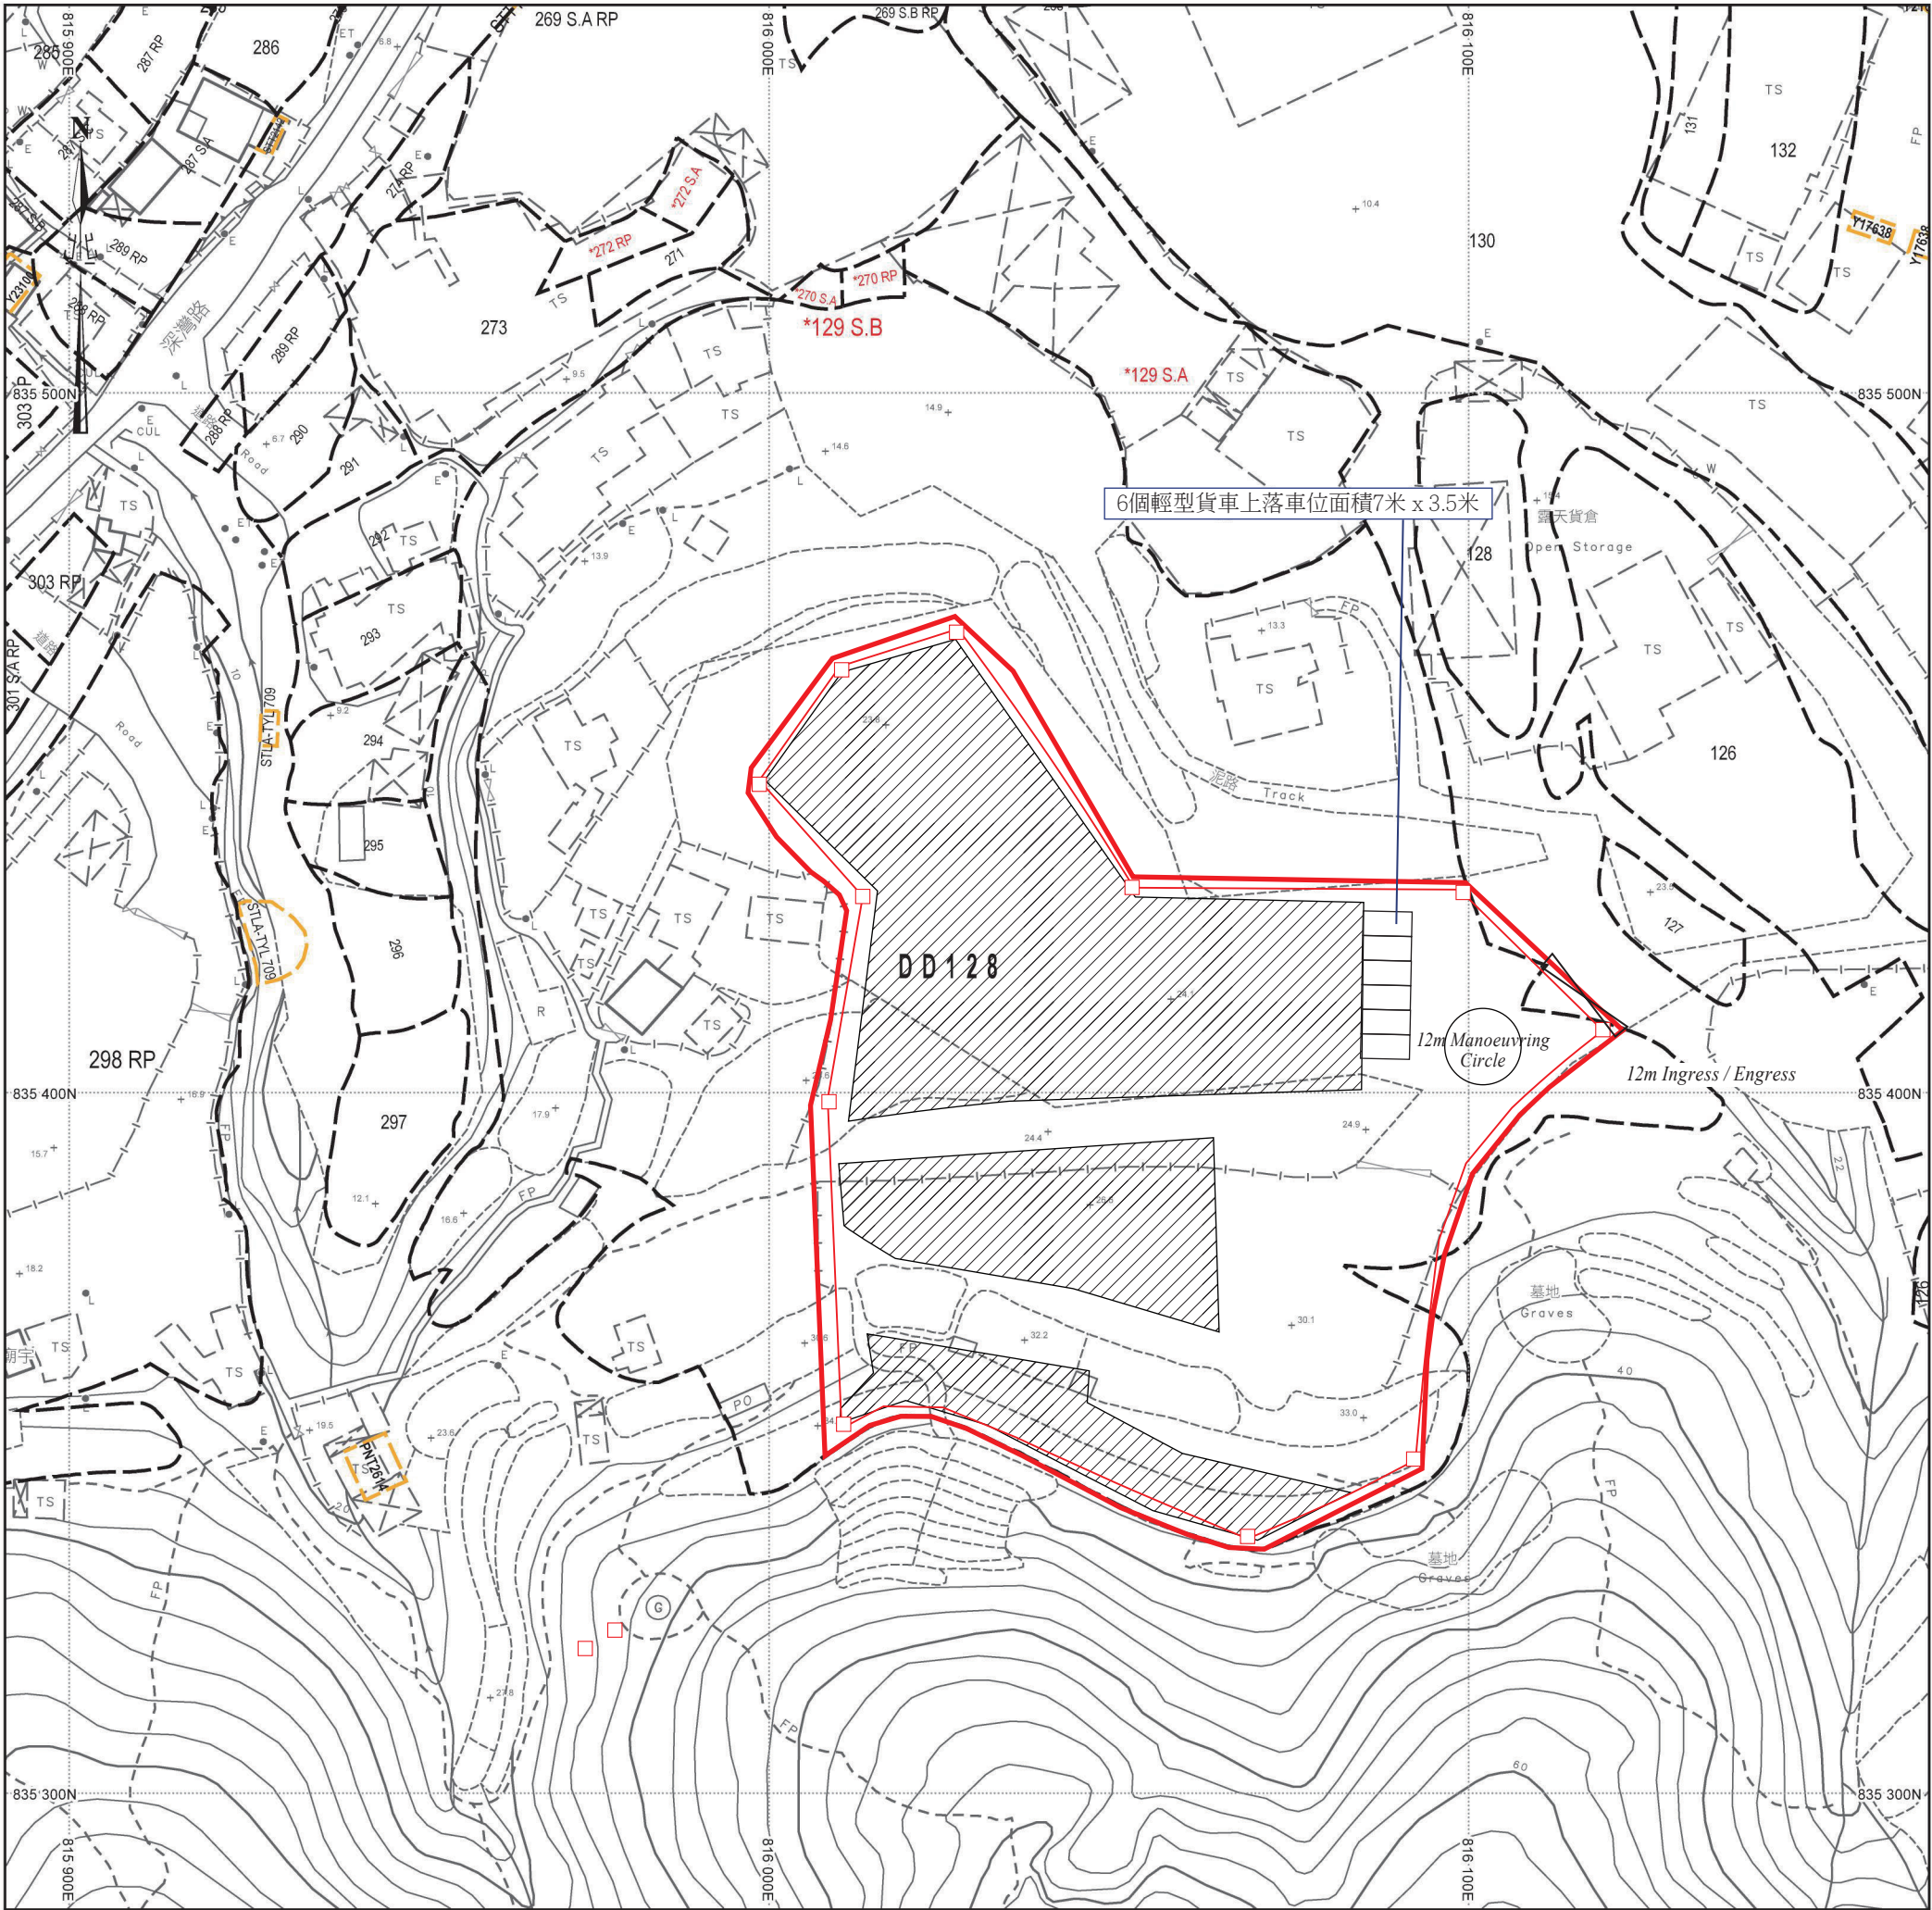
排水建議計劃圖

露天存放建築材料面積：約5070平方米

沙井
-

375mmU型明渠
-

露天存放建築材料範圍

SCALE 1 : 1000

排水系統方面，場地會沿場地邊界（圍邊）鋪設，U 型渠的闊度及渠度約 375mm x 375mm，由於該場地先前已進行填土工程，整體地面已墊高約 0.2 米（200mm）。因此，本次排水渠施工只需於現有填土層額外向下挖掘約 175mm。挖掘工作完全局限於新增的填土層內，挖掘深度遠未觸及原始原生土層（，因此絕不會對現場及周邊之考古價值或地下文物造成任何影響，亦不會對周圍環境產生不良干擾。

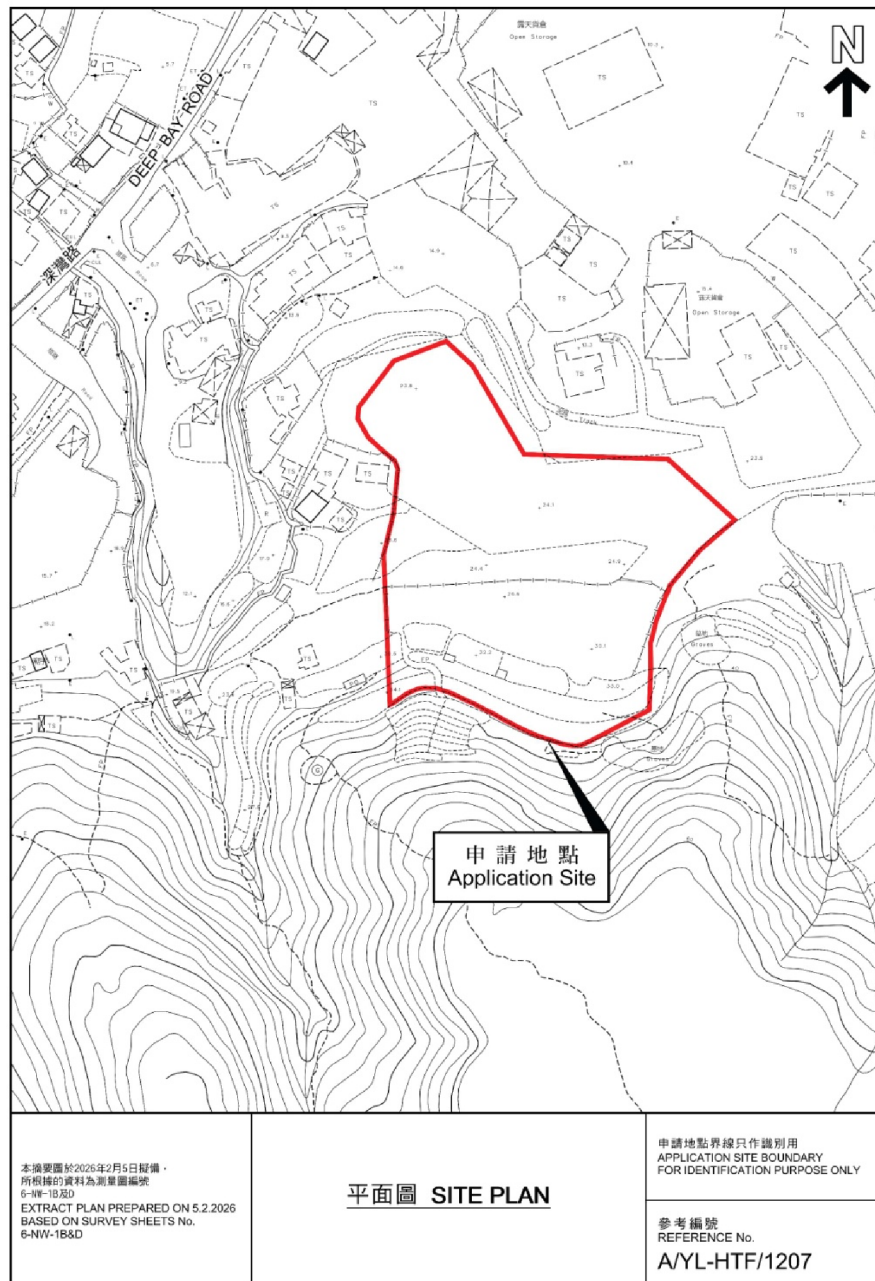
Fig. 1: Site Plan

The site is on the foot of a mountain with level vary from +25.5mPD to +34.0mPD sloping upward towards south. It consists of three platforms with level at around +23.5mPD, +27.0mPD and +32.5mPD. The maximum slope gradient of individual slope within the site is 36 degree.

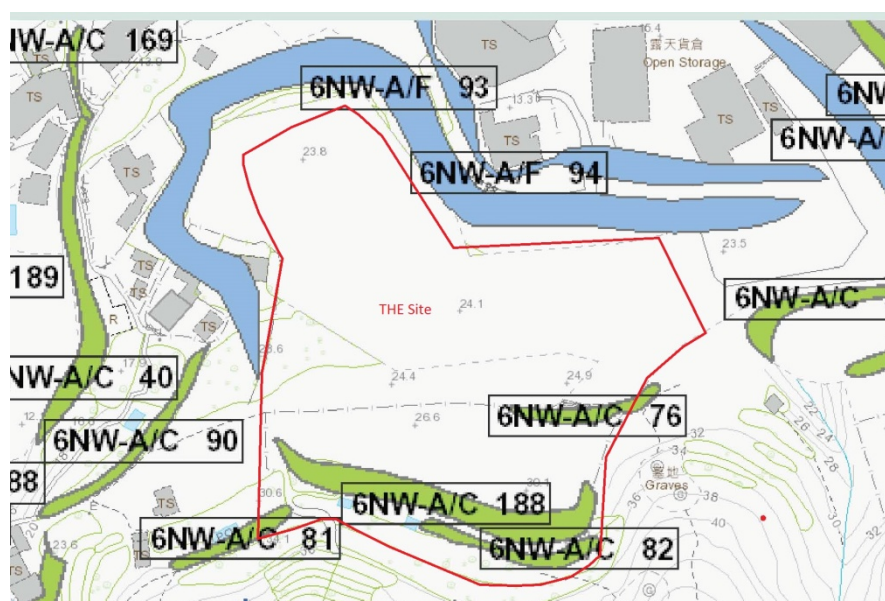
Fig.3: Existing Feature Layout Plan

Major geotechnical features in the vicinity and their Slope Information System (SIS) together with proposed actions are summarized as below:-

2. Section 2.4 of GPRR. The exact locations of all slope features listed in the GPRR should be indicated on a layout plan and the corresponding cross-sections.

All the slope features and the buffer zones are indicated on layout plan and sections.

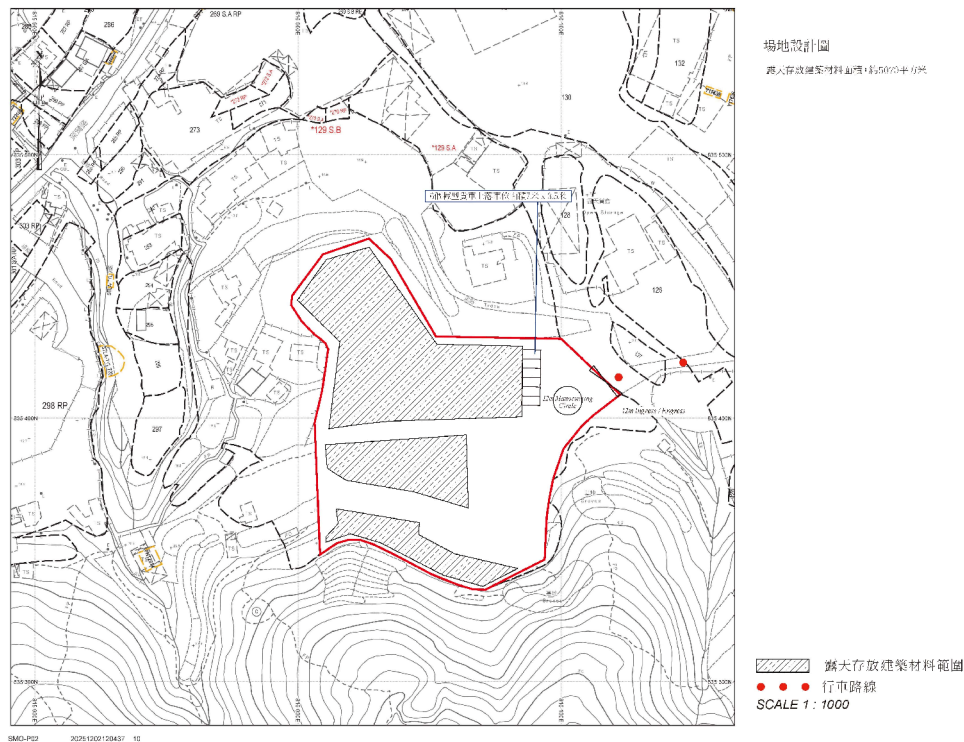
Fig.4: Proposed Layout of the Development

There is no proposed structure on site. The entire proposed site consists of open storage areas, carparking spaces and vehicular access. Fig. 4 shows the proposed layout of the development. **All the open space areas and carparking spaces are all out of buffer zone.** Layout and Section is presented in **Appendix C**

Proposed layout of the application is revised. No uses in the area within the buffer zones.

Proposed layout of the application is revised. No carparking spaces within the buffer zones

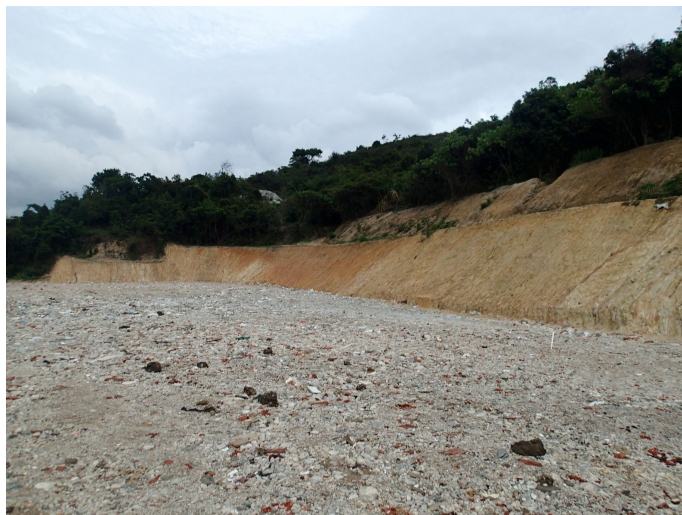
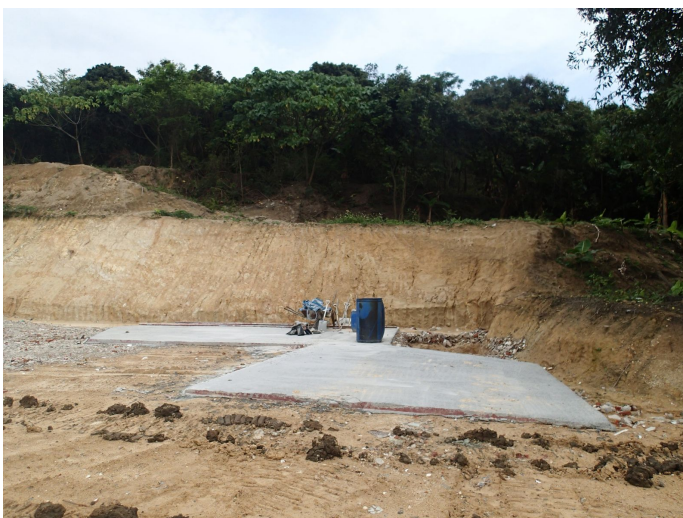
**PHOTO**

Location: At southern portion of Lot 129 S.B in DD128  
Date of Formation: pre-1977  
Date of Construction/ Modification: N/A  
Approximate Coordinates: Easting : 816055    Northing : 835364

(1)    Max. Height (m): 5    Length (m): 85    Average Angle (deg): 50

Slope Part (1)  
Surface Protection (%): Bare: 100    Vegetated: 0    Chunam: 0    Shotcrete: 0    Other Cover: 0  
Material Description: Material type: Soil    Geology: N/A  
Berm: No. of Berms: N/A    Min. Berm Width (m): N/A  
Weepholes: Size (mm): N/A    Spacing (m): N/A

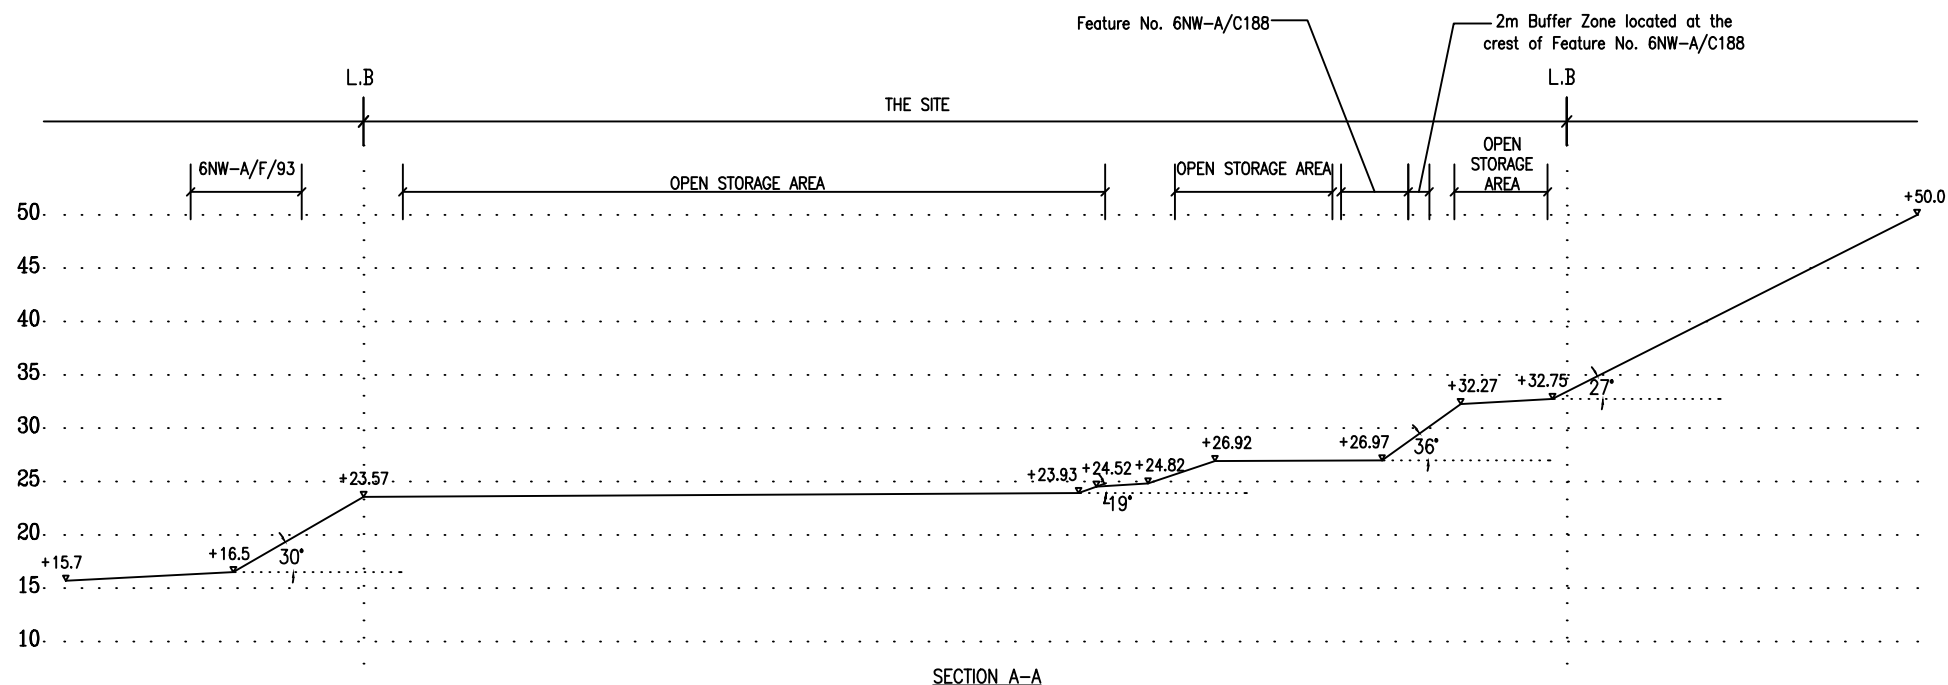
\*Proposed Max. 200mm  
concrete pave within  
open storage area

| 正宏工程顧問有限公司<br>CHING WAN ENGINEERING CONSULTANTS COMPANY | | SECTION A-A | |
|---|---|---|---|
| | | Fig. 2 | 31-8-2026 |

3. Section 3 of GPRR. It is noted that no structures are proposed on site. However, storage areas are illustrated at the slope crests as shown in Section A-A, B-B and E-E, which are within the buffer zone as proposed in our previous comments provided via memo ref. PLN-50-2005-7-YL-HTF dated 15.6.2026. The applicant should therefore demonstrate that the stability of the slopes would not affect or be affected by the proposed storage areas in the GPRR.

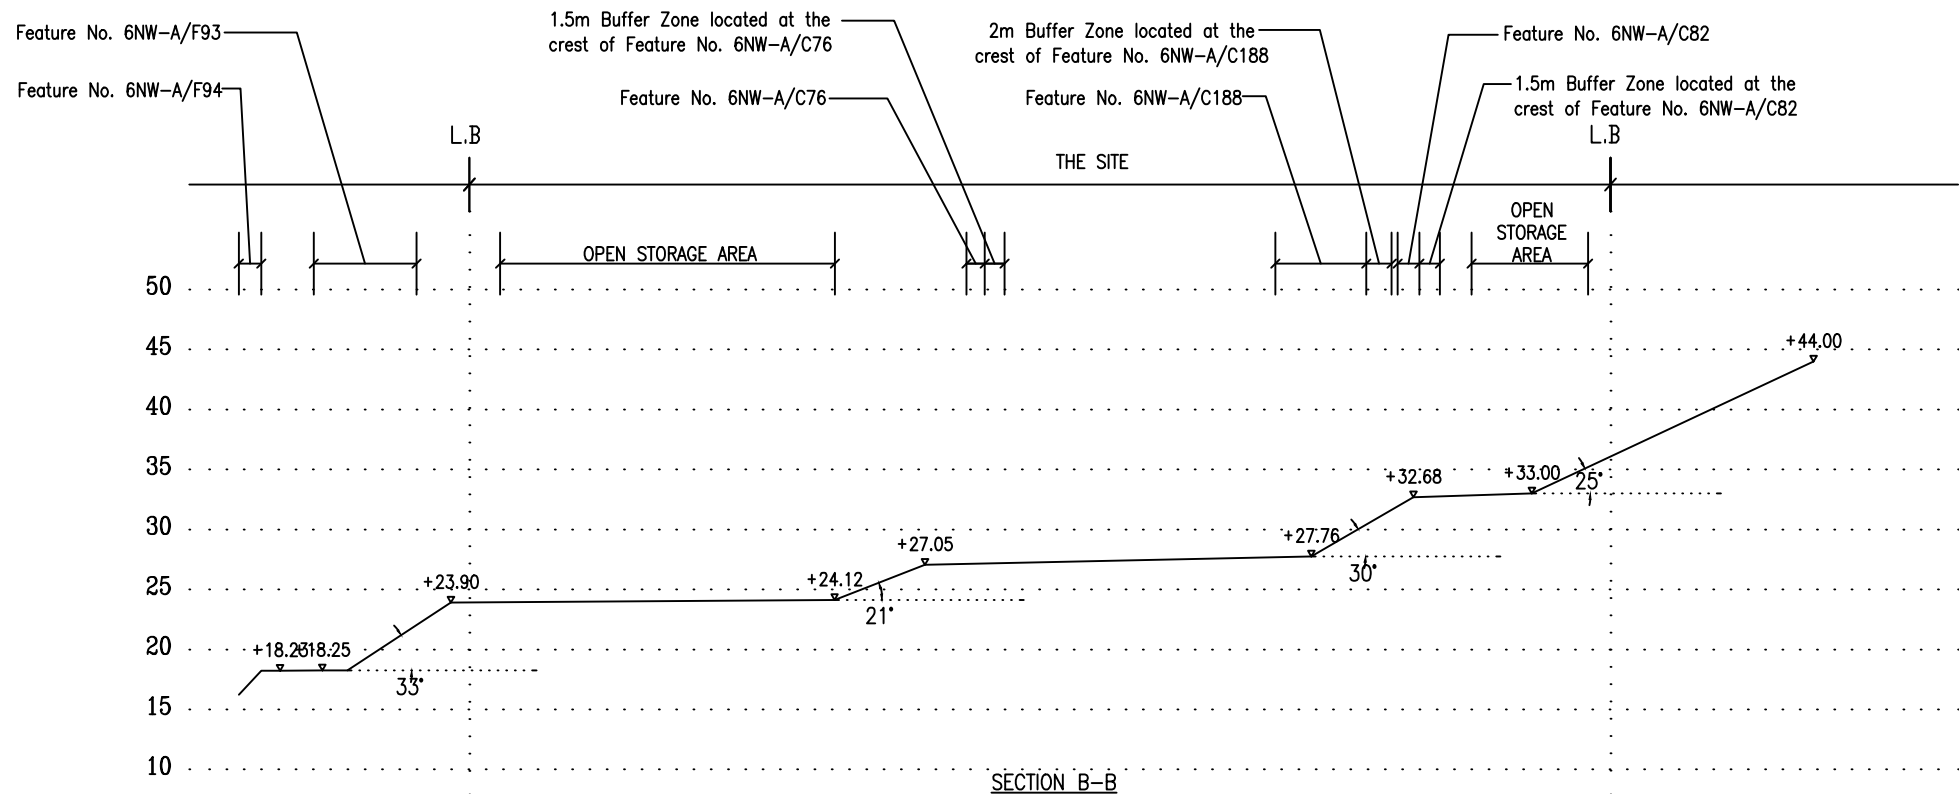
\*Proposed Max. 200mm  
concrete pave within  
open storage area

| 正宏工程顧問有限公司<br>CHING WAN ENGINEERING CONSULTANTS COMPANY | | SECTION B-B | |
|---|--|---|---|
| Project:<br>Proposed Temporary Open Storage of Construction Materials and<br>Associated Filling of Land for a Period of 3 Years at Lot 129 S.B<br>(Part) in D.D. 128 and Adjoining Government Land, Ha Tsuen, Yuen<br>Long(Geotechnical Planning Review Report A/YL-HTF/1207) | | Drawing No.:<br><br>Fig. 3 | Updated on:<br><br>31-8-2026 |

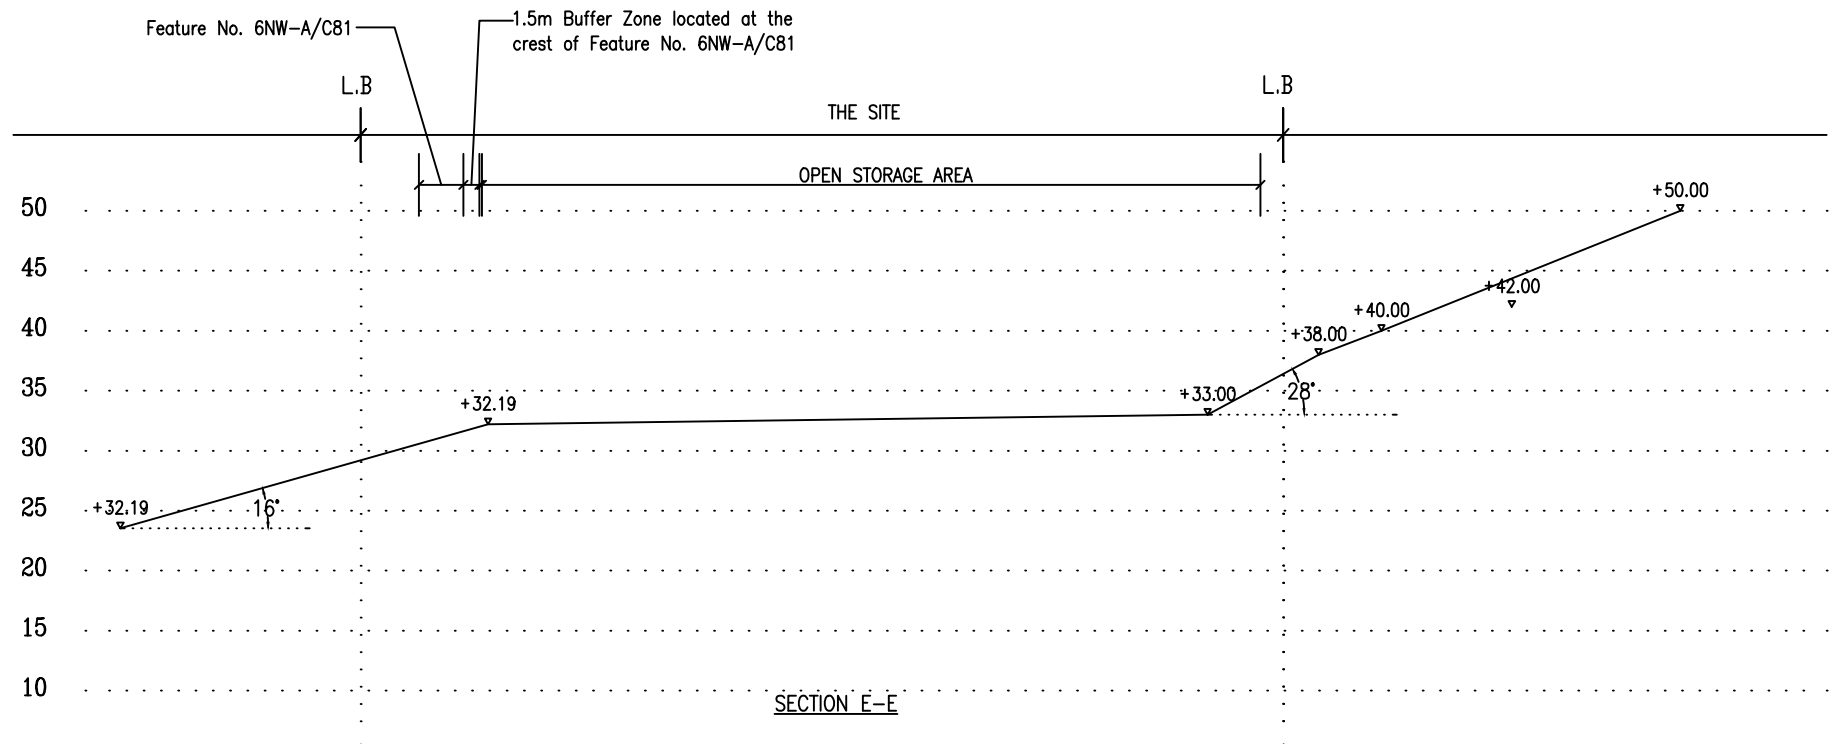
\*Proposed Max. 200mm  
concrete pave within  
open storage area
