GEOTECHNICAL PLANNING REVIEW REPORT (GPRR)  
FOR  
A COMMERCIAL DEVELOPMENT (FIVE SALES SHOPS)  
AT  
LOT 1796, 1797, 1798, 1800, 1801 & 1802 IN D.D. 129,  
DEEP BAY VILLA, YUEN LONG

| Client: | Hoi Fu Man Fung Gondola Co. Ltd. |
| Registered Geotechnical Engineer: | SLN And Associates Ltd. |

SEP 2025

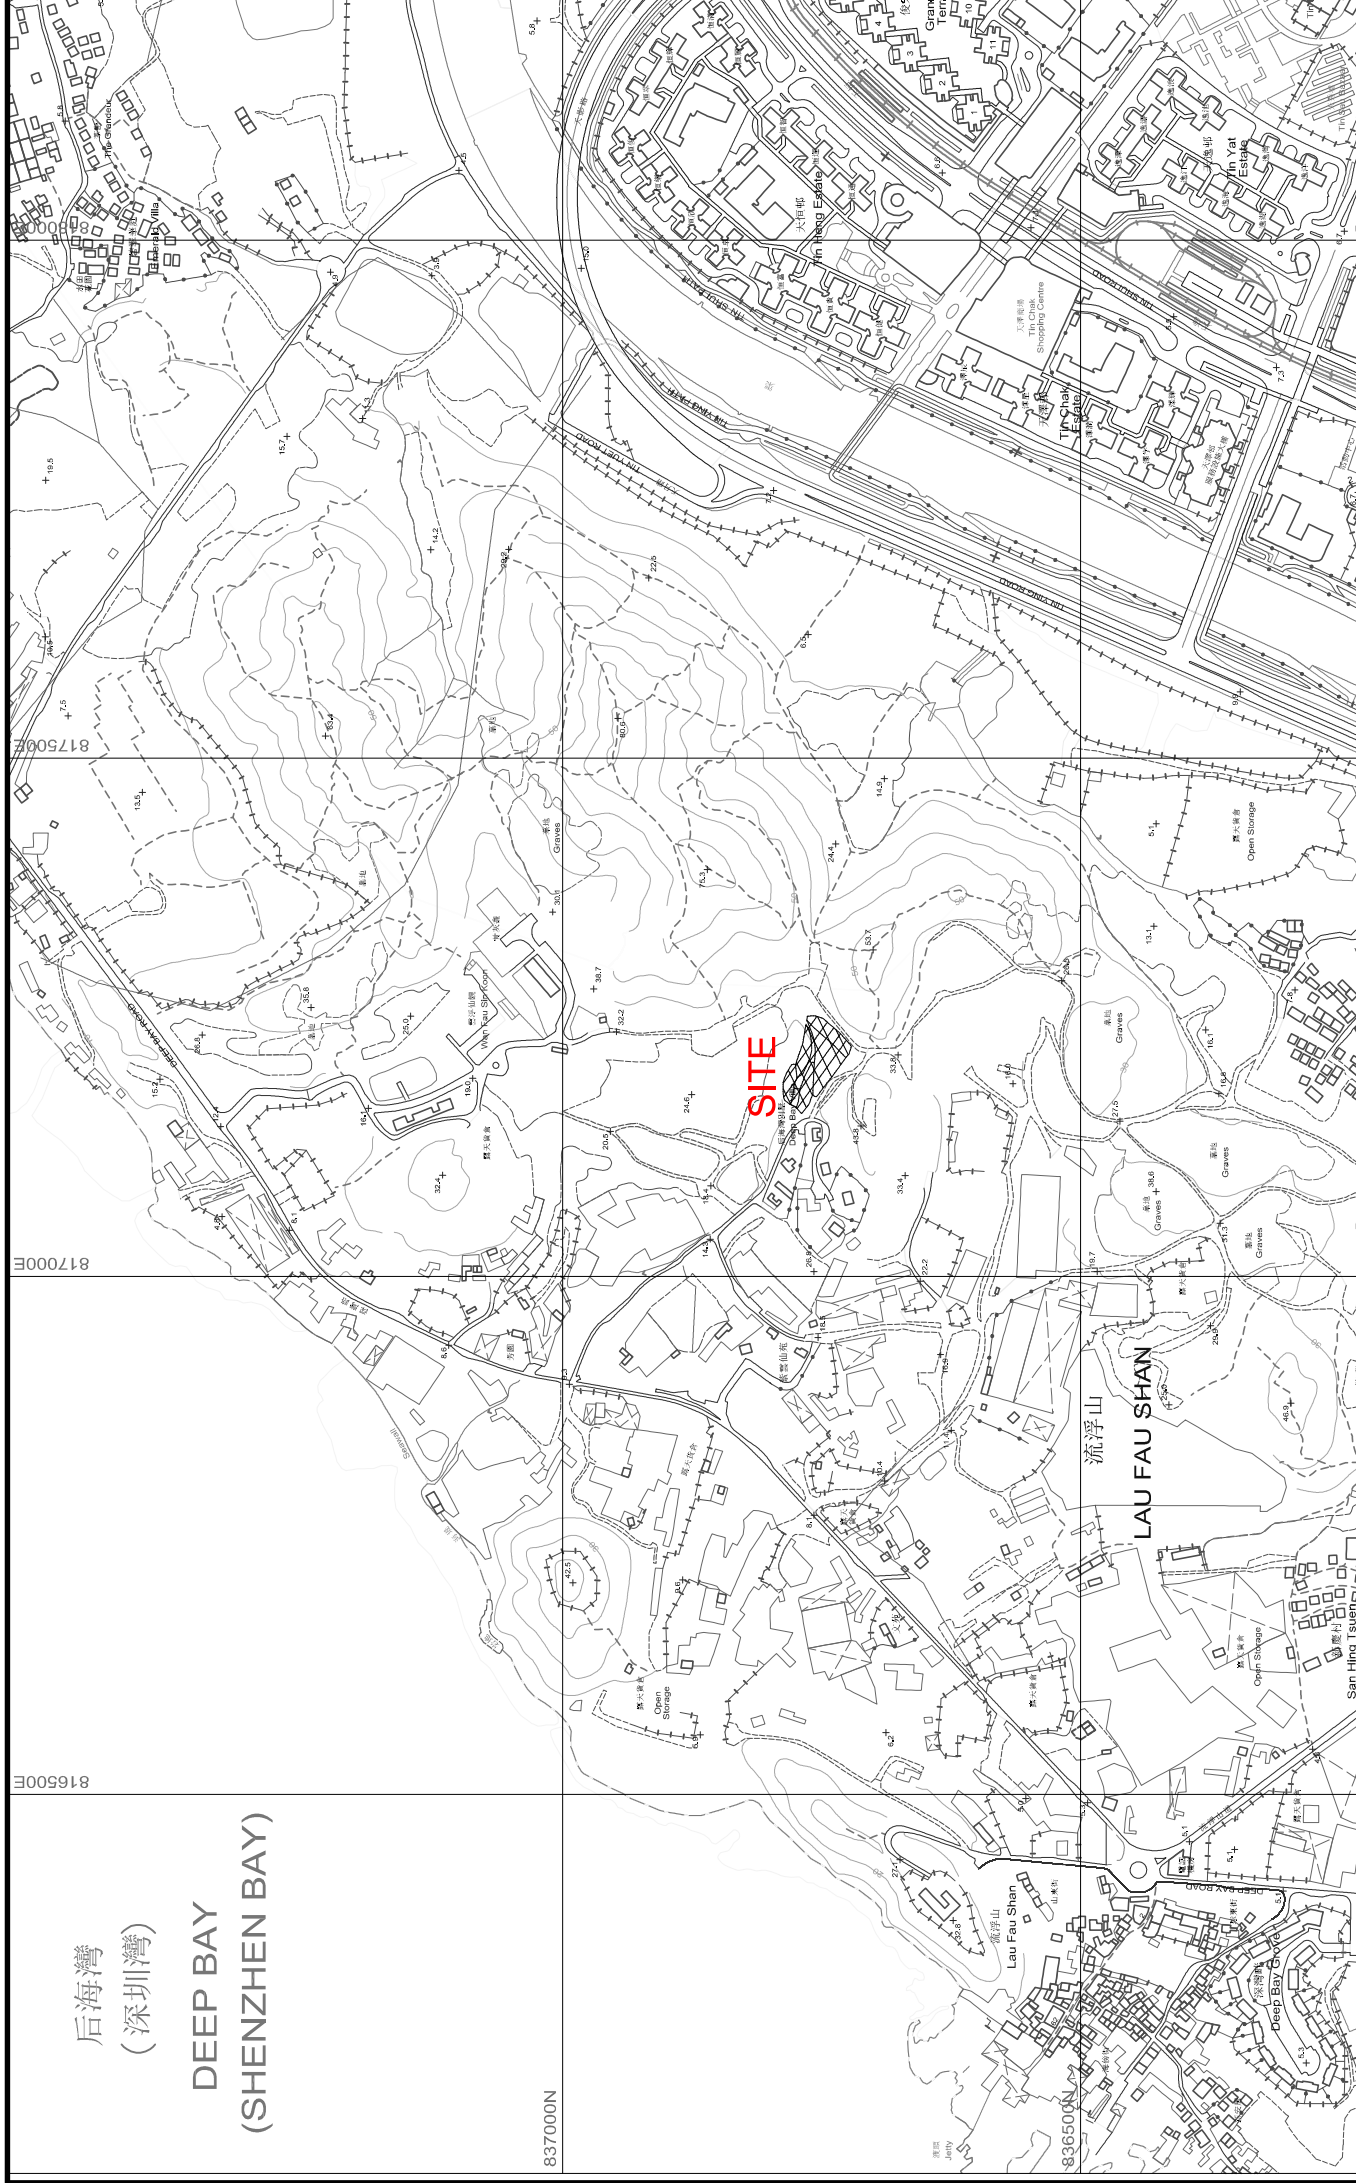
SITE LOCATION PLAN - EXTRACT 1 : 5000 SURVEY SHEET OF SITE

The application site is located at Lot 1796, 1797, 1798, 1800, 1801 & 1802 in D.D. 129, Deep Bay Villa, Yuen Long. A site plan (1:5000) is shown in *Figures 1*.
