GEOTECHNICAL PLANNING REVIEW REPORT (GPRR)
FOR
A COMMERCIAL DEVELOPMENT (FIVE SALES SHOPS)
AT
LOT 1796, 1797, 1798, 1800, 1801 & 1802 IN D.D. 129,
DEEP BAY VILLA, YUEN LONG

Client:	Hoi Fu Man Fung Gondola Co. Ltd.
Planning Consultant:	P & C Engineering Consultancy Co.
Registered Geotechnical Engineer:	SLN And Associates Ltd.

July 2023

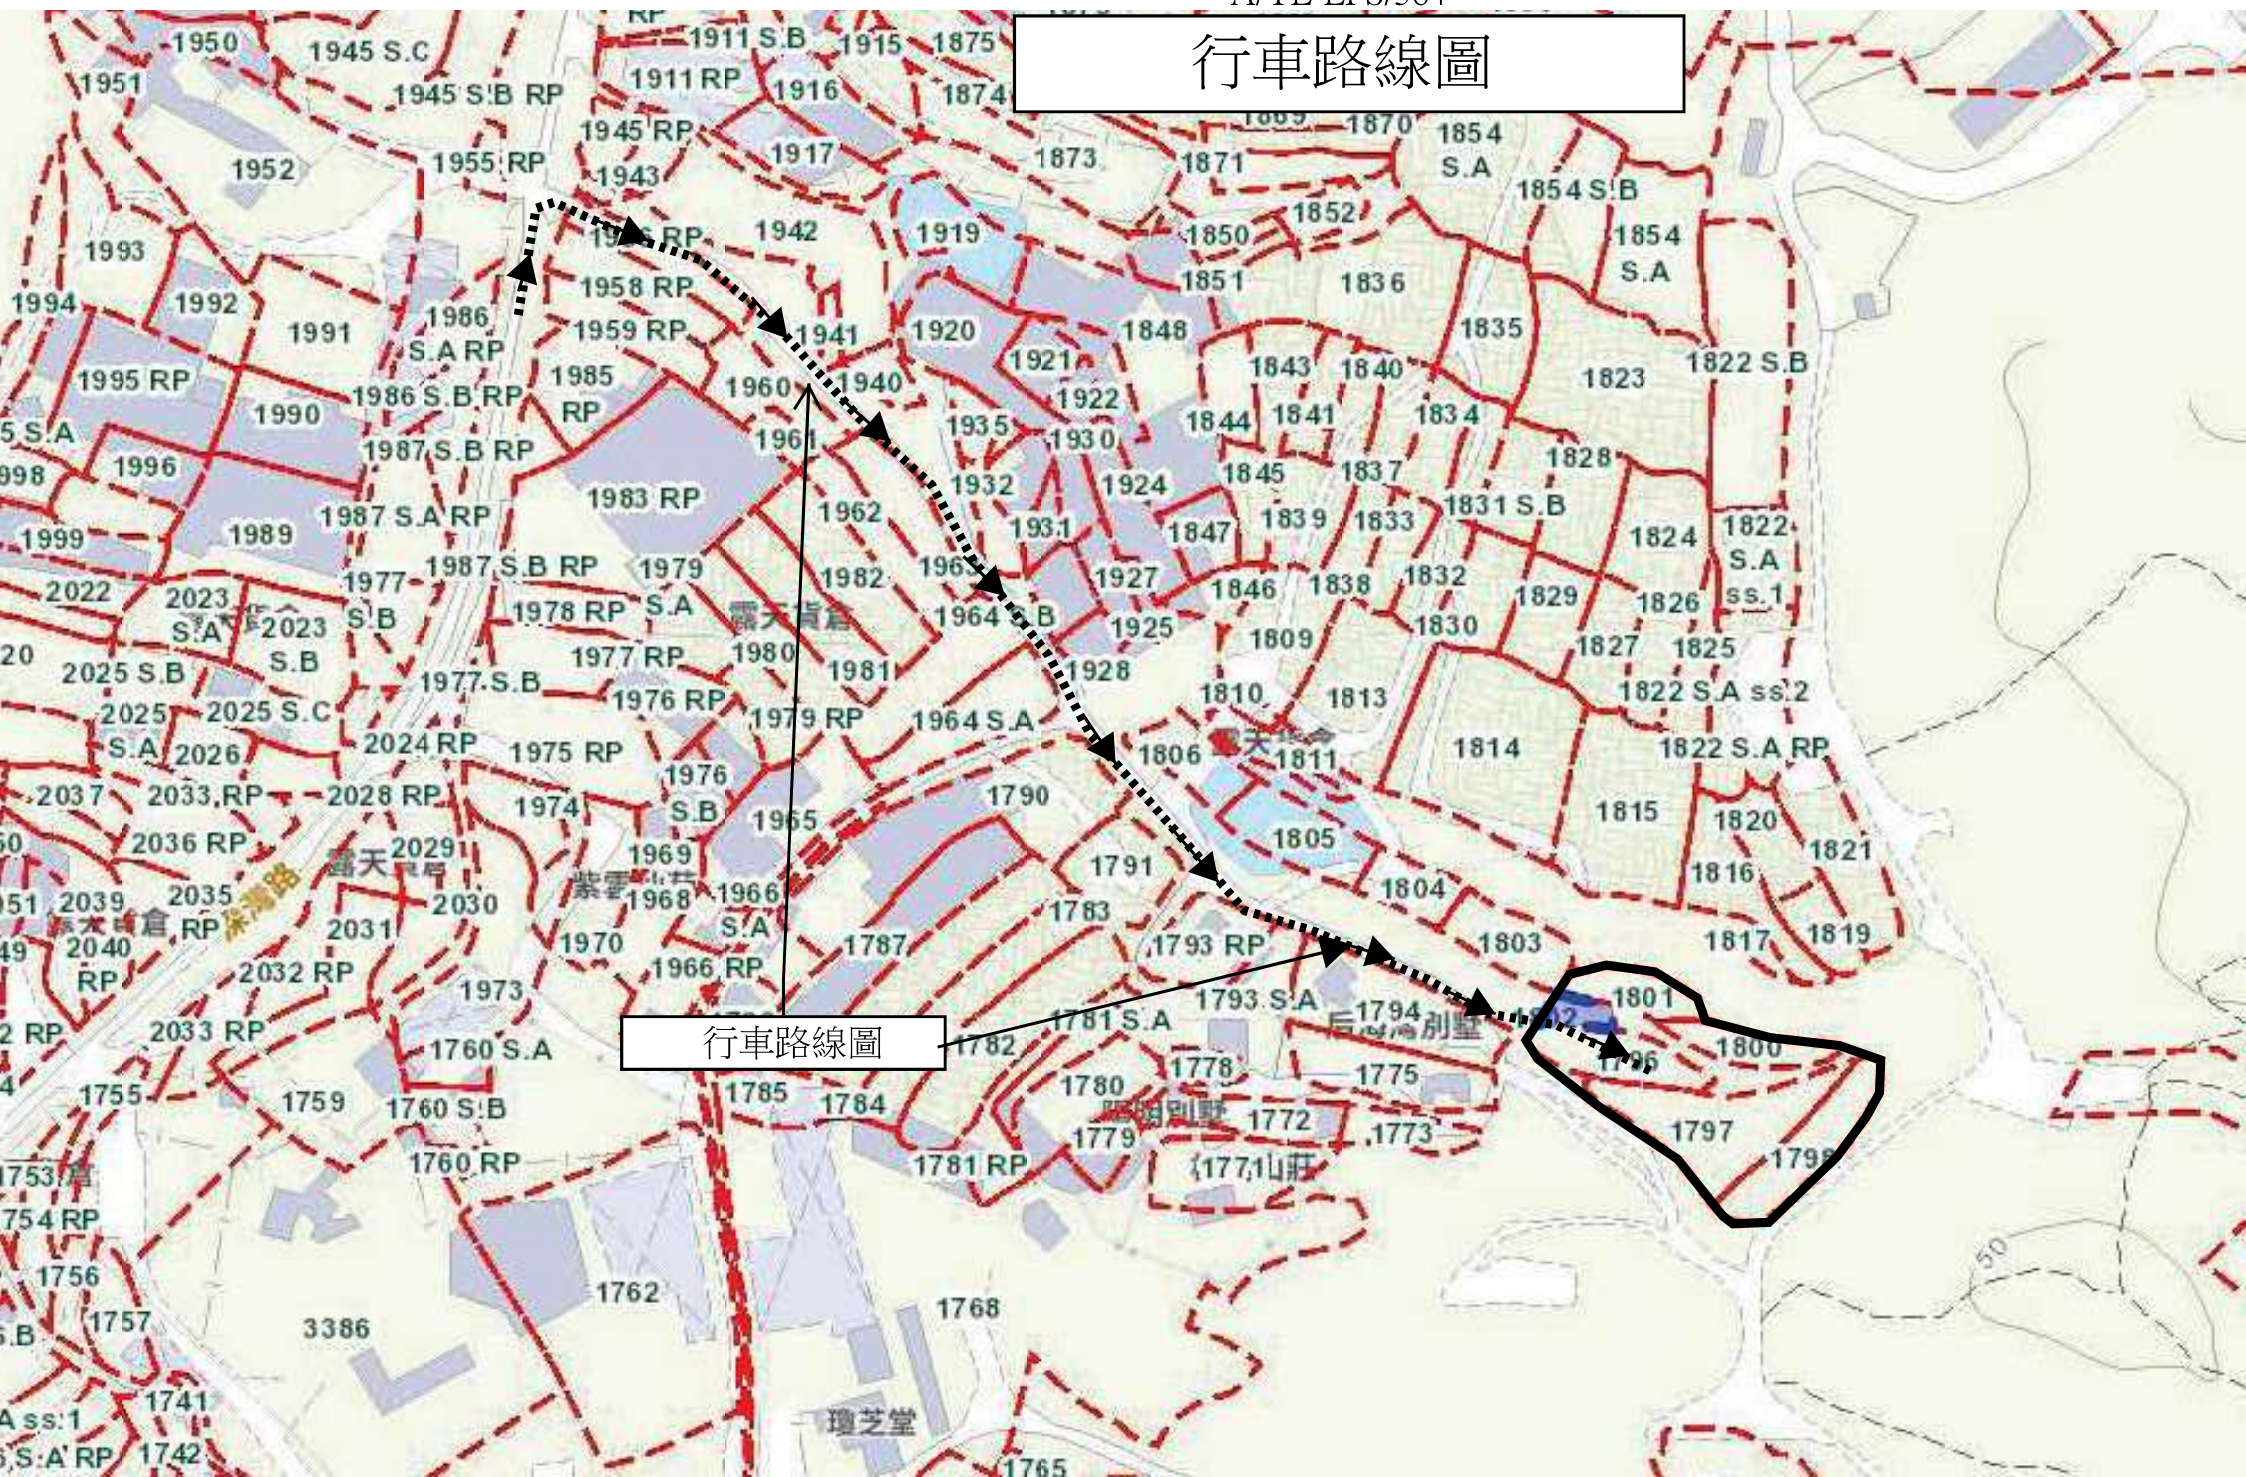
致 城市規劃委員會 每日車輛進出流量評估

輕型貨車 星期1至星期六		私家車 星期1至星期六		私家車 星期日及公眾假期	
	IN	OUT	IN	OUT	IN	OUT
時間						
08:00	1		2		1	
09:00	1	1				
10:00		1				
11:00						
12:00	1			1		1
13:00	1	1	1		1	
14:00		1				
15:00						
16:00						
17:00	2					
18:00		2		2		1
18:30

輕型貨車在星期日及公眾假期休息，不會即出申請場地。

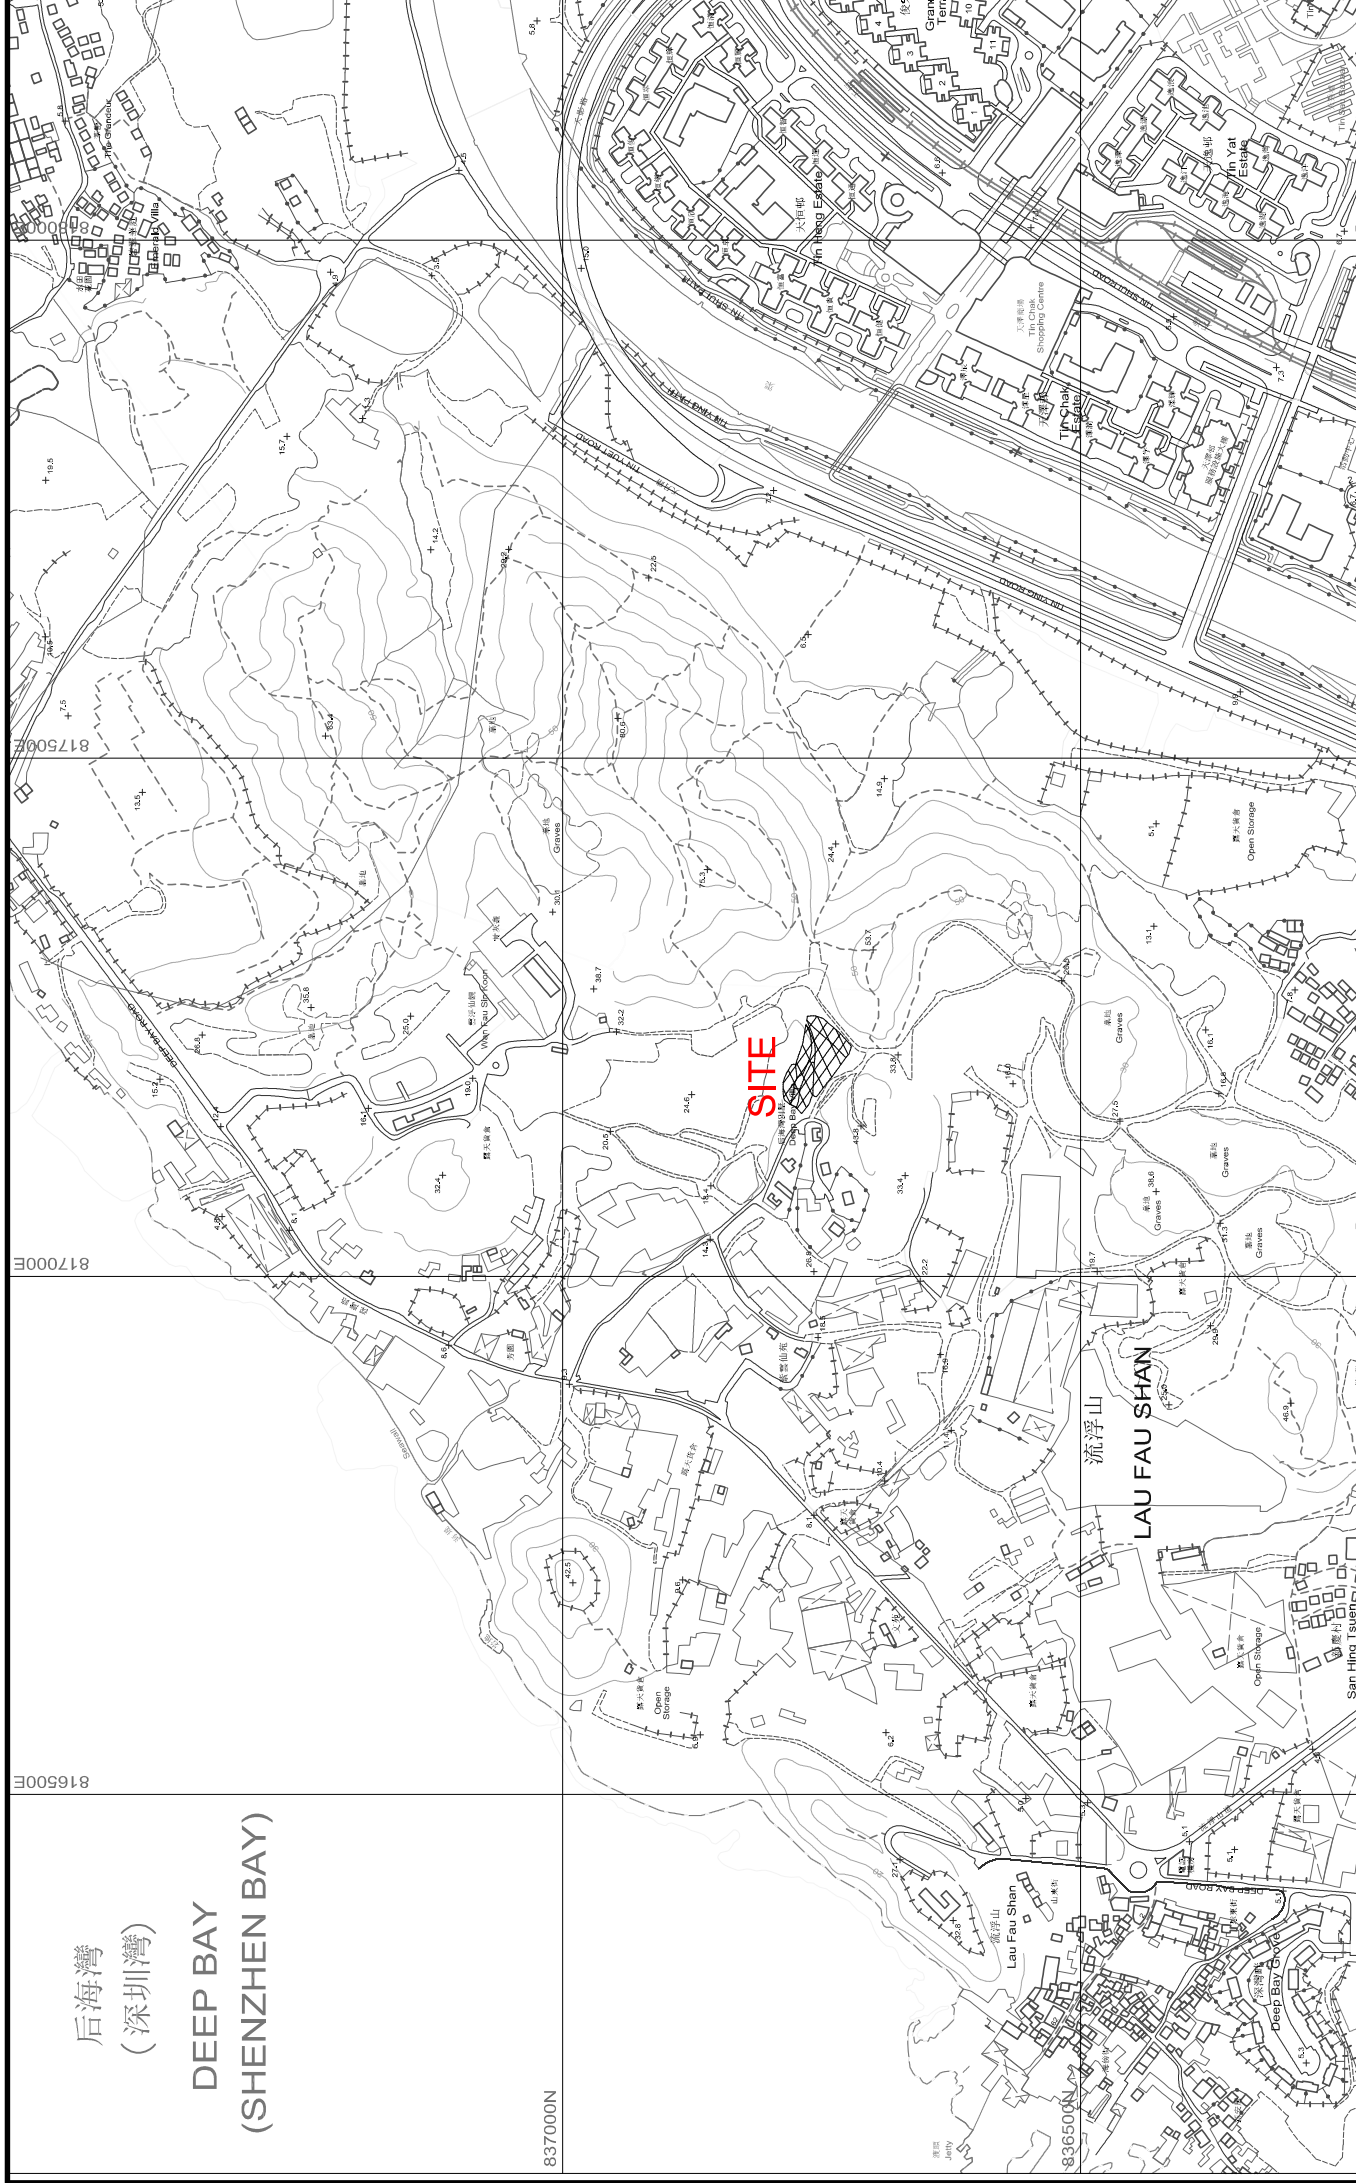
SITE LOCATION PLAN - EXTRACT 1 : 5000 SURVEY SHEET OF SITE

The application site is located at Lot 1796, 1797, 1798, 1800, 1801 & 1802 in D.D. 129, Deep Bay Villa, Yuen Long. A site plan (1:5000) is shown in *Figures 1*.

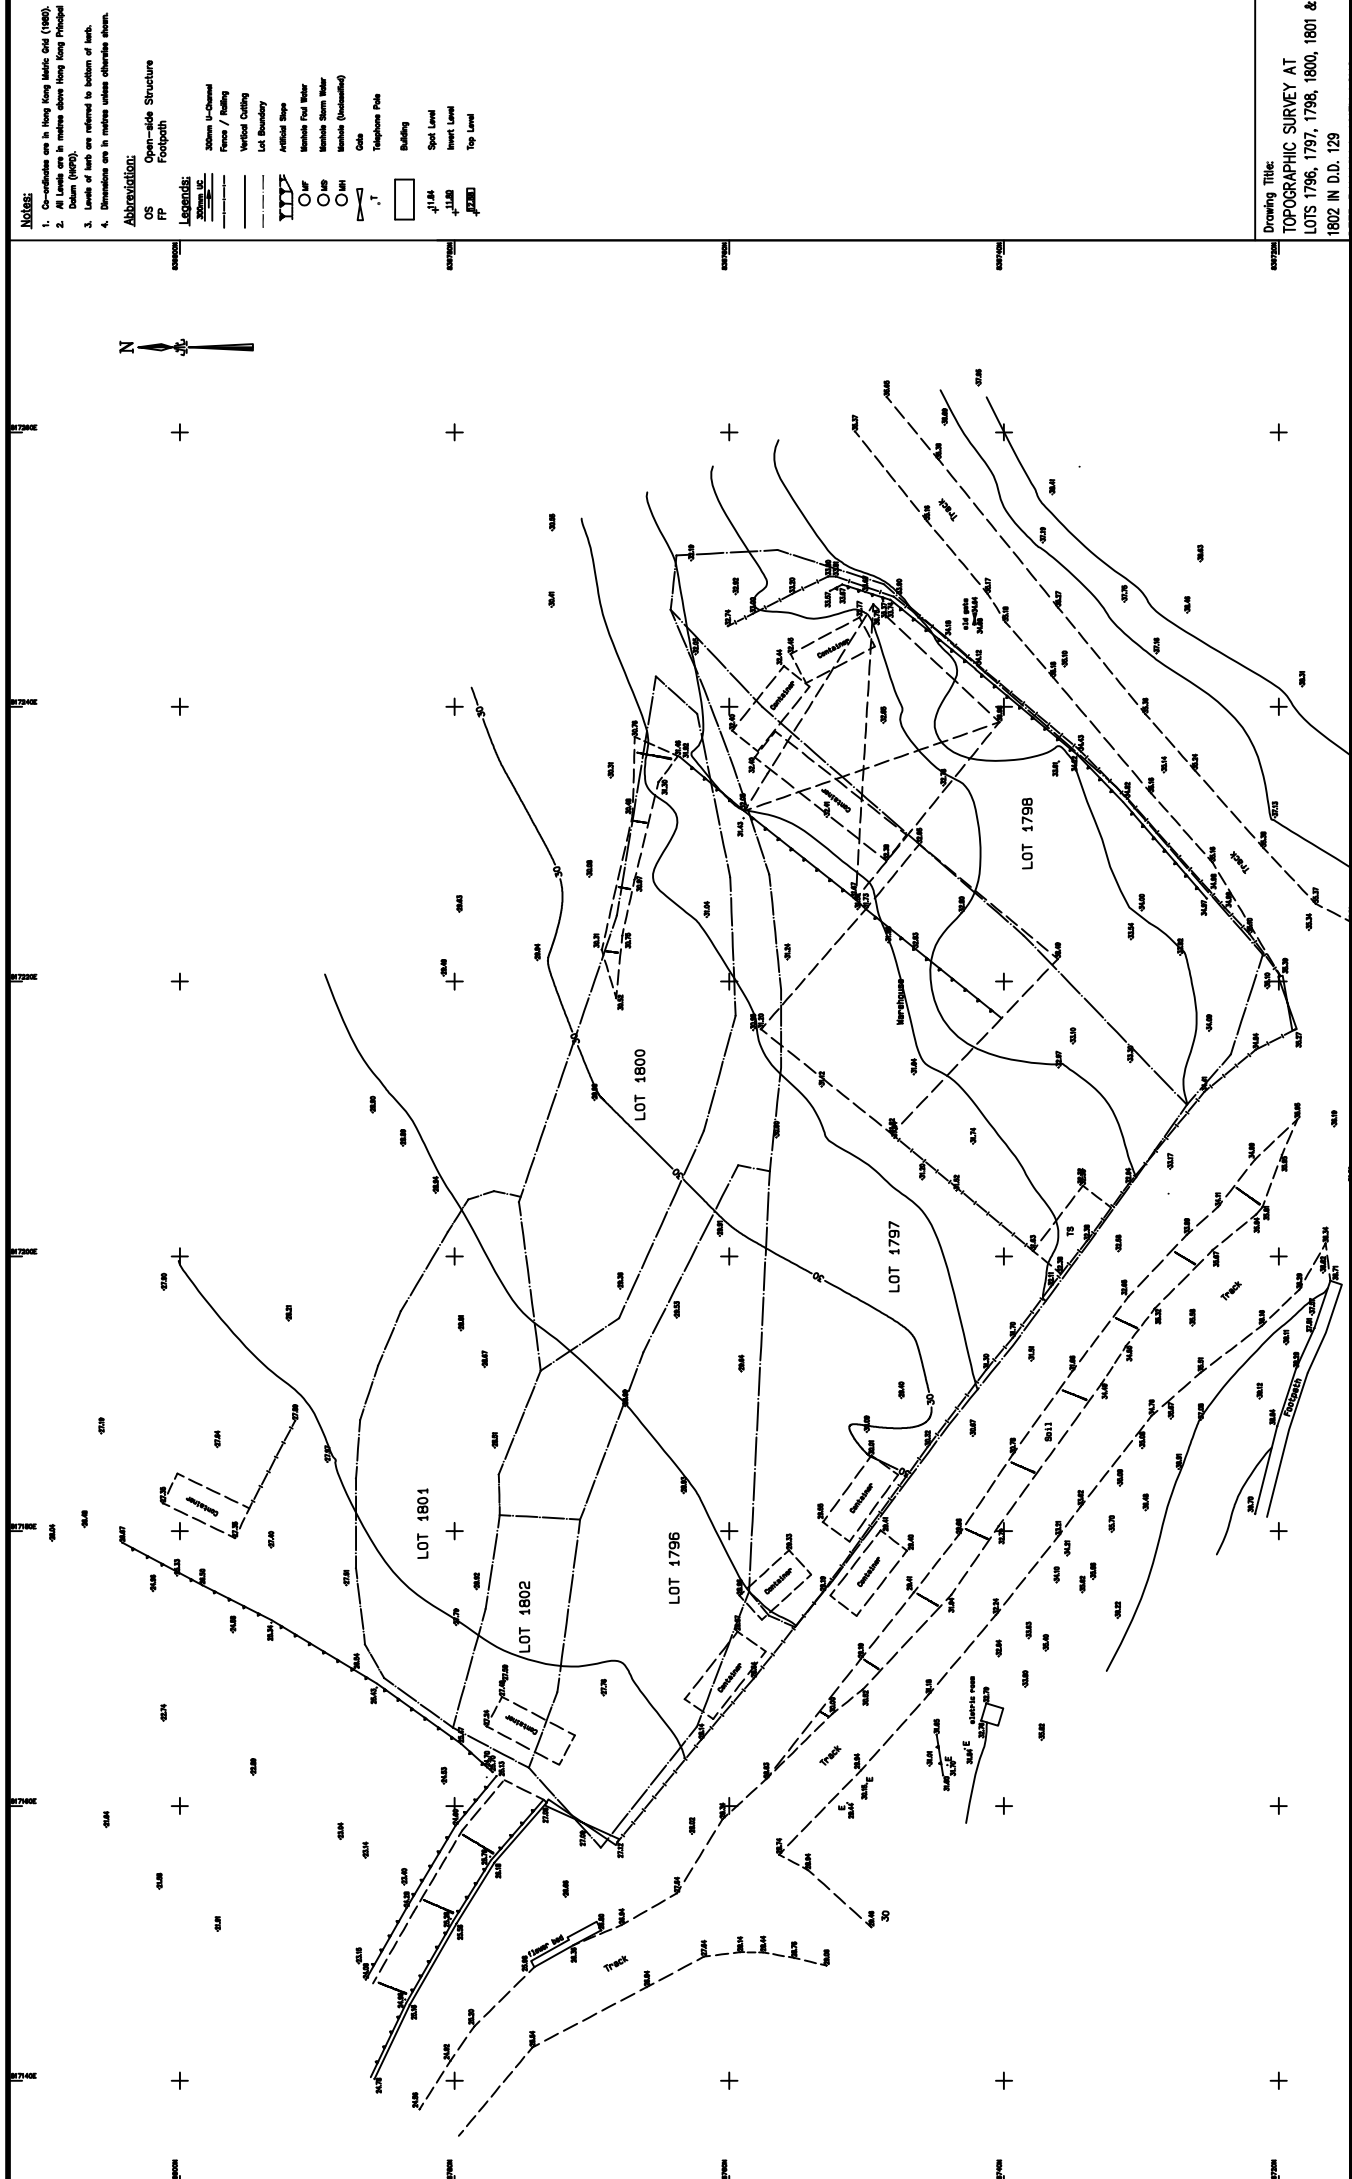
TOPOGRAPHIC SURVEY PLAN OF SITE

The topography of the site now found and presented in a survey plan consists of a gentle sloping ground rising from +26mPD to 34mPD across a length of 85m, which represent a gentle overall sloping angle of 5.5°, dipping to the northwest. It is also found in some spots minor difference in level retained by concrete planks for forming level platforms. However, a deviation from the topographic record kept by the Lands Department is noticed. It is believed that some filling of the ground has been done causing some of the geotechnical features to become dismissed, rendering the current profile a more safe and desirable condition.

A topographic survey plan showing the most updated ground profile of the site is given in *Figure 2a* while another topographic survey plan (1:1000) presenting both current and original ground profiles is attached in *Figure 2b*.

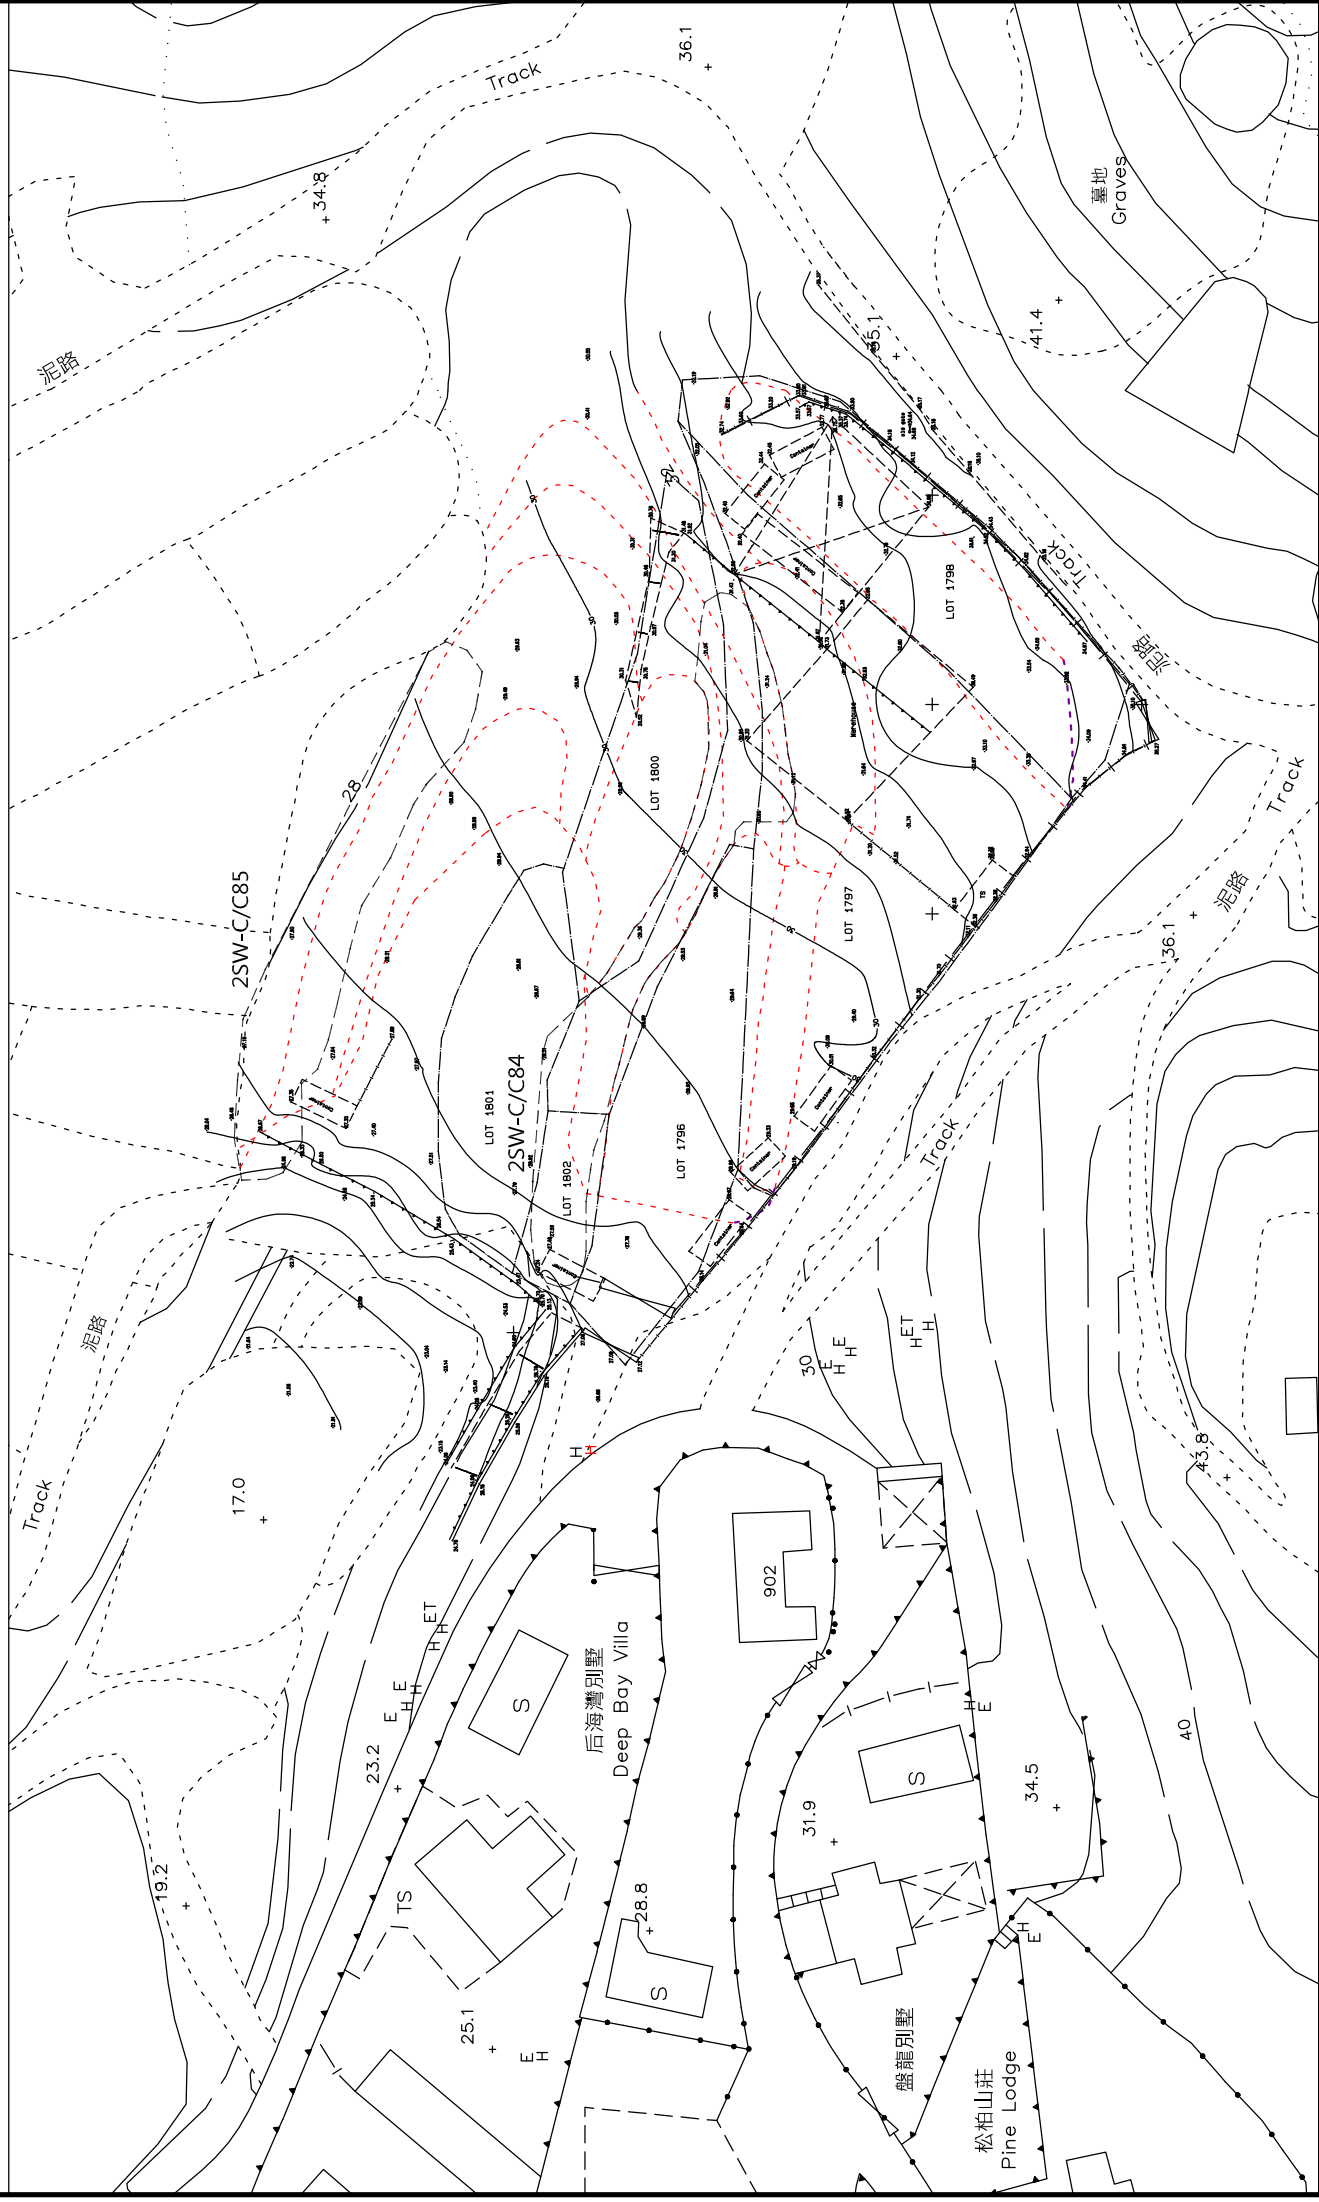
OVERLAP OF 1 :1000 SURVEY SHEET AND TOPOGRAPHIC SURVEY PLAN

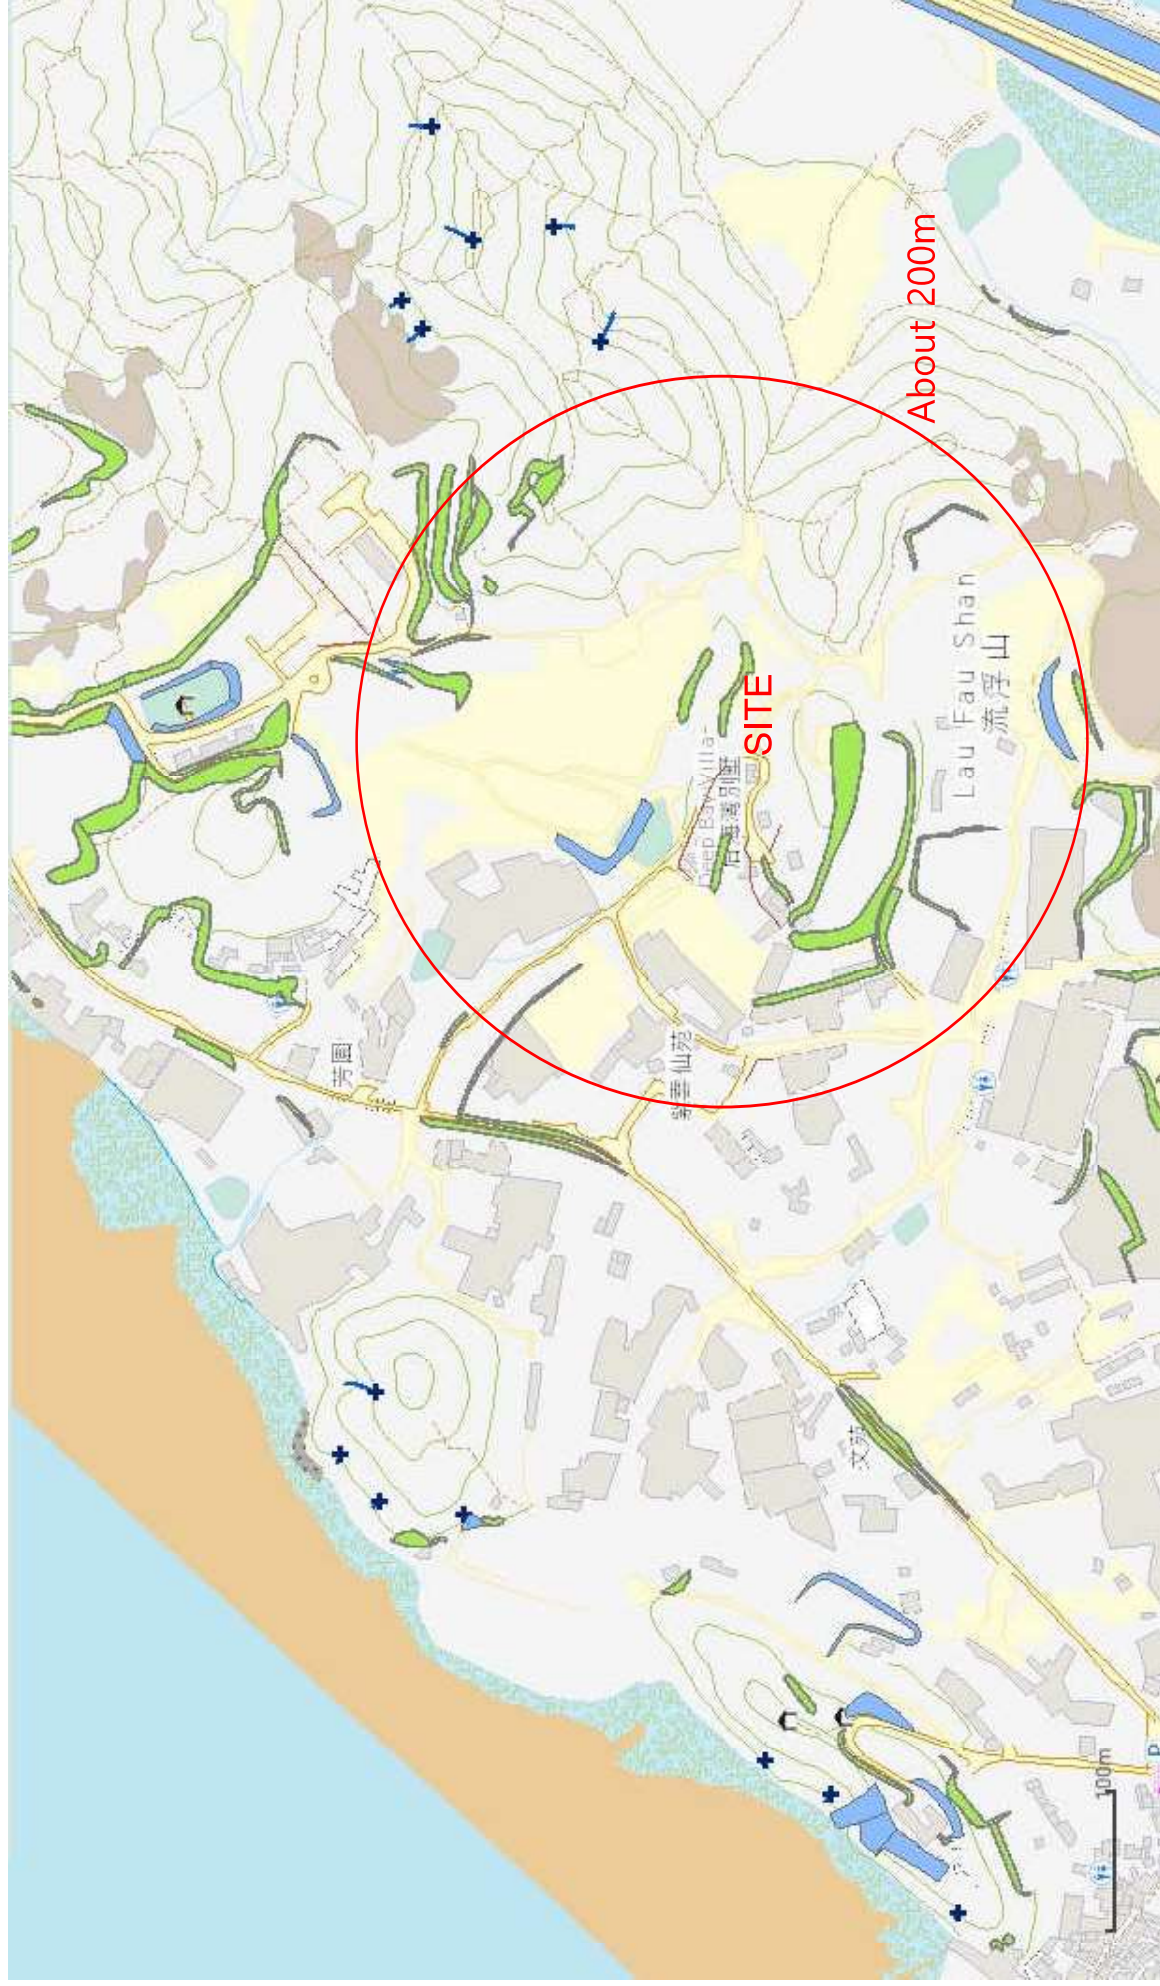
4

NTLI - LANDSLIDE RECORD

According to the Natural Terrain Landslide Inventory (NTLI) provided in GEO’s online SIS, no landslides were observed within 200m offset from the site. A graphical NTLI-Landslide Record is given in *Figure 4*.

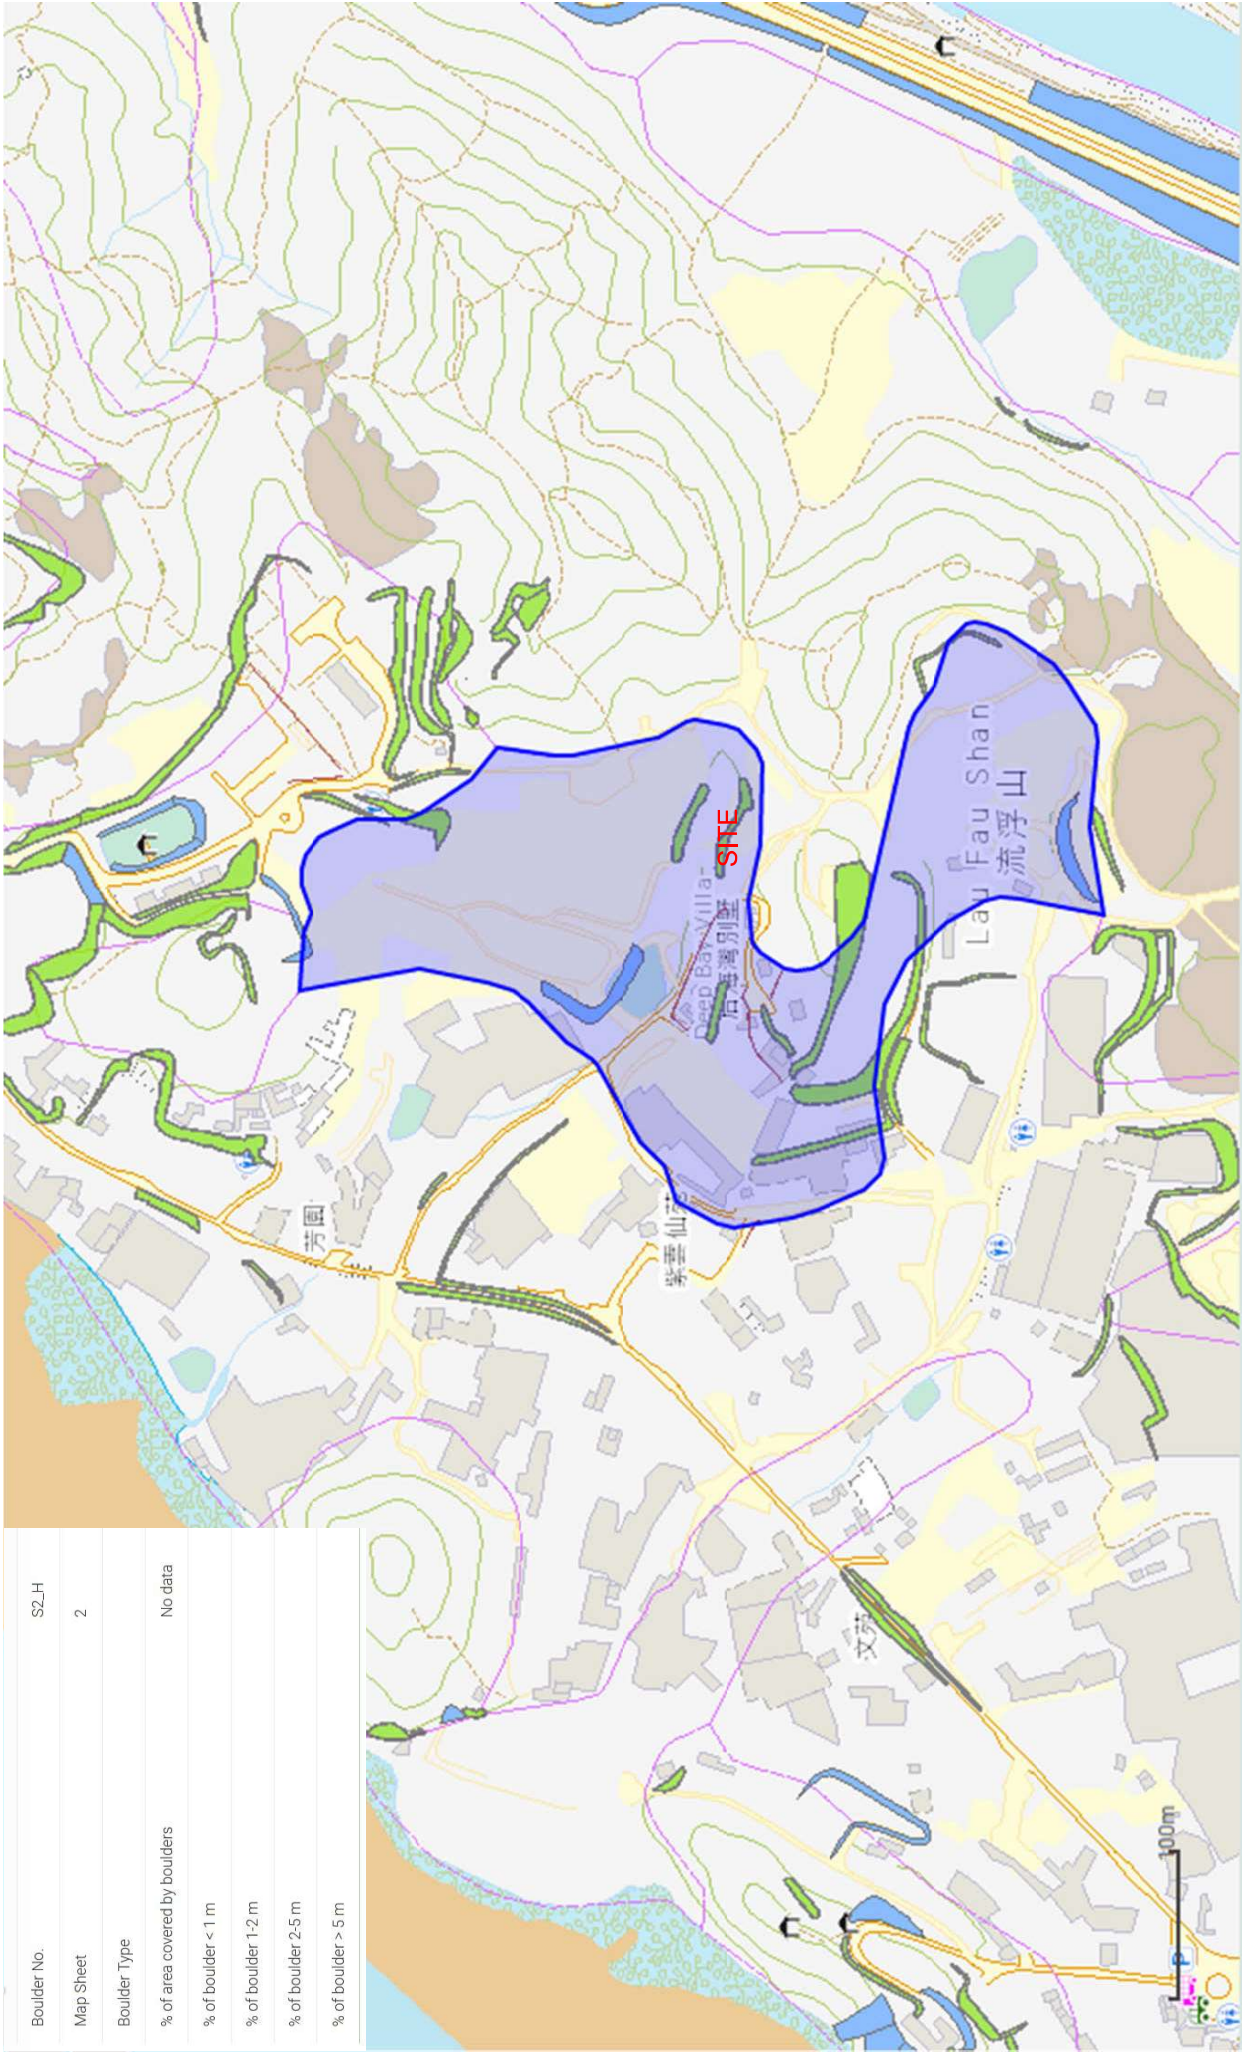
Boulder No.	S2_H
Map Sheet	2
Boulder Type	No data
% of area covered by boulders	
% of boulder < 1 m	
% of boulder 1-2 m	
% of boulder 2-5 m	
% of boulder > 5 m

According to GEO's QRA of Boulder Fall Hazards No.S2_H, no boulder fall records are found in the study area. An extract of QRA of Boulder Fall Hazards No.S2_H is reproduced in *Figure 5*.

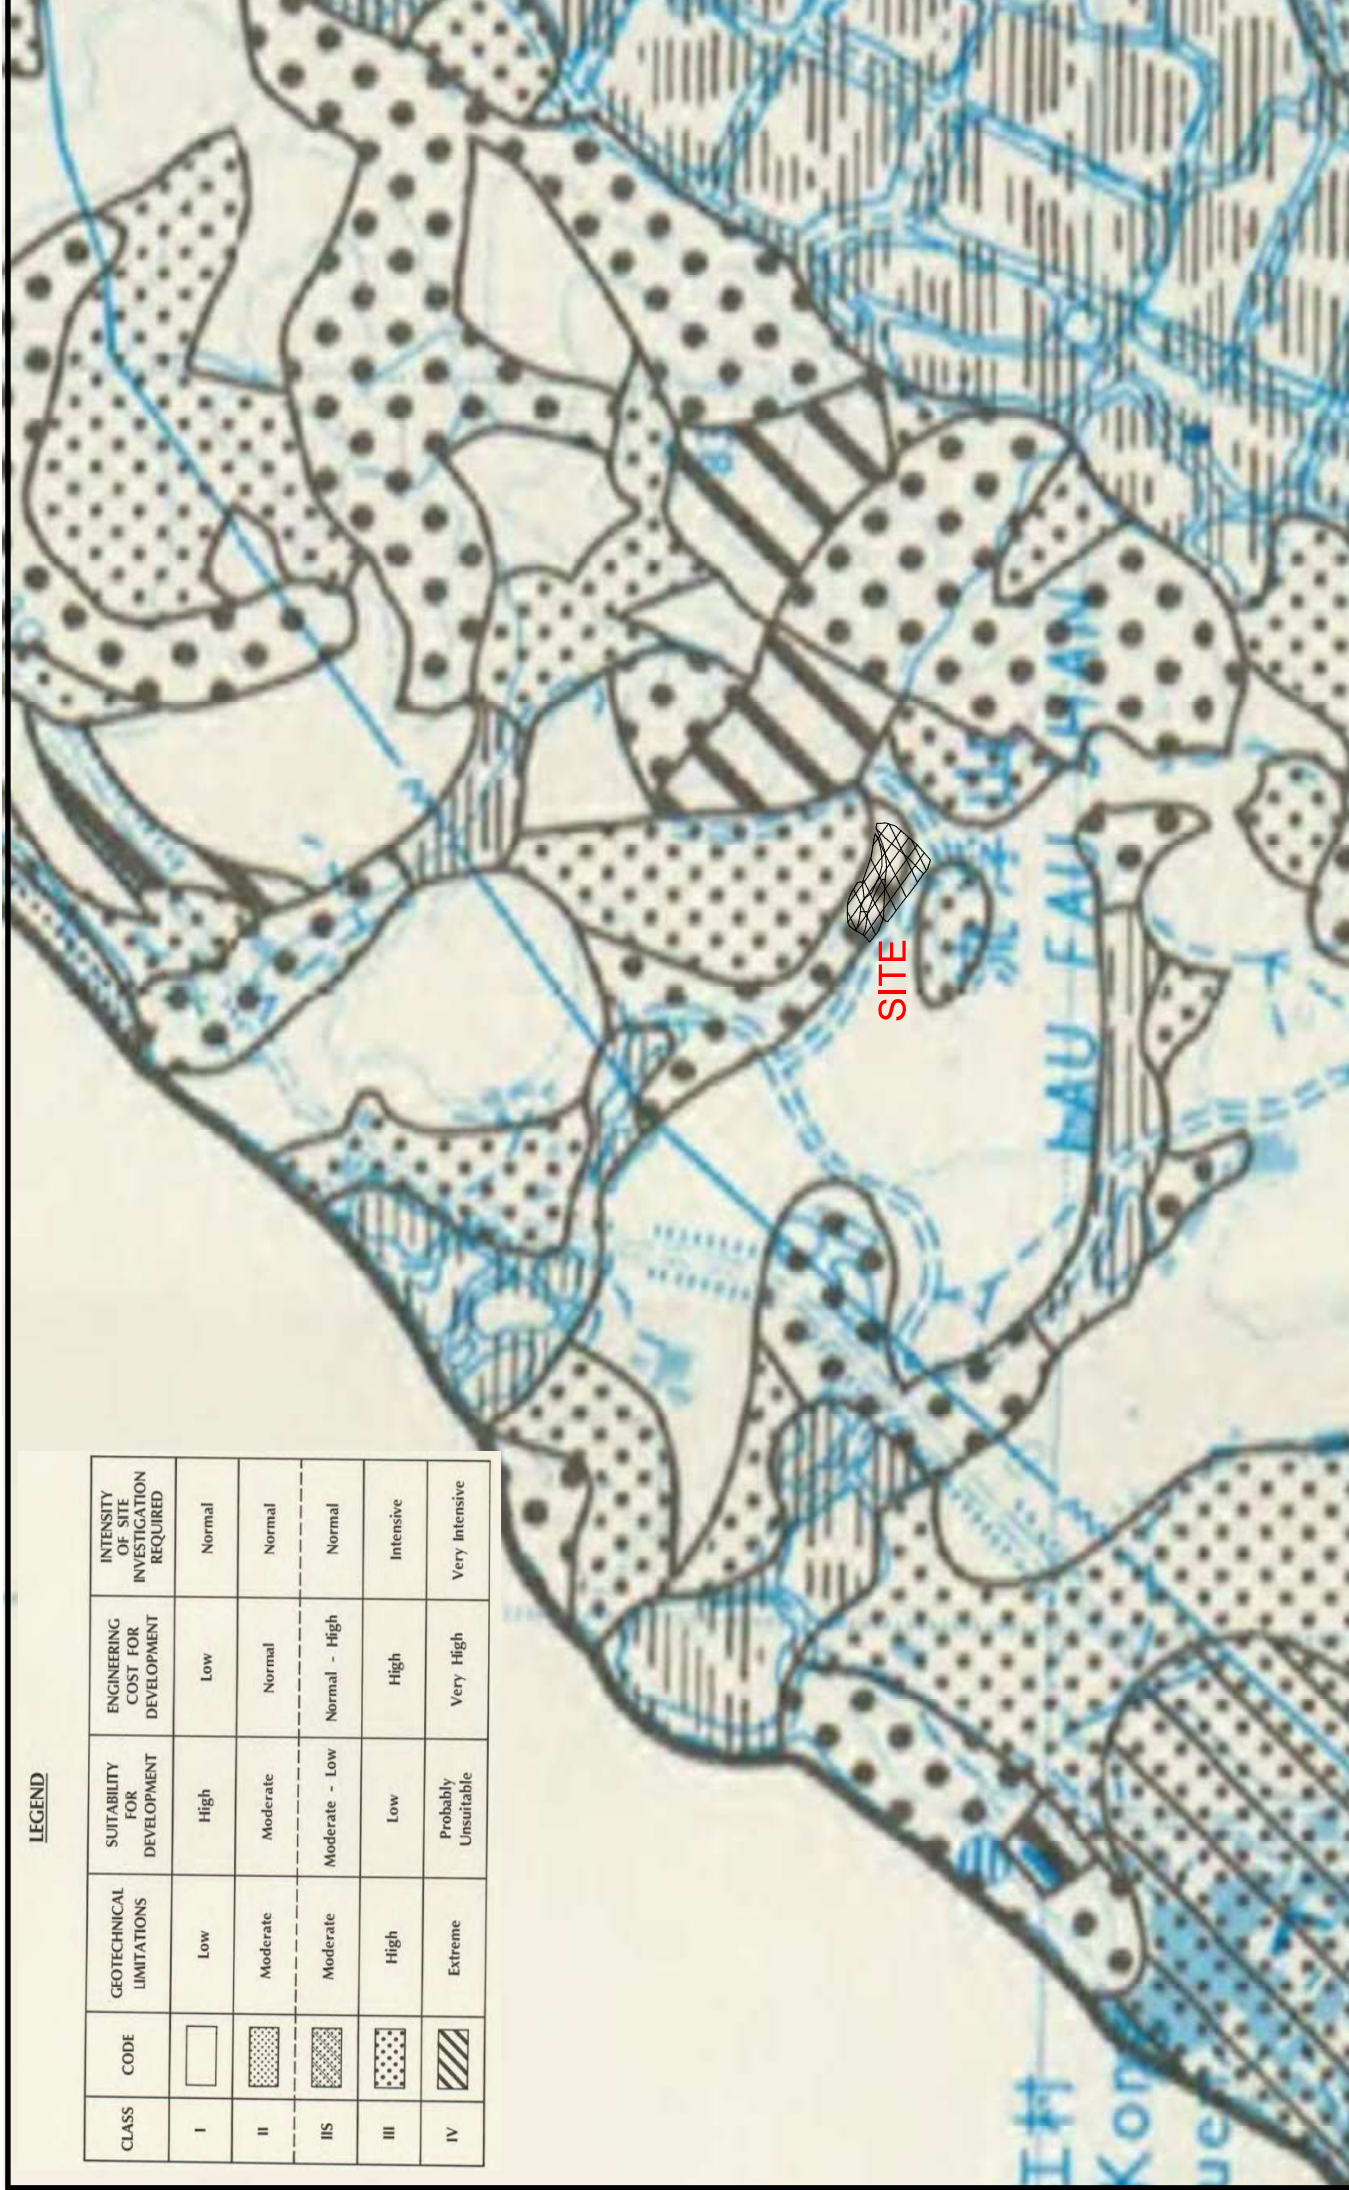
EXTRACT OF GASP REPORT MAP - GEOTECHNICAL LAND USE MAP

As a part of the desk study, reference has been made to Geotechnical Land Use Map (GLUM) enclosed in GASP – Report 4. The map suggests that the site is categorized as GLUM Class III. Development within this class may possibly require intensive geotechnical investigation, and hence the costs associated with site investigation, site formation, foundation and drainage work are likely to be high. Another map called Physical Constraints Map indicates that our site is susceptible to overland flow and periodic inundation. Therefore, a proper drainage system should be put in place to save the area from inundation.

Extracts of the above two maps are shown in *Figures 6 and 7* respectively.
