Redevelopment of Wan Sin Koon LOT Nos. 1856 (Part), 1857 S.A., 1857 RP, 1858, 1859 and Adjoining Government Land STT1345 Lau Fau Shan, Yuen Long

Geotechnical Planning Review Report

2025-08-13

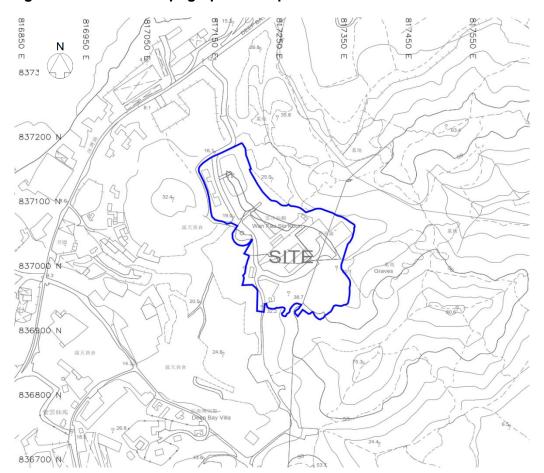
Figure 2.1 1:5000 topographical map

The 1:5000 topographical map and site location plan with adjacent buildings/roads are shown in **Figure 2.1 & 2.2** respectively.

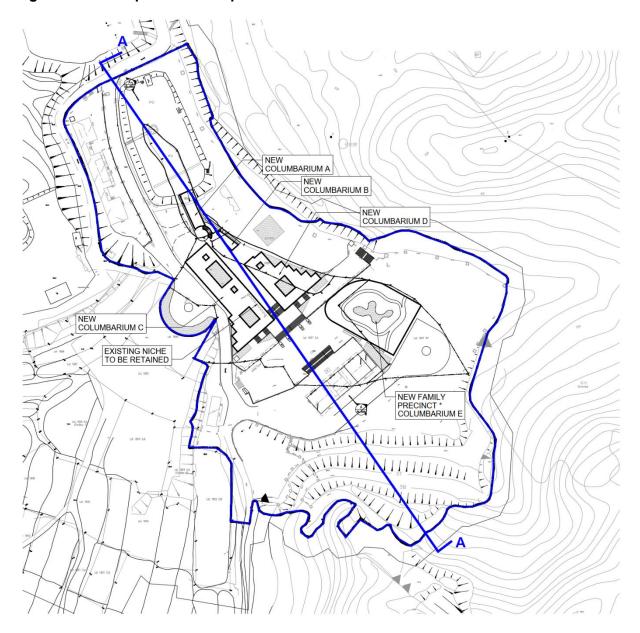
Figure 2.3 Proposed Development Scheme

The proposed layout plan which shown in **Figure 2.3** depicts a columbarium complex, showcasing a thoughtfully organized layout with multiple designated areas. These include four single-storey columbarium blocks labelled A, B, C, and D, as well as a new family precinct zone named Zone E-Family Precinct. An existing niche area is marked for retention, indicating integration of old and new structures.

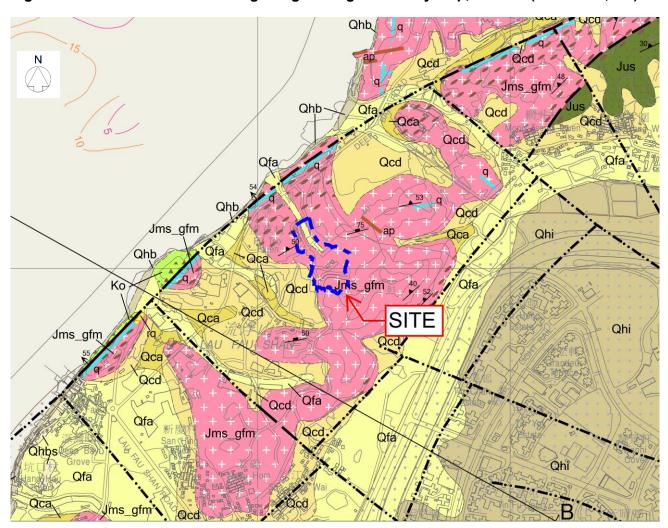
Figure 3.1 Part Plan of The Hong Kong Geological Survey Map, Sheet 2 (scale 1:20,000)

The Hong Kong Geological Survey Map, Sheet 11 (scale 1:20,000) Solid and Superficial Geology of Hong Kong and Kowloon published by the Geotechnical Control Office (GCO, 2012) indicates that the site situated at debris flow deposits (Qpd) and undivided, Clay, slit, sand and gravel well-sorted to semi-sorted Alluvium (Qfa), Slit, sand, gravel and boulders Alluvium (Qca), phyllite, metasiltstone with metasandstone and graphite schist (Mai Po Member), Equi granular to inequigranular fine to medium grained two mica granite (Tsing Shan Granite\_Jms\_gfm). Part Plan of geological map is presented in below and provided in **Figure 3.1**.

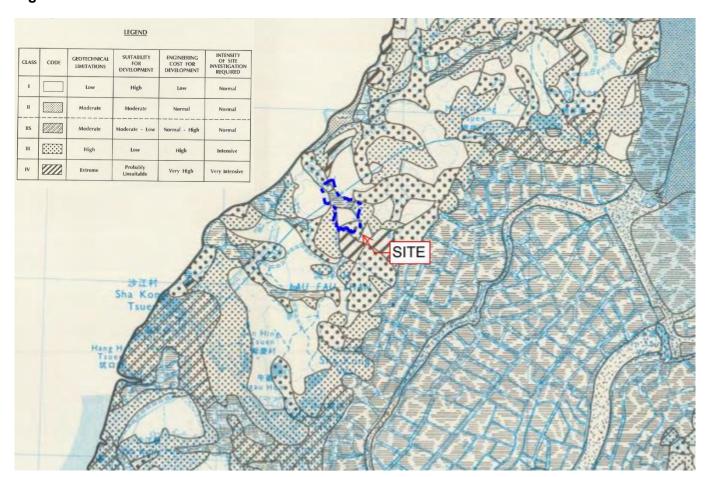
Figure 3.2 Part Plan of the GLUM - North West New Territories

In accordance with the Geotechnical Land Use Map (GLUM) (Ref. No. GASP/20/1/1 2nd Edition) in Geotechnical Area Studies Programme (GASP) Report IV – Hong Kong and Kowloon (1987) issued by CEDD, the terrain in proposed site can be classified as Class I to III. (low to high geotechnical limitations). With reference to cl. 4.1.3 of the report, GLUM Class III terrain is expected to require High geotechnical investigation, and the costs associated with site investigation, site formation, foundation and drainage work will probably be high for the north part of site and lower cost for the south part. Part plan of the relevant GLUM is presented in below and provided in **Figure 3.2**.

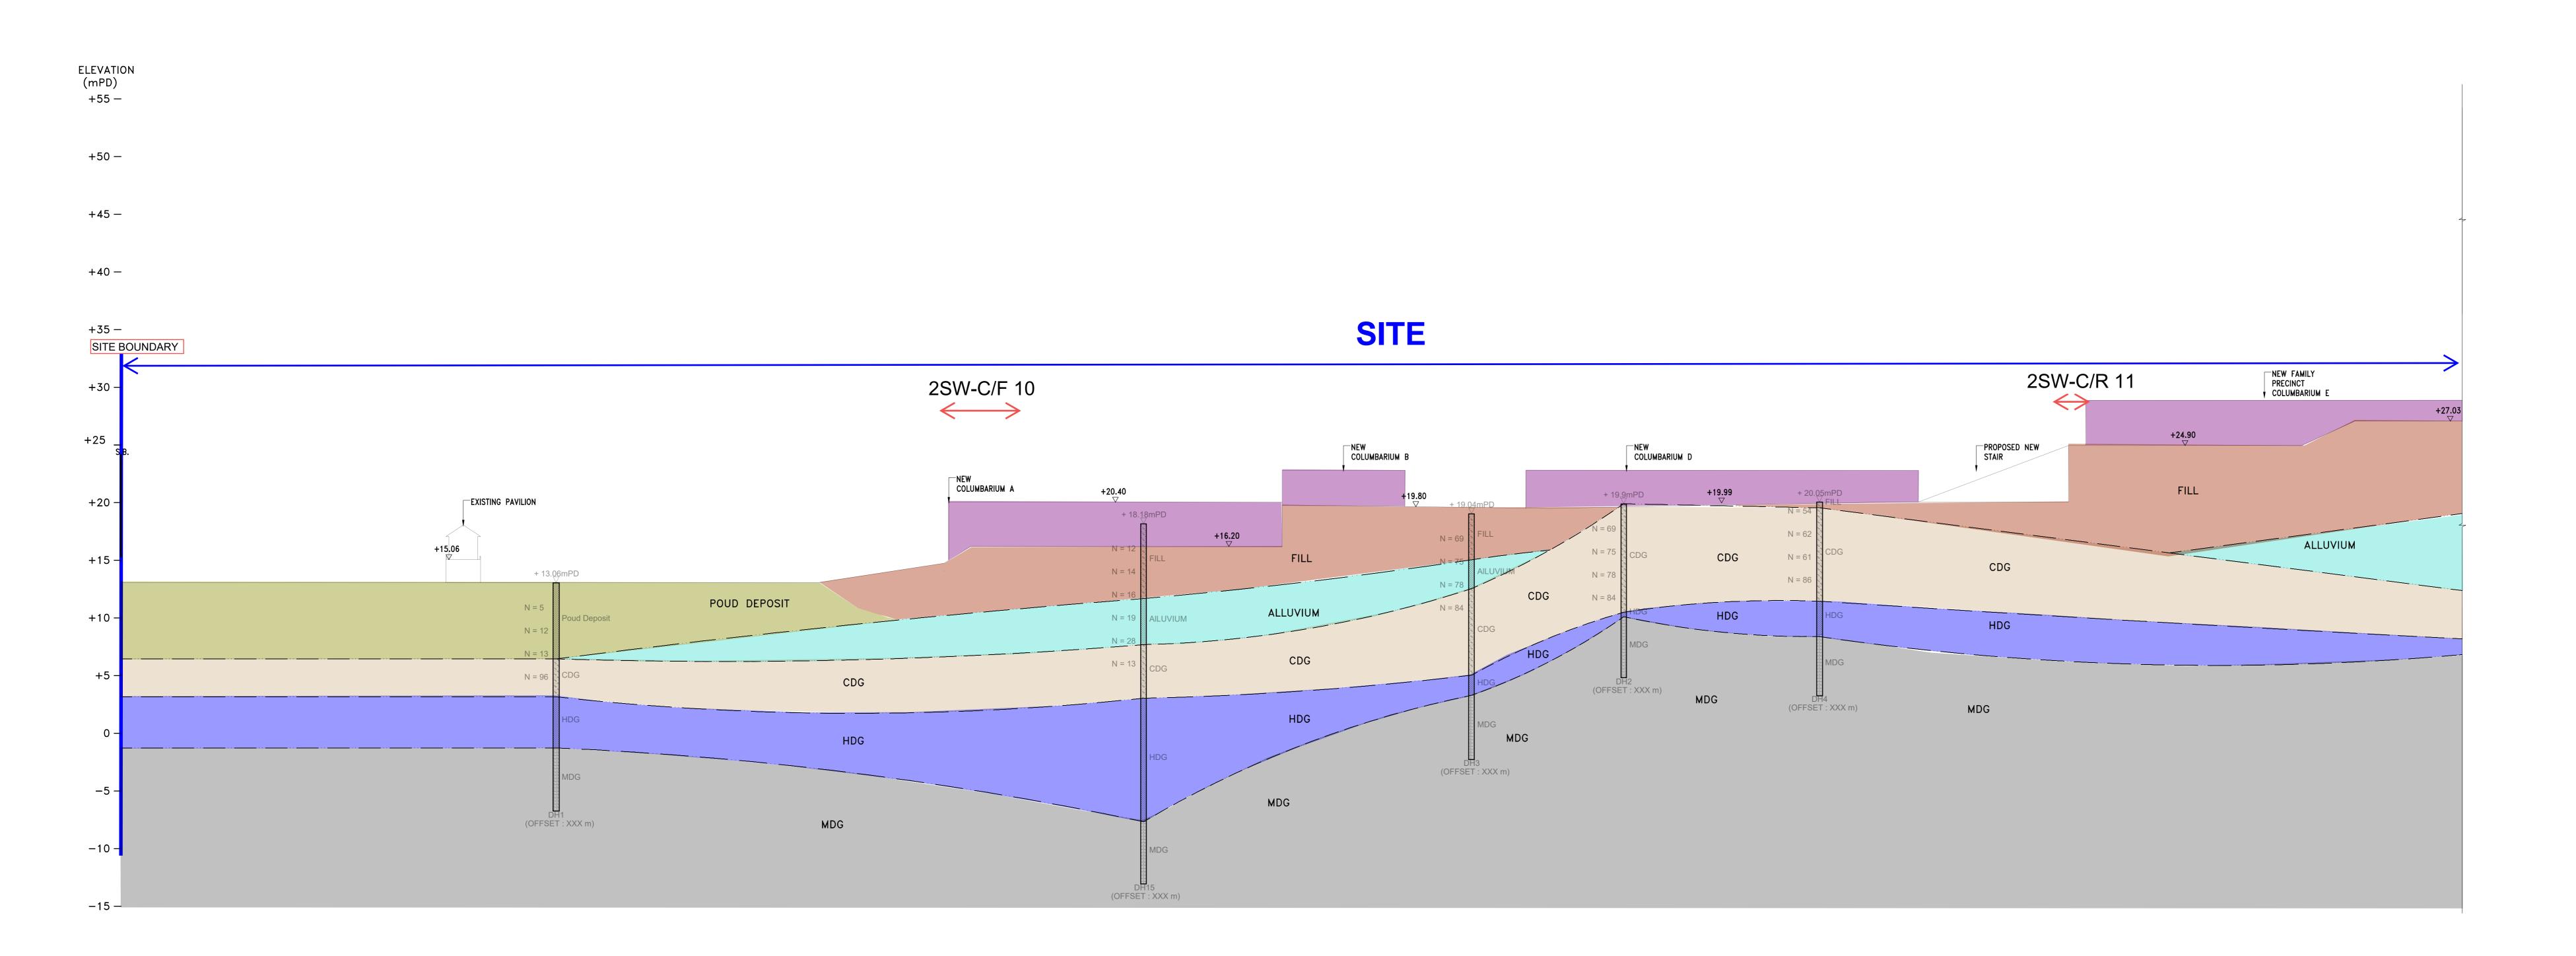
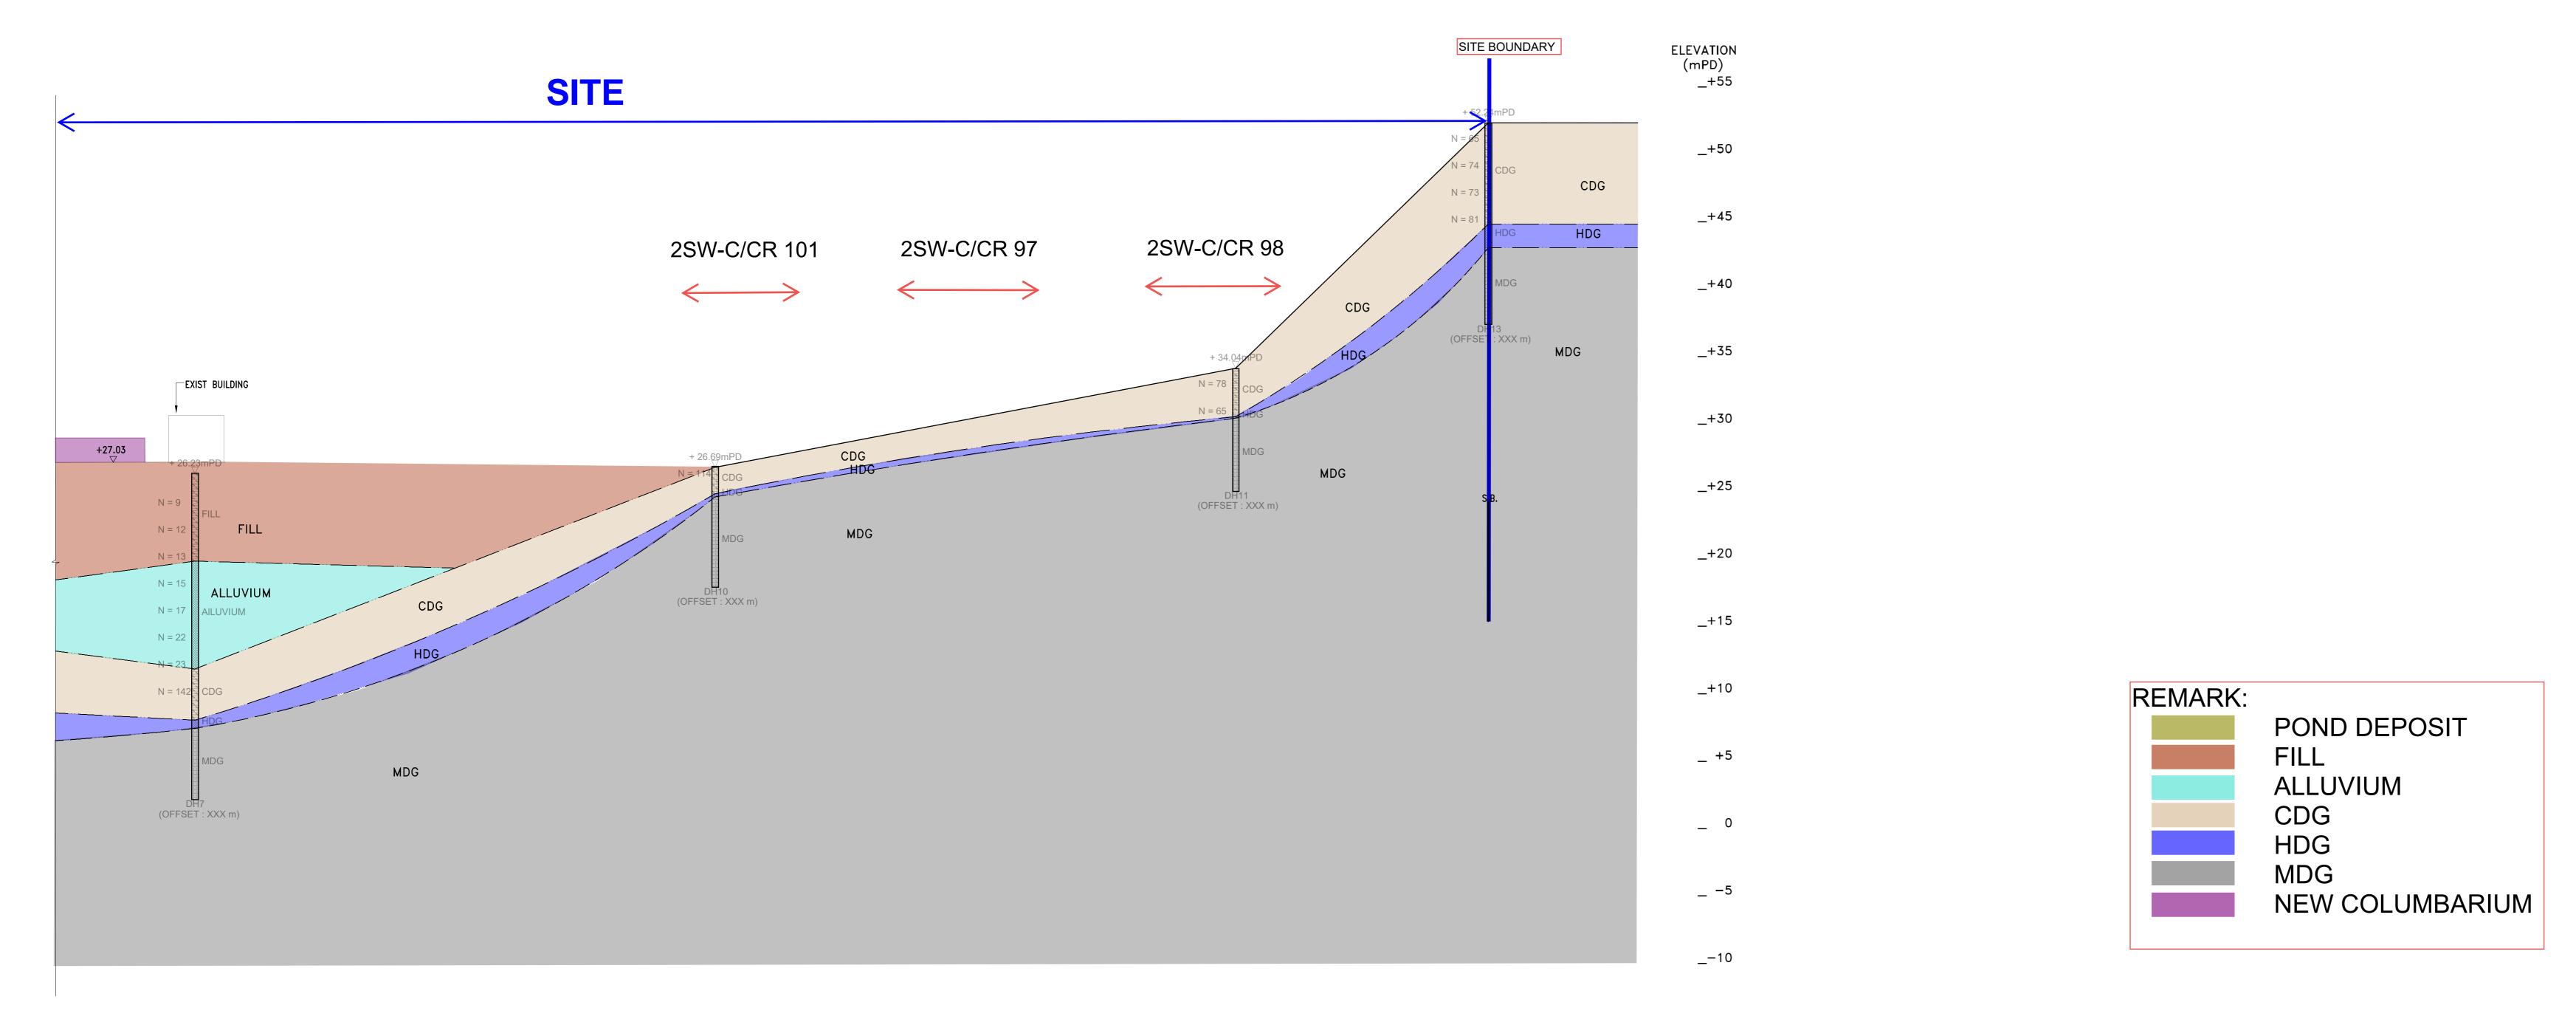
Figure 3.4 Typical Geological Section

Based on the available information, the preliminary typical geological section showing soil / rock profile is shown in **Figure 3.4**. The tentative grade III rockhead level varies from about -7 mPD to +44 mPD.

Previous ground investigation works were carried out by Wai Tat Foundation & Engineering Limited (2007), The Boring Engineering Limited (2011), Vibro (H.K.) Limited (2015), Futher ground investigation works had been carried out by Avance Engineering (HK) Ltd (2023).

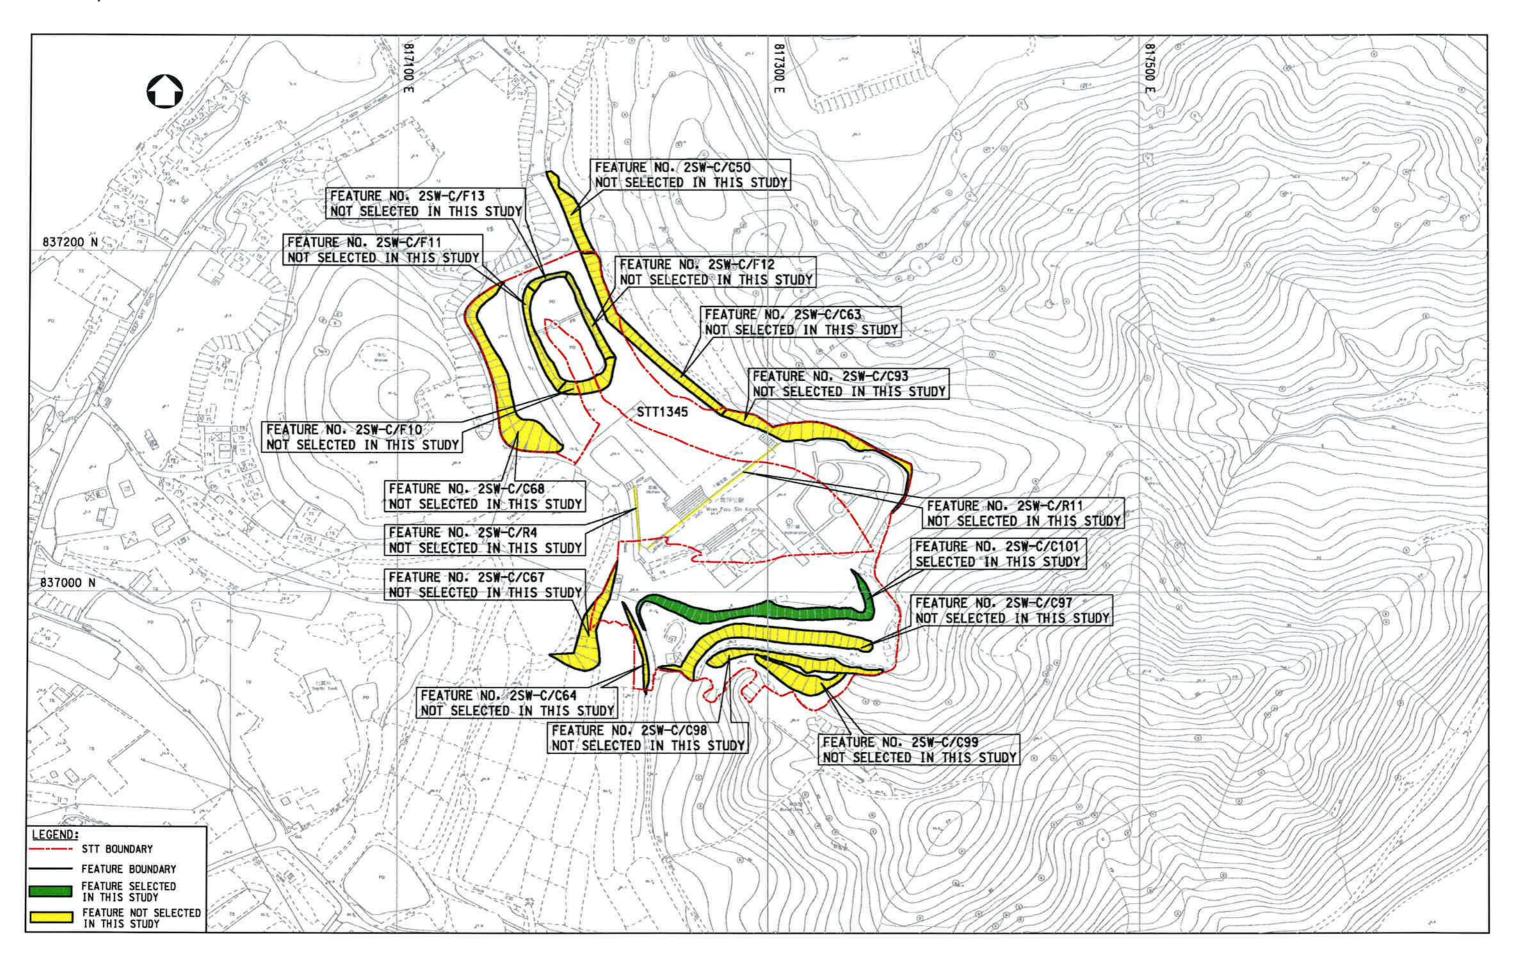
A location plan of the feature is shown below:

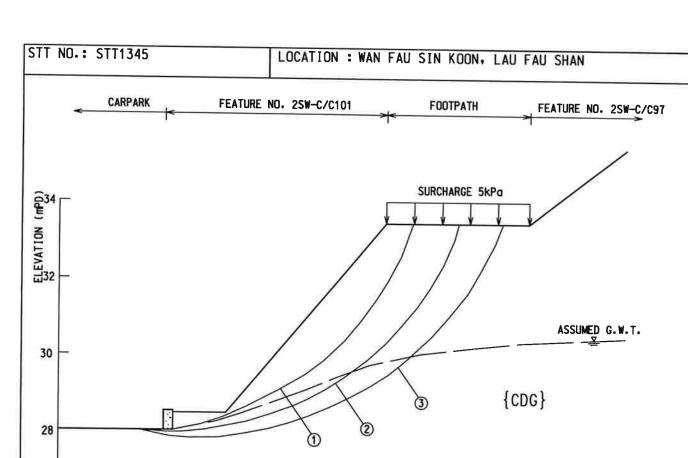
# Scale 1:100 Date JAN. 09 Figure No.

### LEGEND:

① SLIP SURFACE NO. 1 (NO. 1 OF 3)

Figure No.	
1	General Location Plan
2	Location Plan of Section
3	Geological Profile and Stability Analysis of Section 1-1
4	Action To Be Taken

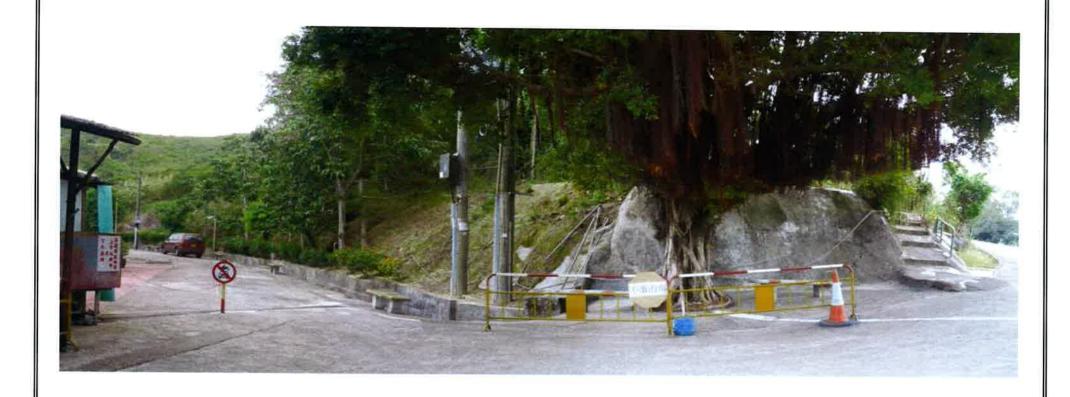
SIDE VIEW OF THE WESTERN PORTION OF THE FEATURE (PHOTO TAKEN IN DECEMBER 2008)

At the time of inspection in December 2008, the study feature was a 160m long cut slope and it was generally facing north. The maximum height of the slope was about 5.5m and the average slope angle was about 50°. The feature was mainly covered with vegetation exc(Plates 1 & 2). There was a 0.5m high concrete retaining wall located at the toe of the western portion of the feature. A 300mm U-channel was running along the toe of the wall. There were water mains running along the slope crest and across the slope with no signs of leakage observed. An open car park and a horticulture garden were located in front of the western and eastern portion of the feature respectively. There was a footpath located at the crest of the western portion of the feature (Plate 3) whereas a densely vegetated open area was located at the crest of the eastern portion of the feature. No signs of seepage or distress were noted during site inspection.

Plate No.	
PH/01	Direction of Plates
1	Side View of the Western Portion of the Feature (Photo Taken in December 2008)
2	General View of the Eastern Portion of the Feature (Photo Taken in December 2008)
3	Crest View of the Western Portion of the Feature (Photo Taken in December 2008)
4	Side View of the Western Portion of the Feature (Photo Taken in February 2012)
5	General View of the Western End Portion of the Feature (Photo Taken in February 2012)

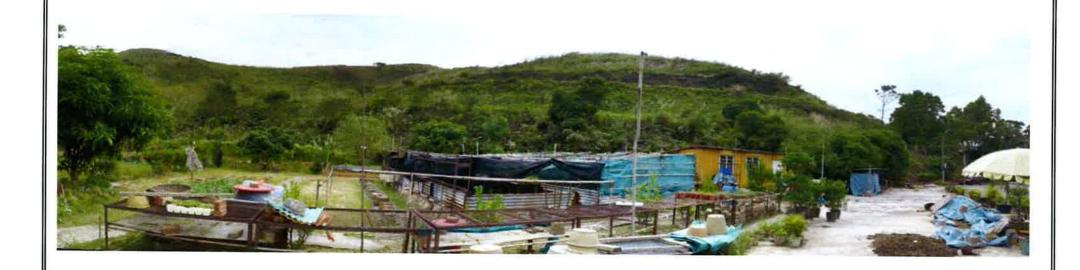
GENERAL VIEW OF THE EASTERN PORTION OF THE FEATURE (PHOTO TAKEN IN DECEMBER 2008)

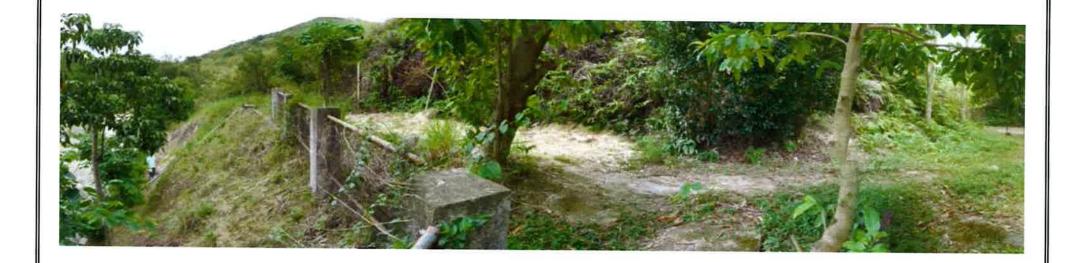
CREST VIEW OF THE WESTERN PORTION OF THE FEATURE (PHOTO TAKEN IN DECEMBER 2008)

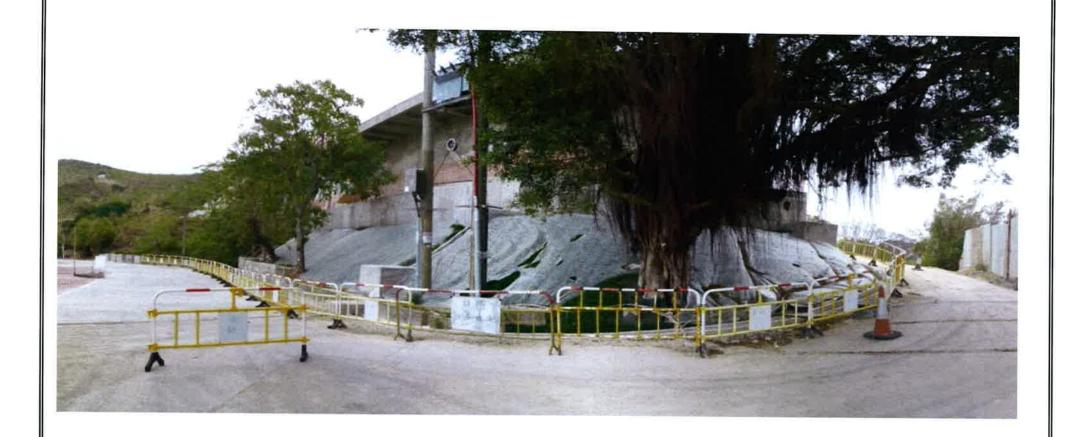
SIDE VIEW OF THE WESTERN PORTION OF THE FEATURE (PHOTO TAKEN IN FEBRUARY 2012)

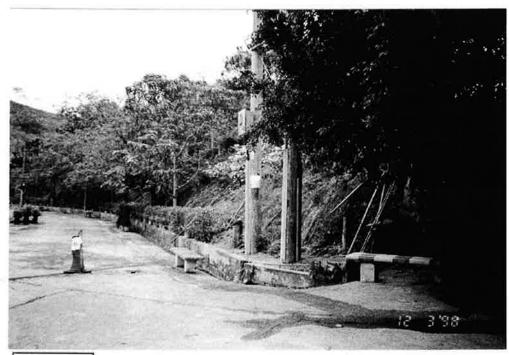
F20

2SW-C/C 101

GENERAL VIEW

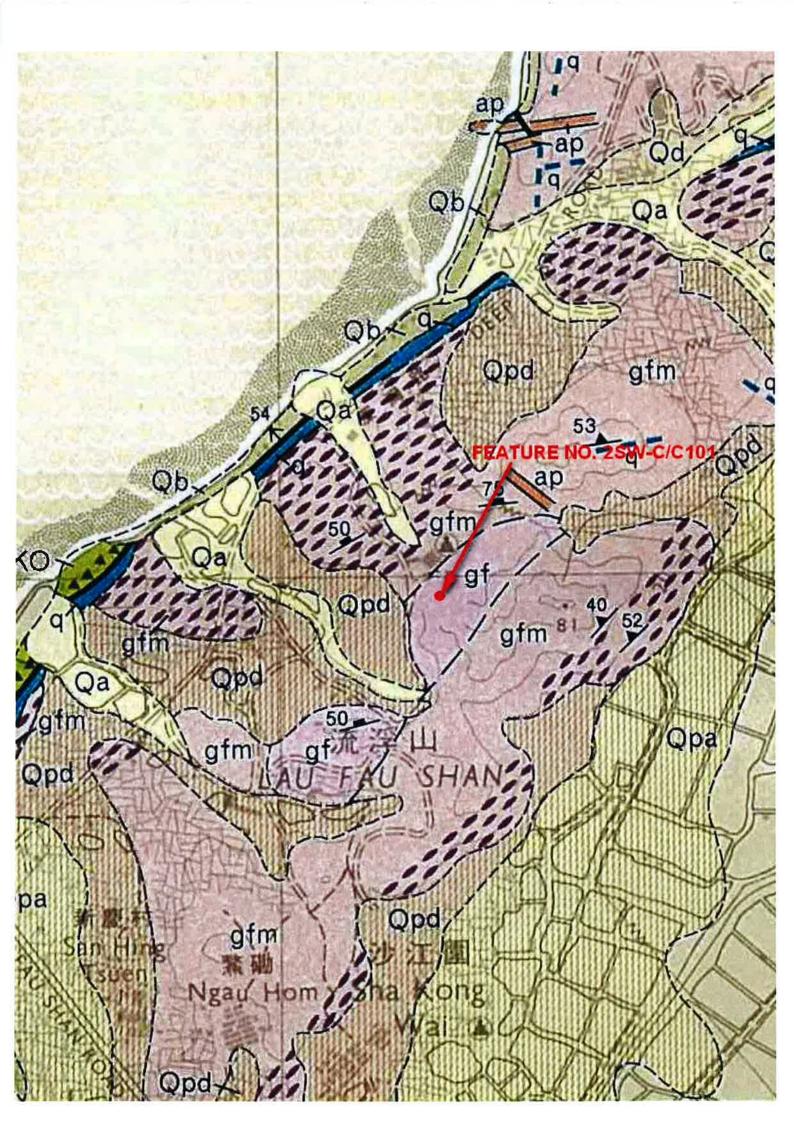
PART PRINT OF 1:20 000 GEOLOGICAL MAP OF HONG KONG SHEET NO. 2

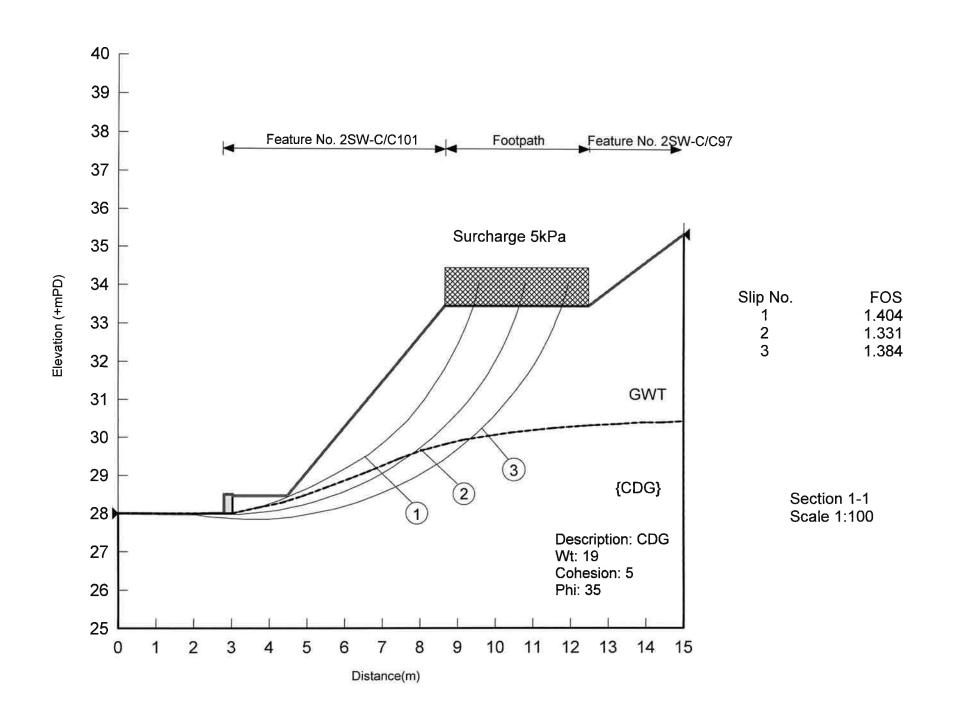
#### Section 1-1.fac

# APPENDIX H STABILITY ANALYSIS OF SECTION 1-1

DATESTAMP 1/7/2009 TIMESTAMP 9:44:00 AM 3=METHOD 3=NO. OF SLIP SURFACES 1=NO. OF RADII 2=SIDE FUNCTION TYPE -734.5000=X-COOR. 556.0000=Y-COOR. COMPUTED AXIS SLIP X-**ITERATION FACTOR OF SAFETY** NO. COORD. COORD. **RADIUS** NO. LAMBDA (MOMENT) (FORCE) 1 -734.500556.000 907.227 0.0000 1.3139058 1.5704787 907.227 907.227 1 -734.500 556.000 6 0.0000 1.3666962 1.3628470 -734.500 556.000 1 3 -0.25001.4041532 1.4069983 2 -734.500 556.000 907.558 1 0.0000 1.4209506 1.2206115 2 2 3 -734.500 556.000 907.558 0.0000 1.2979275 1.2943115 907.558 907.919 907.919 -734.500 556.000 3 1.3314194 1.3332040 -0.25001.2436726 -734.500 1.4492883 556.000 1 0.0000 3 -734.500 556.000 4 0.0000 1.3483138 1.3414110 -734.500 556.000 907.919 1.3842808 1.3855355 -0.2500| SUMMARY OF MINIMUM FACTORS OF SAFETY | MOMENT EQUILIBRIUM: FELLENIUS OR ORDINARY METHOD -734.5000=X-COOR. 556.0000=Y-COOR. 907.5578=RADIUS 1.2206115=F.S. 2=SLIP# MOMENT EQUILIBRIUM: BISHOP SIMPLIFIED METHOD -734.5000=x-COOR. 556.0000=Y-COOR. 907.5578=RADIUS 1.2979275=F.S. 2=SLIP# FORCE EQUILIBRIUM: JANBU SIMPLIFIED METHOD (NO fo FACTOR) -734.5000=X-COOR. 556.0000 = Y - COOR. 907.5578=RADIUS 1.2943115=F.S. 2=SLIP# MOMENT AND FORCE EQUILIBRIUM: MORGENSTERN-PRICE METHOD -734.5000=x-coor. 556.0000=Y-COOR. 907.5578=RADIUS 1.3314194=F.S. 2=SLIP# NORMAL TERMINATION OF SLOPE MOST\_CRITICAL # SLIP\_SURFACE # \_\_\_\_\_\_ SLIP\_SURFACE # **AUTOTENSIONELEV**

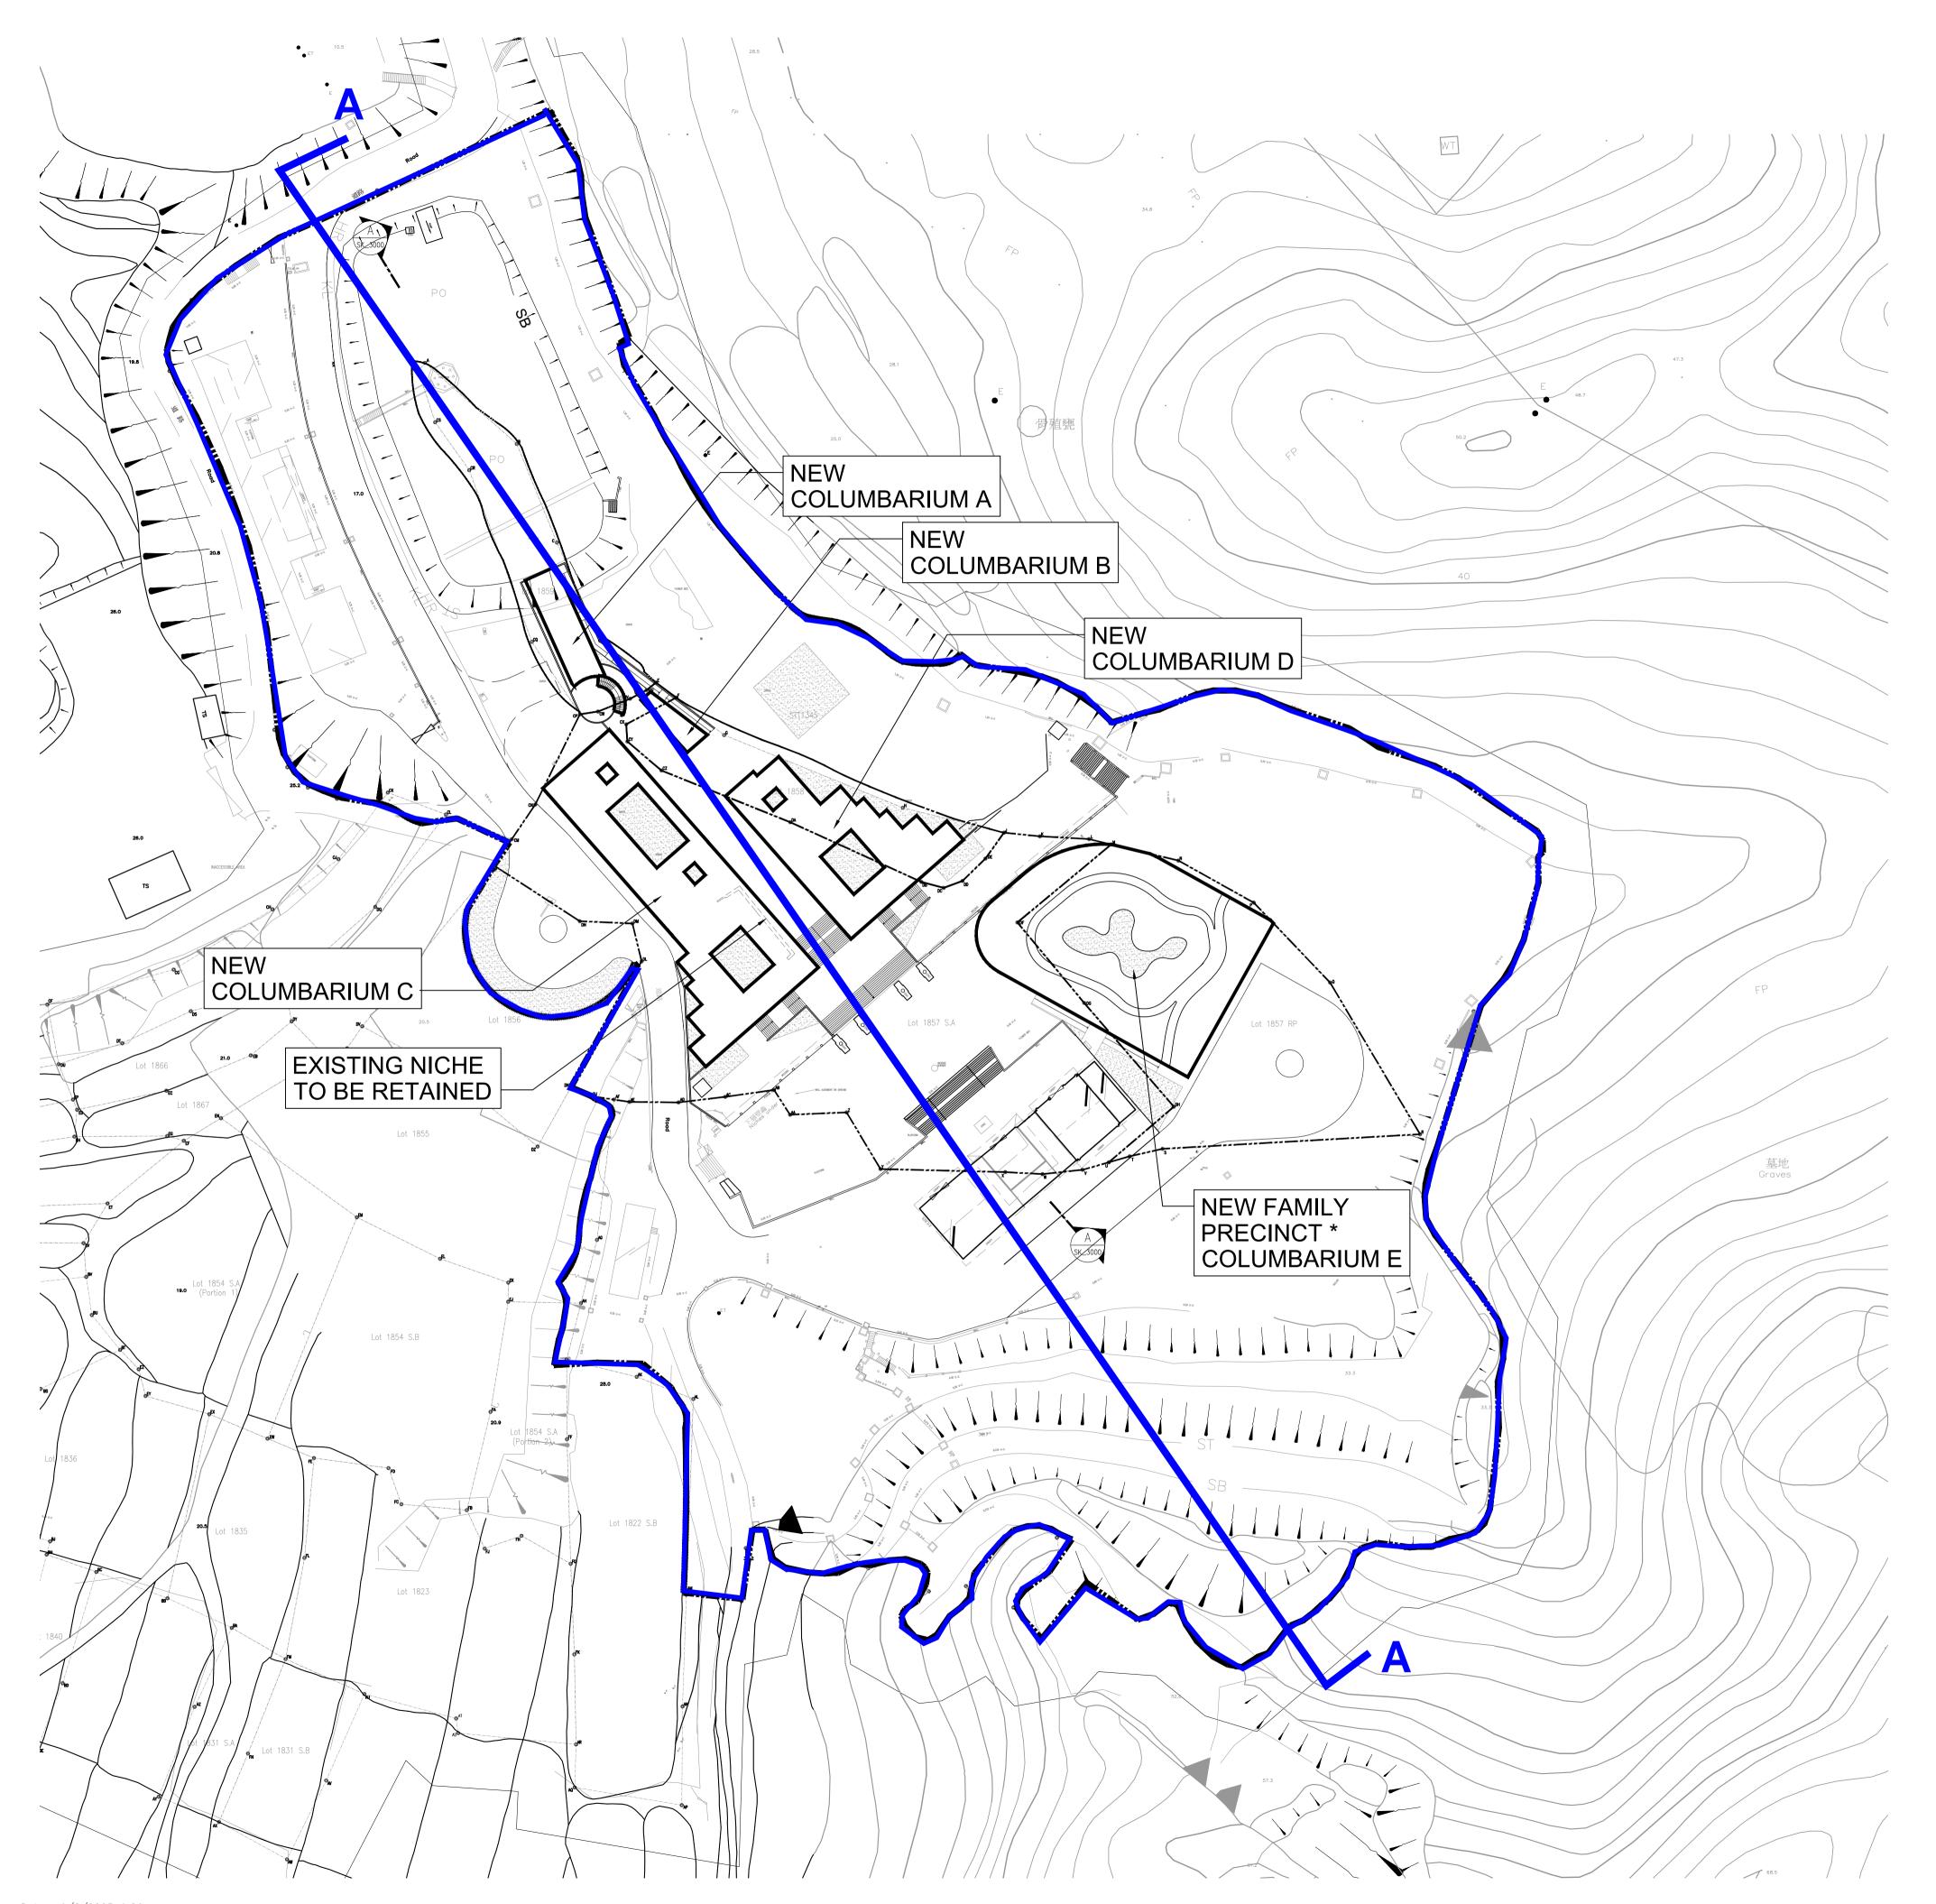
MASTER LAYOUT PLAN Aed 1:600@A1 +

NICHE CALCULATION:

NEW COLUMBARIUM A (QUAD) = 84 No.s

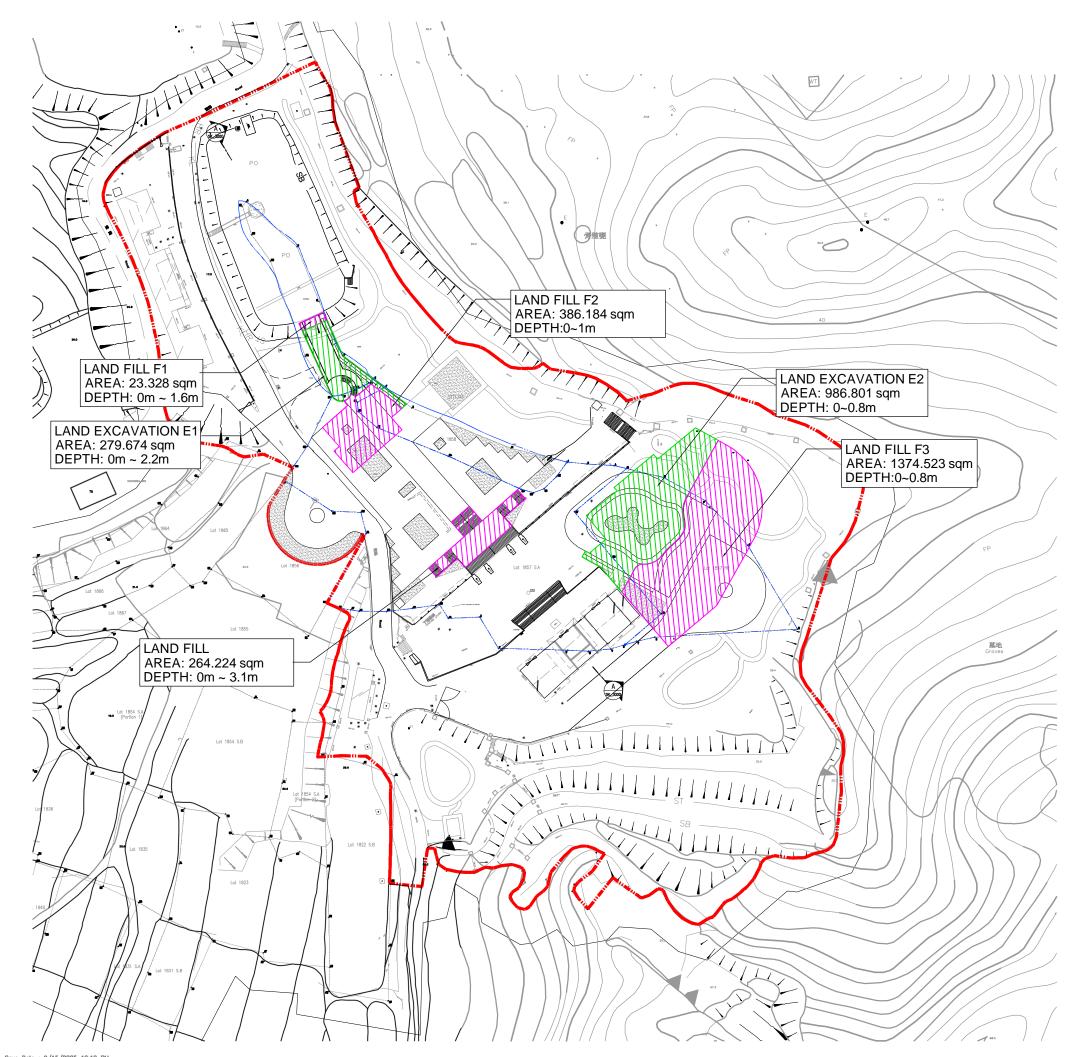
LAND FILL AREA

LAND EXCAVATION AREA

Assume the land fill and excavate depth is measured to site formation level, instead of foundation bottom level
