GEOTECHNICAL PLANNING REVIEW REPORT (GPRR)

**TEMPORARY WAREHOUSES (EXCLUDING DANGEROUS
GOODS) FOR A PERIOD OF 3 YEARS**

**LOTS NOS. 1684 (PART), 1685 (PART) AND 1686 (PART)
IN D.D. 129, LAU FAU SHAN, YUEN LONG, NEW TERRITORIES**

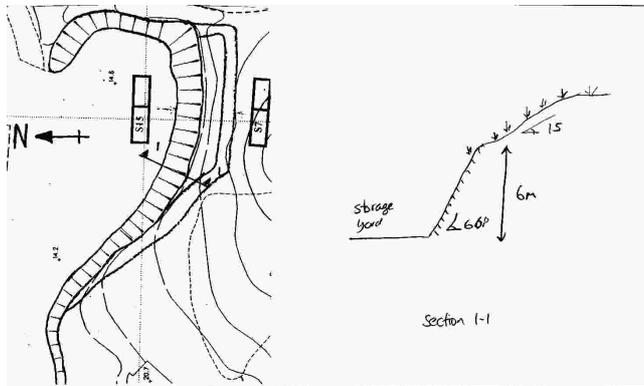
Section No: 1-1
 Height (m): N/A
 Type of Toe Facility: Non-dangerous goods storage site
 Distance from Toe (m): 0
 Type of Crest Facility: Undeveloped green belt
 Distance from Crest (m): 0
 Consequence Category: 3
 Engineering Judgement: P
 Section No: 2-2
 Type of Toe Facility: N/A
 Distance from Toe (m): 0
 Type of Crest Facility: N/A
 Distance from Crest (m): 0
 Consequence Category: 3
 Engineering Judgement: P
 Sign of Seepage: Slope : No signs of seepage
 Wall : N/A
 Criterion A satisfied: N
 Sign of Distress: Slope : Reasonable (near crest)
 Wall : N/A
 Criterion D satisfied: N
 Non-routine maintenance required: N

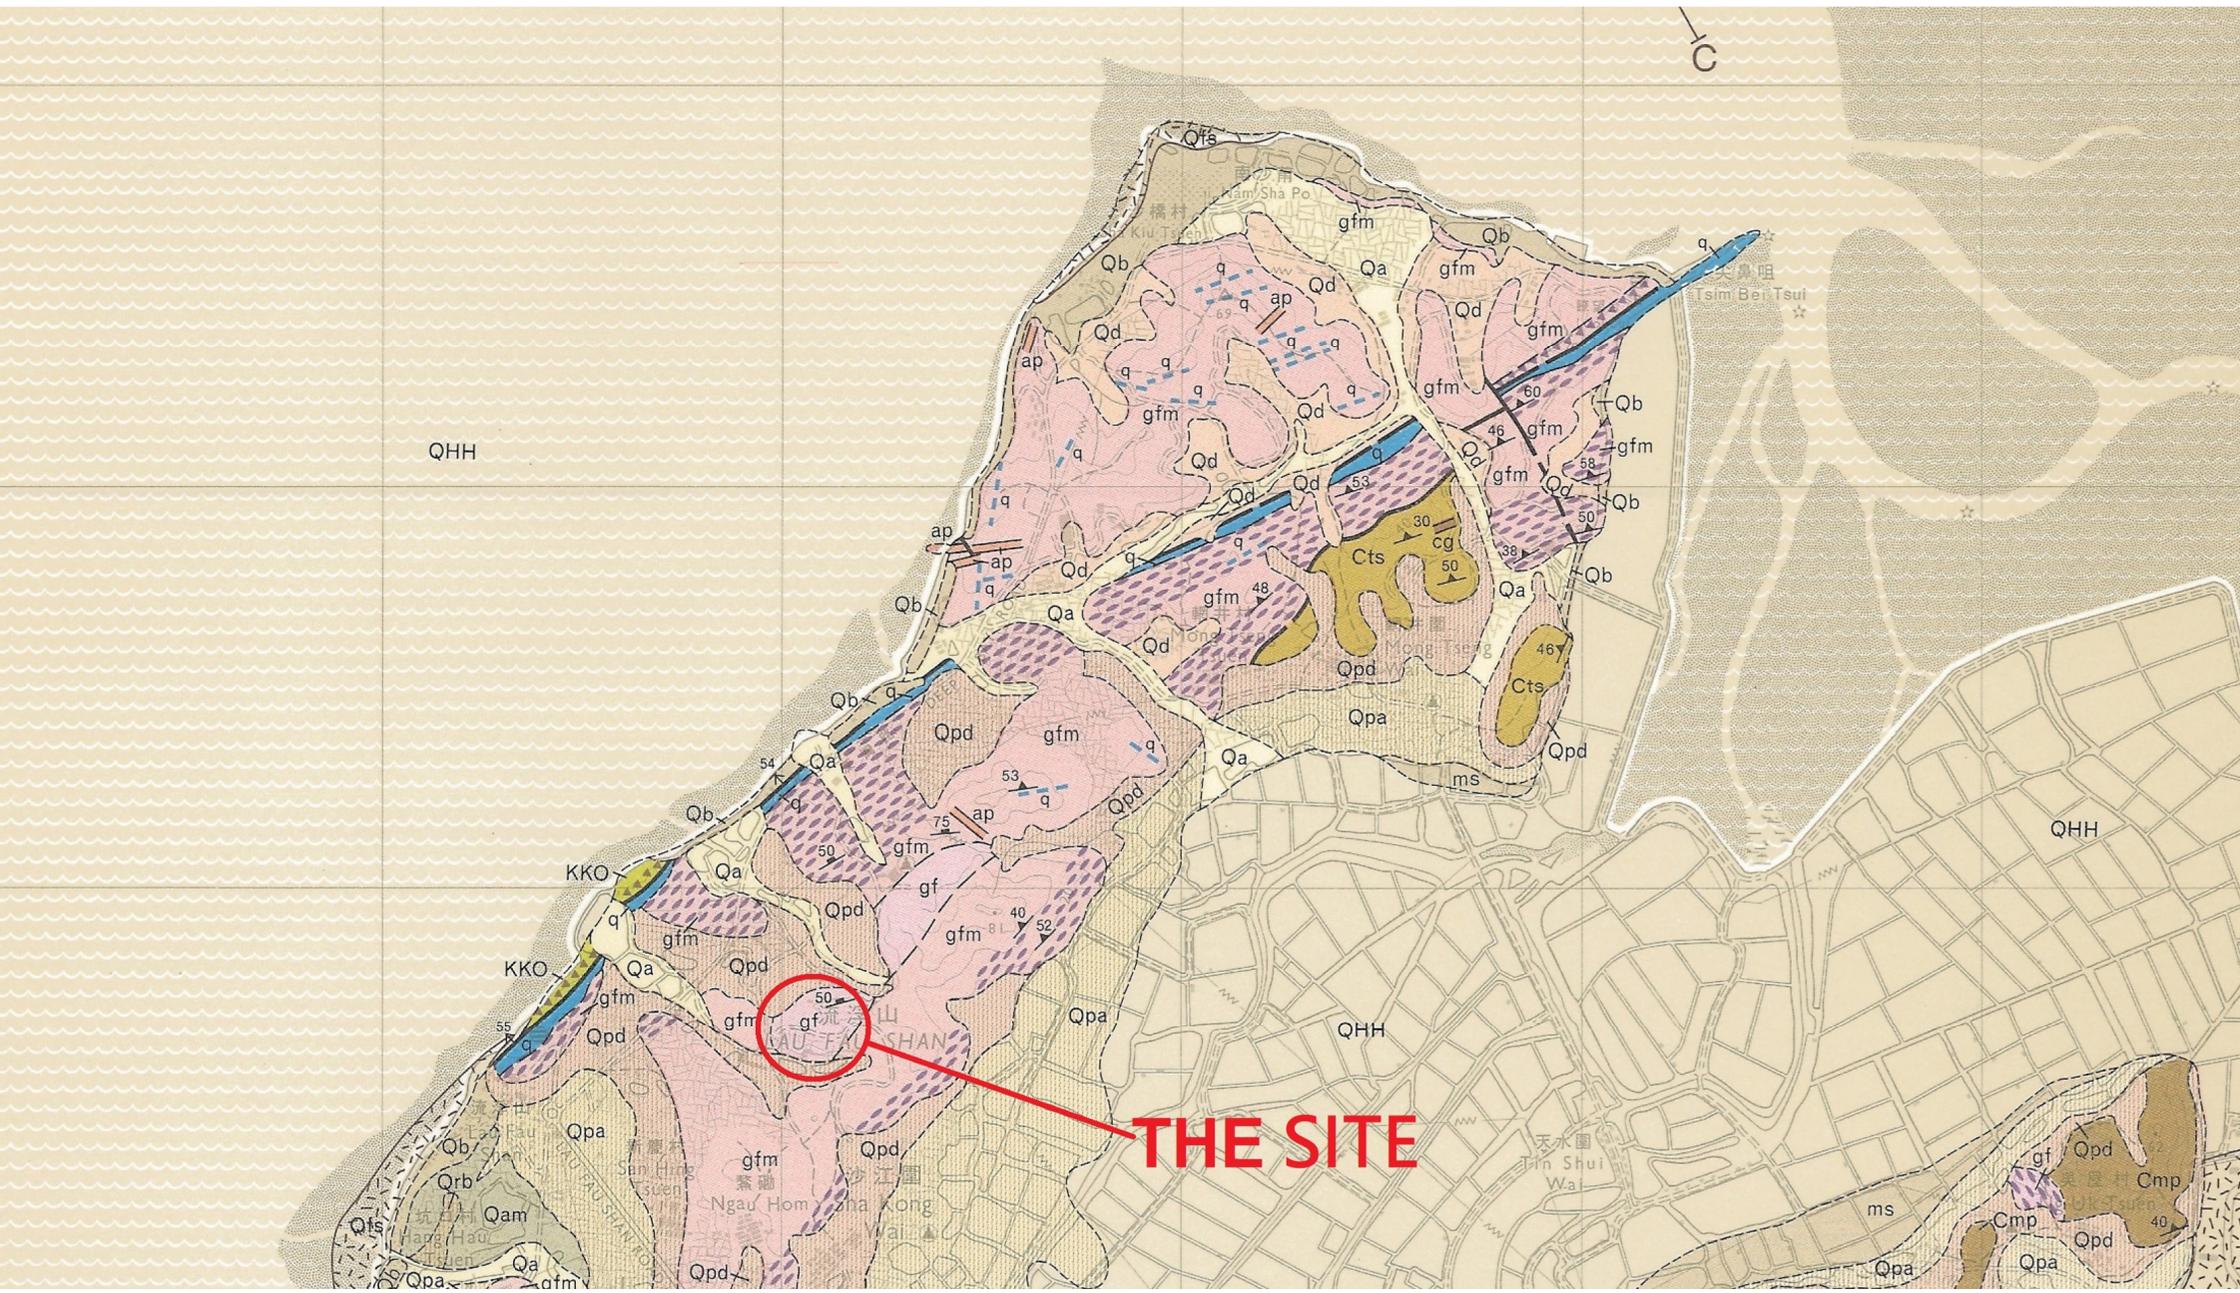
THE SITE

MAJOR INTRUSIVE IGNEOUS ROCKS 主要侵入火成岩

侏羅-白堊紀 JURASSIC-CRETACEOUS	Megacrystic 具大斑晶的		gf	細粒花崗岩, 0.06 - 2 毫米 Fine-grained granite, 0.06-2mm
			gfm	中細粒花崗岩 Fine- to medium-grained granite

APPENDIX C GEOLOGICAL MAP

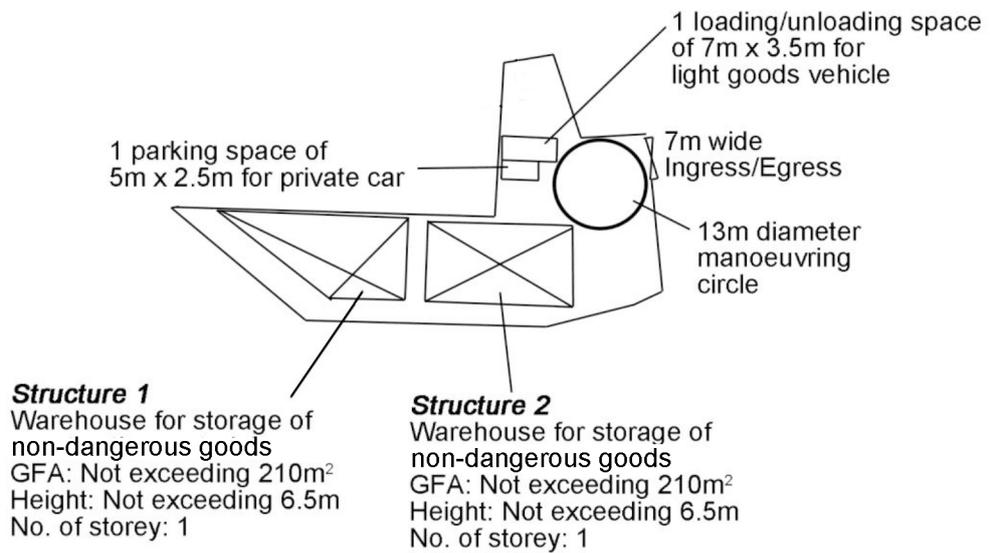
PROPOSED LAYOUT PLAN

Project 項目名稱: Temporary Warehouse (Excluding Dangerous Goods) for a Period of 3 Years at Lots 1684 (Part), 1685 (Part) & 1686 (Part) in D.D. 129, Lau Fau Shan, Yuen Long, N.T.	Drawing Title 圖目: Proposed Layout Plan	Remarks 備註:
	Drawing No. 圖號:	Scale 比例: 1:1000

The proposed planning application has 2 nos. of single storey structures which included 2 nos. of single storey of warehouse for storage of non-dangerous goods at the toe level of Feature No. 2SW-C/C117. No excavation lateral support, foundation and site formation works will be carried out. The proposed layout plan is enclosed in Appendix E.
