**PROJECT NO. P2590**

**GEOTECHNICAL PLANNING REVIEW REPORT (GPRR)  
FOR  
PROPOSED RELIGIOUS INSTITUTION (THE SUPREME KWAN TI TEMPLE)  
AND THE ASSOCIATED EXISTING ACCESS ROAD AND IMPROVEMENTS  
TO THE TAI TONG KWAN TI SQUARE  
AT  
TAI TONG, YUEN LONG**

**GREG WONG & ASSOCIATES LTD.**

| <b>Report No. :</b> | <b>P2590G001</b> |

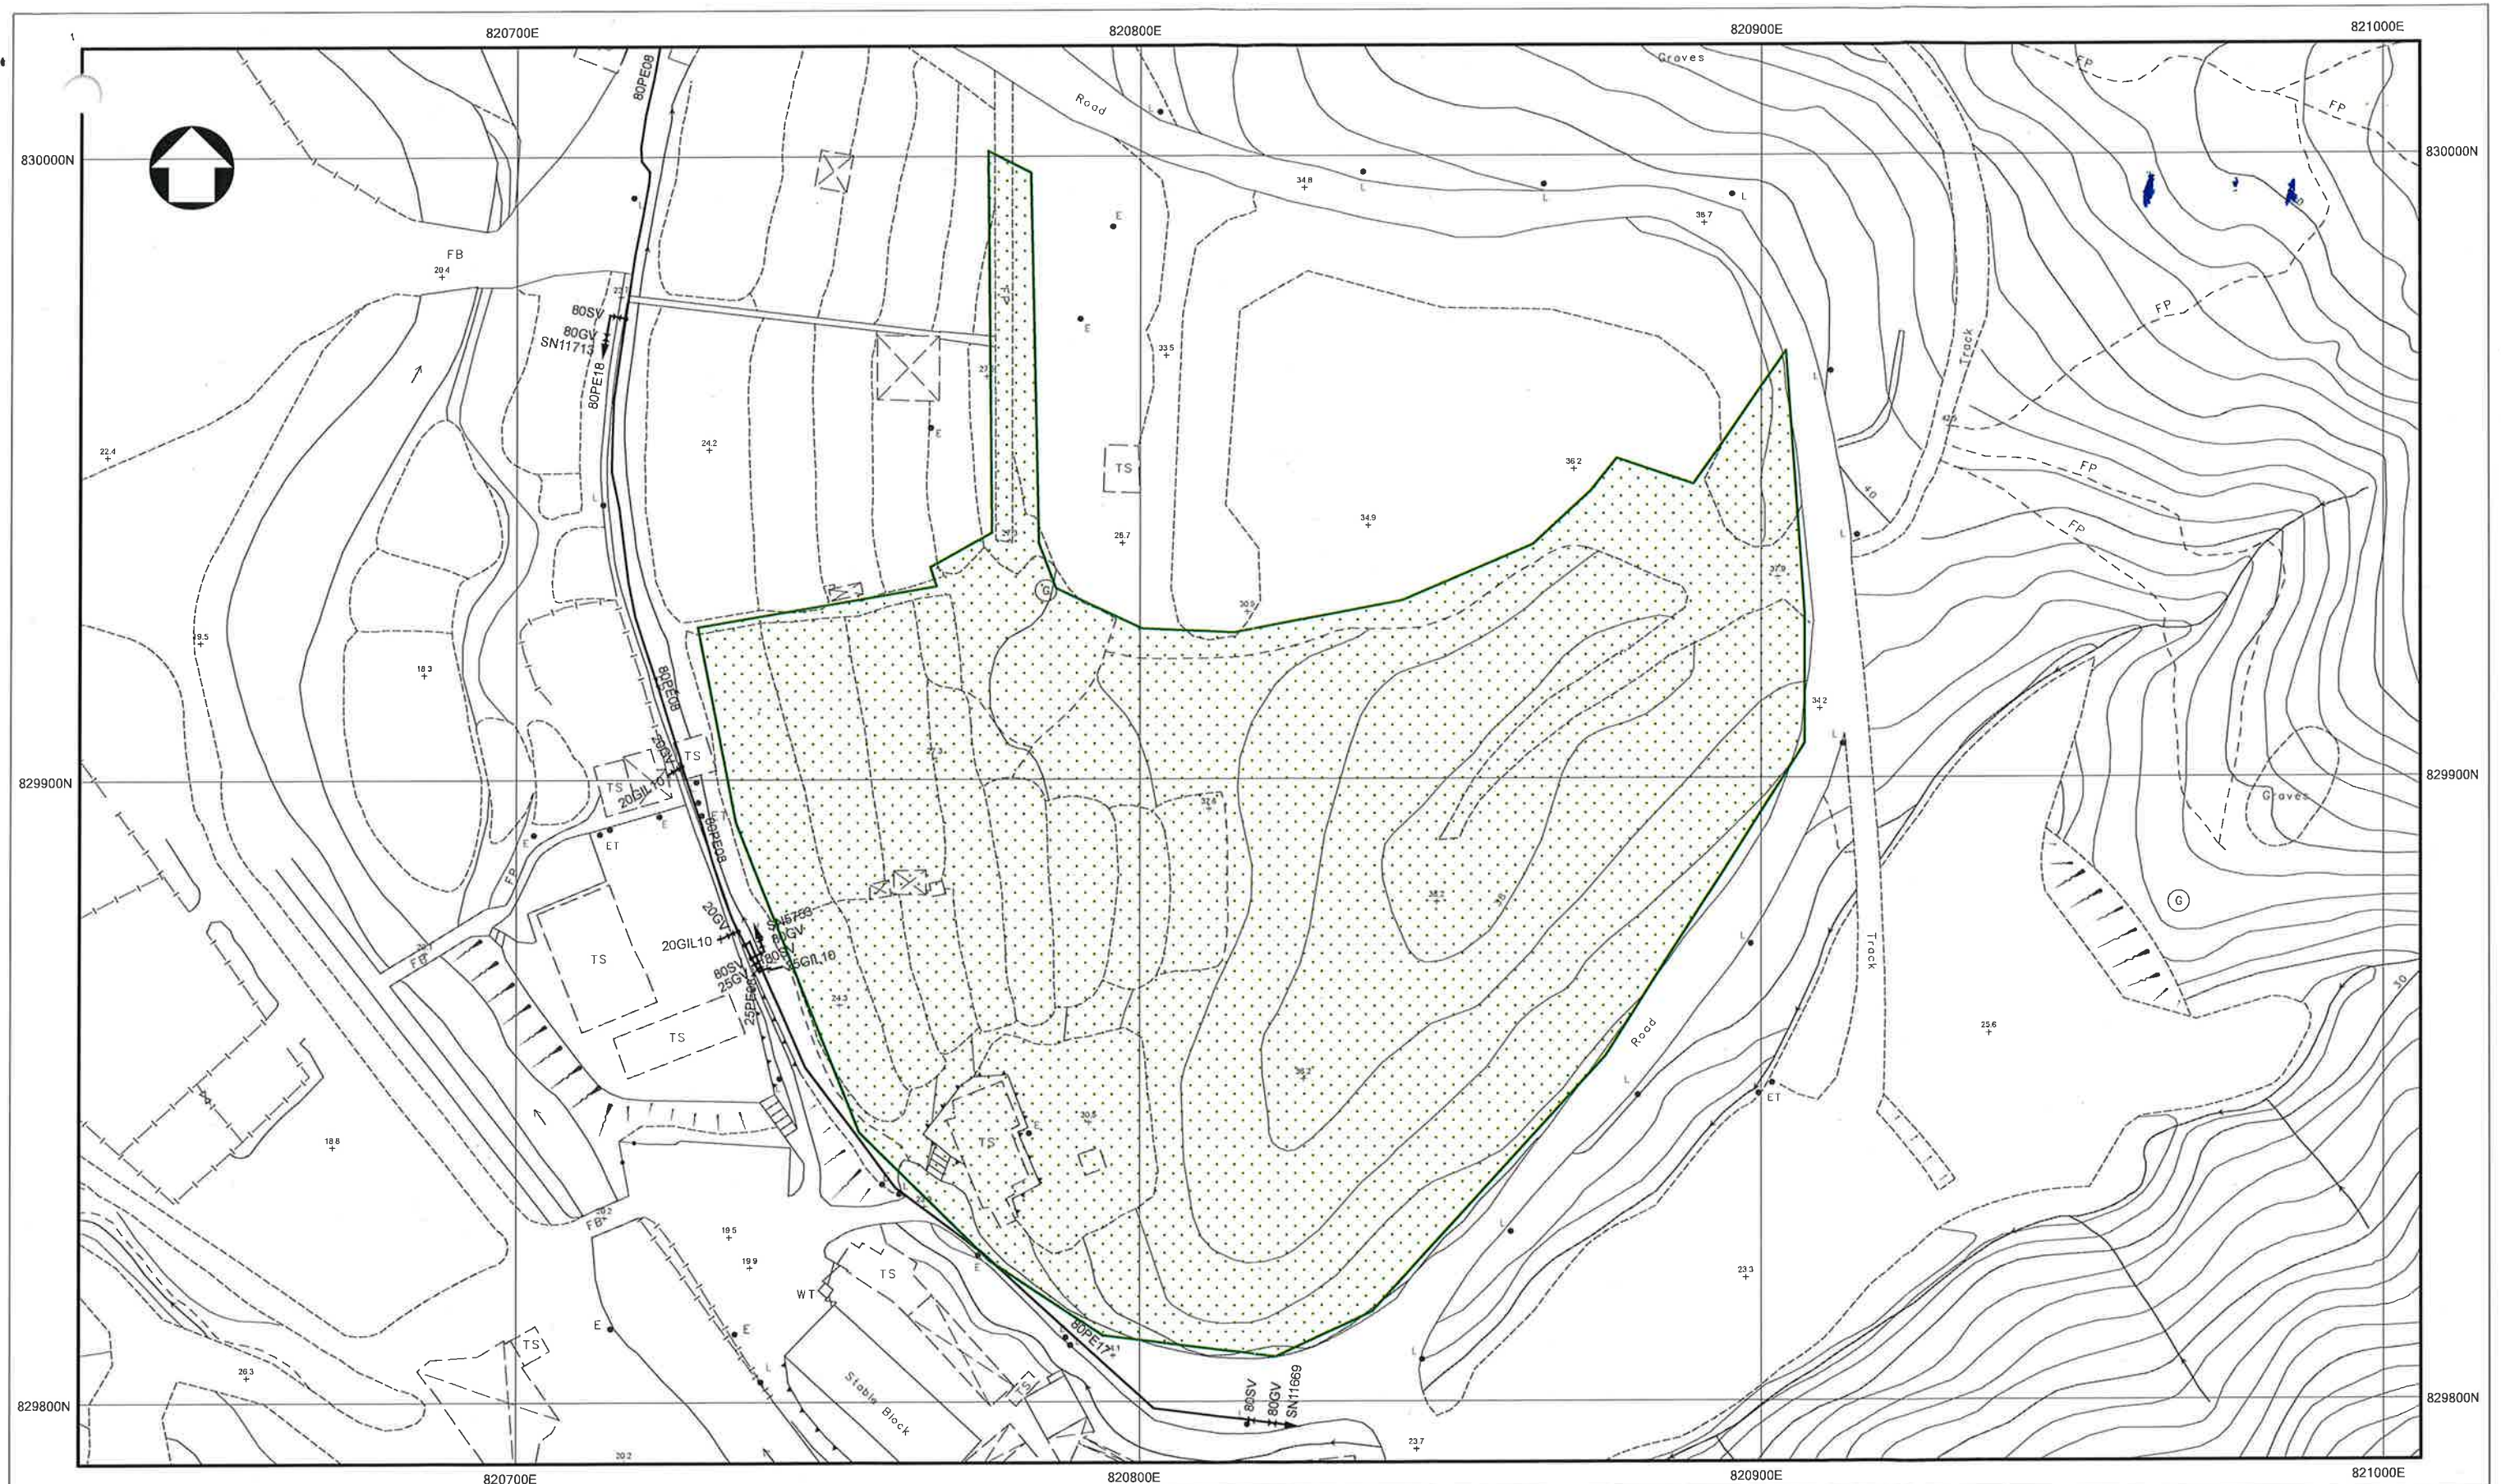
- NOTES:
1. ALL DIMENSIONS ARE IN MILLIMETRES UNLESS OTHERWISE SPECIFIED.
  2. ALL LEVELS ARE IN METRES ABOVE PRINCIPAL DATUM.
  3. INFORMATION ON ALIGNMENT OF MAINS IS OF INDICATIVE VALUE ONLY. WHERE POSITIONAL ACCURACY MAY BE OF IMPORTANCE, DETAILS SHOULD BE SITE CHECKED.
  4. FOR MAINS RECORDS SIGN CONVENTIONS AND DESIGNATIONS SEE SKETCH NO. 3988.
  5. NO EXISTING SALT WATER MAINS IN THE VICINITY OF THE SITE.
  6. NO PROPOSED WATER MAINS IN THE VICINITY OF THE SITE.
  7. NO EXISTING WSD CABLE IN THE VICINITY OF THE SITE.
  8. NO PROPOSED WSD CABLE IN THE VICINITY OF THE SITE.
  9. THE SITE IS NOT WITHIN WSD GATHERING GROUNDS.
  10. NO WSD LAND ALLOCATION / WWR WITHIN THE SITE AREA.
  11. NO WSD SLOPES ARE AFFECTED IN THE VICINITY OF THE SITE.
  12. NO ASBESTOS CEMENT / UNKNOWN MATERIALS MAINS ON THE VICINITY OF THE SITE.
  13. NO CATHODIC PROTECTION MAINS ON THE VICINITY OF THE SITE.

The exact lines and levels of the water mains as well as the materials that the water mains are made of should be established by hand dug trial holes on site if they are of significance to your works. You should instruct your consultants and/or contractors (as the case may be) to take all necessary measures during the design and/or construction stages (as the case may be) to avoid causing damage to the water mains and waterworks installations, for which you will be held responsible. A list of conditions for working in the vicinity of waterworks installations is also attached.

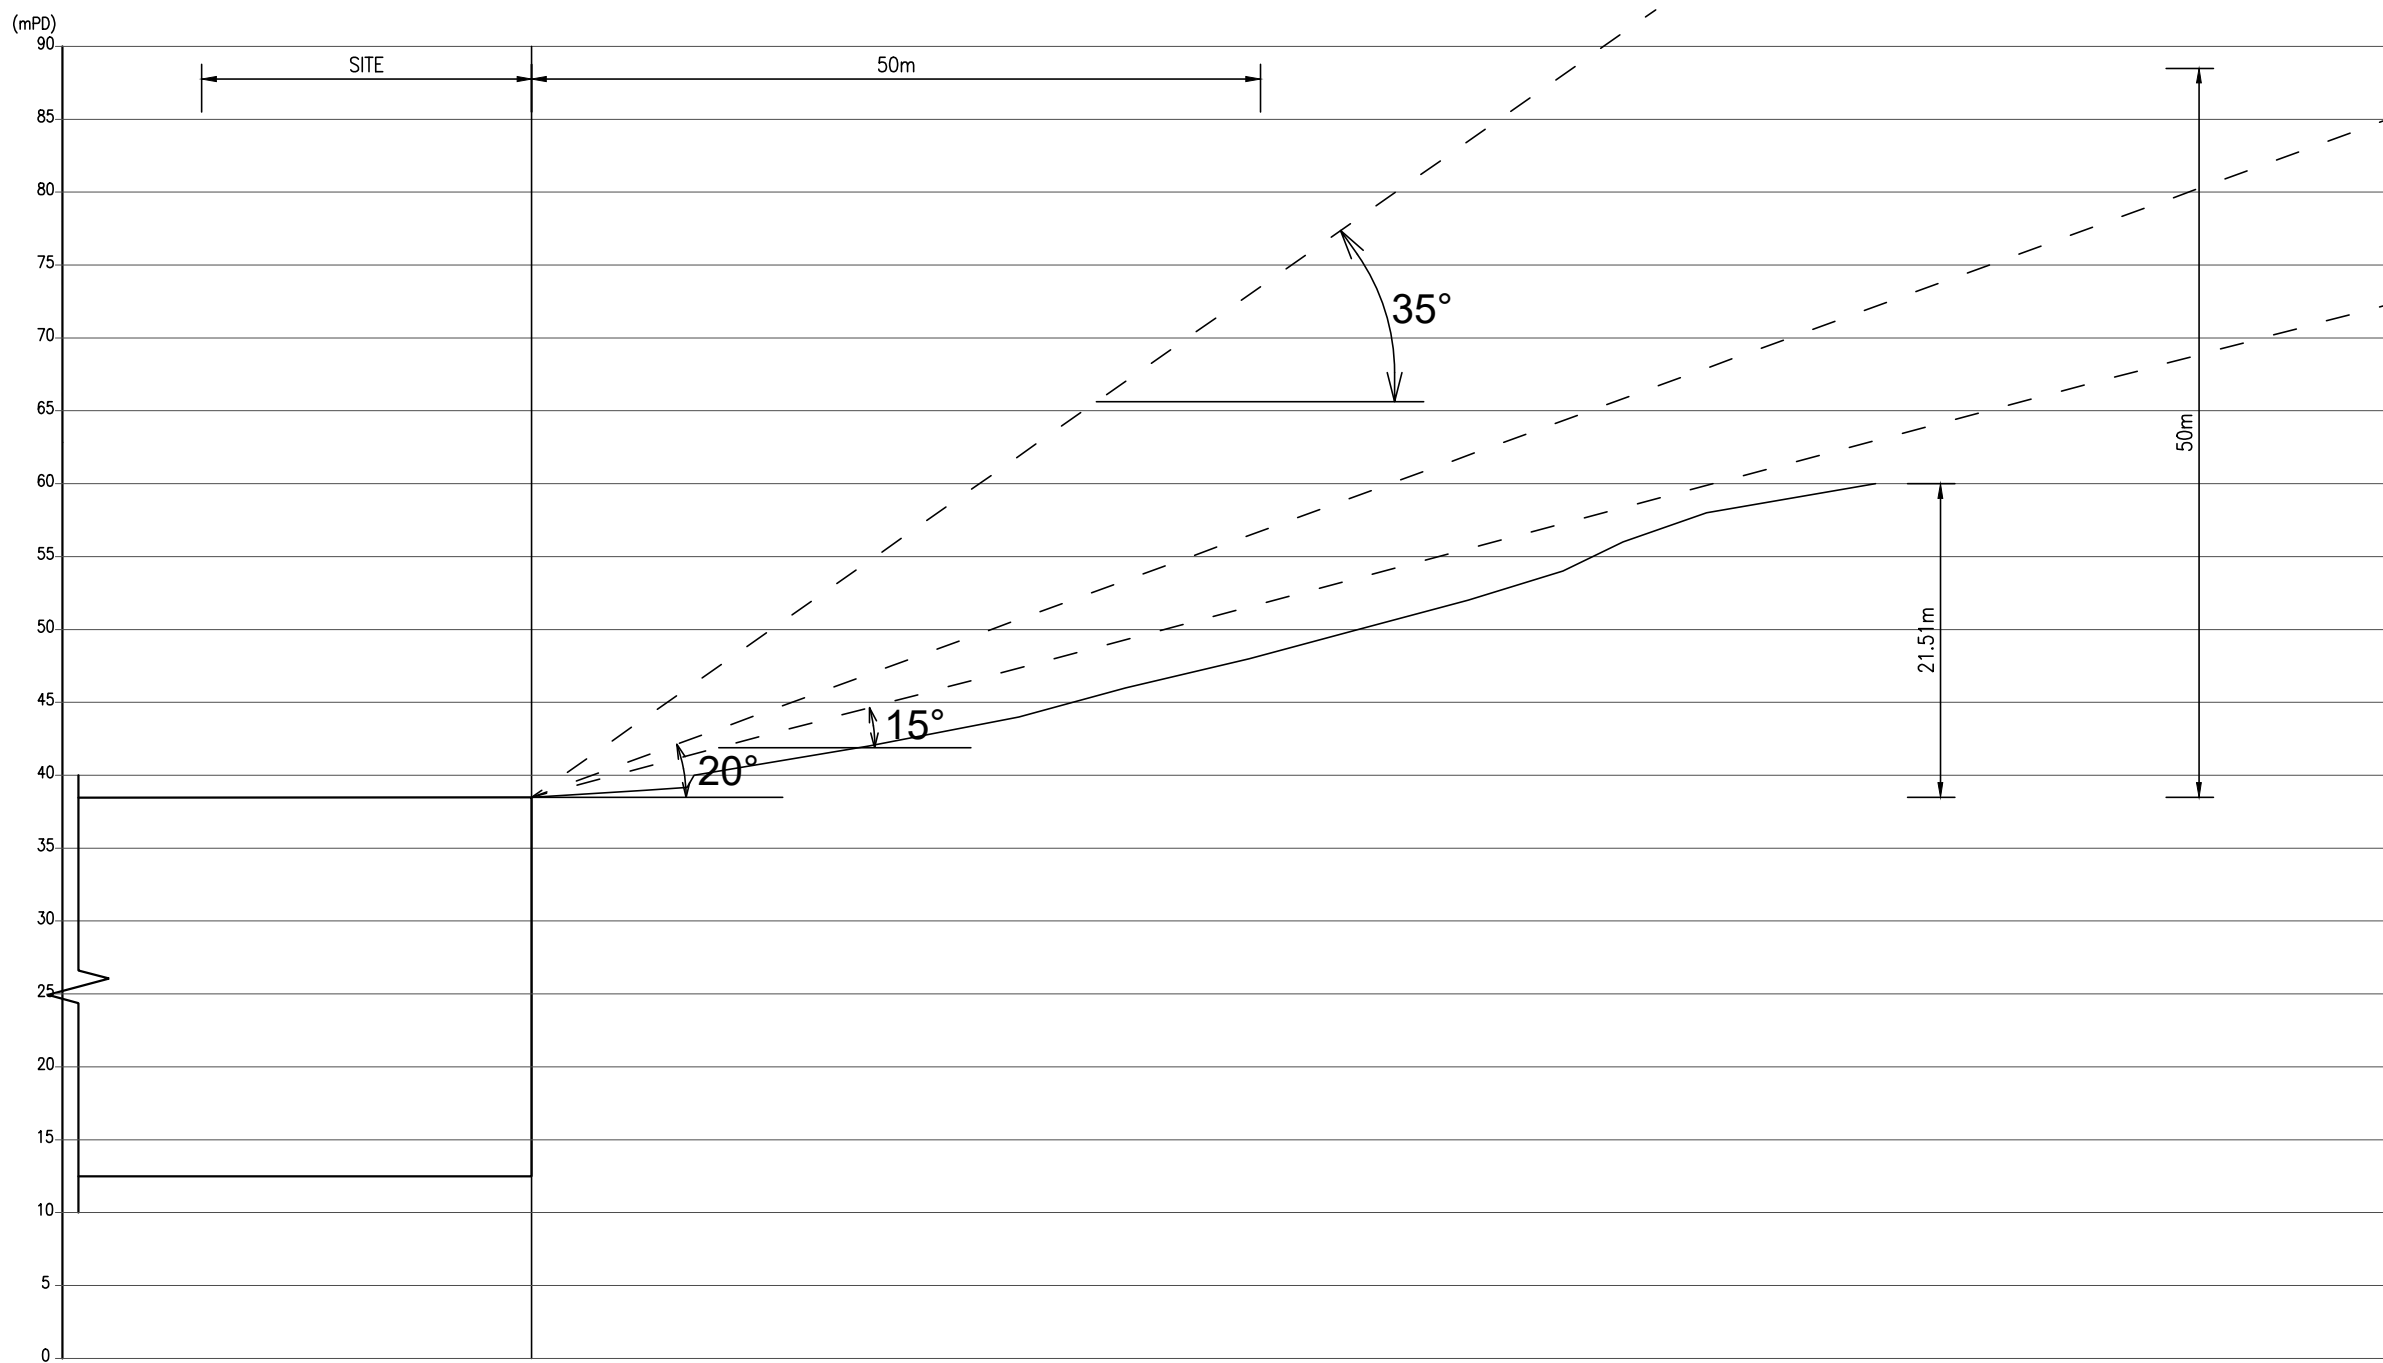
SECTION A-A

GEO REPORT NO.138 (SECOND EDITION)  
IN-PRINCIPLE OBJECTIVE CRITERIA  
SECTION 2.3.3(a)(i)  
Located within an angle of reach of 35  
Deg. from any natural terrain at an  
elevation of 50m or more above the  
proposed site formation level  
No.

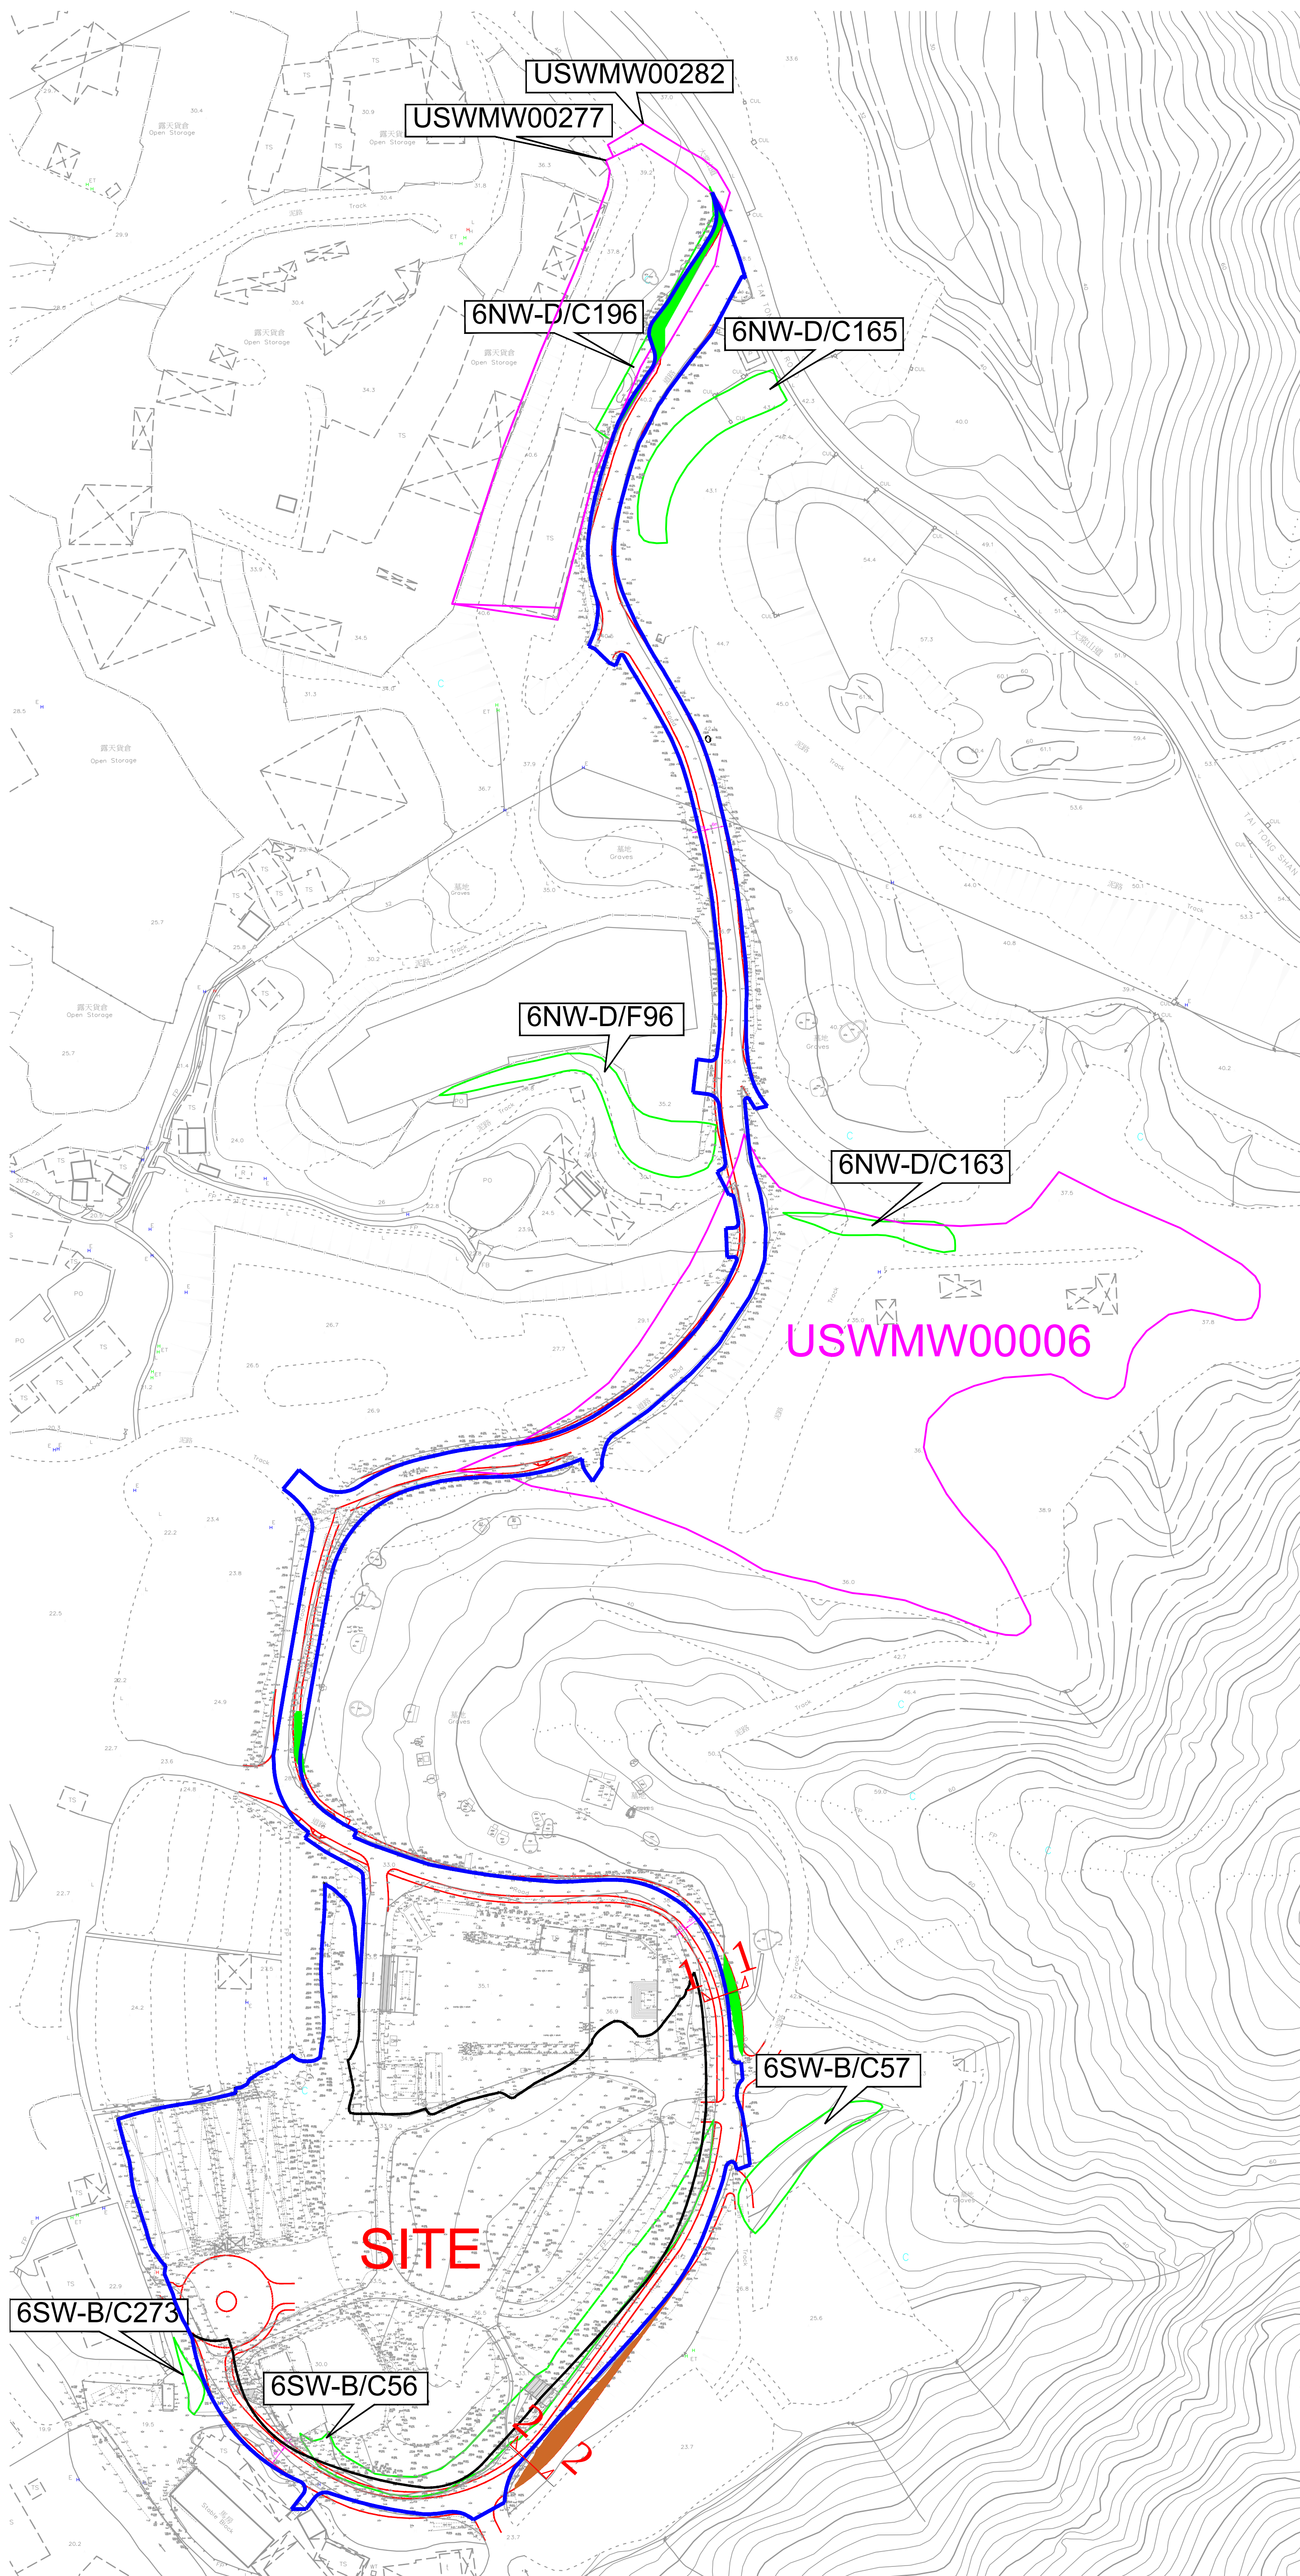
CUT SLOPE

BACKFILL SLOPE
